Ruins Stabilization in the Southwestern United States

Publications in Archeology 10

National Park Service

U. S. Department of the Interior
Washington 1974

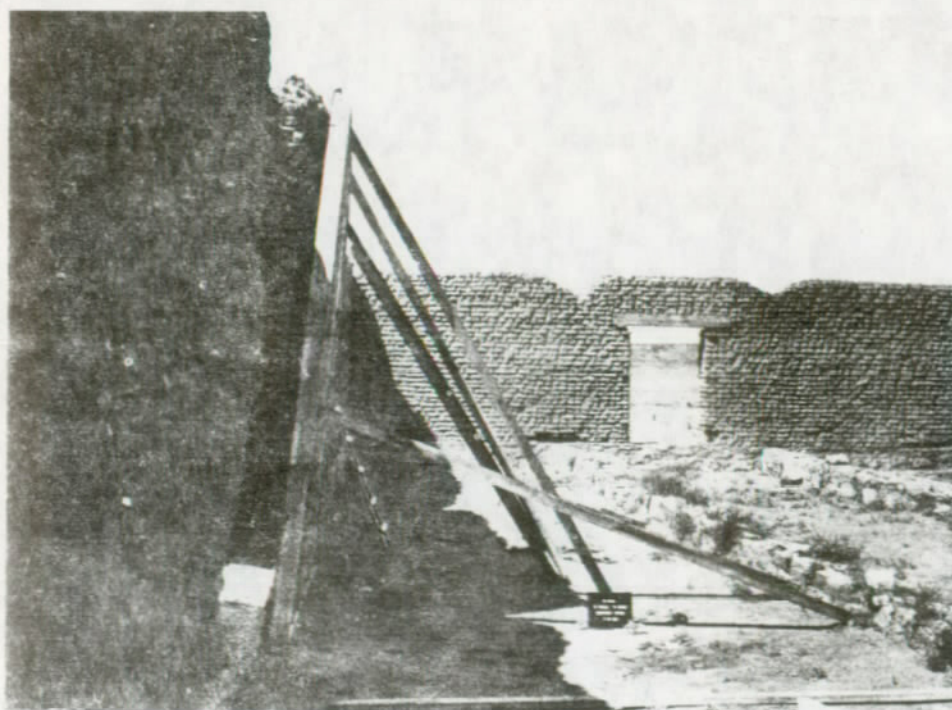
FIGURE 82. Building 3-450, Room 451, north side of south wall, before stabilization. Fort Union National Monument.

North and south walls: Capped (see introduction for detailed explanation of technique) and grouted with soil-cement. Missing adobes above windows were replaced and lintel timbers were replaced where missing. Sprayed with Dow Corning 772 diluted in water at a ratio of 1 to 9.

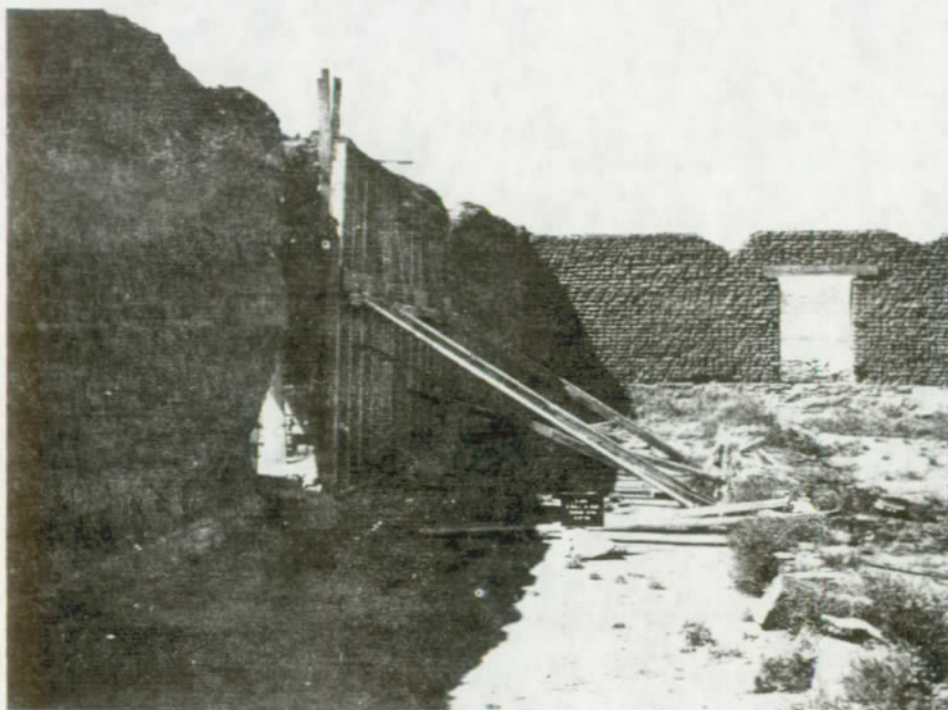
FIGURE 83. Building 3-450, Room 451, north side of south wall, during stabilization. Fort Union National Monument.

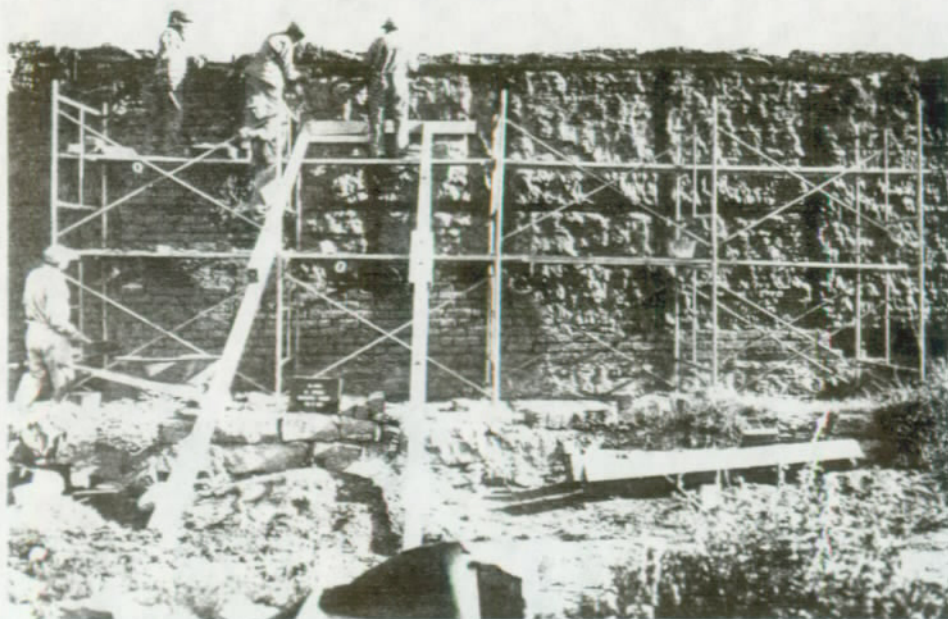
FIGURE 84. Building 3-450, Room 451, north side of south wall, during stabilization. Fort Union National Monument.

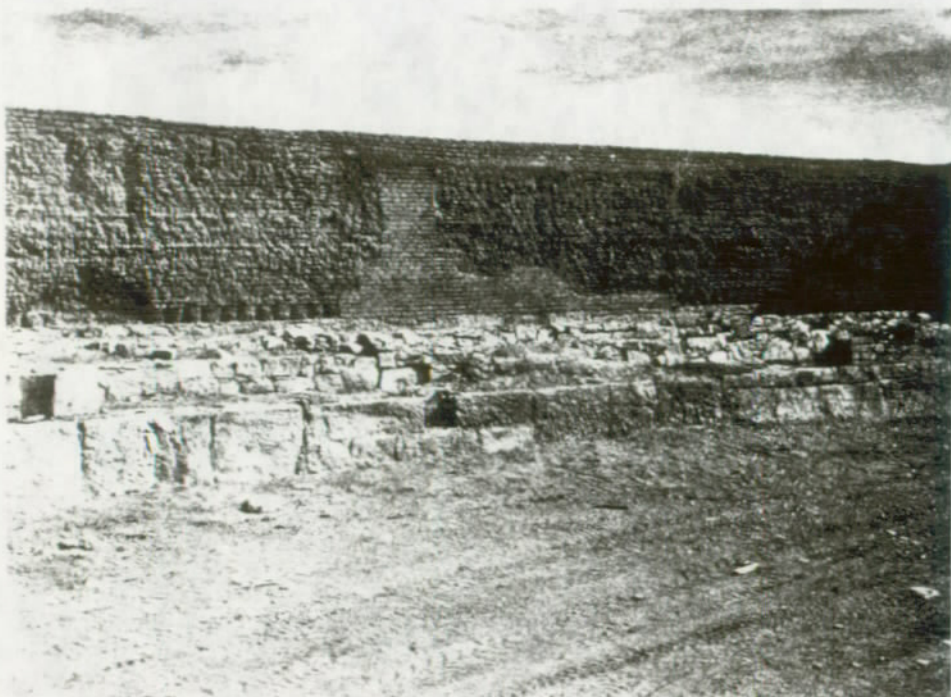
FIGURE 85. Building 3-450, Room 451, north side of south wall, after stabilization. Fort Union National Monument.

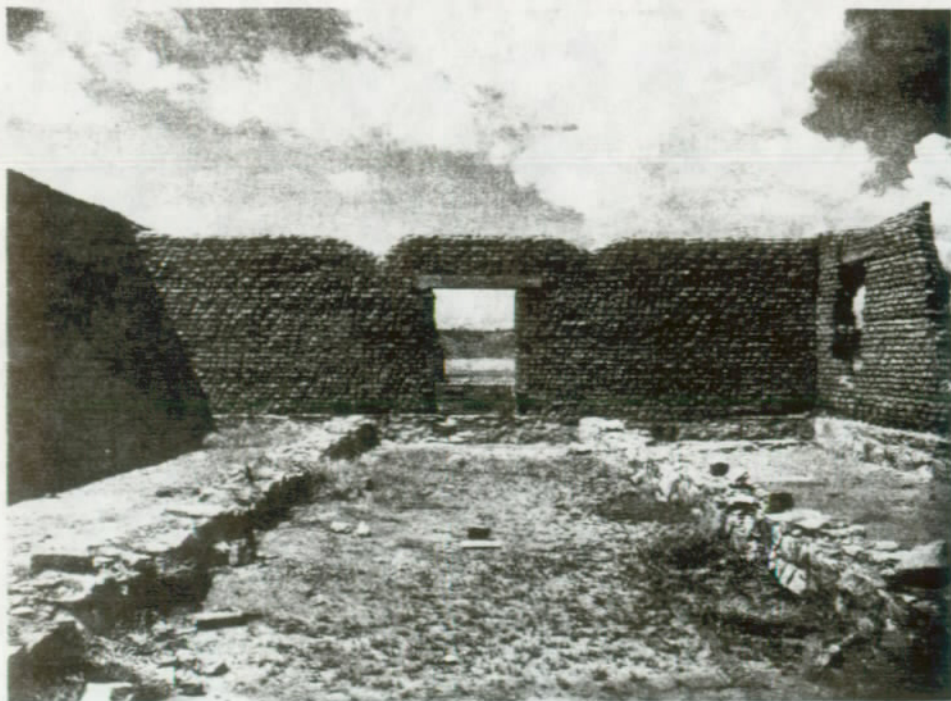
FIGURE 86. Building 3-450, Room 451, east side of west wall, before stabilization. Fort Union National Monument.

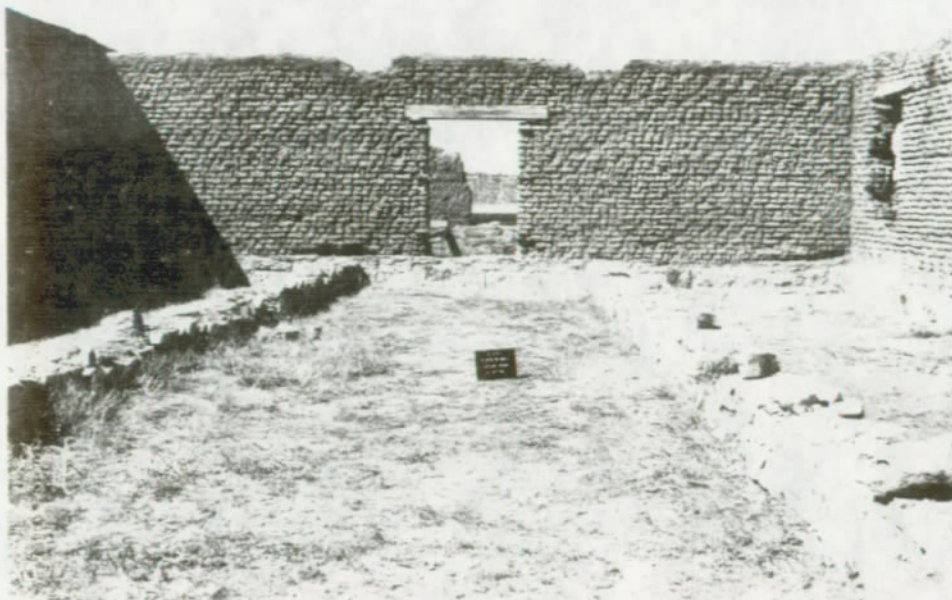
FIGURE 87. Building 3-450, Room 451, east side of west wall, after stabilization. Fort Union National Monument.

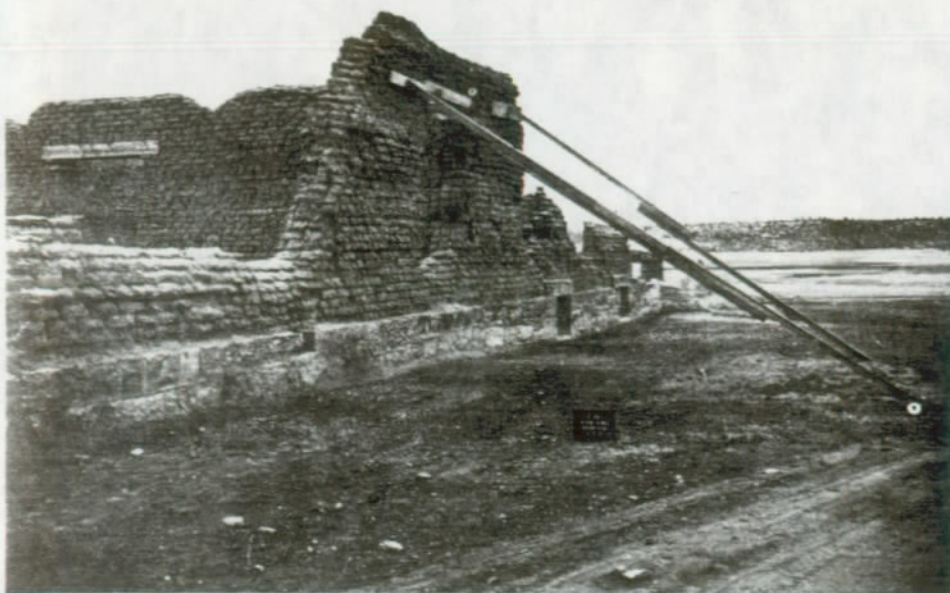
FIGURE 88. Building 3-450, Room 451, north side of north wall, before stabilization. Fort Union National Monument.

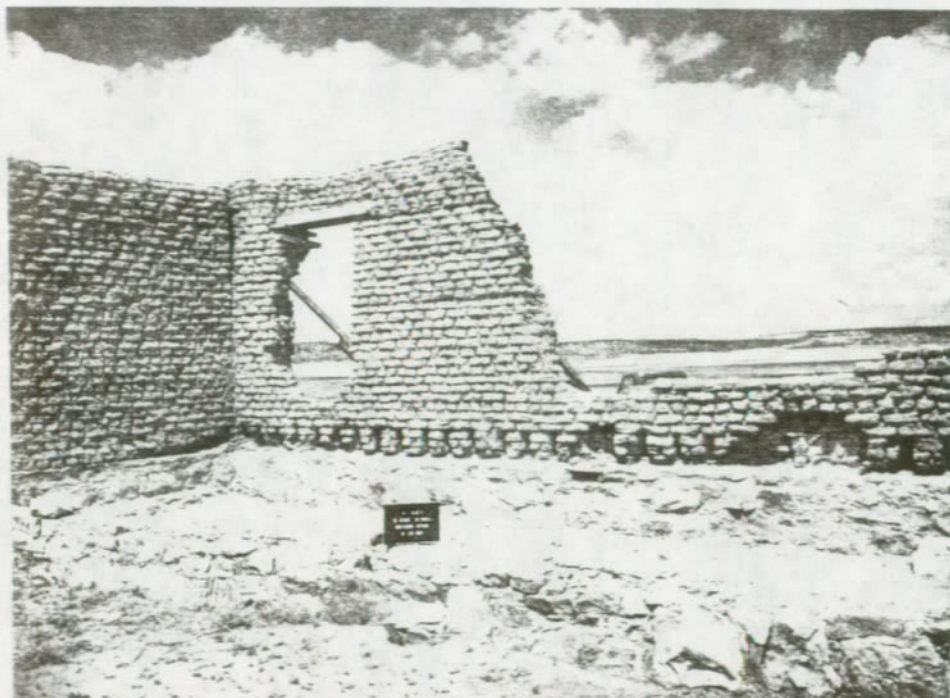
FIGURE 89. Building 3-450, Room 451, south side of north wall, before stabilization. Fort Union National Monument.

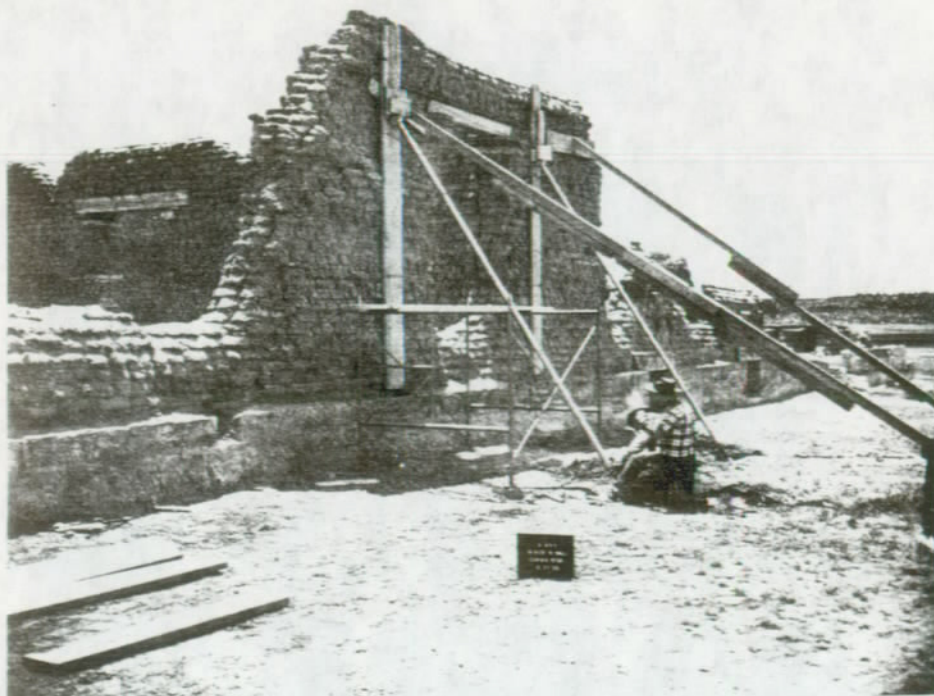
FIGURE 90. Building 3-450, Room 451, south side of north wall, during stabilization. Fort Union National Monument.

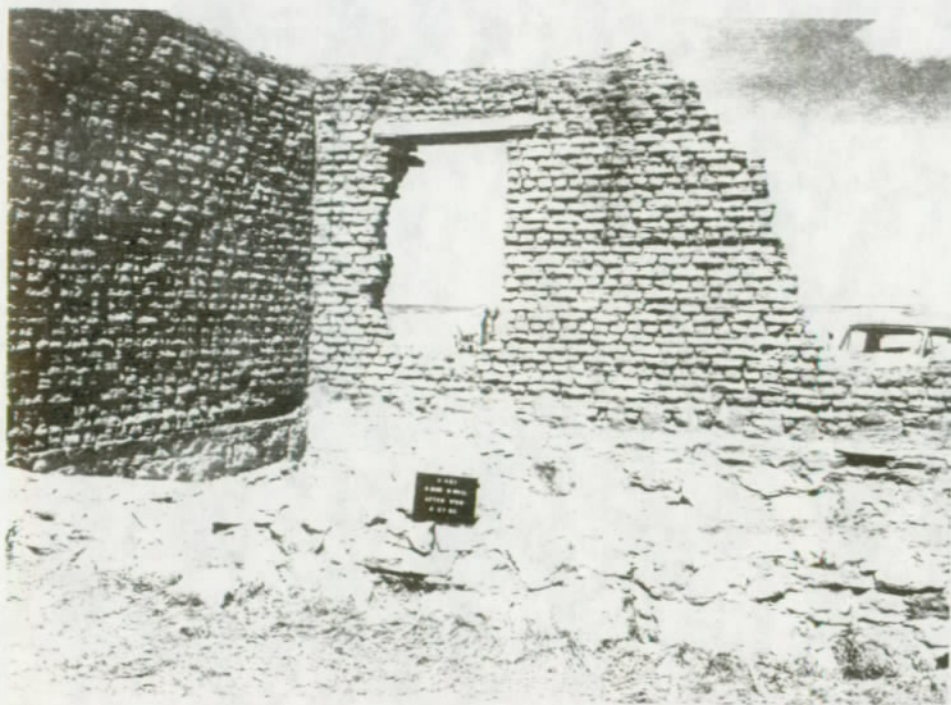
FIGURE 91. Building 3-450, Room 451, south side of north wall, after stabilization. Fort Union National Monument.

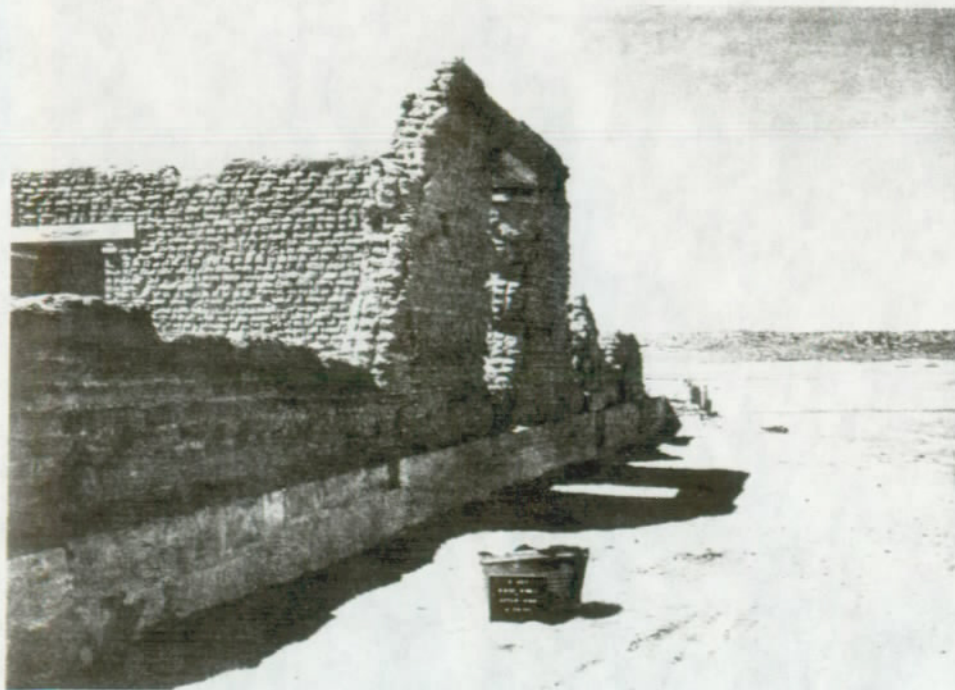
FIGURE 92. Building 3-450, Room 451, north side of north wall, after stabilization. Fort Union National Monument.

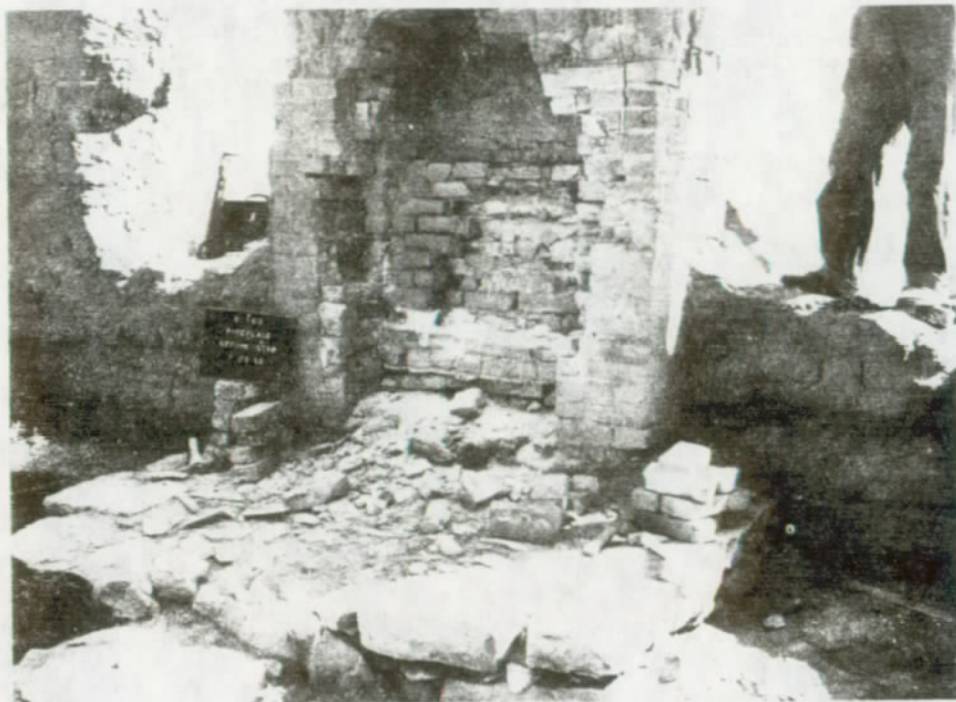
Details (notes on doorways, lintels, etc.): *Chimney and fire-place in east wall. North wall is south wall of rooms 161 and 162. Fireplace badly weakened by missing bricks. Loose bricks in chimney remnant. Brick hearth missing.*

FIGURE 93. Building 6-160, Room 163, fireplace in east wall, before stabilization. Fort Union National Monument.

Materials, construction, and technique in making repairs or accomplishing job: *East wall: Missing foundation stones replaced in fireplace, brick hearth rebuilt with historic brick, missing fireplace brick reset in soil-cement mortar. Missing adobes were replaced in the north, east, and south sides of the flue. The small chimney remnant stabilized by resetting loose bricks in soil-cement mortar and replacing several missing bricks.*

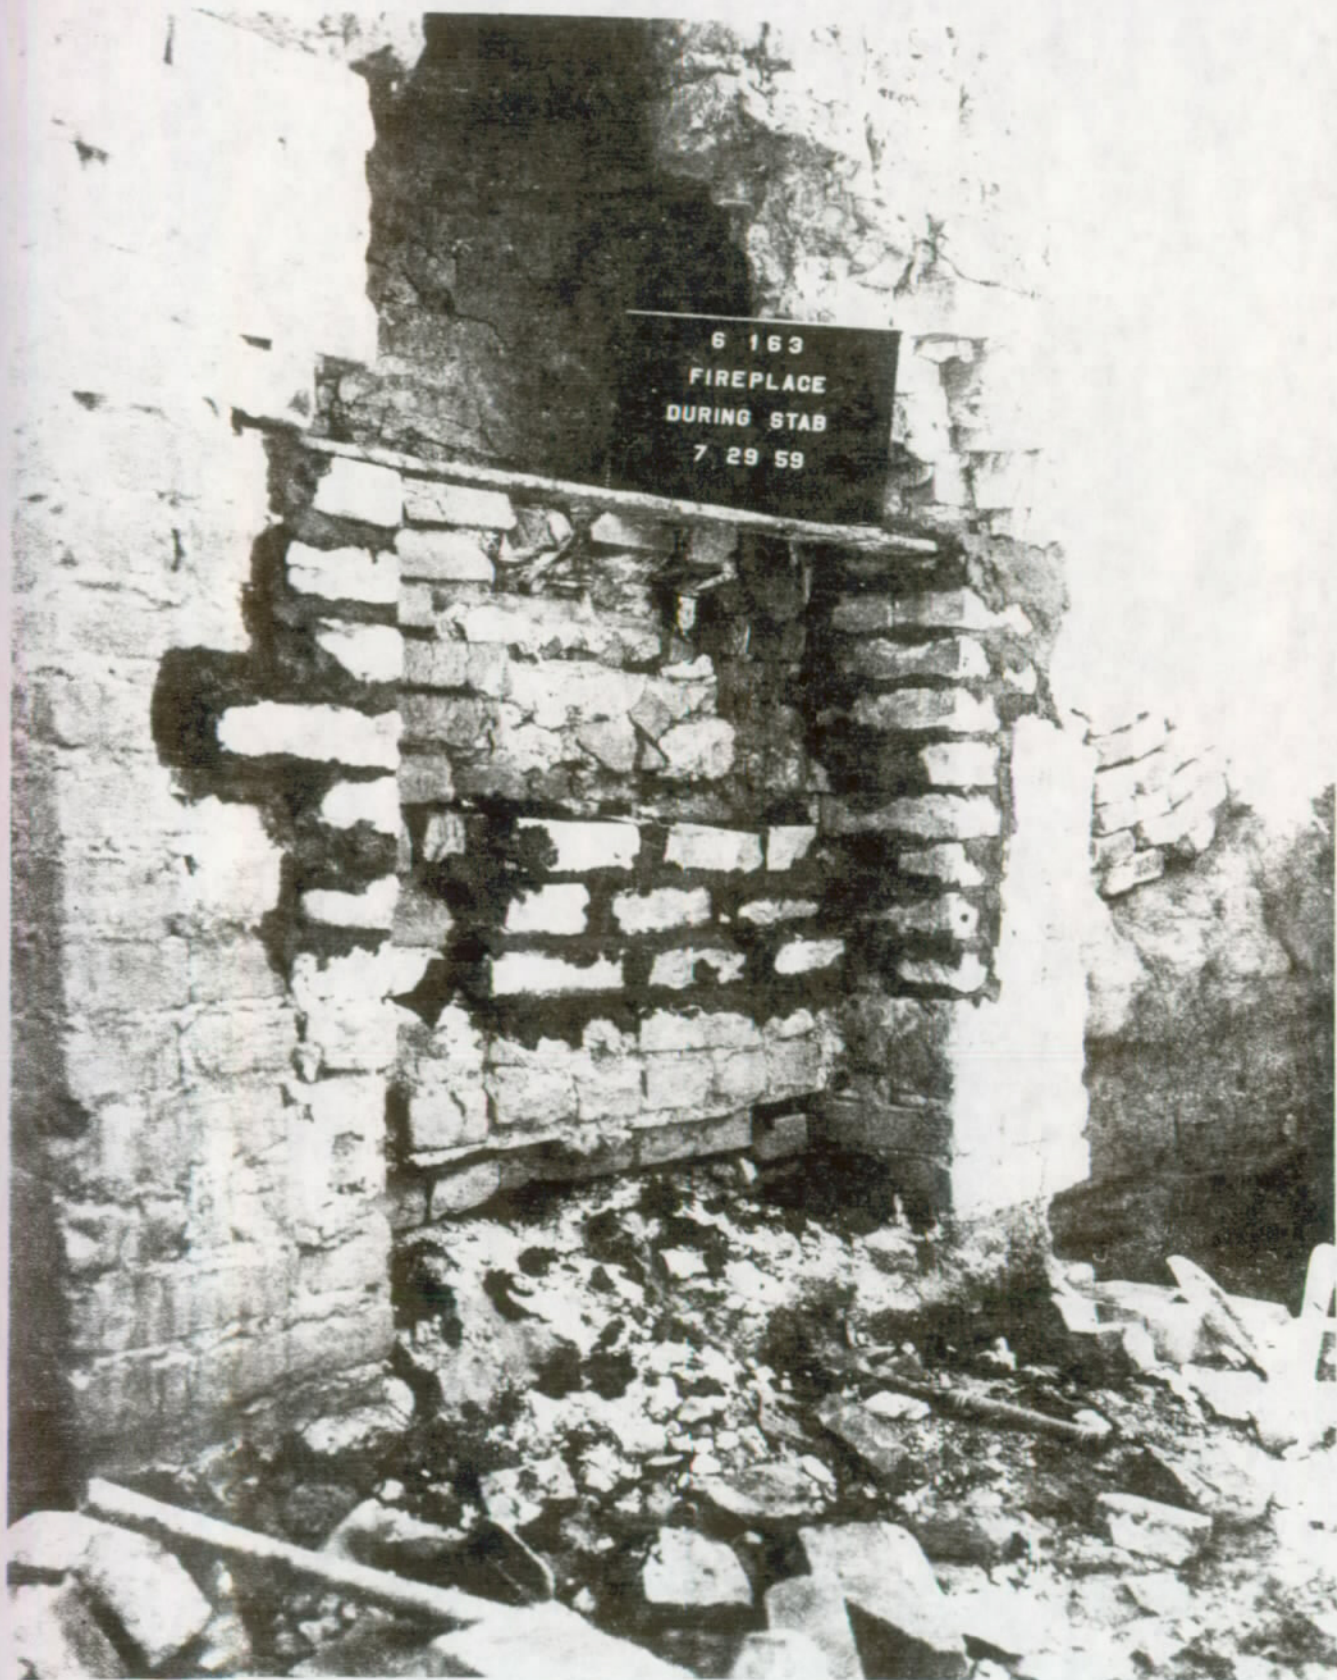
FIGURE 94. Building 6-160. Room 163. fireplace in east wall, during stabilization. Historic bricks are being reset in soil-cement mortar. Fort Union National Monument.

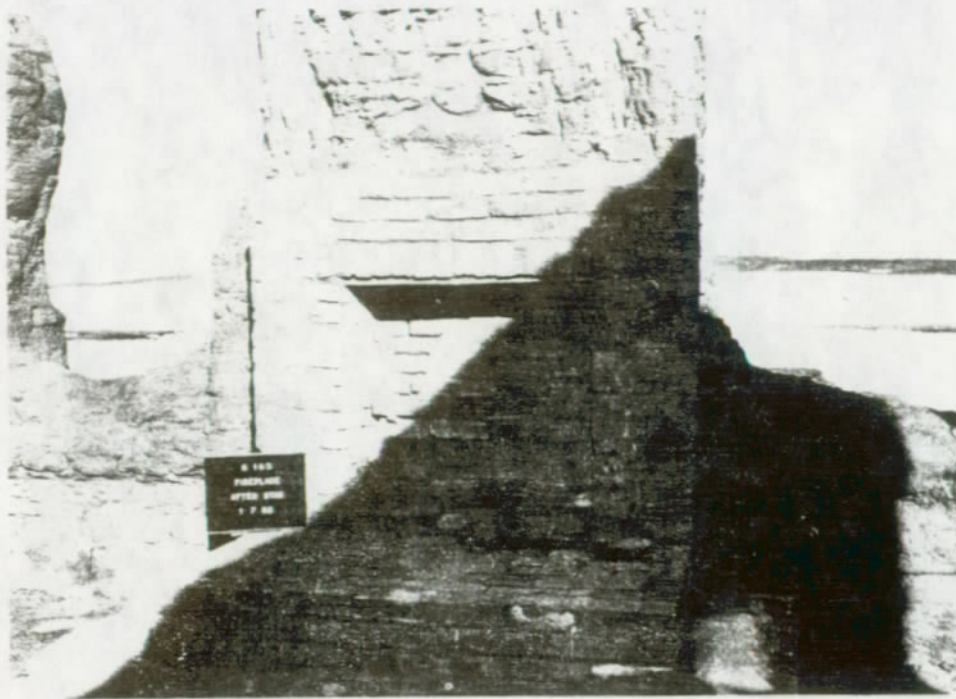
FIGURE 95. Building 6-160, Room 163, fireplace in east wall, after stabilization. Soil-cement mortar used to reset bricks was brushed to prevent shine. Fort Union National Monument.

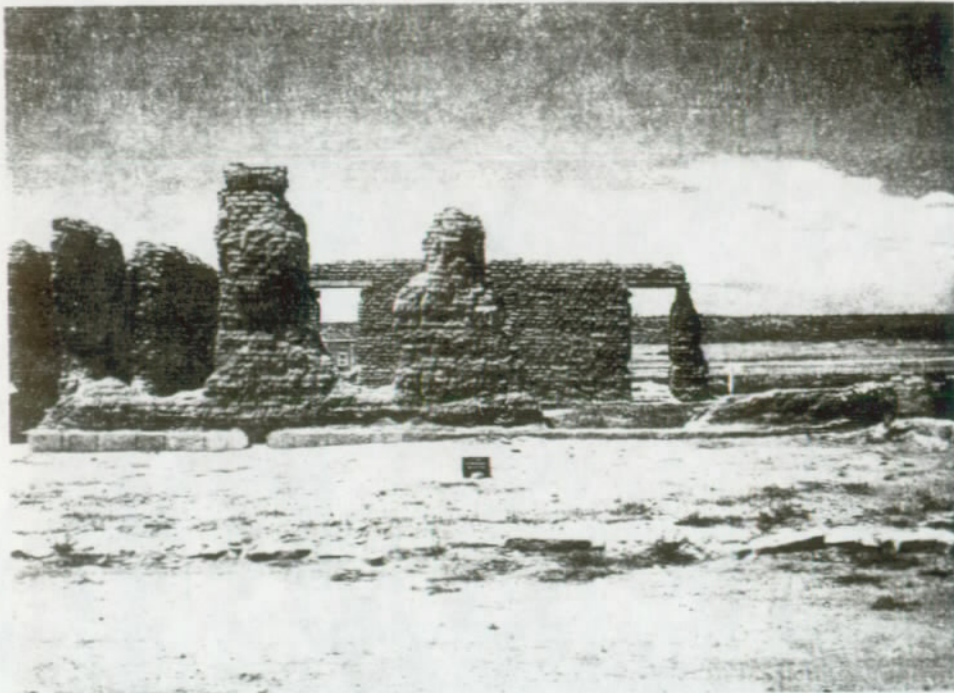
Condition on date work started. Masonry: *Nearly all of east wall missing except for flue. Many adobes missing from all sides of adobe flue. North wall in good condition. Lintels missing from window in south wall. West wall in good condition.*

FIGURE 96. Building 6-160, east side of east wall, before stabilization. Fort Union National Monument.

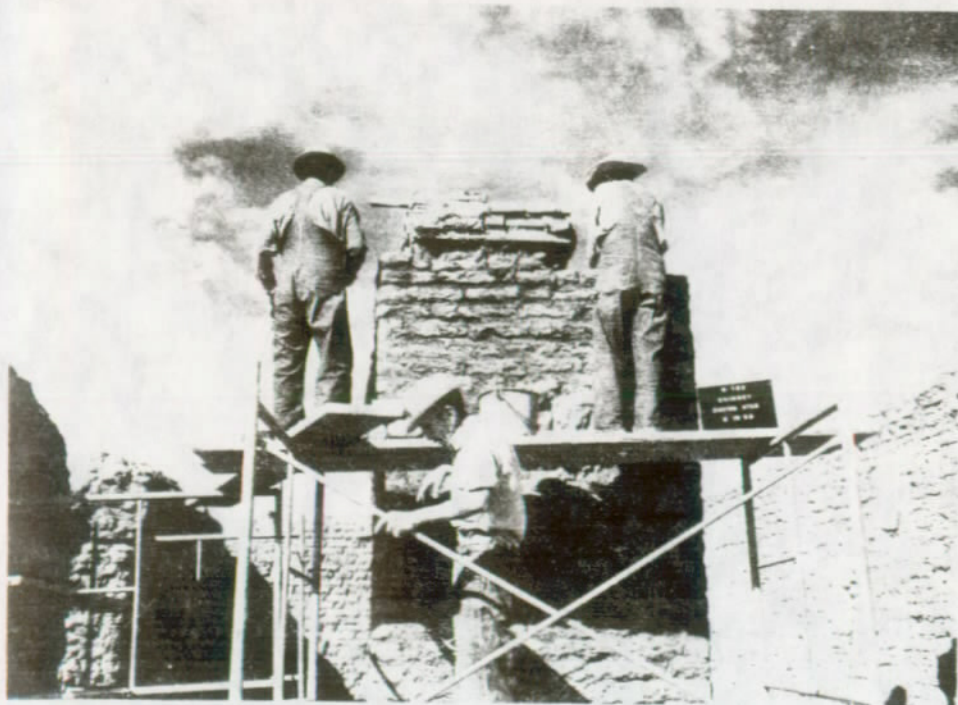
FIGURE 98. Building 6-160, Room 163, flue and chimney in east wall, during stabilization. Fort Union National Monument.

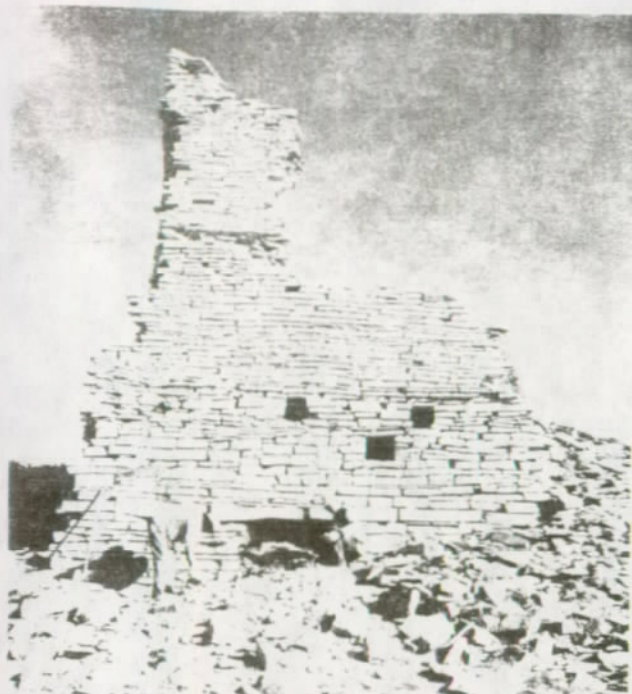
FIGURE 100. Close-up of north wall, Tower Kiva.

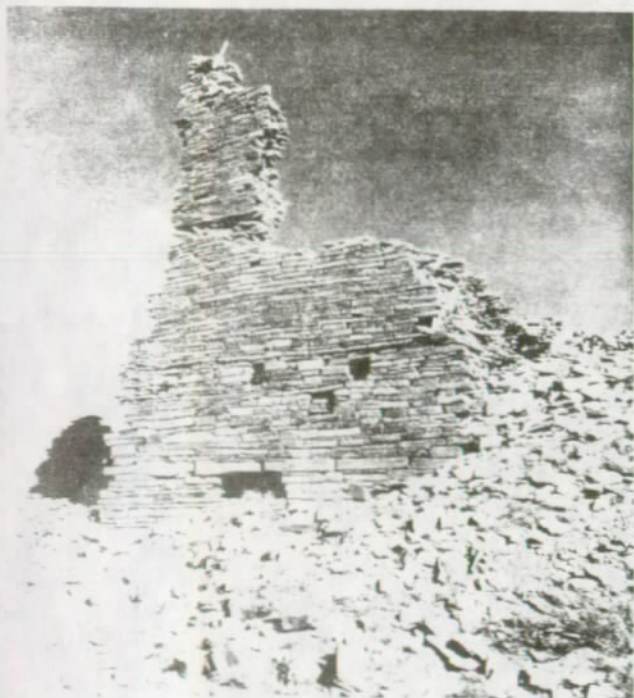
FIGURE 101. Tower Kiva, north wall exterior. Note large hole at base, and eroded insets (arrows) where second, third and fourth stories were slightly stepped back.

Considering its spectacular height, the wall is in good condition, but must be strengthened by repairing, reinforcing and capping to preserve its present condition.

Materials, construction, etc.: The Tower Kiva, north wall exterior. The high, sloping east and west wall stubs were capped, extending the east stub slightly eastward to provide a short but strong buttress section. Two integral members were placed in the west stub where it rises vertically, beginning at the second story level, the members extending to those rising from the east wall. The second and third story ledges or insets were repaired. The several openings including the two square beam holes, and the ventilator beneath them, and the beam holes at the east side were all repaired. The large hole at the base of the wall was filled with repair masonry in cement, the rough interior core being set in cement and the face stones laid in matching tinted cement. Following the above work, the entire wall face was grouted, pointed, and respalled. It was necessary to reset a few loose stones here and there in the facing.

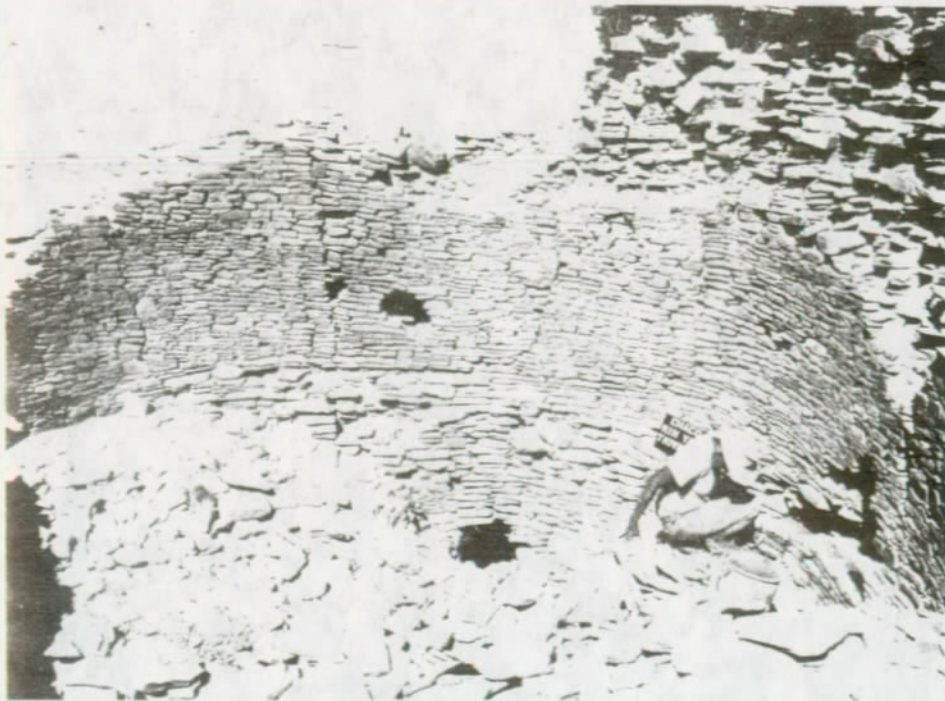
FIGURE 104. Another view showing general condition of lower part of interior.

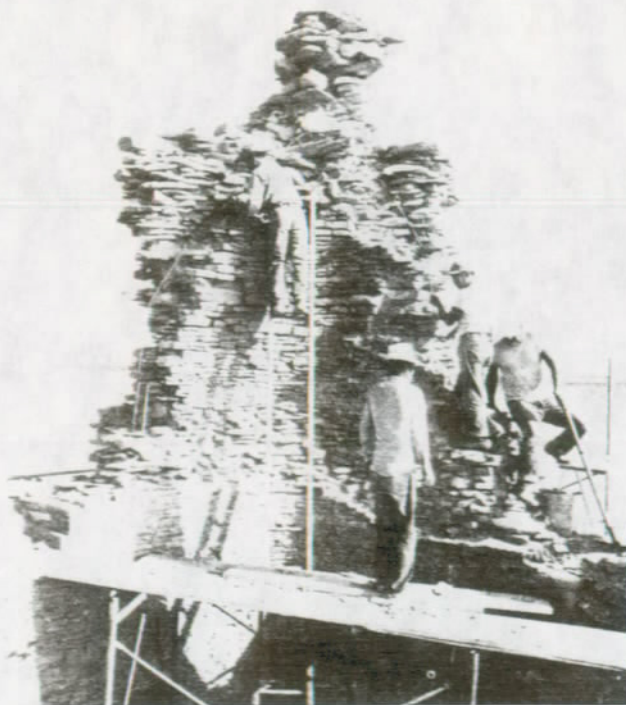
FIGURE 107. Tower Kiva, interior northeast corner, during installation of integral members to strengthen the highest wall section.

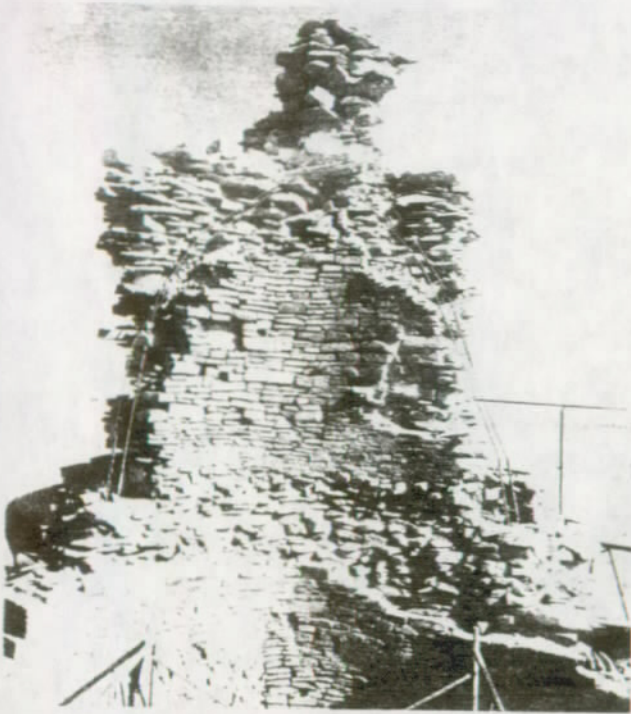
FIGURE 108. Upper portion of Tower Kiva, northeast corner interior, after the integral members were anchored in masonry.

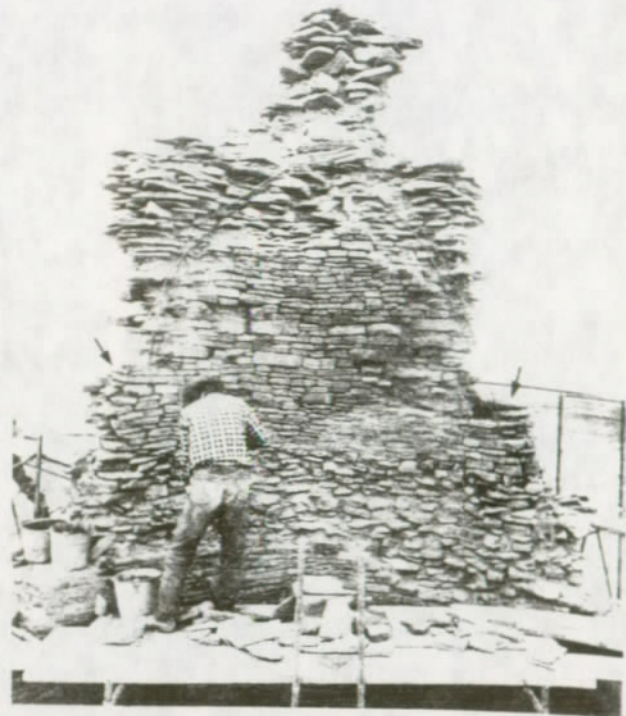
FIGURE 109. Beginning the vertical, reinforced capping (arrows).

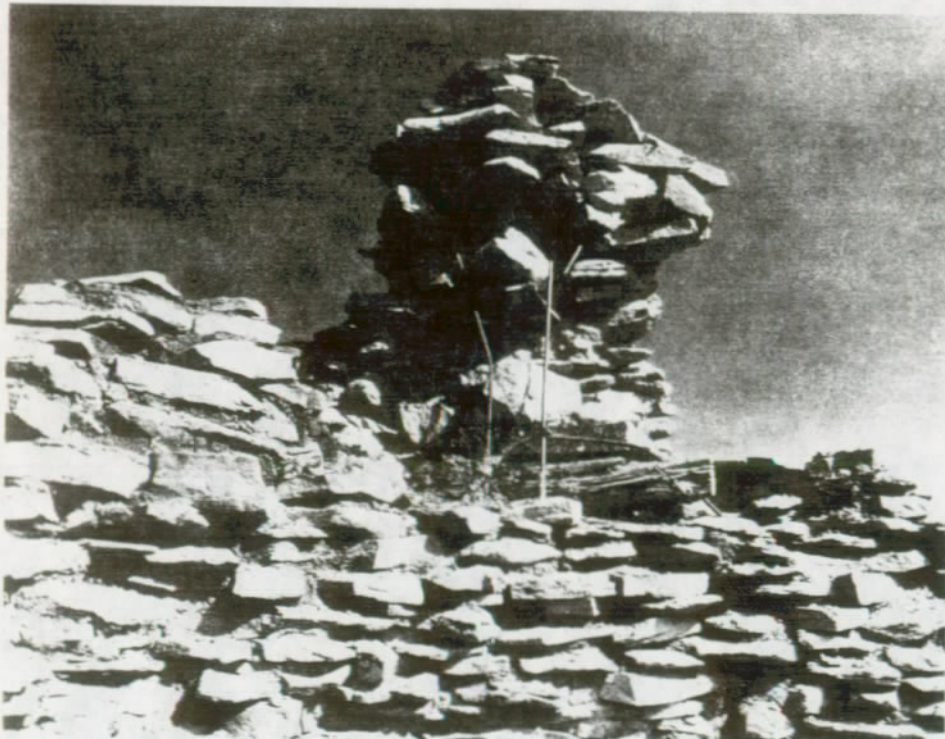
FIGURE 110. Integral members in the form of a T were installed in this top fragment of core masonry after the lower wall section had been strengthened to that point.

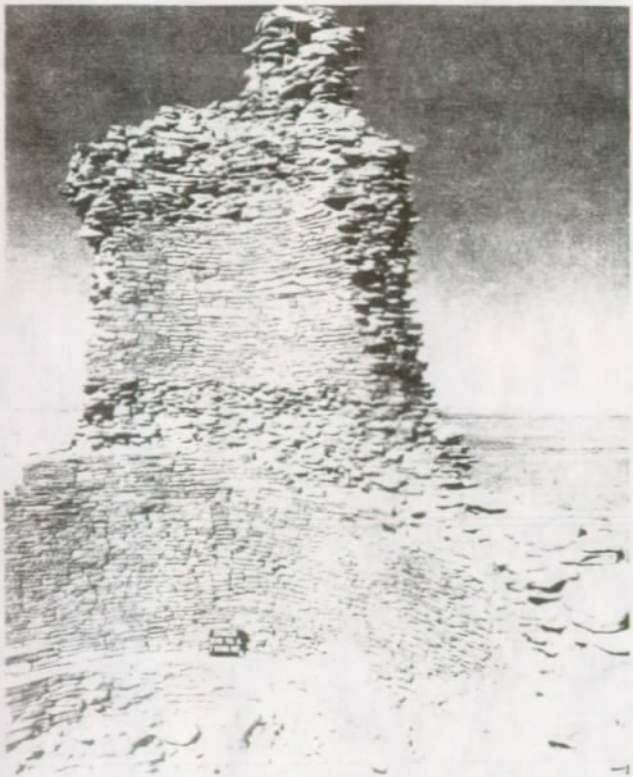
FIGURE 111 The wall at completion of stabilization. The wall is considerably strengthened and tightened, without a serious or objectionable alteration of the original profile.

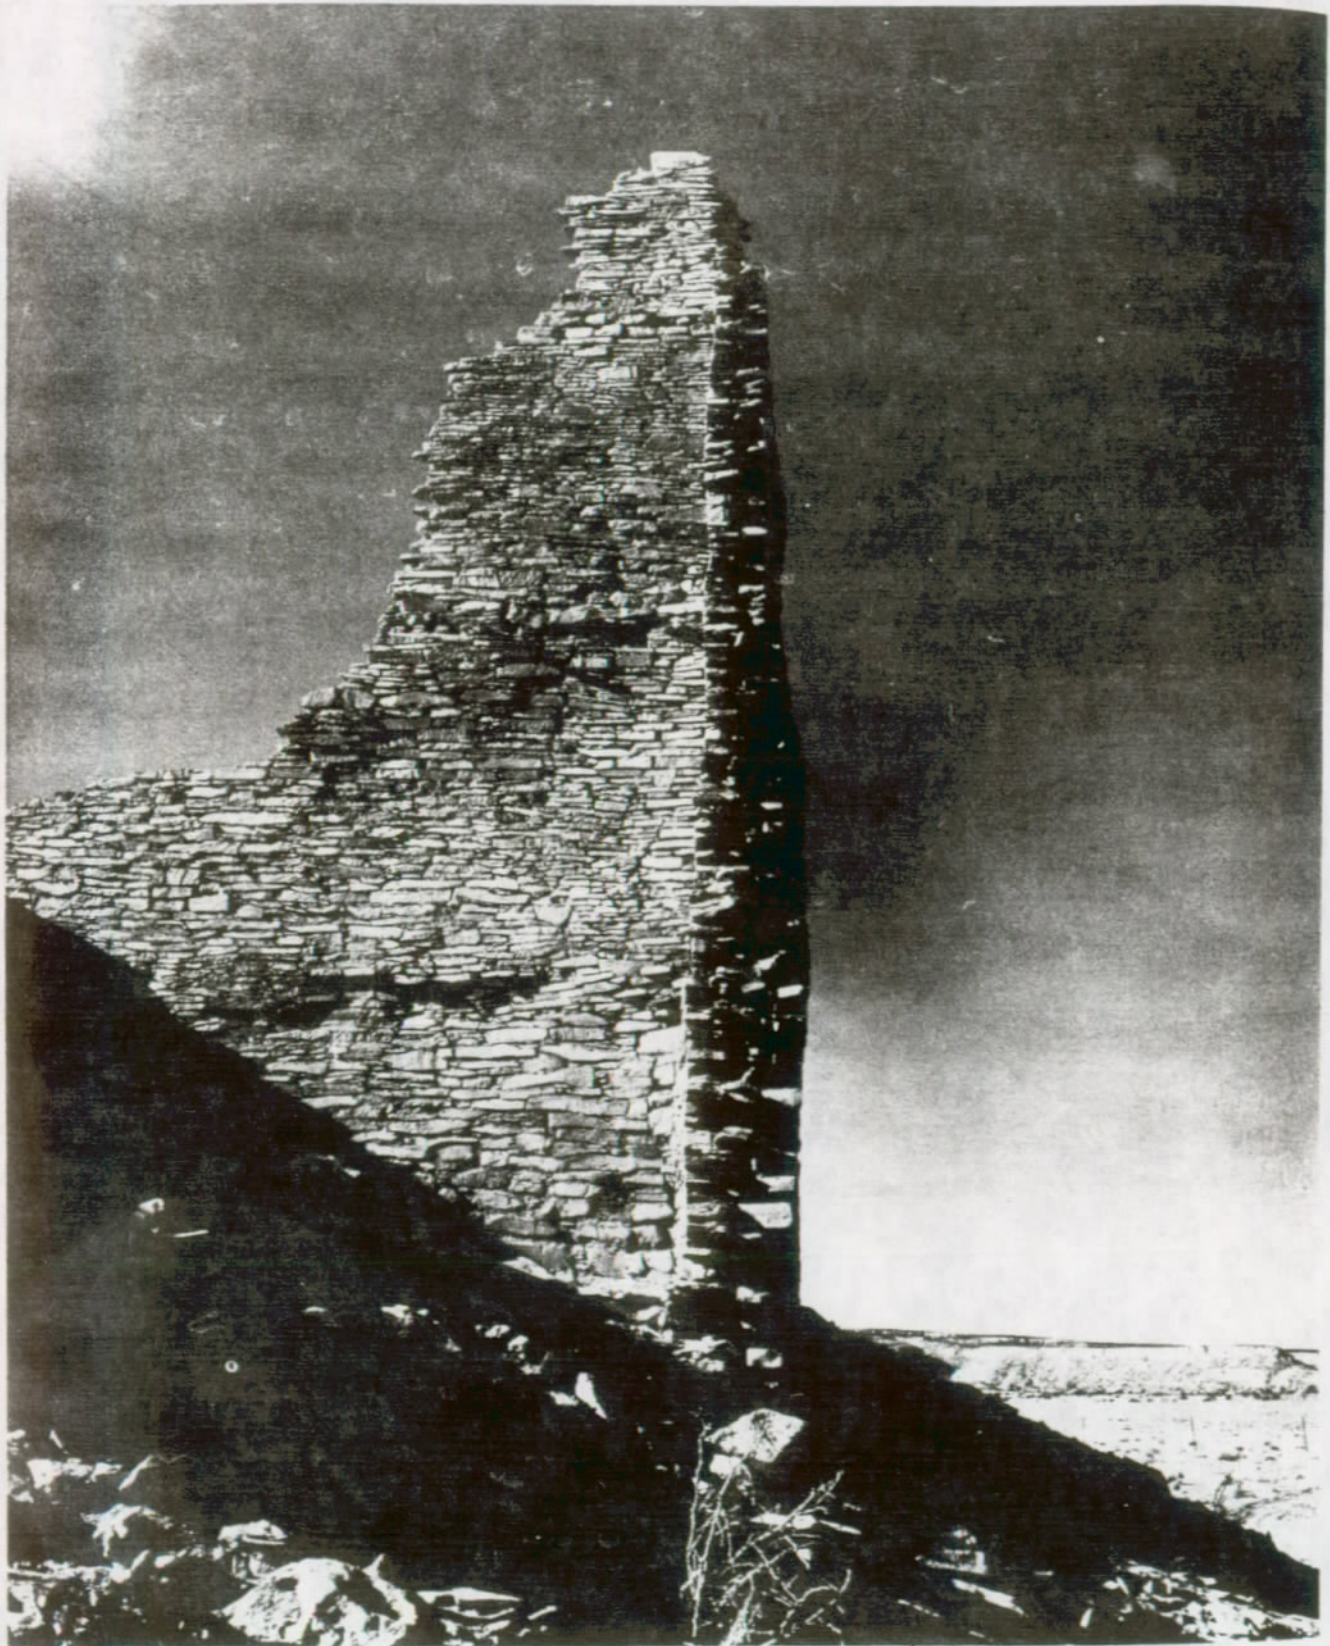
FIGURE 113. View of Tower Kiva showing vertical cap.

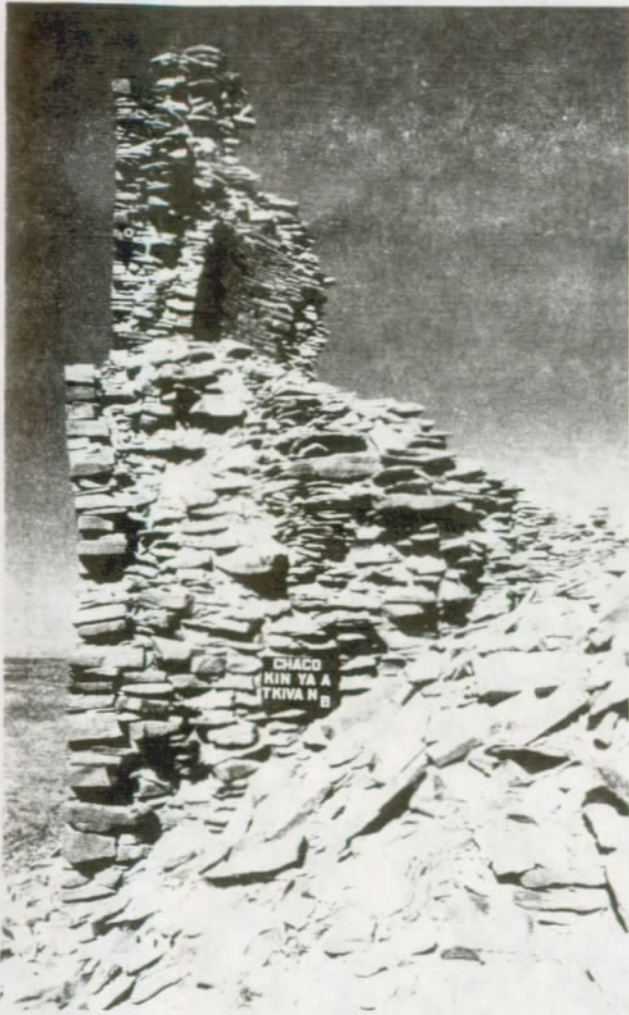
FIGURE 115. Tower Kiva, northwest corner.

Condition, description: The Tower Kiva, west wall. The straight wall here encloses the west portion of the circular kiva. The kiva corners enclosed are exposed to a height of 6' above present fill line. Exterior wall facing is either missing or pretty well covered by fill. A 4' thick section of rough core is exposed at the northwest corner. At the center of the west wall and level with fill both inside and outside the room, is a large U-

shaped opening probably caused by breakdown to timbers embedded in this wall which provided support for the ceiling in the room to the west. The wall core at this U-shaped opening is thin, loose, and porous and is deteriorating rapidly. Visitors who climb to the Tower Kiva enter the circular chamber at this point. Note: visitation to this little known area may be infrequent but there were three or four visitor groups at the ruins during our project within a period of one month.

Materials, construction, etc.: The Tower Kiva, west wall. Both northwest and southwest kiva corners were cleared of surface debris, and capped. The northwest outside corner was excavated until good foundation was encountered, and then the exterior facing was reset to a depth of 18 to 20 courses at the north end, and to a depth of 4 to 5 courses at the south end. The exposed core and veneer around the U-shaped opening in the central section was reset (fig. 115-117).

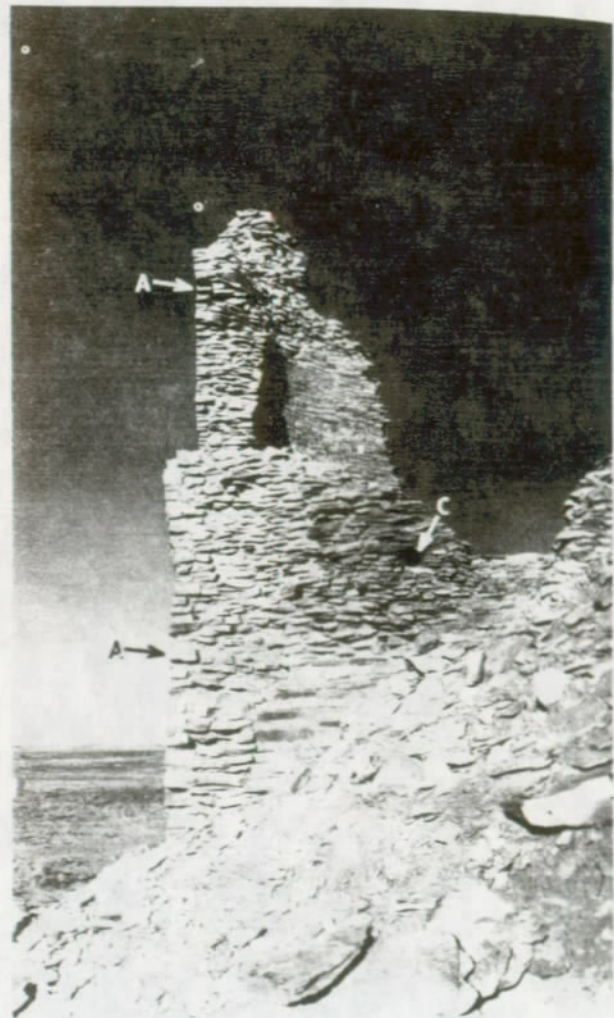
FIGURE 116. North wall stub capped (arrows A), lower portion of west wall facing reset (B), and exposed portion of thick core grouted (C).

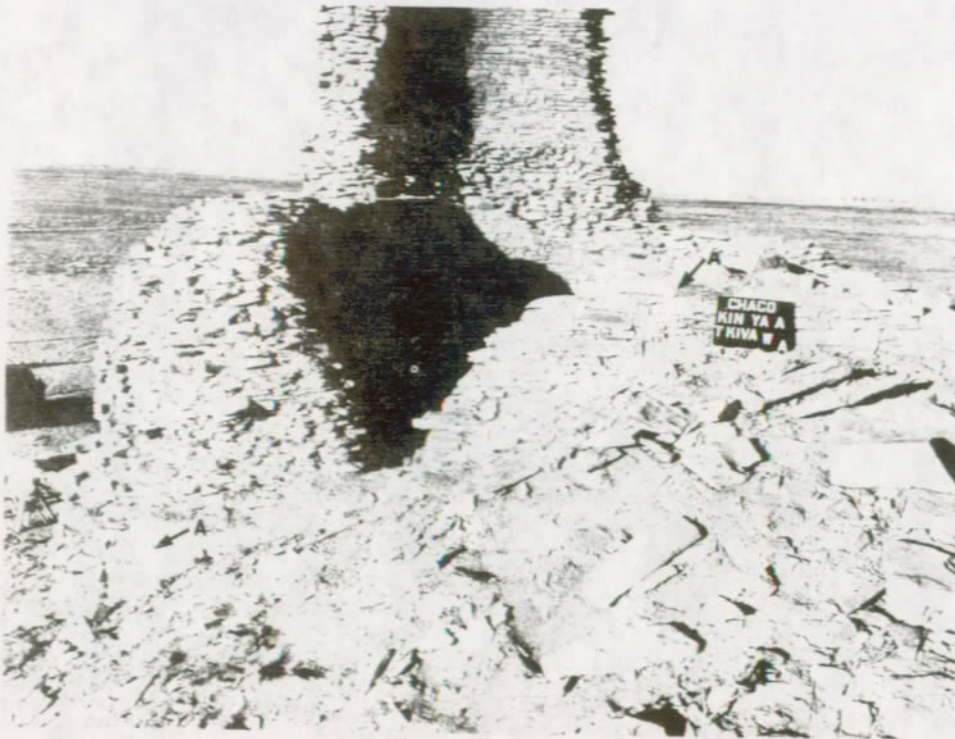
FIGURE 117. Tower Kiva, west wall. This fragmentary section of the square tower enclosing a round one was repaired by resetting the facing (arrow A), capping and grouting the thick core (B).
