Ruins Stabilization in the Southwestern United States

Publications in Archeology 10

National Park Service

U. S. Department of the Interior
Washington 1974

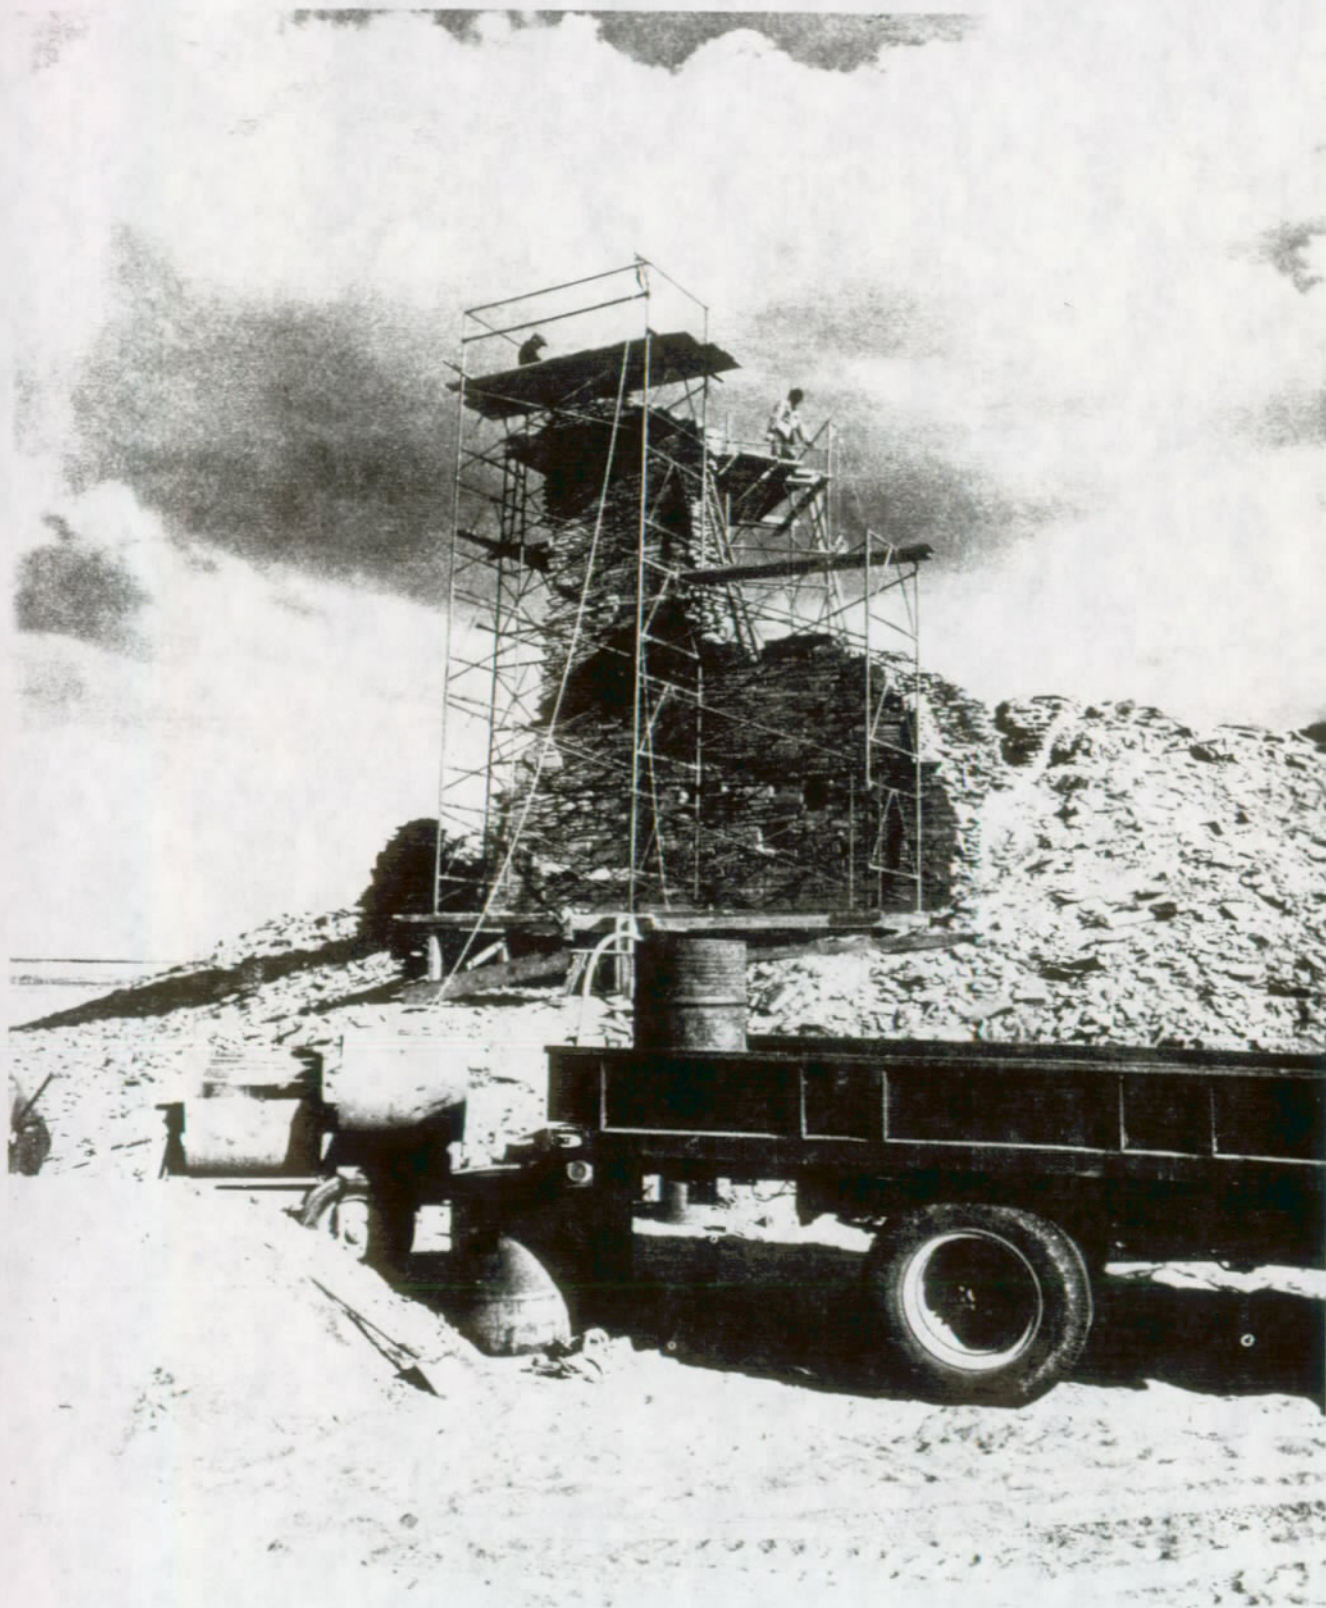
FIGURE 118. Work on the highest portion of the tower. The scaffolding completely surrounded the structure. To provide maximum safety for the workmen, the three sets of scaffolding were anchored at the bases and across the top and through midsections.

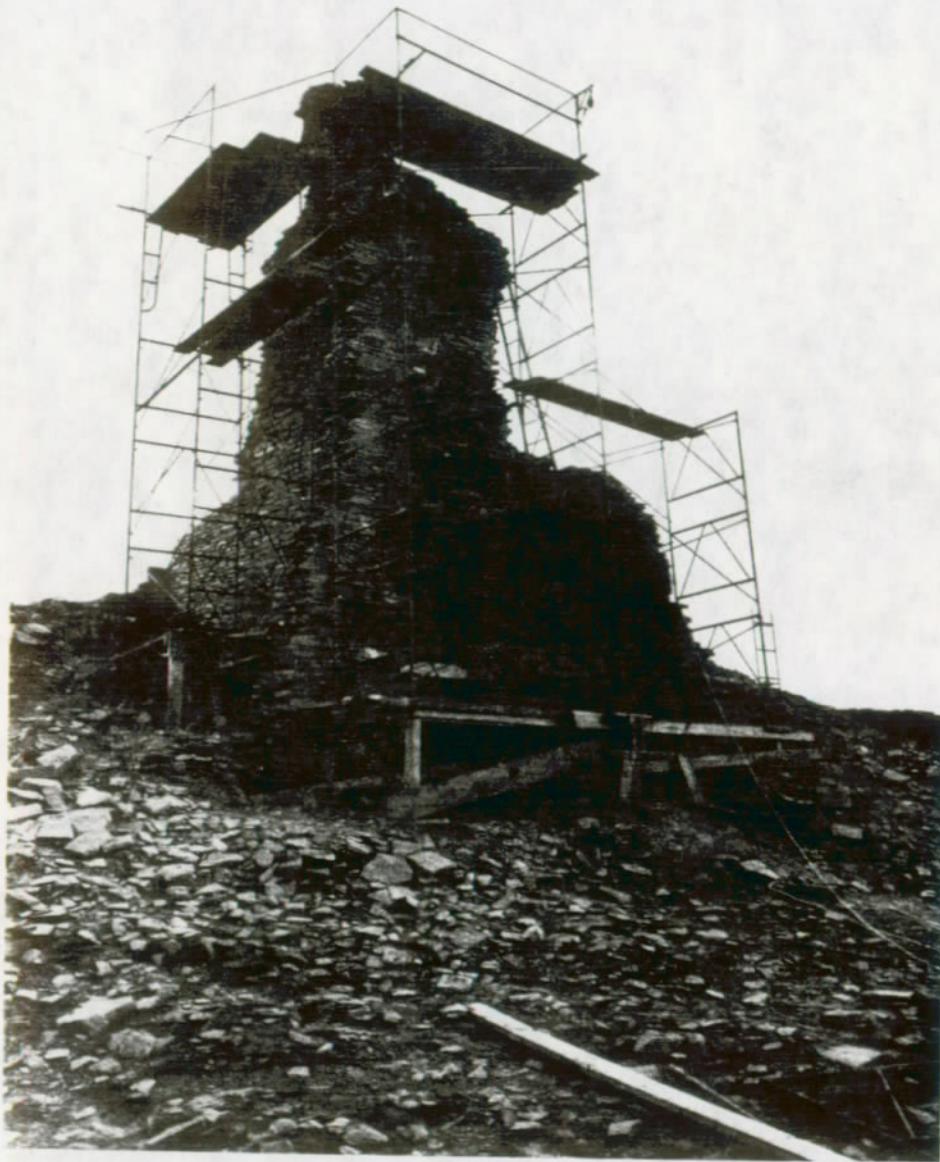
FIGURE 119. Tower Kiva. Scaffolding was anchored on firm and level bases built of heavy timbers.

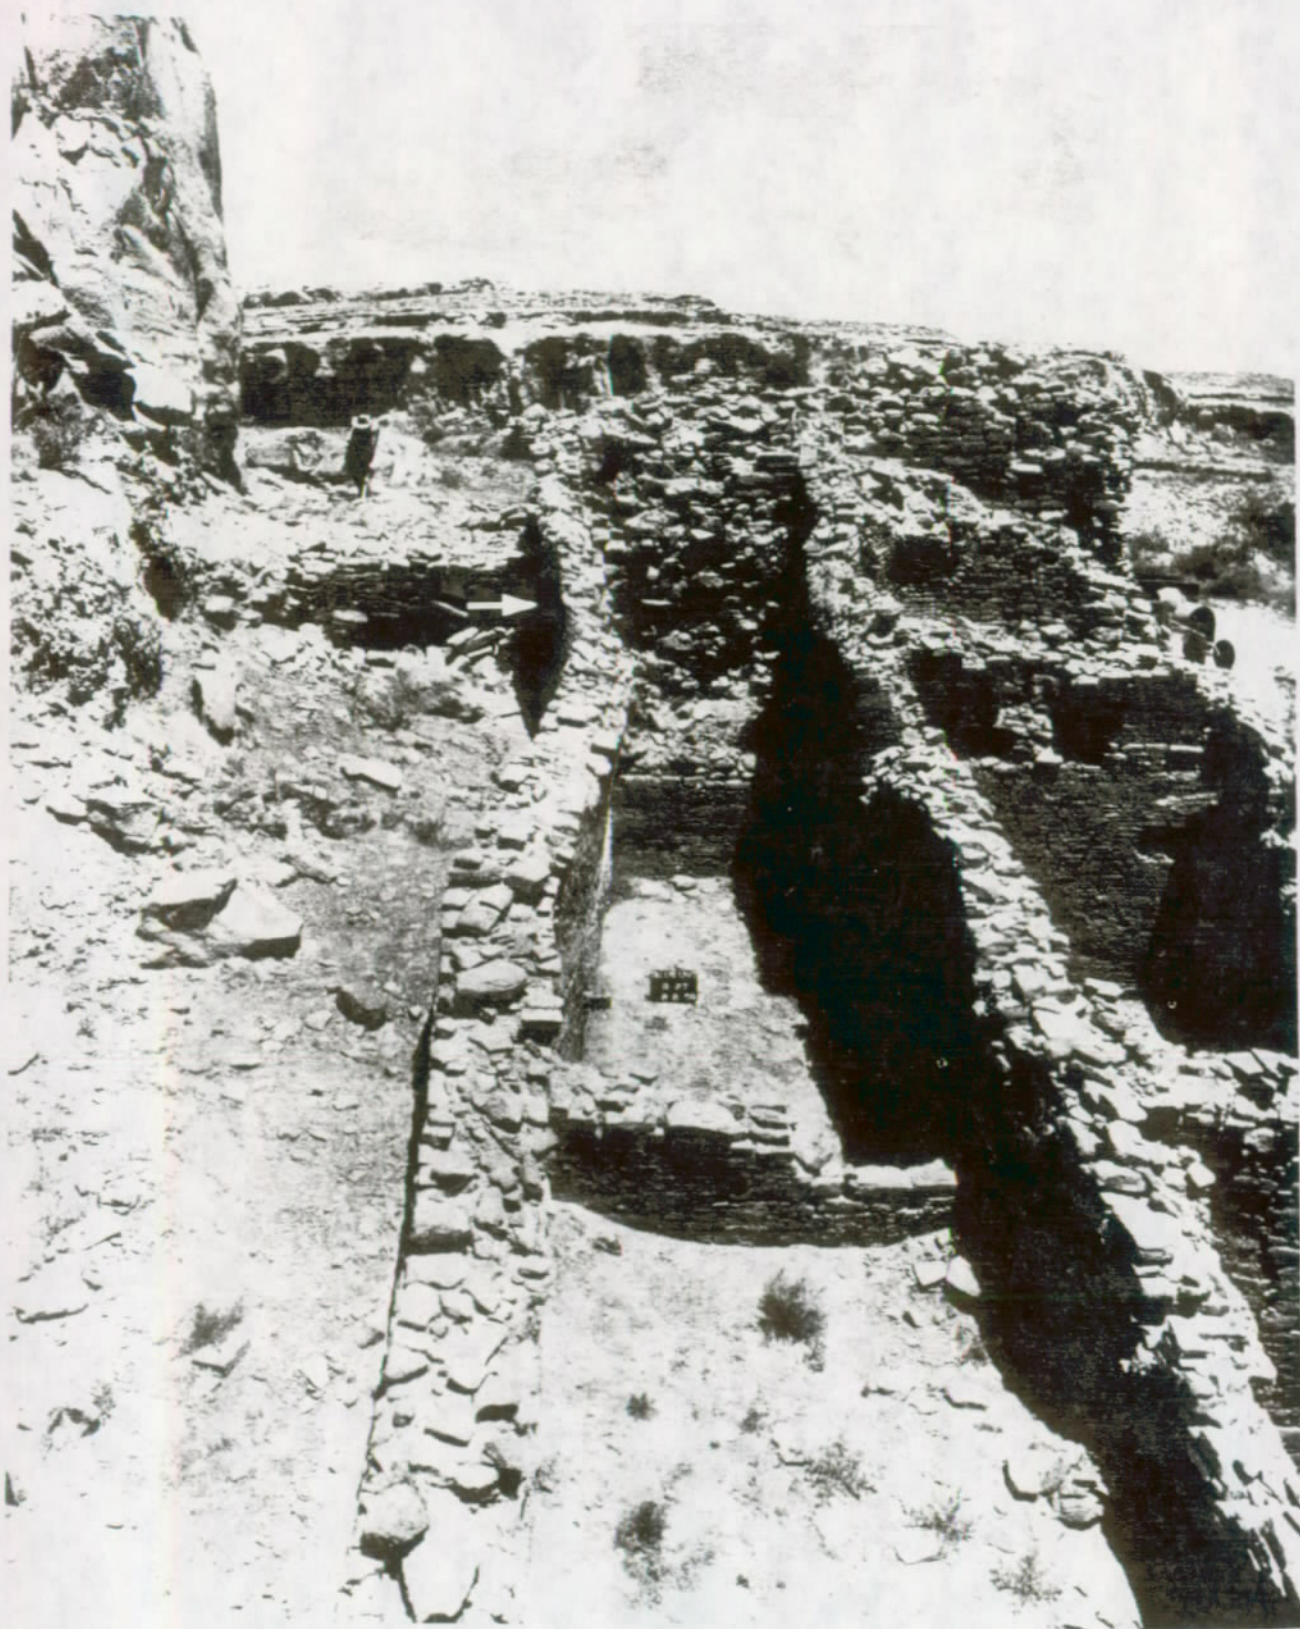
Ancient masonry: North wall above the ledge leans precariously into the room. East and west walls have eroded and are loose at the top. Footings of all four walls are undercut by erosion. Beam holes are eroding where beams have decayed.

FIGURE 120. The wall between Rooms 27 and 28, Talus Unit No. 1, was distorted and pushed out of line by pressure of fill, often damp, at left. Arrow shows direction of force. The purpose of the stabilization was to strengthen the wall against the pressure.

Materials, construction, and technique in making repairs or accomplishing job: *Part of the center section of the leaning wall was removed. A horizontal slab of steel-reinforced concrete was poured so as to abut against the junction on the partition walls. Steel rods were fastened through both wall and slab with turnbuckles between. Using the turnbuckles, the wall was pulled back to nearly vertical position. The stones removed were then replaced in tinted cement. East and west walls had already been patched and strongly capped to bear the load. New stones were set in cement around the wall footings. The beam holes were patched in tinted cement.*

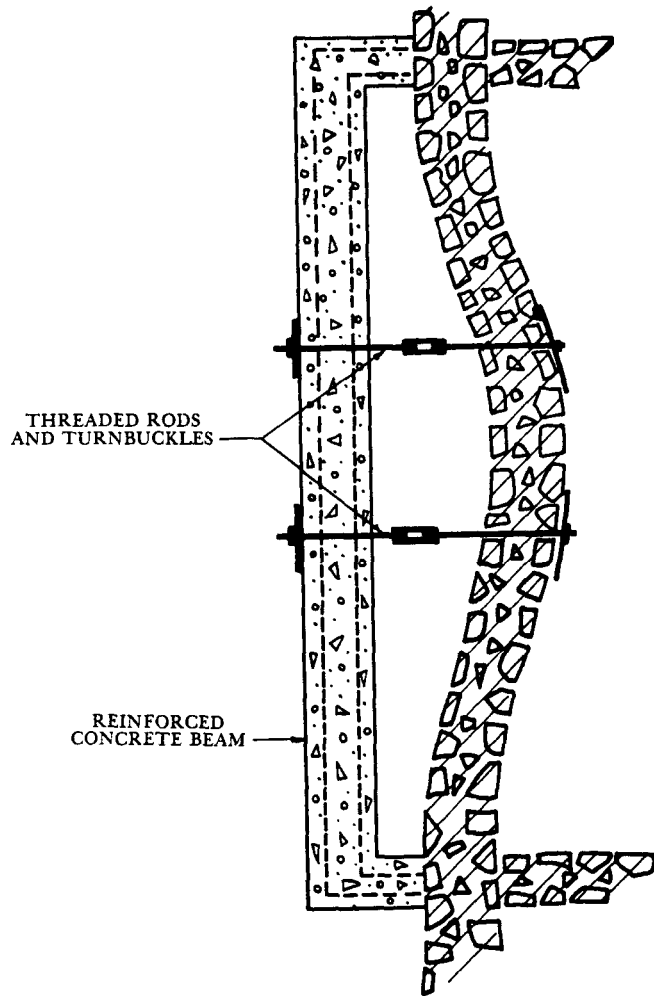
FIGURE 121. Plan of reinforced beam to realign and hold north wall, Room 27, Talus Unit No. 1 (not to scale).

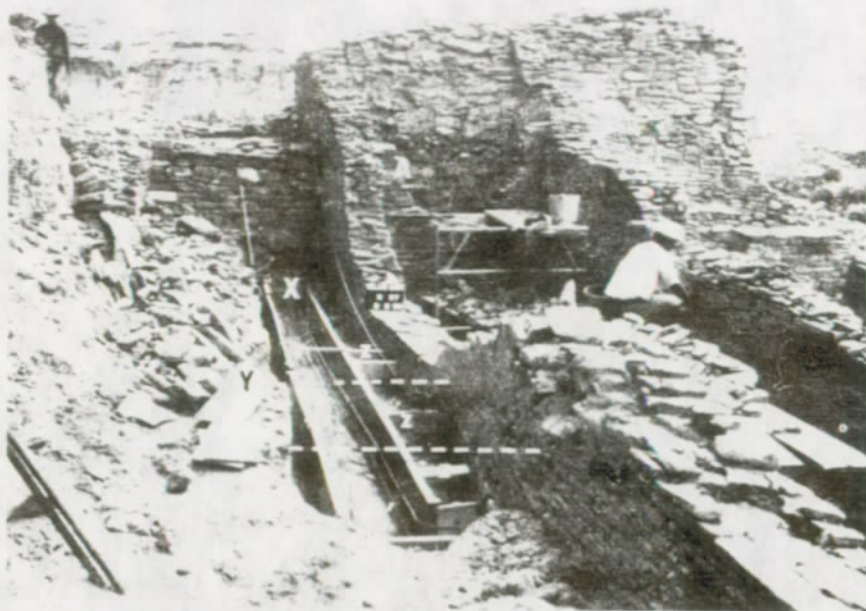
FIGURE 122. Construction of concrete beam shown in figure 121. The frame is complete and reinforcing rods are in place. X—X1—beam, Y—location of threaded rods and turnbuckles, Z—temporary braces. The ends of the beam bear against the wall at each side of the bulged area at points where the wall is braced against movement by partition walls. That at the east shown as A.

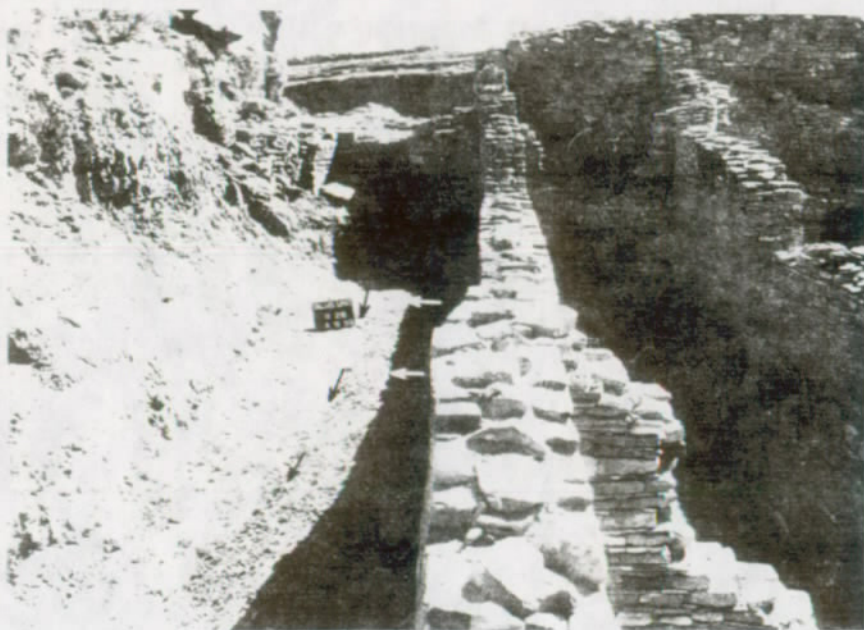
FIGURE 123. This wall in Talus Unit No. 1 has been pulled back into line; the capping is straightened up. The concrete beam dug into Room 28 is covered and the surface of this room (arrows) is graded to carry surface runoff away from the damaged wall.

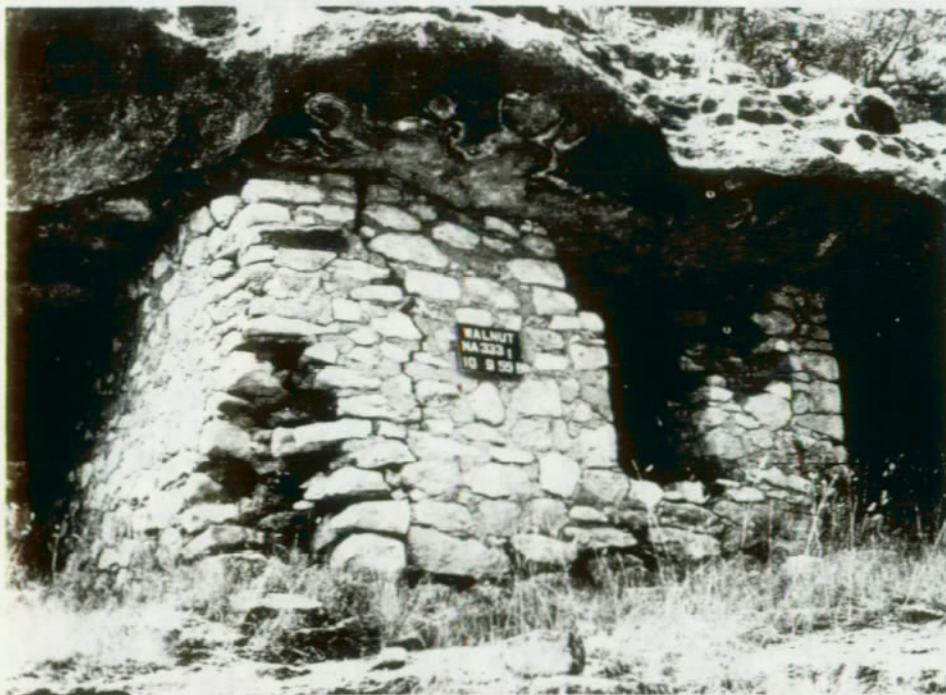
Condition on date when work started. *Ancient masonry: Fair. North Wall: In poorest condition. A large hole beginning at foundation and extending to midsection caused by pot hunters has made this wall extremely weak, and collapsed all of the eastern third except a fragile corner one stone wide. East Wall: Good except for eroded foundation, and the lower third of southeast corner which has collapsed. The V-shaped hole over doorway needs grouting on the north side.*

FIGURE 125. Room 1, east exposure, before replacement of fallen corner. (Walnut Canyon National Monument)

Materials, construction, and technique in making repairs or accomplishing job: *North Wall: The large hole measuring 3' x 4' was filled with repair masonry to save the upper section, and the northeast corner was buttressed also to preserve it. Repair work stained with black mortar color to match original.*

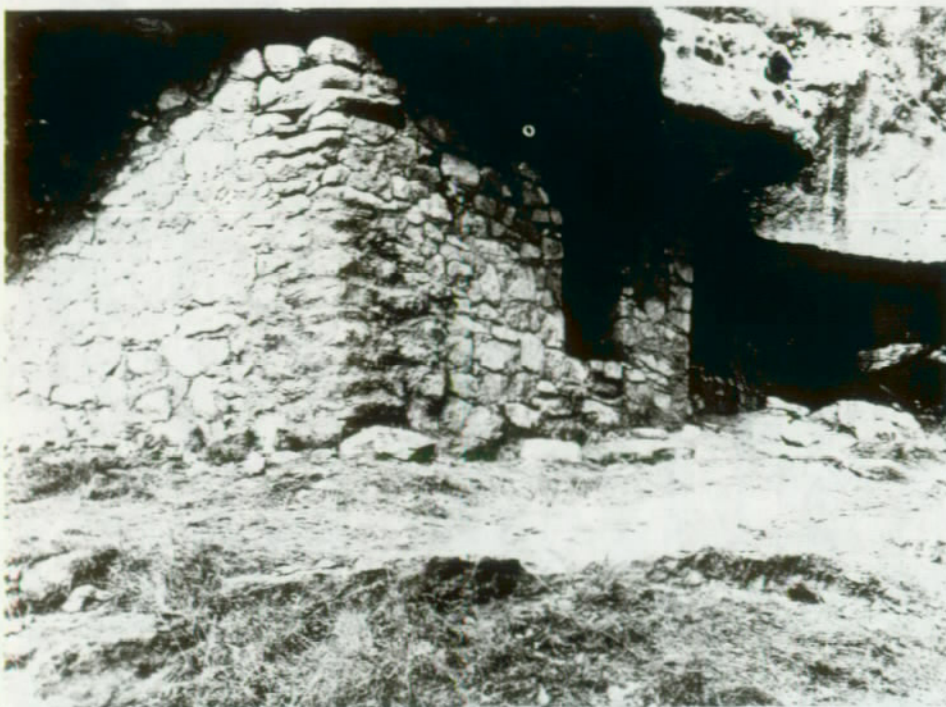
FIGURE 126. Room 1, east exposure, after replacement of fallen corner. The deeply eroded wall base was grouted, and the area above the doorway was partially reset. (Walnut Canyon National Monument)

East Wall: Entire foundation one stone high was grouted and pointed. The south wall also had a few small holes along the foundation row where original soil-mortar had eroded and these were filled. Sill and wall area below door grouted and pointed.
