Blue Ridge Parkway
Saunders Farm
Historic Structures Report

June 2005

Historical Architecture, Cultural Resources Division

Historic Structure Report

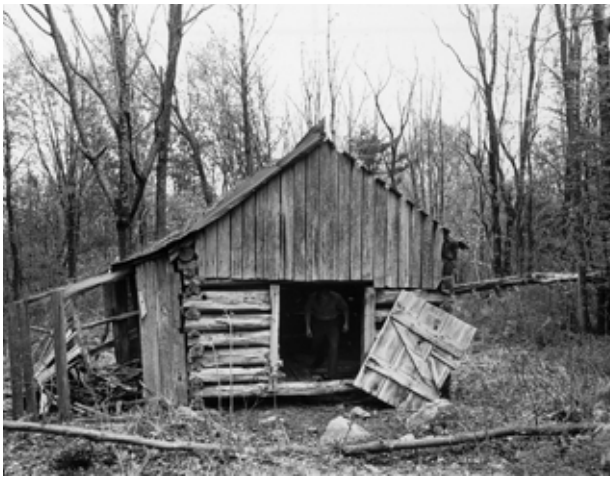
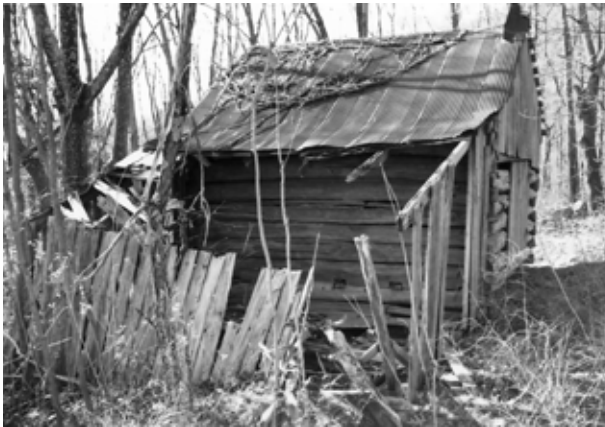
FIGURE 11. View of meat house, c. 1975. (NPS, BLRI coll.)

FIGURE 12. View of meat house in 1975. (NPS, BLRI Coll.)

The only out- building still standing is the so- called “meat house,” a term often used interchangeably with “smoke house,” although rarely so in Virginia. Many households in the rural South smoked their meat, mainly for flavor, but Saunders apparently did not. When interviewed in 1975, the Saunders’ daughter stated that her father did not have a “smoke house,” nor did she refer to a meat house being present on the farm. Her father did keep hogs, however, and would have cured and preserved his meat by salting it in barrels or other containers and, when dry, hanging the sides of salt pork in bags until it was to be used. The present building shows no signs of use as a smoke house, nor are there any signs of use as a place for salting meat. Saunders may have hung some of his meat in the building, but the rather loosely constructed nature of the structure , suggests that it was incapable of having kept out any but the largest vermin.

- Repair roofing on Meat House
- Reconstruct Meat House door
- Replace missing flooring in Meat House
- Reconstruct shed on Meat House
- Preserve stone foundations of ruins in place
- Reconstruct ruined buildings only if deemed necessary for interpretation

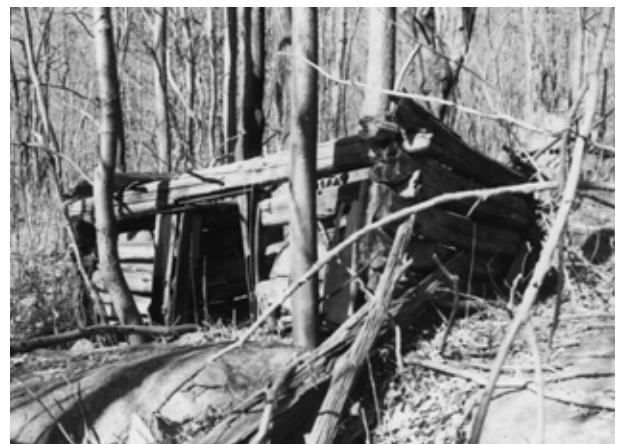
FIGURE 18. View of south end of hog house in 1975. (NPS, BLRI)

first photographed around 1950, a number of the slabs covering the roof were already missing, and by the time the next photographs were taken in 1975, the building was in ruins. No trace of the fence remains.

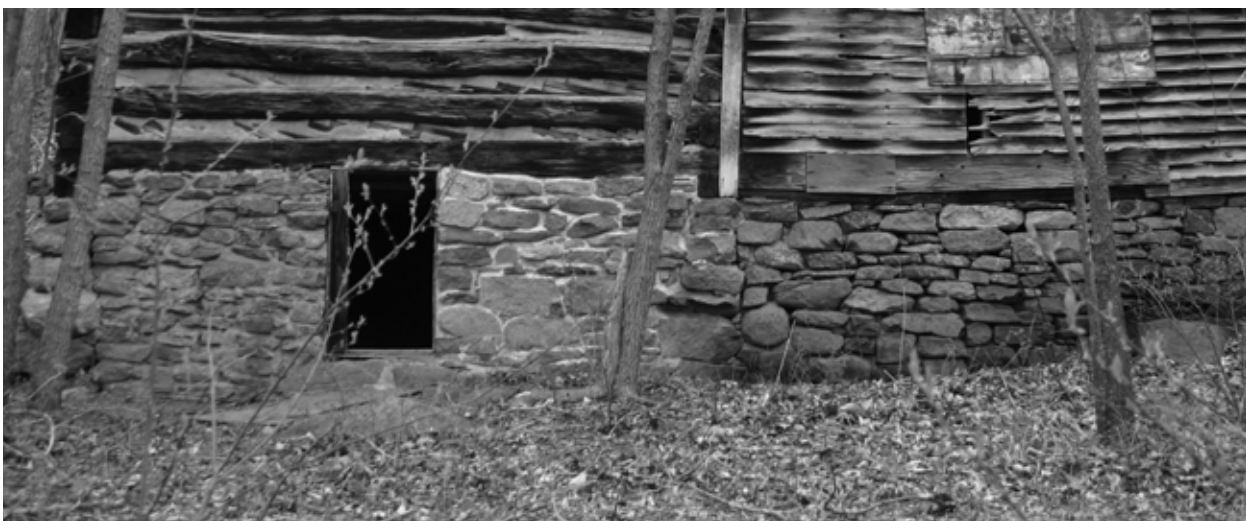
There has been no laboratory analysis of the mortars, but visual analysis distinguishes three separate mortars. The oldest that has not been repointed is that found on the west side of the cellar door and along the front of the house. This mortar is relatively

FIGURE 22. View of foundation at south end of house, showing cellar doorway.

hard, but utilized a course aggregate that was probably taken from one of the nearby creeks and gives the mortar a pinkish- tan cast. It appears similar to the mortar used for chinking of the log pen. On the east side of the cellar door, the historic masonry was reconstructed in 1977 using a hard light- grey mortar that contrasts sharply with the areas that have not been repointed.

The rock foundation under the south side of the wood- framed portion of the house was constructed by Saunders but must have been built sometime after the house's original construction. The foundation here has the appearance of having been dry laid, but in fact, the mortar appears to have contained much less cement and has mostly eroded away.

- Repair and repoint foundation on north and east side of house
- Avoid reconstruction and repoint foundation under Room 102
- Monitor foundation at southwest corner for continuing movement
- Devise means to tie south and west foundation together without reconstruction
- Repair sills on north and east side
- Repair floor and roof framing of enclosed porch (102)
- Locate source of and repair damage to northeast corner of log pen

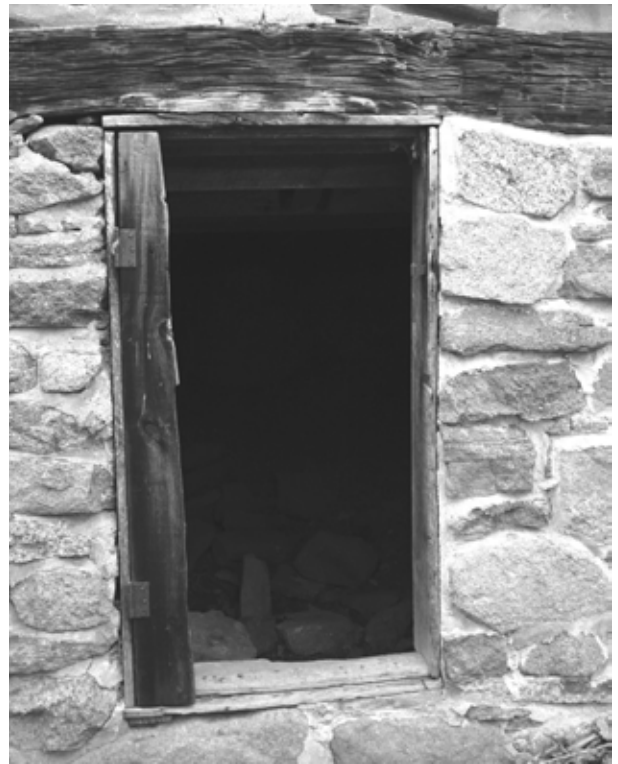
FIGURE 23. View of cellar door. (NPS, 2005)

only the board on the hinge side of the door remains intact.

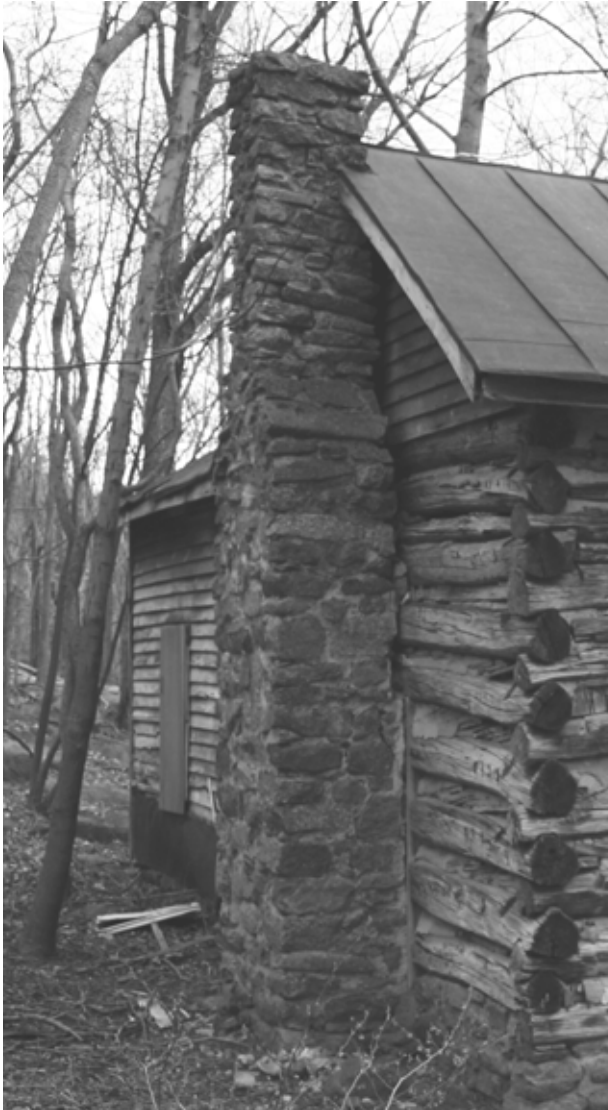
FIGURE 25. View of chimney. (NPS, 2005)

In the Front Room, a piece of terra cotta stove- pipe flue liner was built into the interior face of the chimney breast, probably originally. A similar piece of yellowish terra cotta flue liner was once mounted at the top of the chimney, but it is now lying in pieces at the north end of the house. Sometime after the original construction, an opening was made on the back side of the chimney to serve a flue for a stove at the north end of the log pen loft. The chimney is in fair condition, but some stones have been dislodged from the sides of the firebox inside the house.

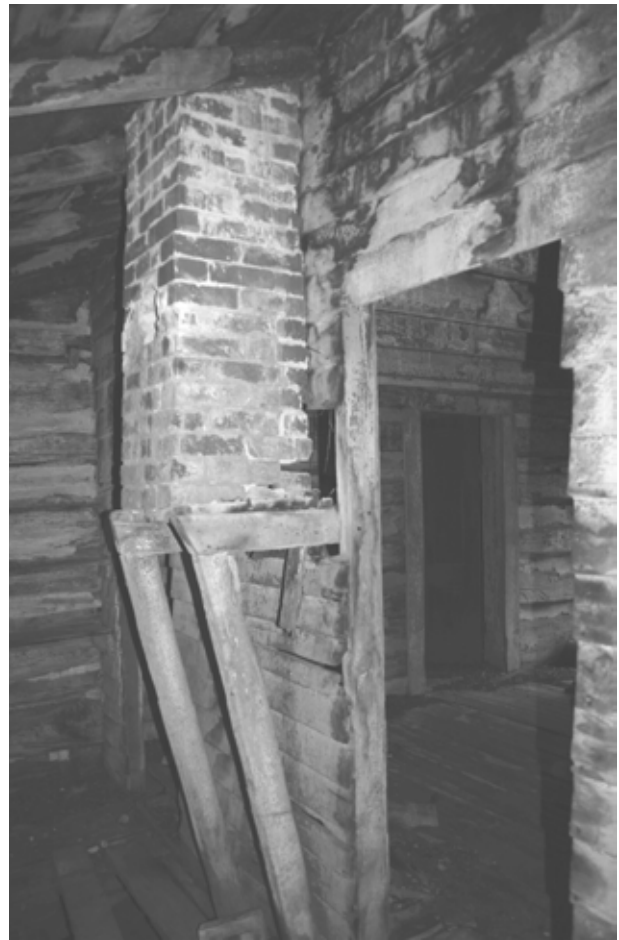
Brick Chimney. The wood- burning cook stove in the kitchen was served by a small brick chimney with a flue on the south wall of the kitchen. Constructed of red, hard- fired brick with a modern

FIGURE 27. View of kitchen chimney. (NPS, 2005)

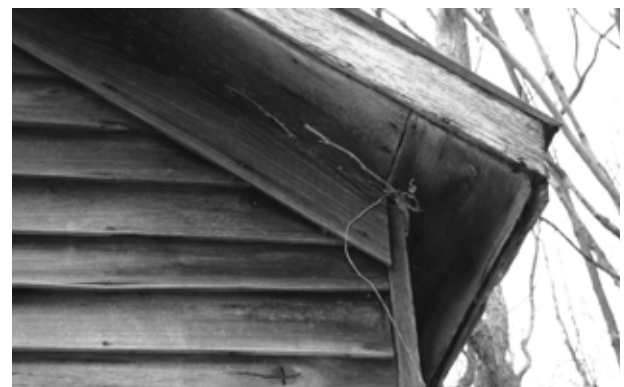
FIGURE 33. View of northeast corner of building showing typical exterior finishes. (NPS, 2005)

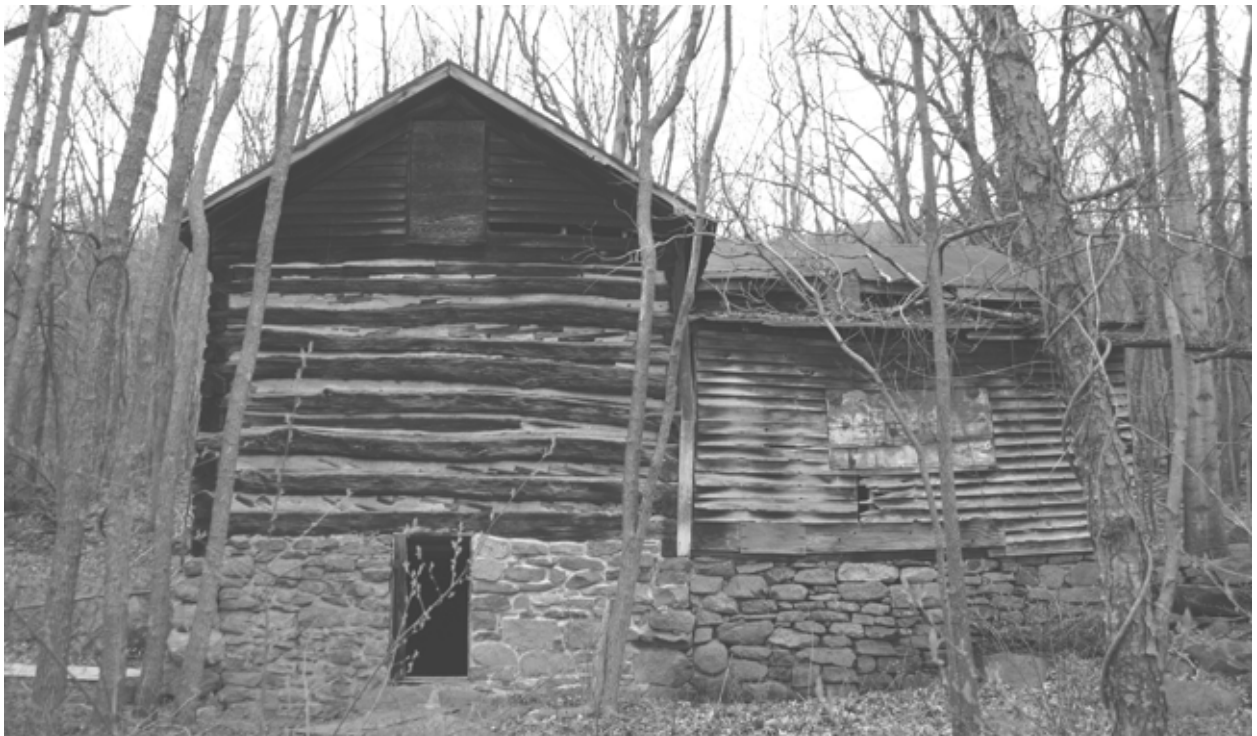
FIGURE 34. View of south side of house. (NPS, 2005)

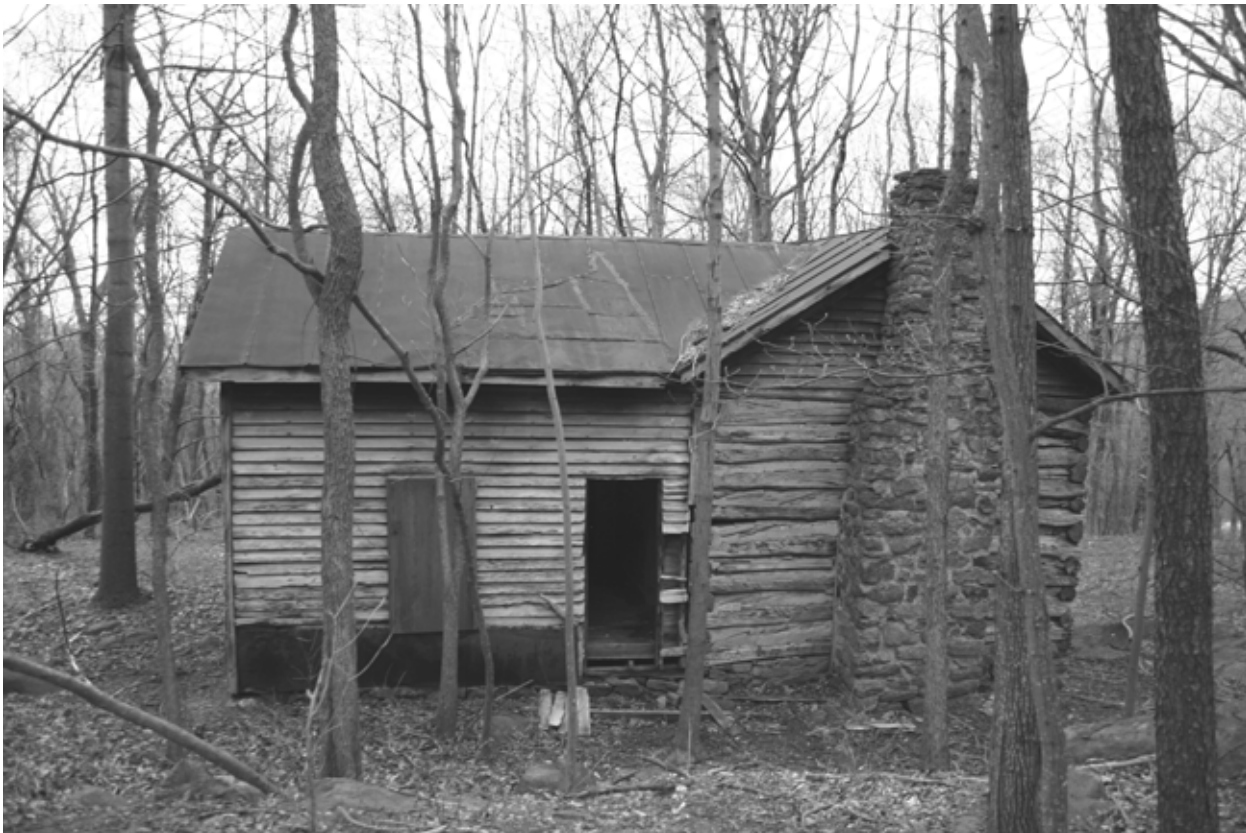
Siding was laid with an exposure of about 5- 1/2", and put up with wire nails. Single boards, 2" by 4", are used as corner boards against which the siding is butted. Siding is missing on the north side to a height of about two feet, and several runs of siding are missing from the east end of the house as well. Eaves extend about a foot beyond the face of the walls and do not have rafter returns. Eaves are boxed to a frieze board around 1" by 6". Windows and doors are cased with plain boards about 6" wide.

Roofing. The rafters are decked with circular-sawn lumber, generally 3/4" thick and around 4" to 11" in width. Roofing is standing- seam metal, probably galvanized steel but badly rusted. For the most part it remains functional except where it has been damaged by falling trees. On the north shed of the kitchen roof, a large area has been roughly patched with sheet metal. Significant damage has been done

FIGURE 36. View of north side of house. (NPS, 2005)

to the roof of the enclosed back porch by a fallen tree that is still lying across the roof.

The roof of the enclosed porch (102) has been badly damaged by a falling tree. The tree should be removed and the area covered with a tarpaulin to prevent water entry. Rafters can be temporarily braced up on the interior. The remainder of the roof appears to be generally shedding water, but if additional leaks are found they should be closed. Since the entire roof covering will have to be replaced, cold asphalt patching compound could be used if necessary.

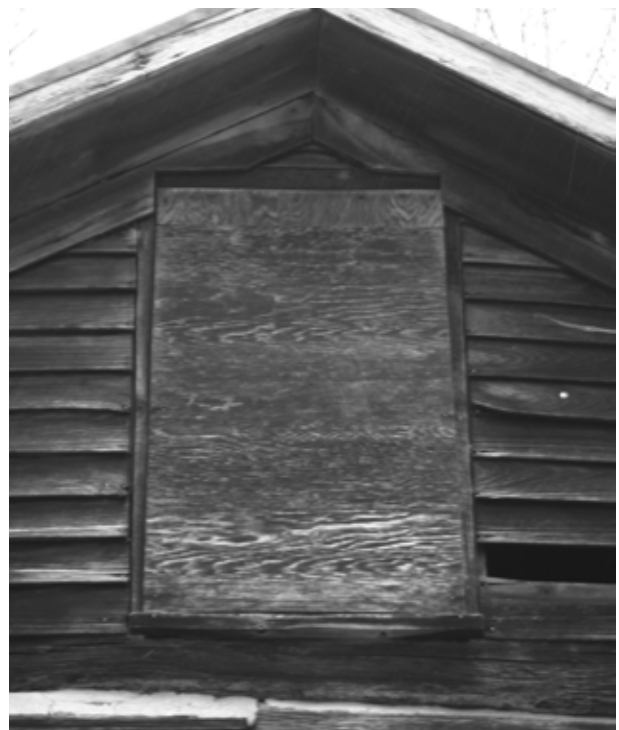
At the south end of the loft of the log pen is another window opening, also measuring around 2'- 0" by 4'- 4". Sash are missing, but historic photographs show they were originally four- over- four like those in the kitchen.

FIGURE 38. View of window in south gable. (NPS, 2005)

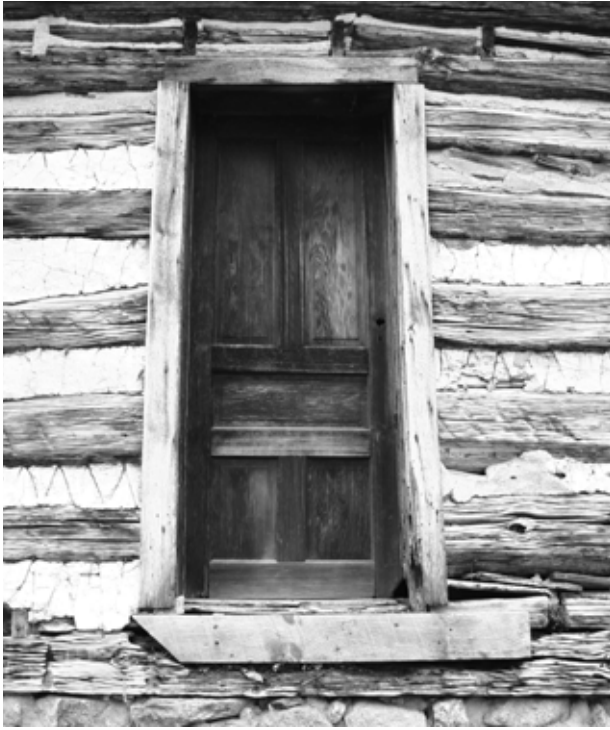
FIGURE 39. View of front door. (NPS, 2005)

Only the front door remains in place; the back door, which is not in its original location, is covered with plywood and the door is missing. The front door is a pine door, 2'-8" by 6'-5", with five raised panels. The door is hung with plain 3" butt hinges and was originally fitted with a vertical rim lock about 3" by 4", but the lock is now missing. The back door may have been similar.

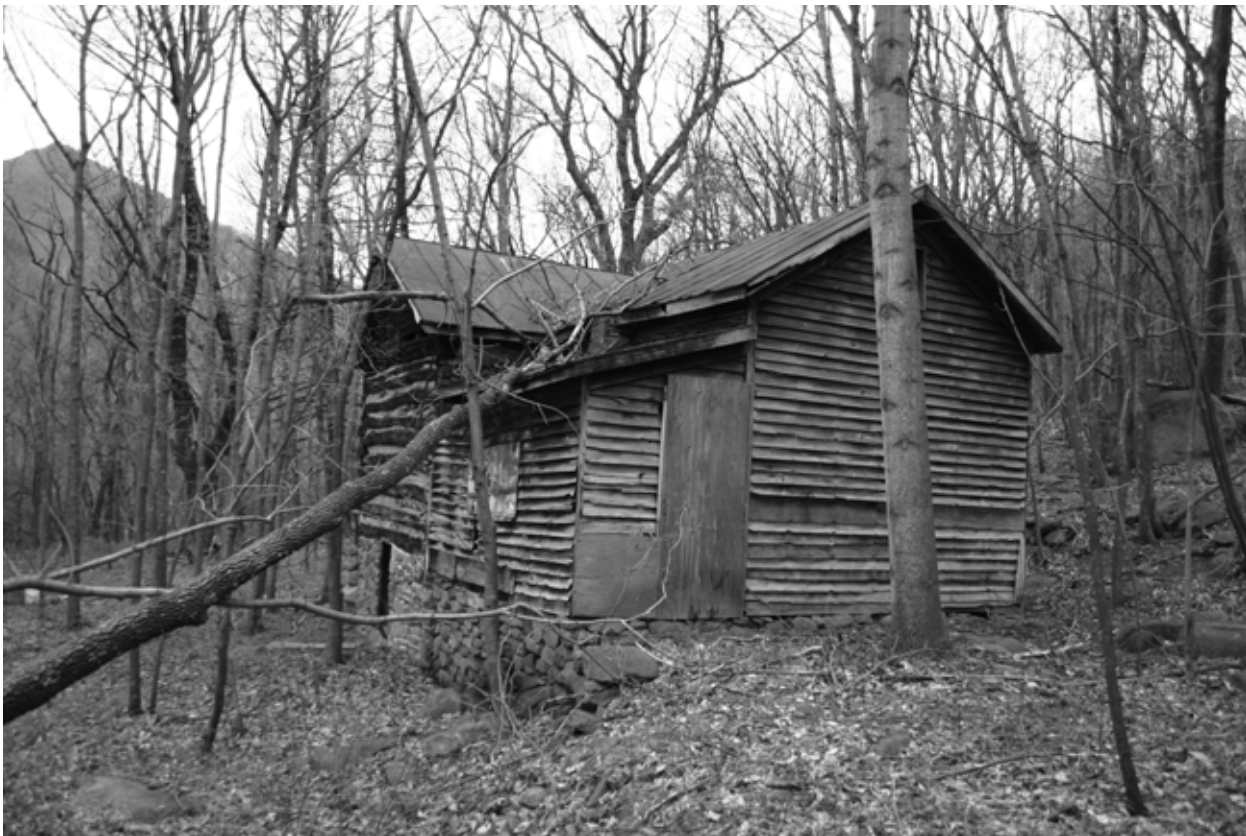
FIGURE 40. View west-northwest of rear and south sides. (NPS, 2005)

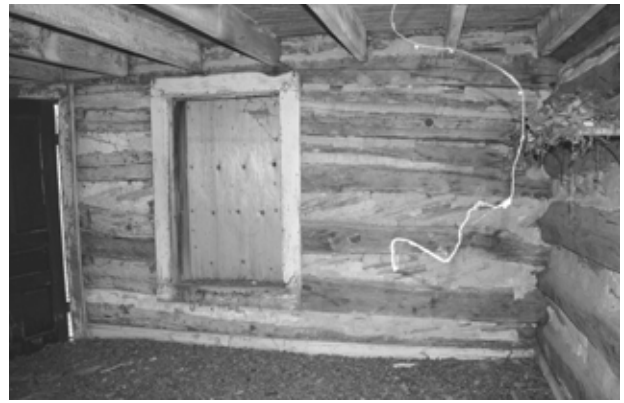
Flooring is tongue- and- groove pine around 2- 1/2” wide. It appears to be mostly intact although the large amount of debris in the room, particularly in the southeast corner, made assessment of its condition impossible.

FIGURE 41. View west in Room 100. (NPS, 2005)

Interior. The interior of the house must be cleared of the large amount of debris that covers the floors in every room. Holes in flooring on the first floor should be covered temporarily with plywood, anchored without the use of nails or screws but secured against animal entry. Plywood can also be laid over the loose boards on the enclosed porch (102).

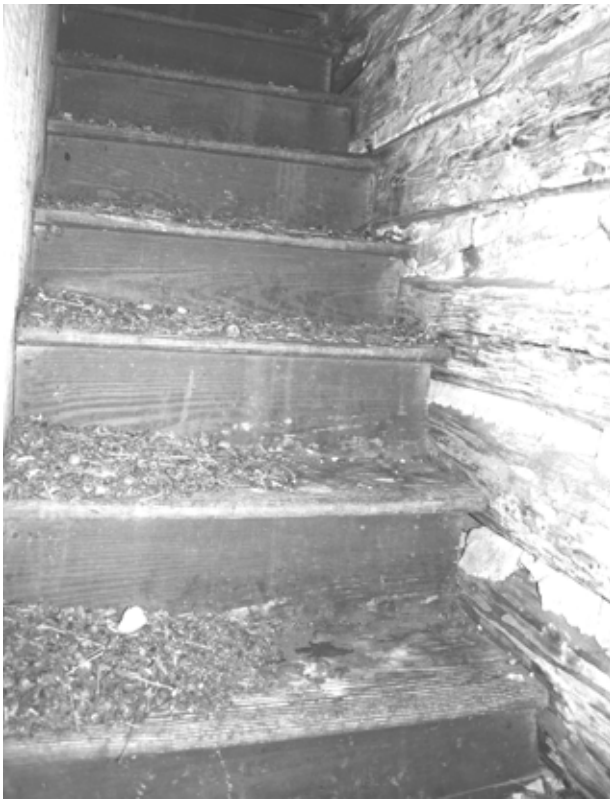
FIGURE 44. View of stairs to second floor of log pen. (NPS, 2005)

An unframed curtain wall of tongue- and- groove boards runs across the room about 32" from the south wall. Composed of tongue- and- groove boards 3- 1/4" wide, the wall encloses the staircase to the second floor and a closet beneath the stairs. The stairs, which have a closed stringer and rise to the east, are about 29" wide with steps 10" wide and a rise of 8". The closet is entered by way of a narrow door less than 20" wide and rising to a height of 75". It is a board and batten door composed of the same tongue- and- groove material as the adjacent wall. Animals have been nesting in the closet, and as a result, there is a large amount of debris mounded inside the closet.

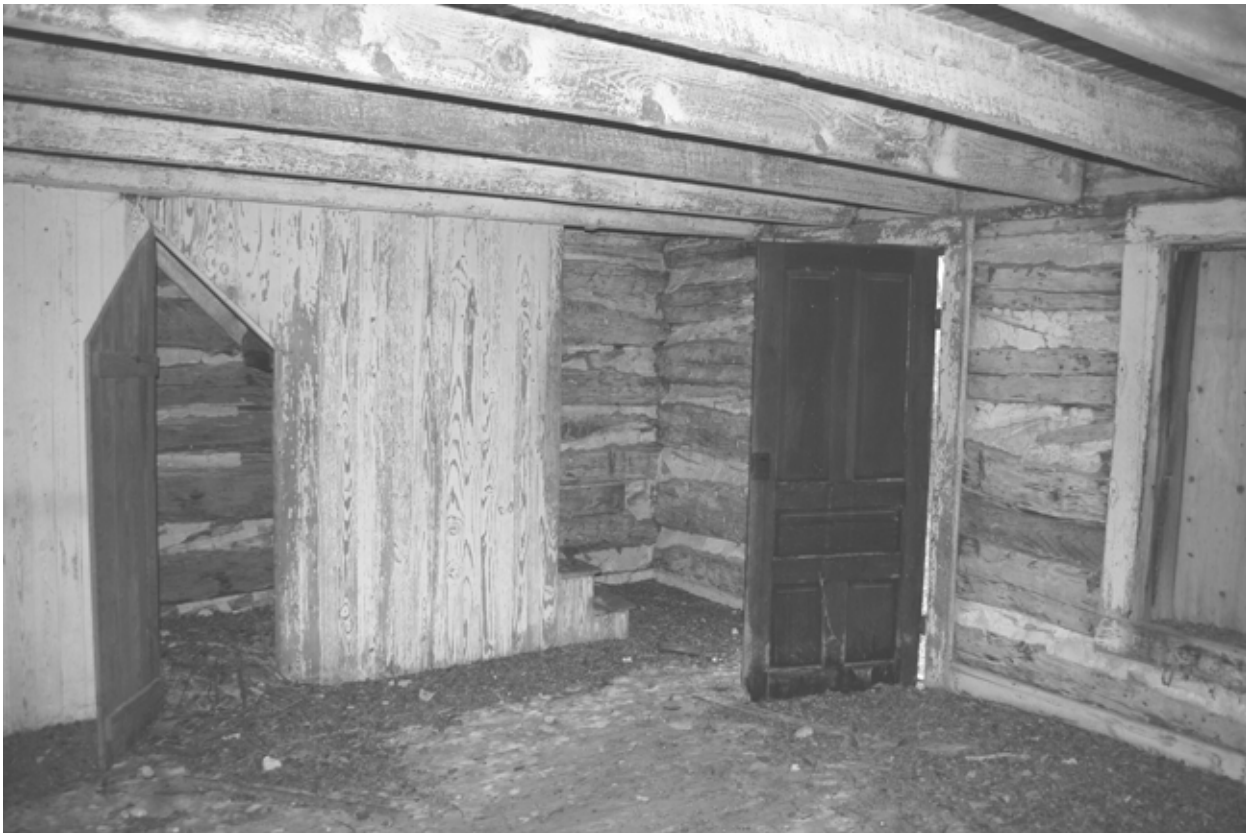
FIGURE 45. View to southwest in Room 100. (NPS, 2005)

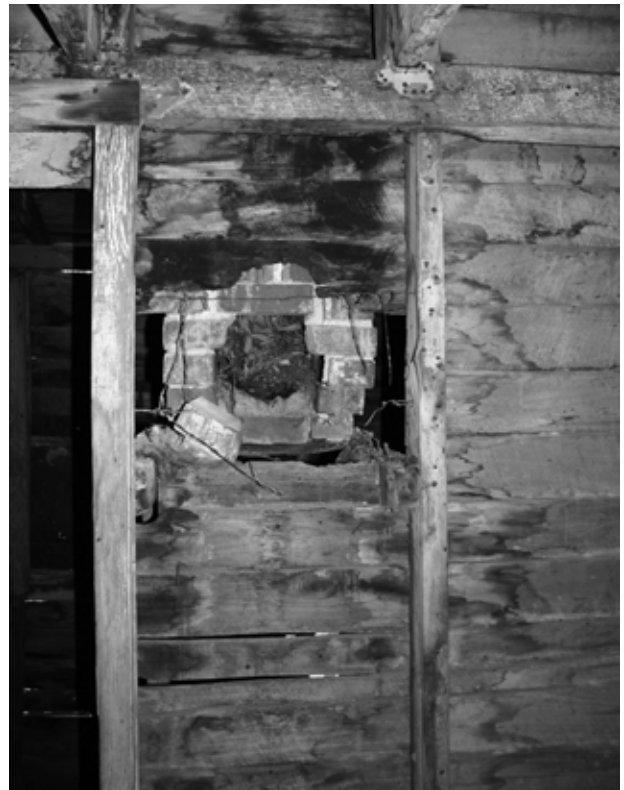
FIGURE 52. View of cook stove flue on south wall of kitchen. (NPS, 2005)

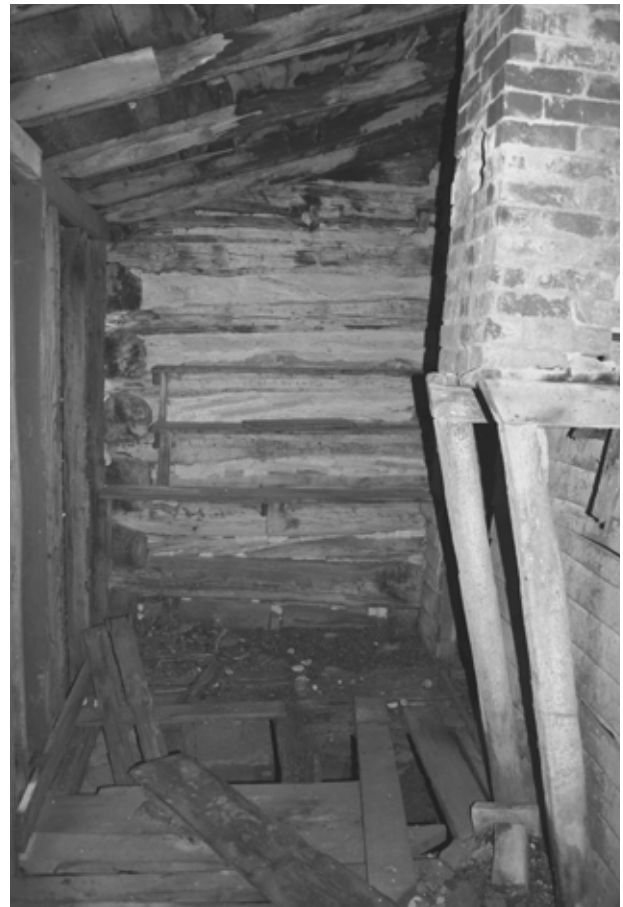
Old Porch (Room 102). The evolution of this space is uncertain, but it seems most likely that it was originally an open porch with a small pantry at the west end that was accessible from the Kitchen. The room is now in nearly ruinous condition, with much of the flooring missing and serious damage from a leaking roof. Sash for the window opening on the south wall and the door on the east wall are both missing.

FIGURE 56. View west in Room 102. (NPS, 2005)

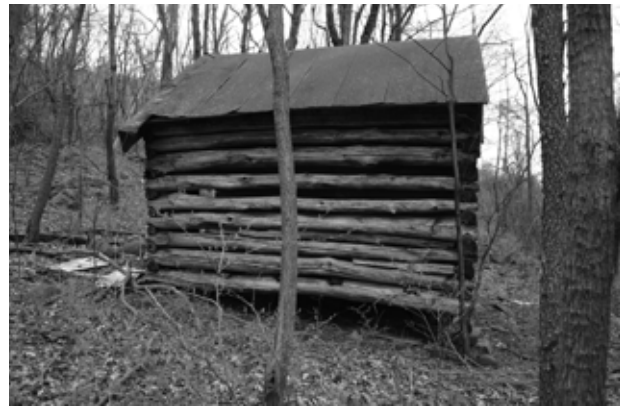
The roof is covered with 24"-wide panels of corrugated steel, which are badly rusted but still without major leaks. The end gables are finished with vertically installed, circular-sawn boards, 6" to 8" wide and attached with wire nails. Floor boards are circular-sawn, 10"-14" wide, but several are missing or only loosely attached to the joists.

FIGURE 58. View of west side of meat house. (NPS, 2005)

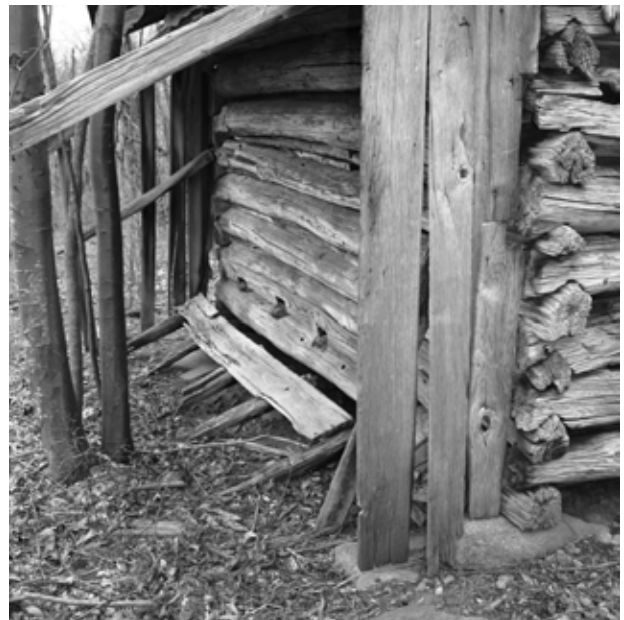
FIGURE 59. View of east side of meat house. (NPS, 2005)

Shed. The ruins of a shed remain along the east side of the meat house. Remains of a rafter as well as a series of stones that appear to have formed a foundation for the shed indicate that the shed extended about eight feet from the meat house. The pitch of the two remaining rafters indicates that the outside wall of the shed would have risen less than four feet above grade.

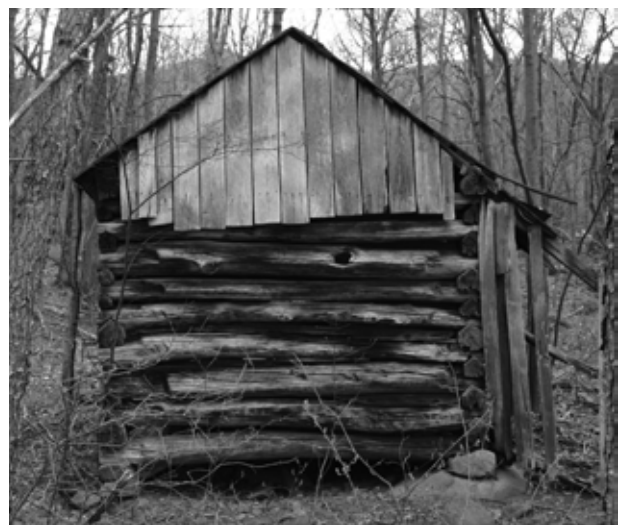
FIGURE 60. View of south end of meat house. (NPS, 2005)

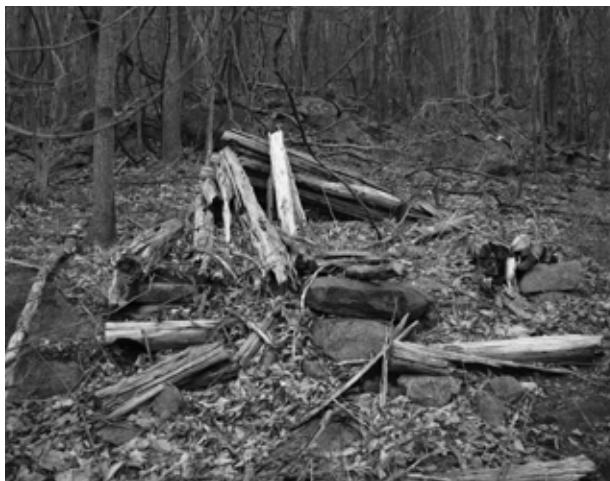
FIGURE 61. View north of chicken house

The ruin north of the house was reportedly used as a hog house and was associated with a hog pen. The other ruin, which is reported to have been a chicken house, is located about a hundred feet east of the house. What appear to be two stone steps are apparent on the south side of the ruins, where the door into the structure was originally located.
