**BUILDING 1, FORT TILDEN  
HISTORIC STRUCTURES REPORT**

**Prepared by:**  
**QUINN EVANS ARCHITECTS**  
1214 Twenty-Eighth Street, NW  
Washington, DC

Project Number: 06256

# BUILDING 1, FORT TILDEN - DRAFT HISTORIC STRUCTURES REPORT

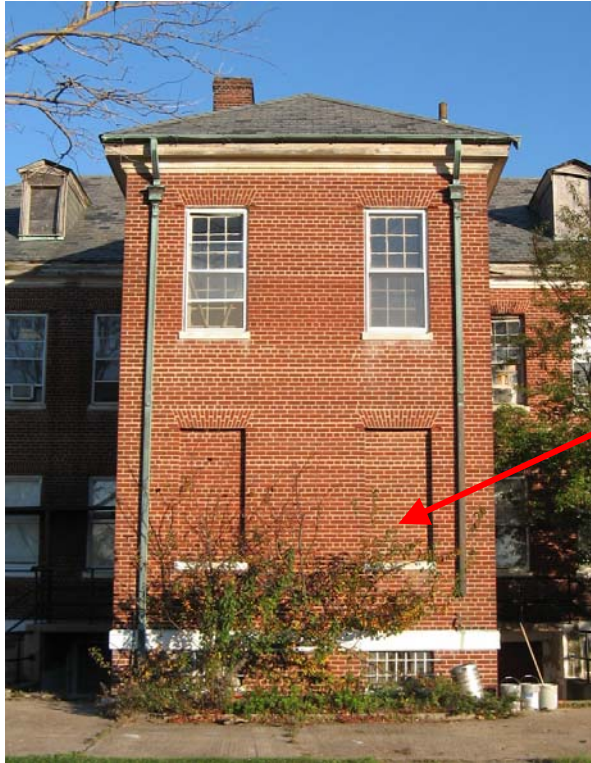
**Figure 2.3**

The eastern window on the back wing is noted on the Conversion First Floor Plan (Figure 2.2) with the following instructions, “Remove existing window frame, trim, etc.; brick up opening to match existing conditions...”. This change is visible in the current building. The western opening never held a window, rather the opening was filled with brick during construction, and the eastern window opening was made to match in 1941. Figure 2.3 is a detail of the existing north elevation of the back wing; both windows are bricked in.

Detail of the South Elevation of Building 1. The arrow highlights the window that was in filled in 1941. Photo is dated November 2006 (QUINN EVANS | ARCHITECTS).

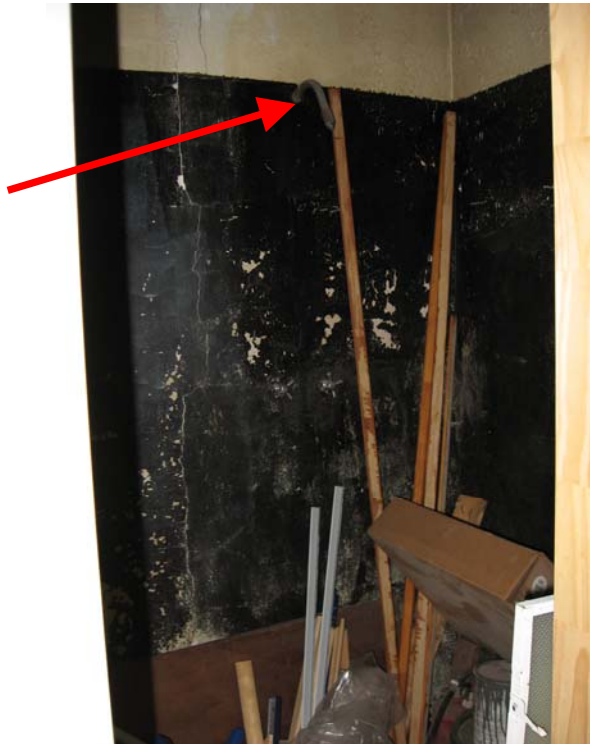
**Figure 2.4**

The Conversion First Floor Plan (Figure 2.2) illustrates that the existing lavatory was divided into a lavatory and shower for the transition to Post Hospital. At this time all fixtures that were to be in the lavatory as shown on the drawing have been removed. The shower room partition still exists and shower heads, located on the outside wall, are visible. The shower room is now used as storage. Refer to Figure 2.4.

Photo of first floor shower room created during the 1941 post hospital conversion (Room # 109). The arrow highlights the visible shower head. Photo is dated November 2006 (QUINN EVANS | ARCHITECTS).

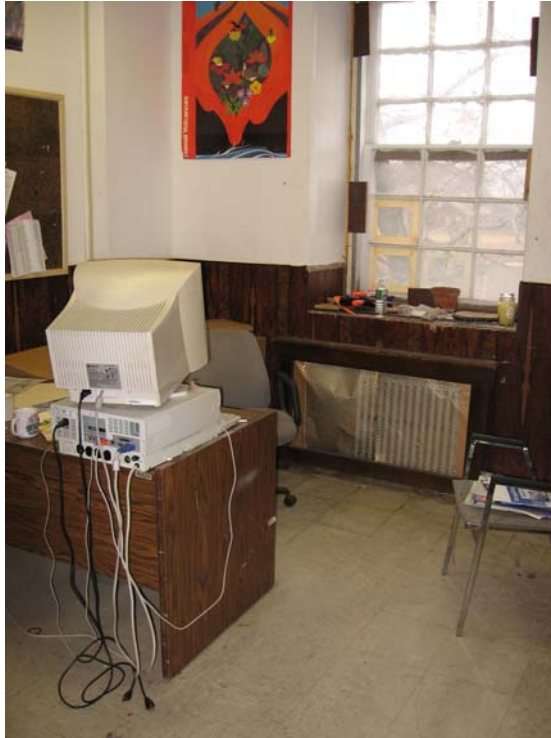
**Figure 2.5**

There is a note on the Conversion First Floor Plan (Figure 2.2) to, "Install Wash Basins as shown in same location on Second Floor." If these wash basins were installed in this location, they are not currently visible and destructive testing would be necessary to confirm that they were installed. Refer to Figure 2.5.

Photo of second floor office, originally N.C.O. #1 Room (Room # 201). Documents show that originally there was a sink in this room; currently there is no evidence of such a fixture. Photo is dated November 2006 (QUINN EVANS | ARCHITECTS).

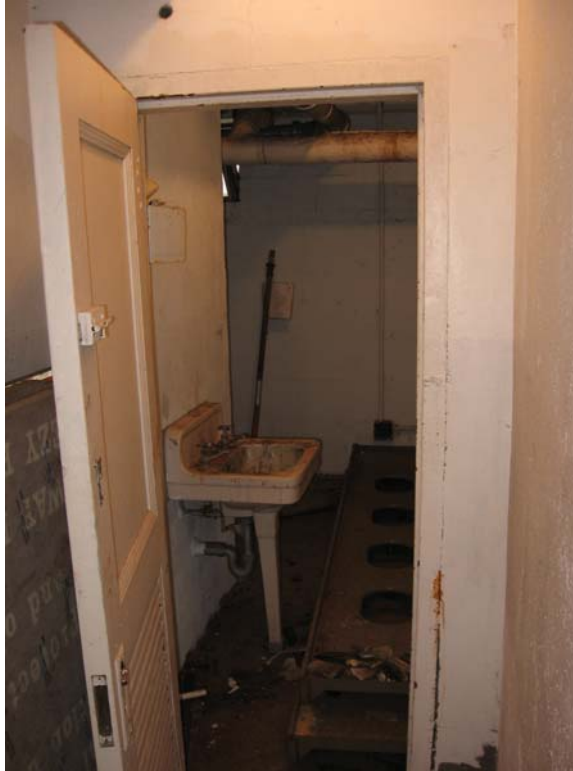
**Figure 2.8**

Photo taken in basement women's dressing room of women's water closet (beyond) with fixtures still remaining (Room # 008). Figure 2.7 shows that the location of the women's water closet door partition is not as drawn on the conversion plan. Refer to Figure 2.1. Photo is dated November 2006 (QUINN EVANS | ARCHITECTS).

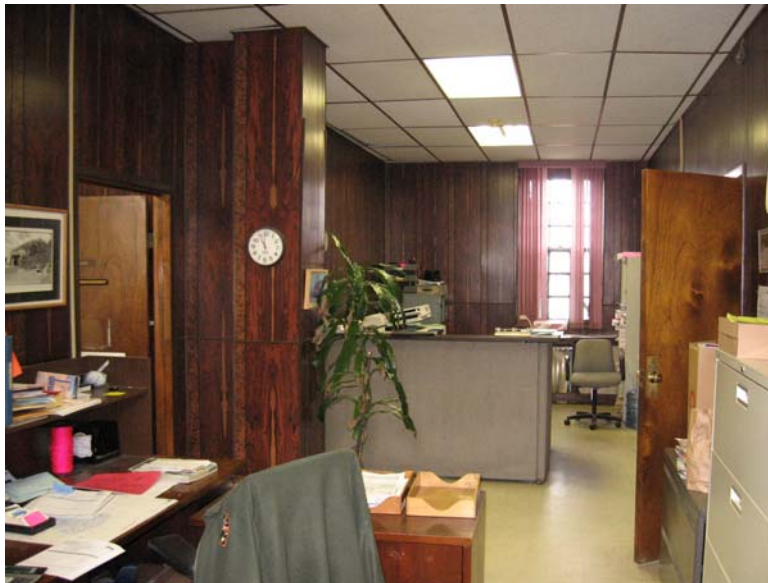
**Figure 2.10**

Photo of second floor office space on the west side of the building (Room # 203). This photo illustrates the suspended ceiling and plywood paneling installed ca. 1974. Photo is dated November 2006 (QUINN EVANS | ARCHITECTS).

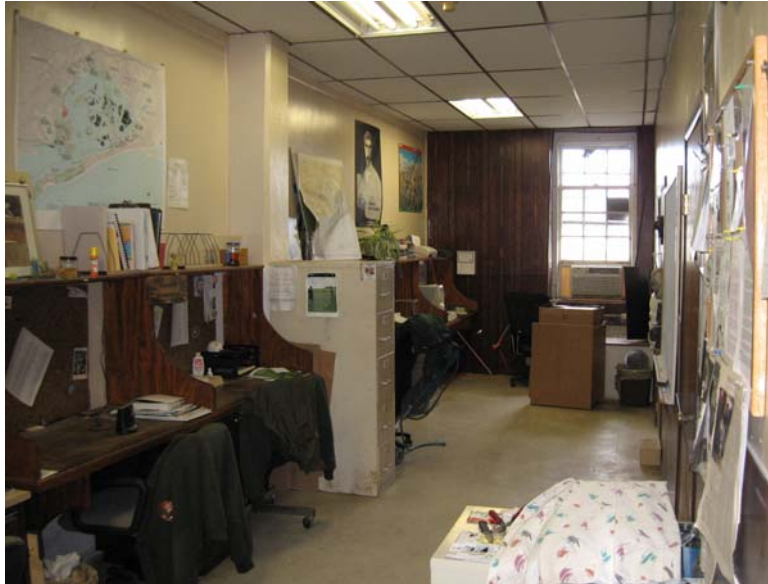
### Figure 2.11

Photo of second floor office space on the east side of the building. The dropped ceiling and end wall paneling appear to have been installed first (Room # 214). Later drywall partitions on the left and right side appear to have been installed to further sub-divide the space. Photo is dated November 2006 (QUINN EVANS | ARCHITECTS).

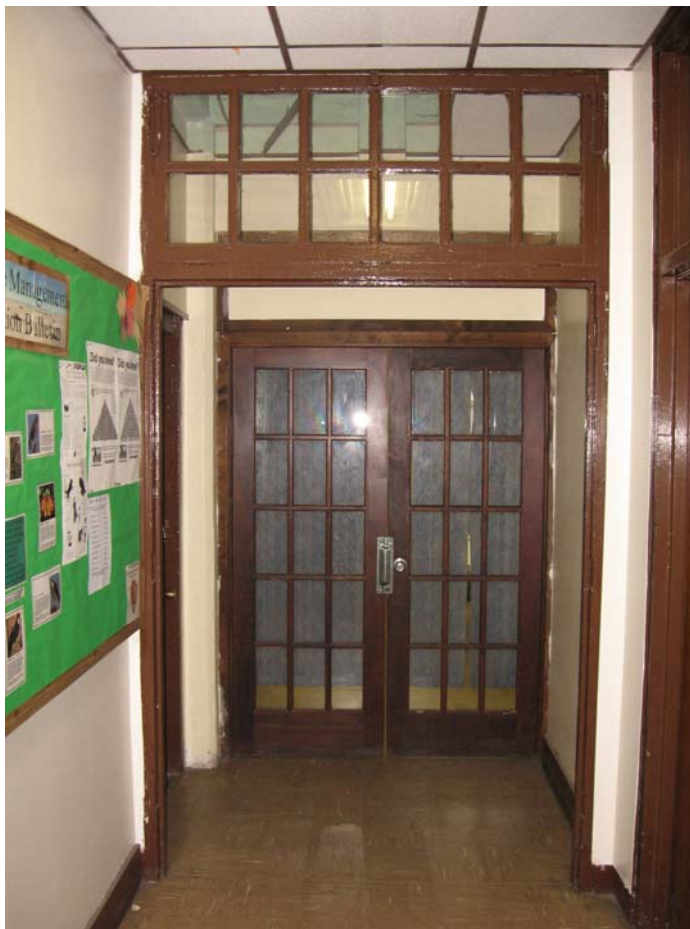
### Figure 2.12

Photo of first floor double doors placed in a different location than shown on the original plans (Room # 102). Photo is dated November 2006 (QUINN EVANS | ARCHITECTS).

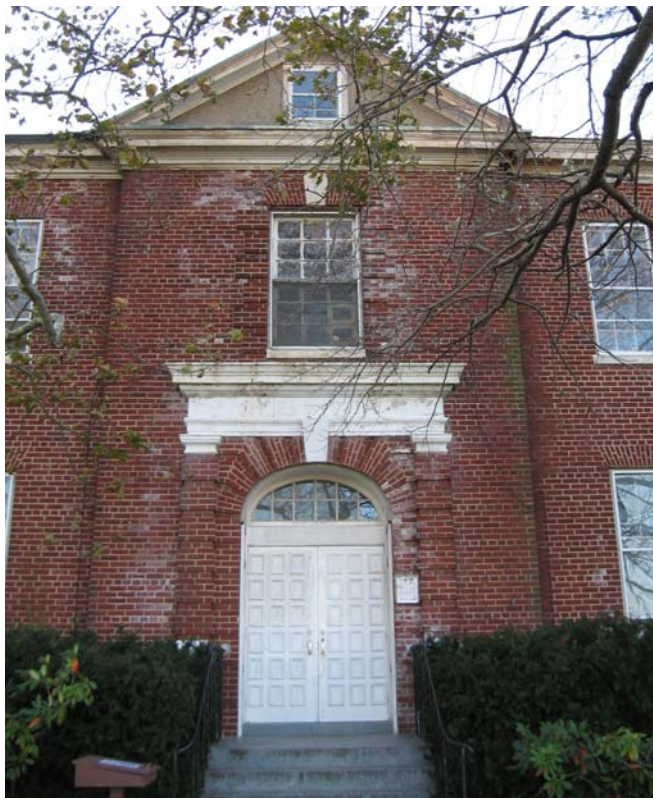
**Figure 3.3**

The main entrance is a significant character-defining feature. The entrance includes brick quoins, a cast stone entablature, cast stone key stones, and a decorative wood cornice. Panel doors are replacements, but the transom above the infill panel appears to be original. Photo is dated November 2006. (QUINN EVANS | ARCHITECTS)

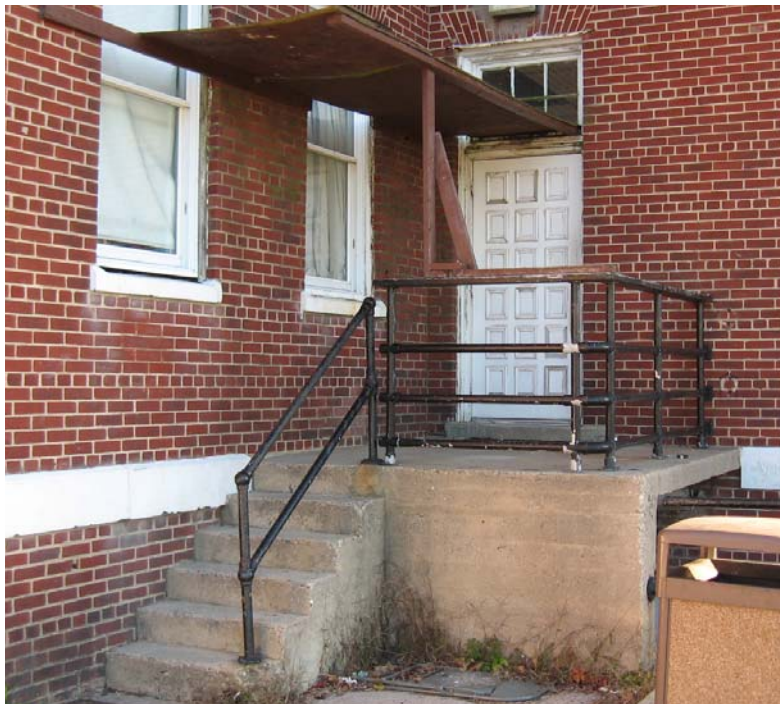
**Figure 3.4**

An image of the western rear entrance. The transom window, railing, concrete steps and landing are original features. The windows and door in this image are modern non-contributing elements; the wood shed is temporary protection for the construction project underway. Photo is dated November 2006. (QUINN EVANS | ARCHITECTS)

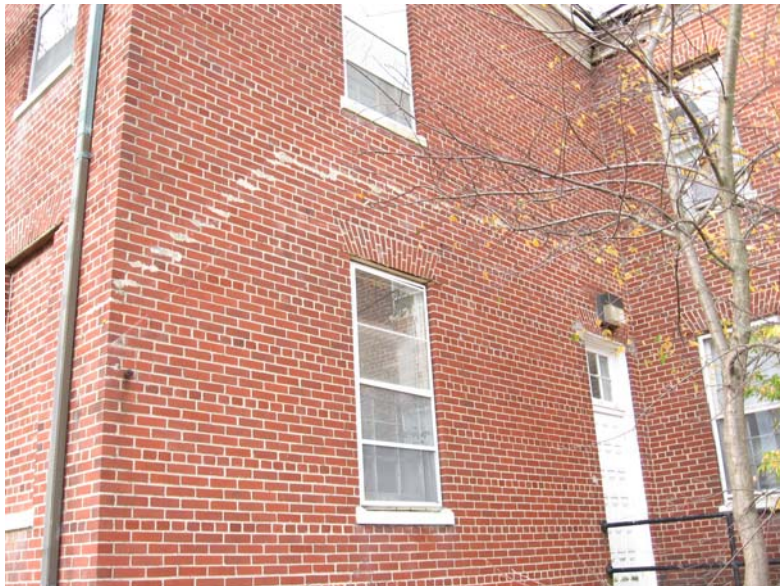
**Figure 3.8**

Photo of eastern rear entrance, showing evidence that at one point a something, perhaps an awning/shed roof, was attached to the brick. Photo is dated November 2006.

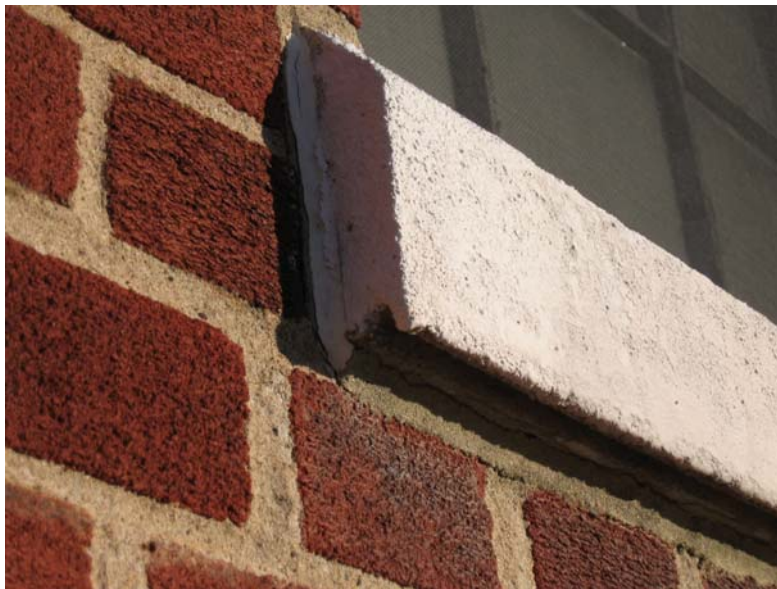
### Figure 3.10

Photo of the cast stone sill with integral drip; the cast stone was originally unpainted. Photo is dated November 2006. (QUINN EVANS | ARCHITECTS)

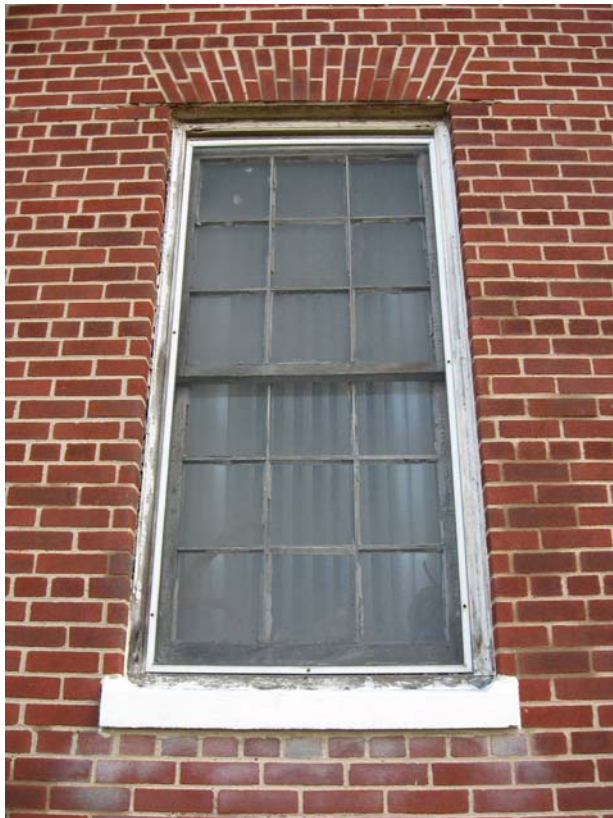
**Figure 3.12**

Typical historic nine-over-nine double hung wood window without the modern exterior storm window that is commonly found on Building 1. The steel lintel is also visible. Photo is dated November 2006. (QUINN EVANS | ARCHITECTS)

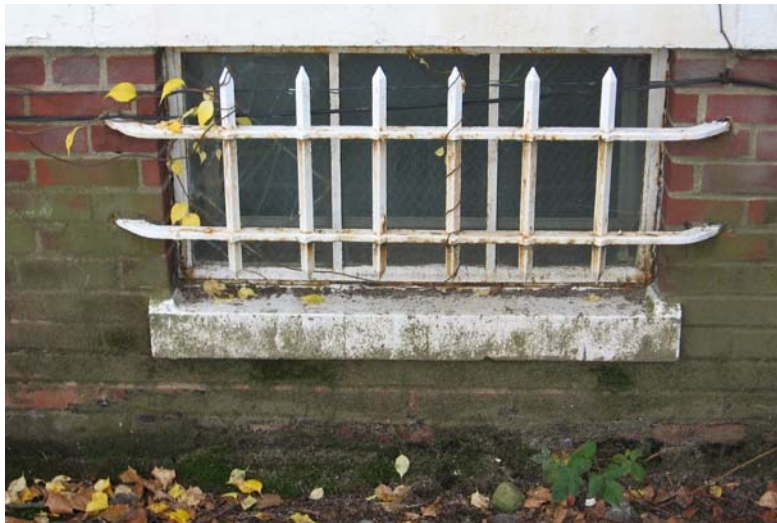
**Figure 3.14**

Example of typical period basement window, which includes the steel frame, glazing, sill and iron security bars. Photo is dated November 2006. (QUINN EVANS | ARCHITECTS)

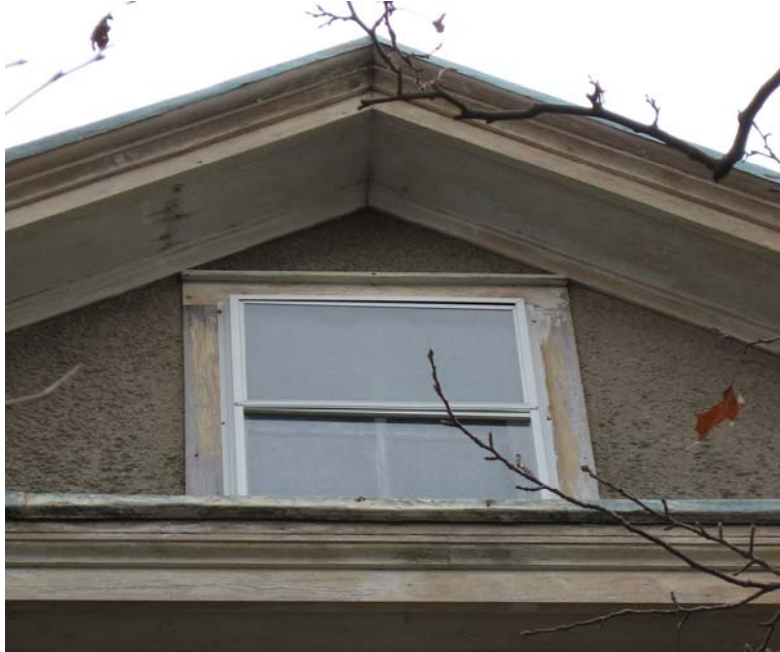
**Figure 3.15**

Detail of period attic casement window on north elevation. Photo is dated November 2006. (QUINN EVANS | ARCHITECTS)

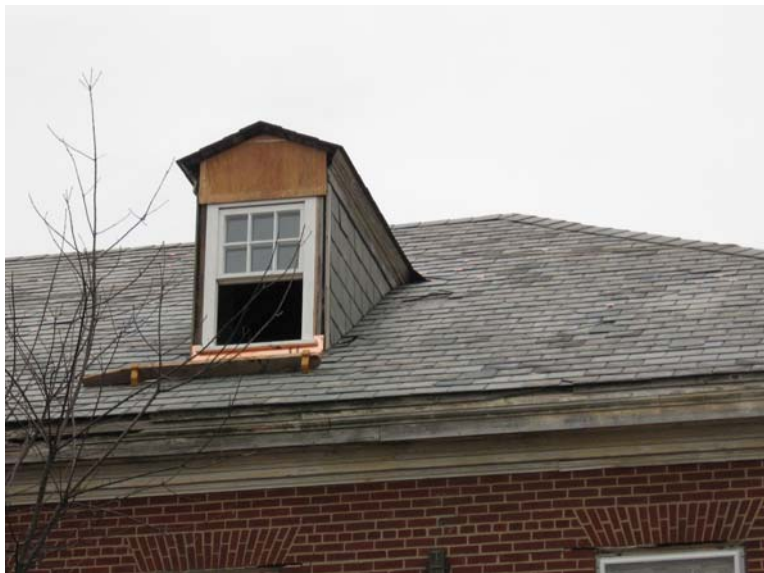
**Figure 3.16**

Detail of rear elevation dormer. A new sash to match the period window design has been installed; complete rehabilitation of dormer in progress. Photo is dated November 2006. (QUINN EVANS | ARCHITECTS)

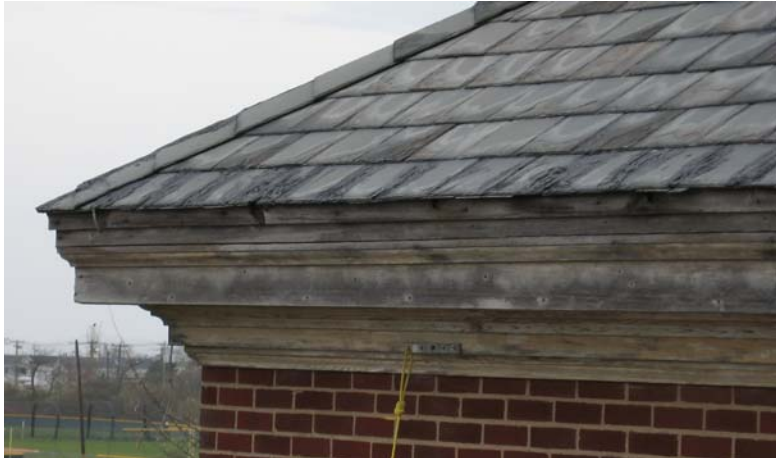
### Figure 3.17

Detail of slate roof. Photo is dated November 2006. (QUINN EVANS | ARCHITECTS)

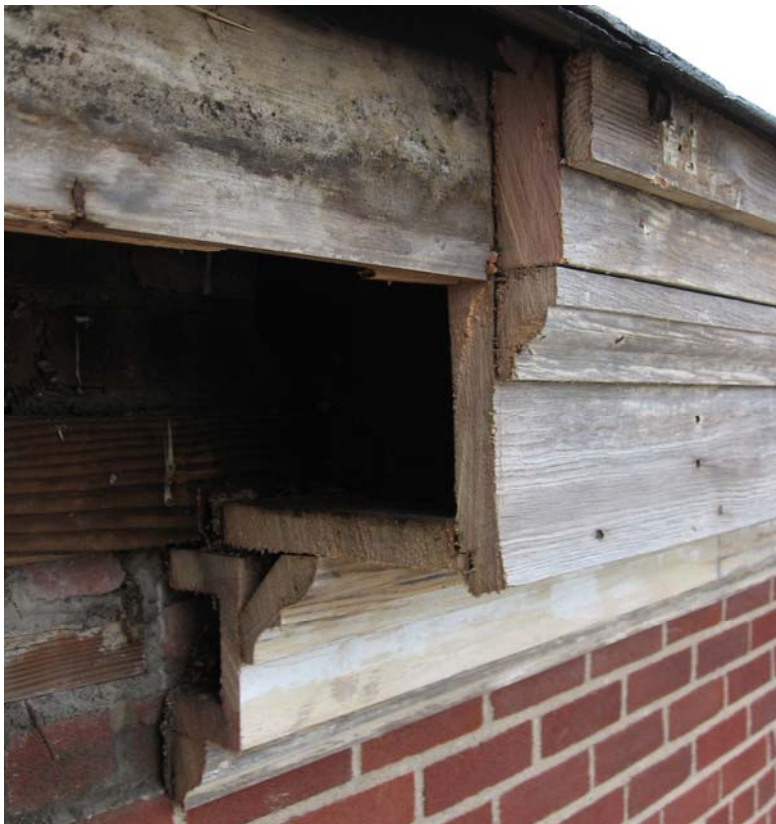
### Figure 3.18

Detail of original building eave assembly taken during recent roof repair project. Photo is dated November 2006. (QUINN EVANS | ARCHITECTS)

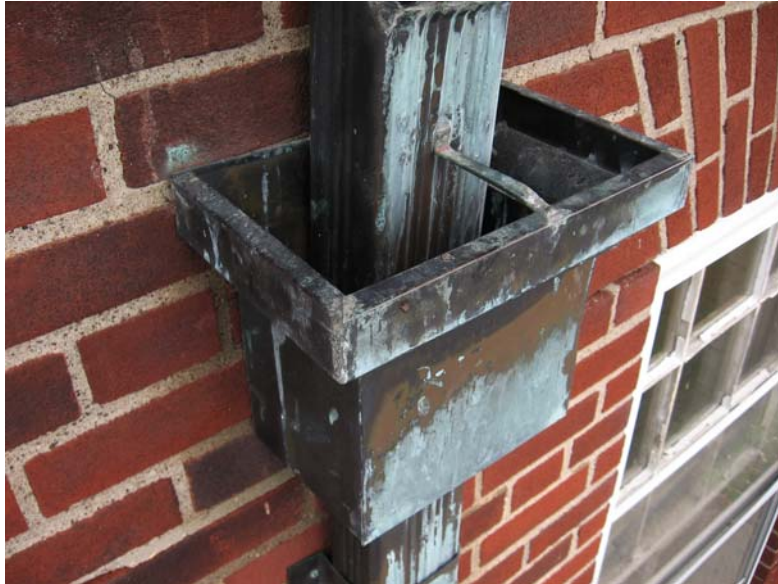
**Figure 3.19**

Detail of downspout and conductor head, which is most likely original. Photo is dated November 2006. (QUINN EVANS | ARCHITECTS)

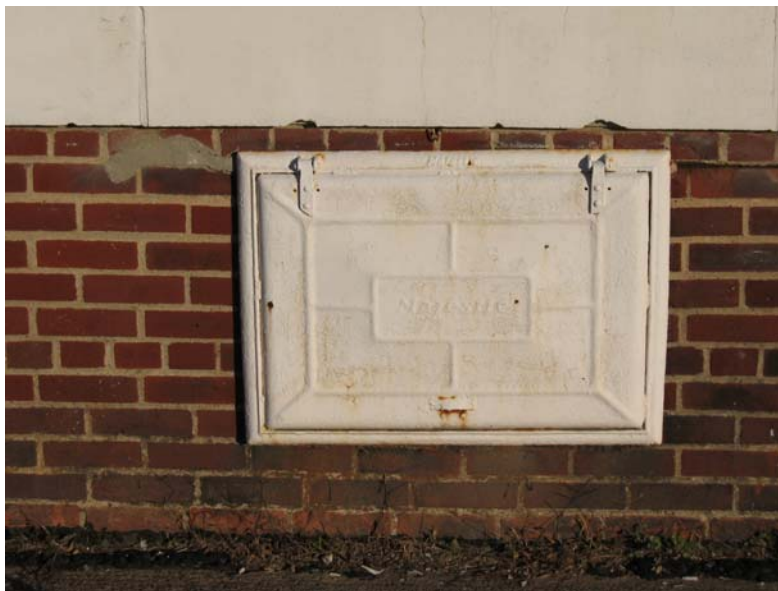
**Figure 3.20**

Detail of period metal coal chute cover on the building's northeast corner. Photo is dated November 2006. (QUINN EVANS | ARCHITECTS)

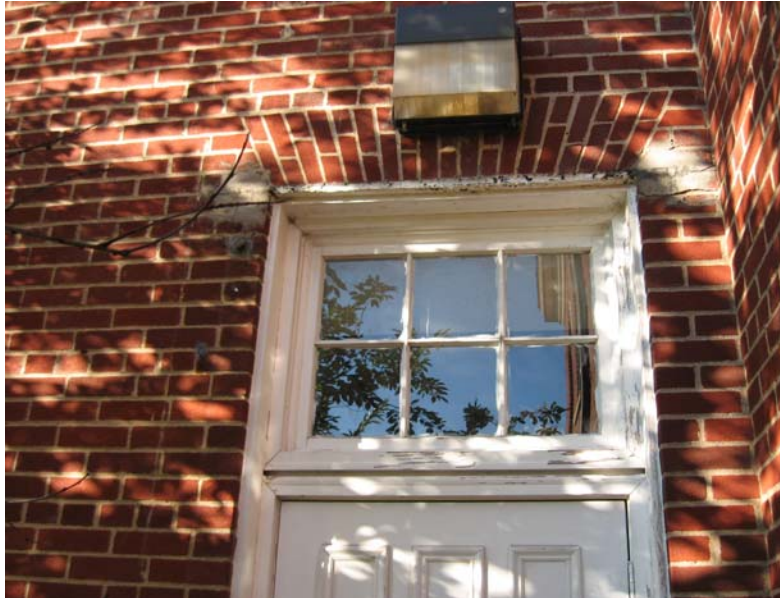
**Figure 3.21**

The current exterior lighting is not period, and is incompatible with the period character of the building. Photo is dated November 2006. (QUINN EVANS | ARCHITECTS)

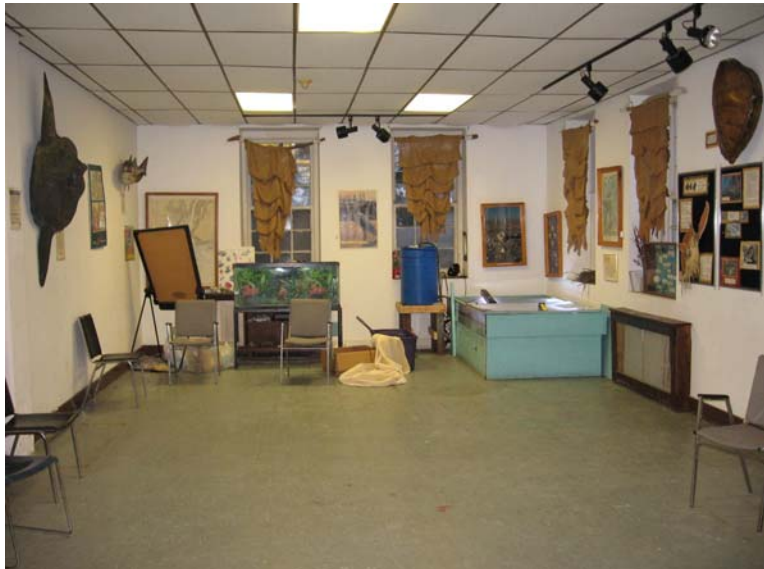
**Figure 3.22**

Room 111 looking east. This exhibit room was originally a “Squad Room” for 21 soldiers. Suspended ceilings have obscured the original room volume. Photo is dated November 2006. (QUINN EVANS | ARCHITECTS)

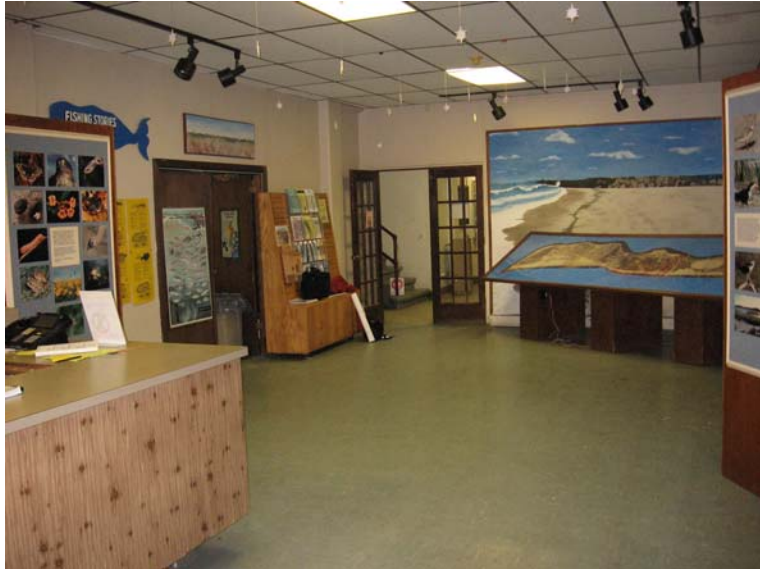
**Figure 3.23**

Room 112 looking west. This space was originally designated as the “Day Room.” Visible is the original door opening into the hallway, and the non-period doors added into the former squad room. Photo is dated November 2006. (QUINN EVANS | ARCHITECTS)

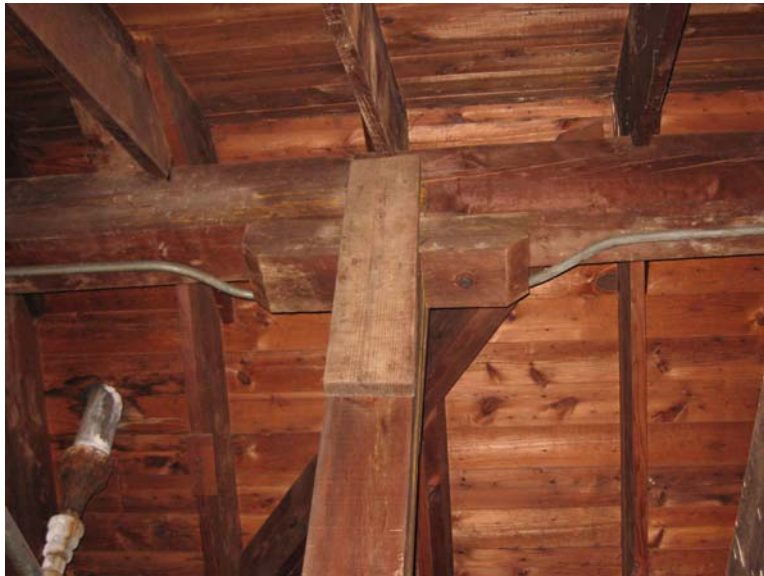
**Figure 3.26**

This view shows one of the two wood columns and the wood ridge beam in the attic. The attic's spatial character is unchanged from its period appearance. Photo is dated November 2006. (QUINN EVANS | ARCHITECTS)

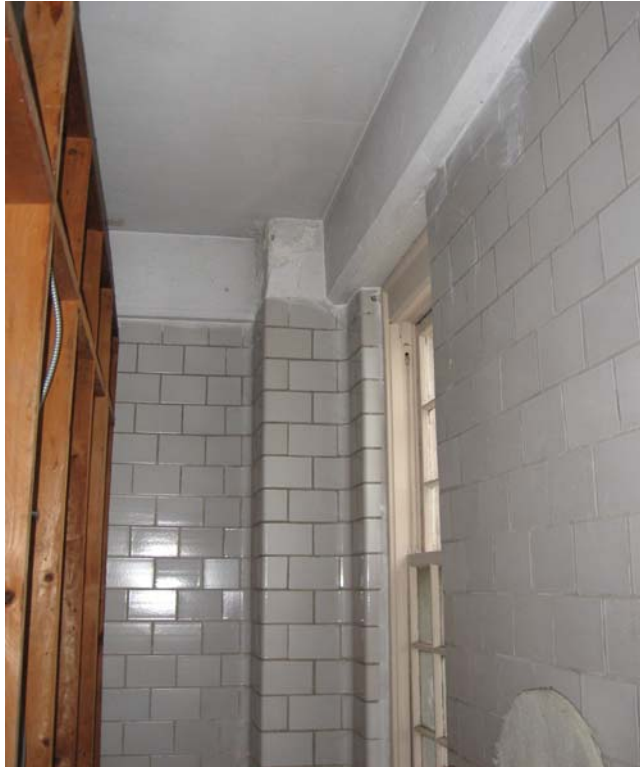
**Figure 3.27**

This photo shows the space between the existing modern lavatory partition (wood framed at left) and the period back wall of the lavatory space (glazed terra cotta wall tile). Photo is dated November 2006. (QUINN EVANS | ARCHITECTS)

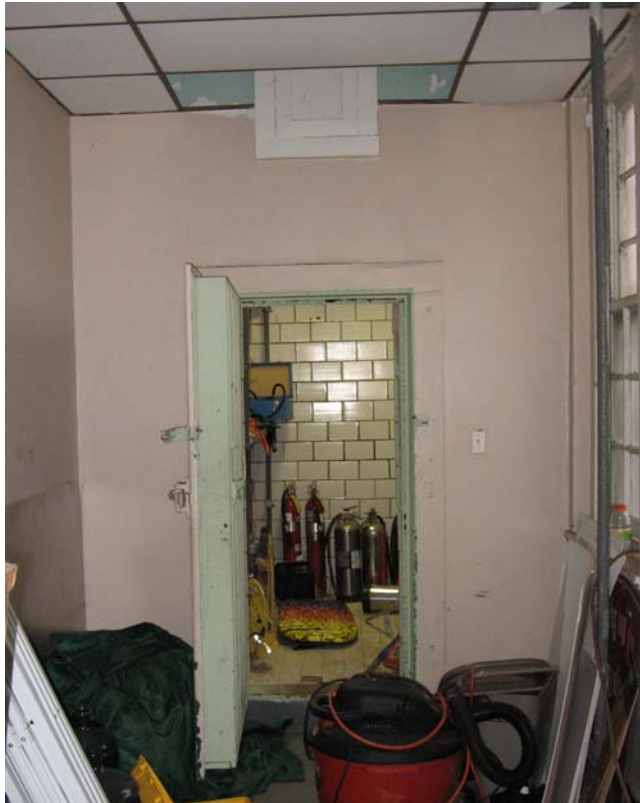
**Figure 3.28**

The period refrigerator is a specialty construction element that contributes to the character of the interior. It is defined by the glazed terra cotta tile and original door. Photo is dated November 2006. (QUINN EVANS | ARCHITECTS)

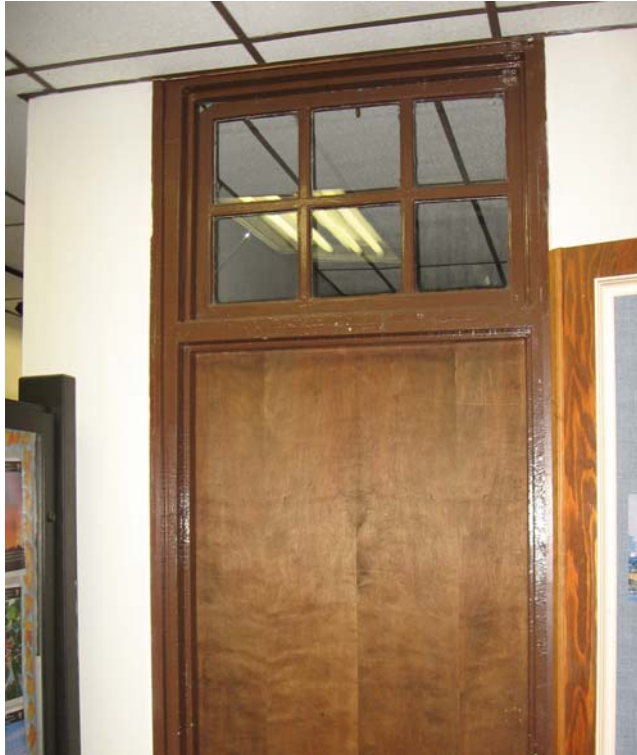
**Figure 3.29**

Typical, period metal door frame and metal transom with the non-contributing flush wood door. The transoms are hoppers and could be opened for ventilation. Photo is dated November 2006. (QUINN EVANS | ARCHITECTS)

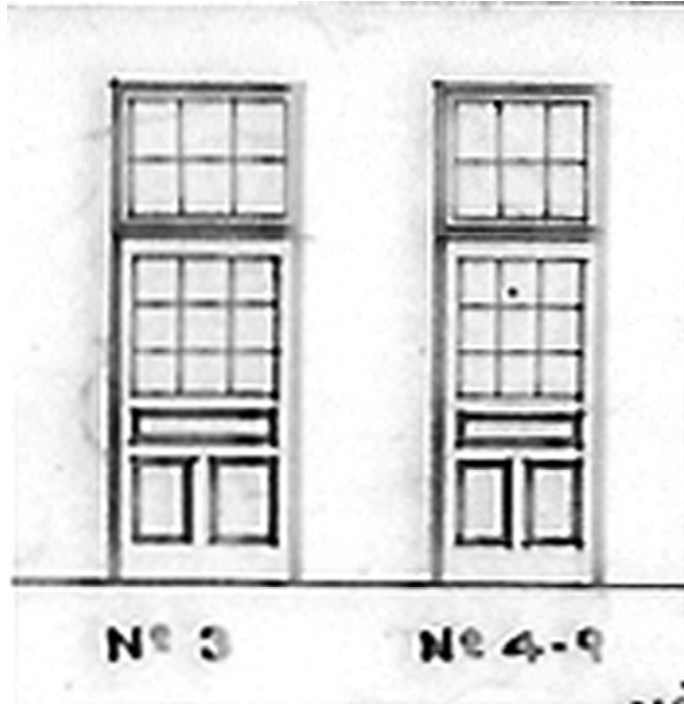
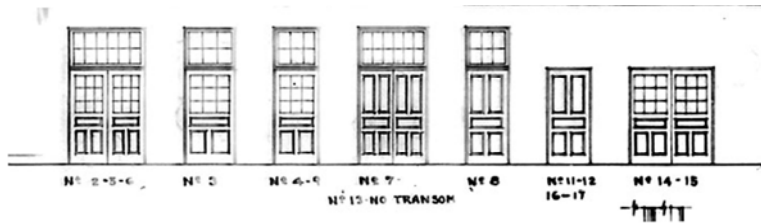
**Figure 3.33**

Door Elevation Details from Sheet Number 621-850, dated December 20, 1930. This drawing was prepared by the Office of the Quartermaster General prior the WPA involvement in the project, but provides the original design intent of the interior doors (refer to Appendix C under the U.S. Army Corps of Engineers – Office of History for additional details).

Almost all of the interior doors are not original, but many of the door frames and transoms in the common corridors are intact and should be retained. The metal door frames need to be stripped of paint in-situ and repainted. New doors more in keeping with the historic appearance are recommended in all openings. The design for the replacement doors can be based on the earliest historic drawings from 1930, which include elevations of the doors in the door schedule; refer to Figures 3.33 and 3.34.

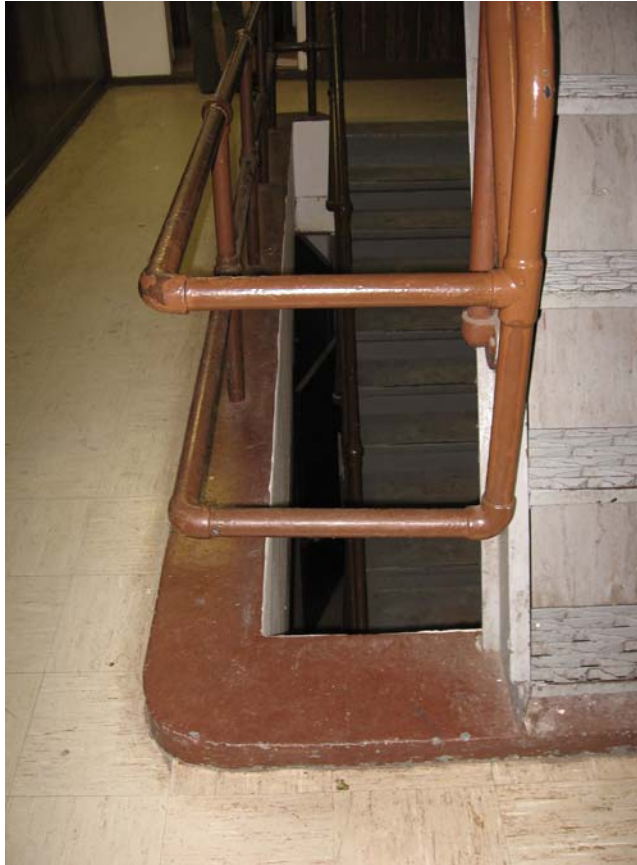
**Figure 3.35**

Photo of concrete stairs, painted concrete curb, steel ships ladder and pipe railing; period features of the building. Photo is dated November 2006. (QUINN EVANS | ARCHITECTS)

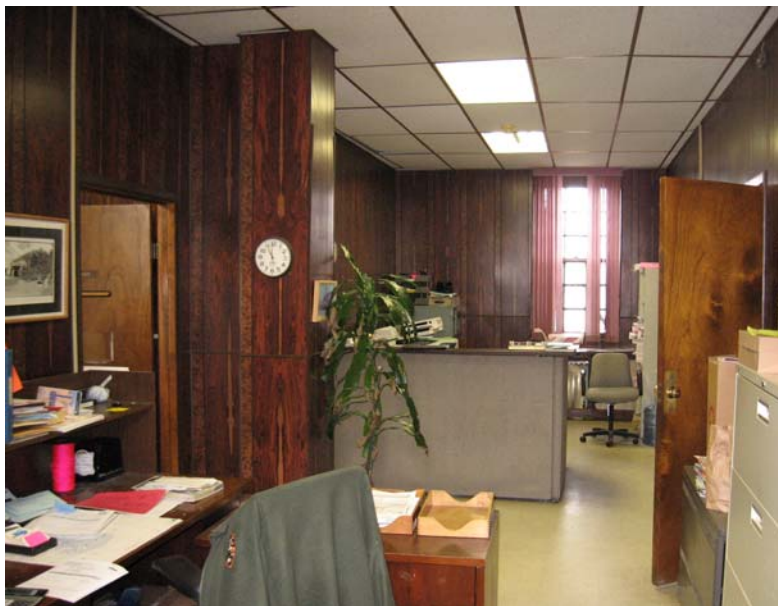
**Figure 3.35**

Example of typical suspended ceiling found on the first and second floors. Pre-finished plywood paneling has also been added to the walls and columns. These features are non-contributing and are incompatible with the period character of the building. Photo is dated November 2006. (QUINN EVANS | ARCHITECTS)

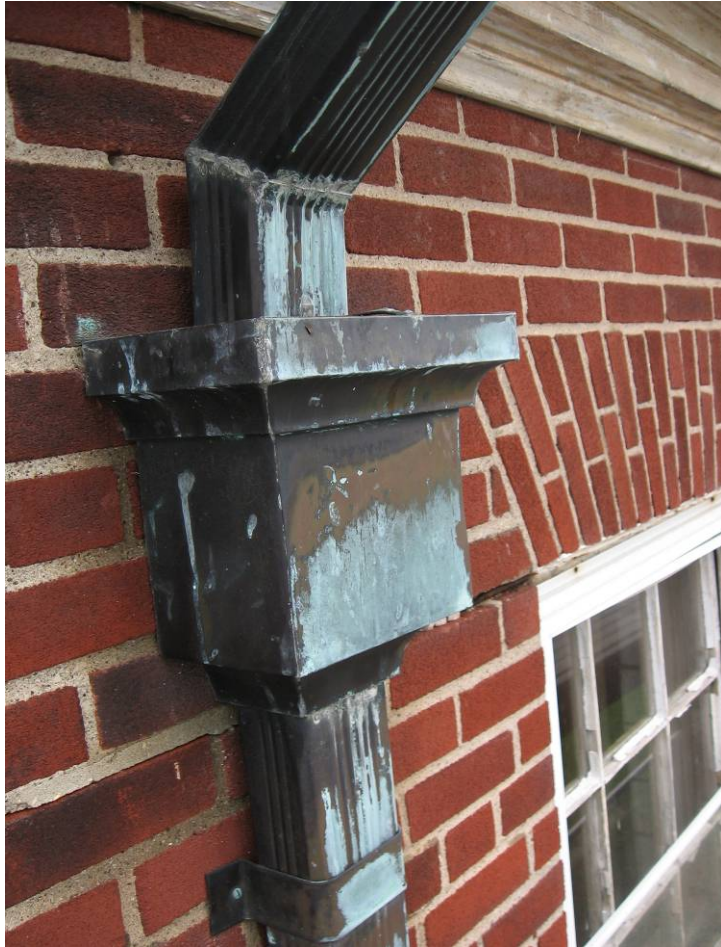
**Figure 4.18**

Photograph of period copper conductor and downspouts. Photo is dated November 2006. (QUINN EVANS | ARCHITECTS)

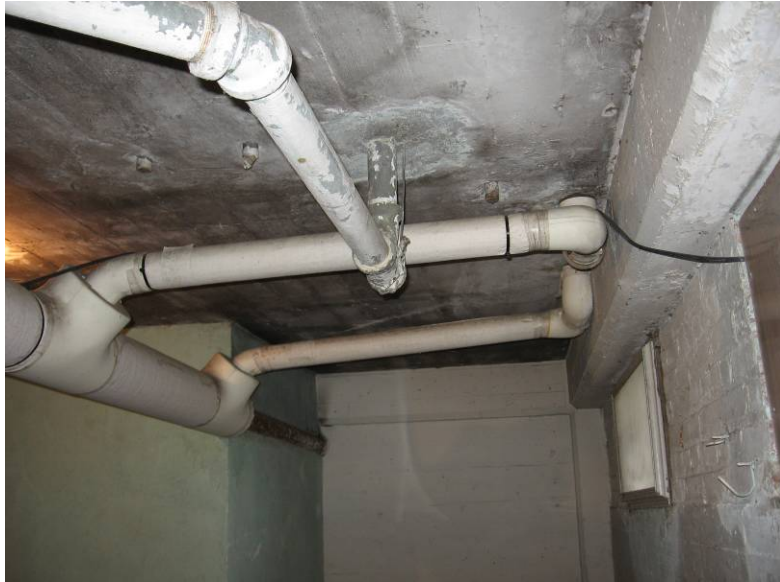
**Figure 4.20**

Flooring                                Building 1's interior flooring was originally concrete. The floor slabs were concrete, poured with two-by-four foot formwork. This pattern of the formwork is visible in the basement. These slabs appear to be in good condition and structurally sound. Refer to Figure 4.20.

Evidence of the planking formwork. Photo is dated November 2006. (QUINN EVANS | ARCHITECTS)

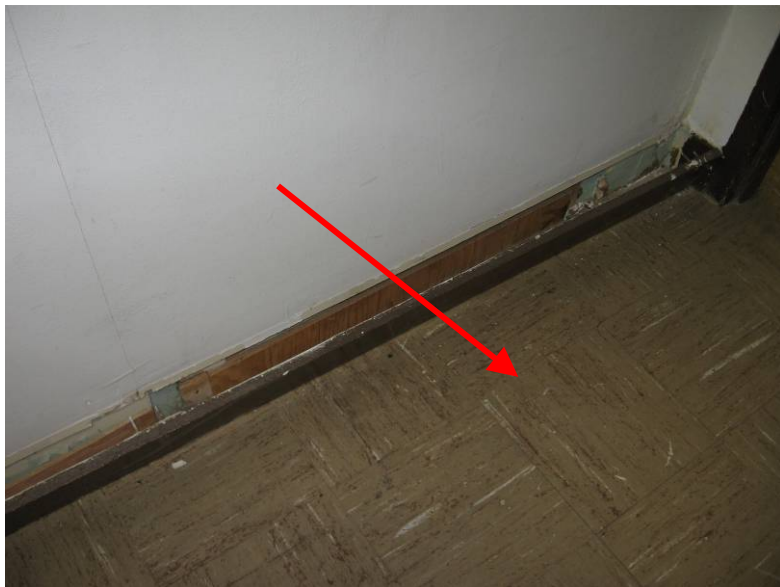
**Figure 4.21**

Most of the concrete floor has been concealed with 12" by 12" vinyl composition tile (VCT) that is non-contributing. The overall condition of the concrete flooring is good. However, the vinyl composition tile is generally in poor condition. Many tiles are cracked, missing, or loose. Tiles are generally quite worn. Refer to Figure 4.21.

This image illustrates the typical vinyl composition tile (VCT) that is typical throughout all of Building 1. Photo is dated November 2006. (QUINN EVANS | ARCHITECTS)

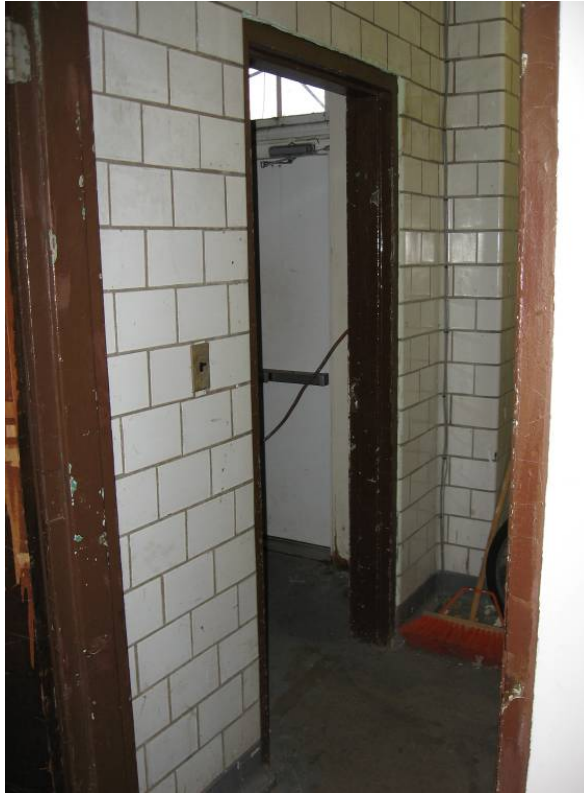
**Figure 4.24**

The glazed terra cotta tile that remains in the first floor storage locker is in fair condition and has no evidence of any cracking or crazing. Refer to Figure 4.24.

Period glazed terra-cotta tile in the passage from the historic pantry to the kitchen is in good condition. Photo is dated November 2006. (QUINN EVANS | ARCHITECTS)

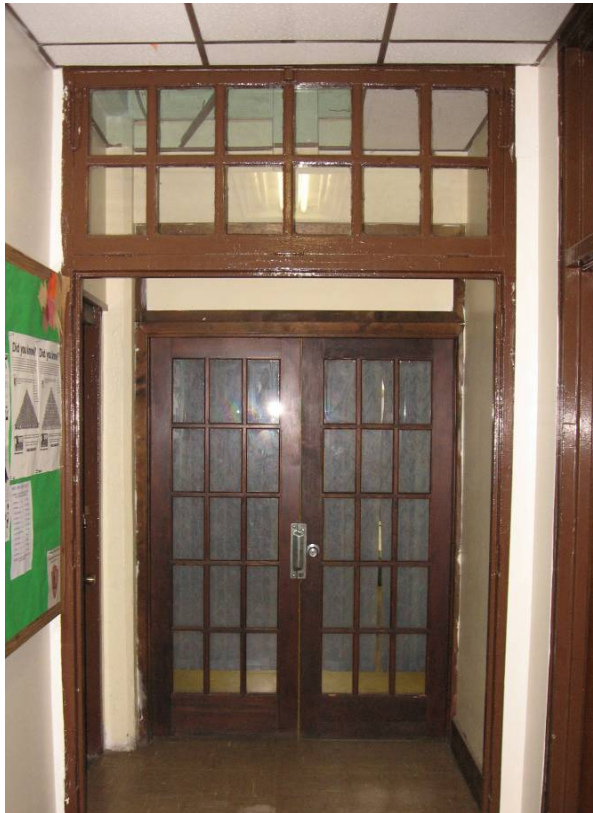
**Figure 4.25**

Almost all of the interior doors in Building 1 are not original and thus modern non-contributing components. However, the metal door frames are period and are in fair condition. In general the modern interior doors are in poor condition. There are many different door types of varied quality and age installed throughout the building. Some have been more abused than others and some have water damage. Those were set within the period metal door frames do not match and appear cheap in quality next to the heavy frames. The period transom windows that remain have been painted multiple times. Refer to Figure 4.25.

Period metal interior double door transom with multiple layers of paint in the foreground; non-period door pair in background. Photo is dated November 2006. (QUINN EVANS | ARCHITECTS)

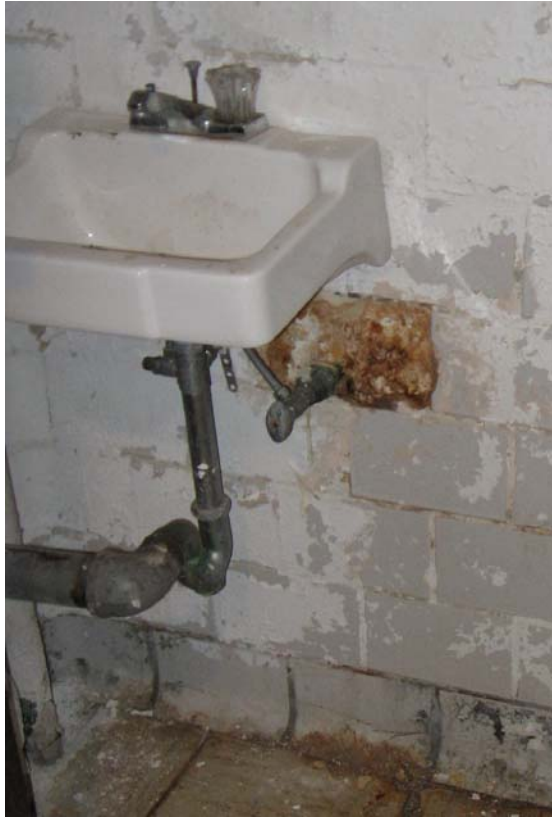
**Figure 4.28**

- On the second floor, the staff facilities are a mixture of fixtures dating from different eras. There is a single water closet and small lavatory that barely works, appears to be part of the original design and may include a period lavatory. Refer to Figure 4.28. Other modern fixtures were added and appear to be located where the period pieces were originally. The southern wall of the lavatory was constructed 3 feet off the perimeter wall. In this space the period urinals remain. Refer to Figure 4.29. The raised shower slab still remains and has been enclosed; it now functions as a telephone closet.

A period lavatory located on the second floor. Photo is dated November 2006. (QUINN EVANS | ARCHITECTS)

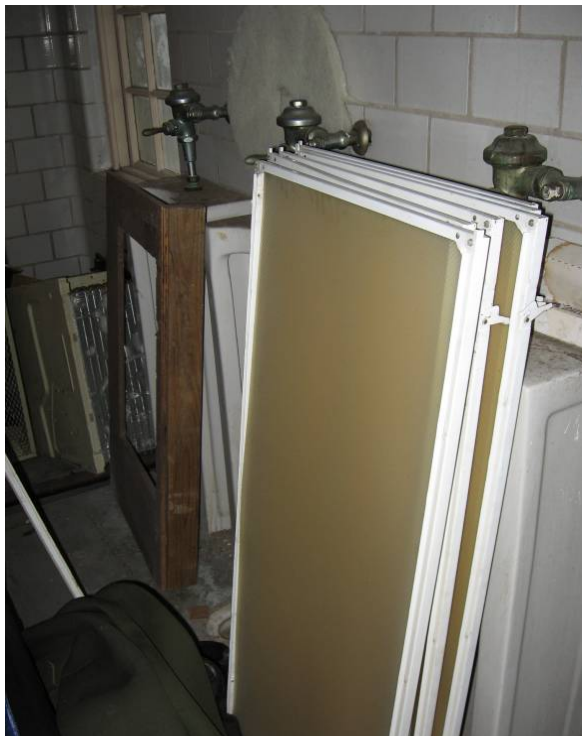
**Figure 4.29**

Period urinals that have been abandoned in the second floor bathroom. Photo is dated November 2006. (QUINN EVANS | ARCHITECTS)
