113/D-SS3  
Grand Canyon

# Yavapai Observation Station

Historic Structure Report

*prepared by*  
Architectural Resources Group  
Architects, Planners & Conservators, Inc.  
San Francisco

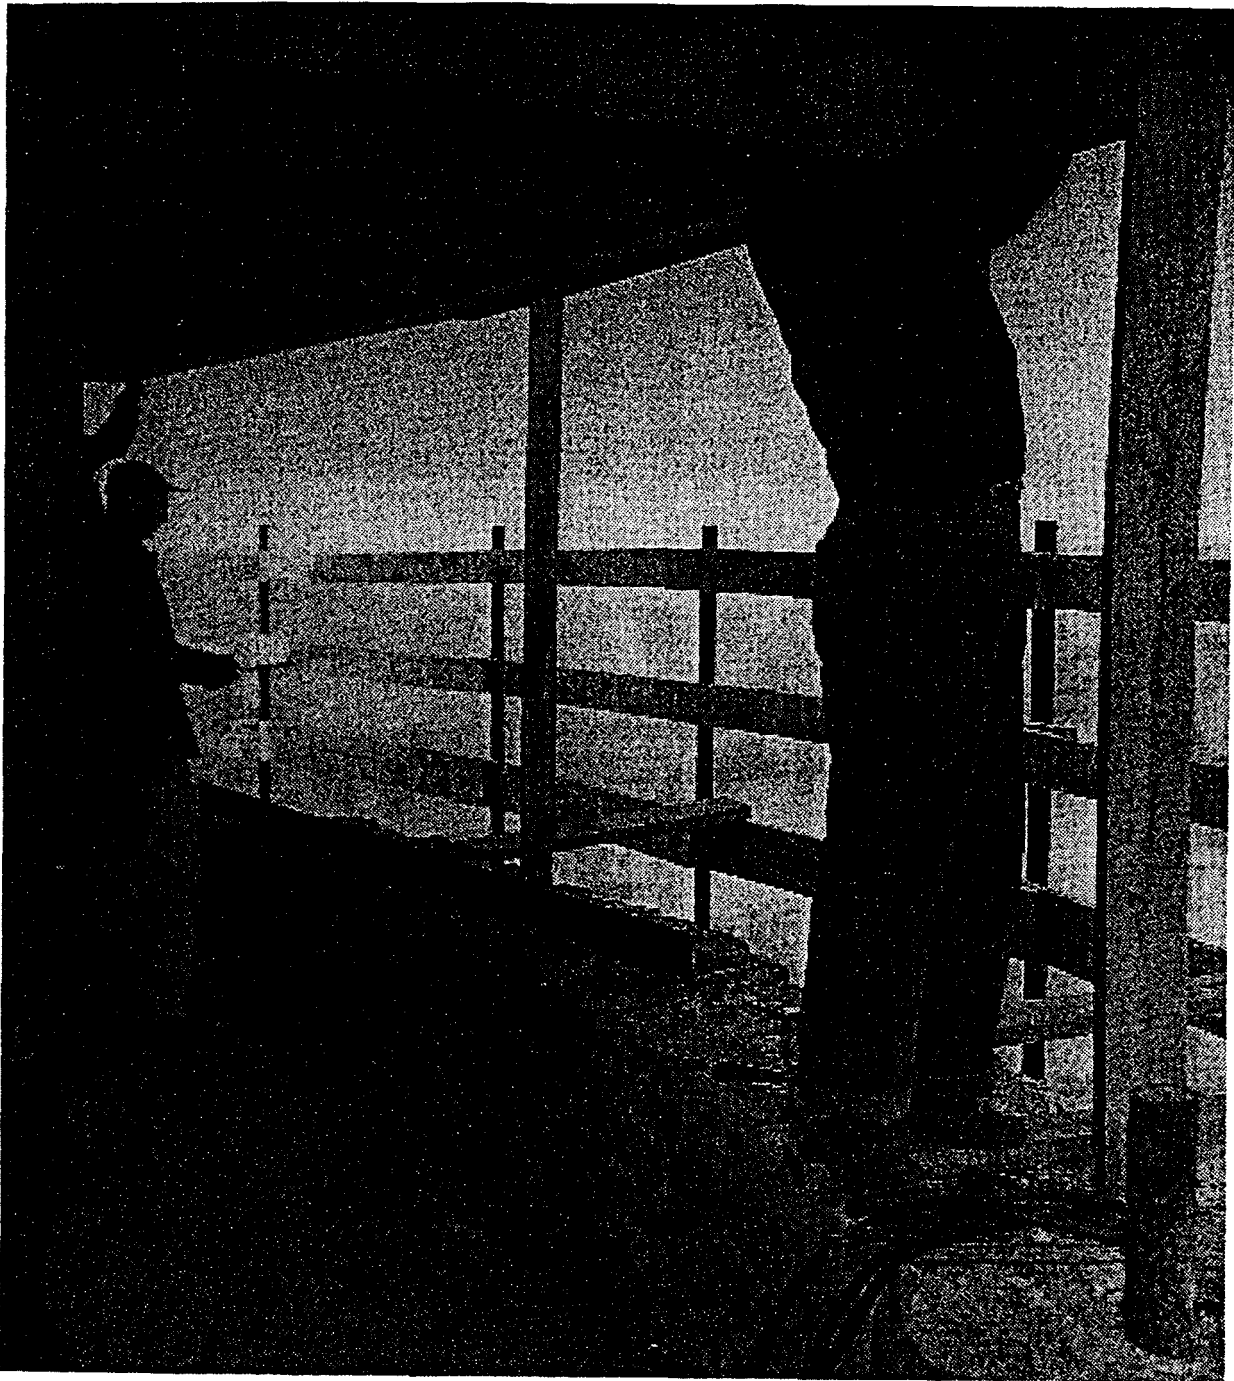
*Figure 36. This photo depicts alterations in progress at the Yavapai Observation Station. The rehabilitation involved a reduction of the roof overhang, raising of the parapet, and installation of glass in the window openings. Photo is dated January 23, 1953. GCNPA Photo Number 2415.*

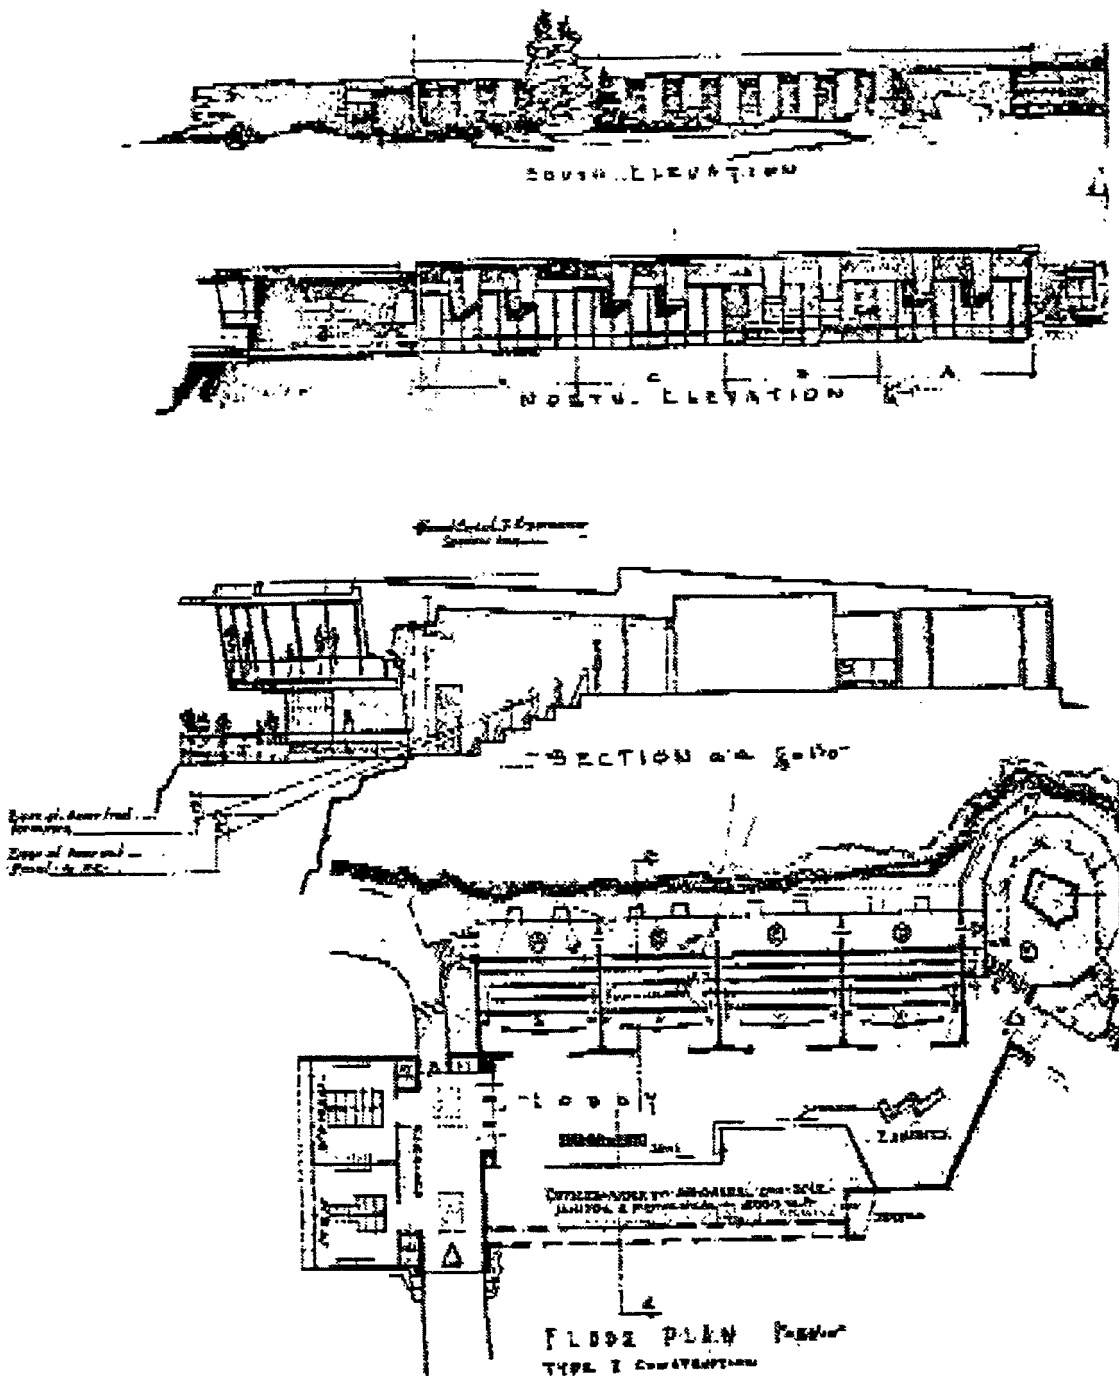
a replacement building was a well developed concept and nearly became a reality. Plans for the proposed Yavapai facility were prepared by Cecil Doty, architect of the Grand Canyon South Rim Visitor Center. (see Appendix E, Figures 46, 47) It was thought that a new interpretive facility was needed to accommodate an increasing numbers of visitors, approximately 15,000 persons a day, and that the only solution was new construction on the same site, as opposed to expansion or alteration of the existing building. The proposed Yavapai Interpretive Facility was intended to provide restrooms, a lounge, a lobby, auditoriums, indoor viewing of the Canyon year-round, minimal office and storage space, and information services. The Construction Proposal went on to state:

Figure 46. The image illustrates elevations, a section and a floor plan by Architect Cecil Doty for the proposed construction of the Yavapai Interpretive Facility, a Mission 66 facility, dated 1966. The proposed project was intended to be sited at Yavapai Point on the location of the existing Yavapai Observation Station, but was never realized. GCNP Archives.

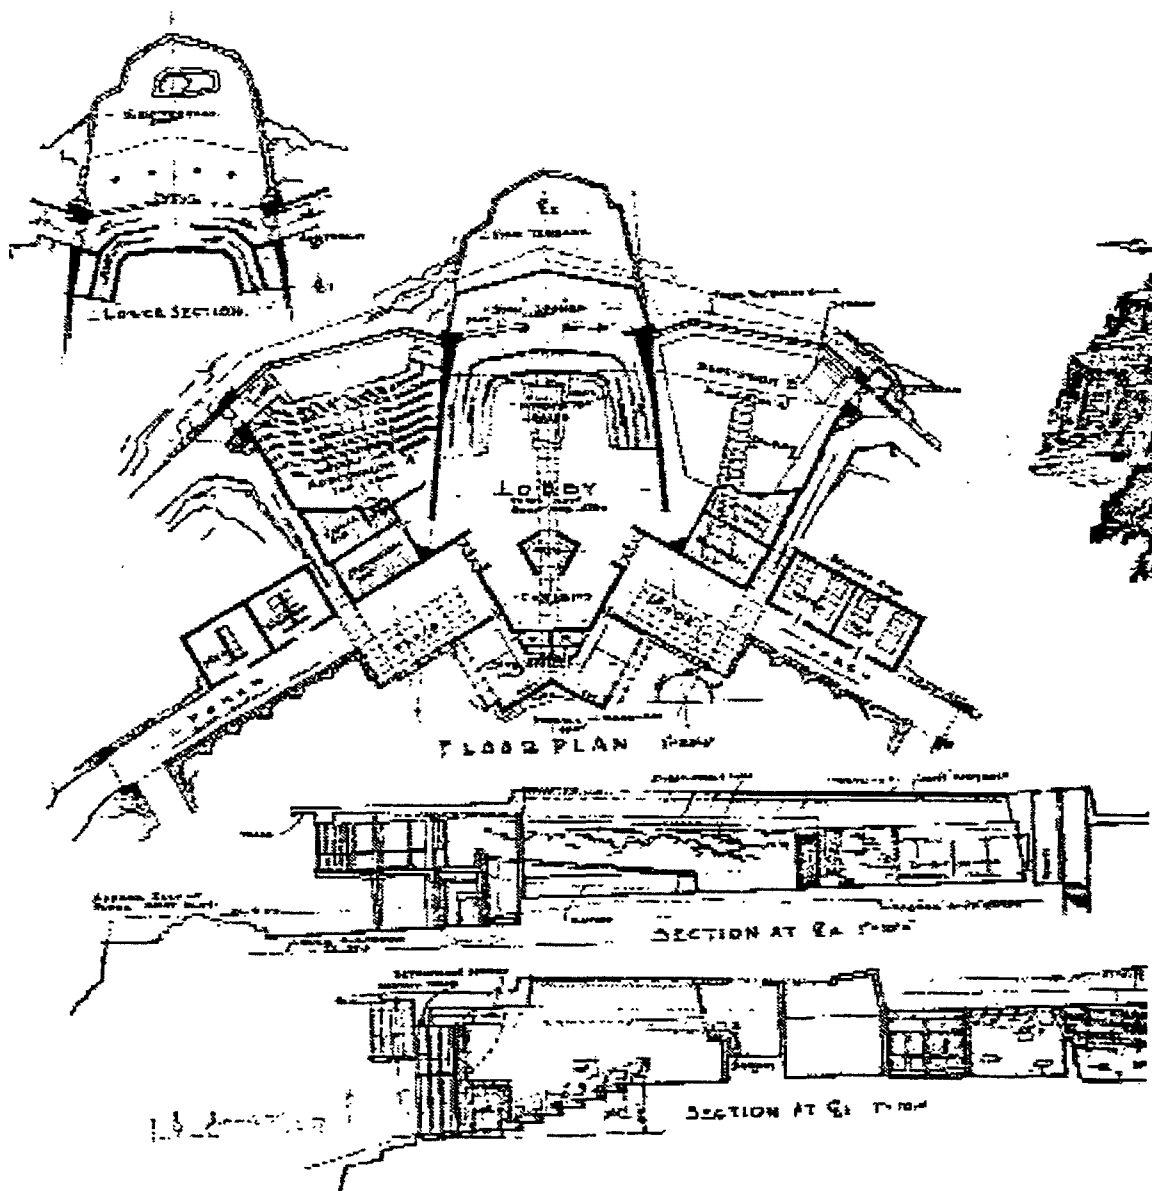
Figure 47. The image illustrates sections and floor plans by Architect Cecil Doty for the proposed construction of the Yavapai Interpretive Facility, a Mission 66 facility, dated 1966. The proposed project was intended to be sited at Yavapai Point on the location of the existing Yavapai Observation Station. Its construction would have required the demolition of the existing building. GCNP Archives.

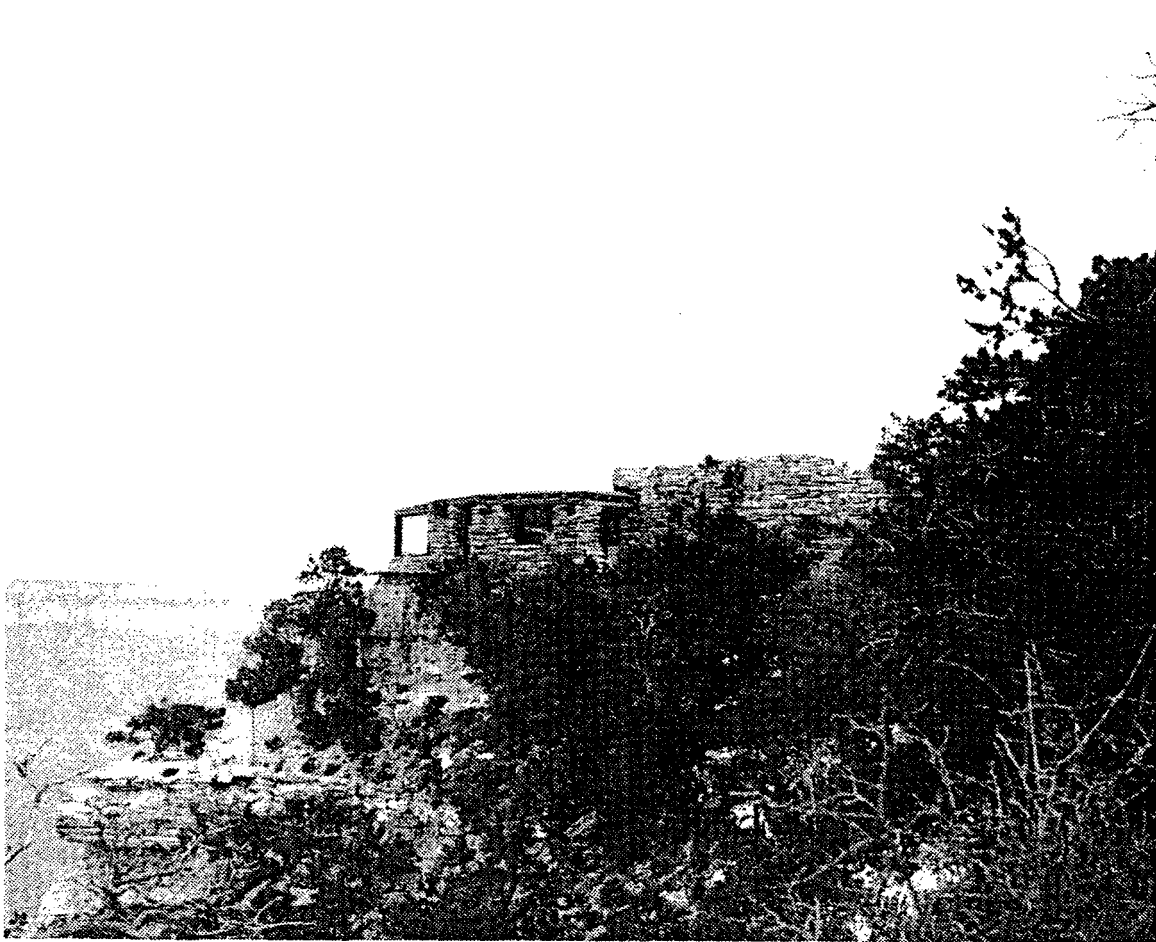
*Figure 50. - The image shows the west elevation of the Yavapai Observation Station illustrating the building's existing profile and glazing. See Figure 5 for a historic view from the same angle that dramatizes the depth of the roof overhang as it was originally constructed. Photo provided by Paul Cloyd at NPS. Photo dated February, 1989 by Jacilee Wray.*

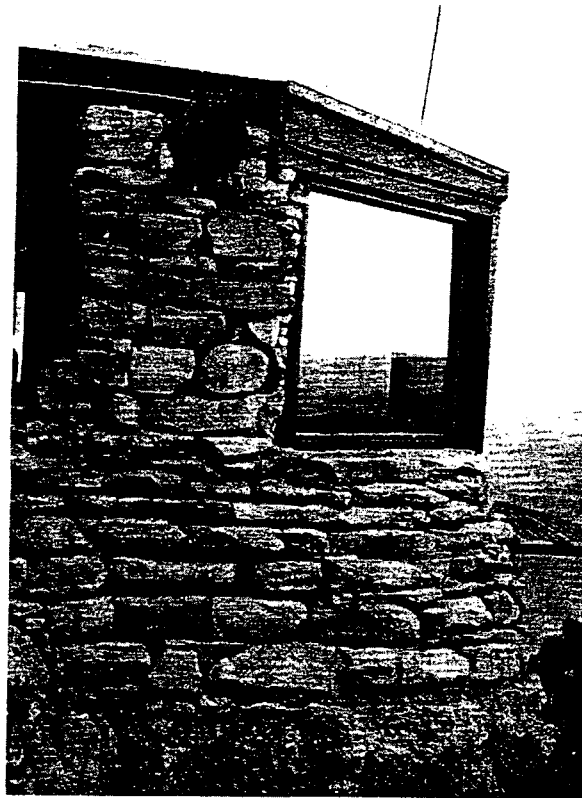
*Figure 57. - The image shows the exterior of the east window of the observation room of the Yavapai Observation Station. Note the addition of rock chinking. Photo dated February, 1989 by Jacilee Wray.*

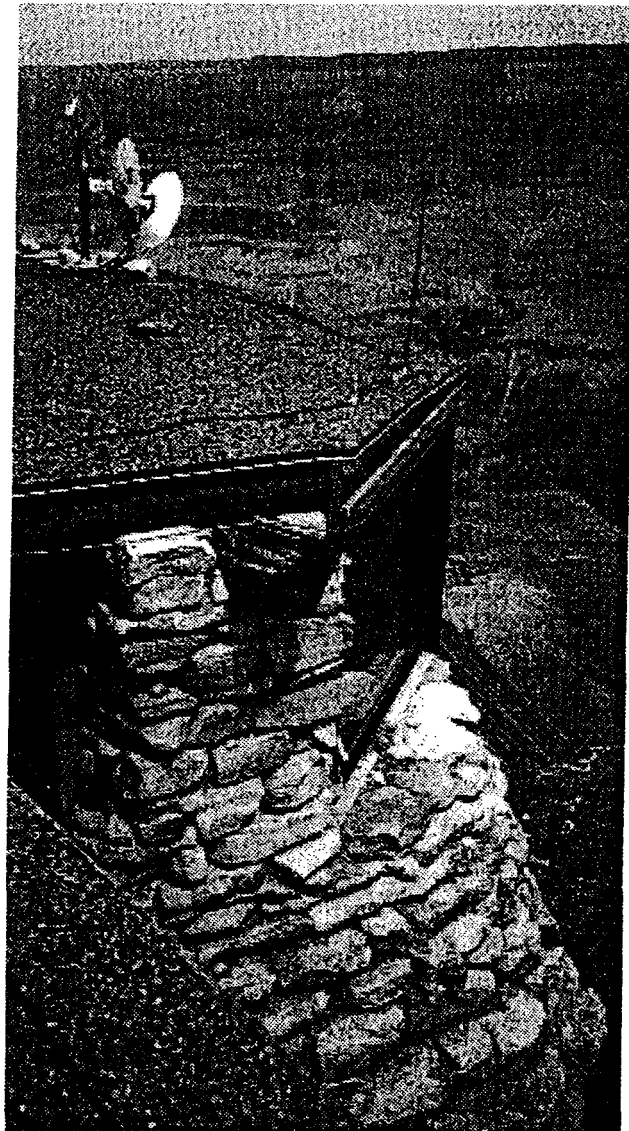
Situated on a prominent point on the South Rim of the Grand Canyon, the building's dramatic siting on the Canyon edge is integral to its design and expression (see **Appendix F, Figure 1**). Flat-roofed and built low to the ground, the one-story stone structure was designed to be particularly unobtrusive in its Canyon rim setting. The structure is located two miles north of the South Entrance Station and half a mile east of the Grand Canyon Village.

*Figure 1. This image illustrates the unique relationship between the Yavapai building and the canyon below. Antennas and dishes on the roof were installed as part of Y2K compliance but are temporary and will be moved when the building is rehabilitated. View is looking down at the eastern corner of the north elevation. Photo dated May, 2000.*

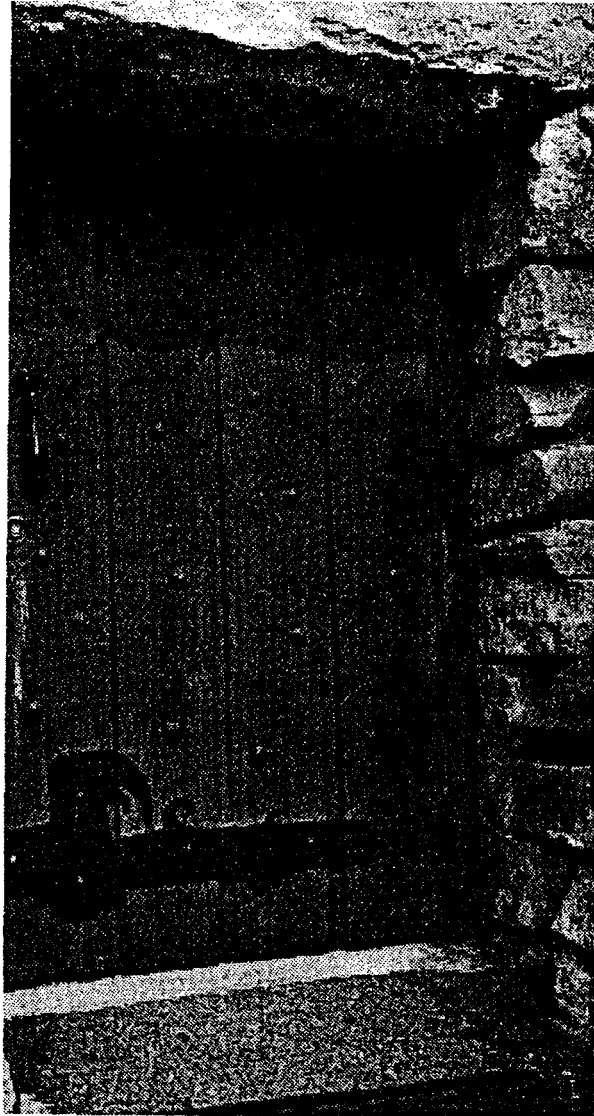
The structure's walls and foundation are principally constructed in native Kaibab limestone boulders. The roof is tar and gravel. Wood is used throughout, in the timber beams, projecting rafters and carved doors rough cut wood siding, laid vertically around the entrances. There are four exterior doors to the building (see **Appendix F, Figures 2, 3**).

*Figure 2. This image depicts the east-facing door just behind the south elevation. This door leads into the back of the shop, formerly the exhibit room. The strap hinge depicts a stylized eagle head. Rounded iron bolts are ornamental. There is no stair, rather the ground slopes up to the threshold. Photo dated May, 2000.*

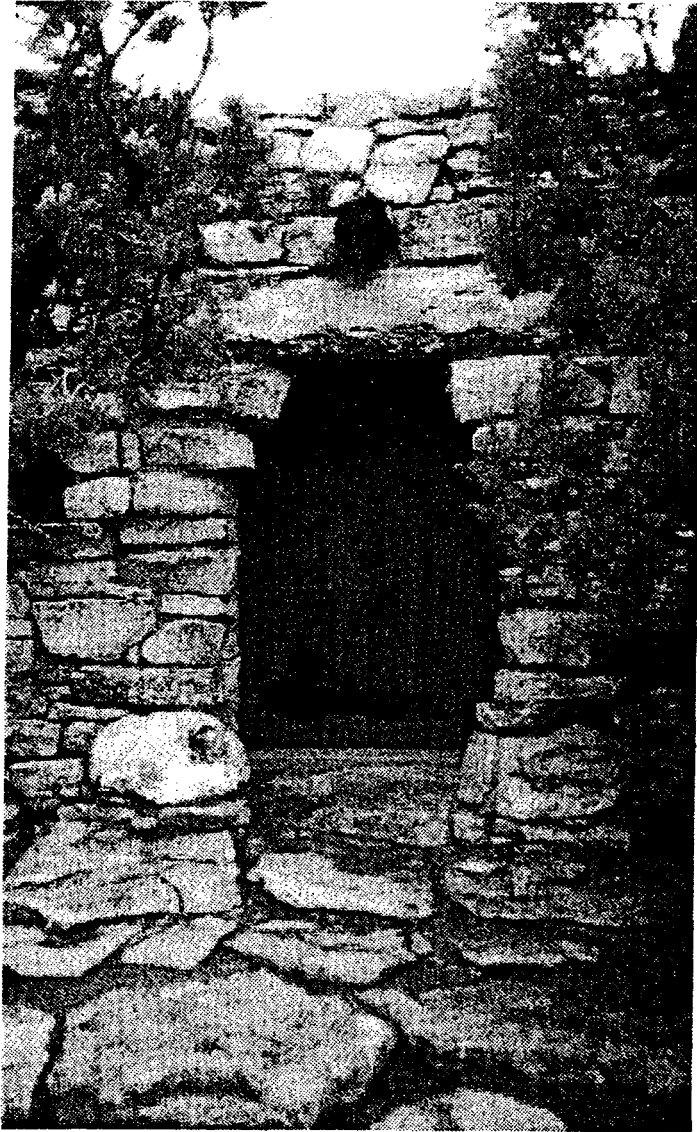
*Figure 3. This image illustrates the entrance on the south side of the building. Photo dated May, 2000.*

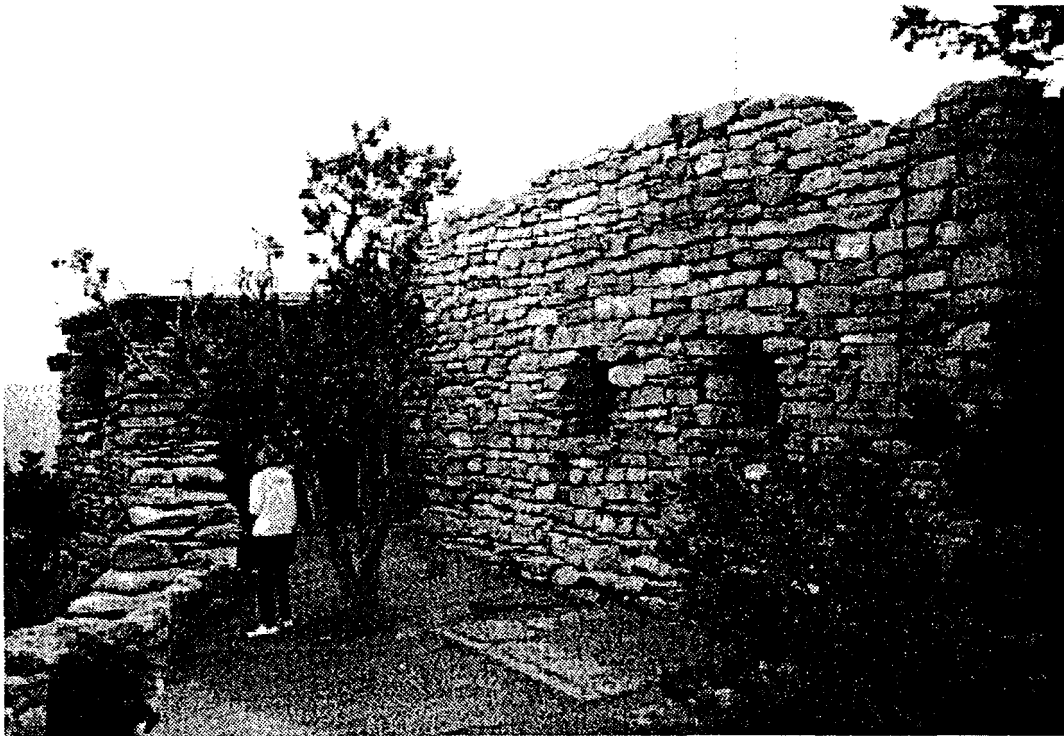
*Figure 4. This image illustrates the west side of the Yavapai building. Photo dated May, 2000.*

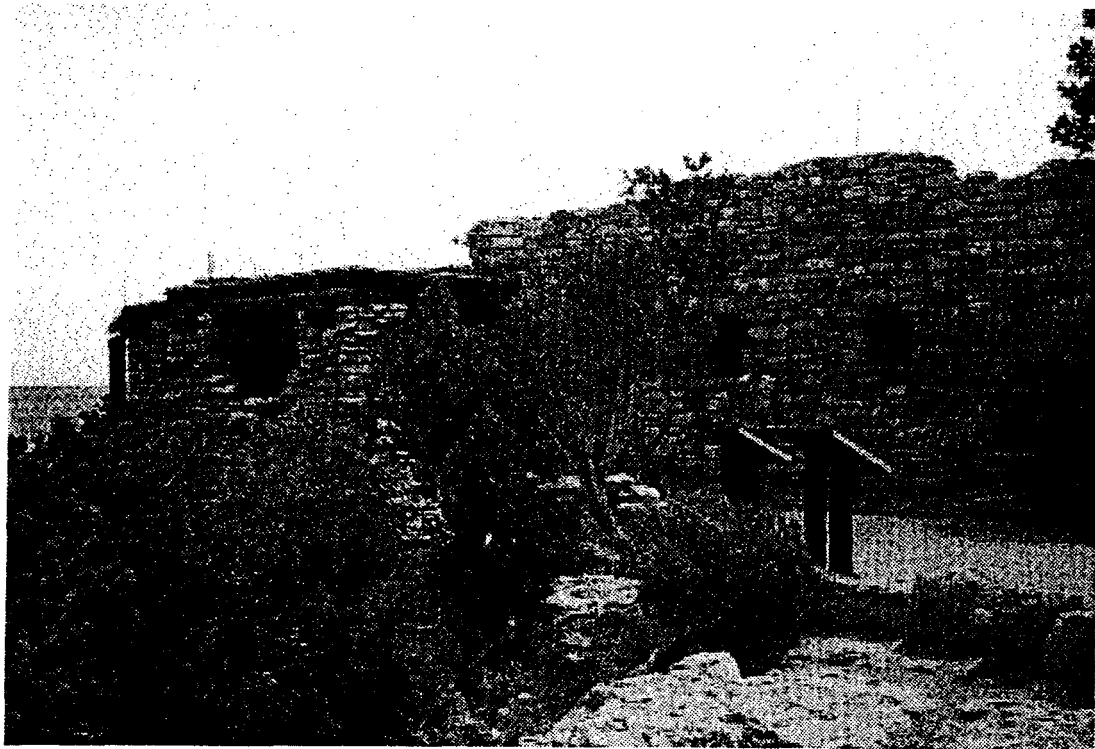
*Figure 5. This image illustrates the western elevation of the Yavapai building. Photo dated May, 2000.*

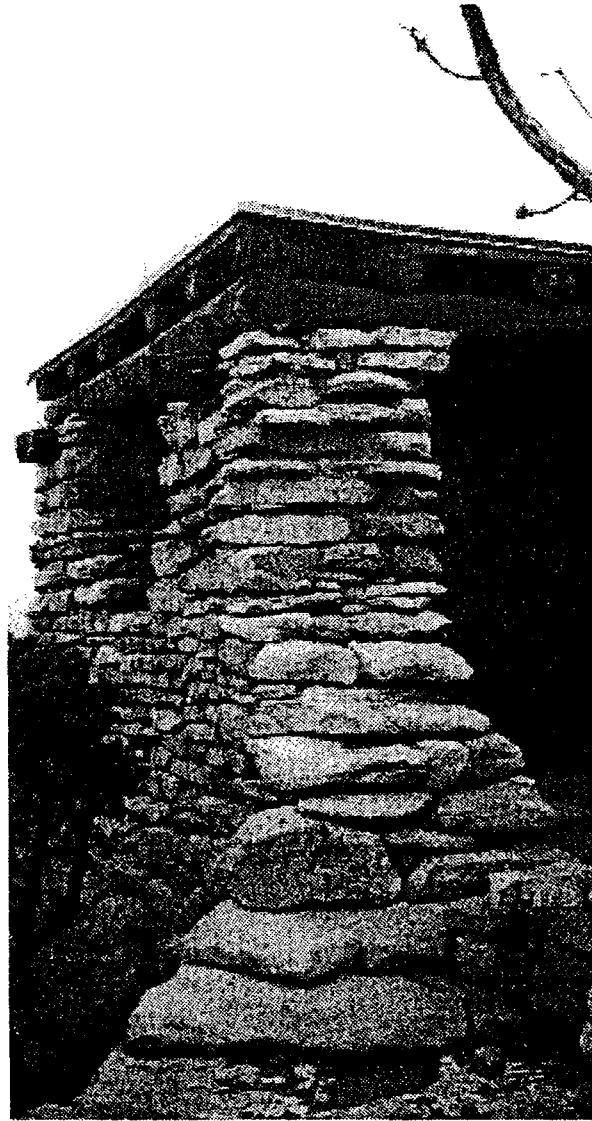
*Figure 6. This image illustrates the native Kaibab stone at the corner pier and west elevation near the west entrance. Mortar was set so as to be invisible between the joints and stones were laid to look as if the pier was constructed without mortar. View is looking toward the north. Photo dated May, 2000.*

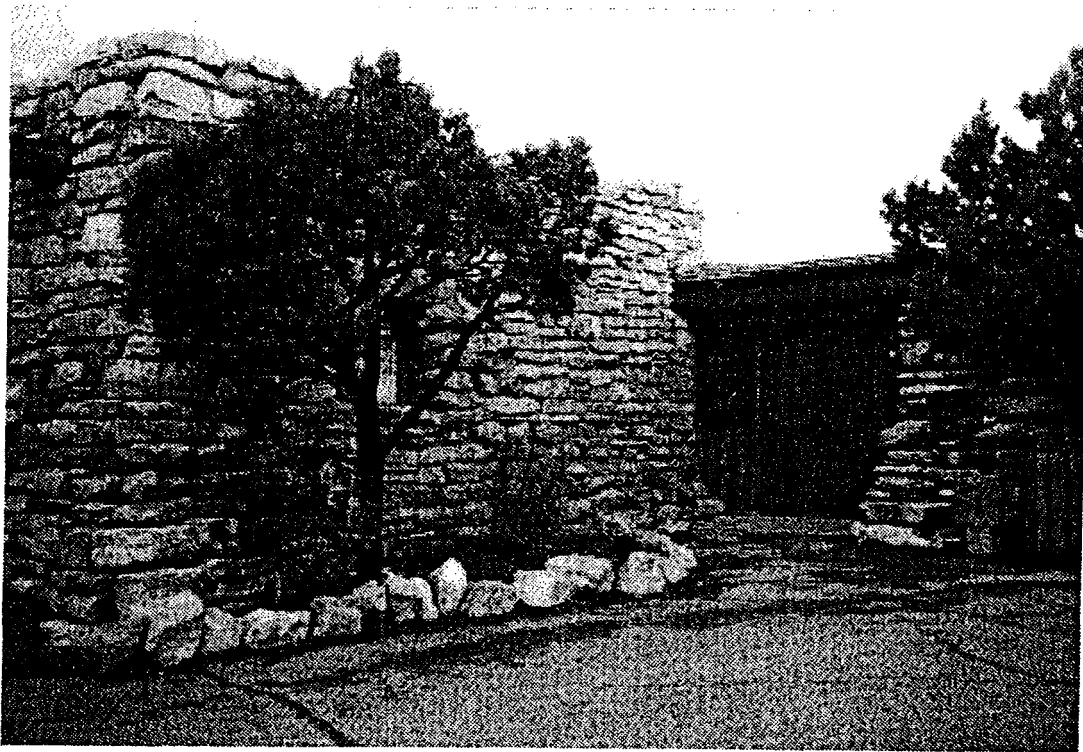
one small opening, now closed with a wood louver, toward the southern side of the building and three larger expanses of glass toward the canyon side. More pronounced at the east elevation are flared out lower courses of the stone walls; this corner treatment serves to mediate any sharp corners and soften the building's profiles (see Appendix F, Figure 7).

*Figure 7. This image illustrates the east elevation of the Yavapai Observation Station. View is looking the northwest. Photo dated May, 2000.*

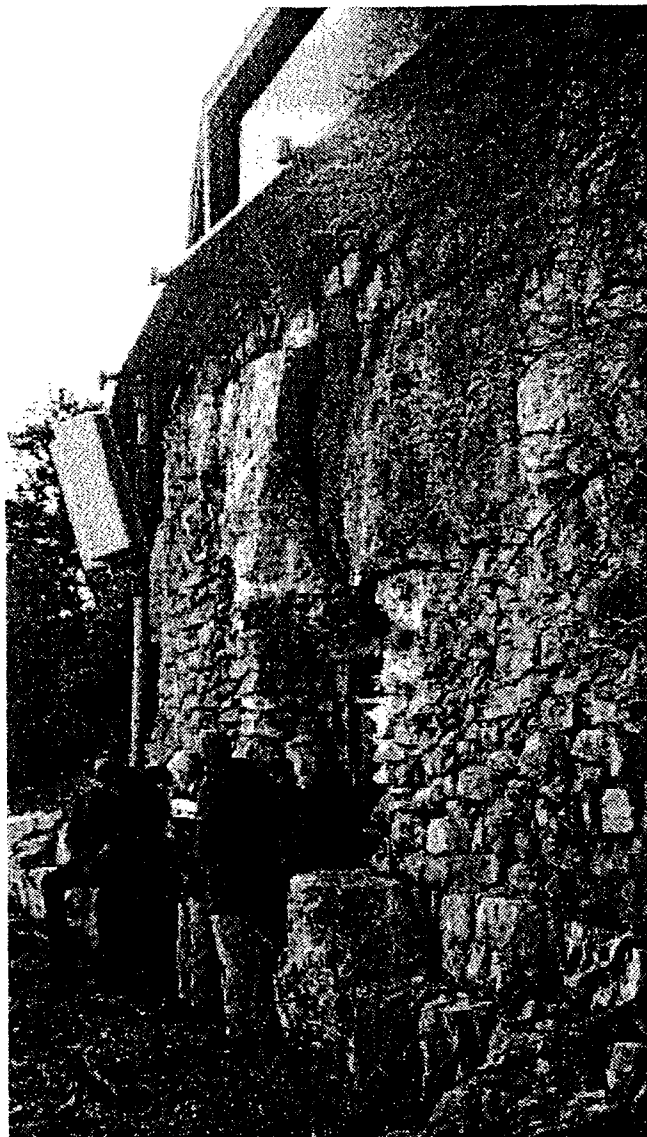
The north elevation dramatically rises straight up from the line of the sheer canyon wall below it (see Appendix F, Figure 8). The defining feature of this elevation are the five large picture windows which form the northern facade.

*Figure 8. This image illustrates the lower northern side of the Yavapai exterior.  
Photo dated March, 2000.*

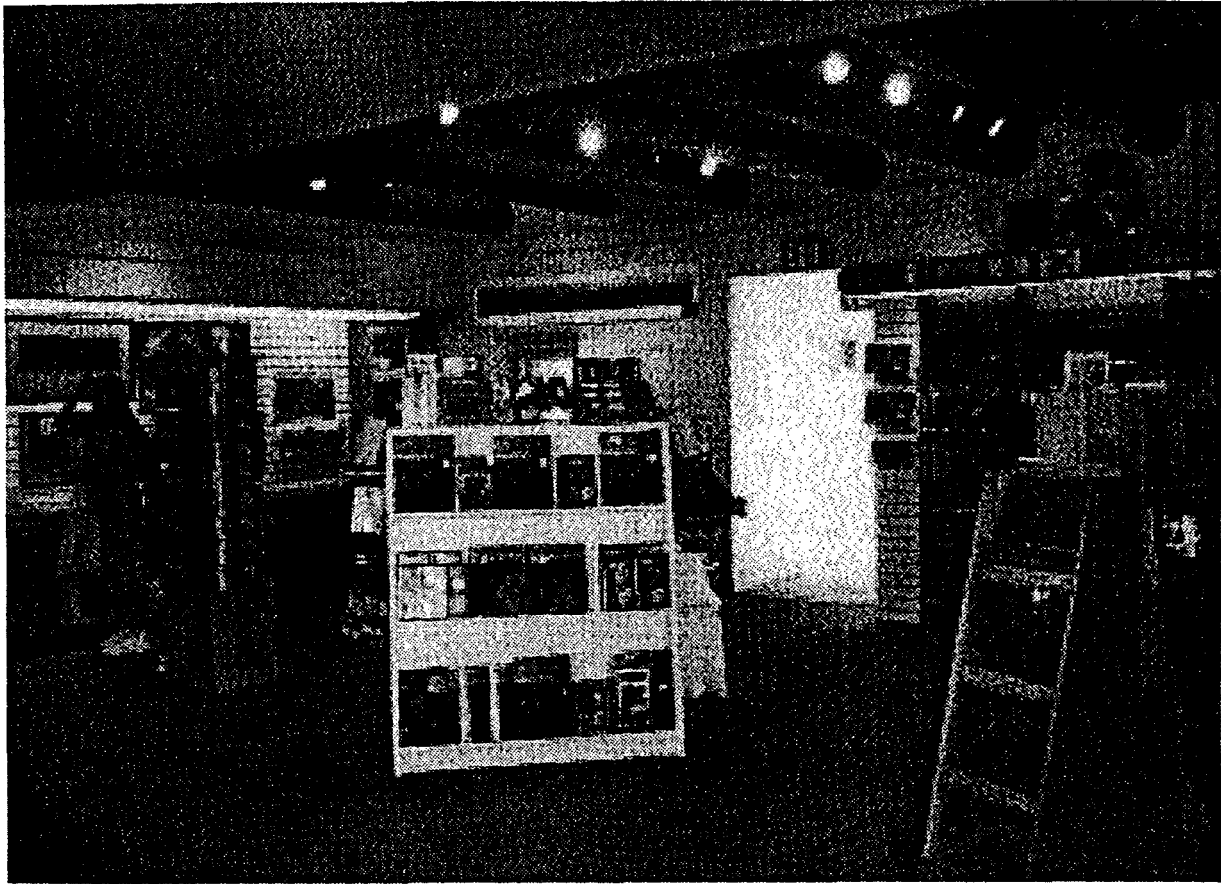
*Figure 10. This image illustrates the interior toward the back of the Yavapai Observation Station. Much of the floor space is given over to the bookstore function: a cash register, check-out desk, free-standing laminated blonde wood book racks, plastic laminate display and shelving system, and fluorescent uplighters and under-soffit strips. Articles for sale are books, framed photographs, videos, postcards and calendars. With the exception of the ceiling rafters, very few original finishes or features are visible. Photo dated May, 2000.*

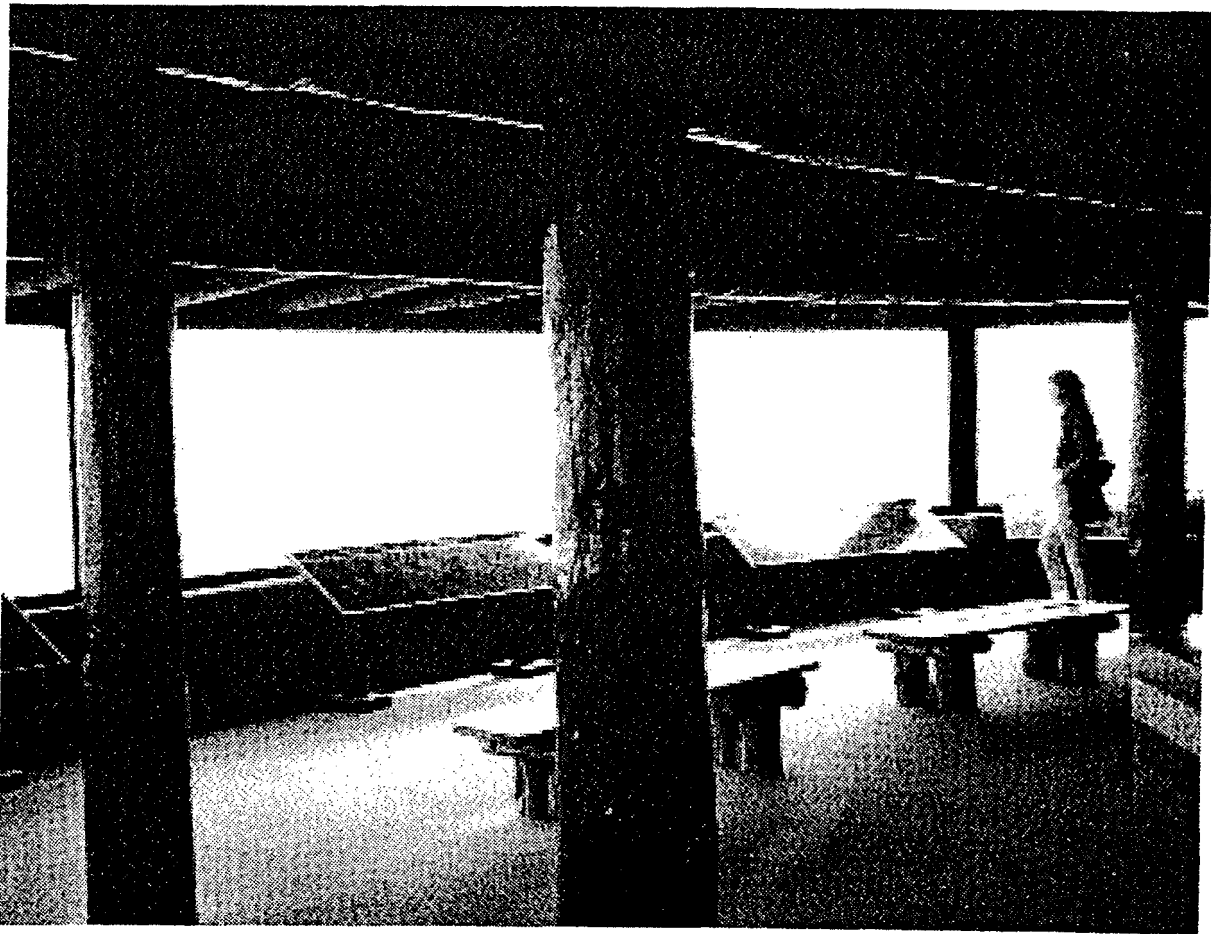
*Figure 11. This image illustrates the northern side of the Yavapai interior. As opposed to the bookstore function of the back half of the interior, the north side of the interior provides space for viewing the canyon. The timber columns on the interior are original. Photo dated May, 2000.*

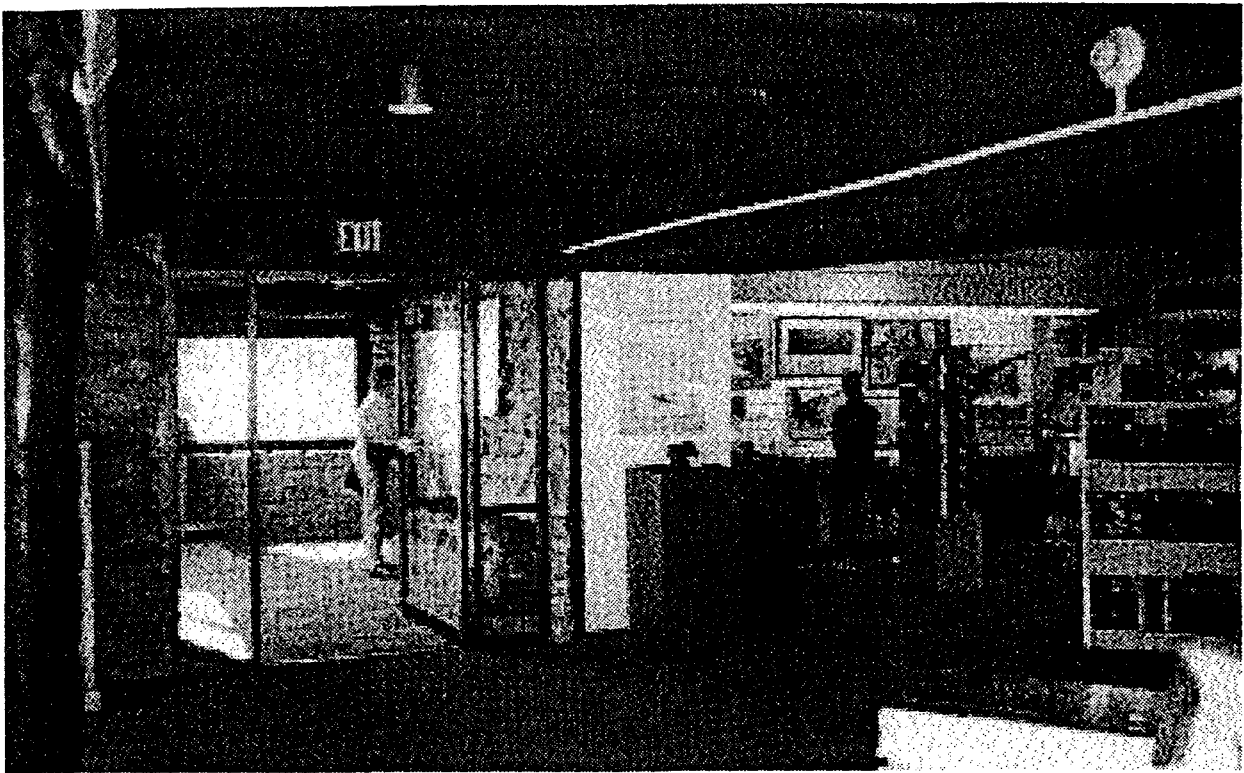
*Figure 12. This image illustrates the eastern side of the Yavapai interior and the eastern entrance where glass doors have been installed. Photo dated May, 2000.*

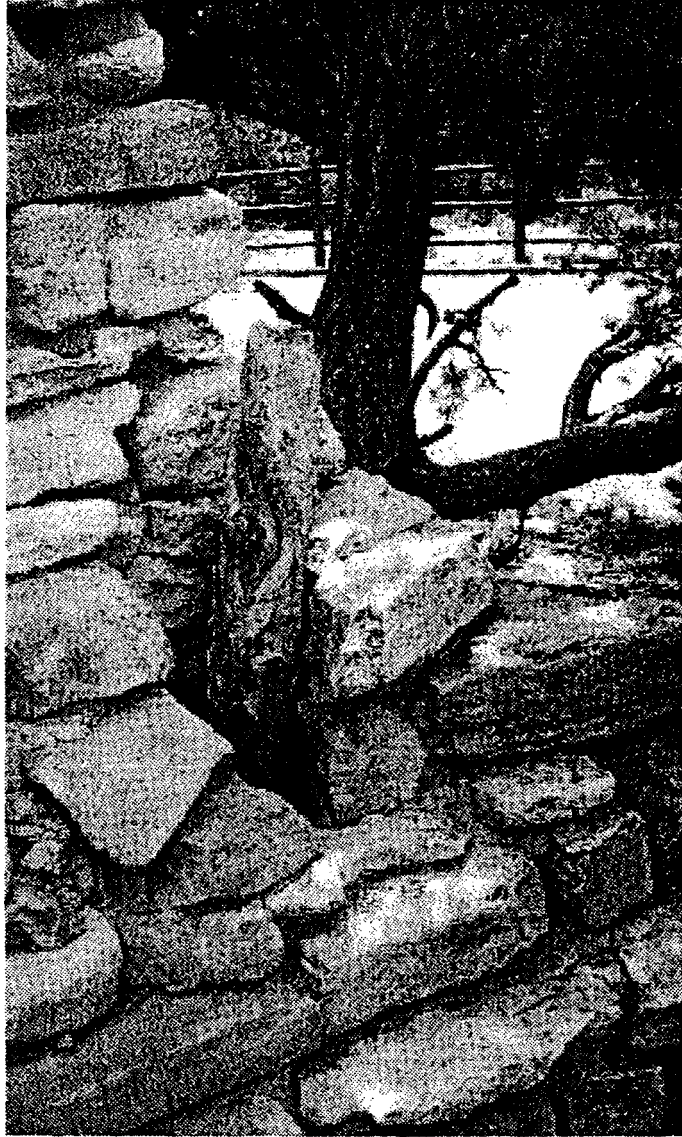
*Figure 14. This image illustrates the tree well on the west side of the building, though the tree is no longer extant. Maier, ever sensitive to the surrounding landscape, incorporated this unplanned feature into the building during construction to accommodate an existing tree rather than cut it down. Photo dated May, 2000.*

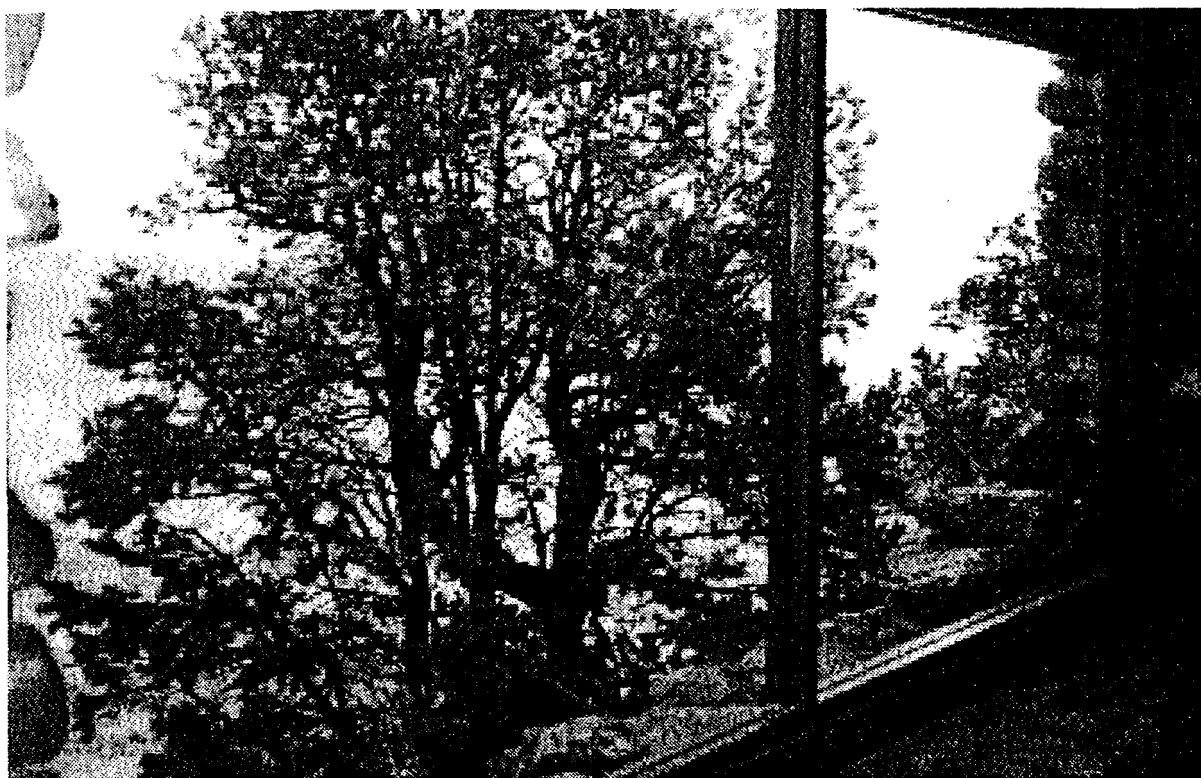
*Figure 18. This image illustrates the windows on the east side of the Yavapai interior, inside the foyer entrance. The windows were installed in 1979, replacing the 1953 glazing. The windows look to the north. Photo dated May, 2000.*

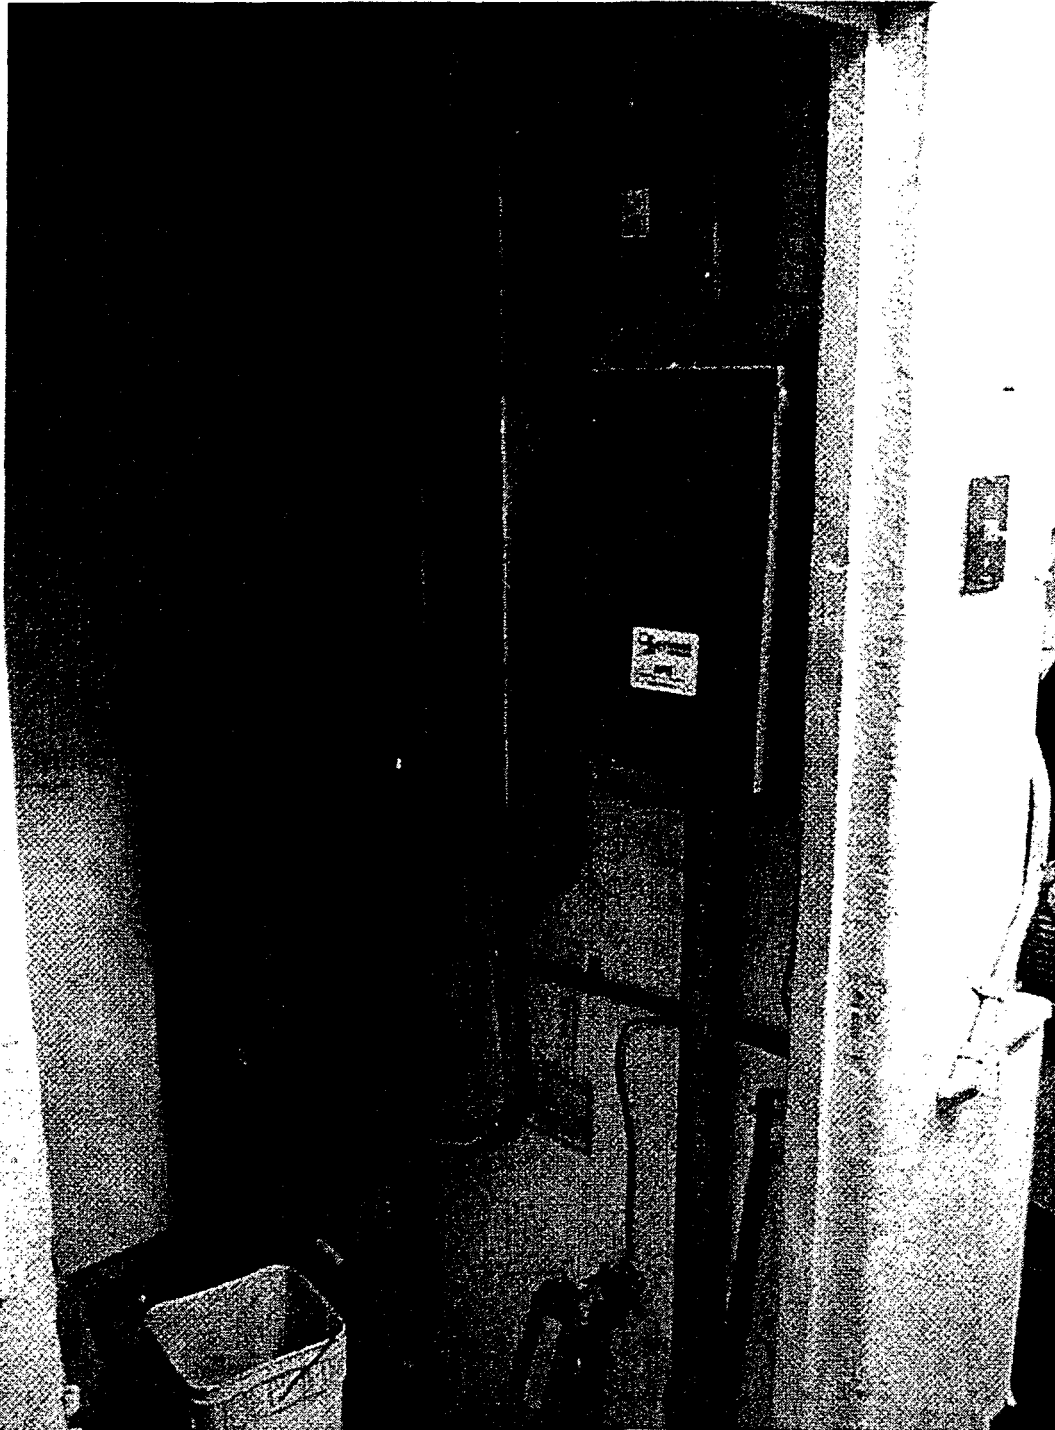
2: Electrical Panels

All existing panelboards should be replaced with new panels during the renovation phase.

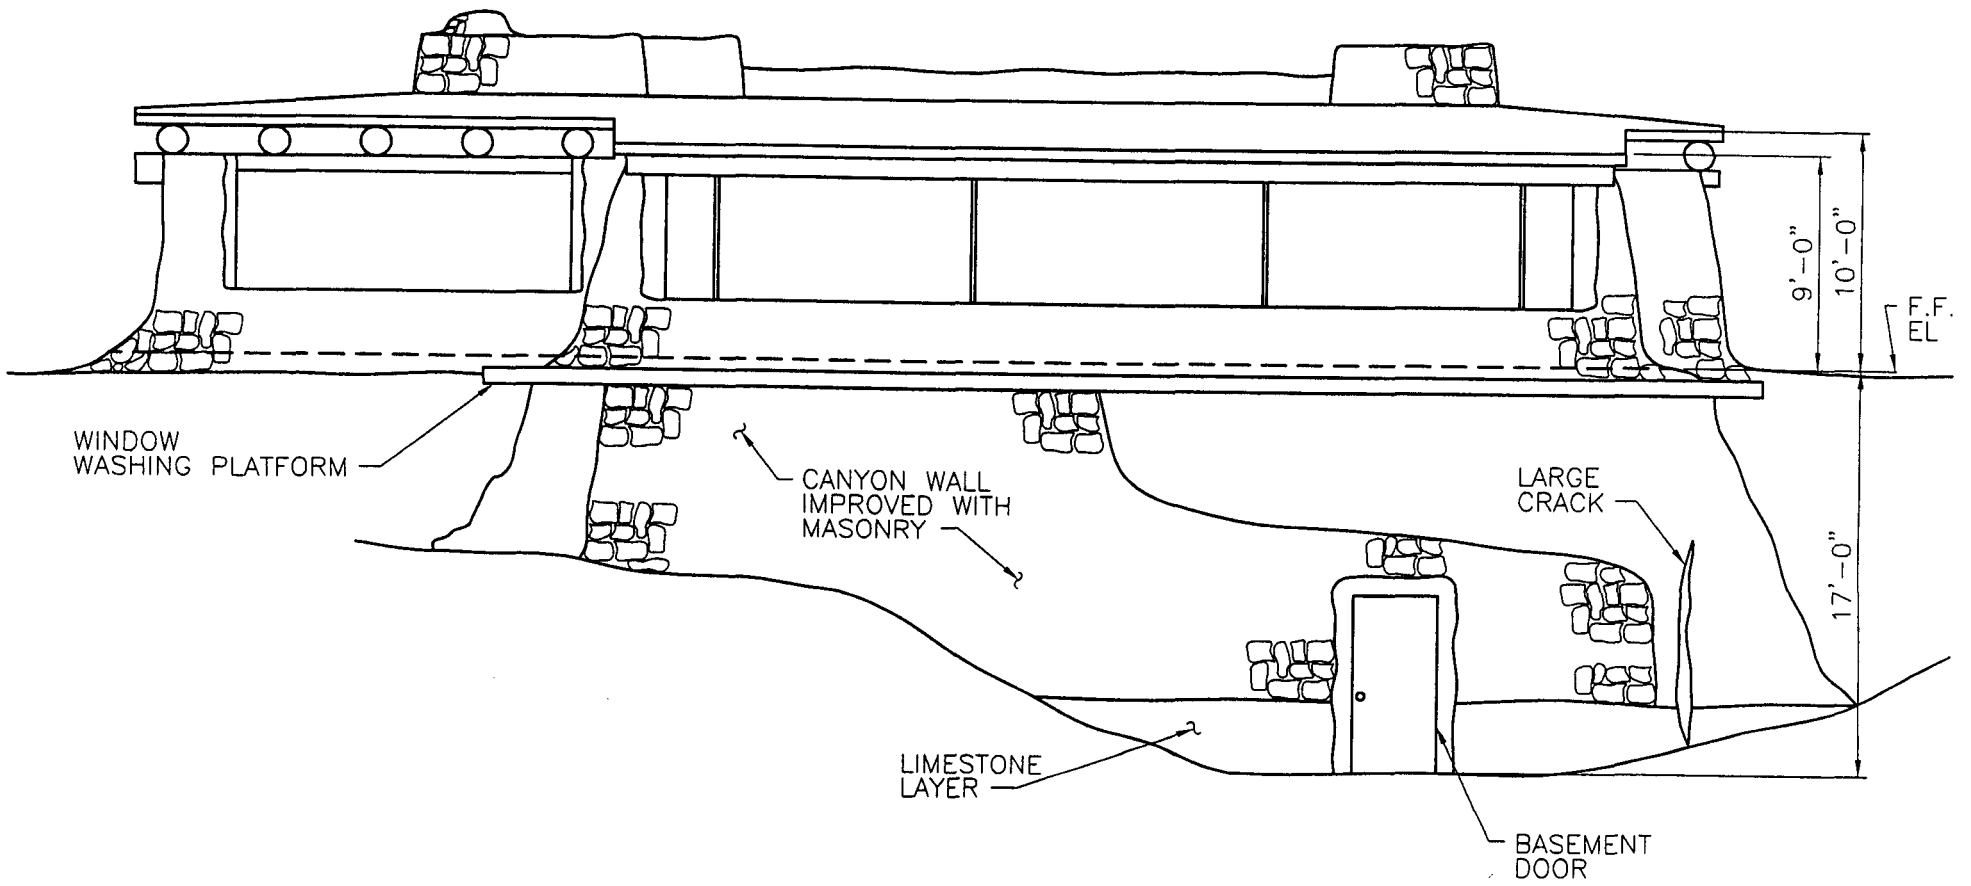
FIG. 4 YAVAPAI POINT MUSEUM

Aligned with the north wall of the building, is the canyon edge. In areas it has been patched or improved with stone masonry to support the curved north side of the building. A portion of this masonry work encloses the "Basement," which has a single door opening on the north side, see Figure 4.
