113/D-SS3  
Grand Canyon

# Yavapai Observation Station

Historic Structure Report

*prepared by*  
Architectural Resources Group  
Architects, Planners & Conservators, Inc.  
San Francisco

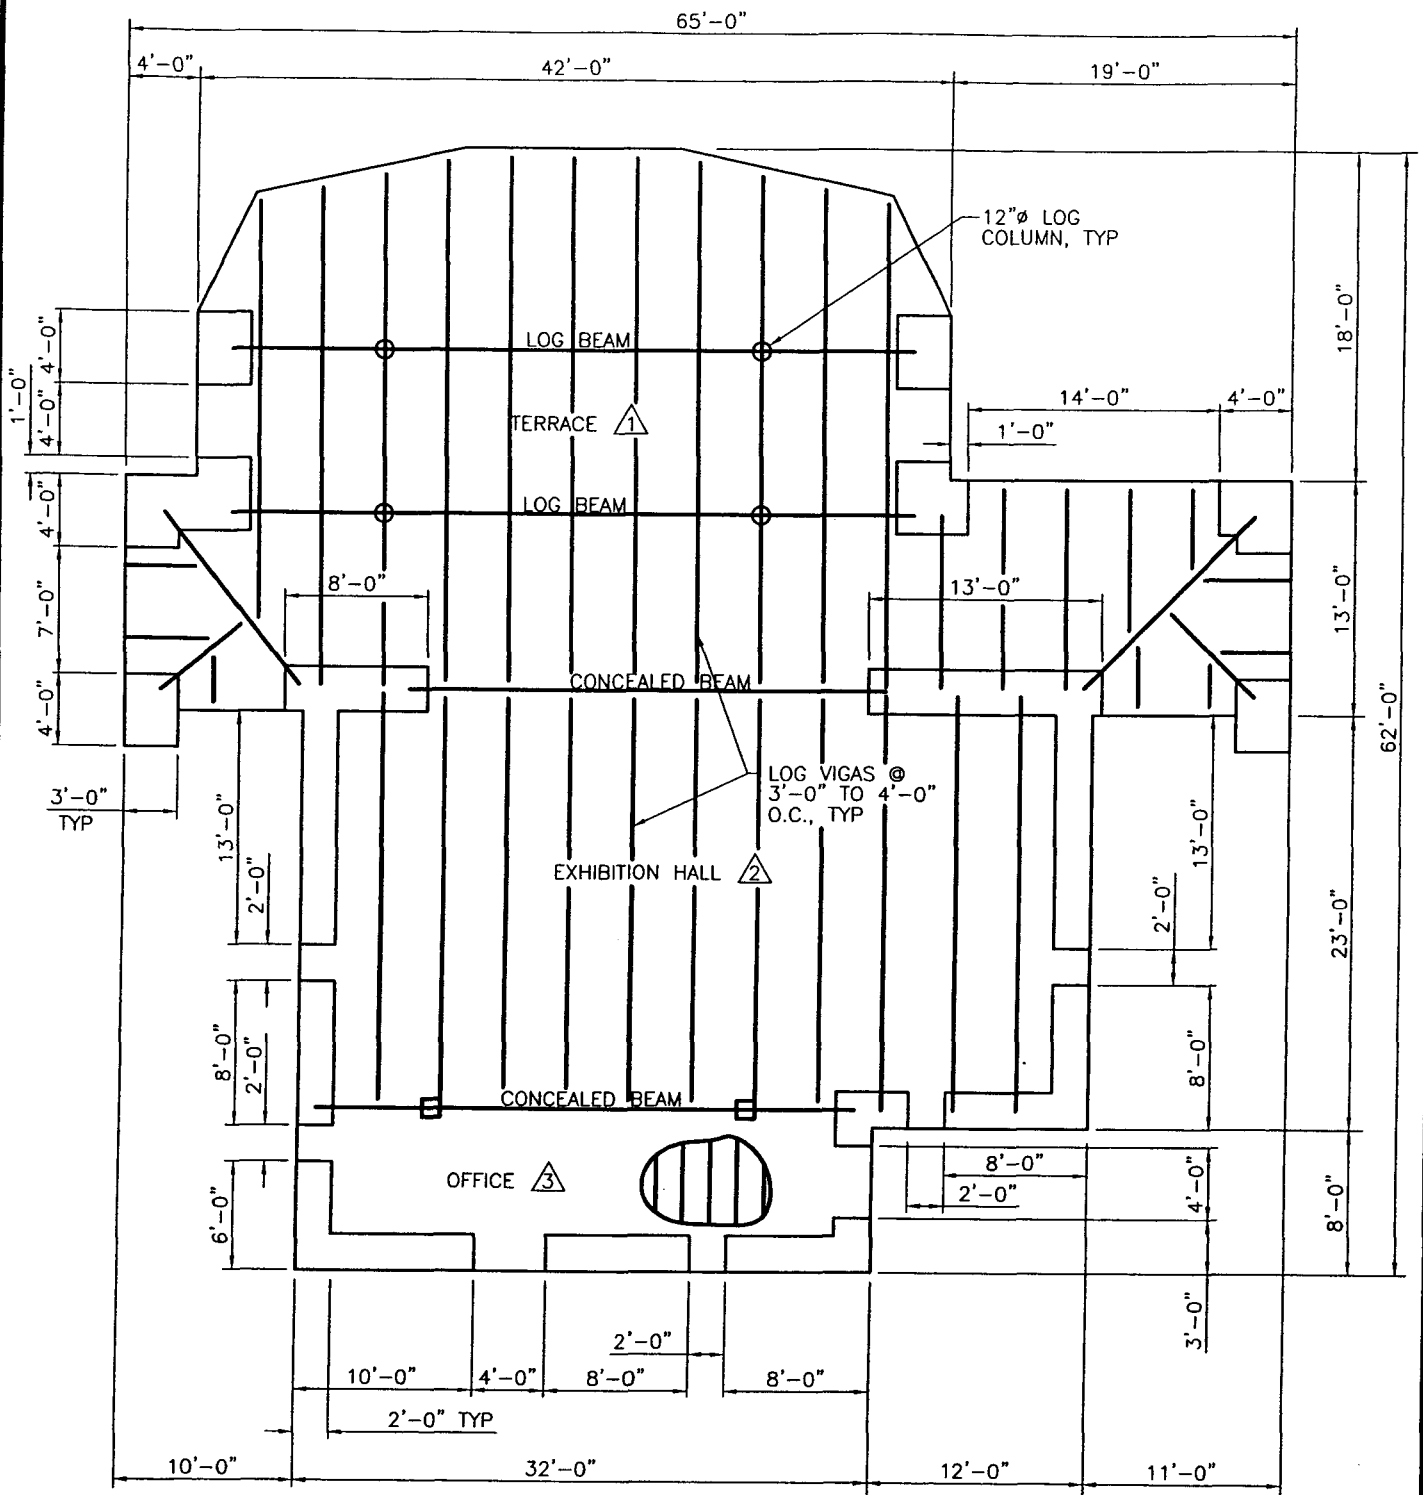
FIG. 5 YAVAPAI POINT MUSEUM

The roof of the Terrace consists of built up tar and gravel roofing over 3/8" plywood over 1 x 10 straight sheathing. The sheathing is supported by vigas spanning from the beam between the Exhibition Hall and Terrace, over two column supported log beams, and cantilevering out to the curved north wall. In the original configuration, there was no north wall, so it is reasonable to assume the vigas still act as cantilevers, and are not supported by the more recently installed window framing. See Roof Framing Plan, Figure 5.

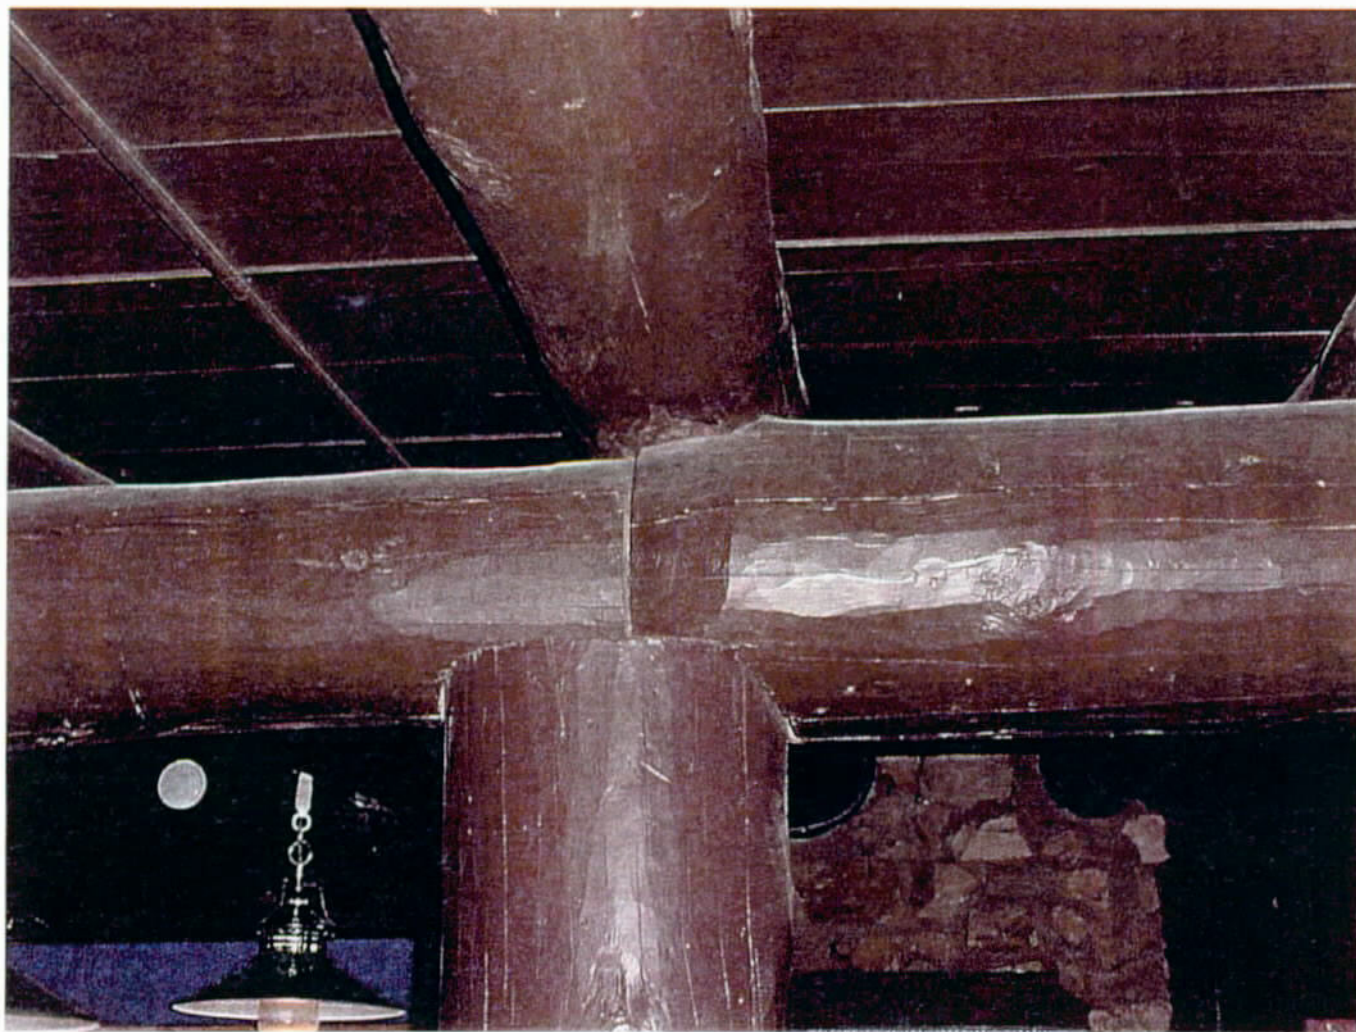
FIG. 14 YAVAPAI POINT MUSEUM

Although they may exist, positive connections between the log columns and the foundation, and between the columns and the beams, could not be verified with the limited investigation permitted. This condition occurs at four log columns in the Terrace area of the building. Unlike the roof to wall connections, the bearing length at the column to beam connections is very short (see Figure 14), and without positive connection, the possibility exists of the roof beams moving off the column and losing support.

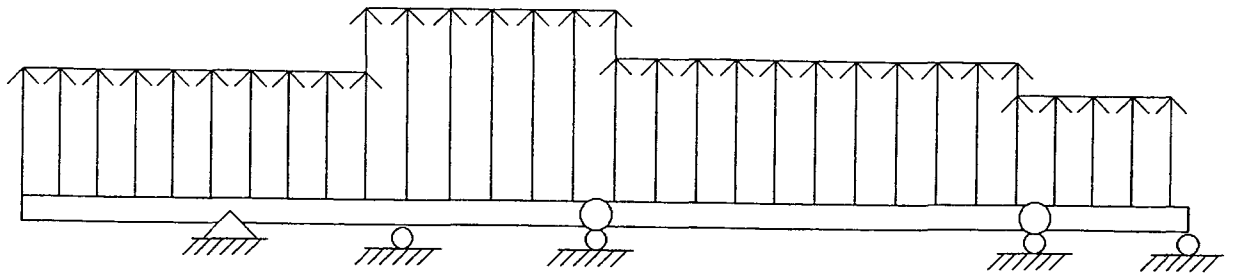
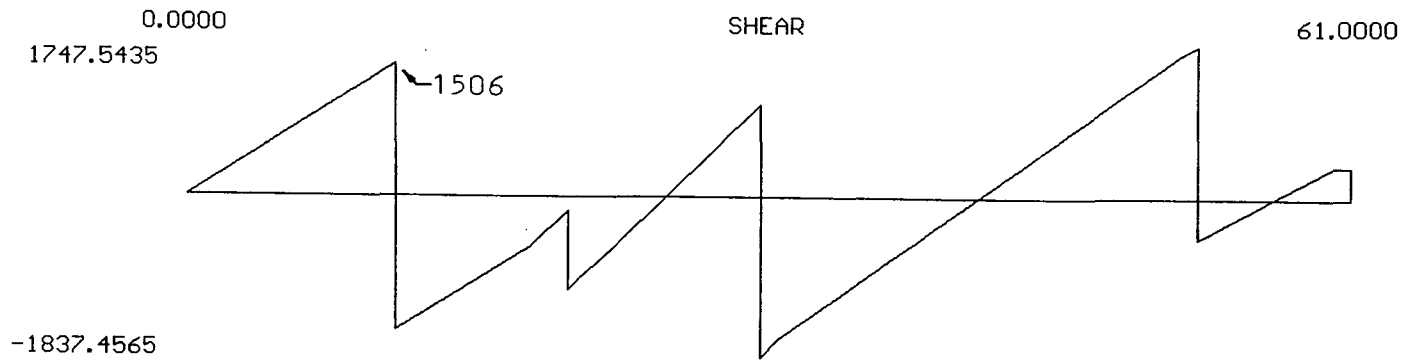
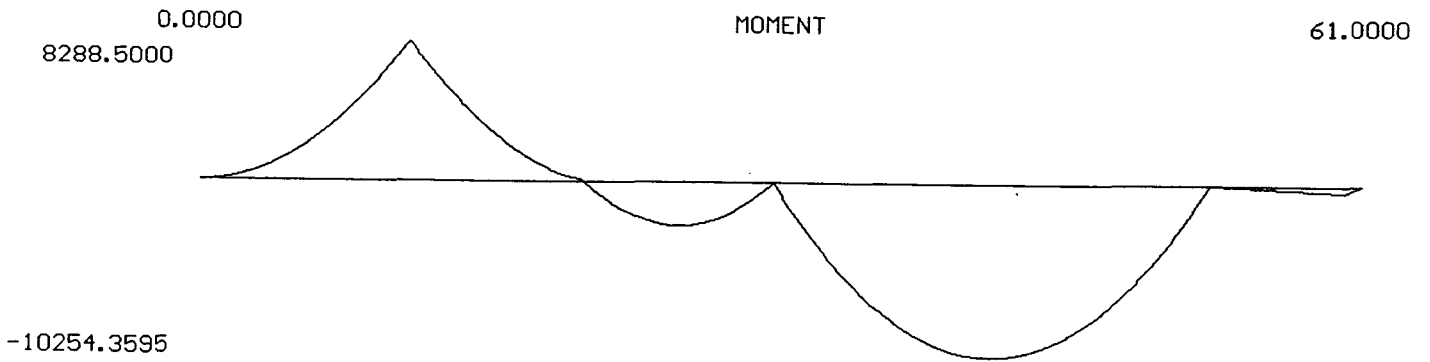
9b Continued:

Name	Location	Vertical	Moment
Rs01	11.0000	-3045.0144	_____
Rs02	20.0000	-919.4727	_____
Rs03	30.0000	-2882.9695	_____
Rs04	53.0000	-2212.1685	_____
Rs05	61.0000	-361.3750	_____
