Comet

Submerged Cultural Resources Site Report

Channel Islands National Park

Submerged Resources Center
Professional Reports
Number 17

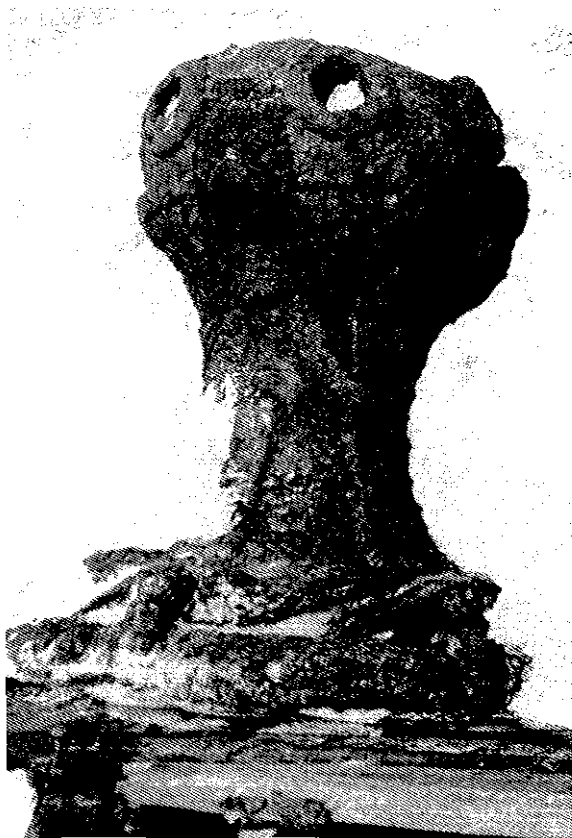
Figure 1.3. *Comet's* capstan in 1984. NPS photo by Reed McClusky.

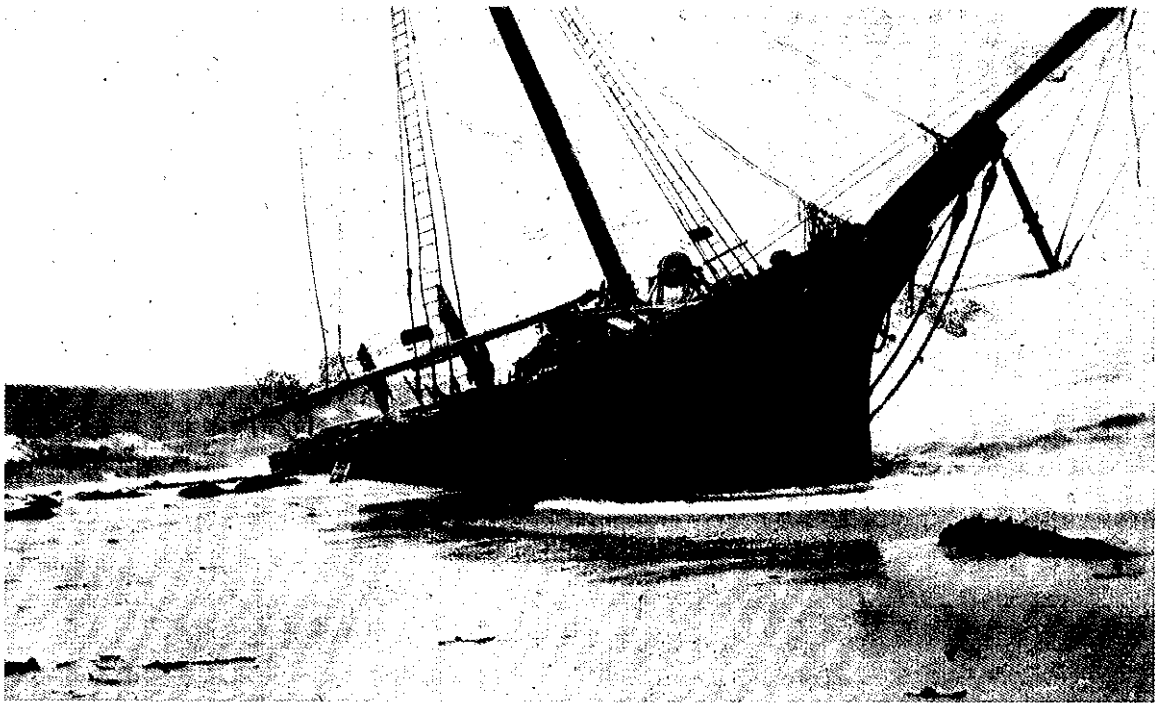
Comet wrecked on San Miguel Island August 30, 1911 (Figure 3.3). The vessel left Aberdeen, Washington, August 23 loaded with approximately 500,000 BF of lumber bound for San Pedro, California. On Wednesday, August 30 at 8:00 P.M., while sailing in heavy seas with a thick fog, *Comet* struck what was reported as Richardson Rock, approximately 20 mi. south of Point Conception and 7 mi. north of San Miguel Island in the Santa Barbara Channel (NA 1911:RG 36:Wreck Report Number 221). It was later determined that the schooner actually hit Wilson Rock, which is 22 mi. northwest of the island and closer to *Comet's* final resting place (*Santa Barbara Independent* [SBI], 14 September 1911; *LADT*, 15 September 1911:15). After the vessel struck the rock, it was pulled off by the current and began drifting south towards San Miguel Island. The *Comet's* master, Captain Nicolas Borgenson, noted:

I thought when the *Comet* was freed from her first perilous position, that I would be able to bring her to Santa Barbara, but she filled rapidly and I soon found that she was badly stove in. She became water logged and I knew the best I could do was to beach her on San Miguel. She is lying in a favorable position and unless the seas become heavy, we may be able to get her off. Her hull must be in bad shape. There was a hard wind as well as a heavy fog when she struck. The ship’s chronometer must have been faulty for we were about ten miles off our course [*Santa Barbara Morning Press* [SBMP], 2 September 1911:8].

Figure 3.3. *Comet* aground at Simonton Cove, San Miguel Island. Photo courtesy of Santa Barbara Museum of Natural History.

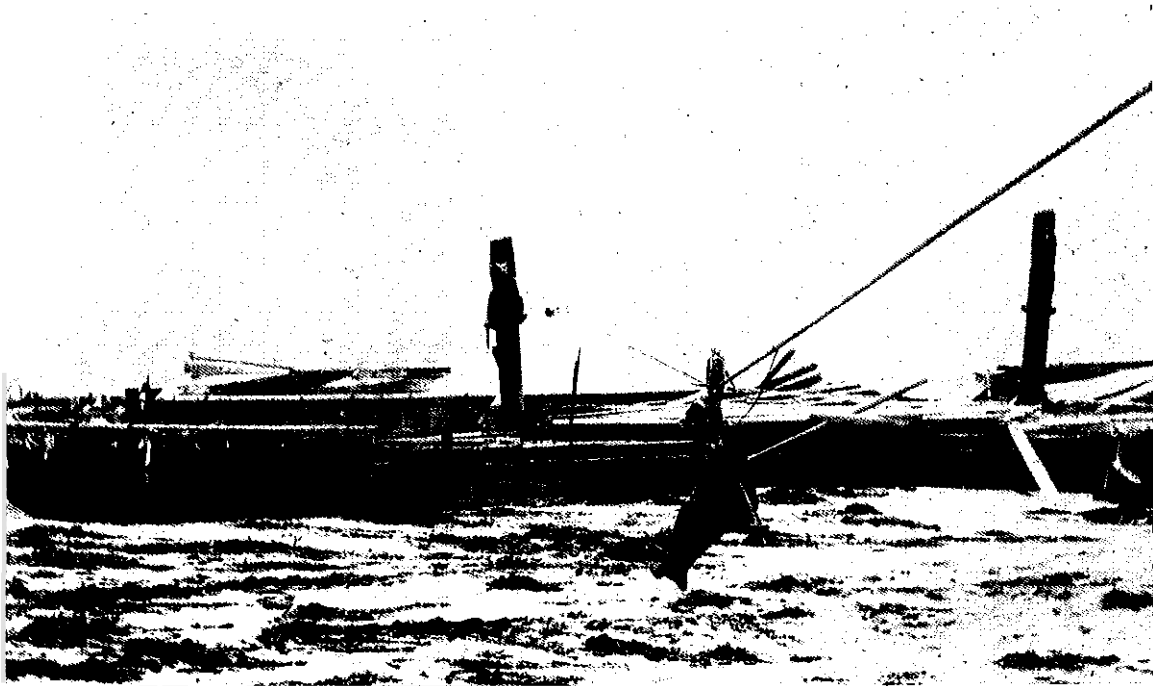
A series of photographs were taken of *Comet* sometime after the wreck and before the vessel broke up (Figures 3.4 and 3.5). These photos, from the Santa Barbara Museum of Natural History's collection, show the schooner lying broadside to the surf, port side to sea. The vessel is firmly embedded in the sand, probably between the mean high- and low-tide lines. The foremast is still standing, but the main- and mizzenmasts are gone. Two photographs, taken from the forecastle deck looking forward, show a man and woman standing on *Comet's* bow (Figures 3.6 and 3.7). These photographs are the key evidence in identifying the wreck in Simonton Cove as *Comet*. In the background of the photographs is an easily identifiable rock formation that is east of the wreck in Simonton Cove today (Figure 3.8). Analysis of the

Figure 3.4. *Comet*aground in Simonton Cove, San Miguel Island, with unidentified woman. Photo courtesy of Santa Barbara Museum of Natural History.

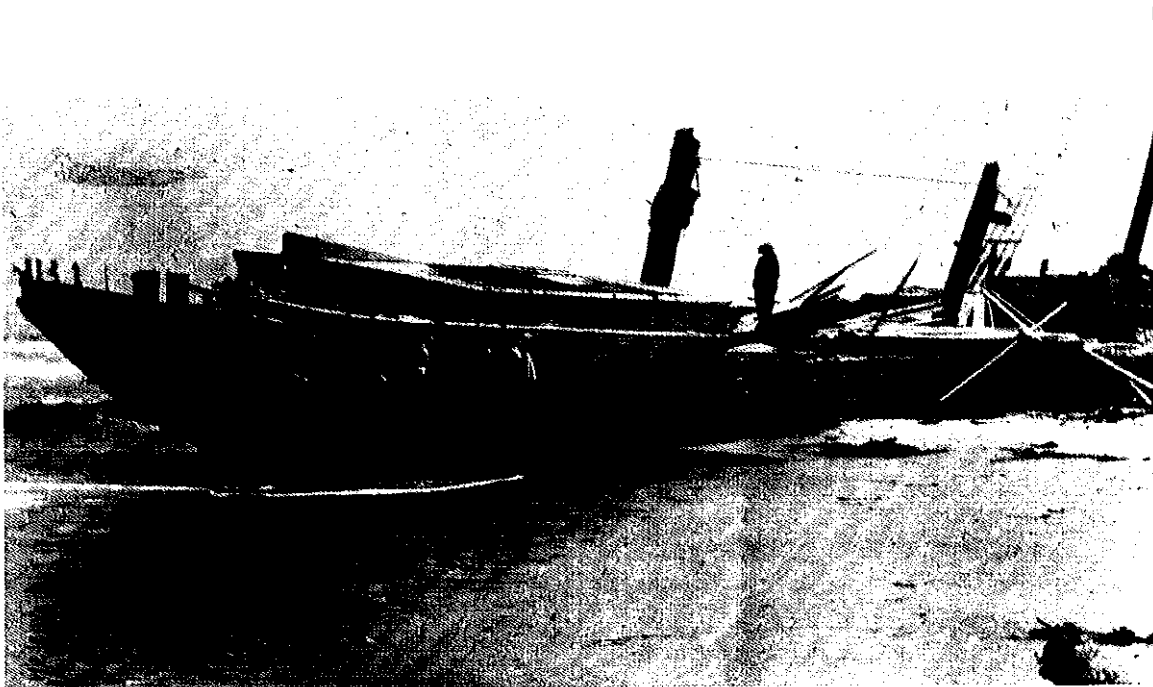
Figure 3.5. *Comet's* stern, aground in Simonton Cove, San Miguel Island. Photo courtesy of Santa Barbara Museum of Natural History.

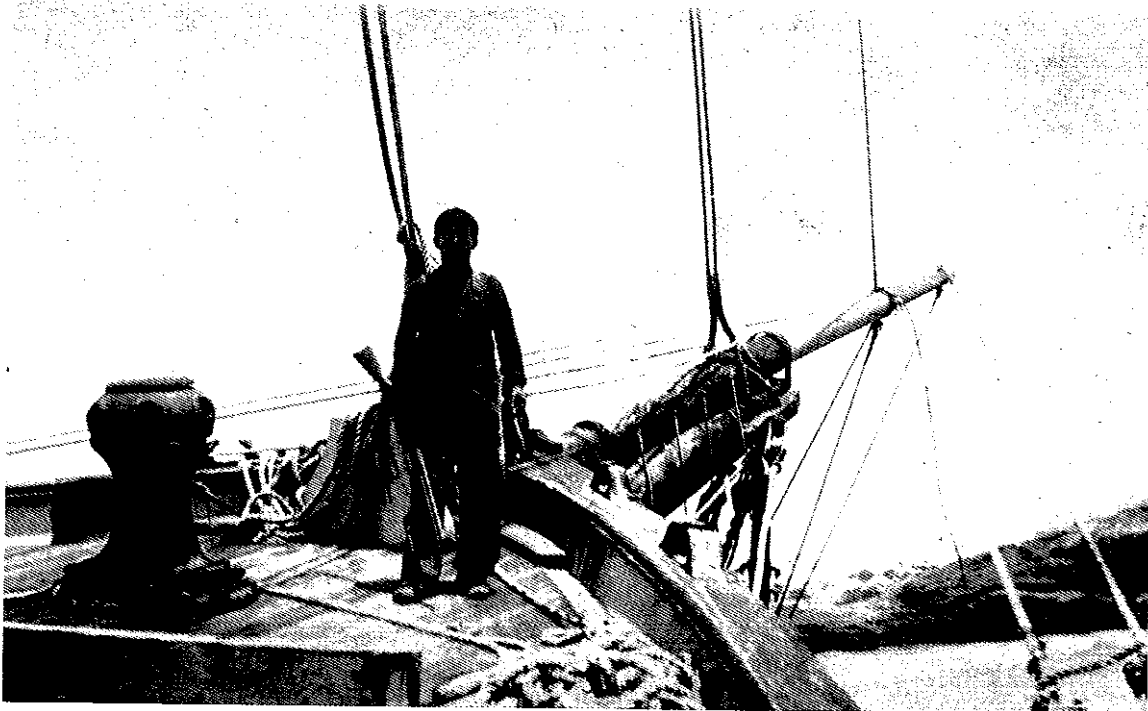
Figure 3.6. Unidentified man on *Comet's* forecastle deck. Note the capstan which is still mounted in the same location today. Also, note the rock ledge in the background which can be compared to Figure 3.8. Photo courtesy of Santa Barbara Museum of Natural History.

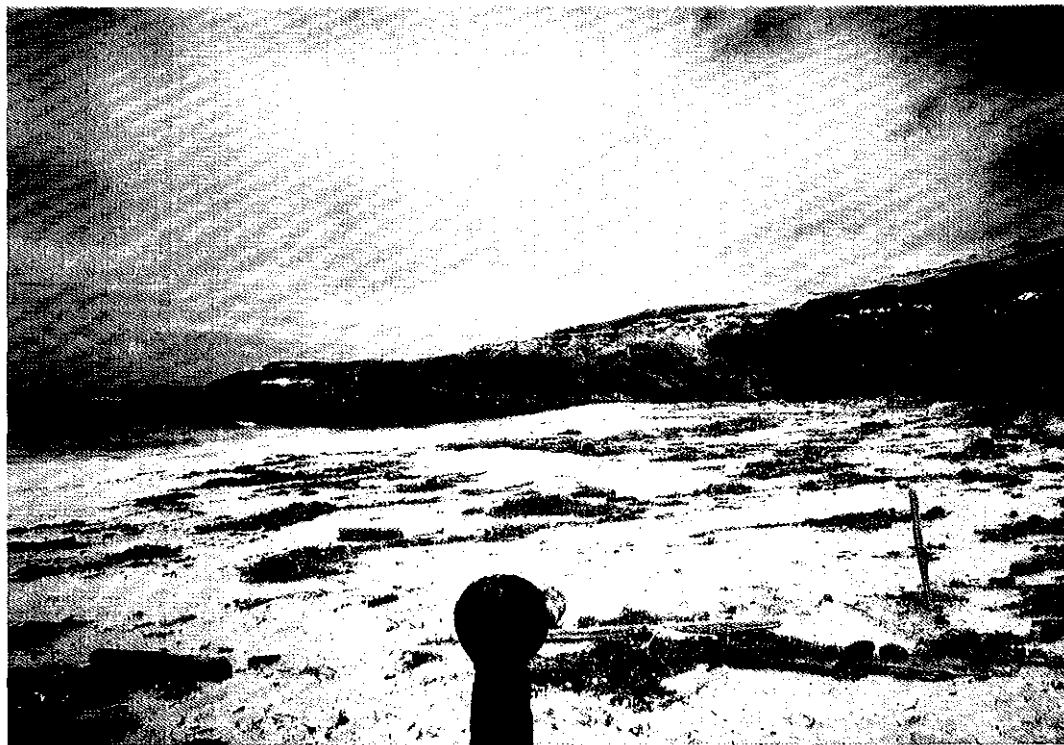
Figure 3.8. Anchor stock sticking out of the sand in Simonton Cove in the 1980s. Compare the rock ledge in the background to Figure 3.6. NPS photo by Don Morris.

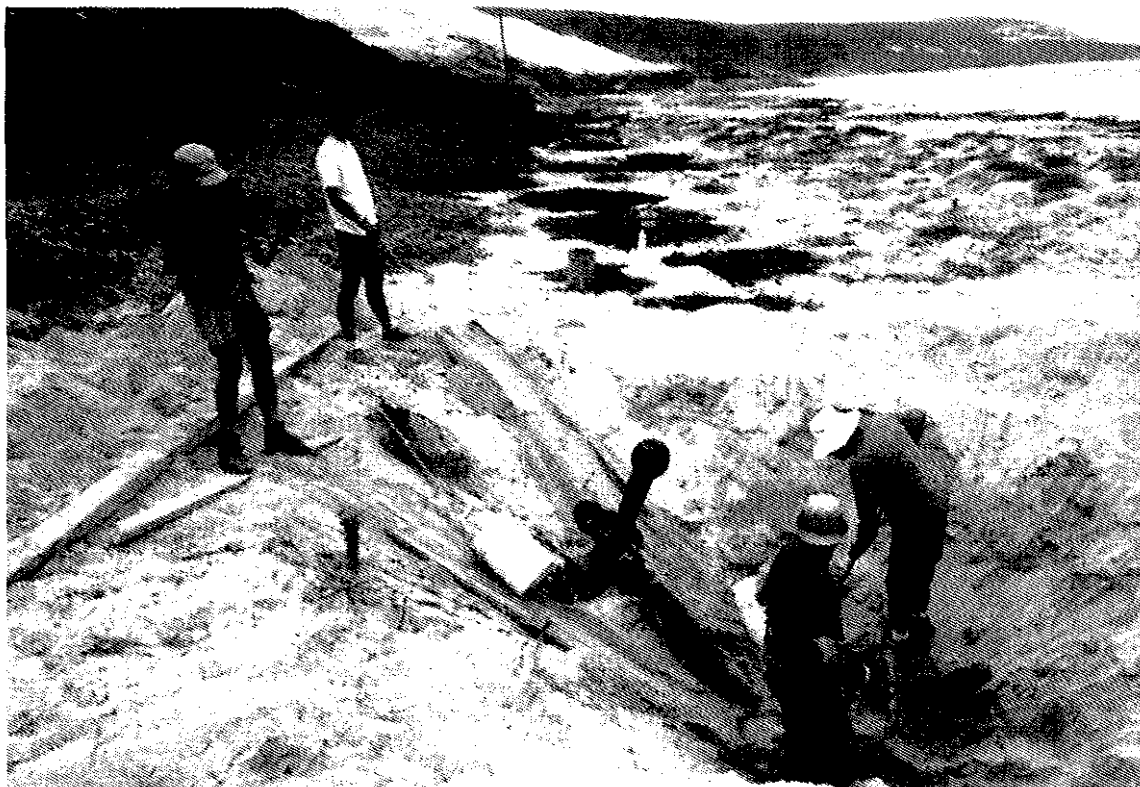
Archeologists and volunteers spent several days digging (Figure 3.9), which uncovered the anchor and a few unidentified timbers. Although the timbers located are certainly from *Cornet*, no details could be recorded because the walls of the hole kept collapsing as the timbers were exposed. In total, about 16 m³ of sand were removed from a hole 6.4 m in diameter at the top and 2.1 m deep. The exposed anchor

Figure 3.9. Volunteers working to expose *Comet* wreckage in October 1993. Just the tip of the anchor stock was exposed before digging began. NPS photo by Matt Russell.

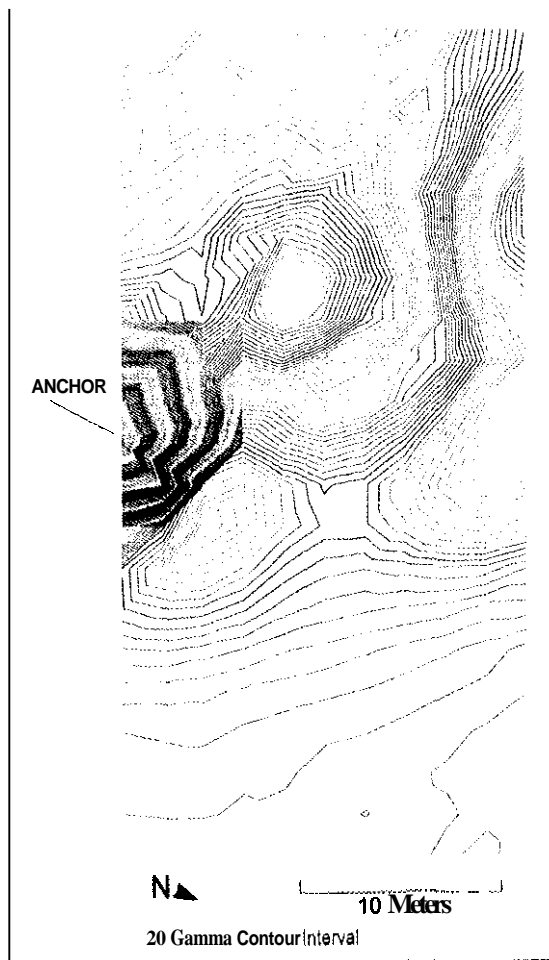
region just east of the anchor is relatively quiet. The anchor itself shows up as a very large anomaly, greater than 2,000 gammas (nanoteslas). Adjacent to the anchor to the north is a distinct, several-hundred-gamma anomaly. The area northwest showed a series of large anomalies that extended throughout the rest of the survey area. Although it is impossible to determine exactly what caused the anomalies, the contour map represents a highly concentrated area of magnetic intensity around the anchor (Figure 3.10). These anomalies surrounding the anchor indicate that structure appearing in the 1984 photographs was still extant.

Figure 3.10. *Comet* site magnetometer data. The survey block is 40 m by 20 m.

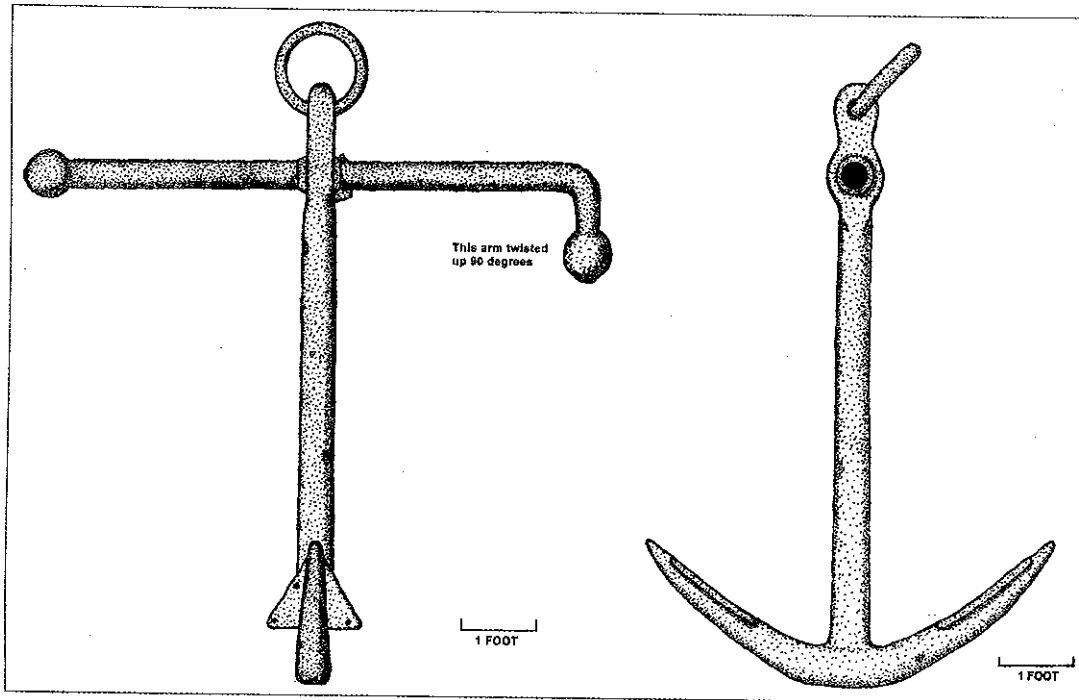
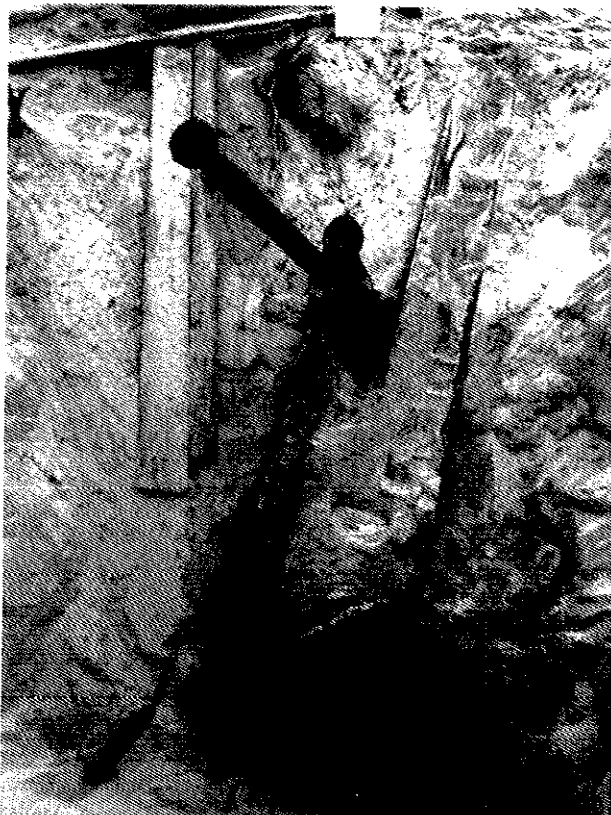
is iron, with a collapsible iron stock (Figures 3.11–3.13). The anchor is fitted with a ring, but no cable is present. The overall length is 7 ft. 11 in.; stock length is 7 ft. 9 in. Anchor arms are 3 ft. long, with 5 ft. 6 in. between palm tips. The palms measure 1 ft. 3 in. wide by 1 ft. 6 in. long, and 1¼ in. thick.

Figure 3.11. *Comet's anchor.* Drawing by Matt Russell.

Figure 3.12. *Comet's anchor* after exposure in 1993. NPS photo by Matt Russell.

Figure 3.13. *Comet's* anchor ring. NPS photo by Malt Russell.

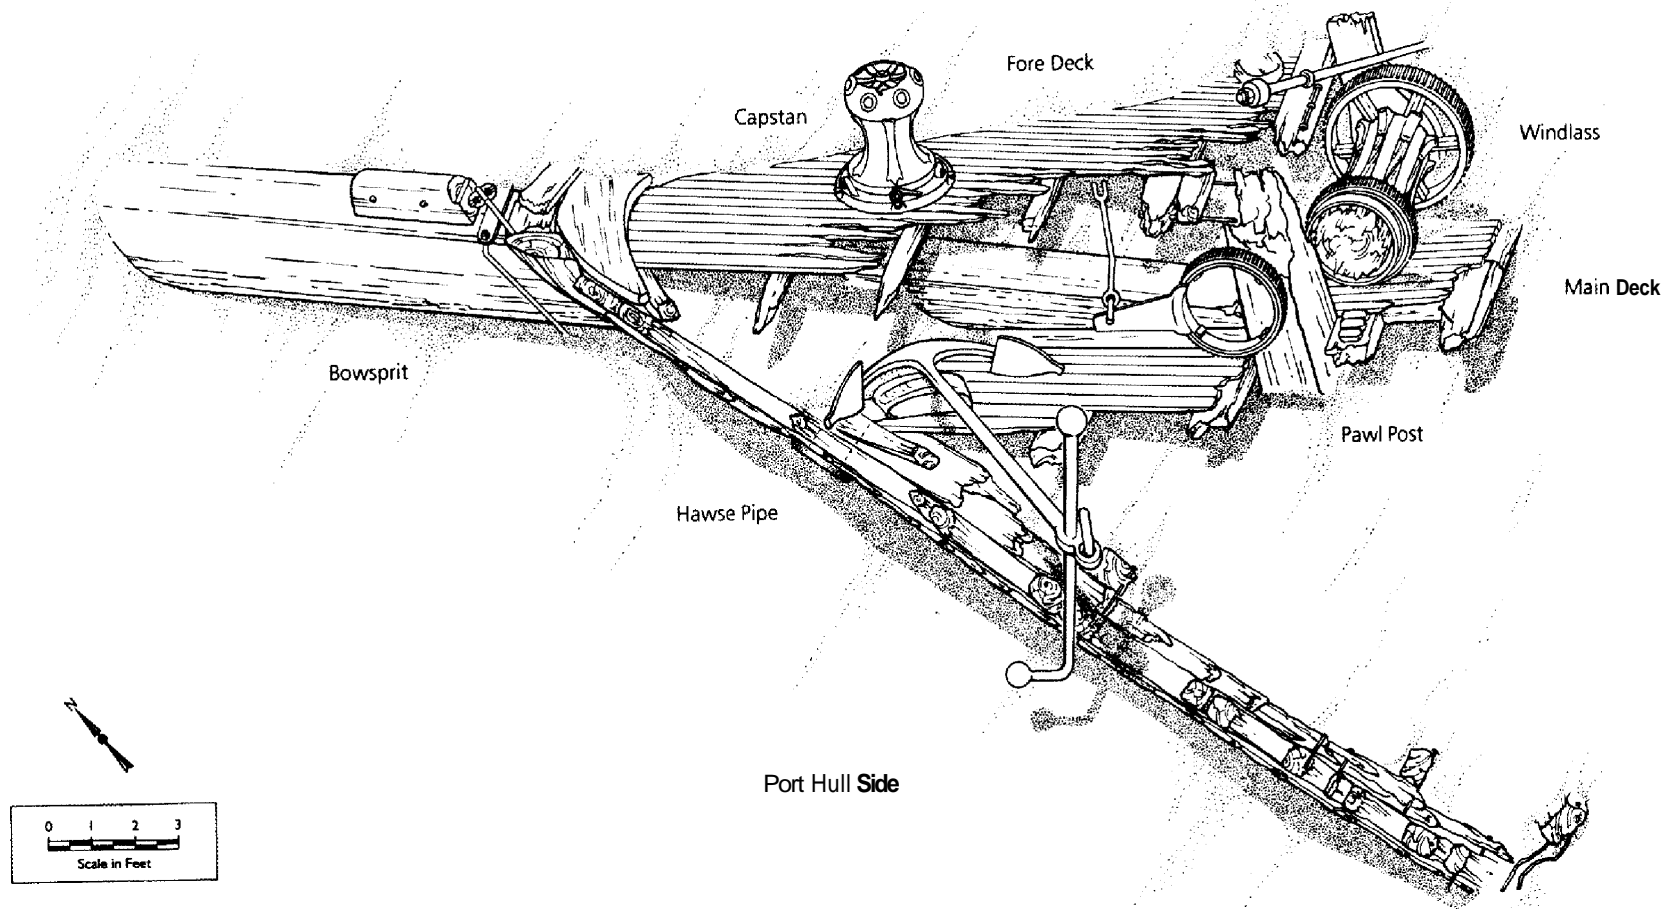
Figure 4.7. *Cornet* site plan. **Field** drawing by Matt Russell. Final drawing by Robert Turner.

Nearly all *Comet's* original bow structure and related features are represented on the site (Figure 4.7). Exposed structural elements include port-bow framing and outer-hull planking; the partially intact forecastle deck and forecastle-deck beams; the partially intact main deck and main-deck beams below the forecastle deck; the pawl post (sometimes called a pawl bitt or Samson post) extending through the main deck and broken off at the forecastle-deck level; the bowsprit, extending from where it is stepped into the pawl post's forward face to about 19ft. forward of the bow; the forecastle- and main-deck deck-hooks and waterway hooks; and several bow pointers. Other features present are bow rigging elements and ground tackle features including an anchor; the capstan mounted in its original location on the forecastle deck; the intact log windlass' starboard half, still mounted in its original location on the main deck, along with the iron parts of the windlass' port half; the port bow stopper or riding chock; and the port hawse pipe. Although more of the wreck is exposed than the 1984 photographs show, much of the starboard bow still lies deeply buried in the sand and was not documented.

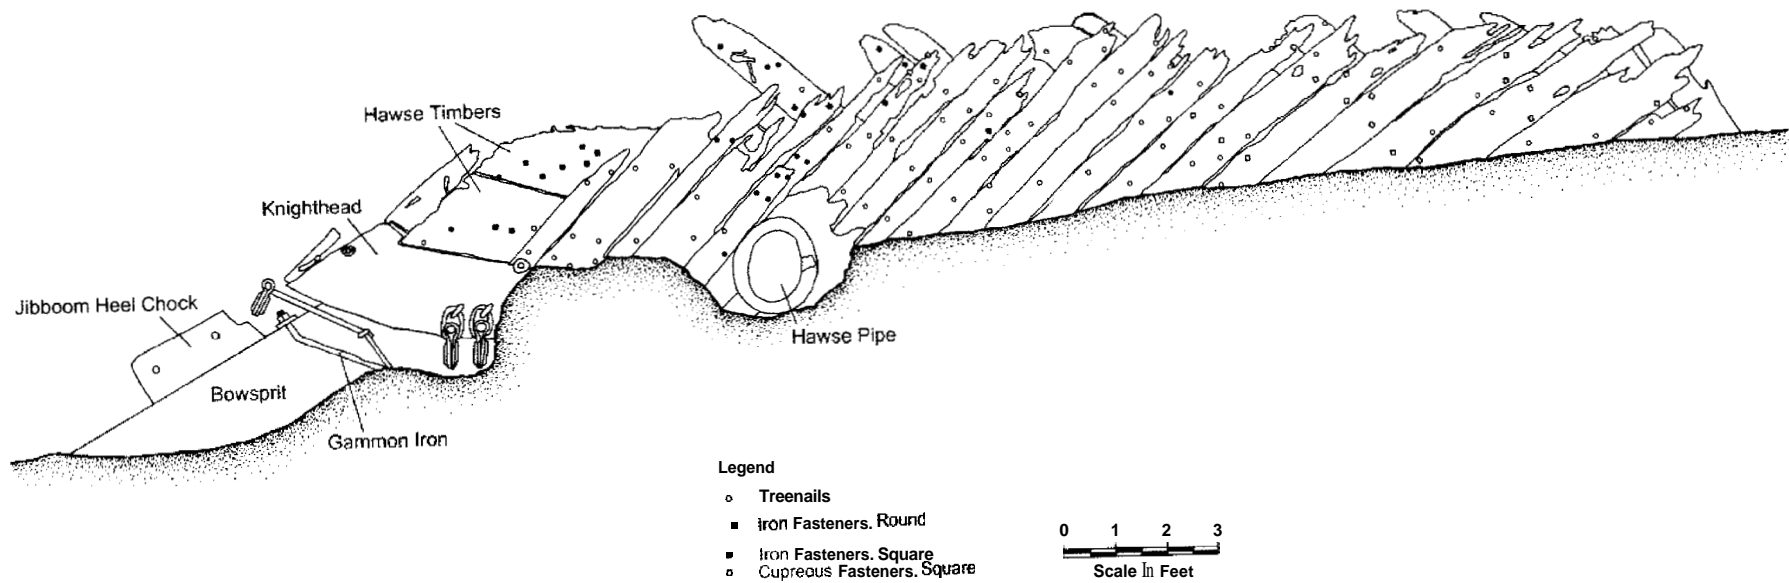
Figure 4.11. *Comet* port elevation drawing. Drawing by Jim Bradford.

A total of 21 outer hull planks were recorded, varying in width from 5 in. to 1 ft. 2 in. and from 1 to 2 in. thick (see Figure 4.11). *Comet's* contract states planking should be 4 in. thick, while *Rules for the Construction of Wooden Vessels* specifies it should be 3½ in. thick (JPSL 1886; American Shipmasters' Association 1879:xxviii). Erosion likely accounts for the difference between *Comet's* outer hull planking thickness and the thickness recorded in historical documents. Outer hull planks were fastened to the frames with a combination of trenails, round iron fasteners,

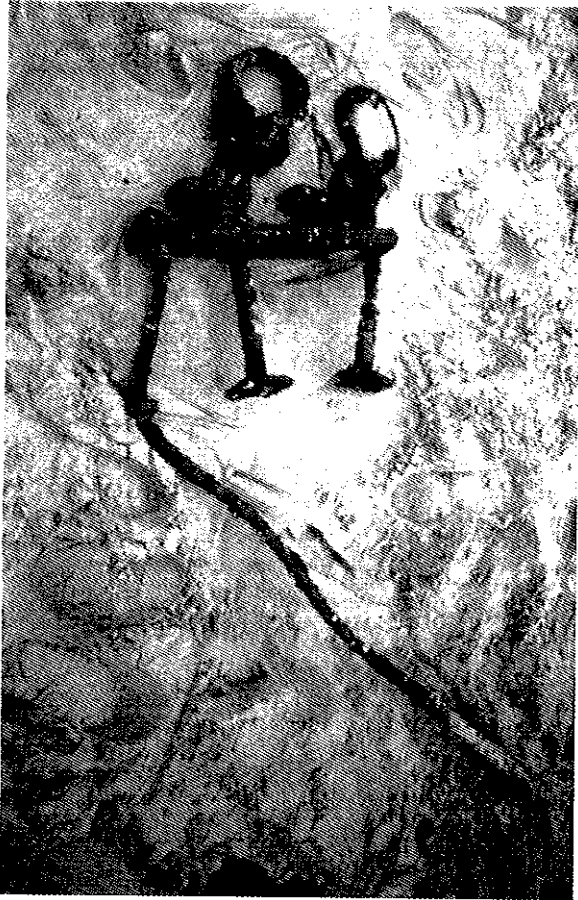
Located off *Comet's* port bow is an unattached iron rigging element (Figure 4.26 and 4.27; see also Figure 4.12). It consists of a 4 ft. 3 in.-long iron rod with a 5 in. long x 2%

in. wide x ½ in. thick plate on one end, attached to an 11%-in. long x ¾ in. diameter iron fastener that is attached to a 1 ft. 6½-in. long x 1-in. thick iron plate. The plate is pierced by two 1 ft. 3-in. long x 1-in. diameter eyebolts, each of which has an iron ring attached to an iron strop from a bull's eye or deadeye (the wooden block is no longer present), similar to those described above. In addition, the iron plate has two iron hooks cast as part of its upper surface. Although documentary research could not identify the element's proper name, its function was identified. This object was originally fastened to the foreside of the port cathead and provided the attachment point for the inner- and outer-jibboom guys, or shrouds (see Figure 4.25) (Underhill 1958:64). Chapelle (1973:398) notes that "as long as the schooners carried jibbooms, the jibboom shrouds were set up with hearts, or small deadeyes, and lanyards on the foresides of the catheads." C.A. Thayer has similar,

Figure 4.26. Rigging element off *Comet's* port bow. NPS photo by Matt Russell.

though not identical, rigging elements on the foresides of its catheads, which support the jibboom guys (Figure 4.28). In addition, historical photos of *Comet* wrecked in Simonton Cove give indirect evidence for this identification. Although the photos do not show the cathead or this particular element, they depict the jibboom guys coming to a point that can only be on the foresides of the catheads (see Figures 3.6 and 3.7). The iron hooks are called jib stay hooks (Greenhill and Manning 1995:103), and the iron rod was a brace between the cathead and the rail (Chapelle 1973:398). The rod's angle identifies this object coming from the port, rather than the starboard, cathead.

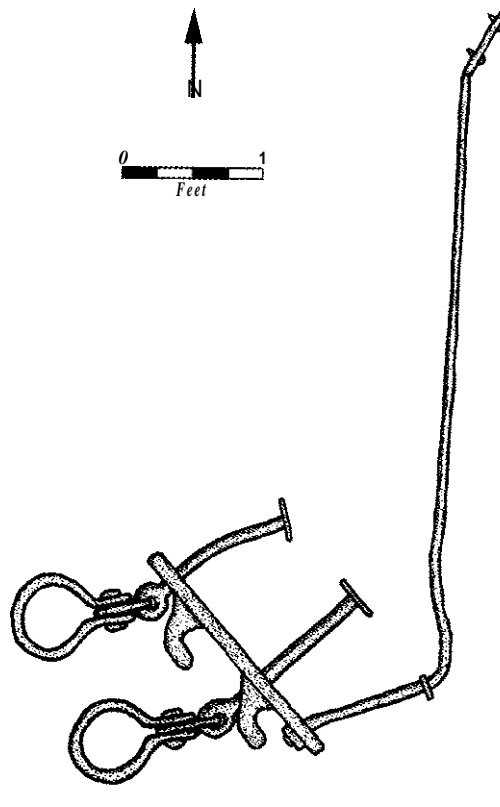
Figure 4.27. Rigging element from port cathead that secured the jibboom guys. Drawing by Matt Russell and Don Moms.

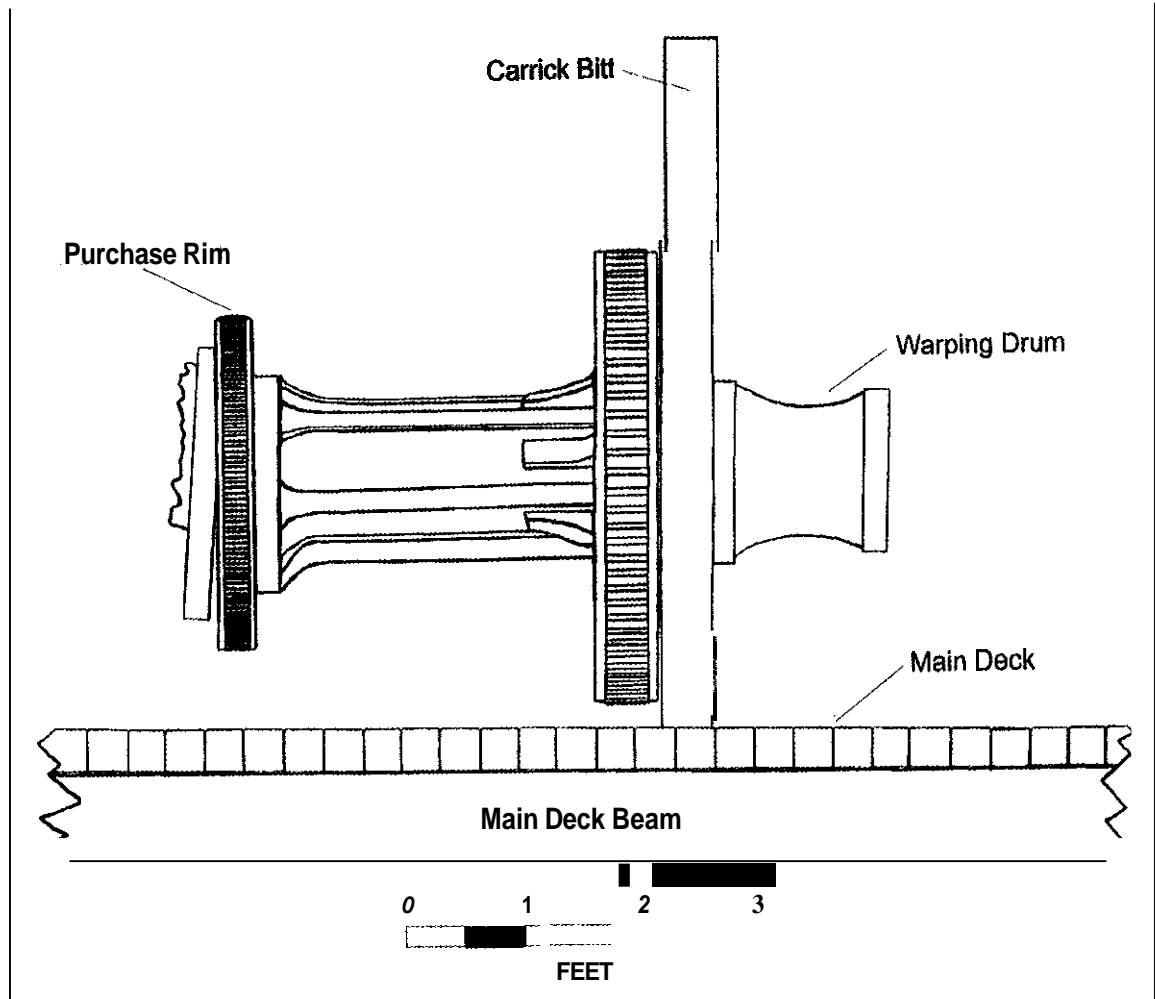
Figure 4.36. *Comet's* windlass, elevation view looking forward on main deck. Drawing by Jim Bradford and Matt Russell.

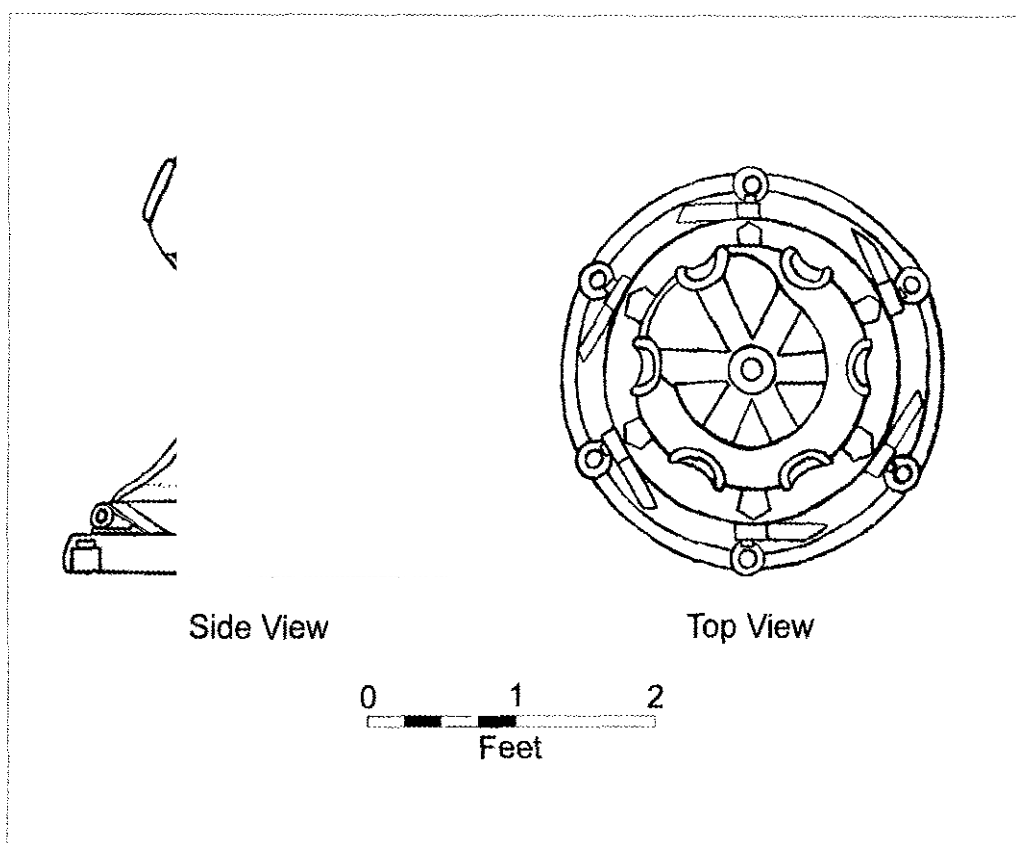
Figure 4.45. *Cornet's* capstan. Drawing by Jim Bradford

A hand-powered capstan is mounted in the center of the forecastle deck (Figures 4.44 and 4.45). It is not linked to the windlass, so is not technically part of the ground tackle. It was used for warping only, including such tasks as handling lines and assisting with raising sail (Campbell 1974:135). The capstan is 2 ft. 10 in. tall, with a 2 ft. 8-in. diameter base and 1 ft. 8-in. diameter head. This is presumably the “#3 capstan” specified in *Cornet's* contract.
