**WILLIAM JOHNSON HOUSE
NATCHEZ NATIONAL HISTORICAL PARK
NATCHEZ, MISSISSIPPI**

HISTORIC STRUCTURE REPORT

ANN BEHA ASSOCIATES

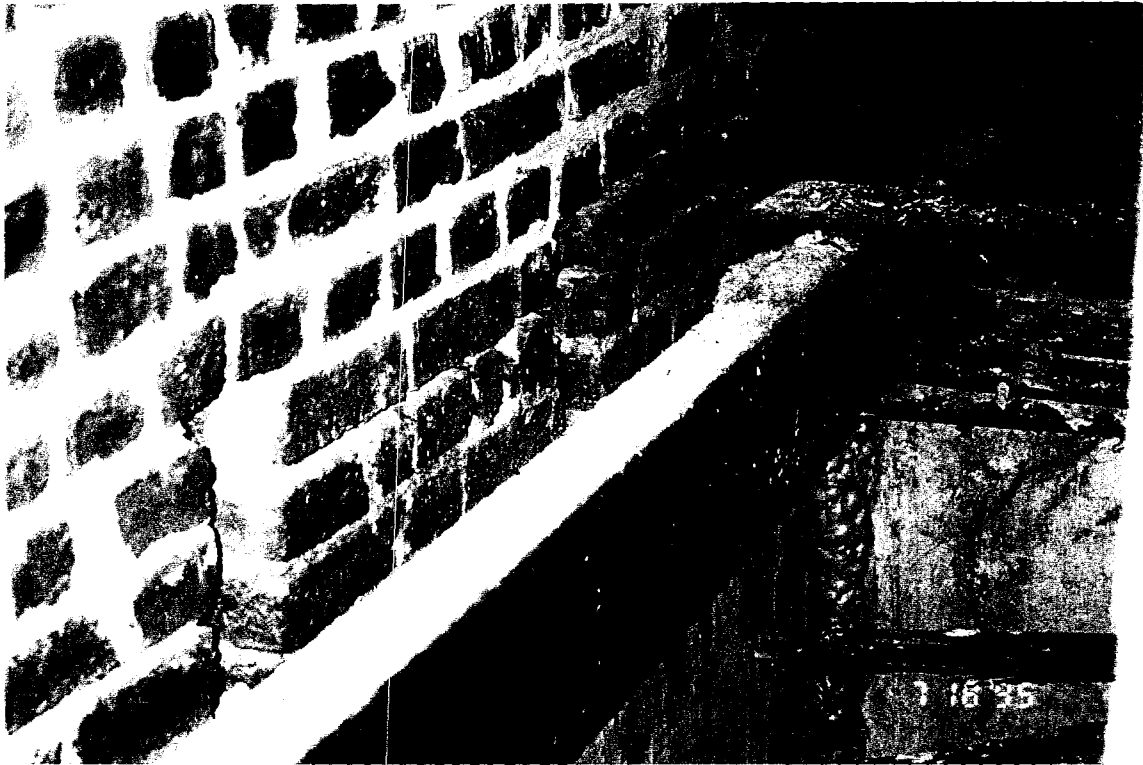
22-A Main House - Gap in wall injected with foam at southeast corner of second floor.

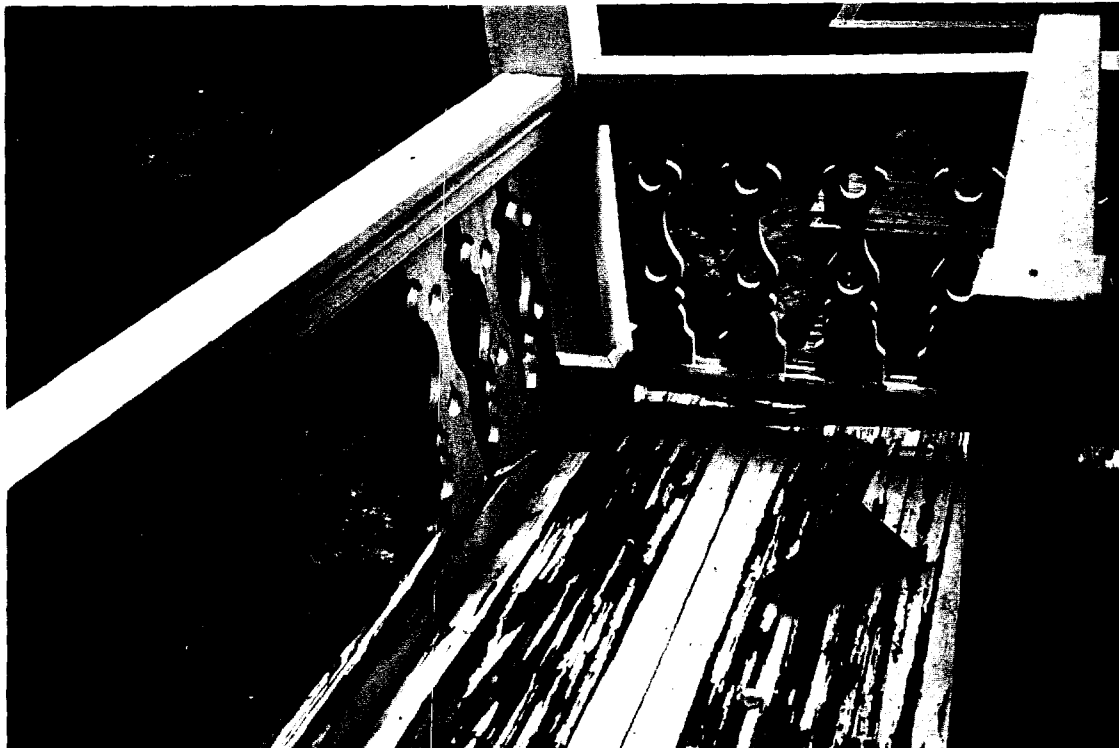
The paint on the stairs and second-floor decking is peeling, leaving 50%-75% of the bare wood exposed. Several of the boards are cupping. The bottom of the balustrade has rotted on the east end of the porch and become detached from the corner post (26-A). Approximately ten balusters are missing from the east balustrade.

27-A Main House -
Peeling
paint on
porch,
and rotted
balustrade.

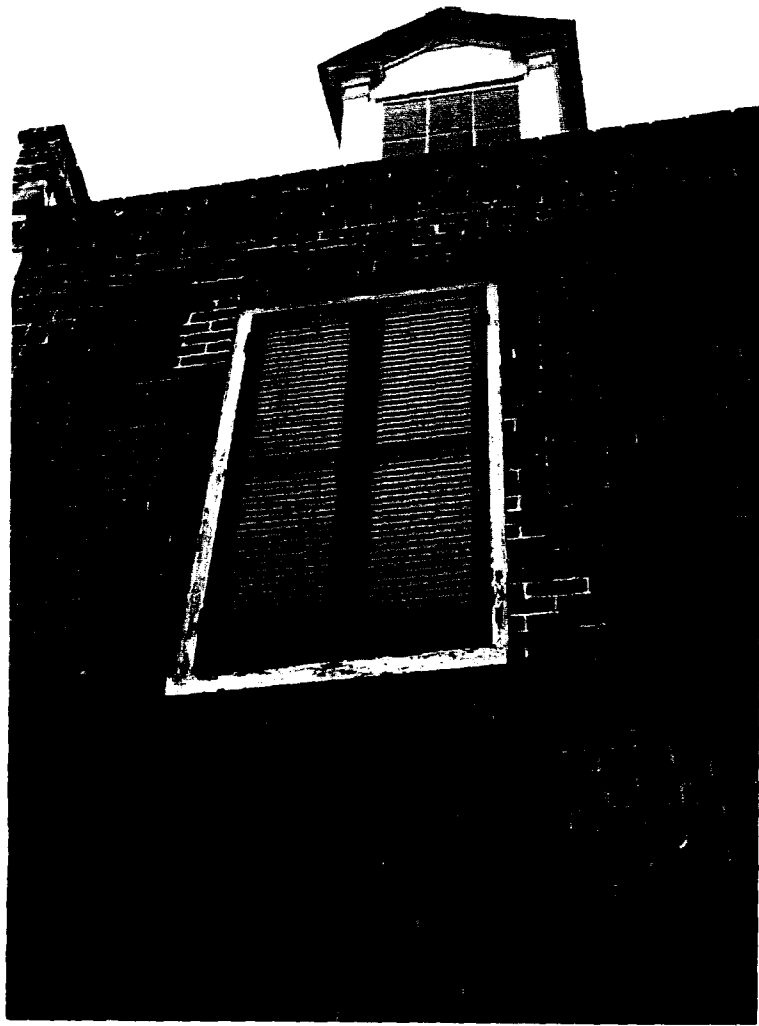
Existing Conditions. In general, the windows are in good condition. On the north facade, the window frames on the second floor need to be scraped and painted (28-A). The doors should be replaced with units which are historically appropriate. (See discussion in Chapter 5.0.) On the west elevation, the second-floor left window needs to be caulked around one-third of the frame. The upper half of the frame on the other second-floor window is unpainted (29-A).

28-A Main House - Peeling paint on north facade window frames.

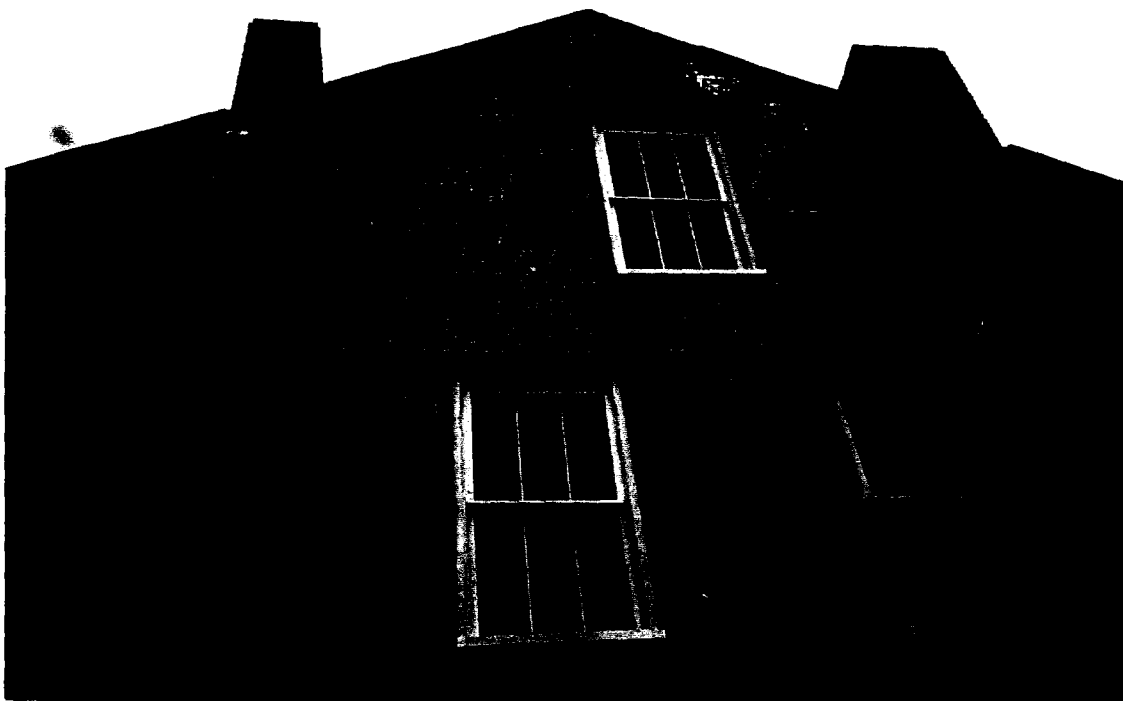
29-A Main House - Gap between left window frame and wall on west elevation. Right window frame and sash unpainted.

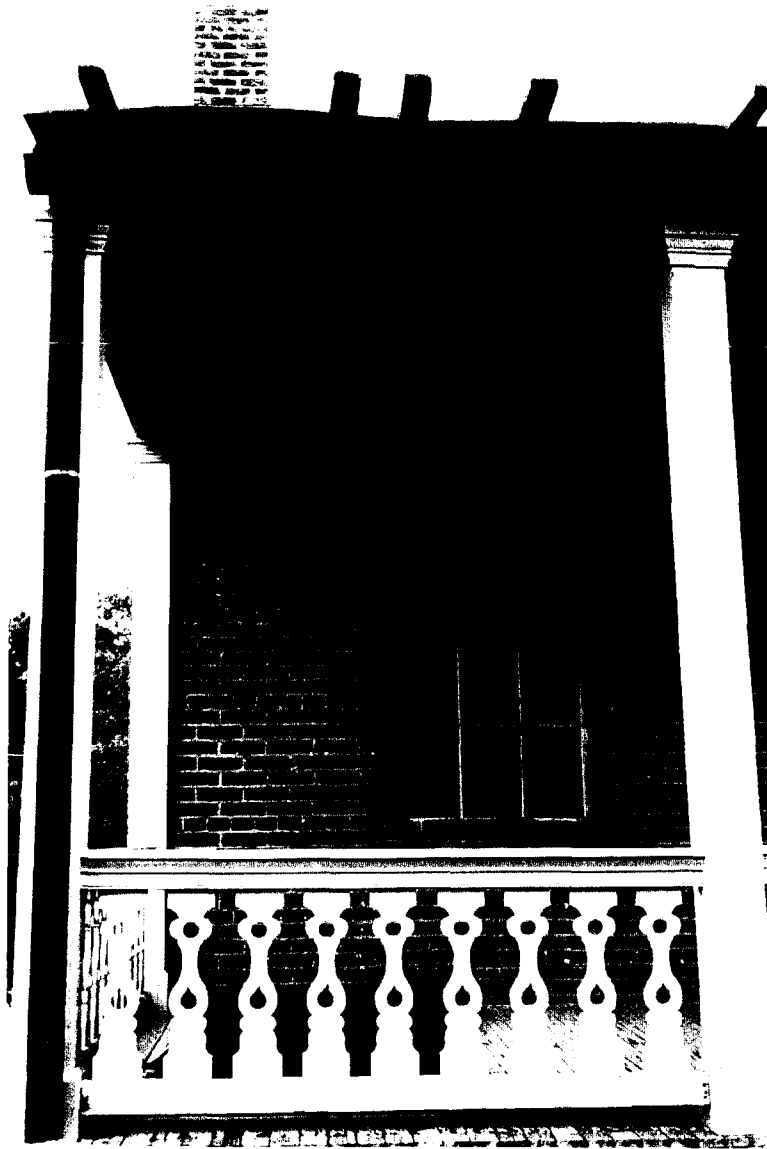
30-A Main House - Second-floor window frames on south elevation need to be caulked and painted.

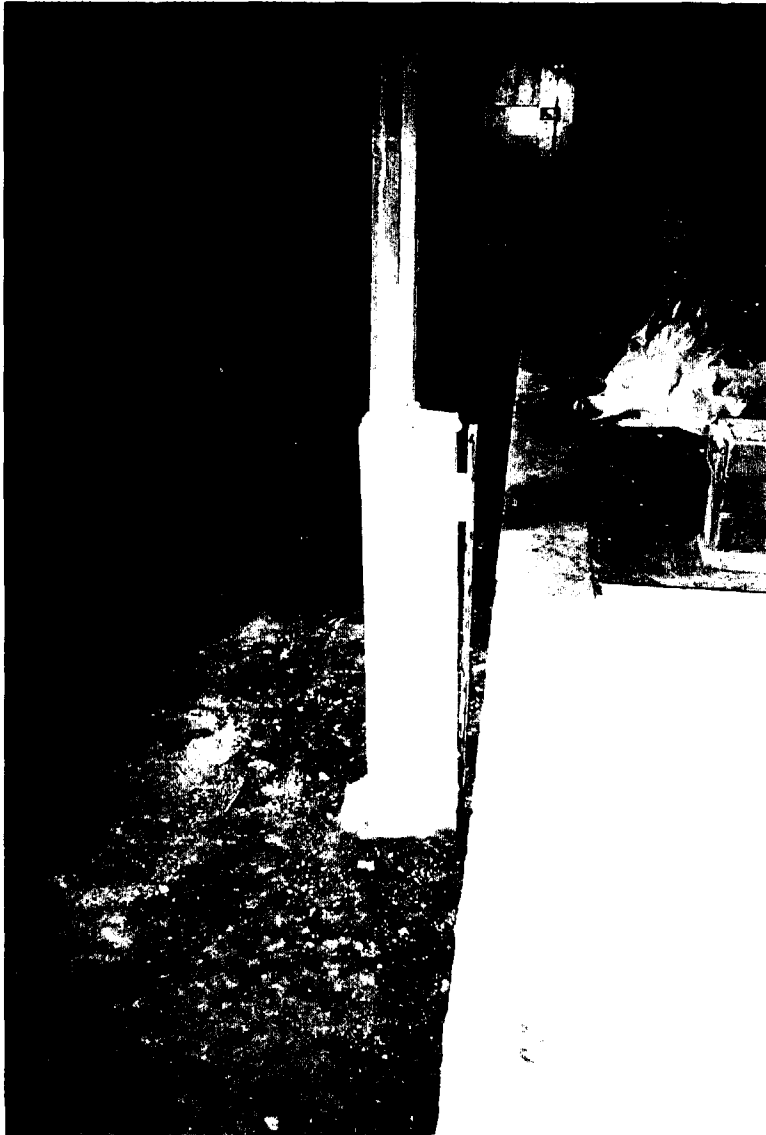
44-S Main House - View of bottom of weather column supporting second-floor partition wall above.

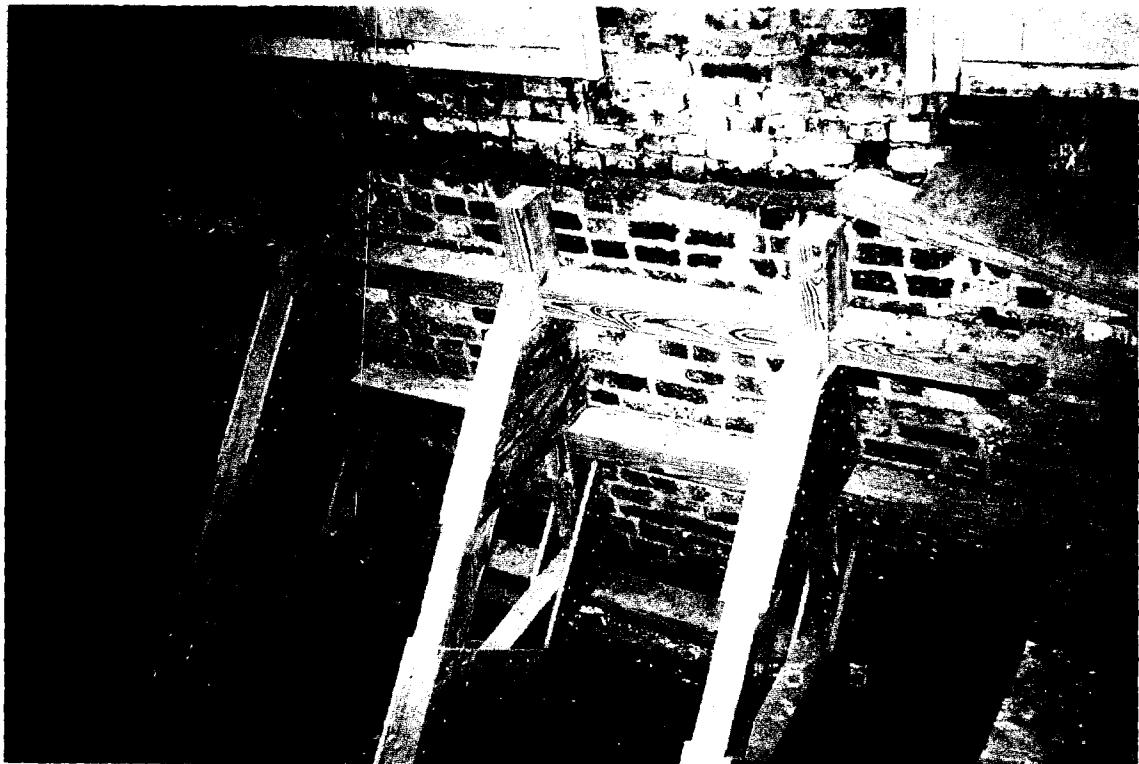
51-S Main House - View of north end of basement, showing diagonal bracing installed by National Park Service.

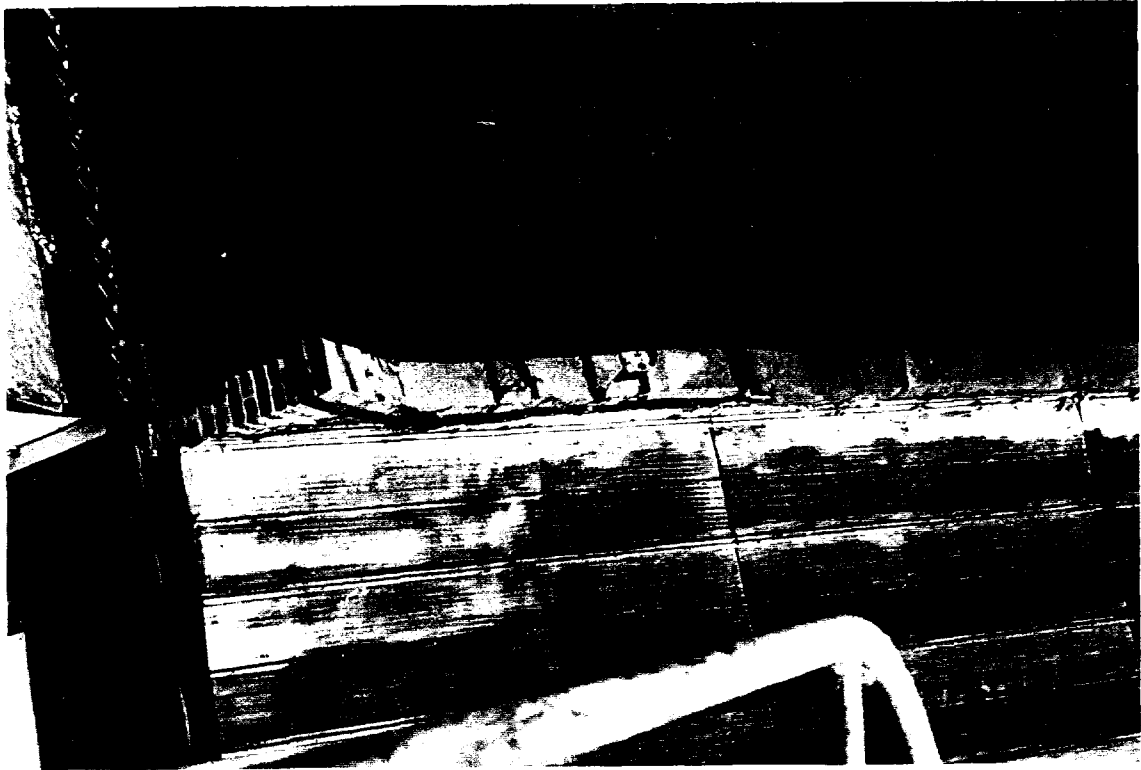
56-S Main House - View of southern half of the coping of the "party" wall between the William Johnson House (top) and the McCallum House (bottom).

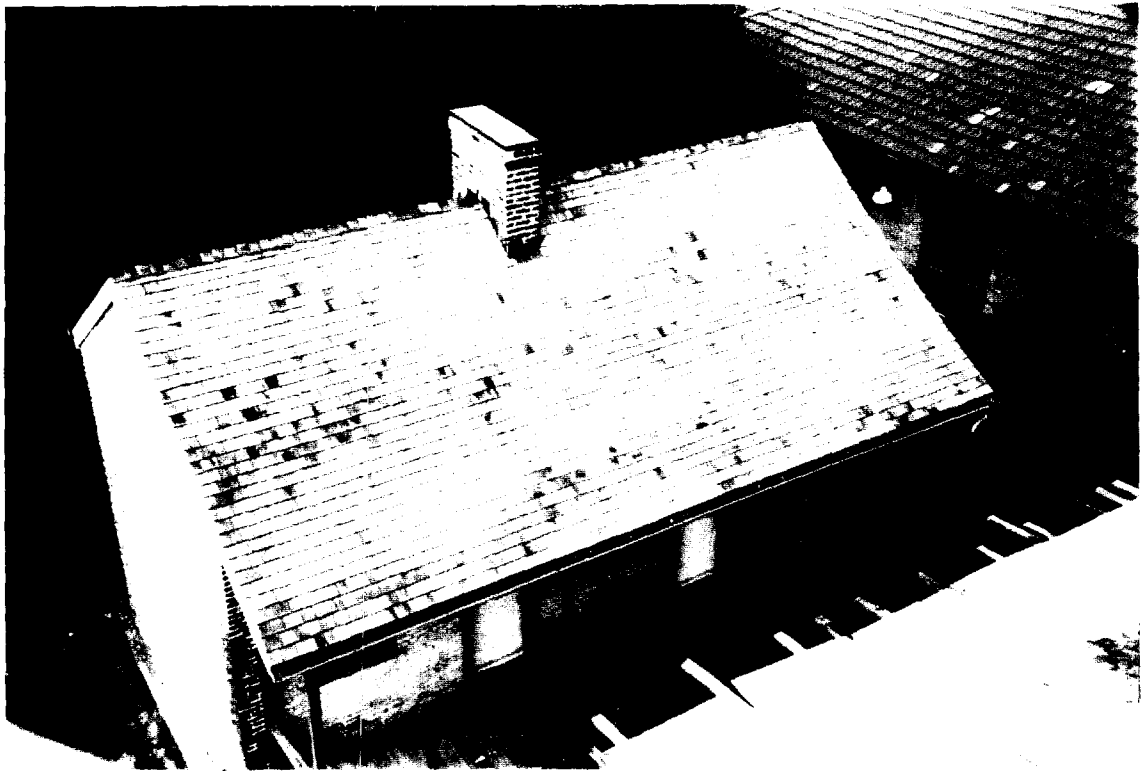
58-S Dependency - View of the northern half of the roof of the dependency.

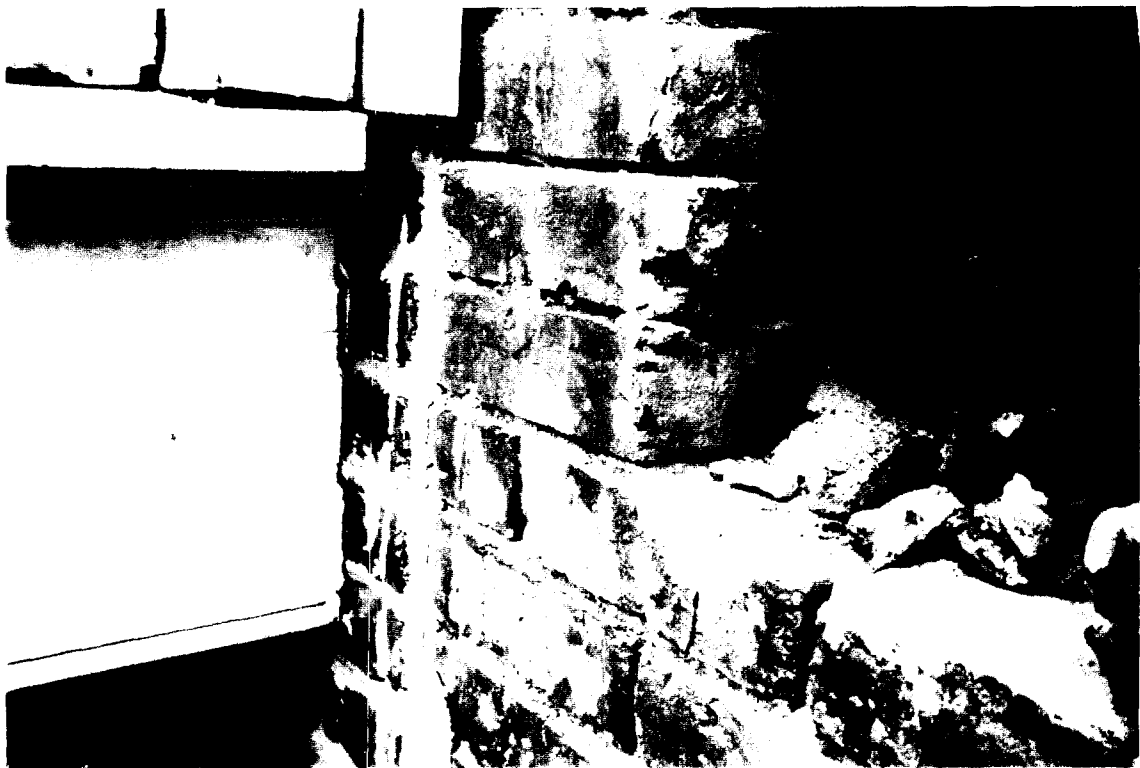
63-S Main House - View looking west into probe in the south elevation.
South porch framing is at left.
