MELROSE ESTATE
NATCHEZ NATIONAL HISTORICAL PARK

NATCHEZ, MISSISSIPPI

HISTORIC STRUCTURES REPORT
VOLUME II
PAINT AND CONCRETE ANALYSIS

ANN BEHA ASSOCIATES

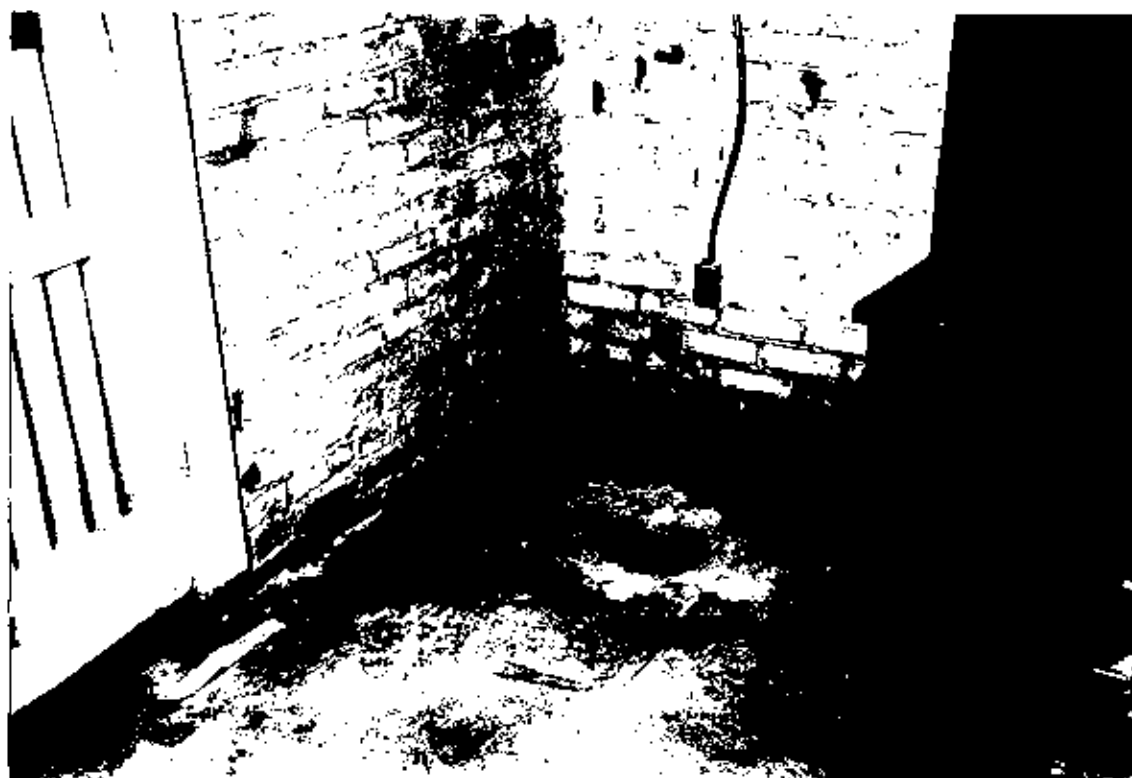
Photograph P41. Location of core sample in the southwest corner of Room 04 in the Melrose House.

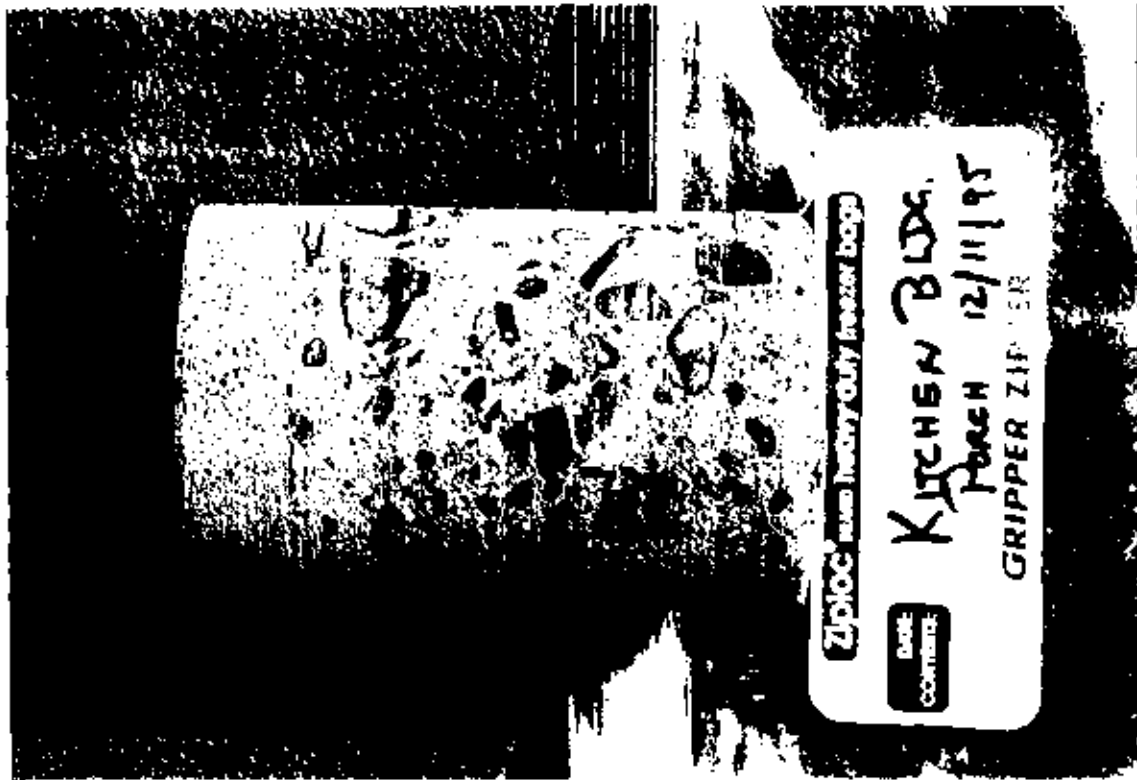
Photograph P44. Gallery core sample from the southeast corner of the Melrose Kitchen's gallery.

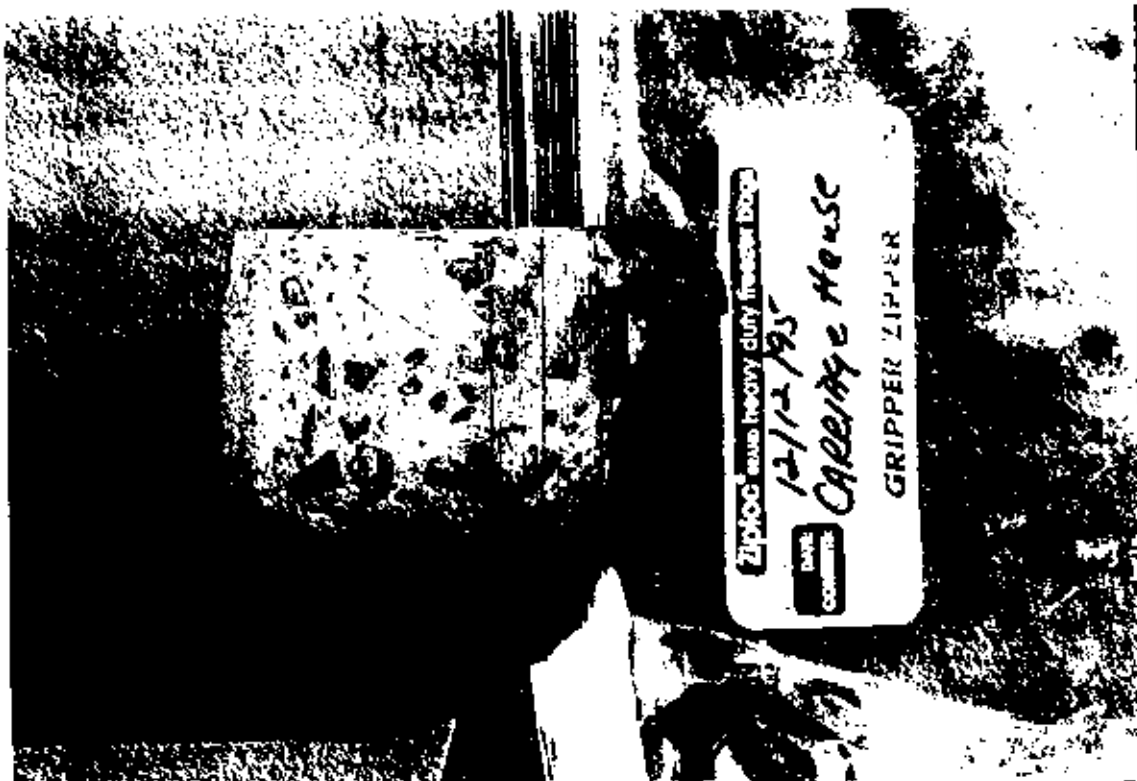
Photograph P52. Floor core sample from the northeast corner in the Melrose Carriage House.
