historic structure report
architectural data section

PISCATAWAY PARK
MARSHALL HALL

HISTORIC STRUCTURE REPORT
ARCHITECTURAL DATA SECTION
FOR
MARSHALL HALL
PISCATAWAY PARK

January 1983

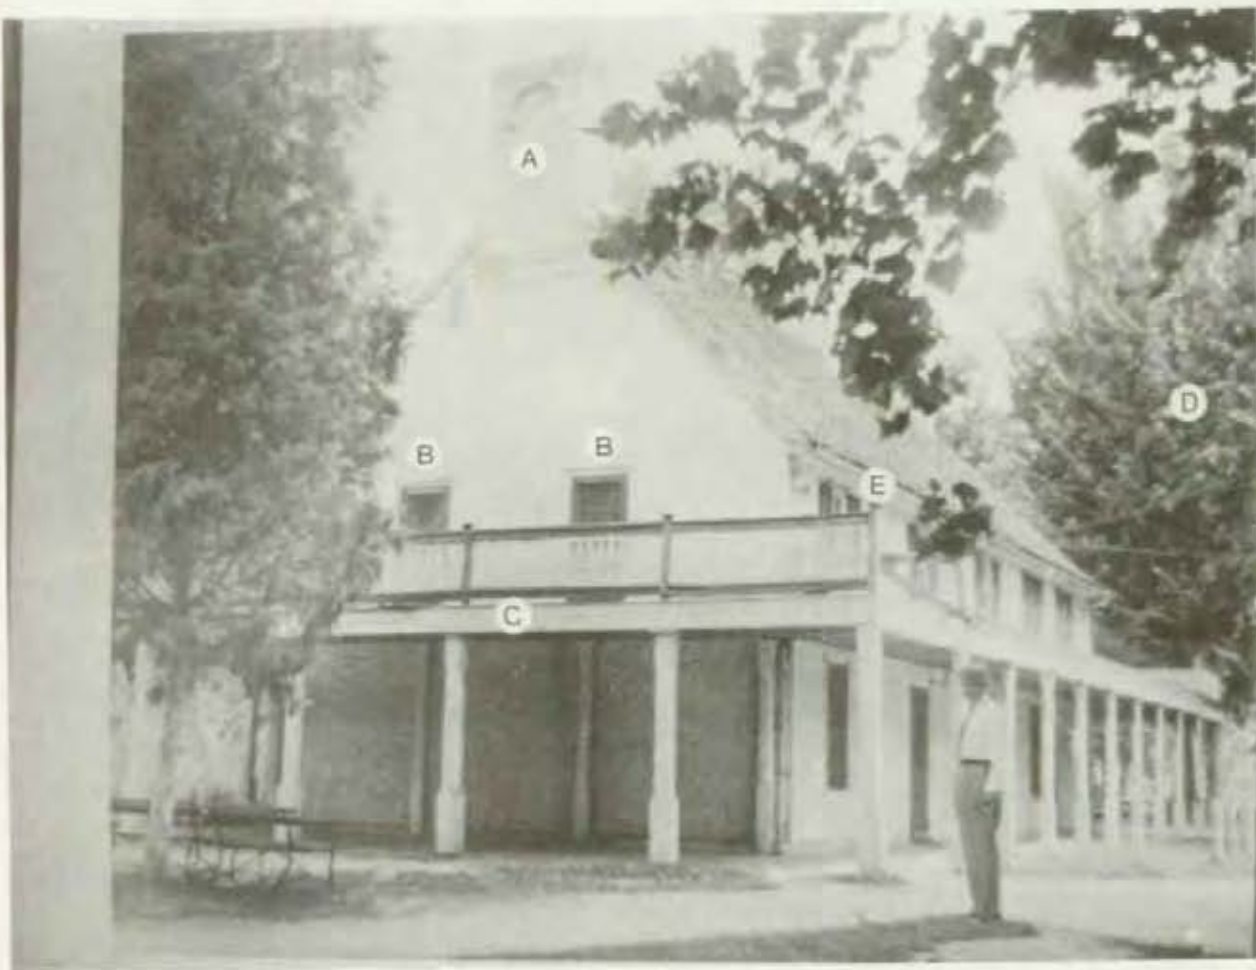
3
A SOUTH (SIDE) AND EAST (REAR) - MARSHALL HALL

- A. Arched blind panel, chimney stack was rebuilt in 1966 -- panel was reconstructed but arch was not
- B. Doors opening onto veranda -- these were later changed to windows
- C. Veranda c. 1890
- D. Ginko trees c. 1800
- E. Modillioned cornice with ogee crown and bed mouldings c. 1760 -- removed in 1966¹³

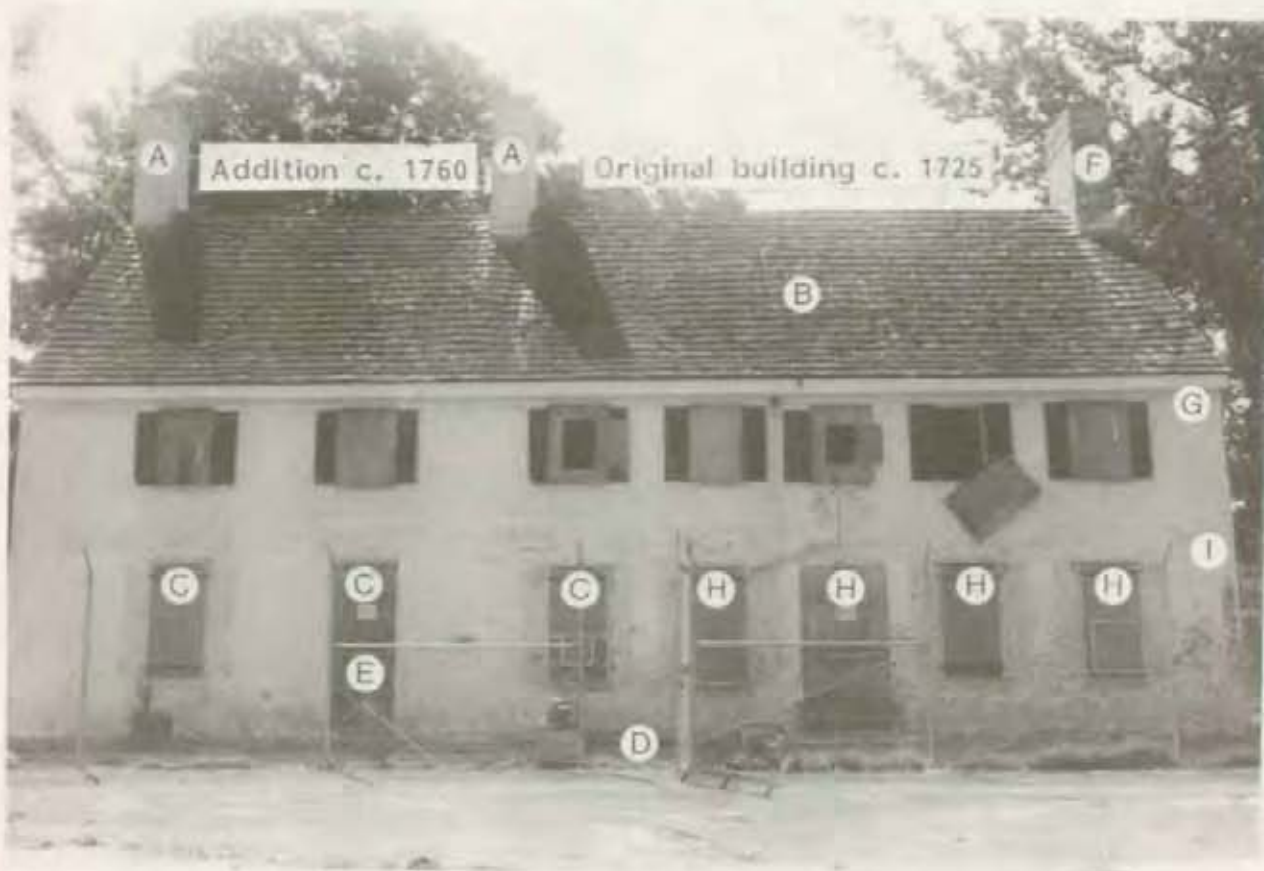
2 WEST ELEVATION
B

| <p>A. Original chimney with corbelled cap - (typical of colonial architecture)

See 7 , 8
E , E</p> <p>B. Wood shingle roof-installed 1966 - historically roof was probably horizontally hung riven clapboard</p> <p>C. Brick flat arch - bricks chisled to imitate the arches in the original building</p> <p>D. Moulded brick water table</p> <p>E. Door 101 originally a window (queen closers do not extend below window level - water table is continuous under the opening)</p> | <p>F. Chimney reconstructed 1966 -
See 6
E</p> <p>G. One and one-half story construction (typical of colonial architecture)</p> <p>H. Brick flat arch using gauged, rubbed and moulded brick (typical of colonial architecture)</p> <p>I. Flemish bond brick work with queen closers and glazed headers (typical of colonial architecture)
See 9
E</p> |

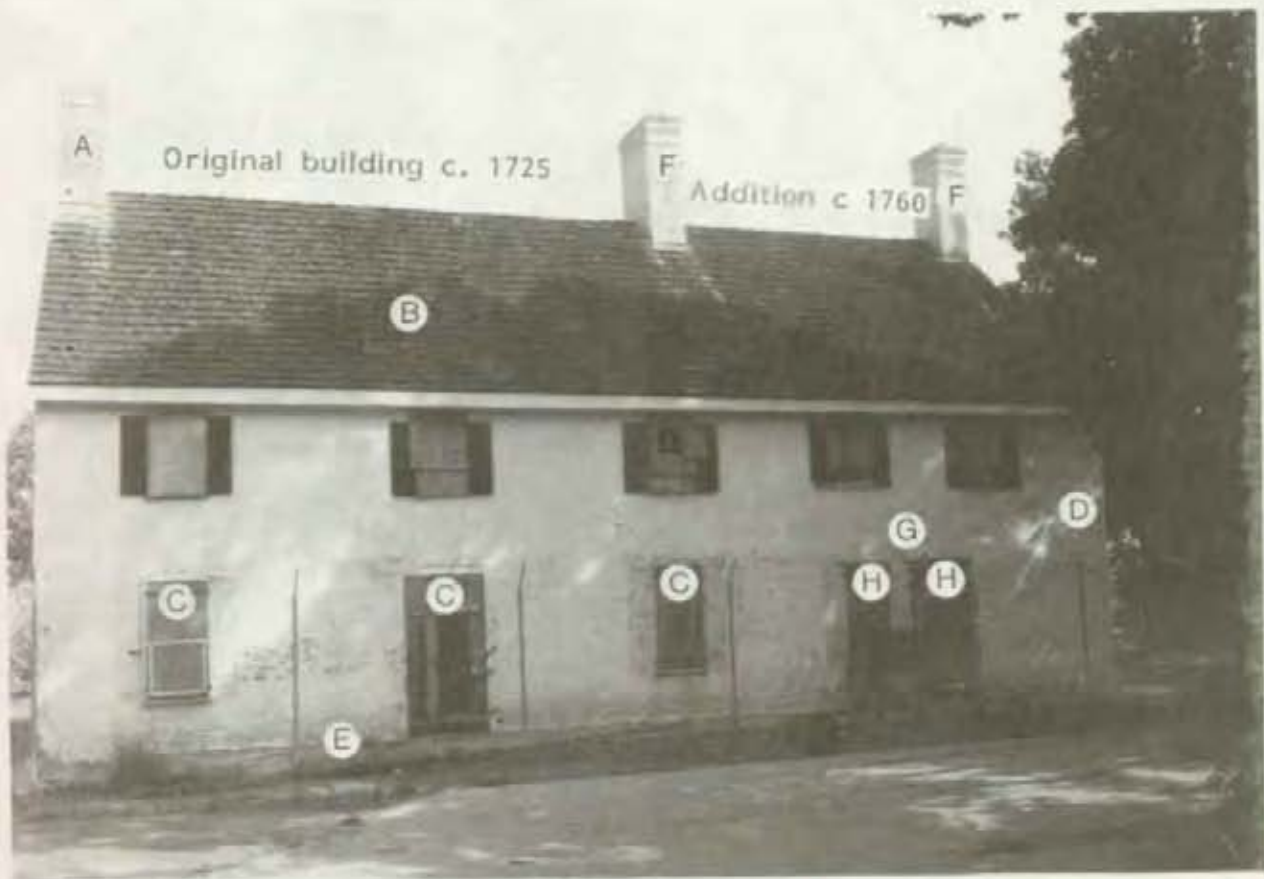
4 EAST ELEVATION
B

| <p>A. Chimney reconstructed 1966 See $\frac{6}{E}$</p> <p>B. Wood shingle roof installed - 1966</p> <p>C. Segmental arch</p> <p>D. Flemish bond brickwork with glazed headers and queen closers (typical of colonial architecture) See $\frac{9}{B}$</p> | <p>E. Moulded brick water table (typical of colonial architecture)</p> <p>F. Original chimney with corbelled caps (typical of colonial architecture) See $\frac{9}{E}$, $\frac{8}{E}$</p> <p>G. Brick arch of original opening</p> <p>H. Flat arch</p> |

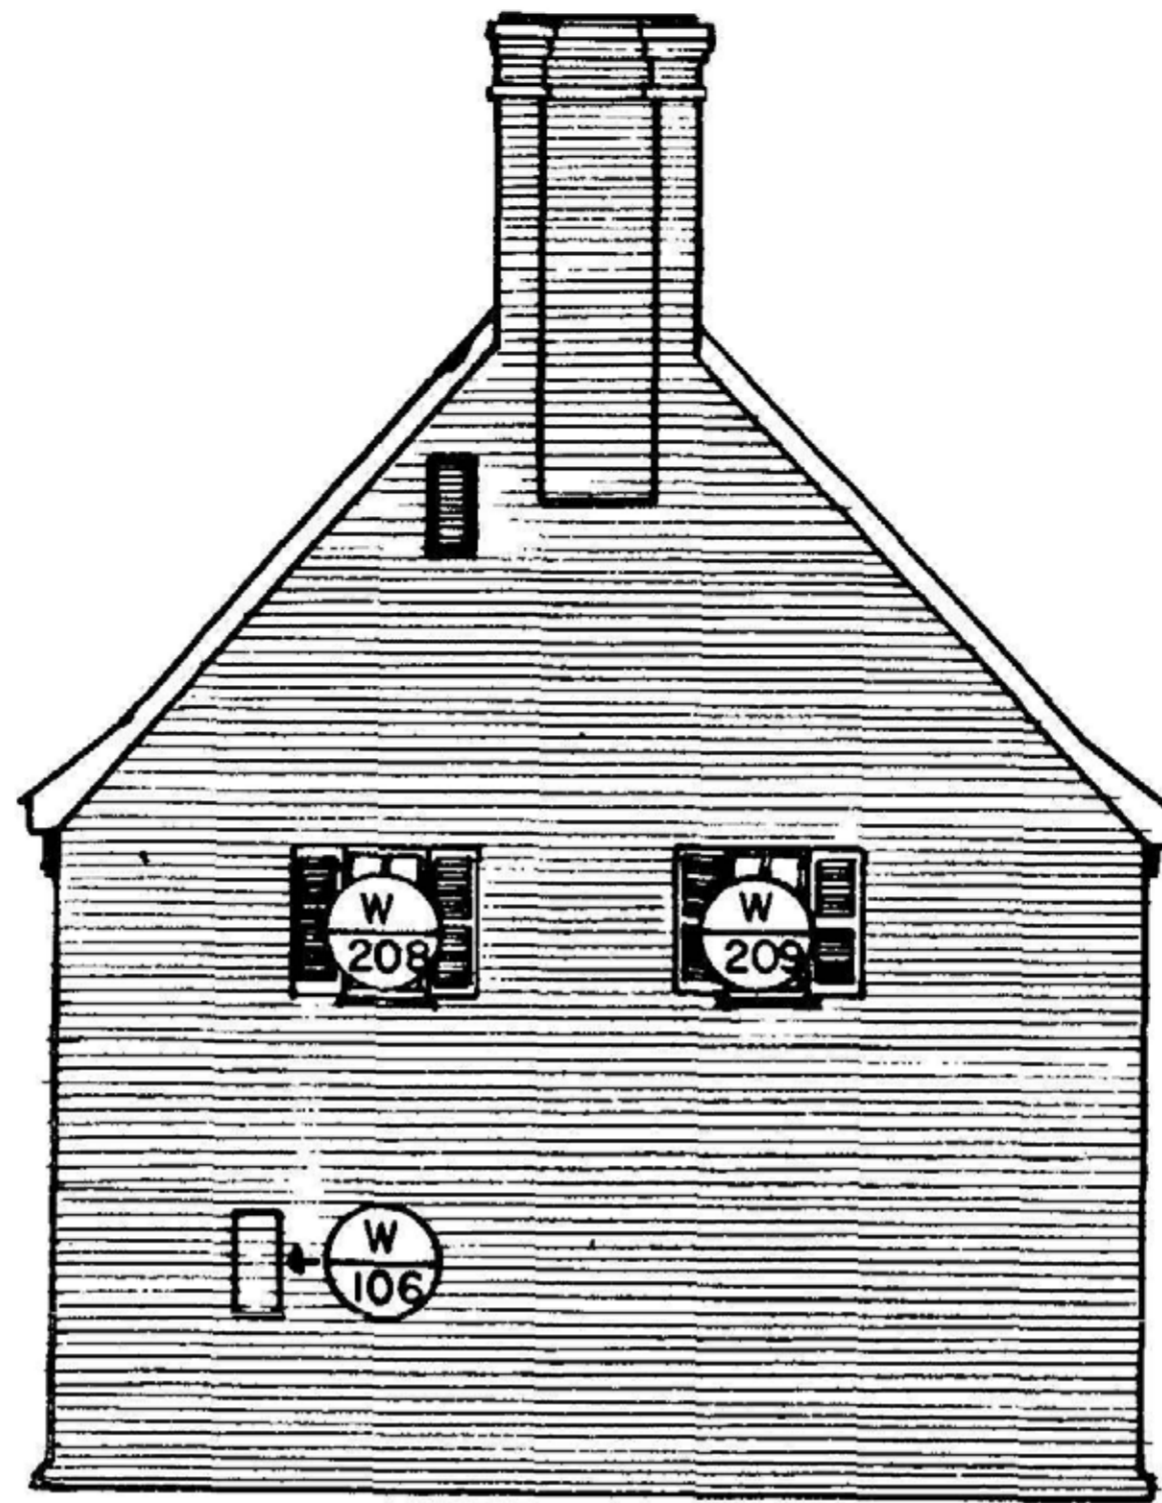
5 SOUTH ELEVATION
B

Originally this elevation contained two openings -- the roof vent and window 106. Window 106 was bricked up at an unknown date. Windows 208 and 209 were added c. 1890 and were originally doors that opened onto a veranda. When the porch was removed the doors were changed to windows. The chimney on this elevation was reconstructed in 1966. Historically the chimney contained an arched blind panel.¹⁷ Although the panel was reconstructed, the arch was not.

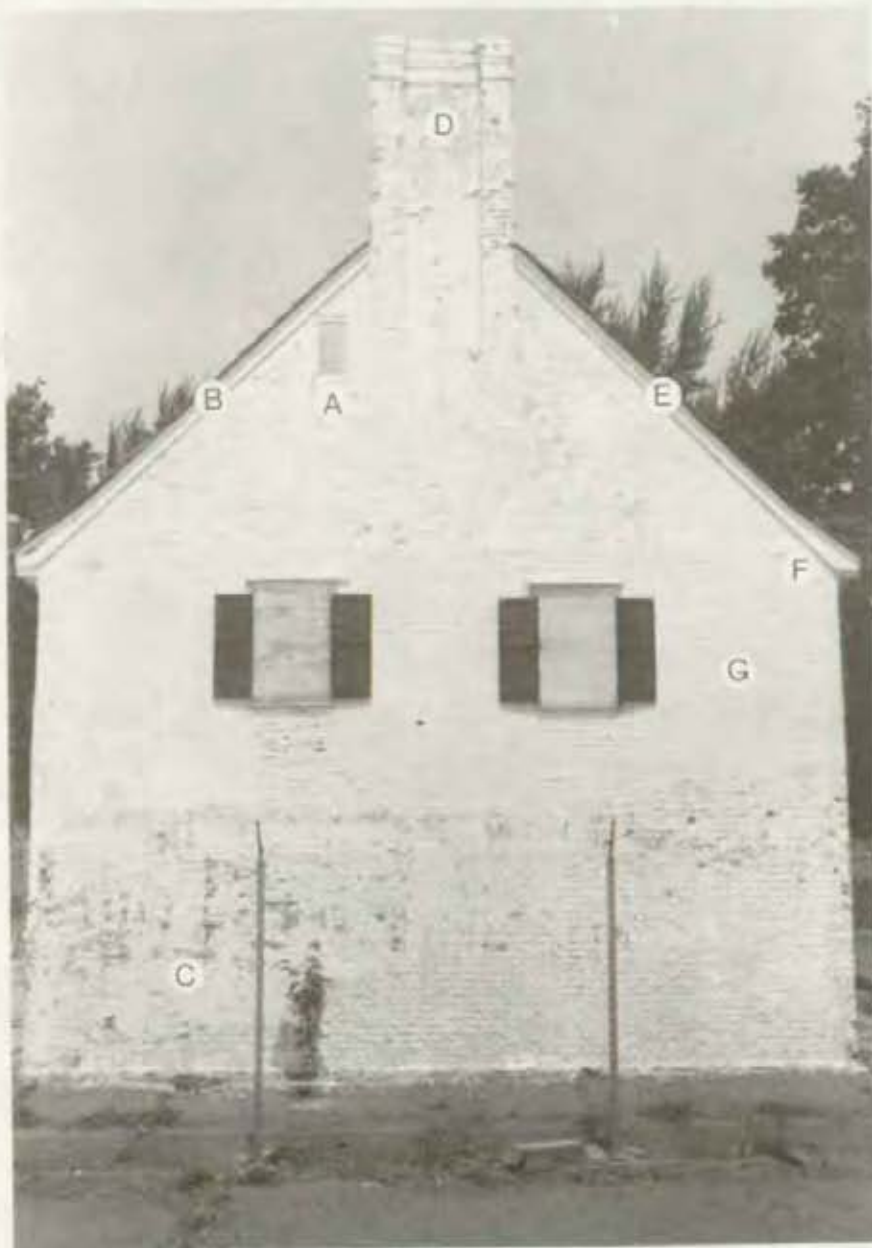
6 SOUTH ELEVATION
B

| <p>A. Original roof vent opening</p> <p>B. New barge board</p> <p>C. Bricked up window opening</p> <p>D. Chimney reconstructed in 1966

See $\frac{6}{E}$</p> | <p>E. Steeplly angled roof (typical of colonial architecture)</p> <p>F. Flared roof eaves - (typical of Maryland colonial architecture)
See $\frac{5}{E}$, $\frac{88}{E}$, $\frac{94}{E}$</p> <p>G. Flemish bond brick with glazed headers and queen closers (typical of colonial architecture) See $\frac{9}{B}$</p> |

- A. Replace roof vent
- B. Reconstruct blind arch in chimney
- C. Replace barge board
- D. Reconstruct roof with historic slope and flare and eaves

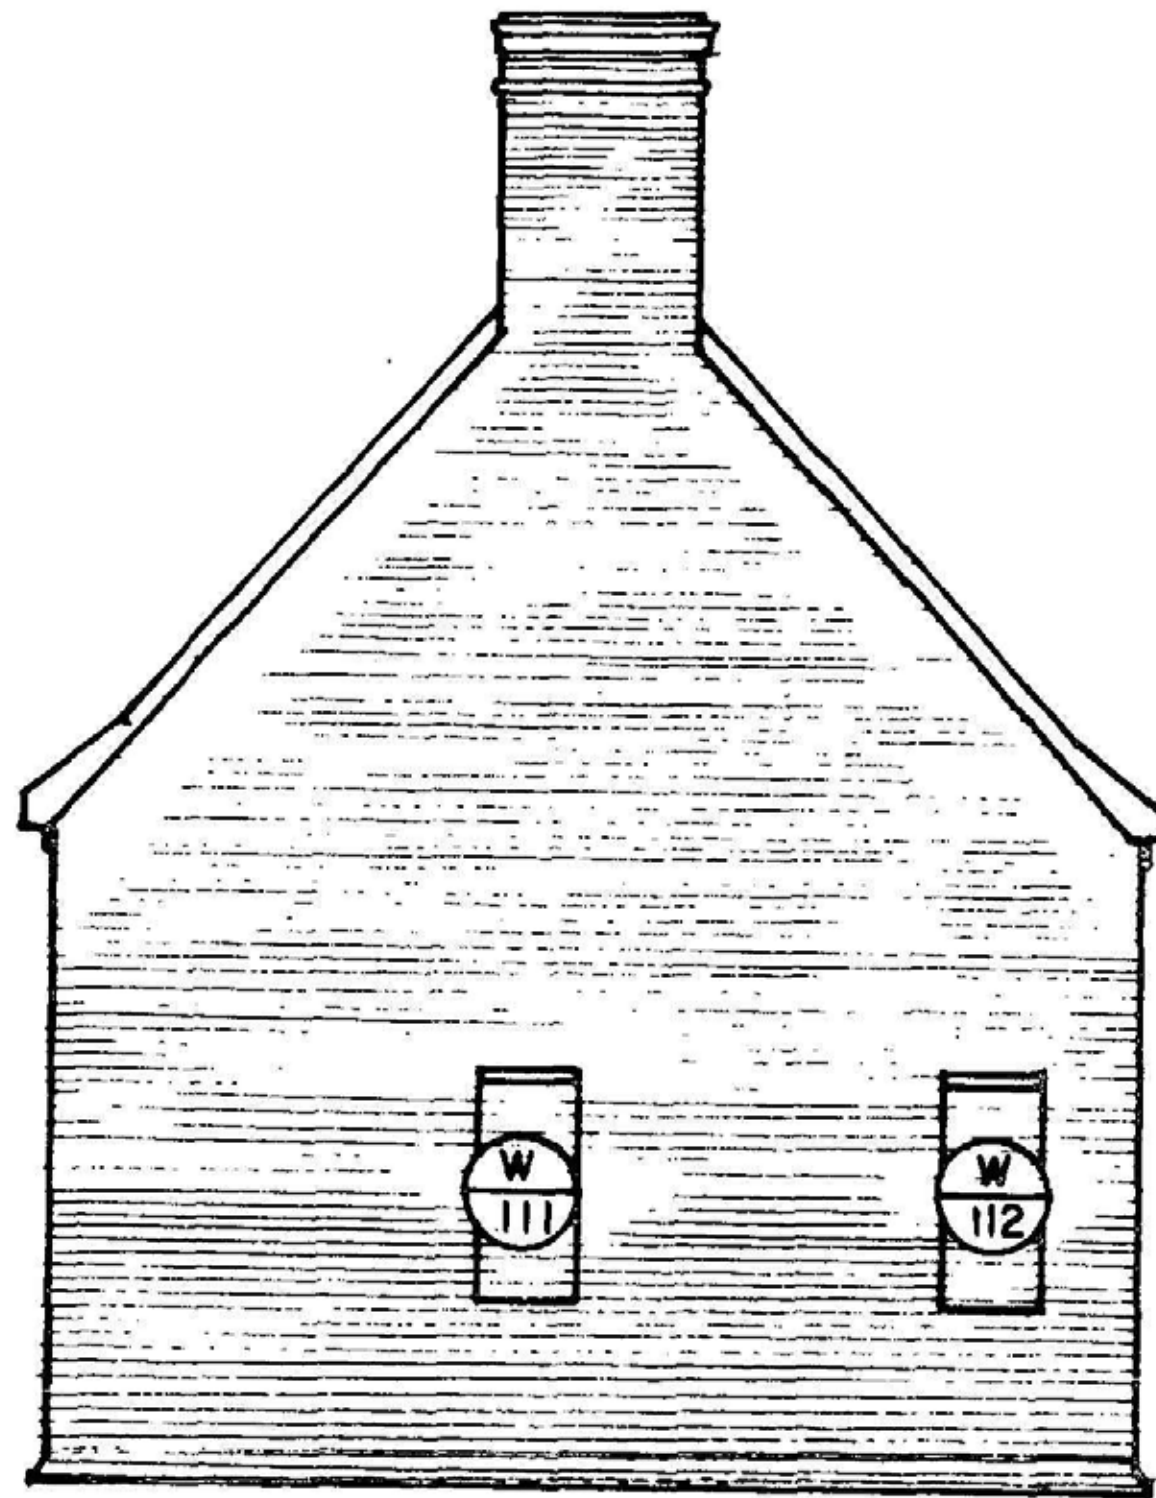
7 NORTH ELEVATION
B

The north elevation (c. 1760) contained no opening at the time of this study. Historically, it contained two windows. Windows 110 and 111 flanked the fireplace and were spanned by flat arches of alternating stretcher and header bricks for window 110. The windows were bricked up at the time the addition was remodeled, c. 1800.

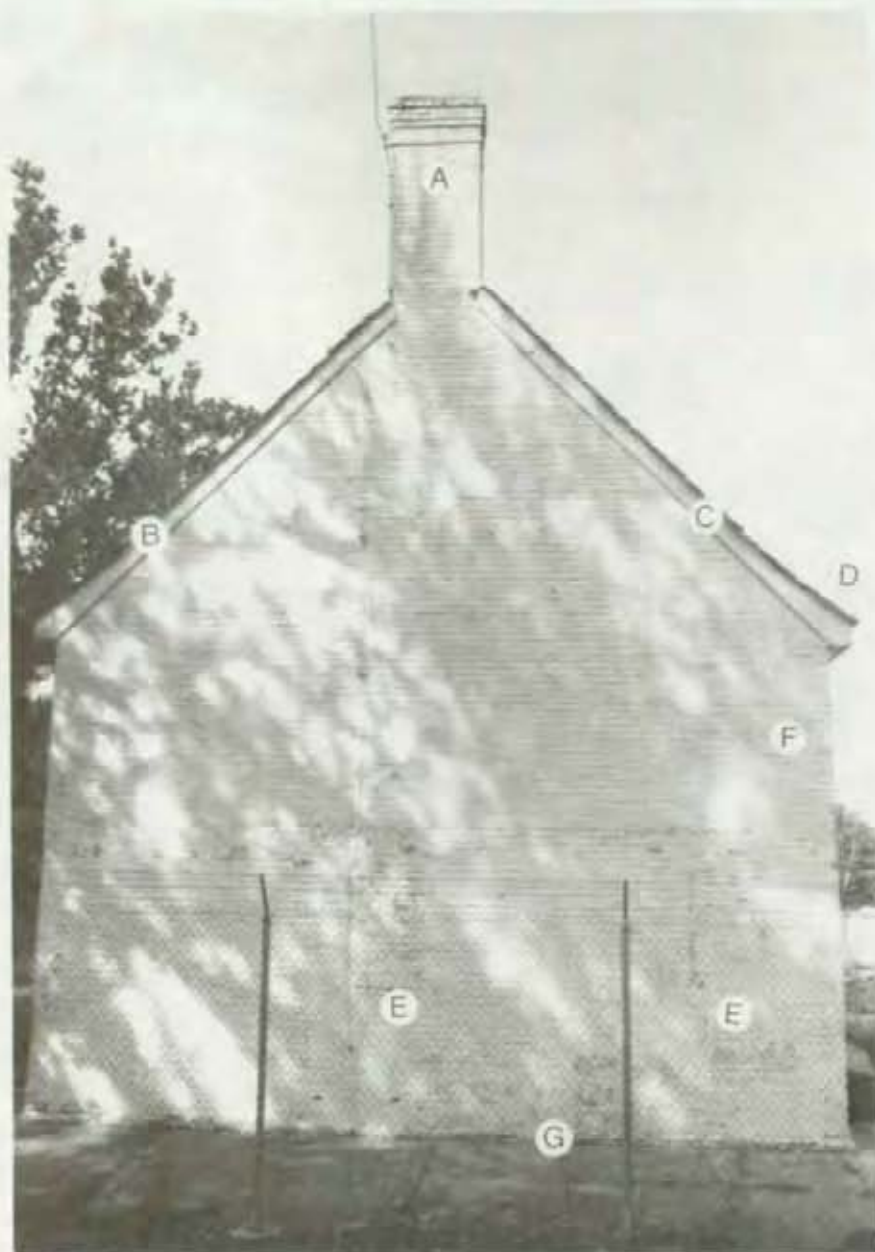
8
B NORTH ELEVATION

| <p>A. Original chimney with corbelled cap (typical of colonial architecture) See 8

E</p> <p>B. New barge board</p> <p>C. Steeply pitched roof (typical of colonial architecture)</p> <p>D. Flared roof eaves (typical of Maryland colonial architecture) See 5
E</p> | <p>E. Historical window openings See 4
E</p> <p>F. Flemish bond brickwork using glazed headers and queen closers (typical of colonial architecture)</p> <p>G. Moulded brick water table (typical of colonial architecture)</p> |

A. Replace barge board

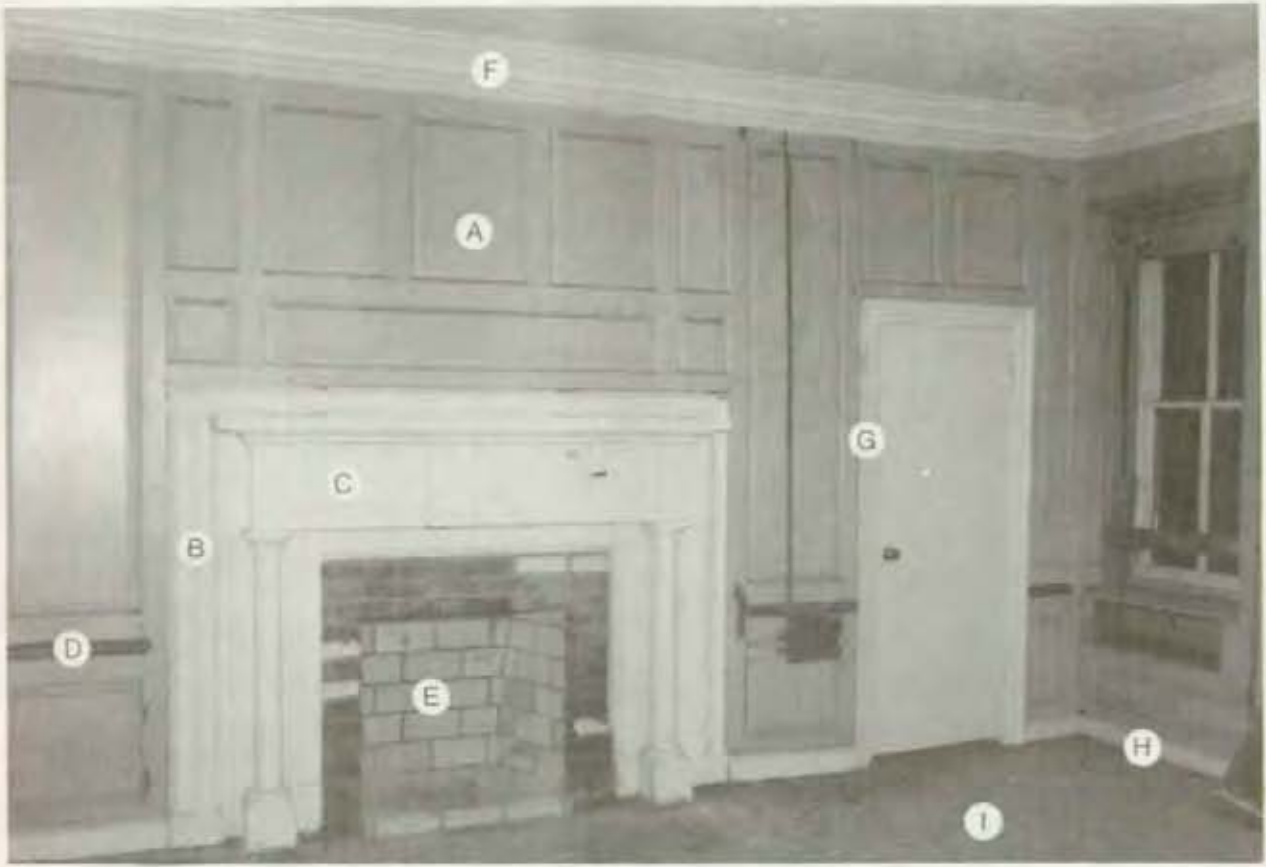
11 ROOM 101 - SOUTH ELEVATION
B

- A. Historical fielded panels See $\frac{36}{E}$, $\frac{39}{E}$
- B. Historical bolection moulding (typical of colonial architecture) See $\frac{44}{E}$
- C. Later Victorian mantel See $\frac{43}{E}$, $\frac{45}{E}$, $\frac{46}{E}$, $\frac{47}{E}$
- D. Ghost of chair rail
- E. New brick infill in fireplace
- F. Historical moulded wood ceiling cornice (typical of colonial architecture) See $\frac{41}{E}$
- G. Original door moulding (Door 106 sim.) See $\frac{15}{E}$
- H. Historical base board See $\frac{40}{E}$
- I. Random width floor boards

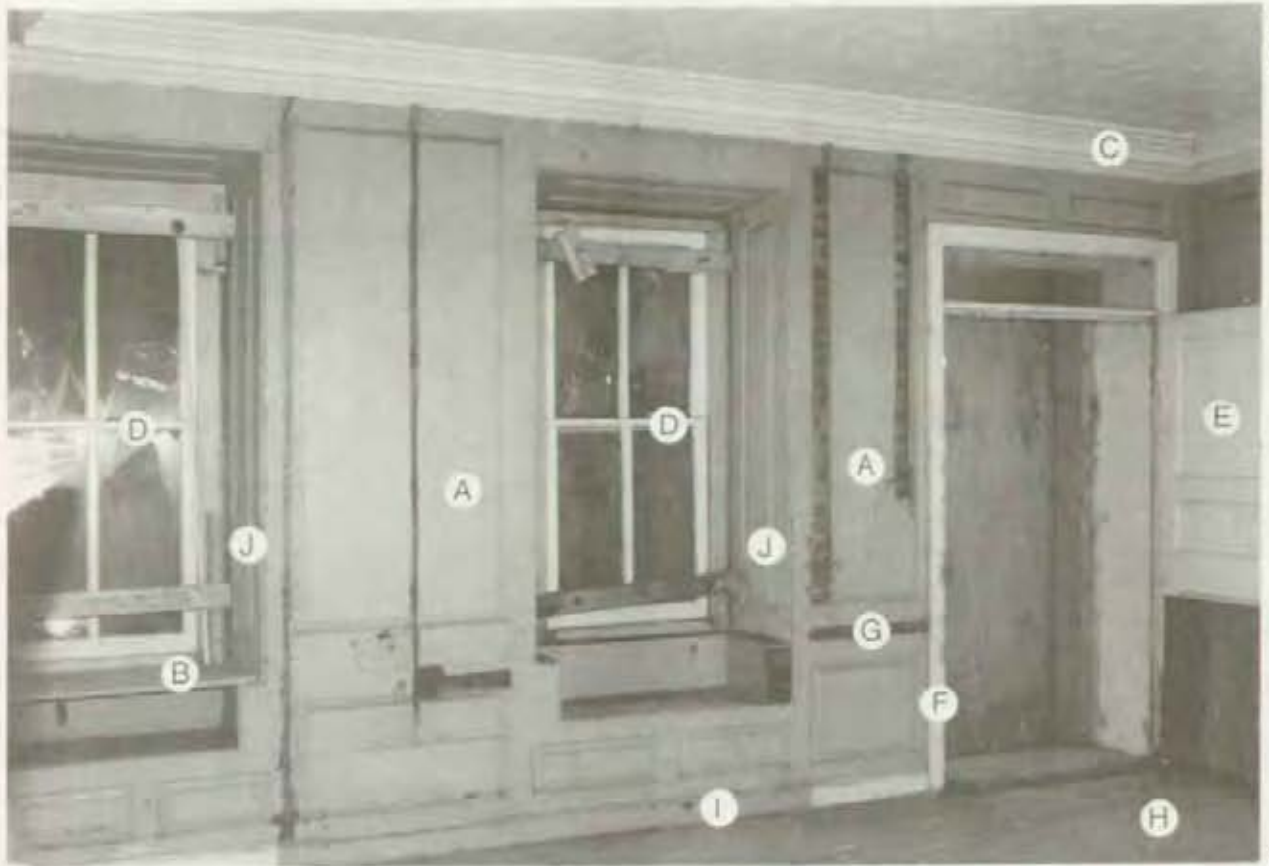
12 / B ROOM 101 - WEST ELEVATION

| <p>A. Historical fielded panels

See 38 / 39 / E, E</p> <p>B. Window shelf -- attached to window seat with cut nails -- paint layering indicated shelf was not original
See 13 / B</p> <p>C. Historical wood ceiling cornice (typical of colonial architecture)
See 41 / E</p> <p>D. Victorian sash See 18 / E</p> | <p>E. New door</p> <p>F. Original door jamb See 9 / E</p> <p>G. Ghost of chair rail</p> <p>H. Random width floor boards</p> <p>I. Historical base board See 40 / E</p> <p>J. Historical reveal panel
18 / E, 19 / E, 20 / E</p> |

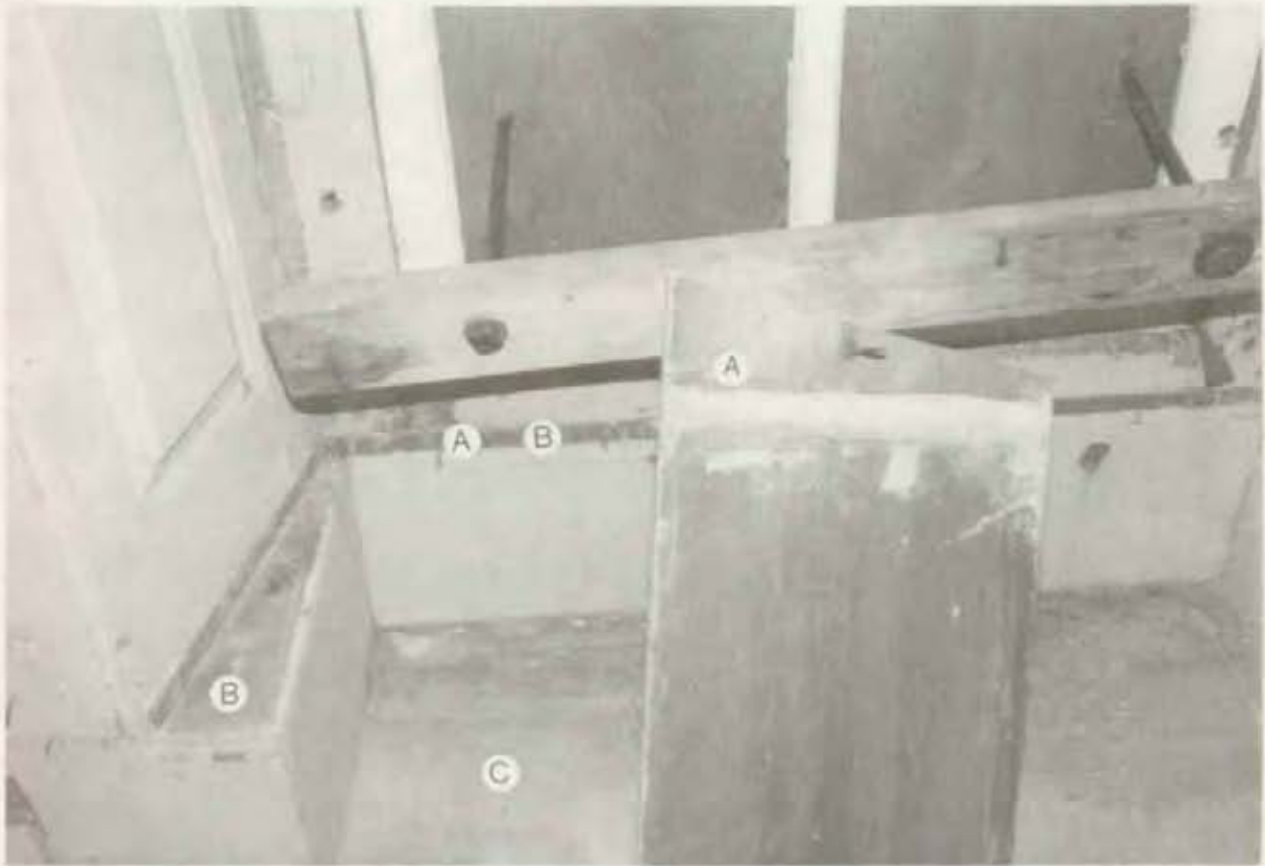
13
B ROOM 101 - WINDOW DETAIL

- A. Paint line indicating shelf was a later addition
- B. Original paint
- C. Historical window seat

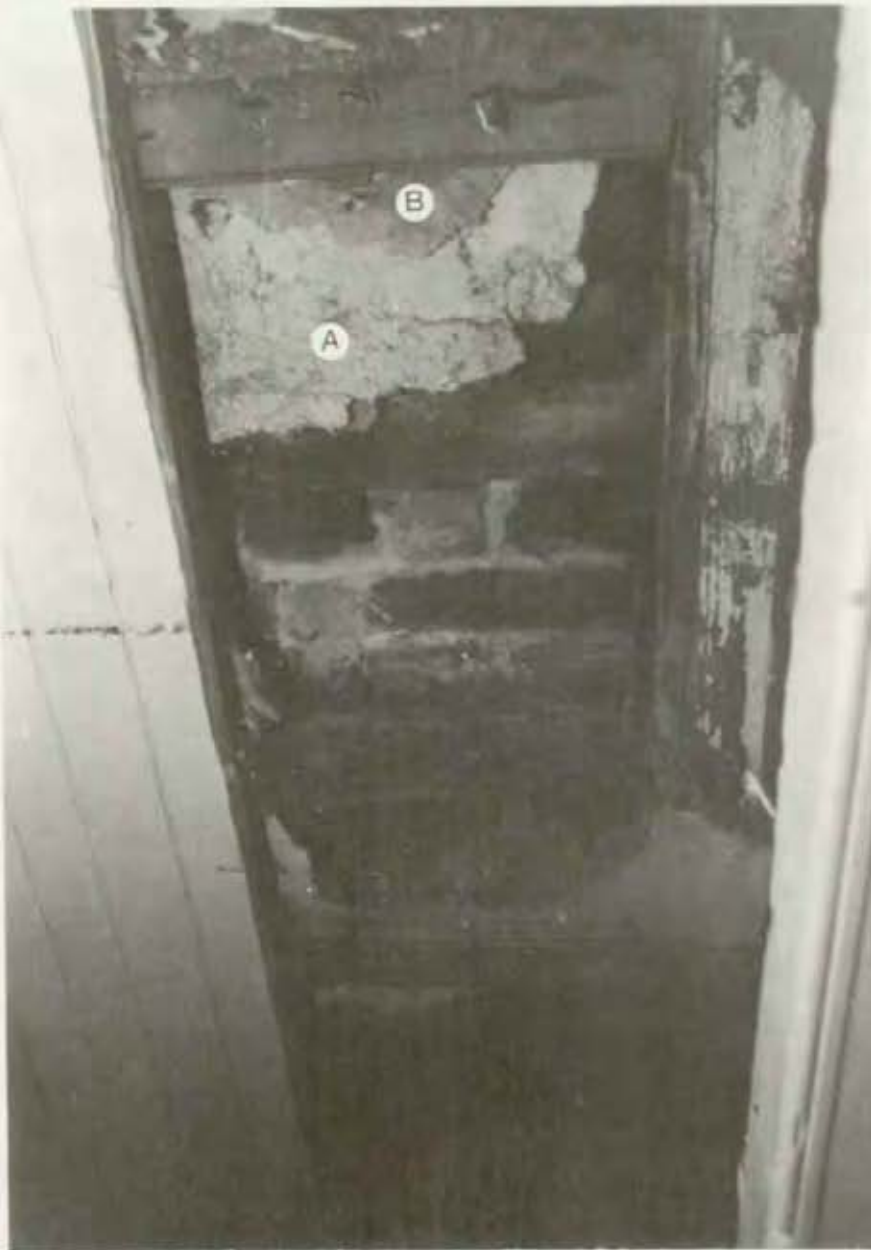
16 ROOM 102 - WEST ELEVATION
B

- A. Plaster on brick
- B. Wallpaper c. 1800 (sample at Harpers Ferry Center)

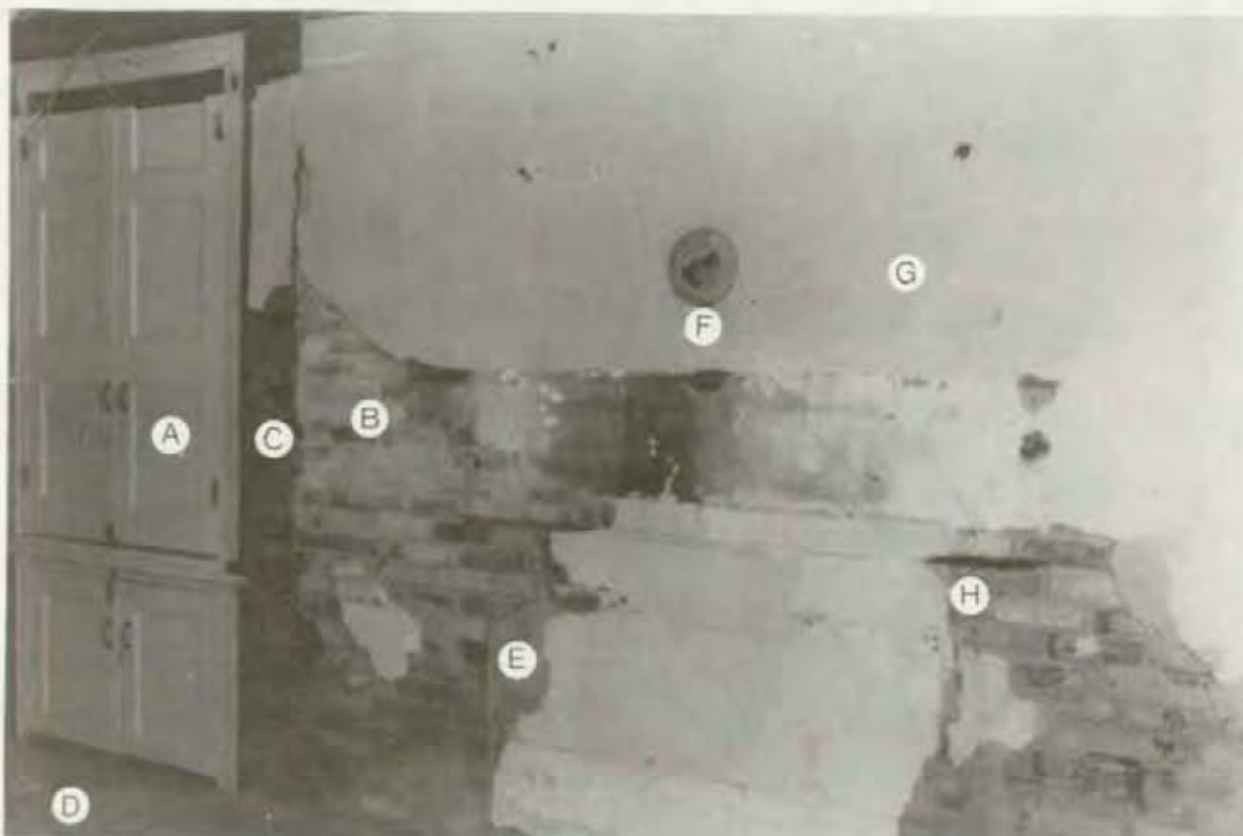
18 - ROOM 103 - NORTH ELEVATION
B

| <p>A. Cupboard c. 1800 (Cupboards rm. 104 sim.) See 58

E, 59
E, 60
E</p> <p>B. Used brick-installed to increase depth of wall See 49
E</p> <p>C. Split wood lath See 49
E</p> <p>D. Random width floor boards</p> | <p>E. Bricked up fireplace opening 49
E</p> <p>F. Flue opening for stove</p> <p>G. Plaster on brick</p> <p>H. Chimney bar See 49
E</p> |

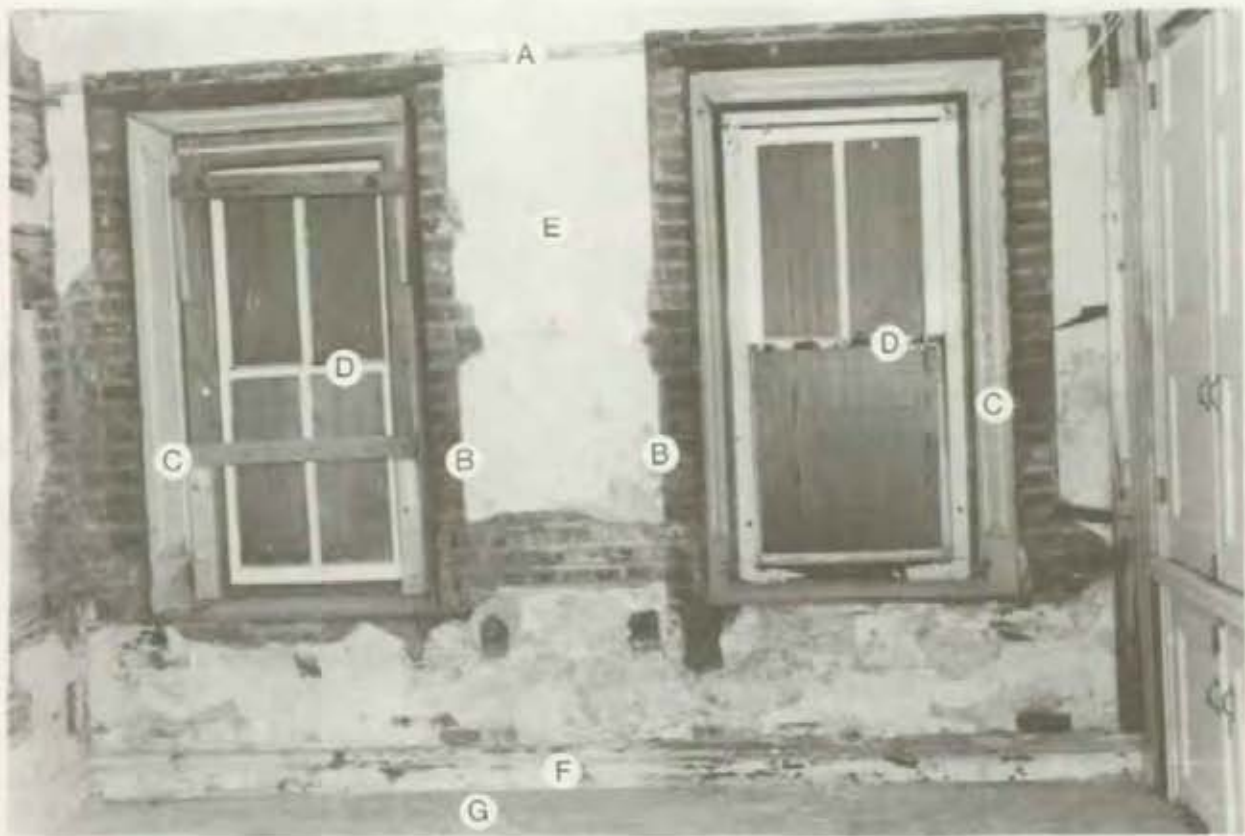
19 ROOM 103 - WEST ELEVATION
B

- A. Ghost of picture moulding
- B. Plaster line of window trim
- C. Historical reveal panels
See 21 22 23
E E E
- D. Victorian window sash
- E. Plaster on brick
- F. Historical base
- G. Random width floor boards

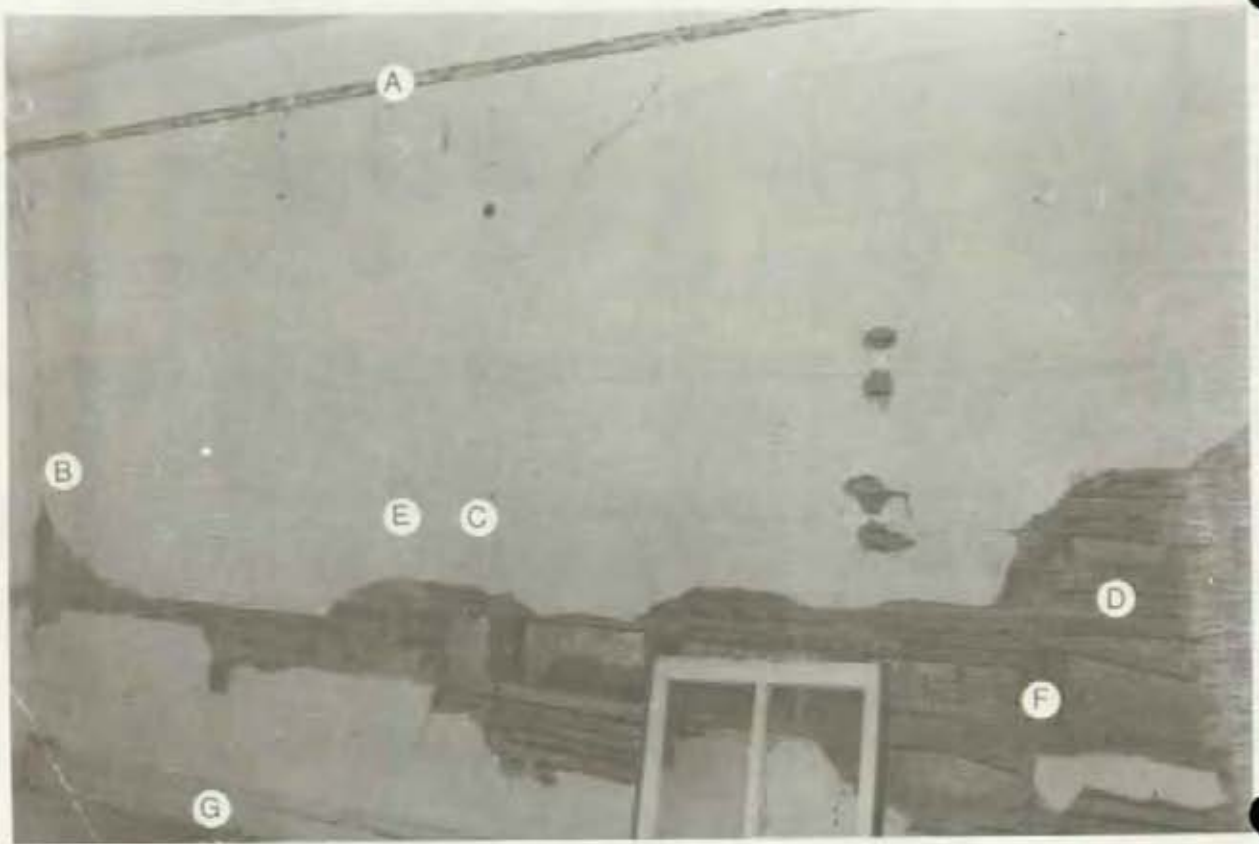
20 ROOM 103 - SOUTH ELEVATION
B

| <p>A. Ghost of picture moulding</p> <p>B. Brick wall -- not tied into wall, it abuts 50

E</p> <p>C. Plaster on wood lath</p> <p>D. Split lath attached with rose headed hand wrought nails with fire drawn points</p> <p>E. Plaster on brick See 50
 E</p> | <p>F. Wood studs in front of plaster on brick See 50
 E</p> <p>G. Historical base</p> |

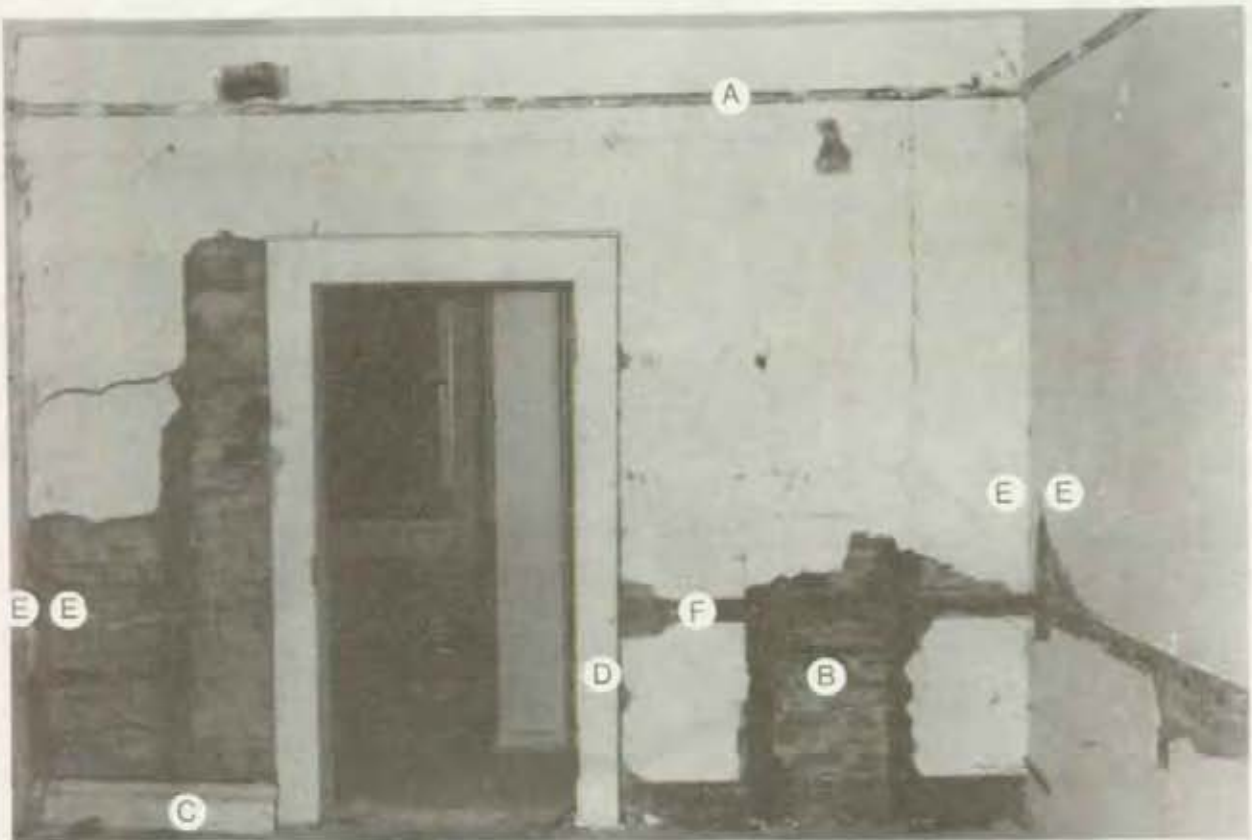
21 ROOM 103 - EAST ELEVATION
B

- A. Ghost of picture moulding
- B. Brick nogging (typical construction technique in colonial architecture)
- C. Historical base
- D. Modern door jamb
- E. Brick walls butt jointed
- F. Ghost of chair rail

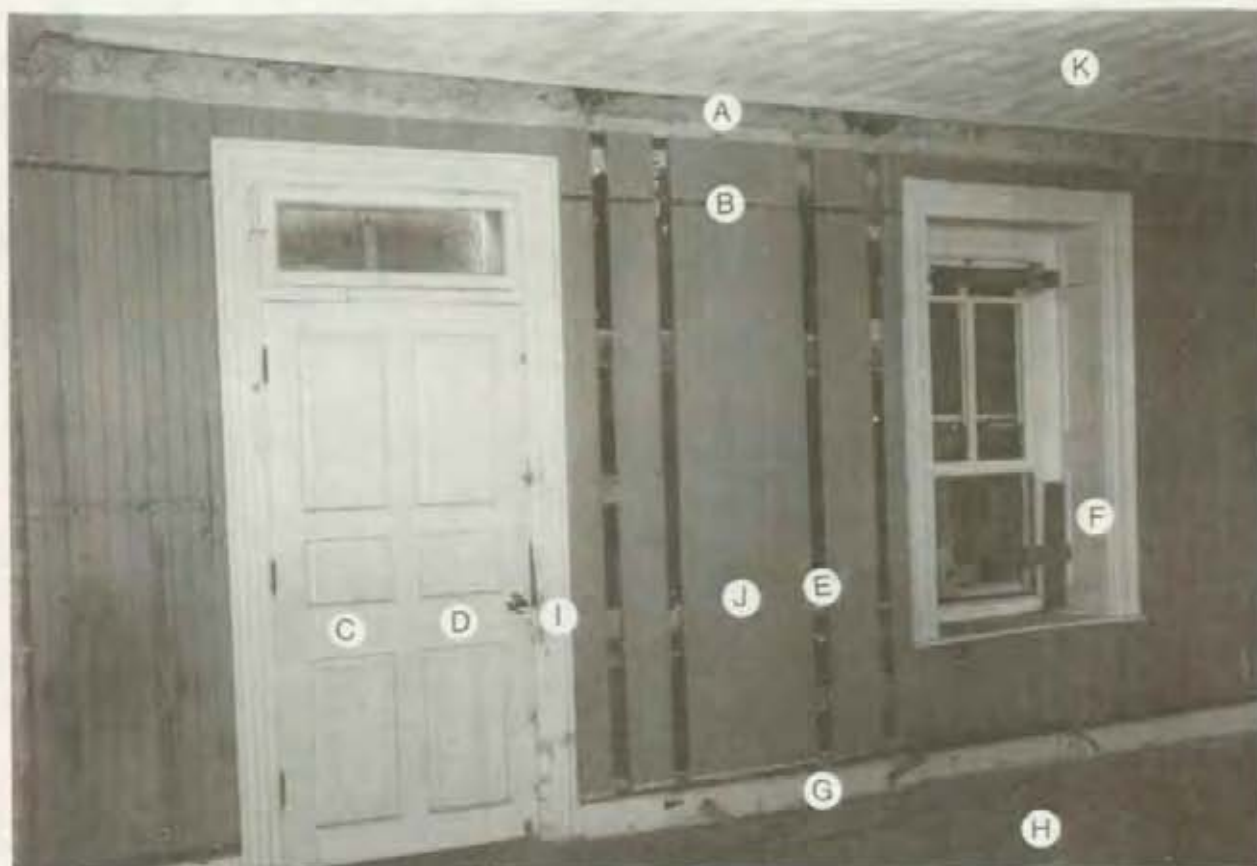
23
B ROOM 104 - WEST ELEVATION

| <p>A. Ghost of plaster ceiling cornice</p> <p>B. Ghost of picture moulding</p> <p>C. New panel door</p> <p>D. Door 101 originally a window

See 2
B</p> <p>E. Plaster painted with water proofing</p> <p>F. Window trim and reveal panel added
c. 1800 (W109, W108, D112, D104 sim)
See 18
E, 19
E, 20
E</p> | <p>G. Base See 53
E</p> <p>H. Uniform width floor boards</p> <p>I. Door trim See 9
E</p> <p>J. Modern paneling</p> <p>K. New plaster ceiling</p> |

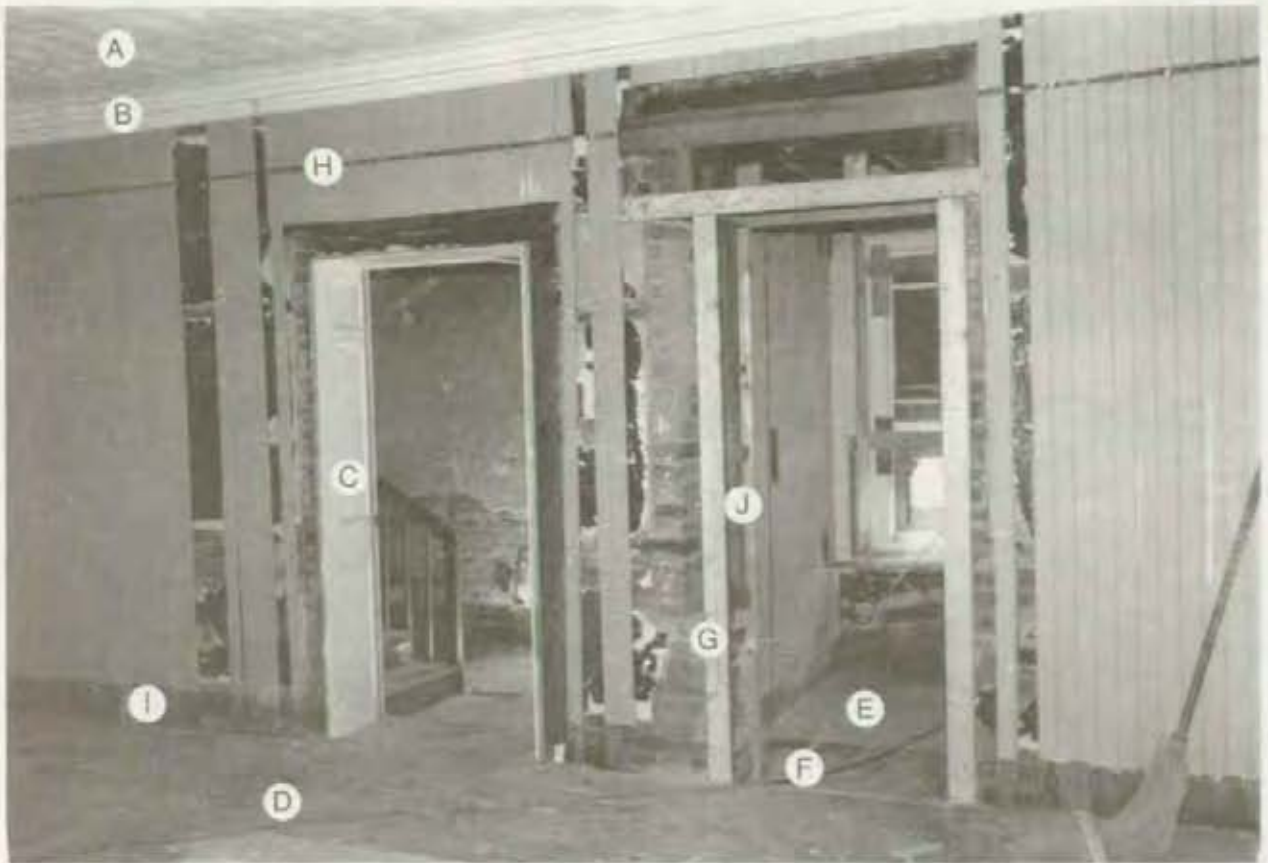
24
B ROOM 104 - EAST ELEVATION

| <p>A. New plaster ceiling</p> <p>B. Plaster ceiling cornice - added c. 1800 See 52

E</p> <p>C. Reveal panel added c. 1800 (D 104 sim.) See 14
E</p> <p>D. Uniform width floor boards</p> <p>E. Doorway -- historically a splayed window opening</p> | <p>F. Historical brick floor See 26
B</p> <p>G. Base of splayed window opening</p> <p>H. Ghost of picture moulding</p> <p>I. Ghost of baseboard</p> <p>J. Historical window jamb</p> |

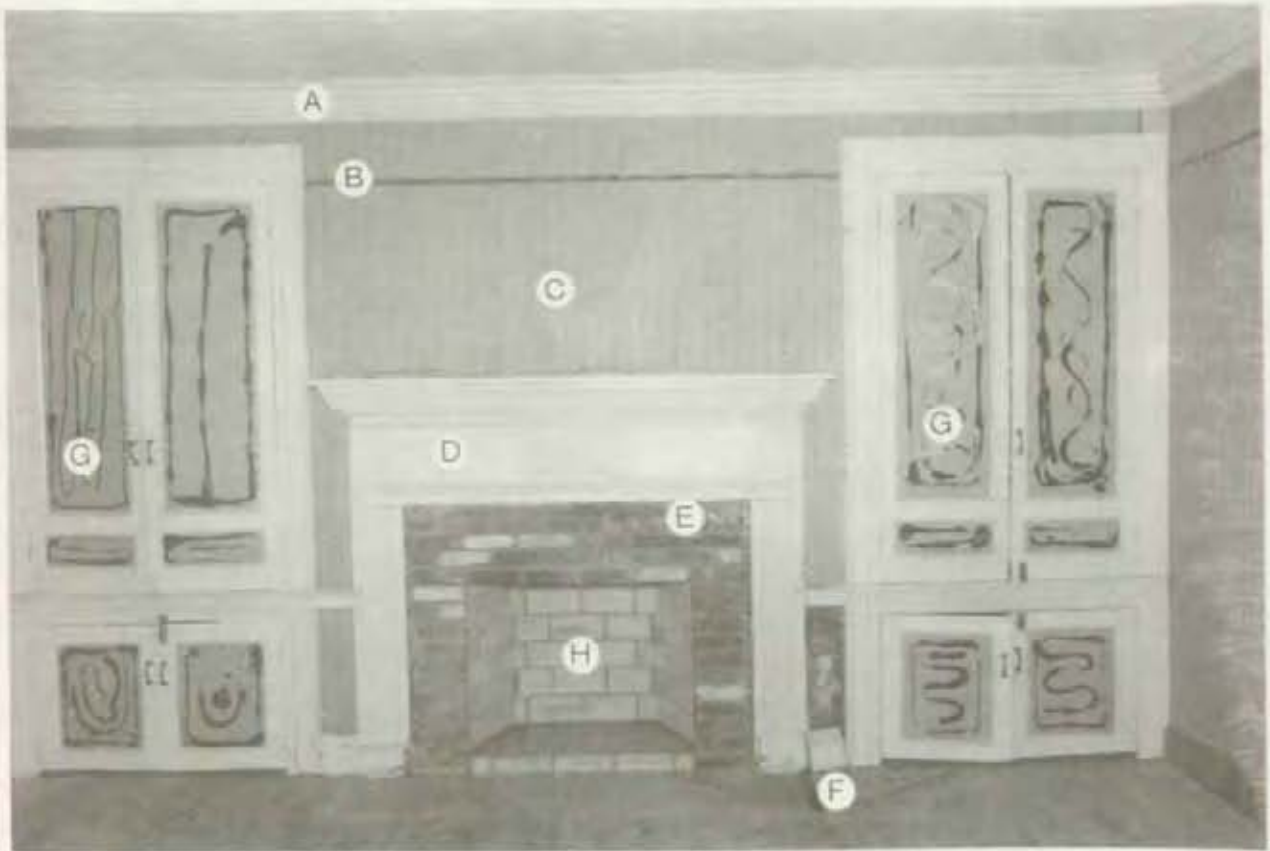
25
B ROOM 104 - NORTH ELEVATION

| <p>A. Plaster ceiling cornice See 52

E</p> <p>B. Ghost of picture moulding</p> <p>C. Modern paneling</p> <p>D. Federal-style mantel c. 1800
See 53
E 56
E 57
E</p> <p>E. Brick headers spanning original fireplace opening See 55
E</p> <p>F. Baseboard c. 1800 See 53
E</p> | <p>G. Cupboard c. 1800 (Cupboard in rm. 103 sim.)
See 58
E 59
E 60
E</p> <p>H. New fire brick</p> |
