historic structure report
architectural data section

PISCATAWAY PARK
MARSHALL HALL

HISTORIC STRUCTURE REPORT
ARCHITECTURAL DATA SECTION
FOR
MARSHALL HALL
PISCATAWAY PARK

January 1983

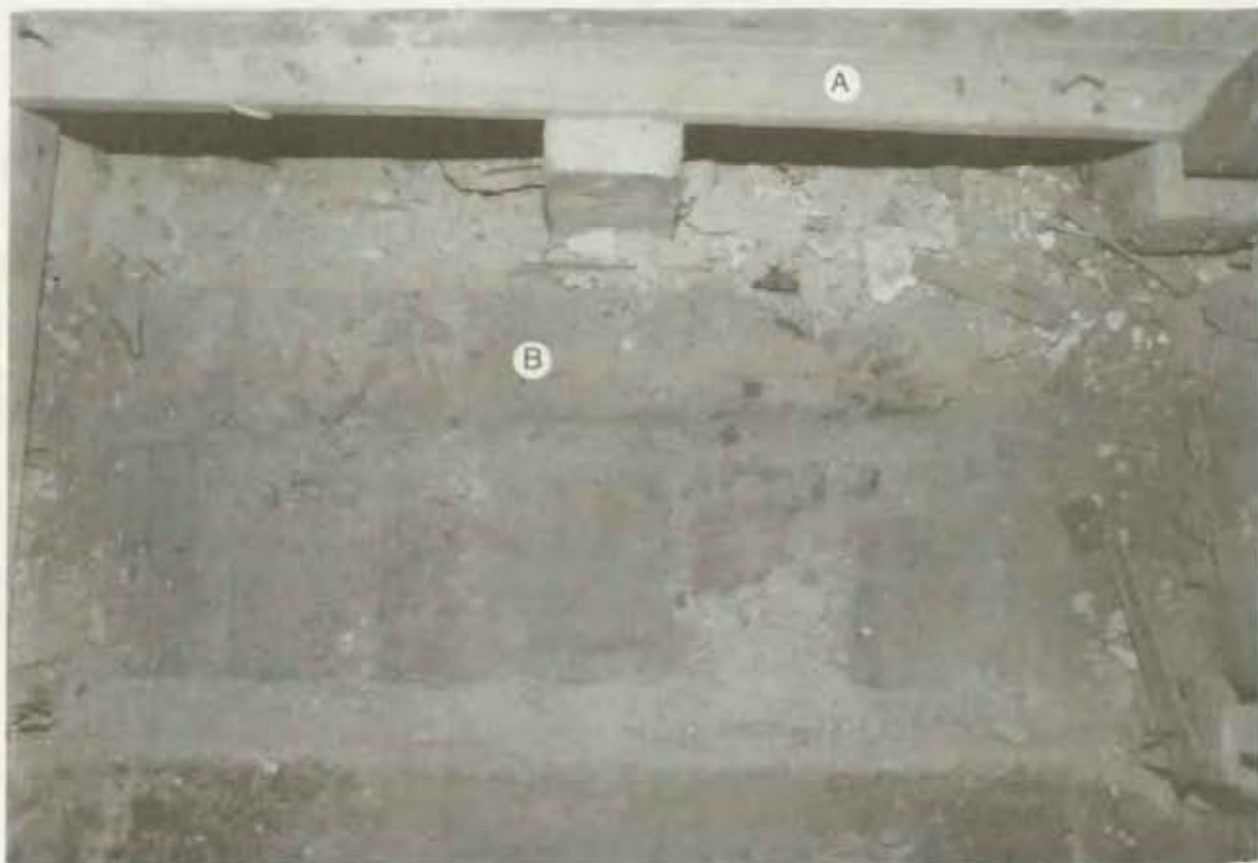
26 ROOM 106 - DETAIL
B

- A. Uniform board width floor
- B. Historical brick floor c. 1760

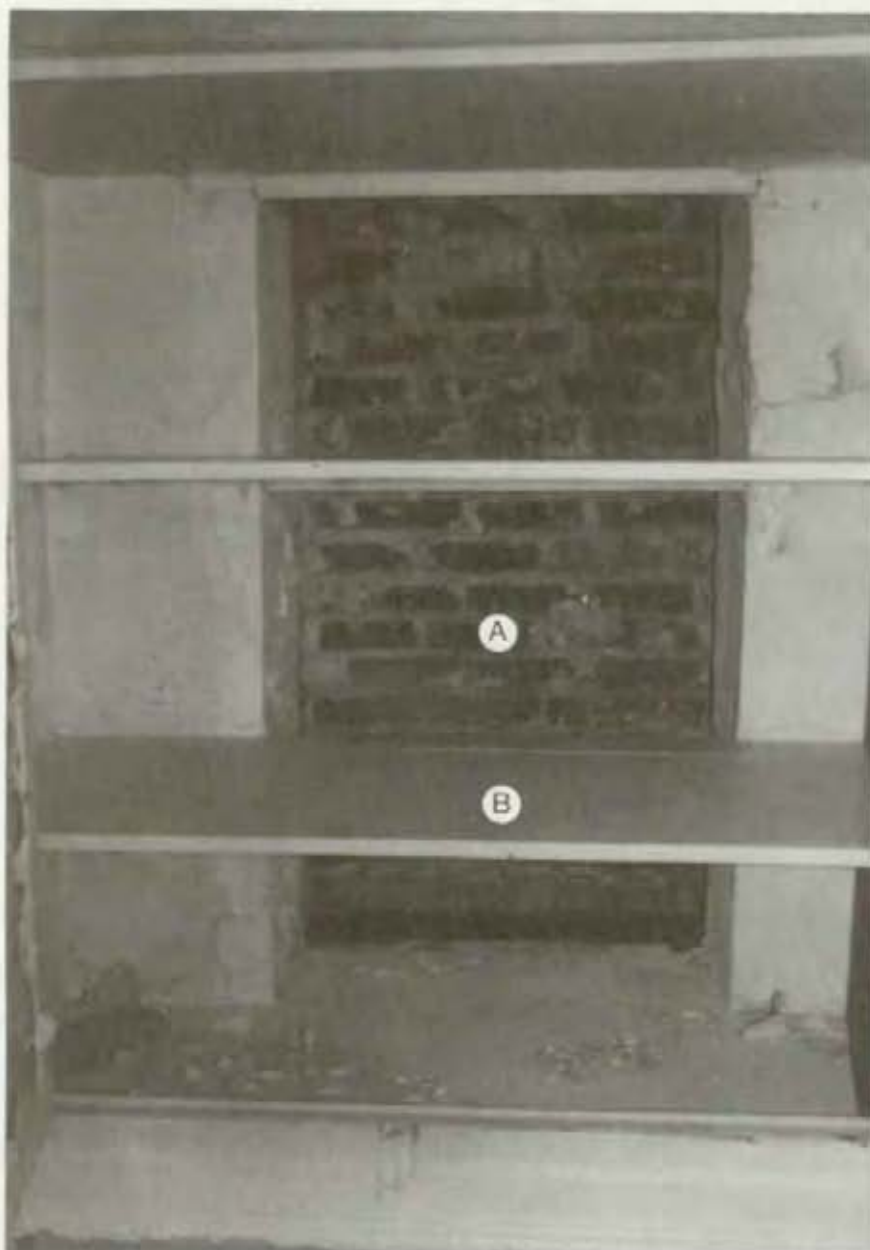
27
B ROOM 104 - WINDOW DETAIL

- A. Historical window opening bricked up c. 1800
- B. Cupboard shelf

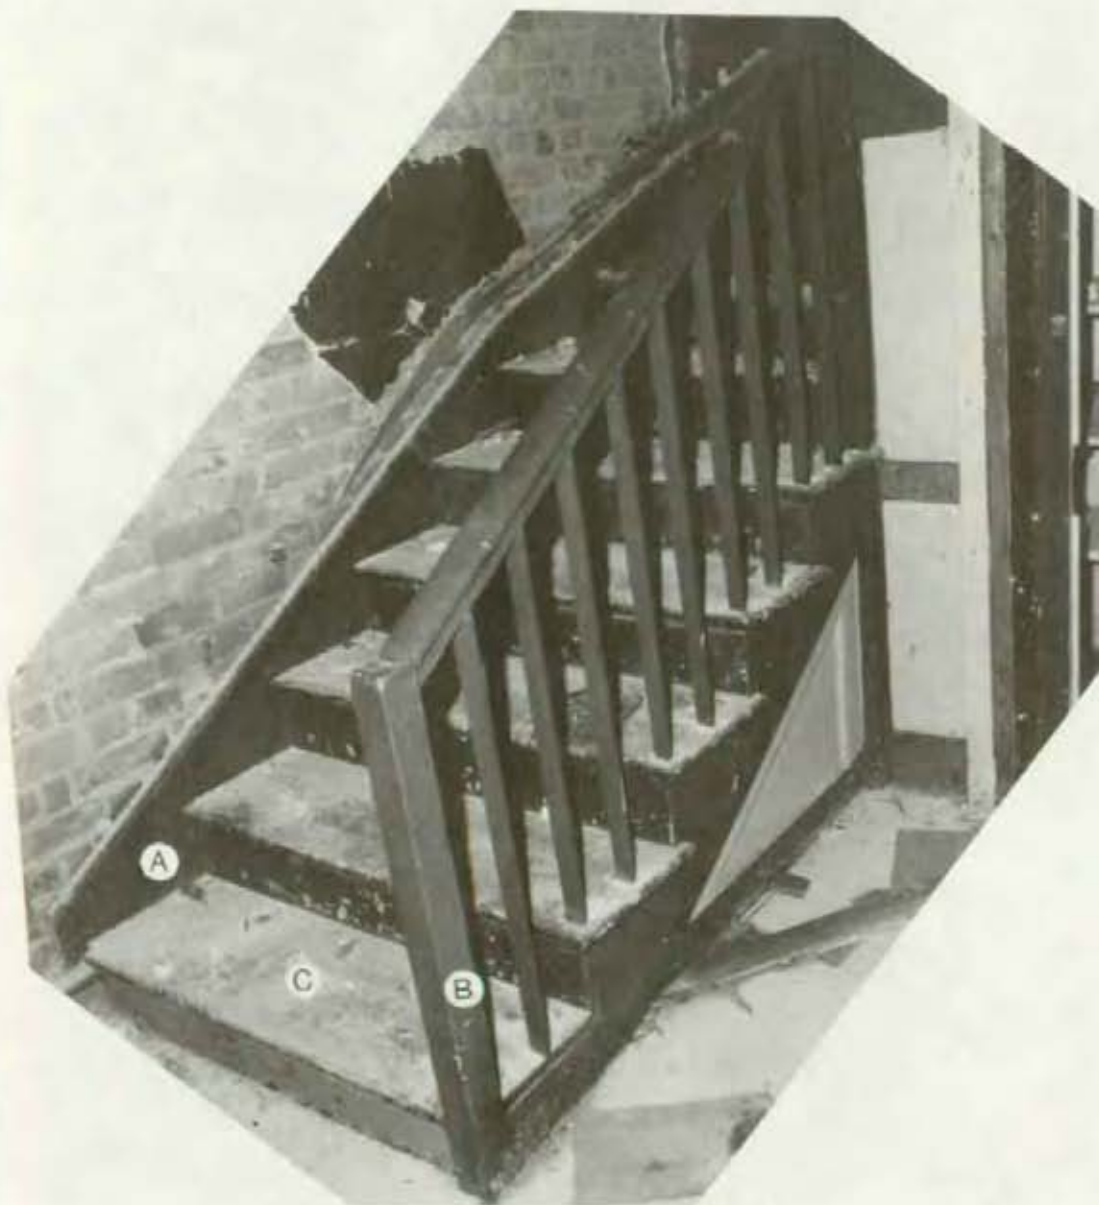
(29)
B ROOM 105 - STAIR DETAIL

- A. Original base c. 1800 See (82)
E
- B. Original stair and balustrade c. 1800 See (62)
E, (63)
E
- C. Original tread and risers c. 1800

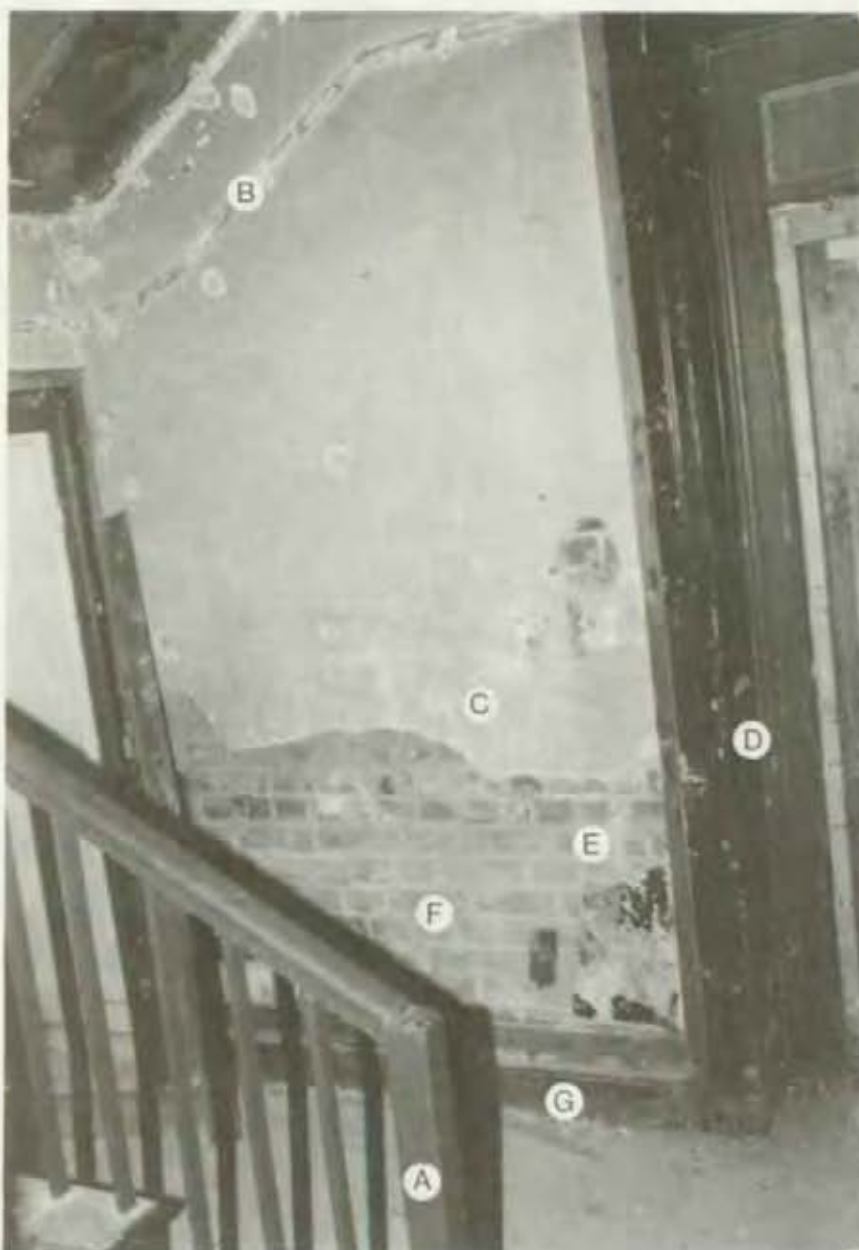
30
B
ROOM 105 - EAST ELEVATION

- A. Stair balustrade added c. 1800 See 63
E
- B. Ghost of picture moulding
- C. Plaster on brick
- D. Reveal lining c. 1800 (D112, W101, W108, W109 sim.) See 13, 14
E, E
- E. Struck joints -- indicates this was historically an exterior wall
- F. Brick joints not struck beyond this point
- G. Base added c. 1800 See 82
E

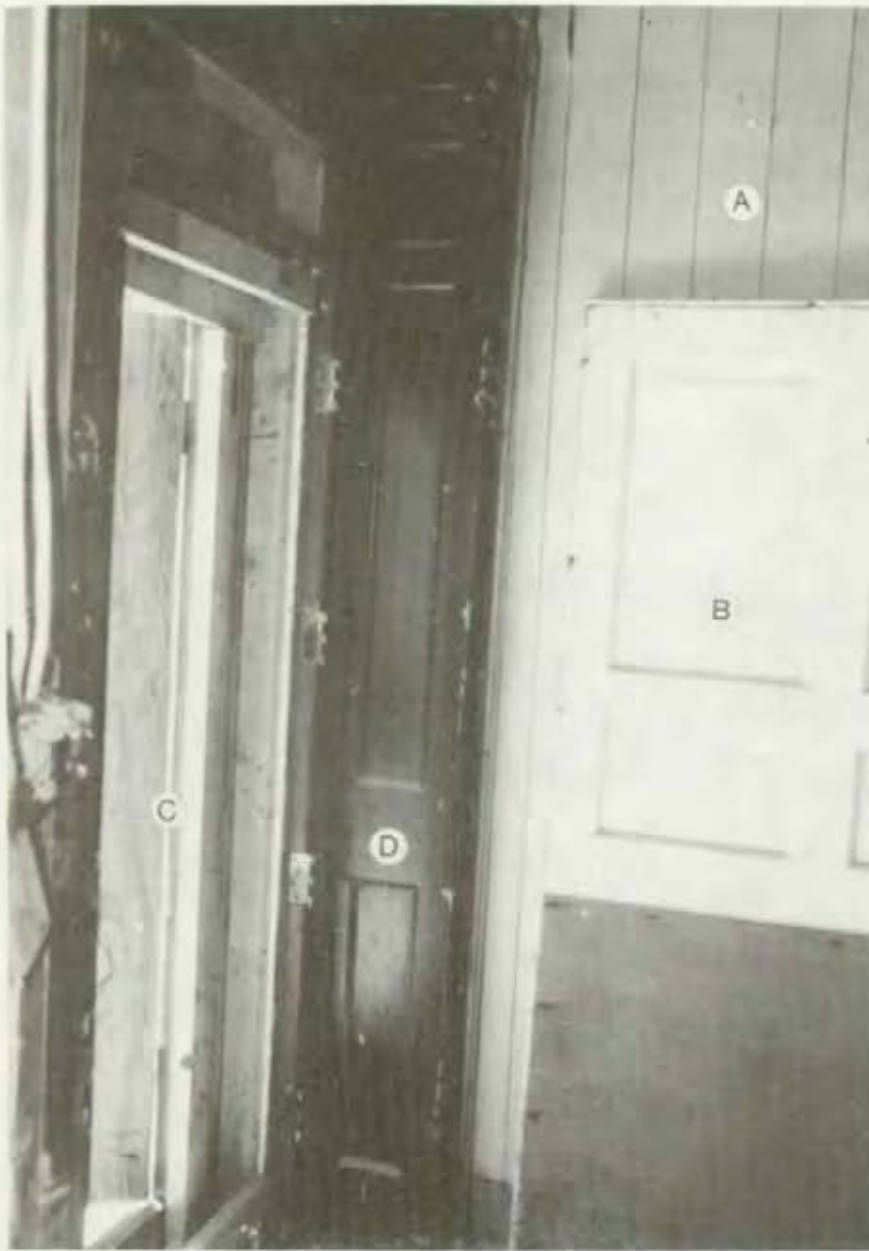
31 ROOM 105 - DOOR DETAIL
B

- A. Wall installed between door 104 and window 109
- B. New door
- C. Doorway added c. 1800
- D. Door frame and reveal lining installed c. 1800 (D112, W101, 108, 109 sim.) See 13, 14
E E

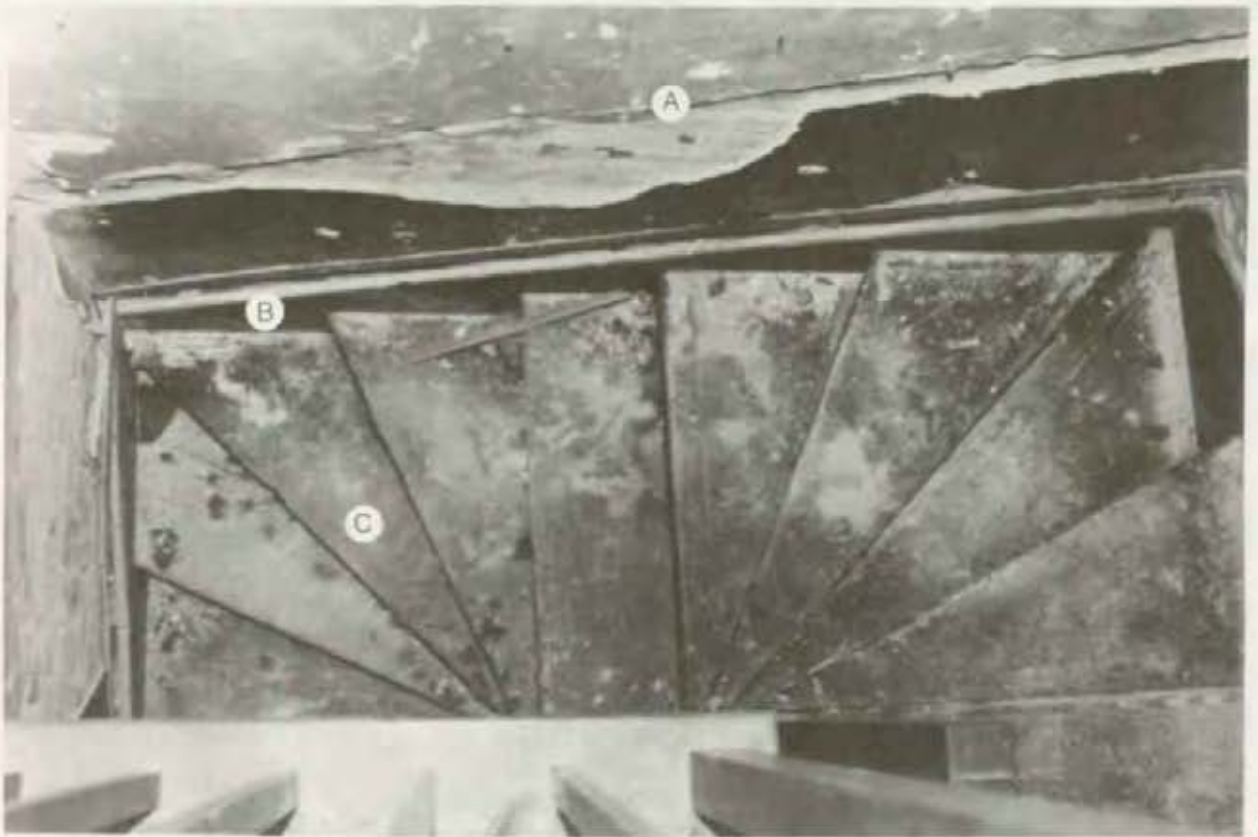
32
B ROOM 105 - STAIR DETAIL

- A. Ghost of handrail
- B. Base c. 1800 See 82
E
- C. Original risers and treads c. 1800
See 62
E

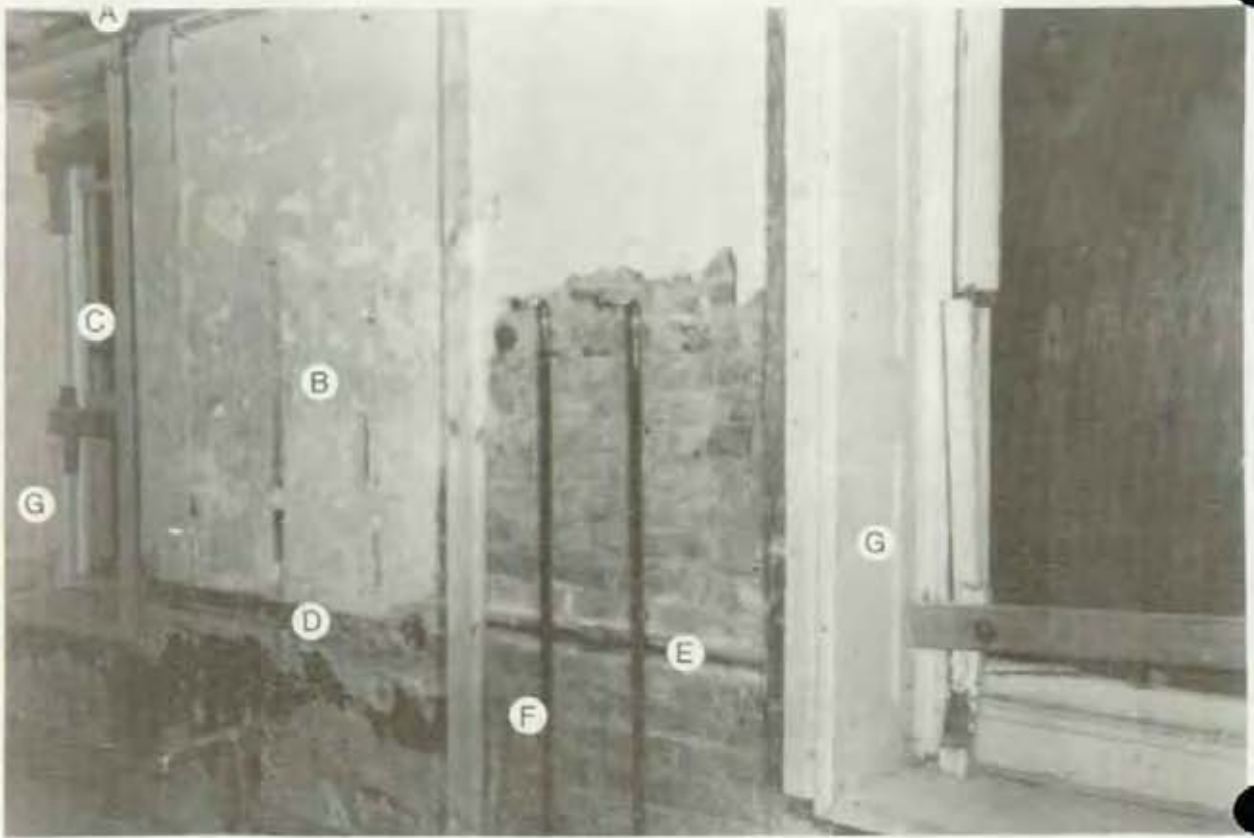
34
B ROOM 106 - EAST ELEVATION

- A. Plaster ceiling cornice See 64
E

G. Window reveal panels and trim
installed c. 1800 (W109, W101,
D105, D112 sim.) See 13 14
E E
- B. Plaster on brick
- C. Window placed in existing arched
opening c. 1800 (W108, W101, D105,
D112 sim.) See 25 26 27 28
E E E E
- 18 19 20
E E E
- D. Struck joints
- E. Wood nailer for chair rail
- F. Northeast corner of c. 1725 house-
wall removed c. 1800

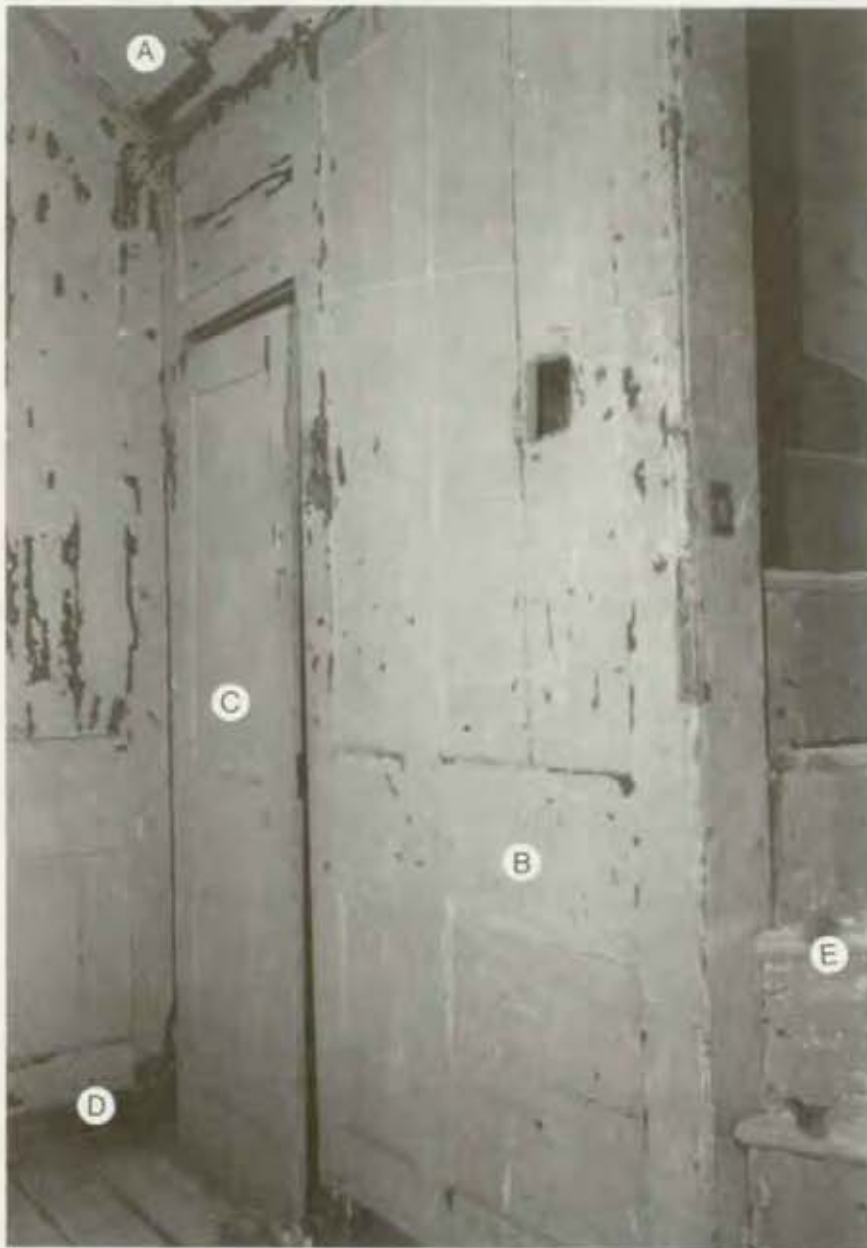
36
B ROOM 107 - SOUTH ELEVATION

| <p>A. Paneled stair soffit</p> <p>B. Floor to ceiling wood panels See 66

E</p> <p>C. Historical closet door with hardware
See 38
B</p> | <p>D. Ghost of baseboard</p> <p>E. New stair treads and risers</p> |

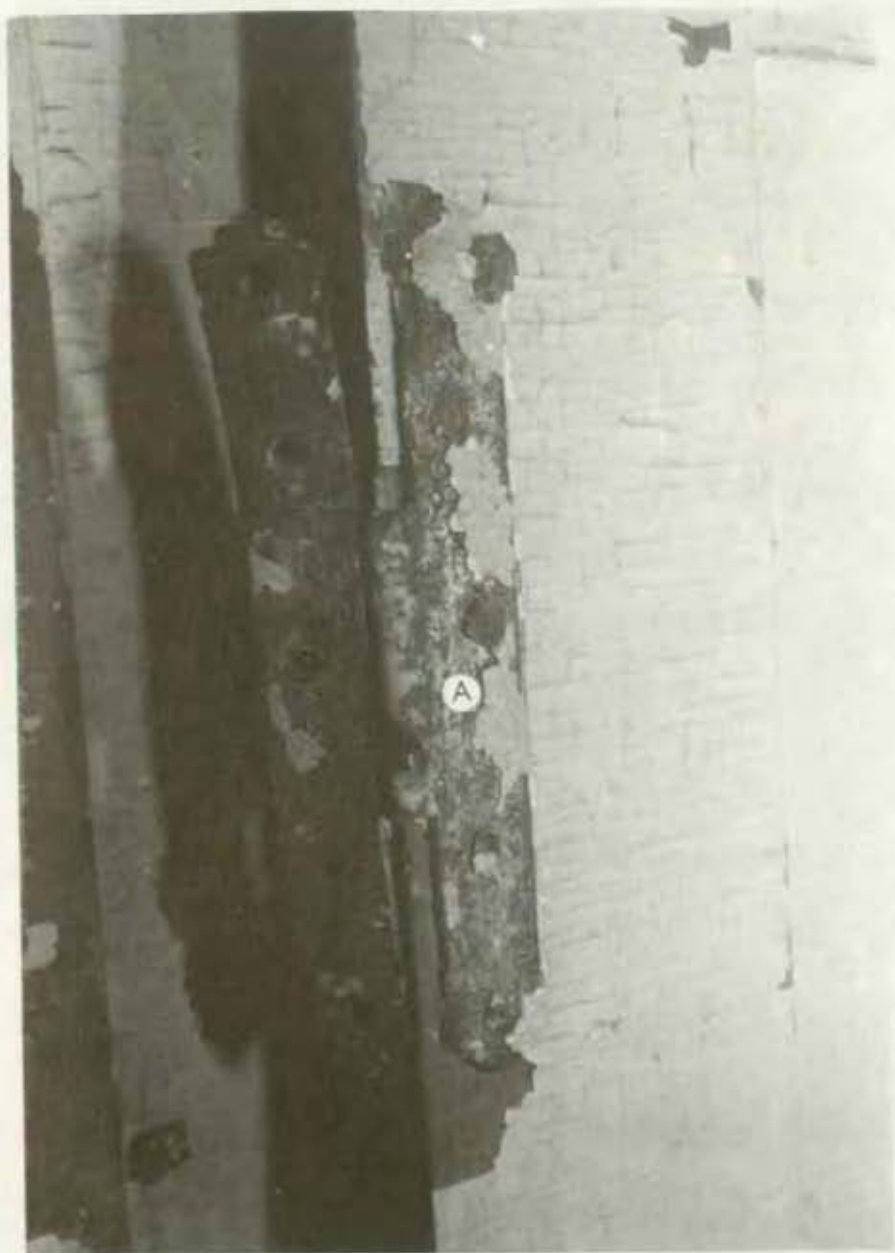
ROOM 107 - DETAIL

A. Historical H-hinge on closet door

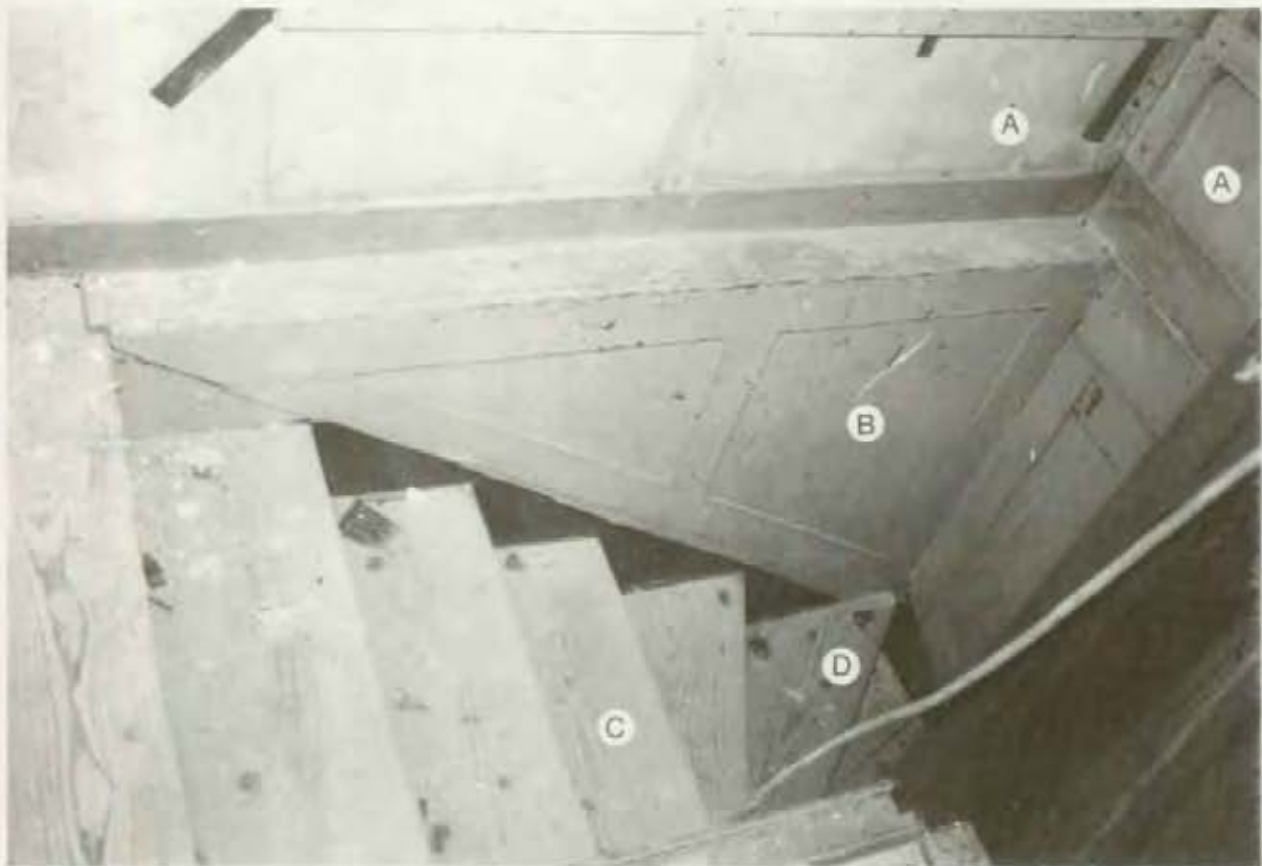
$\frac{39}{B}$ STAIR 2

- A. Plaster on wood lath
- B. Historical wood paneling See $\frac{71}{E}$
- C. New stair treads and risers
- D. Stairs beginning and ending with winders (typical of colonial architecture) See $\frac{69}{E}$

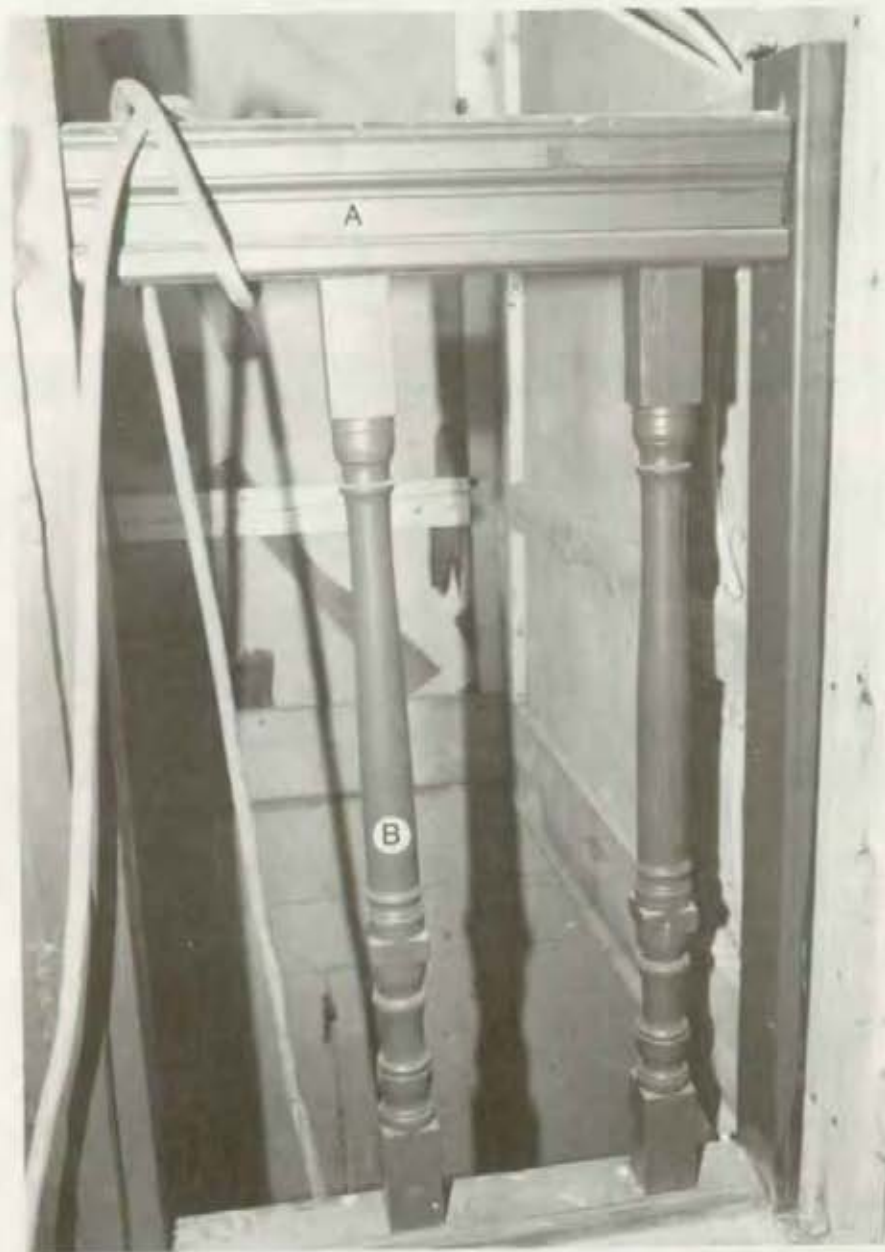
(40) STAIR 2 BALUSTRADE
B

A. Historical stair rail See (73)
E

B. Non-historical stair baluster

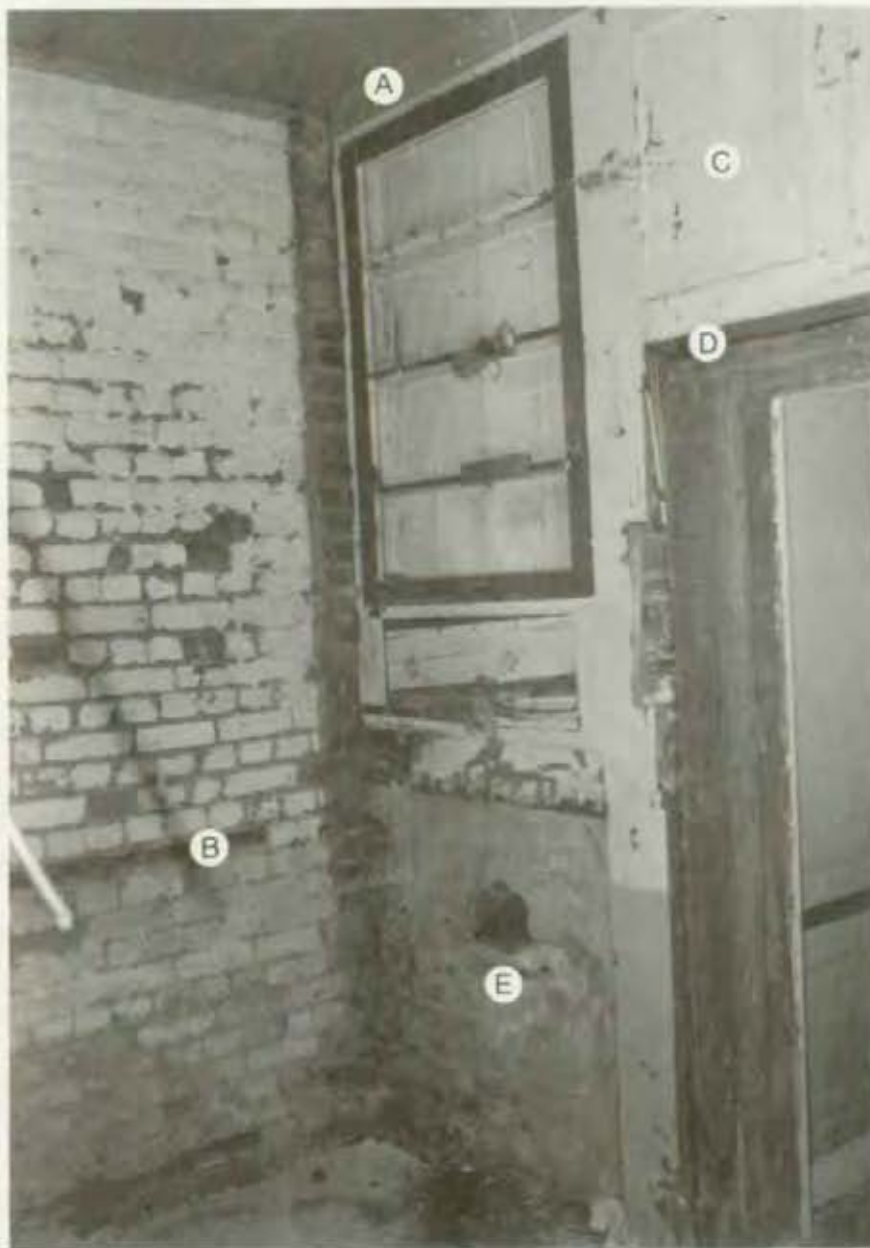
42
B ROOM 108 - SOUTH AND WEST ELEVATIONS

A. Wood ceiling cornice See 77
E

B. Cavity for wood nailer

C. Historical wood panels See 76
E

D. Ghost of door trim See 76
E

E. Bricked up oven See 76
E

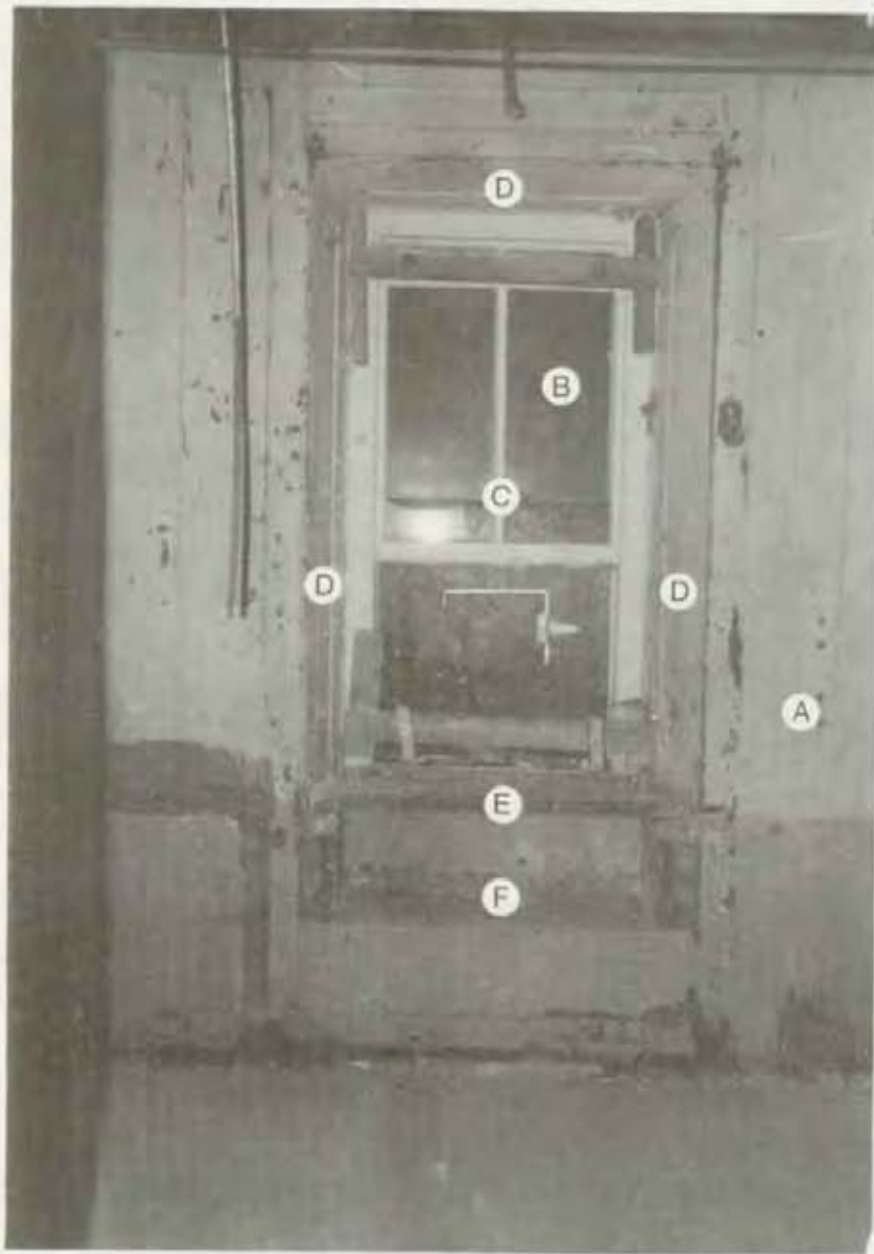
43
B ROOM 108 - EAST ELEVATION

| <p>A. Historical wood panels See 76

E</p> <p>B. Historical window opening (W104, W105 sim.) 22
E, 23
E, 24
E</p> <p>C. Victorian window sash</p> | <p>D. Historical reveal panel (W104, W105 sim.) See 24
B</p> <p>E. Shelf installed under window (W104, W105 sim)</p> <p>F. Window seat See 13
B</p> |

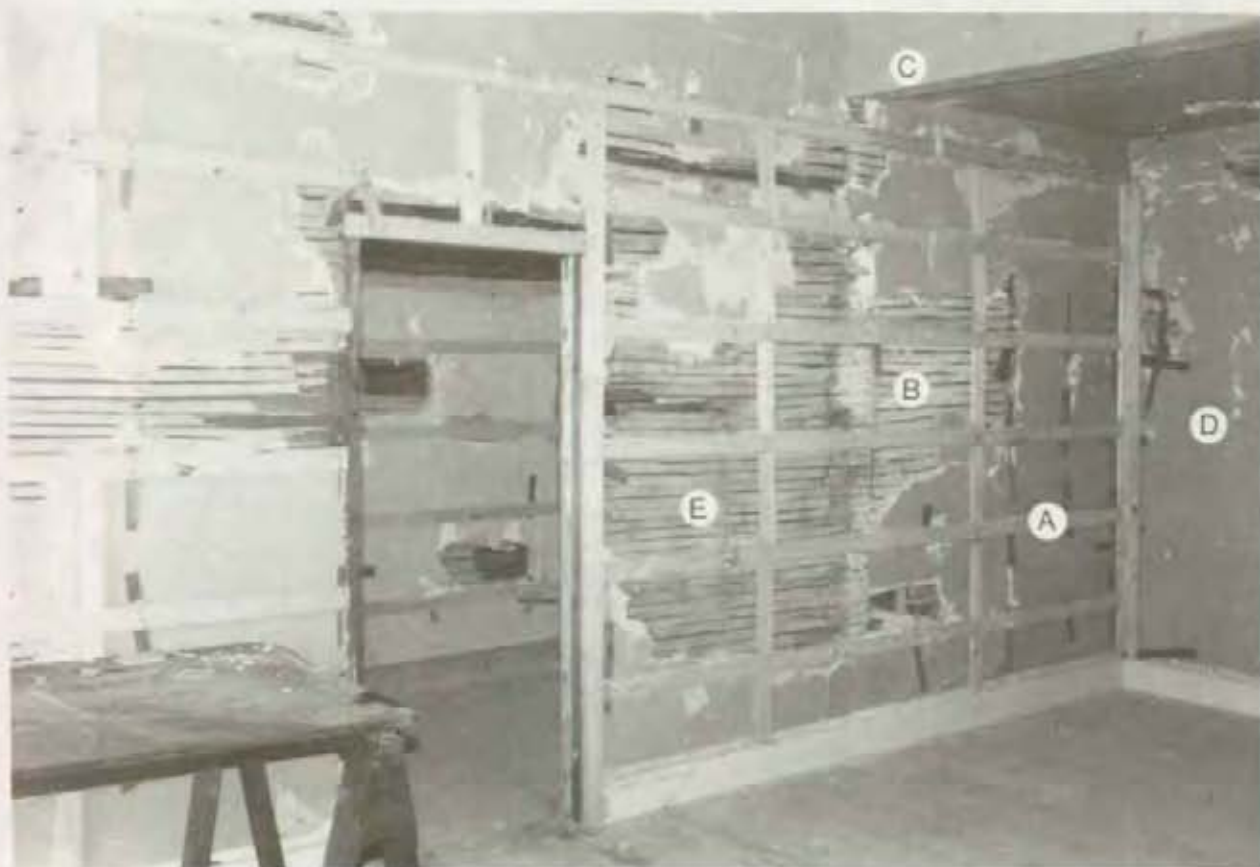
ROOM 201 - NORTH ELEVATION

- A. Modern furring strips
- B. Historical door location and framing
- C. Location of removed partition wall
- D. Wall erected 6 feet back from original partition wall at time of remodelling
- E. Plaster on split lath attached to wood studs

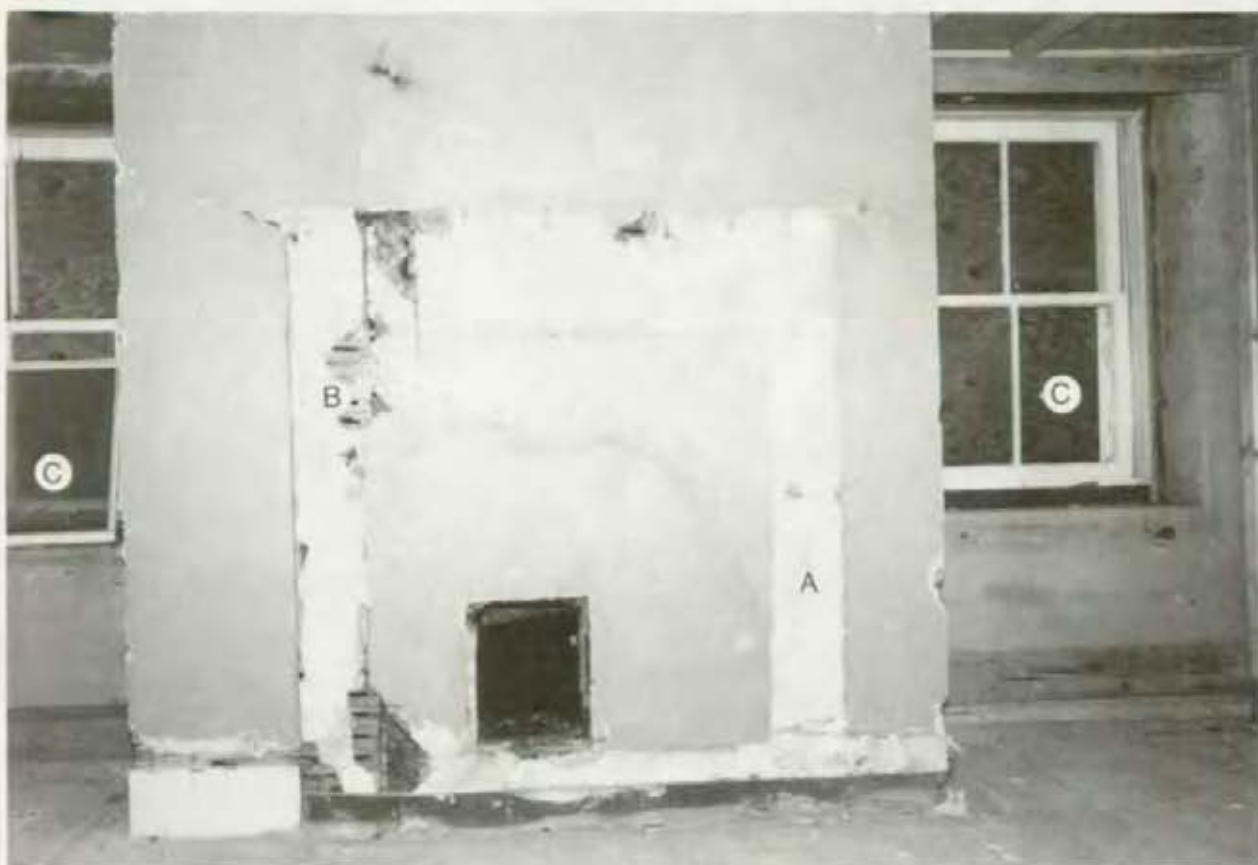
46
B ROOM 201 - SOUTH ELEVATION

- A. Ghost of mantel See 78
E
- B. Lath patch where partition wall
was removed
- C. Window - previously a door added
c. 1890

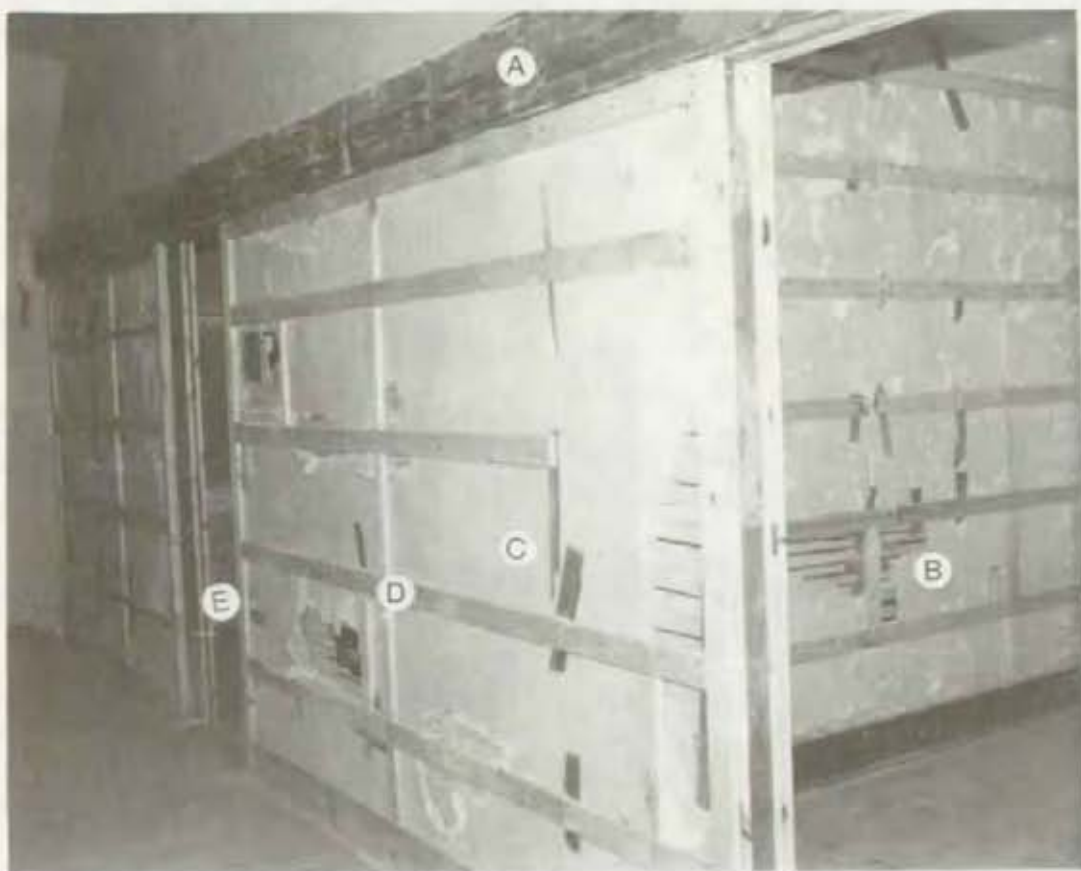
48
B ROOM 202 - NORTH ELEVATION

- A. Tie beam-cut with an adze
- B. Doorway to room 203
- C. Plaster on split lath
- D. Modern furring strips
- E. Doorway to room 207

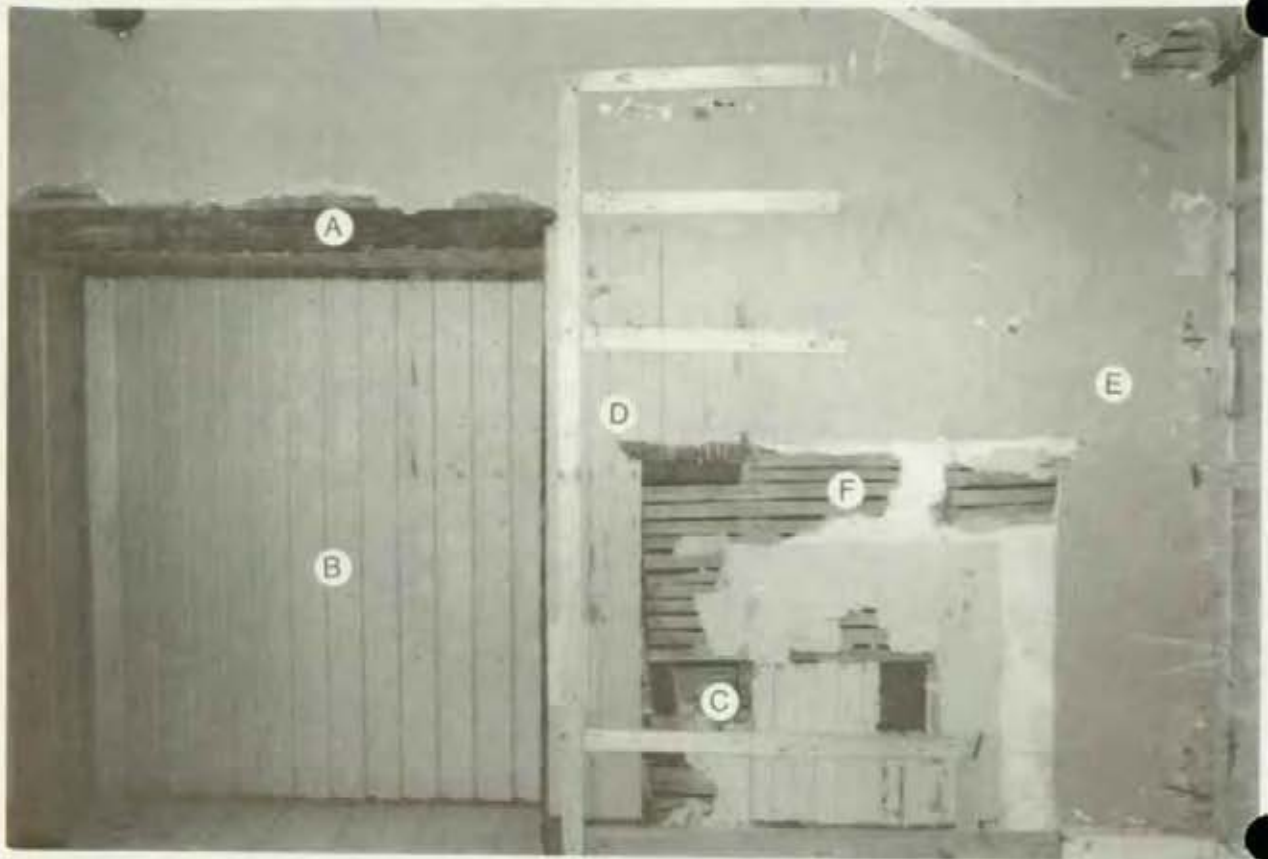
$\frac{50}{B}$ ROOM 203 - NORTH ELEVATION

| A. Tie beam | D. Vertical board patch |
| B. Non-historical wood paneling installed inside closet See $\frac{80}{E}$ | E. Plaster on wood lath |
| C. Wallpaper attached to brick behind wall See $\frac{51}{B}$ | F. Ghost of mantel See $\frac{79}{E}$ |

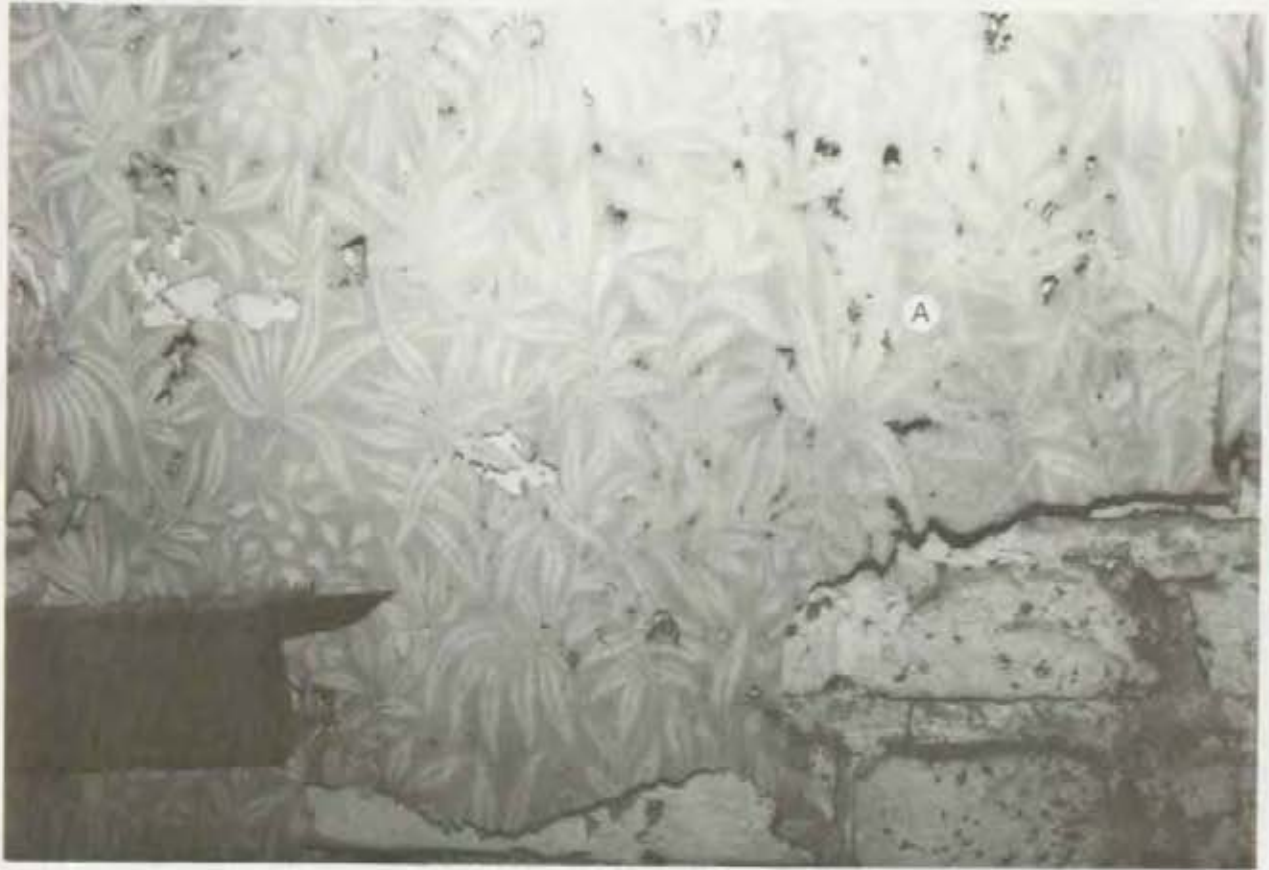
51
B ROOM 203 - DETAIL

- A. Wallpaper (c. 1885) on north wall of room 203 - (sample located at Harpers Ferry Center)

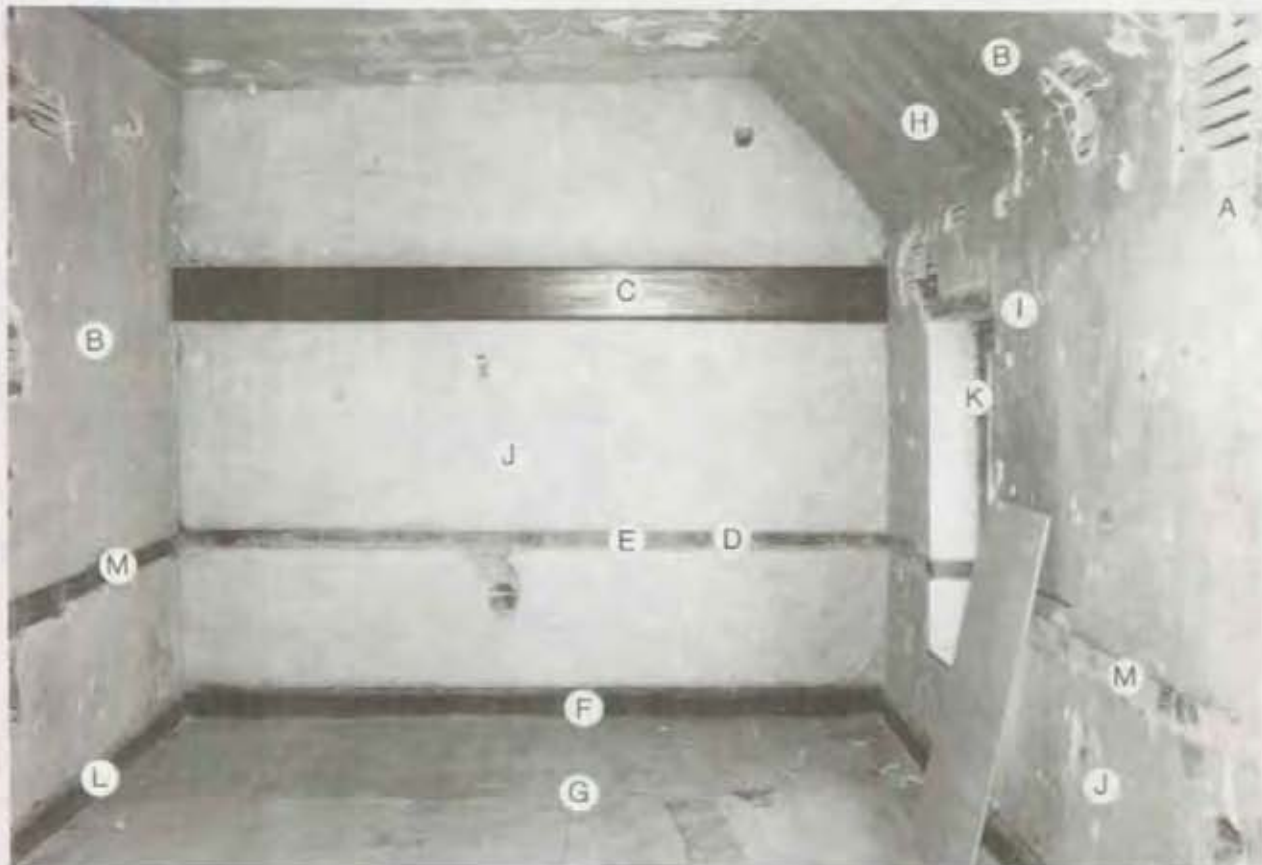
53 ROOM 204 - SOUTH ELEVATION
B

| A. | Location of removed tie beam that defined earlier partition wall | G. | Uniform board width floor |
| B. | Plaster on wood lath | H. | Ceiling sloped to follow roof line (typical of all rooms on second floor) |
| C. | Tie beam enclosed in moulding

See $\frac{81}{E}$ | I. | Top of exterior brick wall |

| D. | Plaster on brick (exterior north wall of c. 1725 house) | J. | Plaster on brick |
| E. | Struck mortar joints of exterior c. 1725 wall | K. | Historical window location |
| F. | Base See $\frac{82}{E}$ | L. | Base See $\frac{83}{E}$ |
| | | M. | Ghost of chair rail |

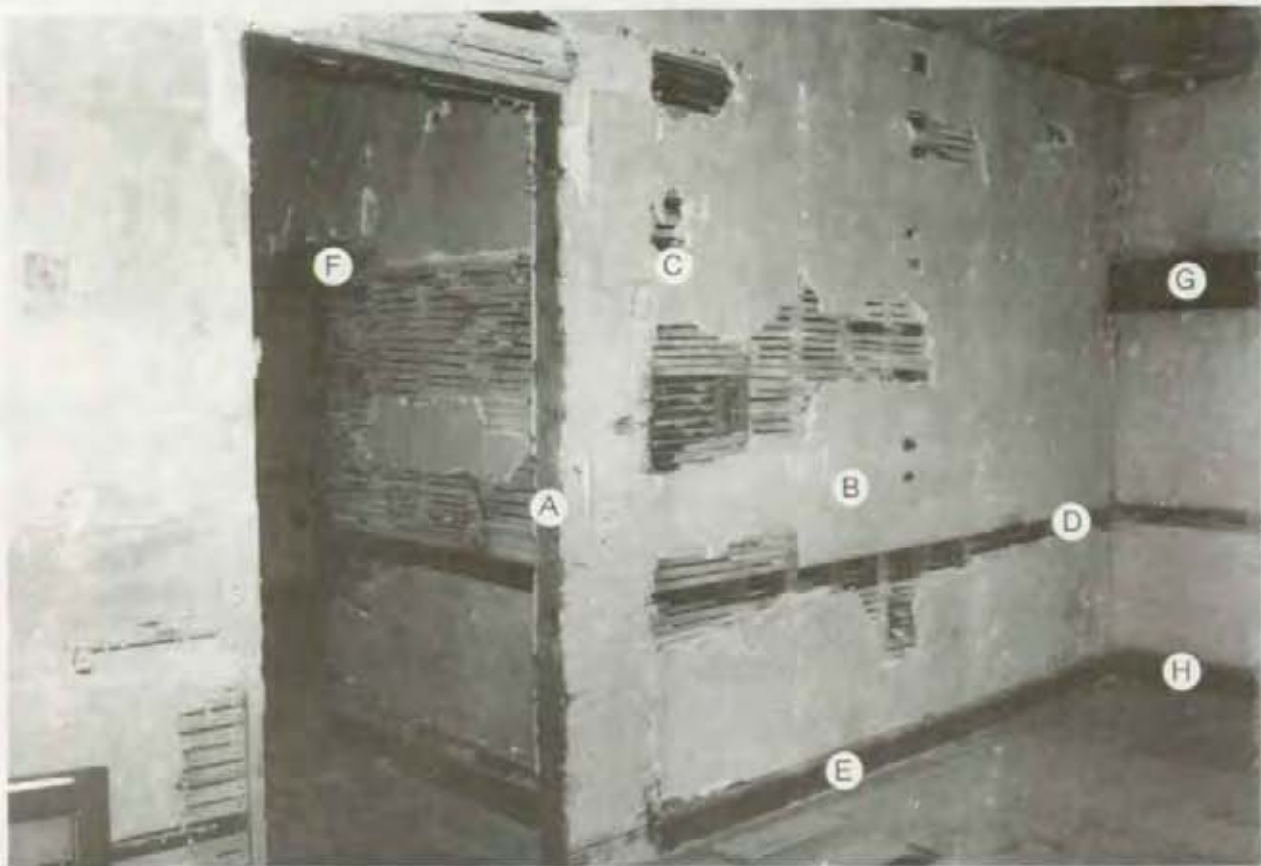
54 - ROOM 204 - EAST ELEVATION
B

| A. Doorway enlarged at time of remodeling | E. Base See 83

E |

| B. Plaster on lath | F. Tie beam |
| C. Location of removed tie beam that defined earlier partition wall | G. Tie beam enclosed in moulding See 81
| D. Ghost of chair rail | H. Base See 82
