historic structure report
architectural data section

PISCATAWAY PARK
MARSHALL HALL

HISTORIC STRUCTURE REPORT
ARCHITECTURAL DATA SECTION
FOR
MARSHALL HALL
PISCATAWAY PARK

January 1983

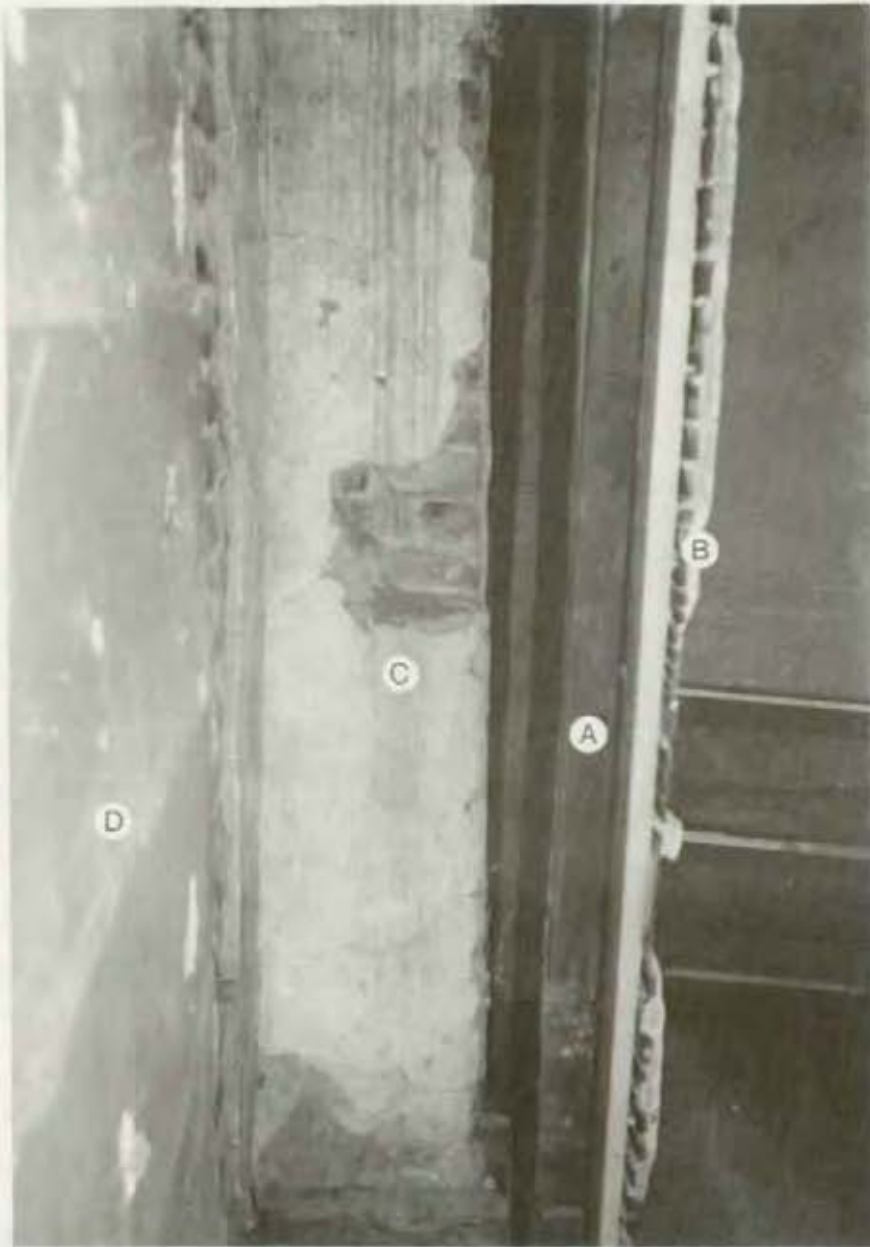
55 ROOM 204 - DETAIL
B

- A. Stud wall added at time of remodeling to cover chimney breast
- B. Plaster on wood lath
- C. Plaster on brick chimney breast
- D. Plaster on brick wall

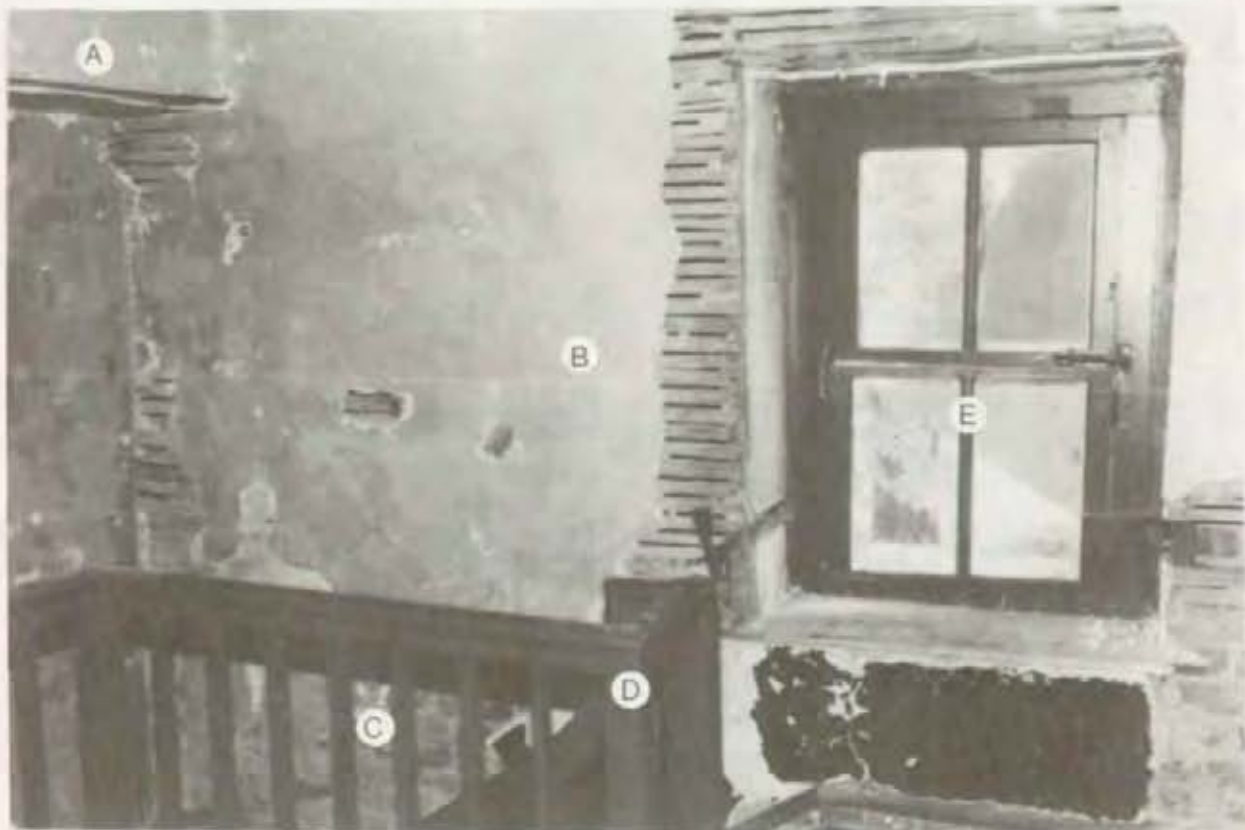
57 ROOM 205 - EAST ELEVATION
B

- A. Tie beam
- B. Lath and plaster added at time of remodeling (the east and west 2nd floor walls are one brick wythe less than the first floor wall)
- C. Plaster on brick
- D. Original balustrade
- E. Historic window - sash is a later addition of interior awning over casement (W201, W202, W211 sim.)
See 29
E

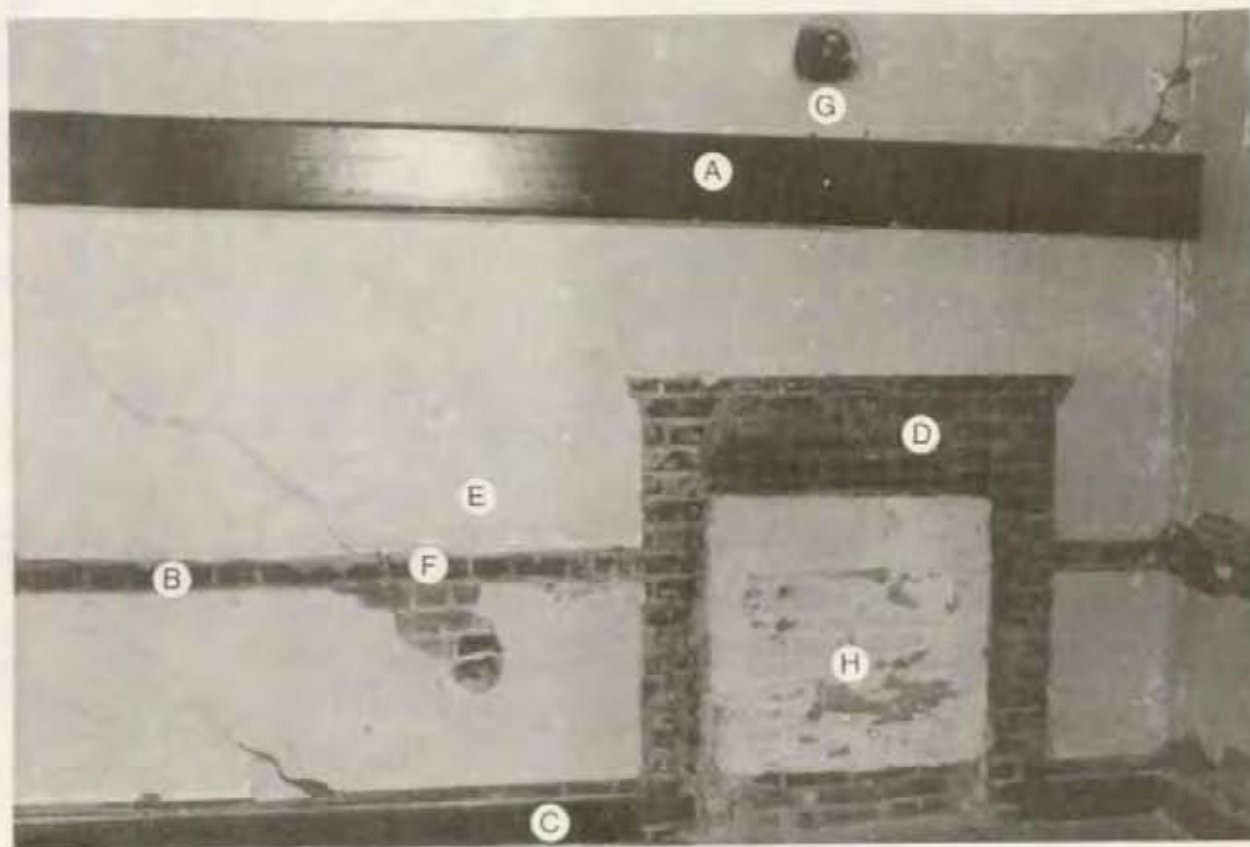
59 ROOM 206- SOUTH ELEVATION
B

| A. Tie beam enclosed in moulding | E. Plaster on brick (historic exterior north wall of c. 1725 house) |
| C. Base. See $\frac{82}{E}$ | G. Flue opening for stove |
| D. Ghost of mantel. See $\frac{85}{E}$ | H. Bricked up fireplace opening |

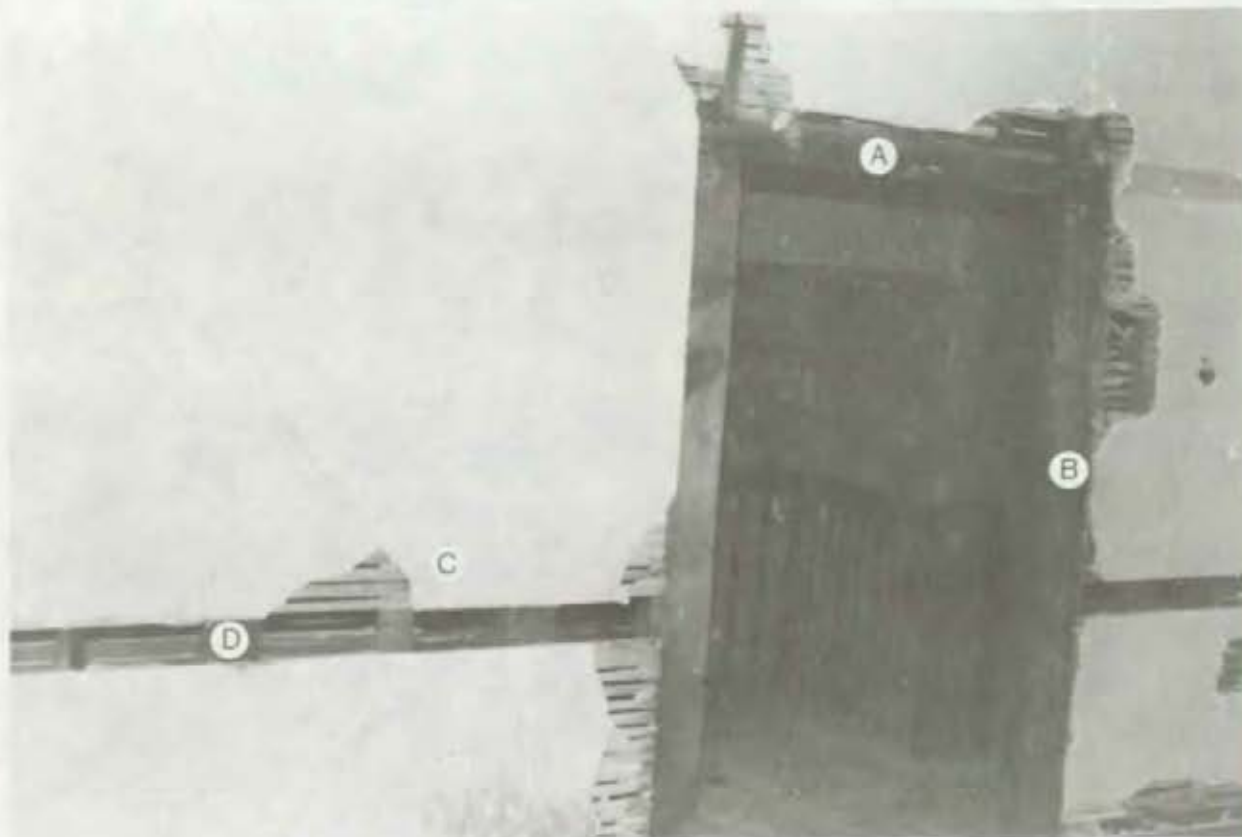
60 ROOM 206 - NORTH ELEVATION
B

- A. Tie beam
- B. Door frame cut with an adze
- C. Plaster on wood lath
- D. Ghost of chair rail

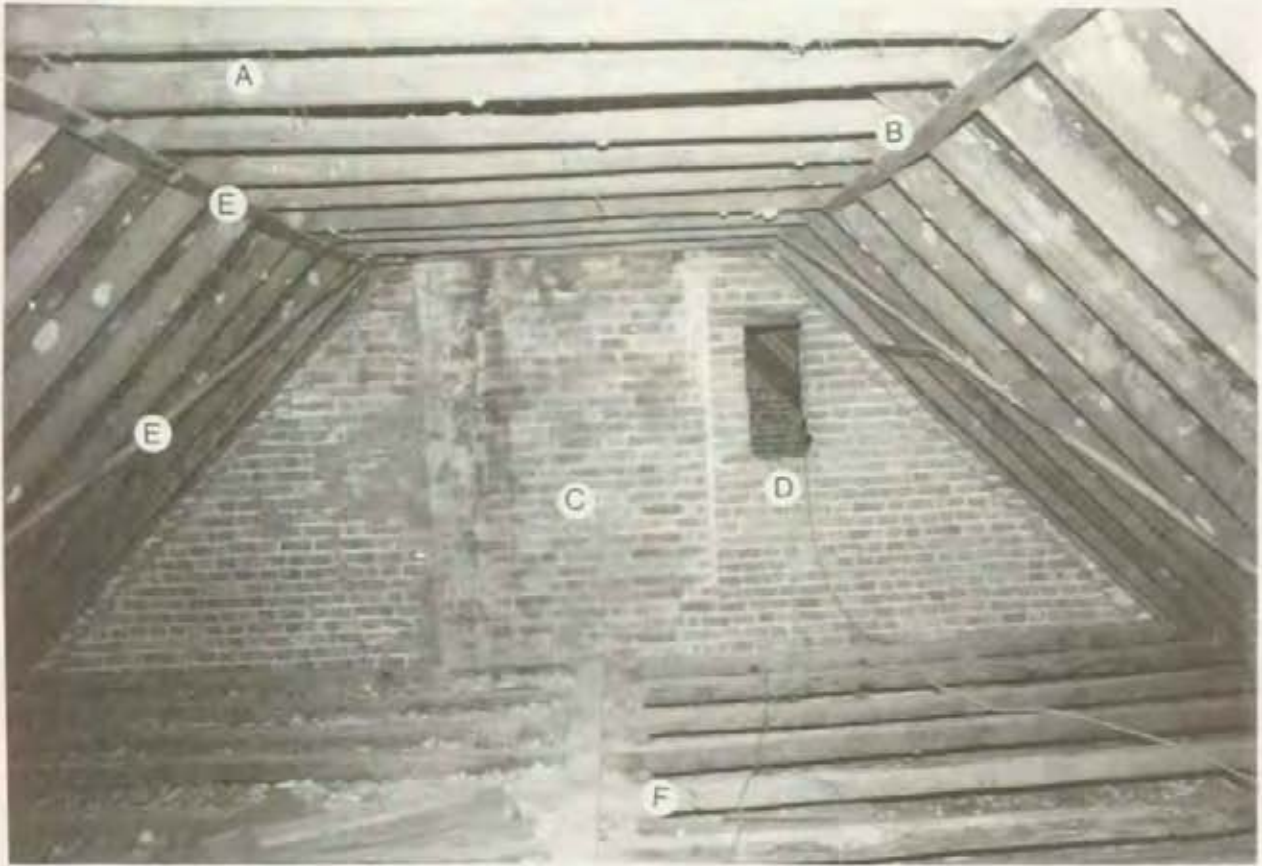
62
B
 ATTIC - NORTH ELEVATION OF CA. 1725 HOUSE

- A. Collar tie See 88E, 89E
- B. Mortice and tenon joint
- C. North chimney of c. 1725 house
- D. Roof vent
- E. Horizontal and diagonal braces that held four rafters in place during construction of the house
- F. Collar tie defining higher 2nd floor ceiling height See 88E

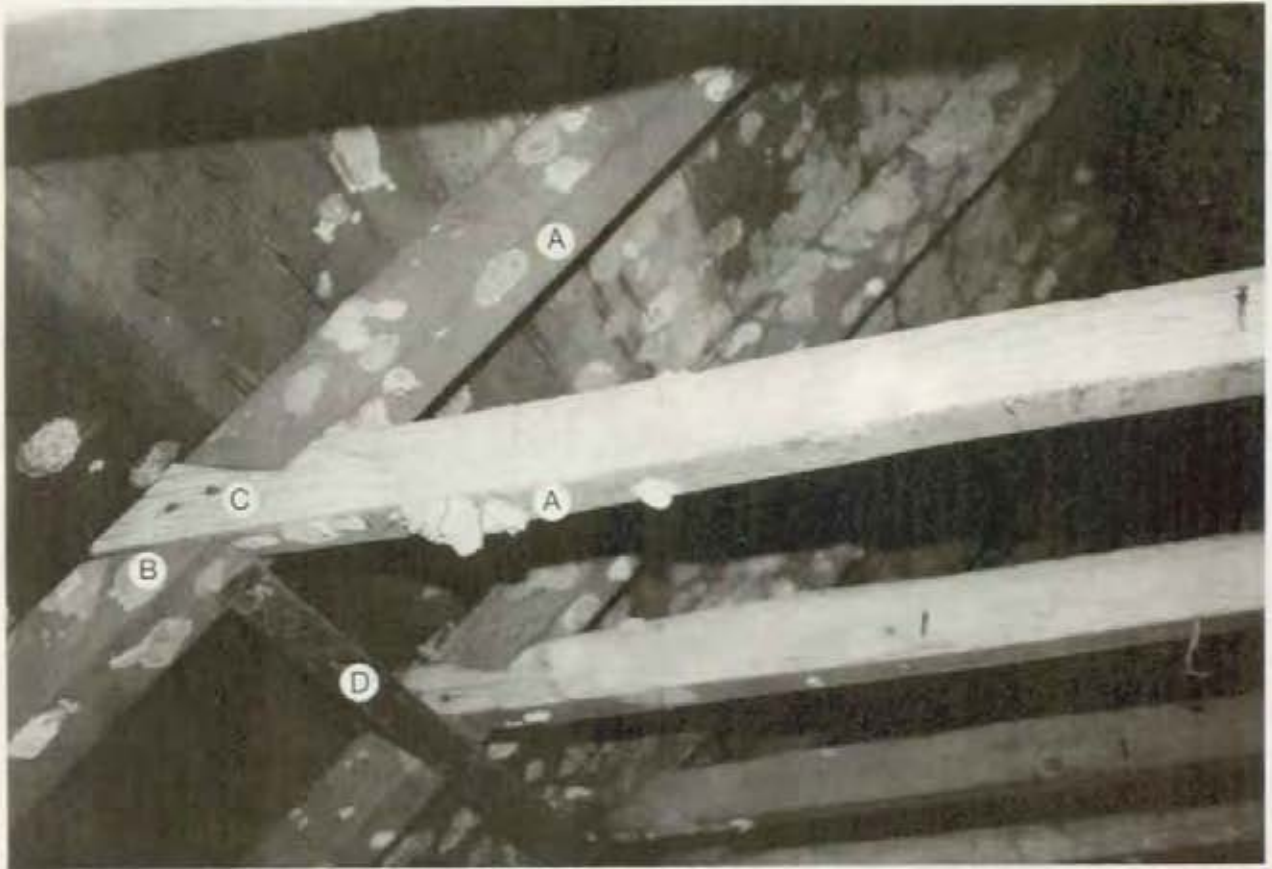
64 ATTIC - DETAIL
B

- A. Collar tie defining higher 2nd floor ceiling height See 88
E
- B. Wood stud partition wall between rooms 203 and 207 See 90
E
- C. Rose headed nails
- D. Bean cut with an adze
- E. Collar tie defining lower 2nd floor ceiling height See 88
E
- F. Plaster on split lath

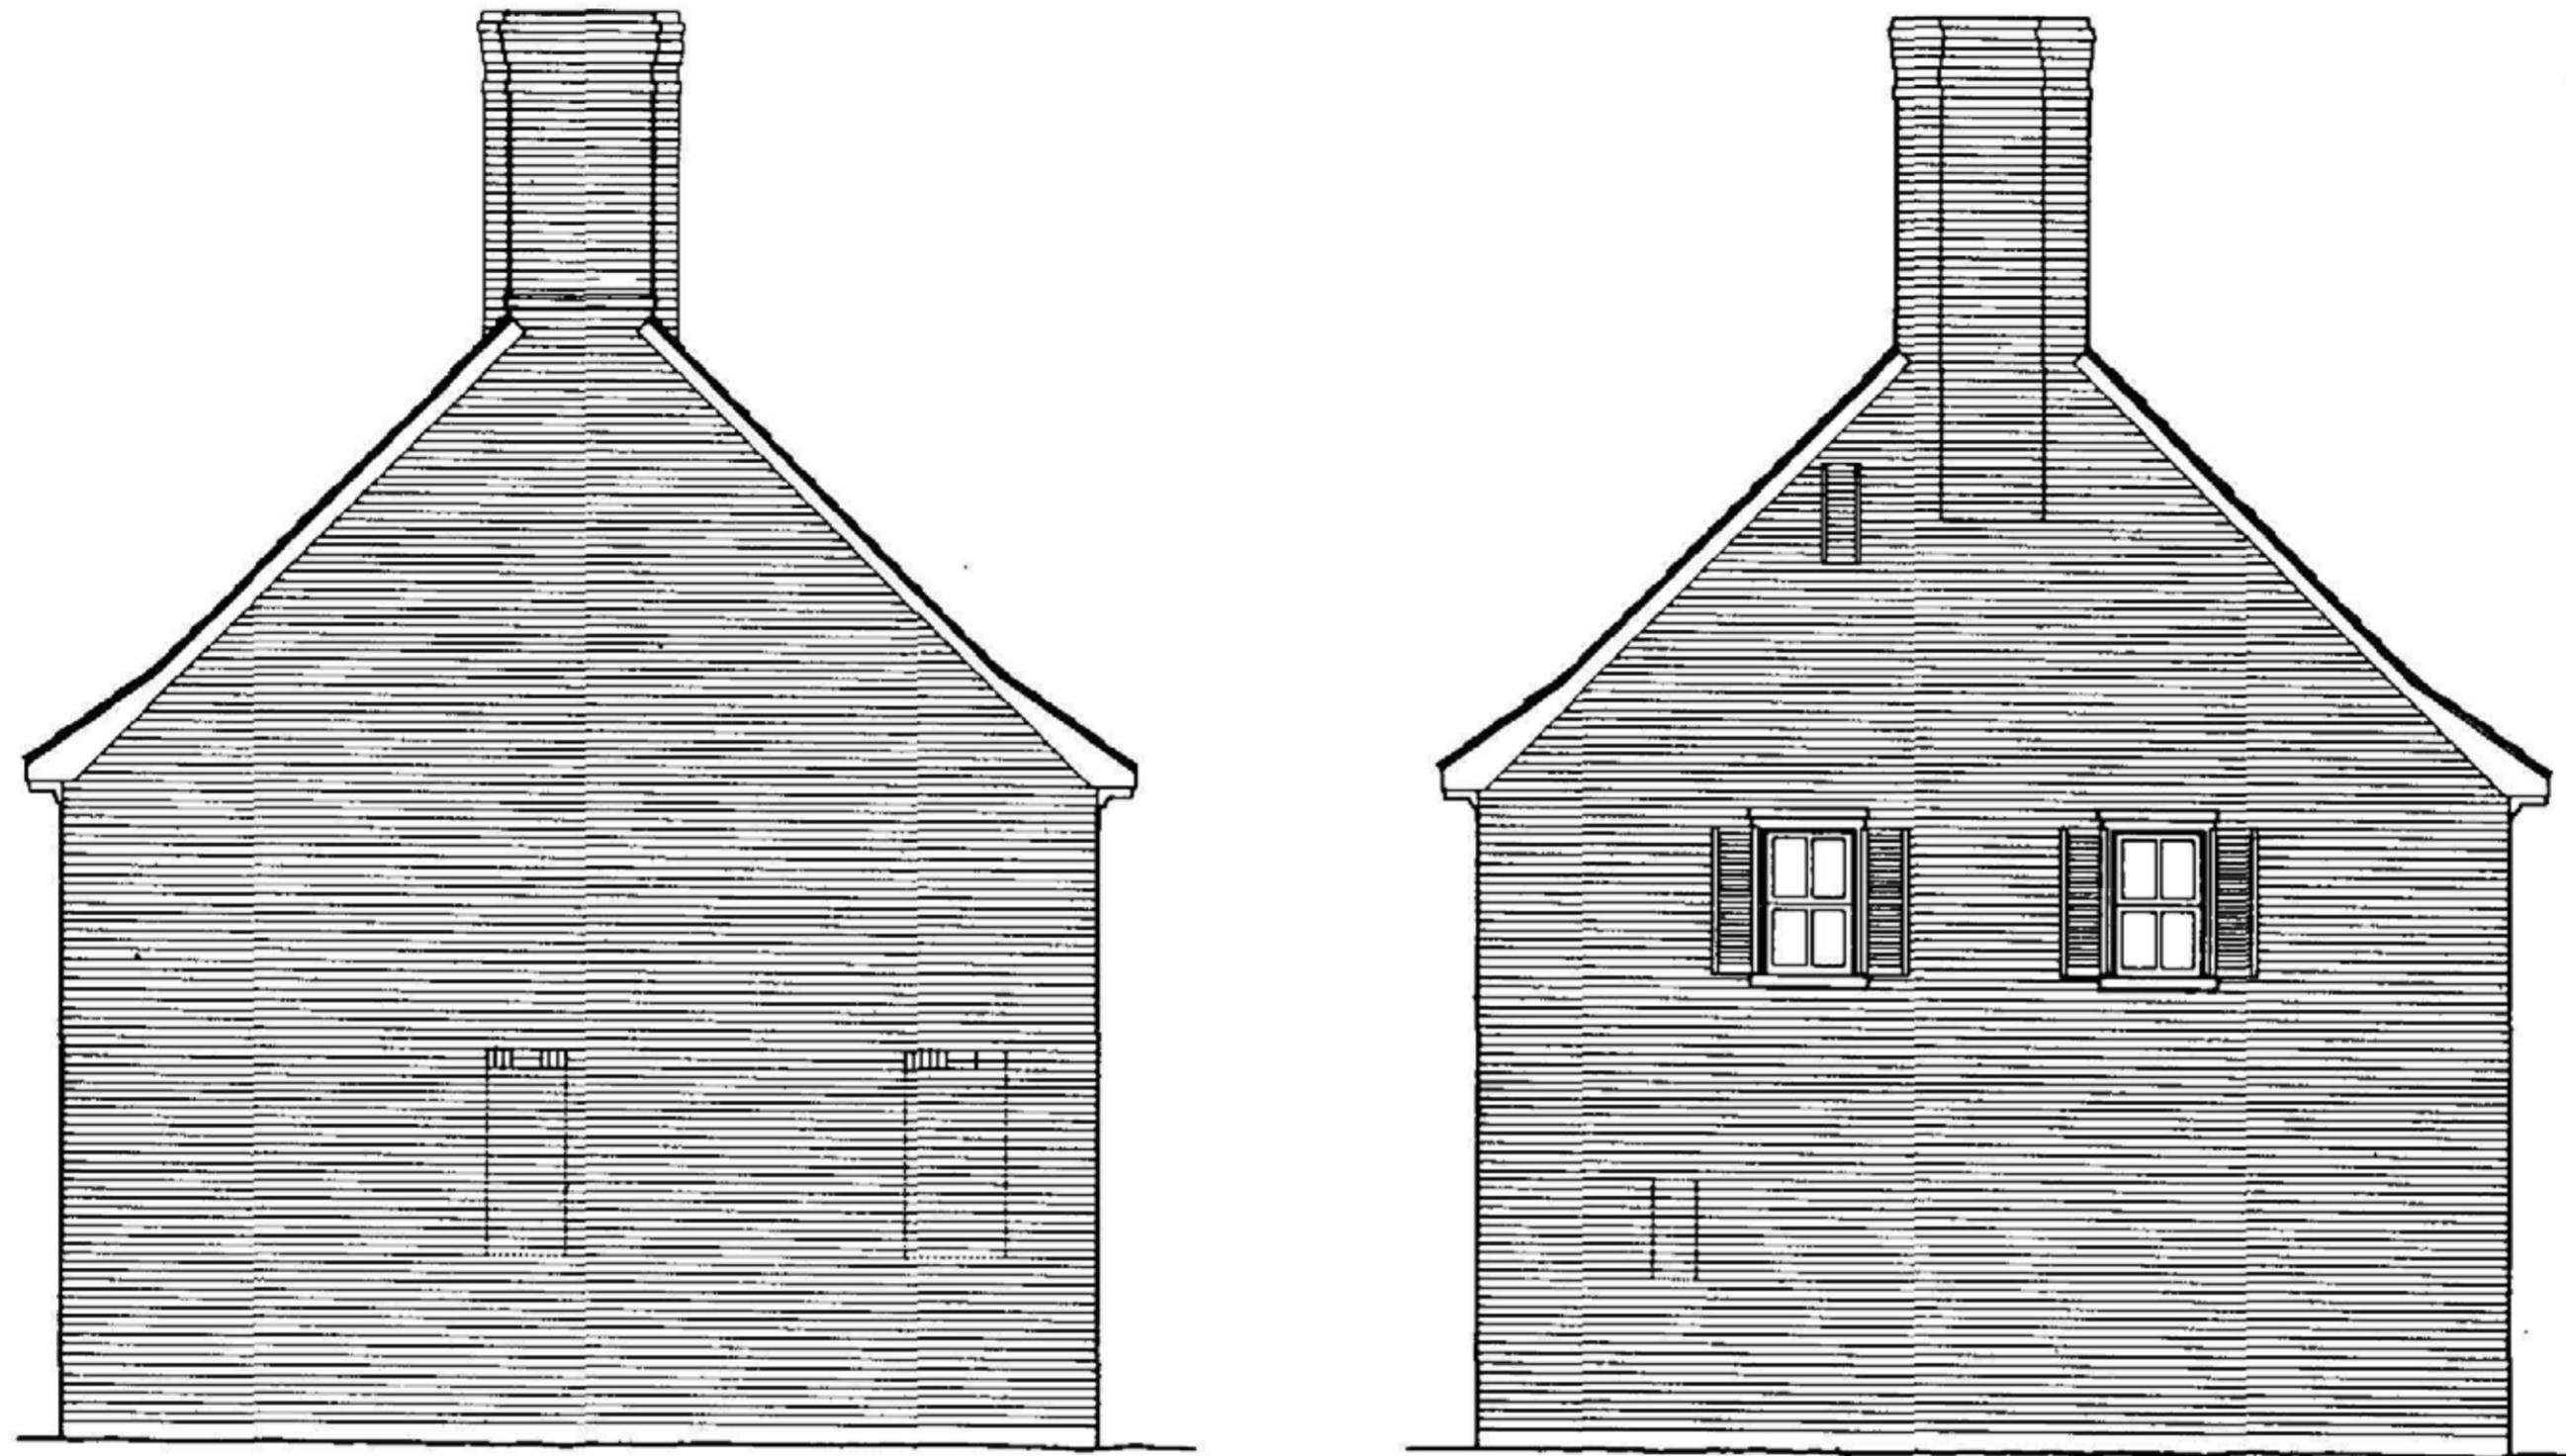
NORTHEAST ELEVATION

DASHED LINES INDICATE ORIGINAL WINDOW OPENINGS

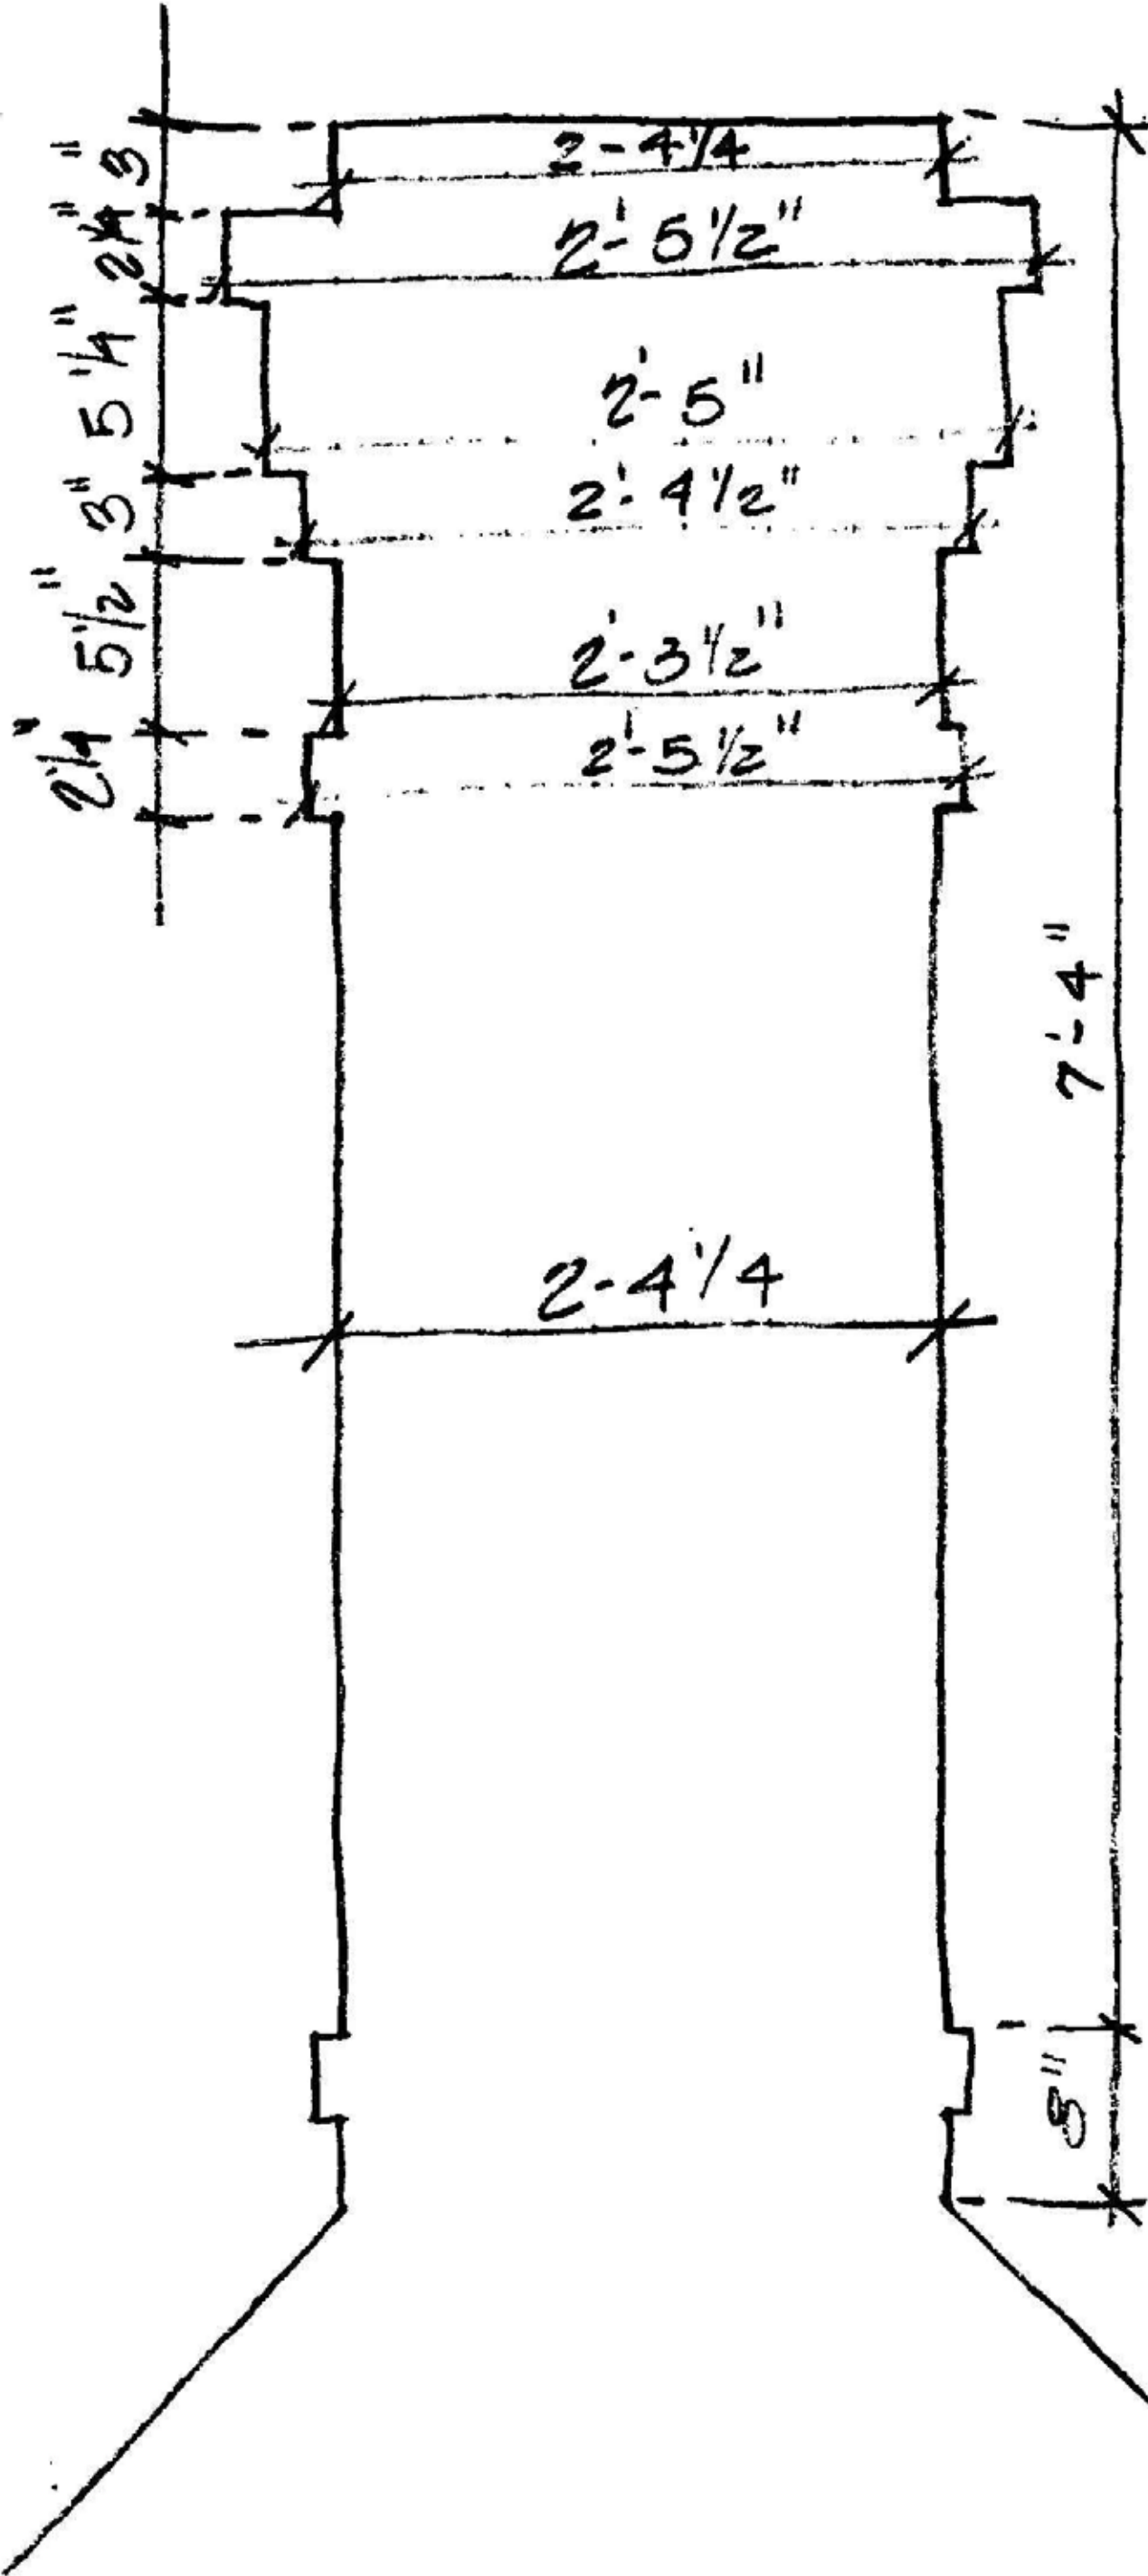
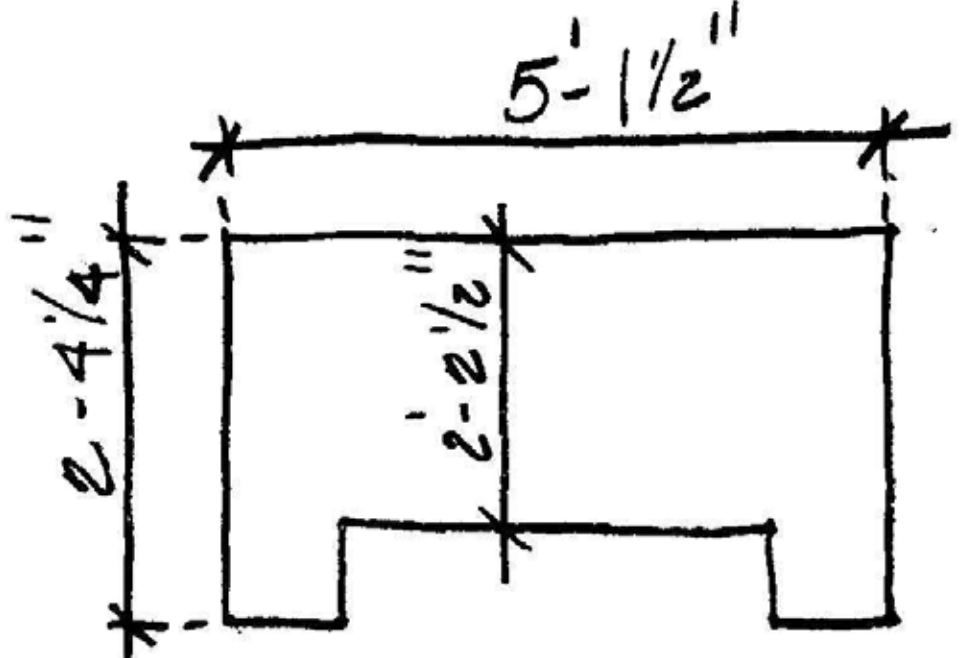
6
E

SOUTH CHIMNEY - (REBUILT 1966)

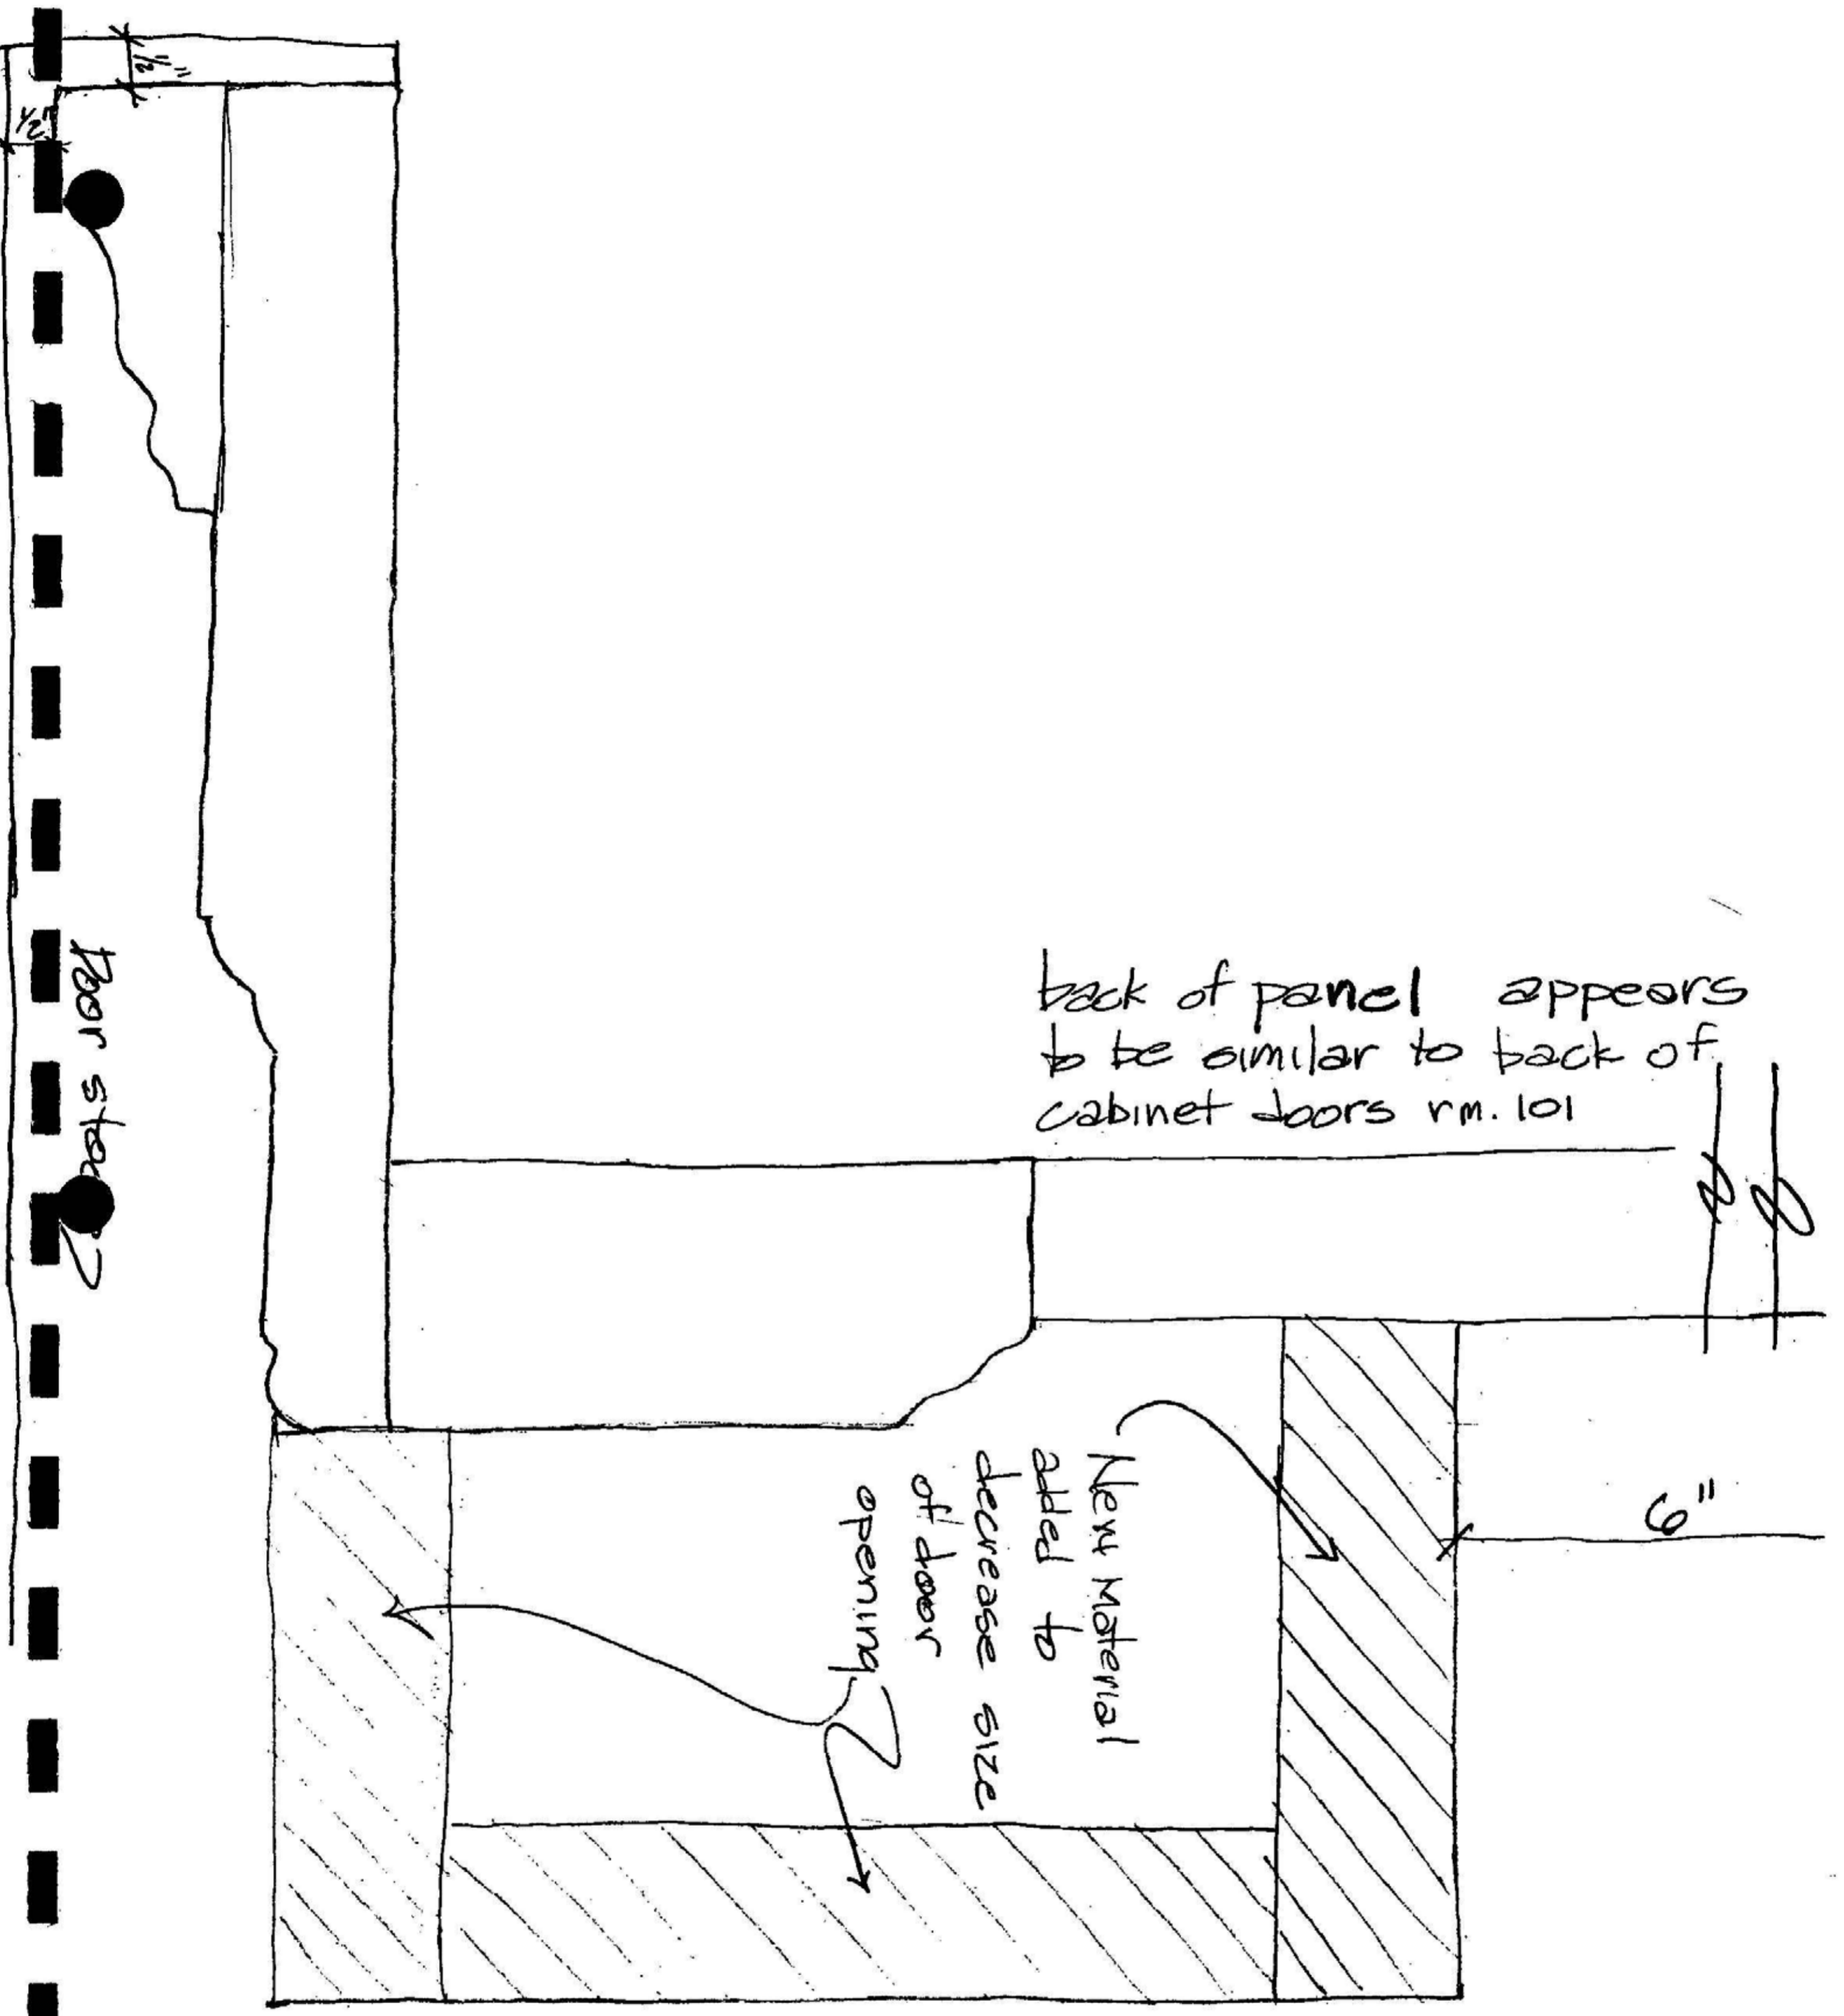
15
E

back of panel appears to be similar to back of cabinet doors rm. 101

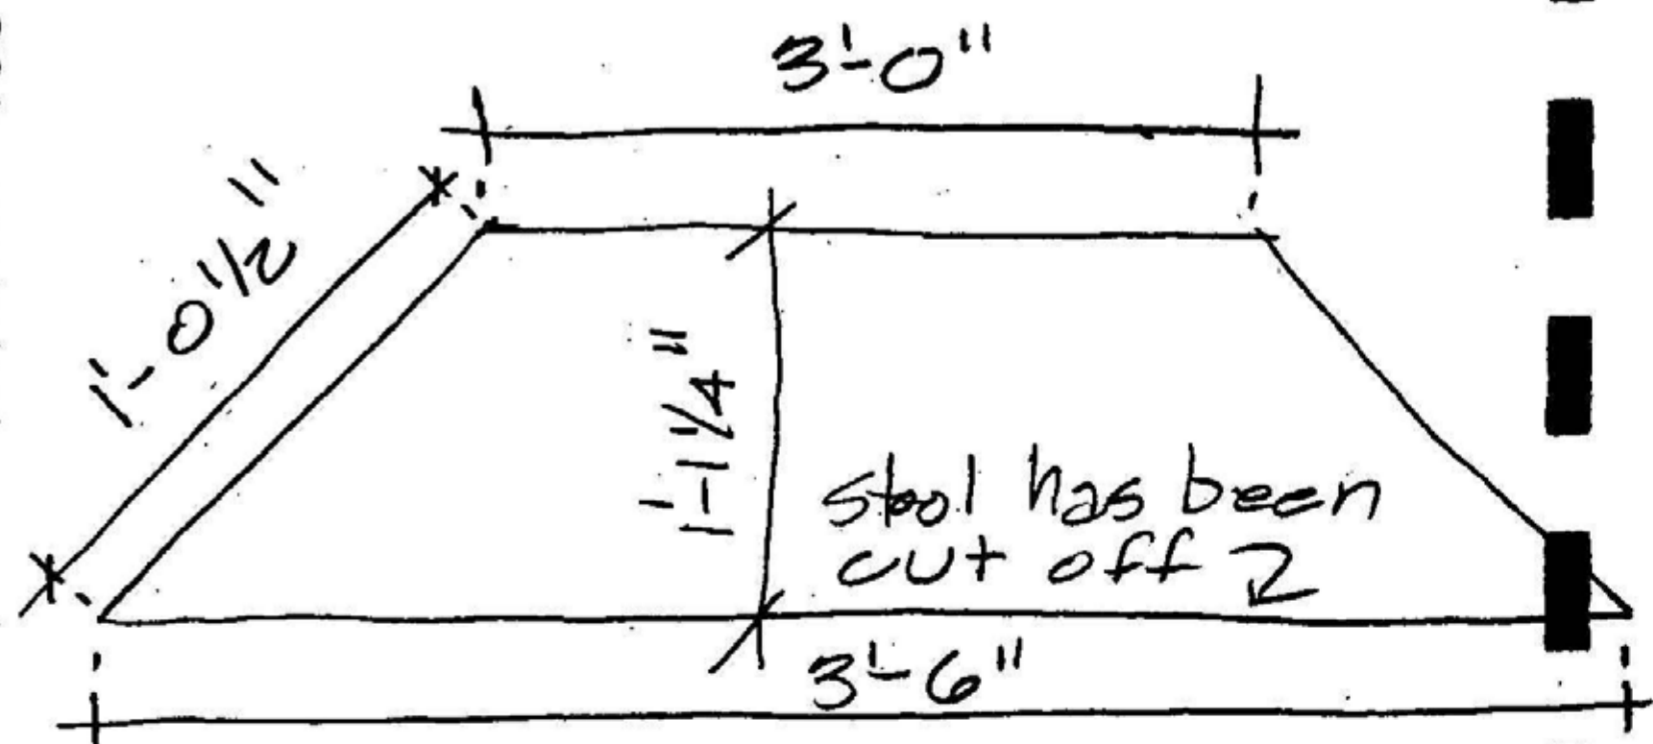
23 WINDOW 102
E

Sill has been cut off 2

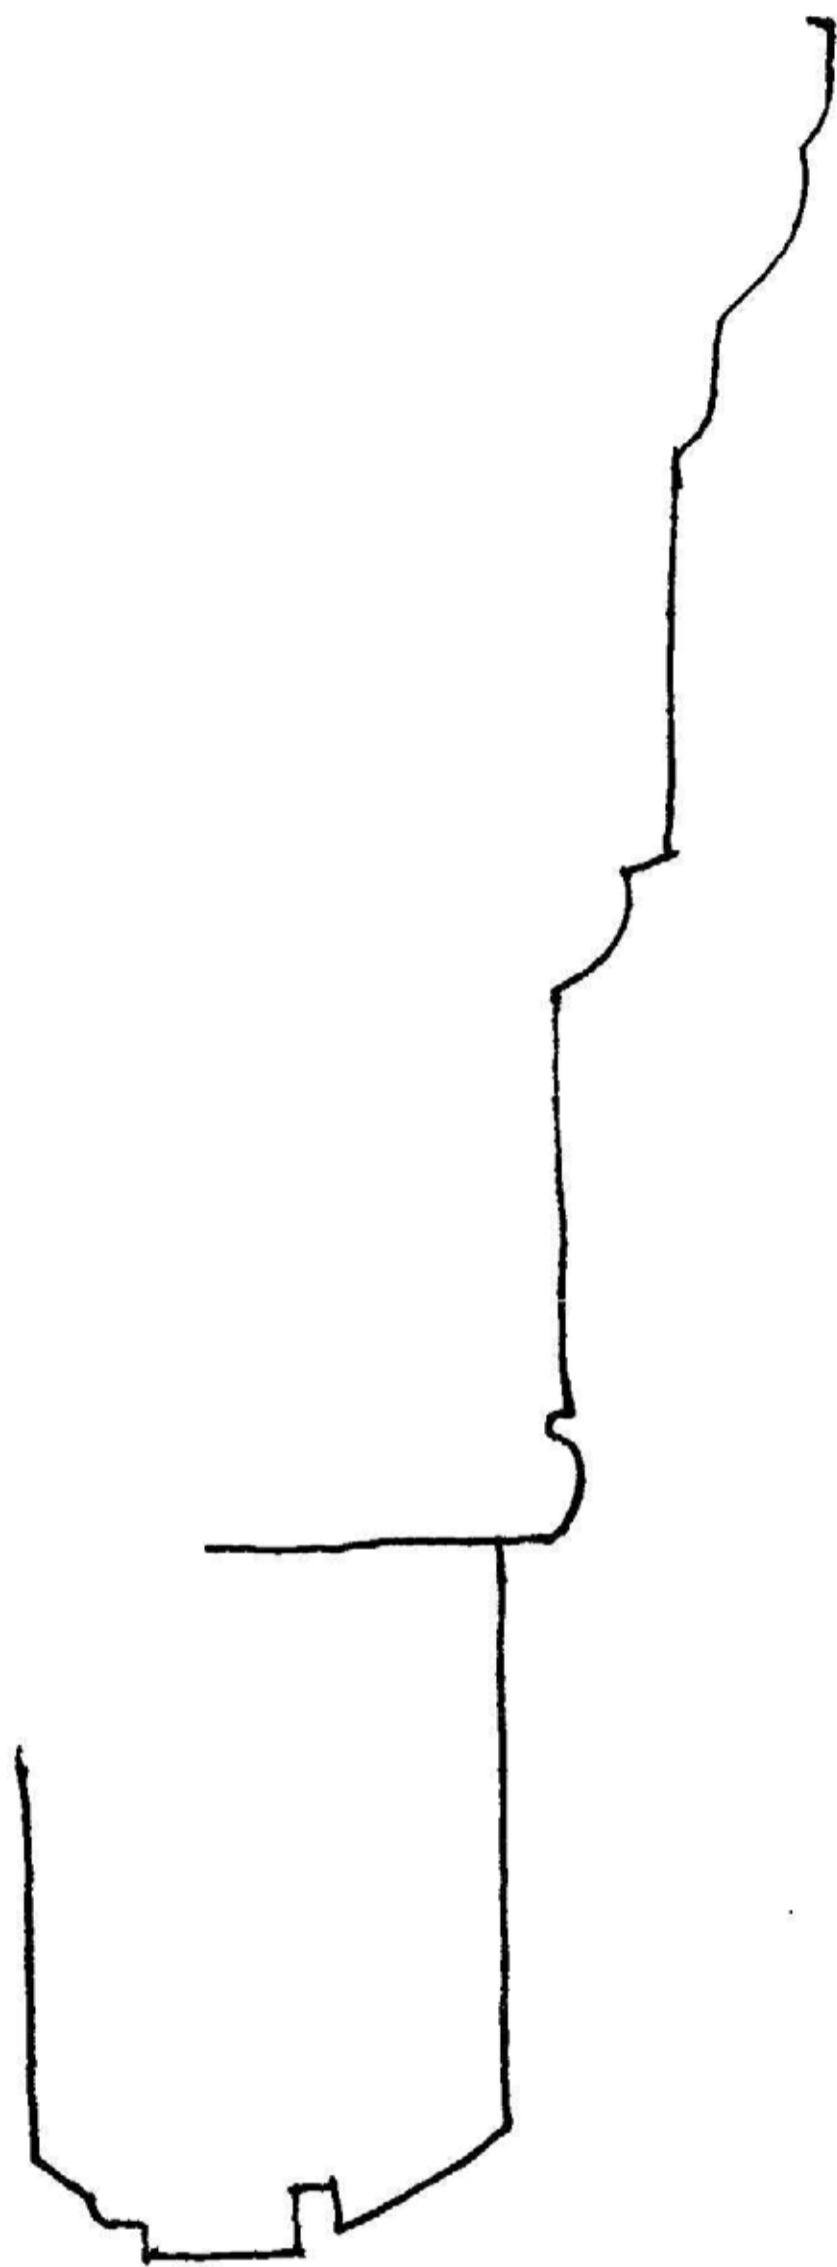
27
E WINDOW 108 - HEAD

later trim
installed
with cut
nails
