historic structure report
architectural data section

PISCATAWAY PARK
MARSHALL HALL

HISTORIC STRUCTURE REPORT
ARCHITECTURAL DATA SECTION
FOR
MARSHALL HALL
PISCATAWAY PARK

January 1983

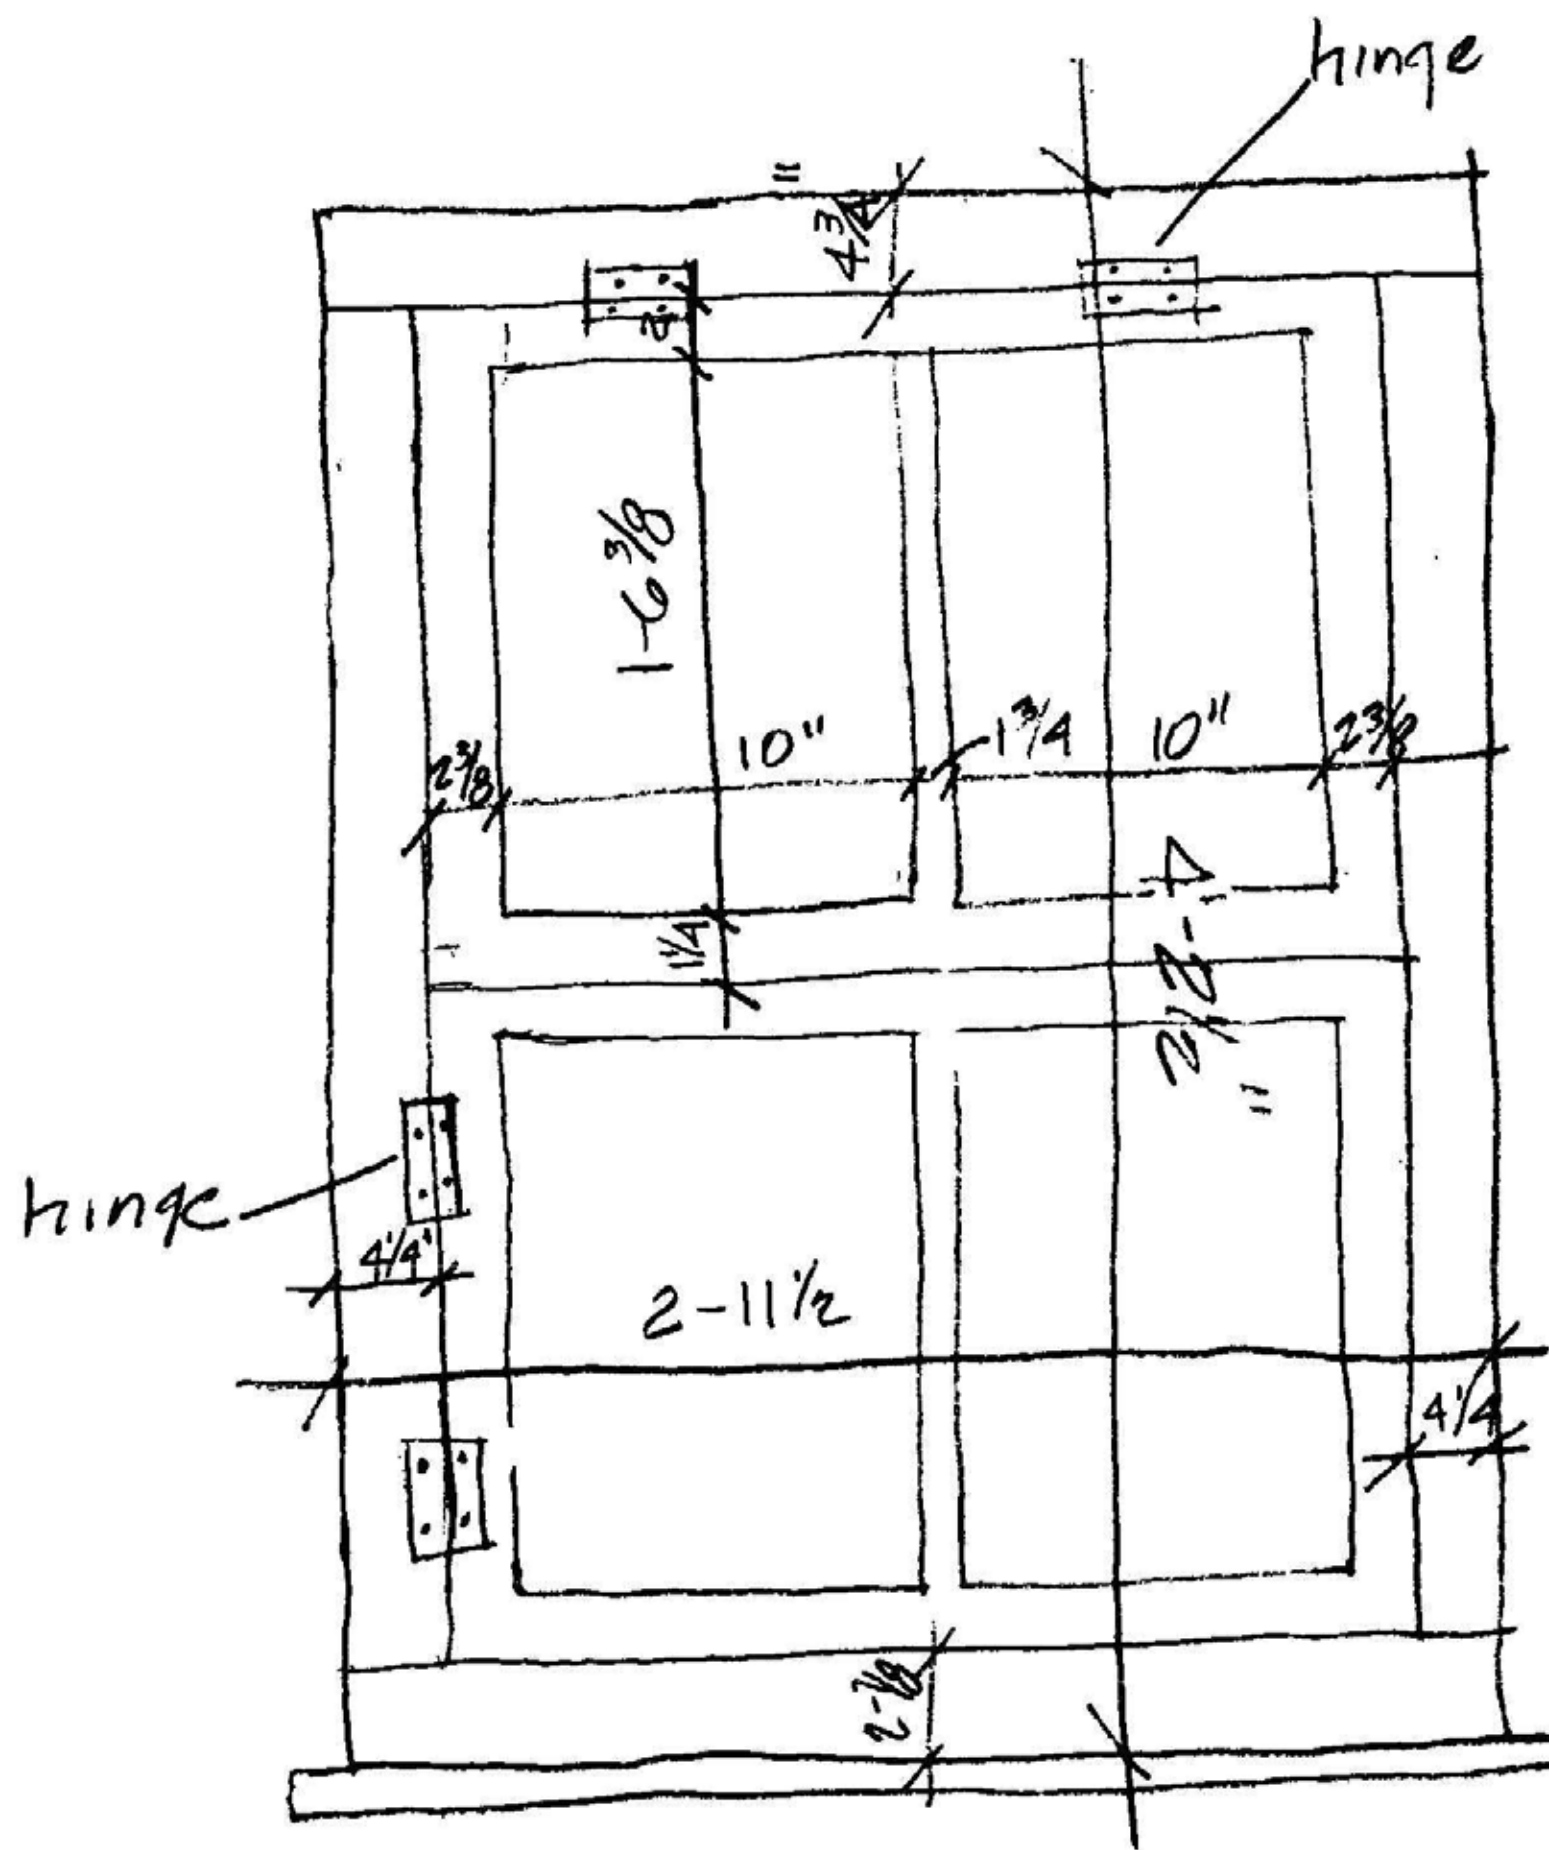
29
E WINDOW 202 (W201, W213, 214 SIM)

Note: sill has been replaced with modern material

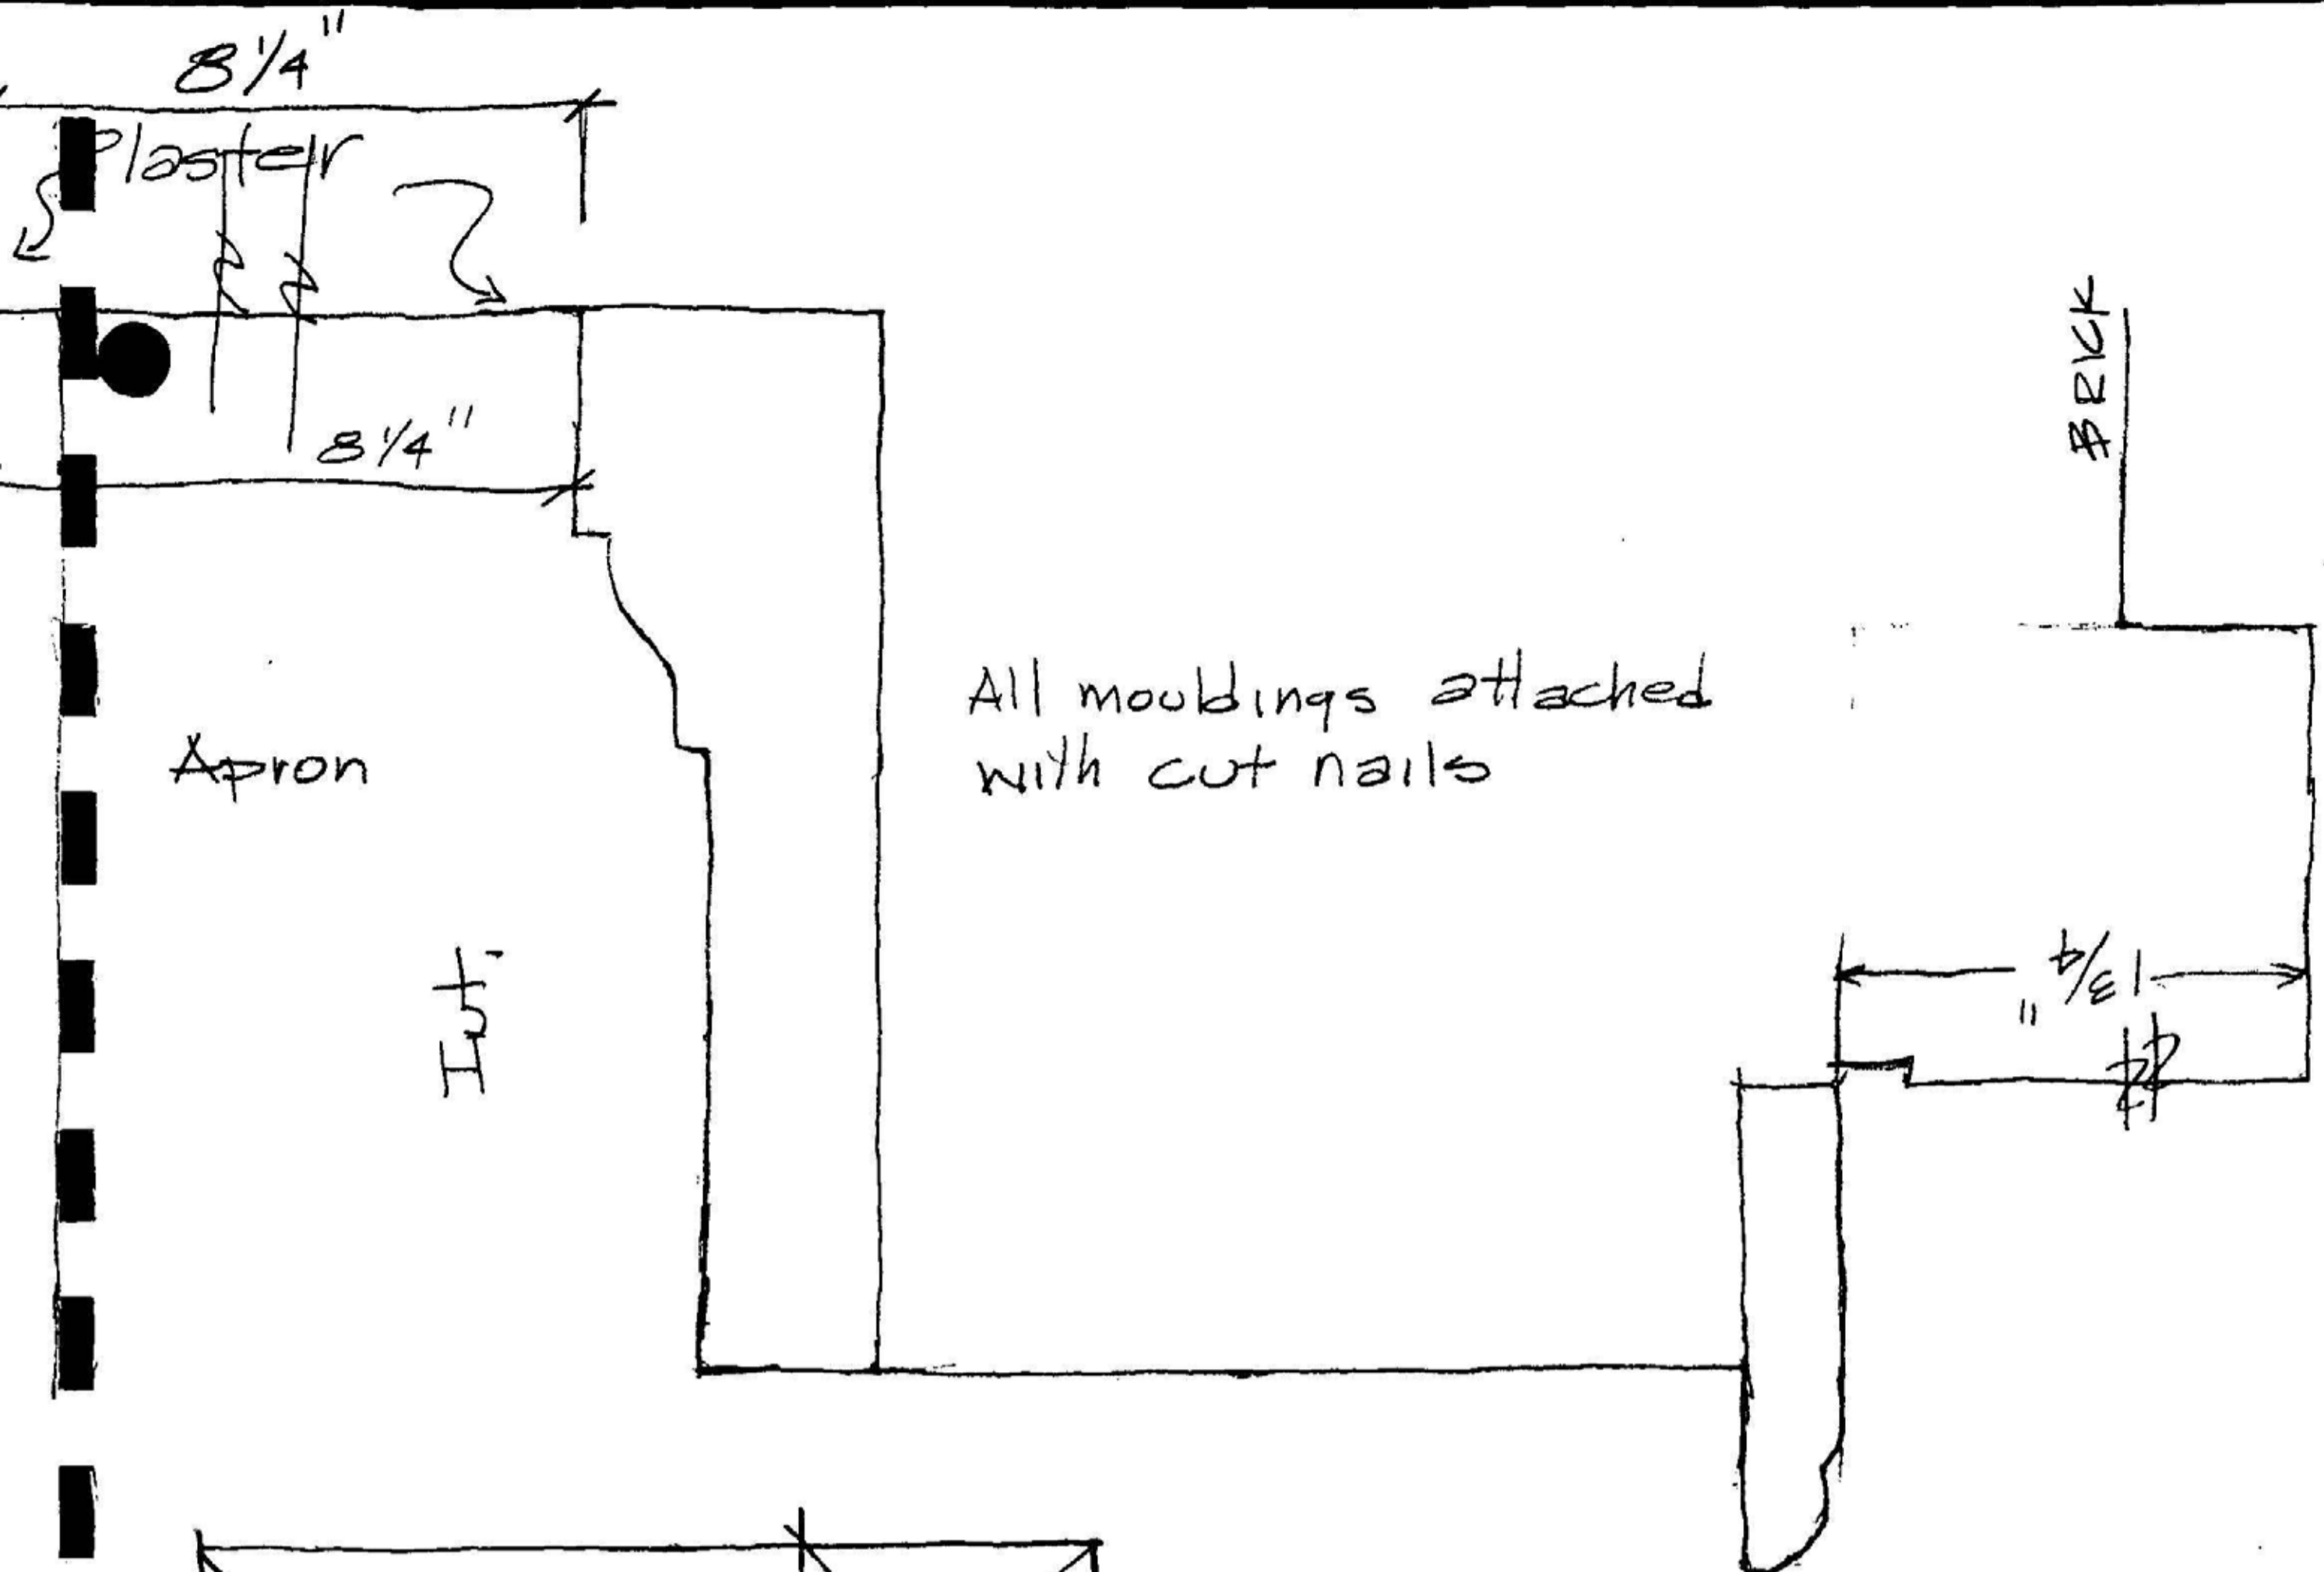
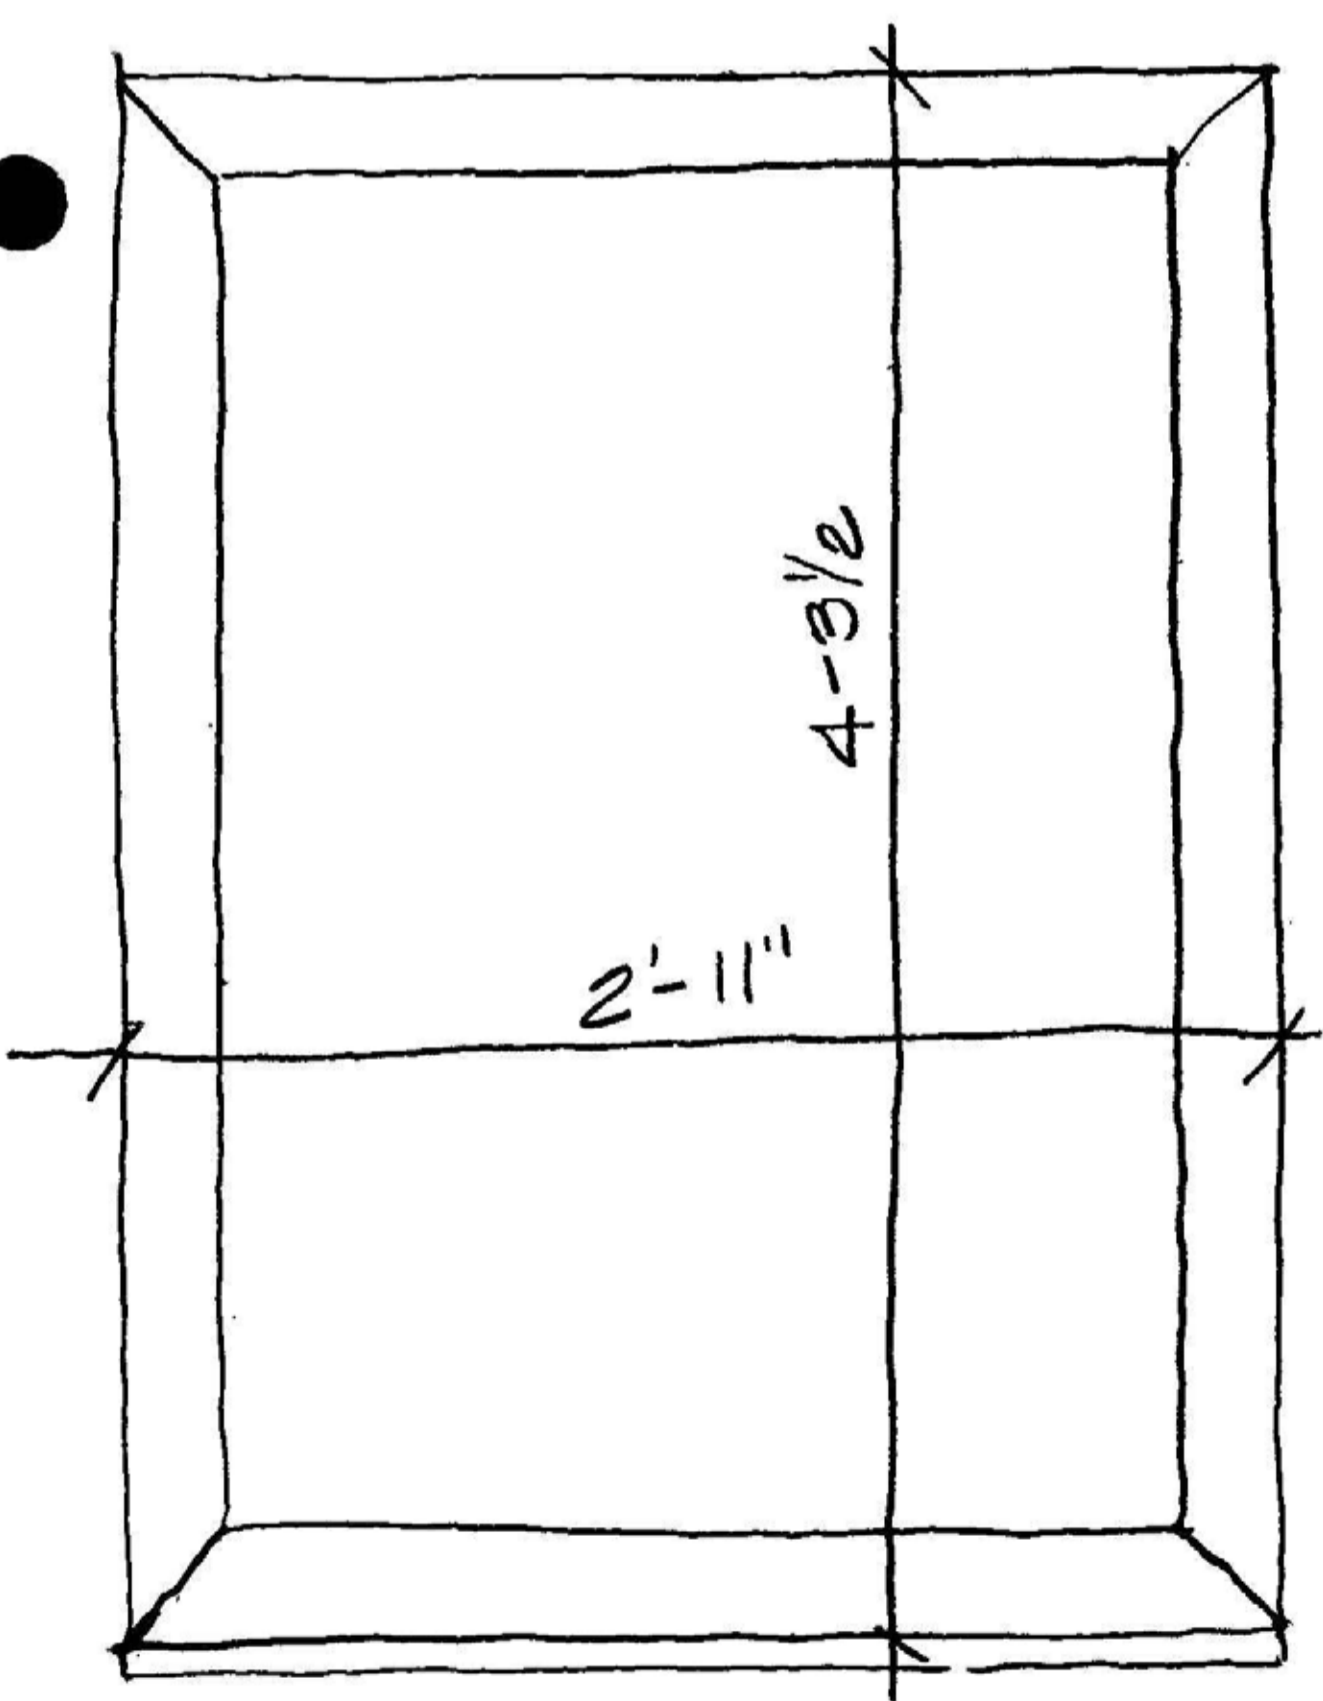
(32 E) WINDOW 206 - All other windows located on the second floor of the c.1725 house are missing

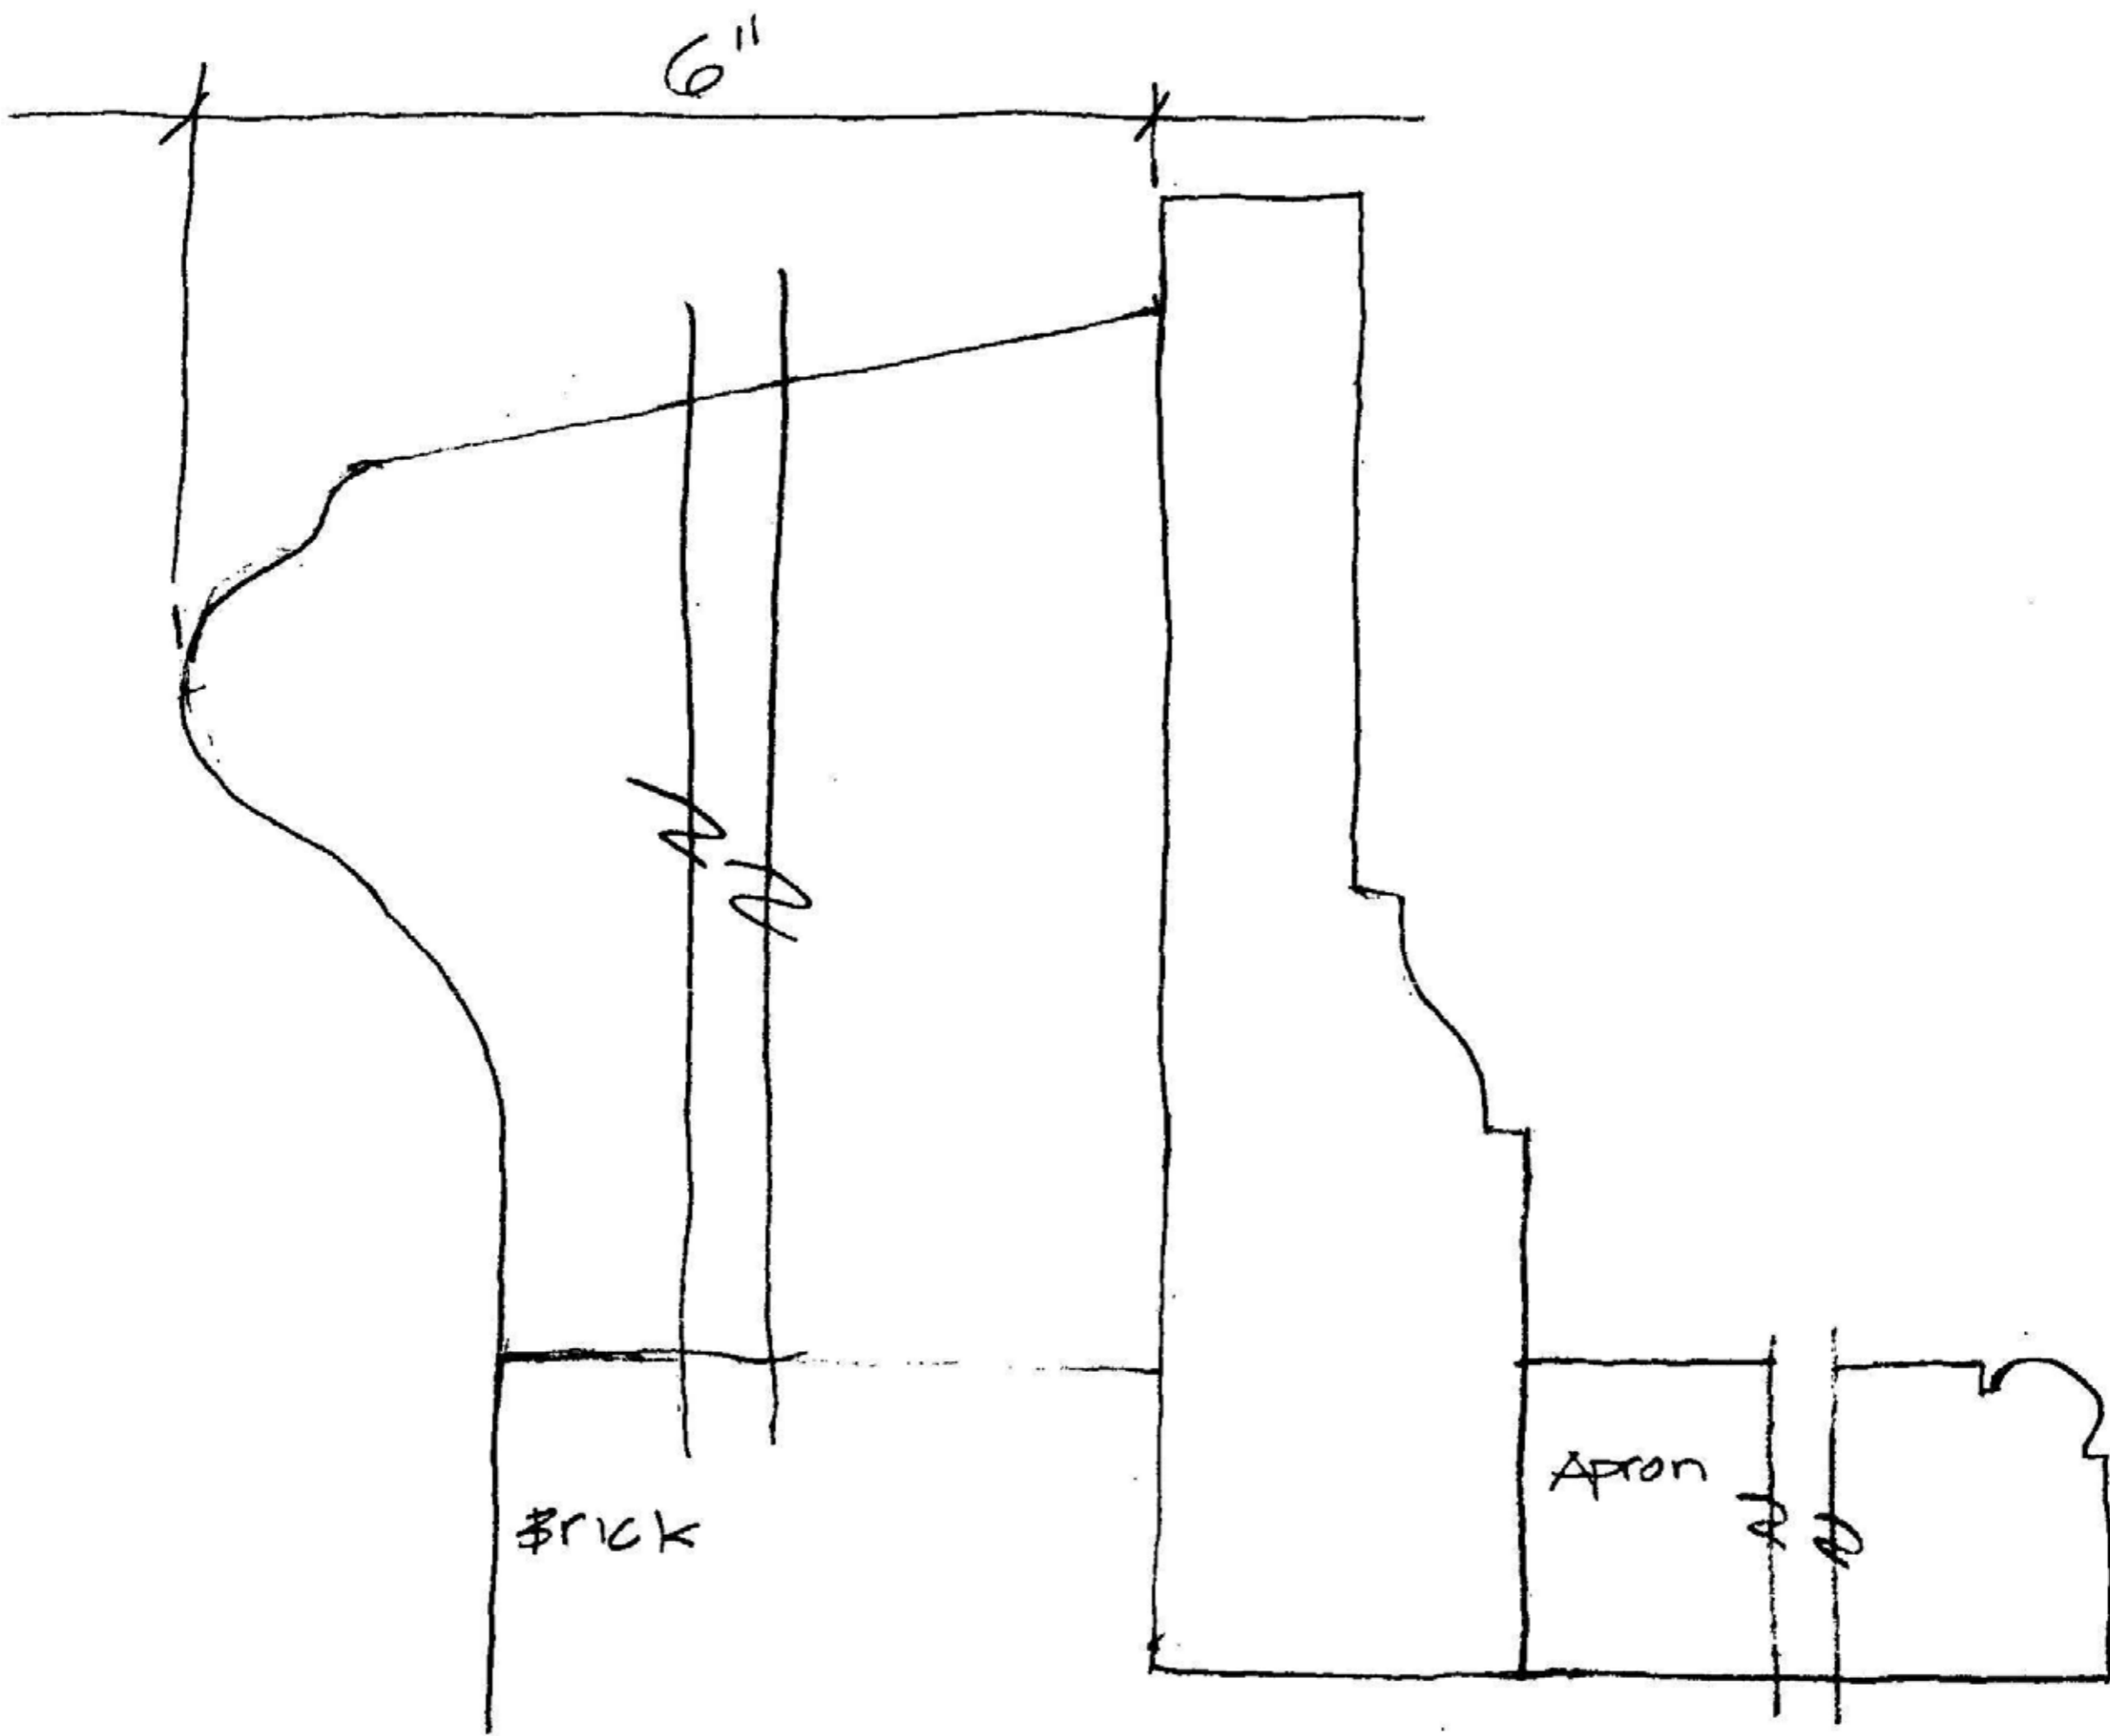
33
E

All other windows located on the second floor of the original bldg. are missing;

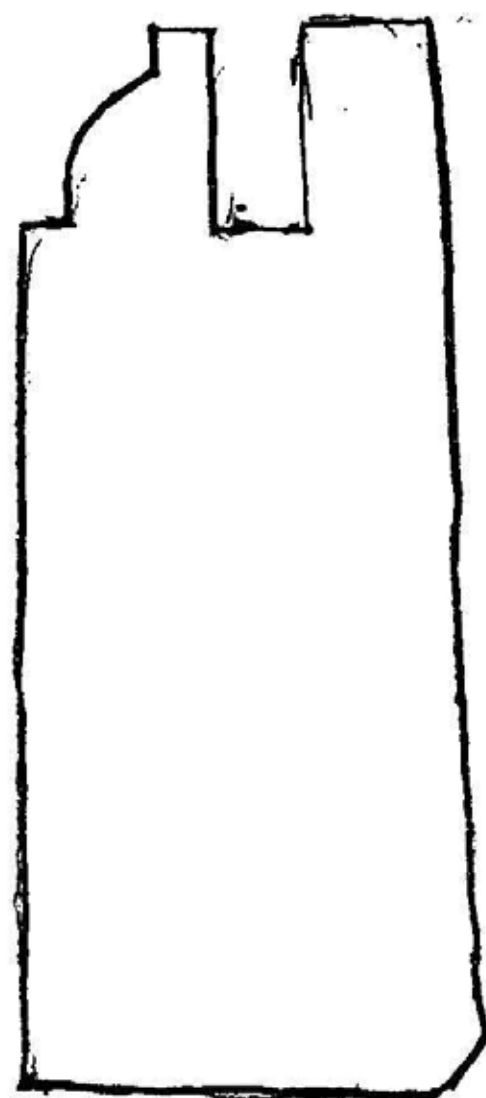
61
E

RM. 104 - WINDOW SASH USED AS NAILER

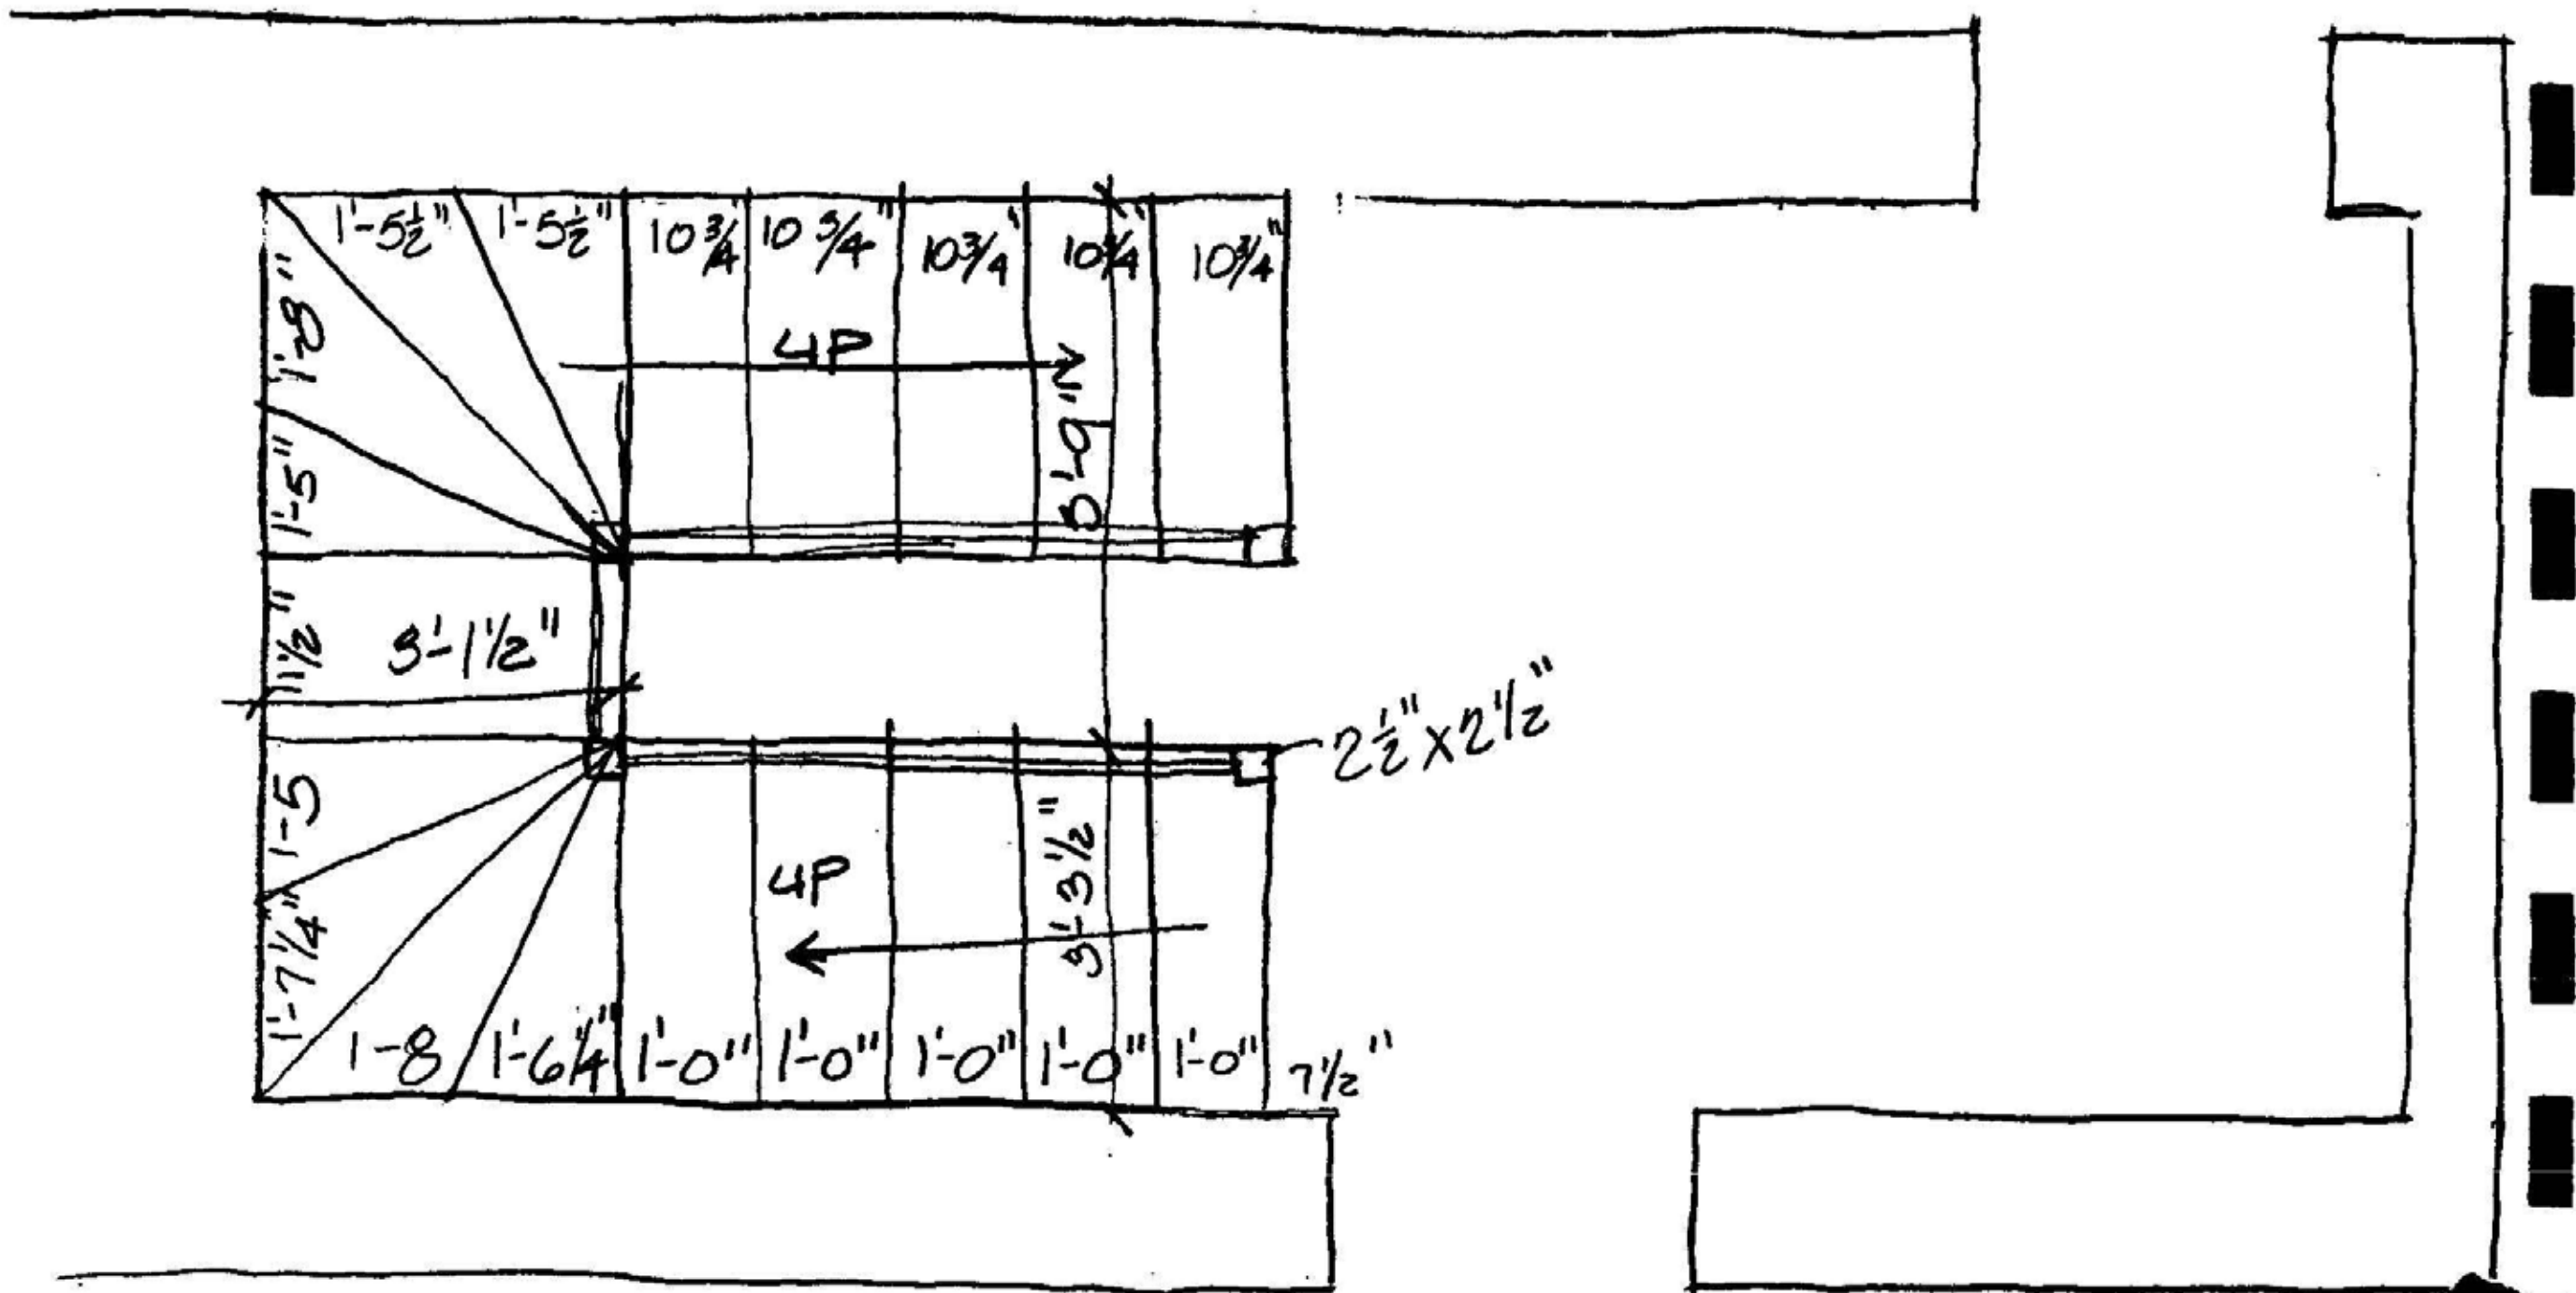
62
E

RM. 105 - STAIR 2

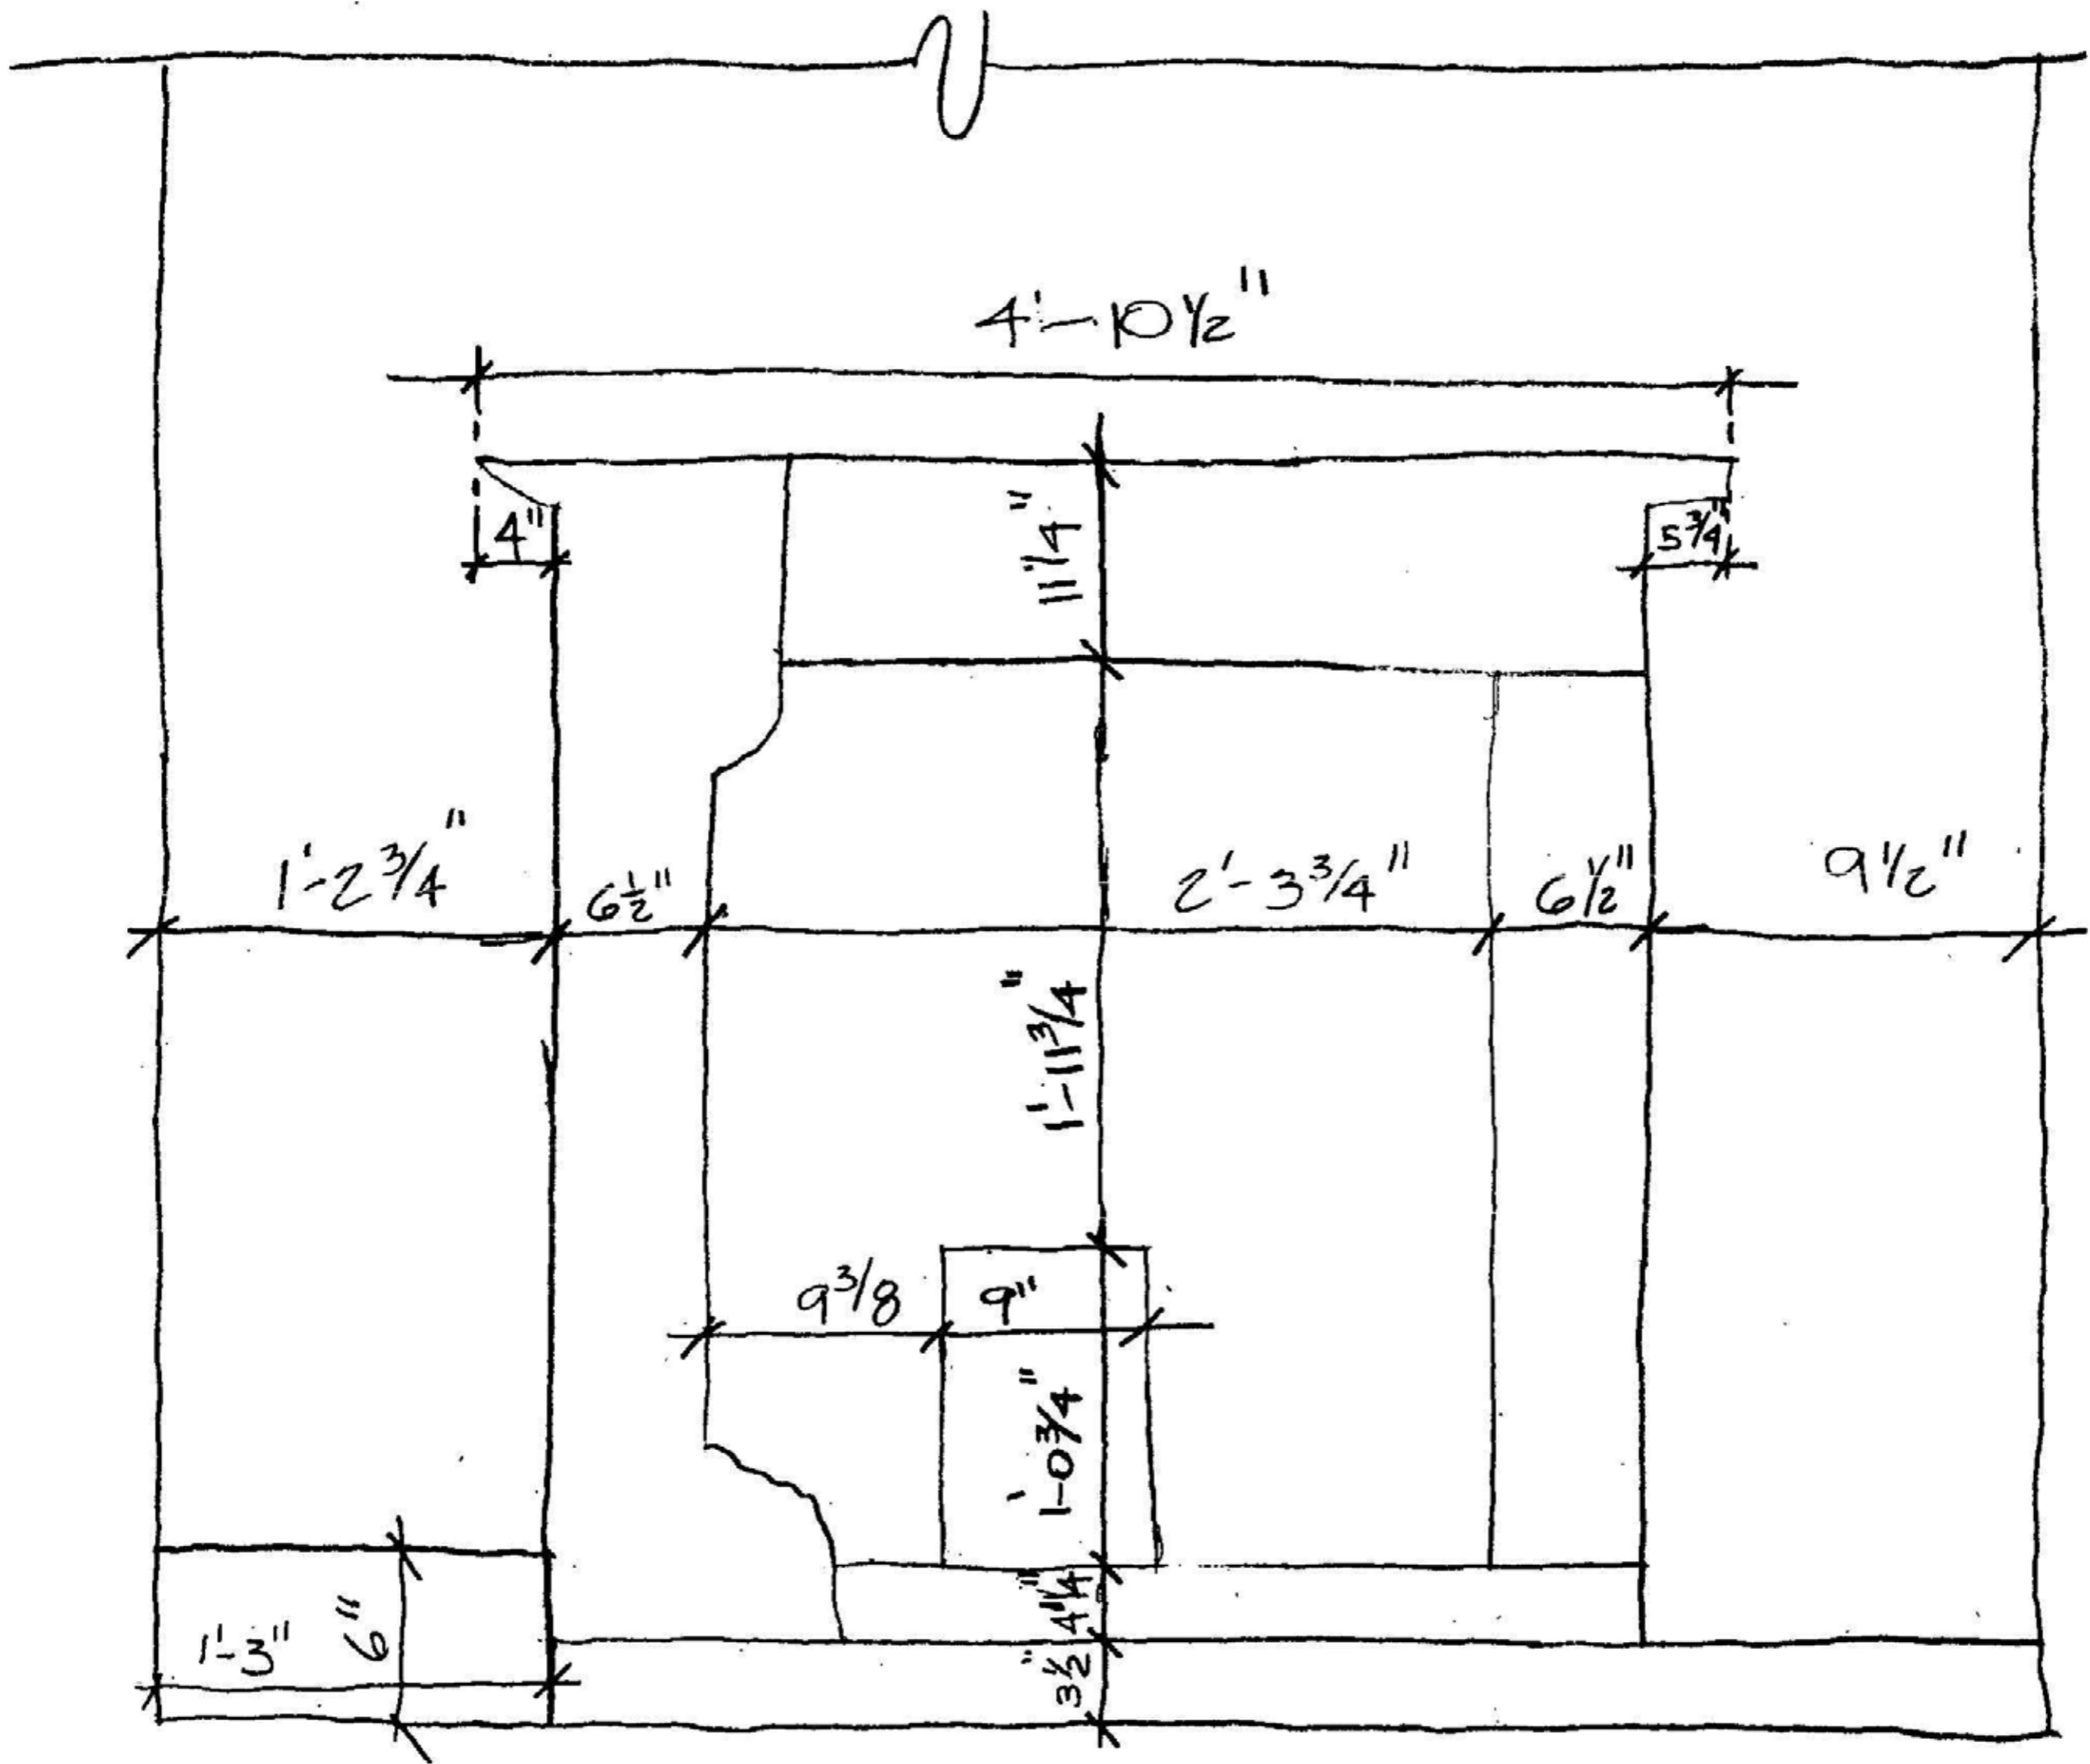
78
E

RM. 201 - GHOST OF MANTEL - SOUTH WALL
