historic structure report
architectural data section

PISCATAWAY PARK
MARSHALL HALL

HISTORIC STRUCTURE REPORT
ARCHITECTURAL DATA SECTION
FOR
MARSHALL HALL
PISCATAWAY PARK

January 1983

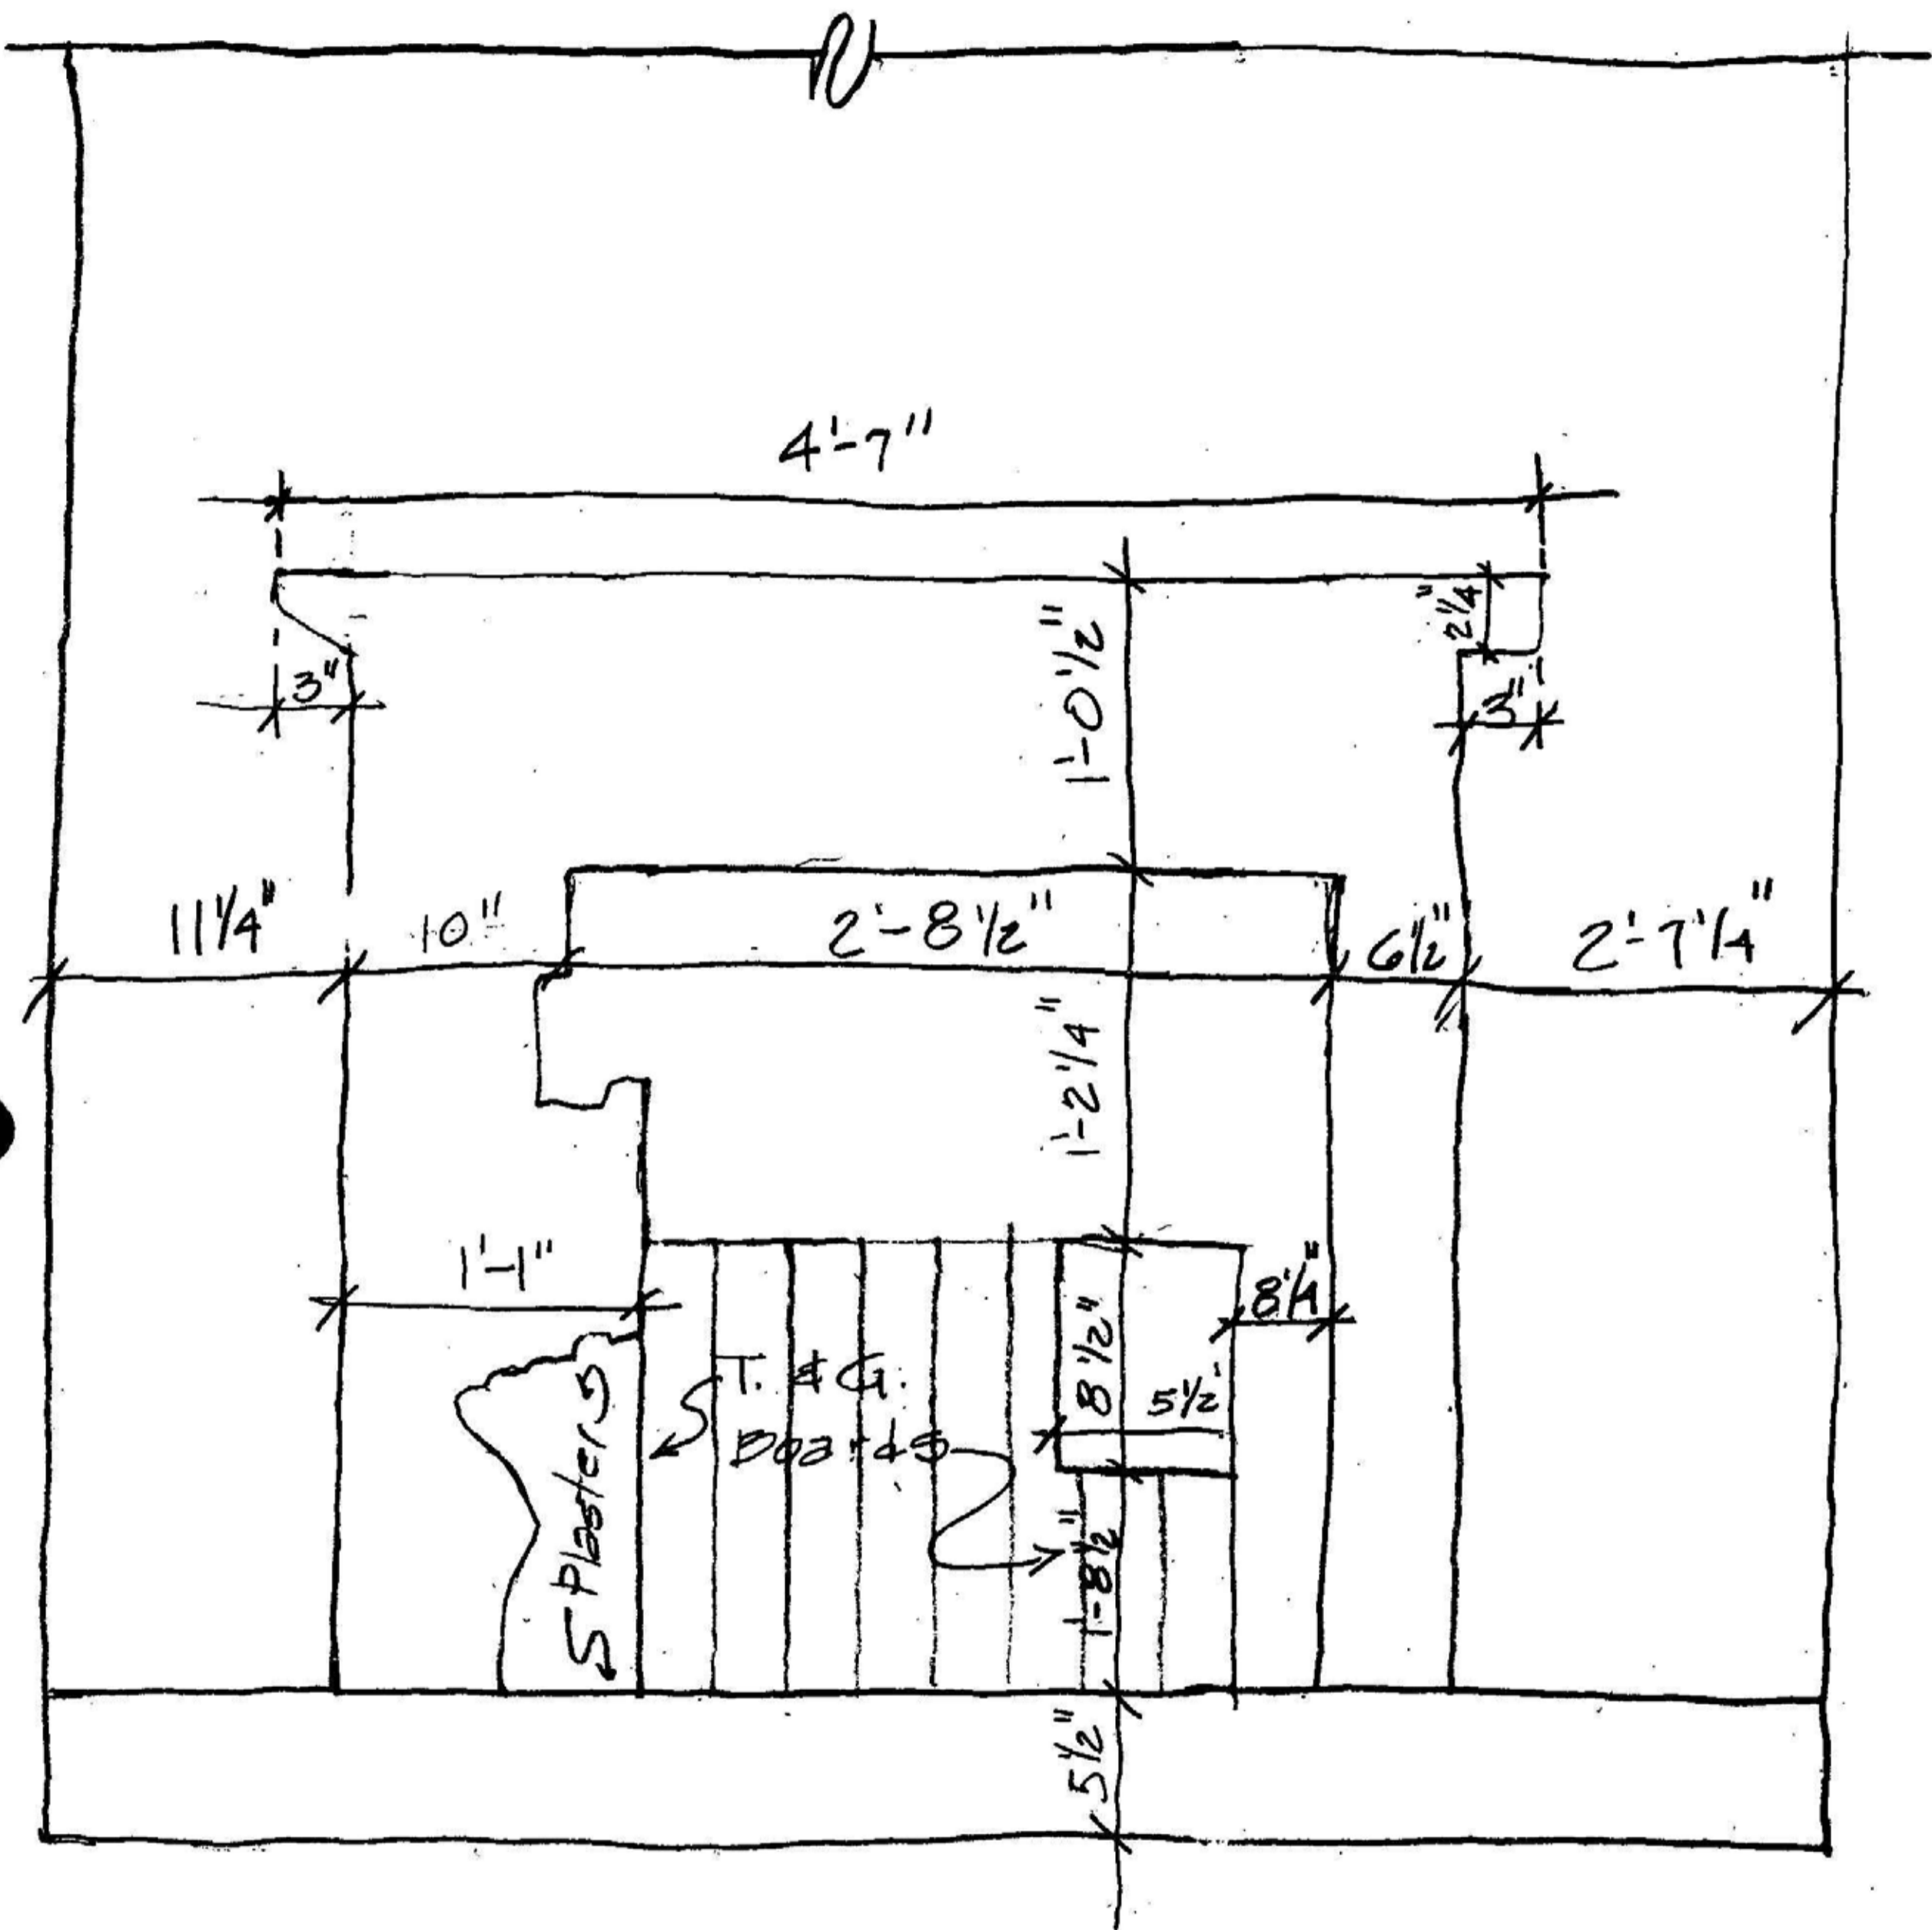
79
E

RM. 203 - GHOST OF MANTEL - NORTH ELEVATION

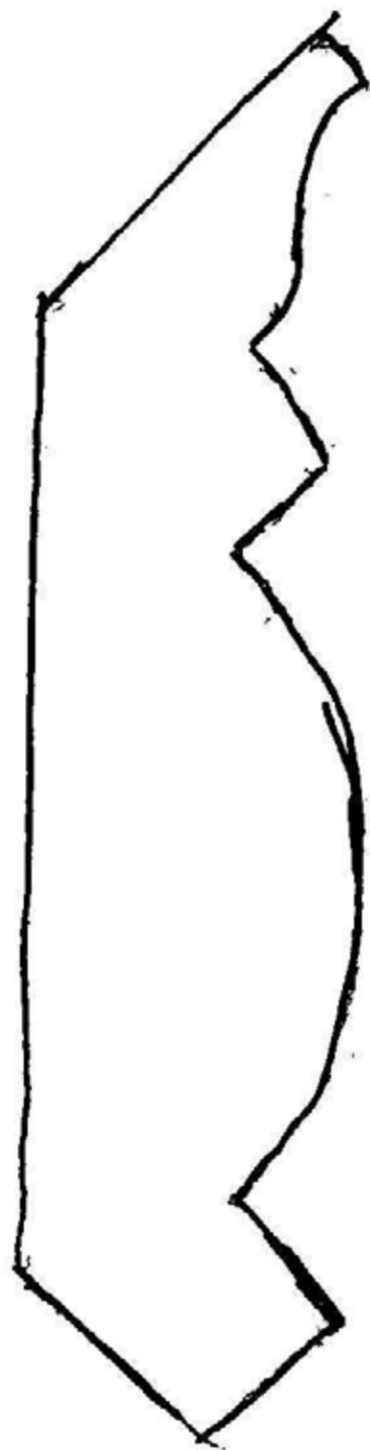
95
E

Moulding (wood) found in attic

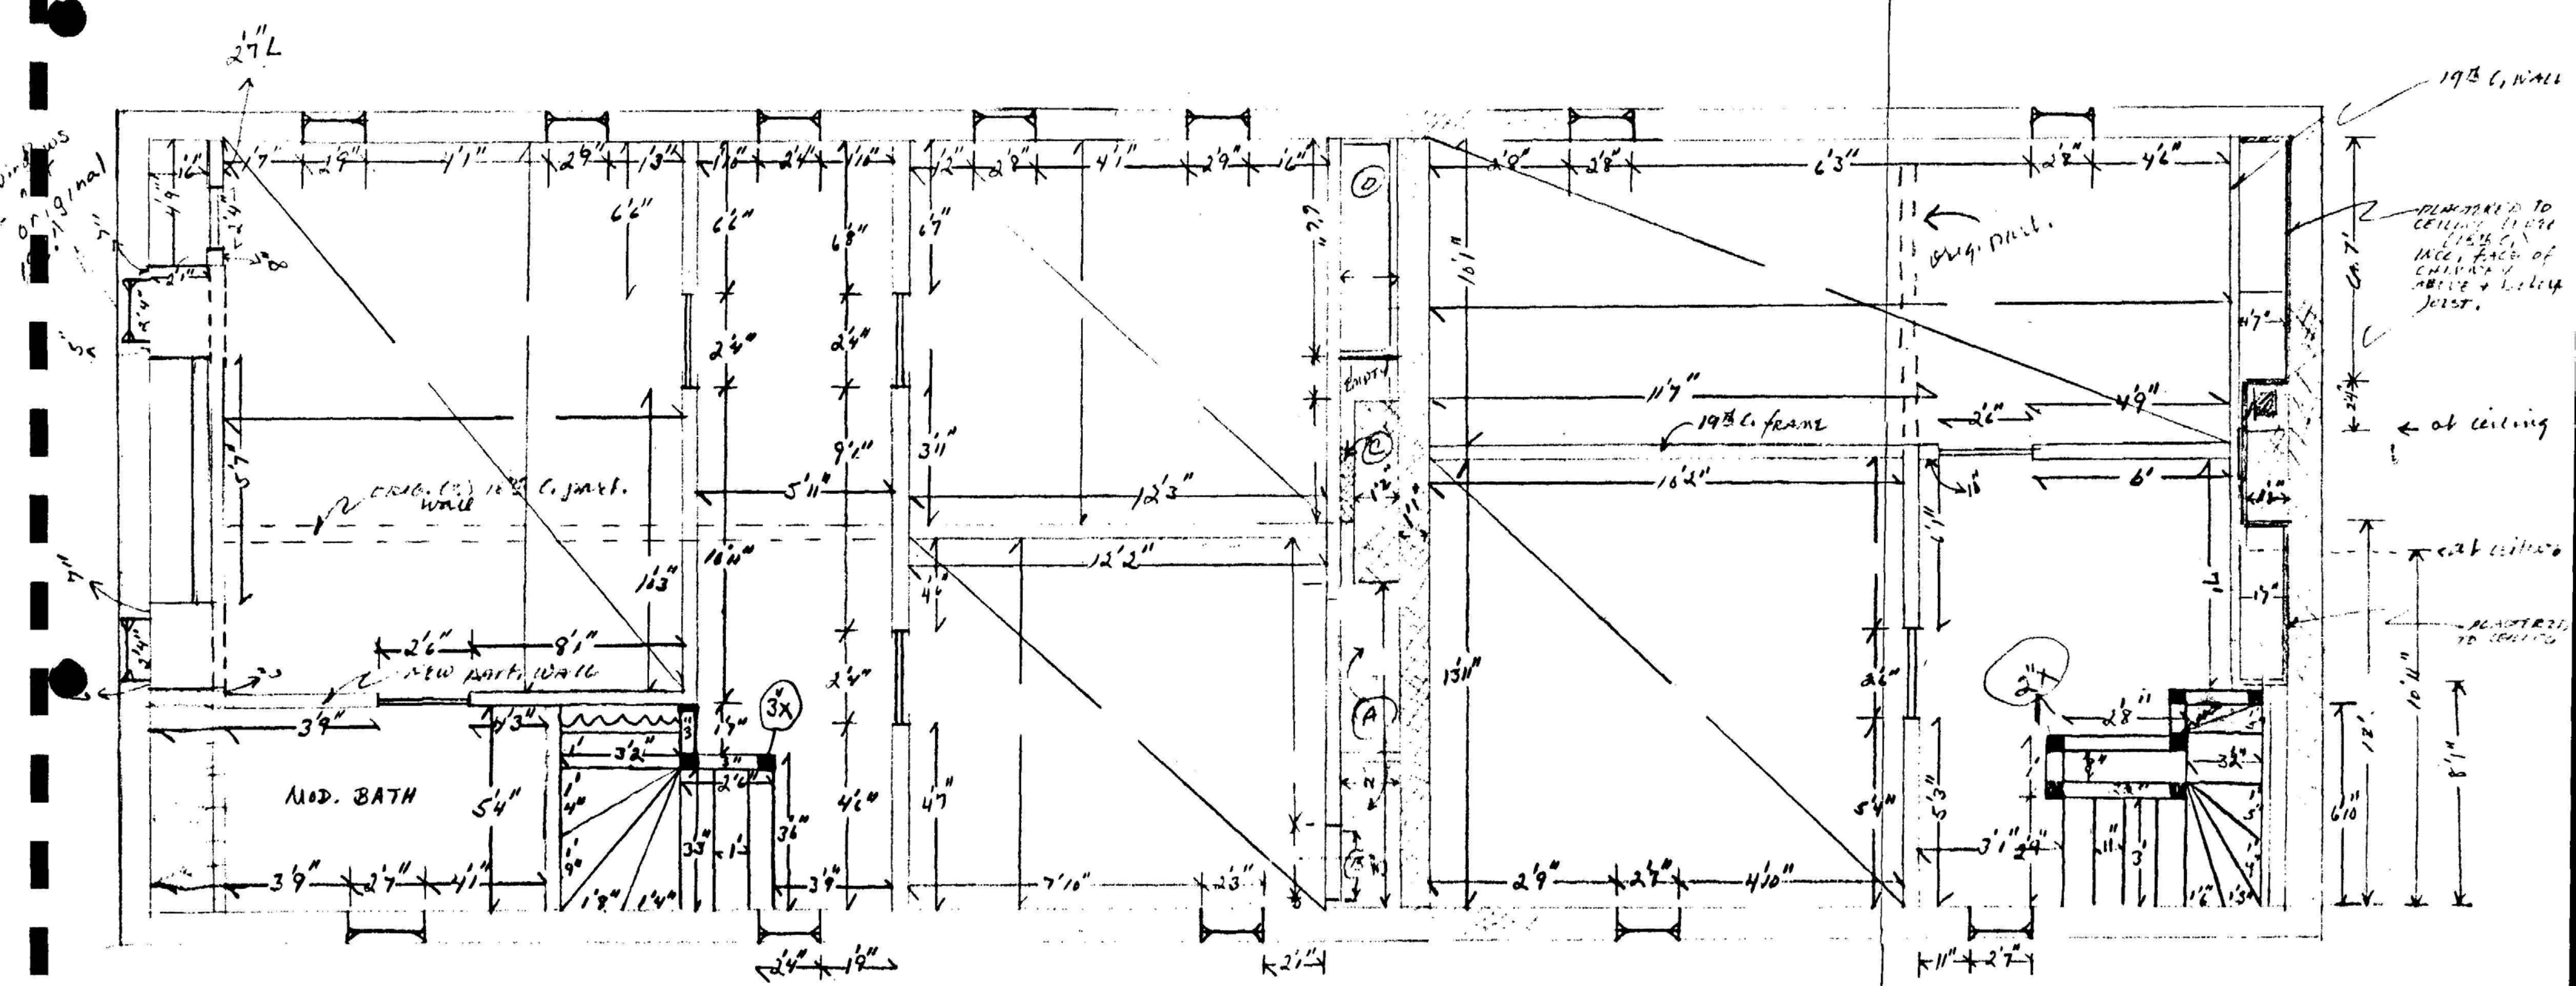
MARSHALL HALL
 CHAS. CO. INC. RIVER
 14. floor plan 8/71

- Ⓐ - con. area for attic entrance (no plaster, pess. vert. board)
- Ⓑ - door opening now sealed
- Ⓒ - flue
- Ⓓ - 19th C. closet - no plaster, vert. board

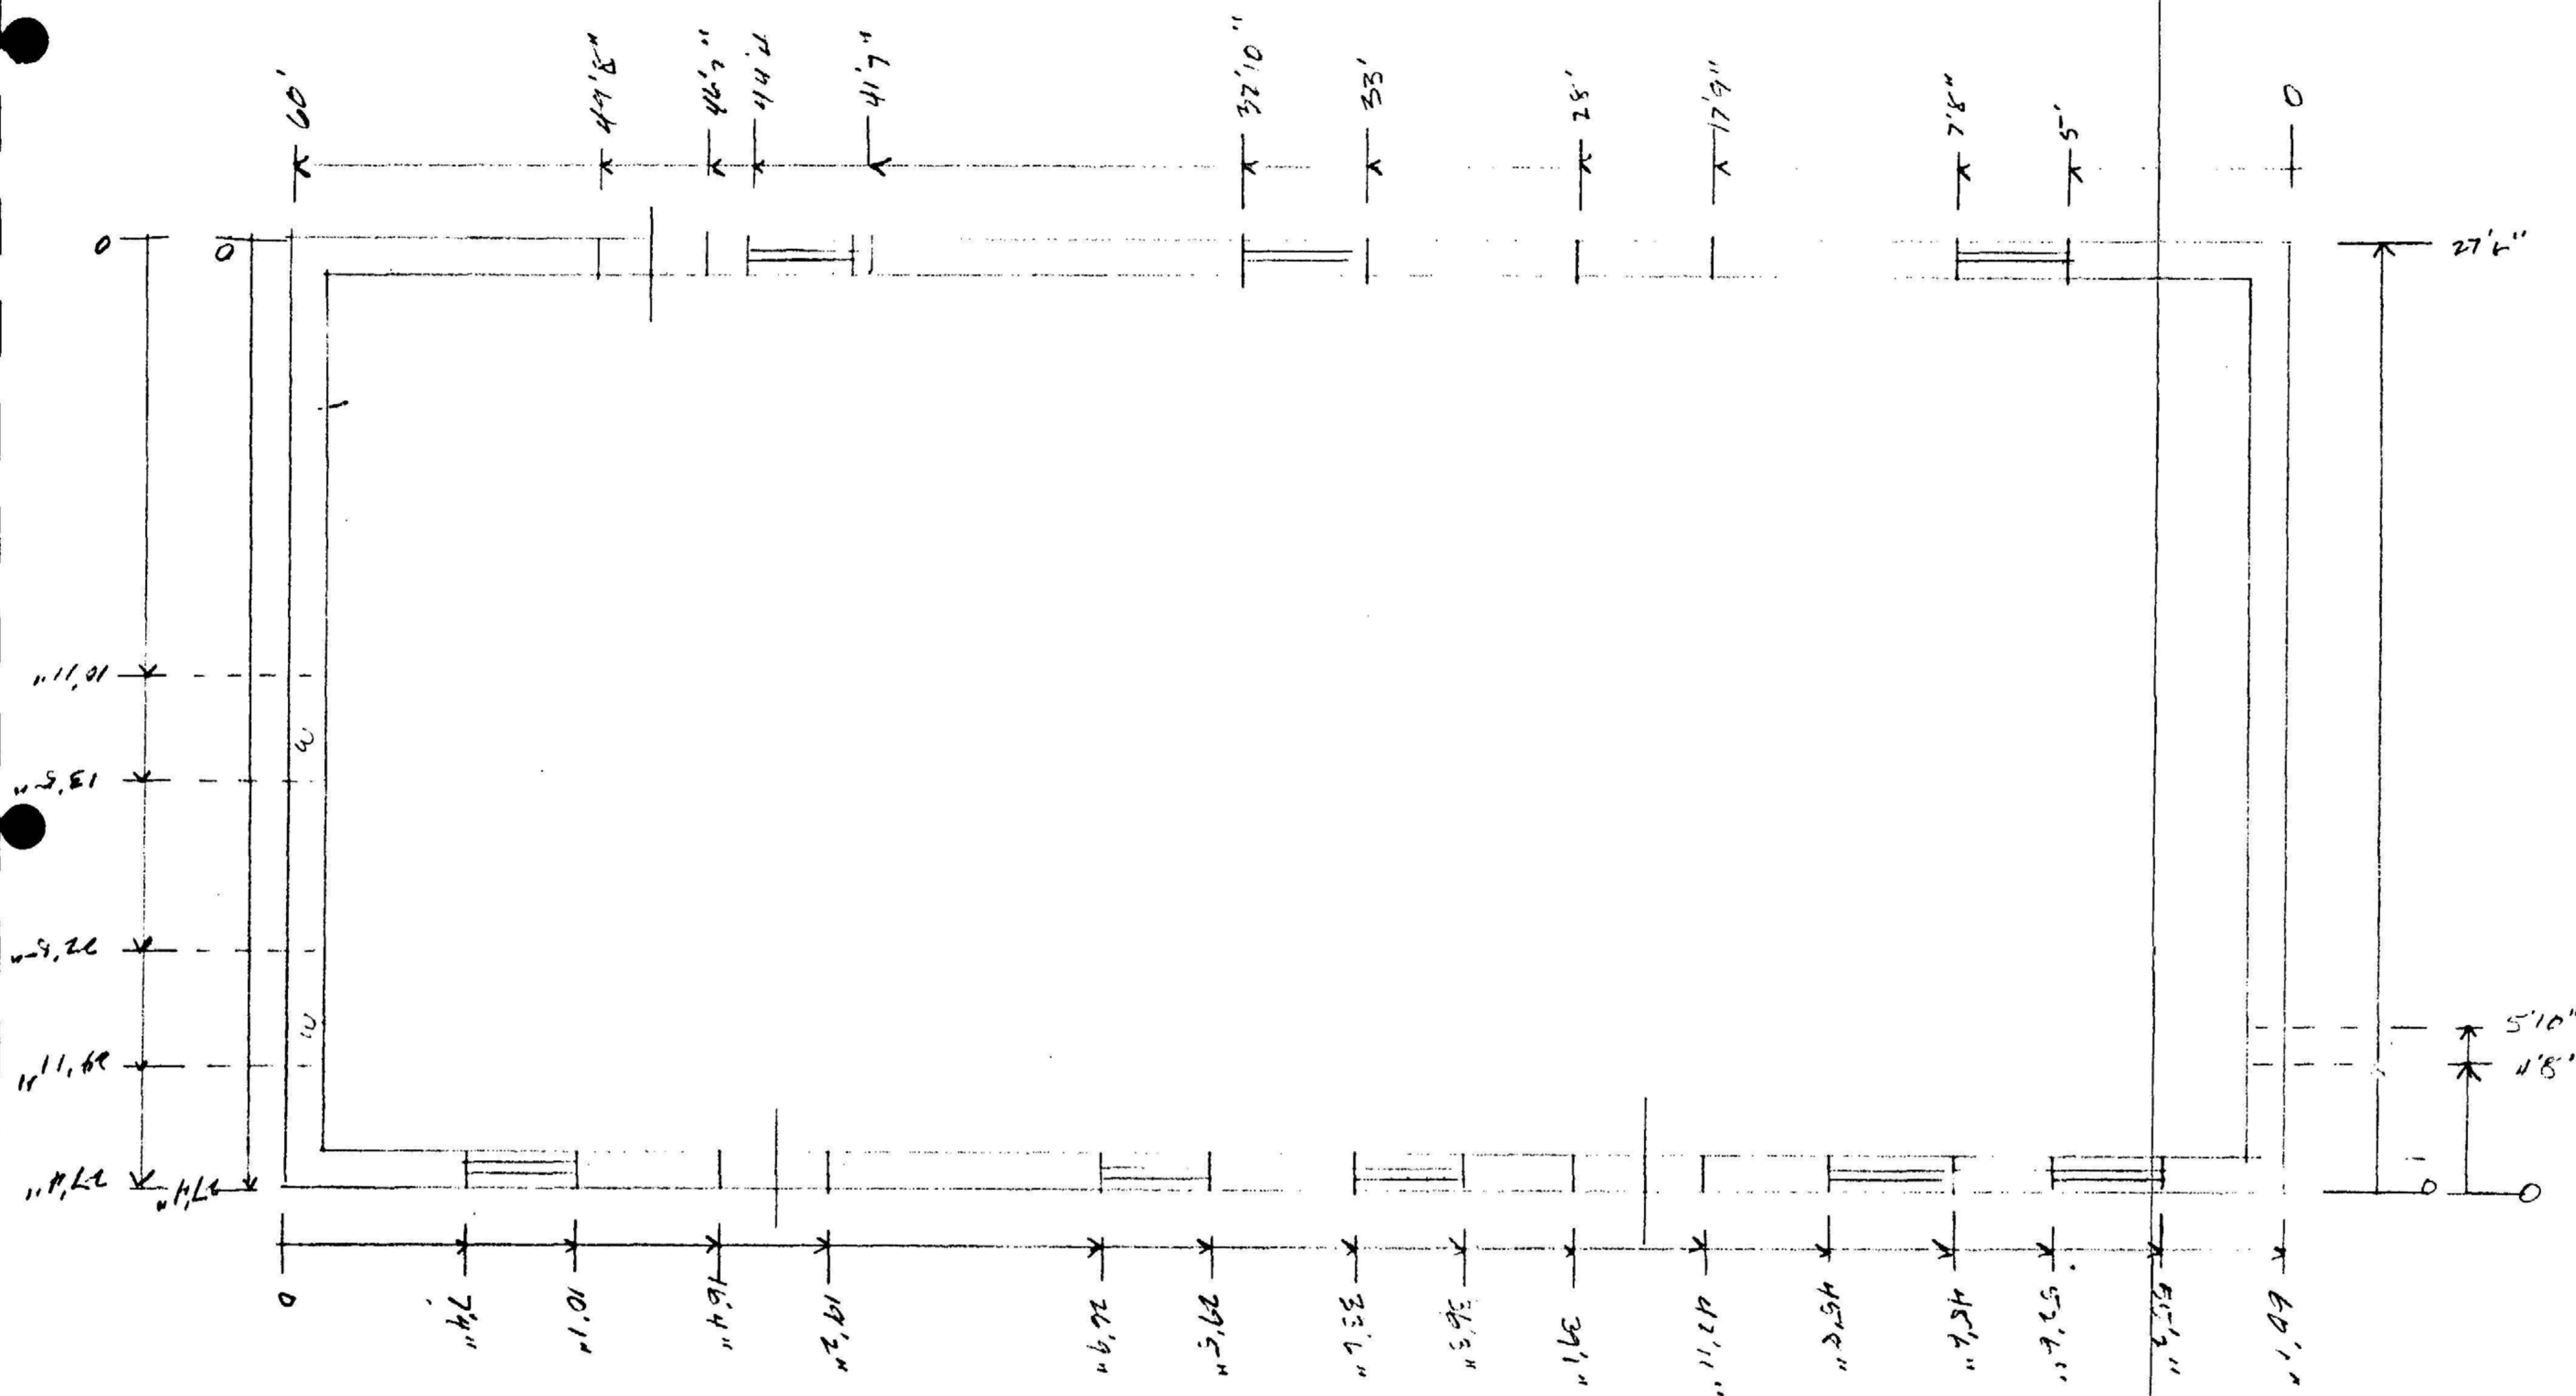
MARSHALL HALL.
 FREE EXT. MEAS. 871

TE
 ID "A" appears later
 with window head
 "B" cut into wall
 with first treatment of
 window head.

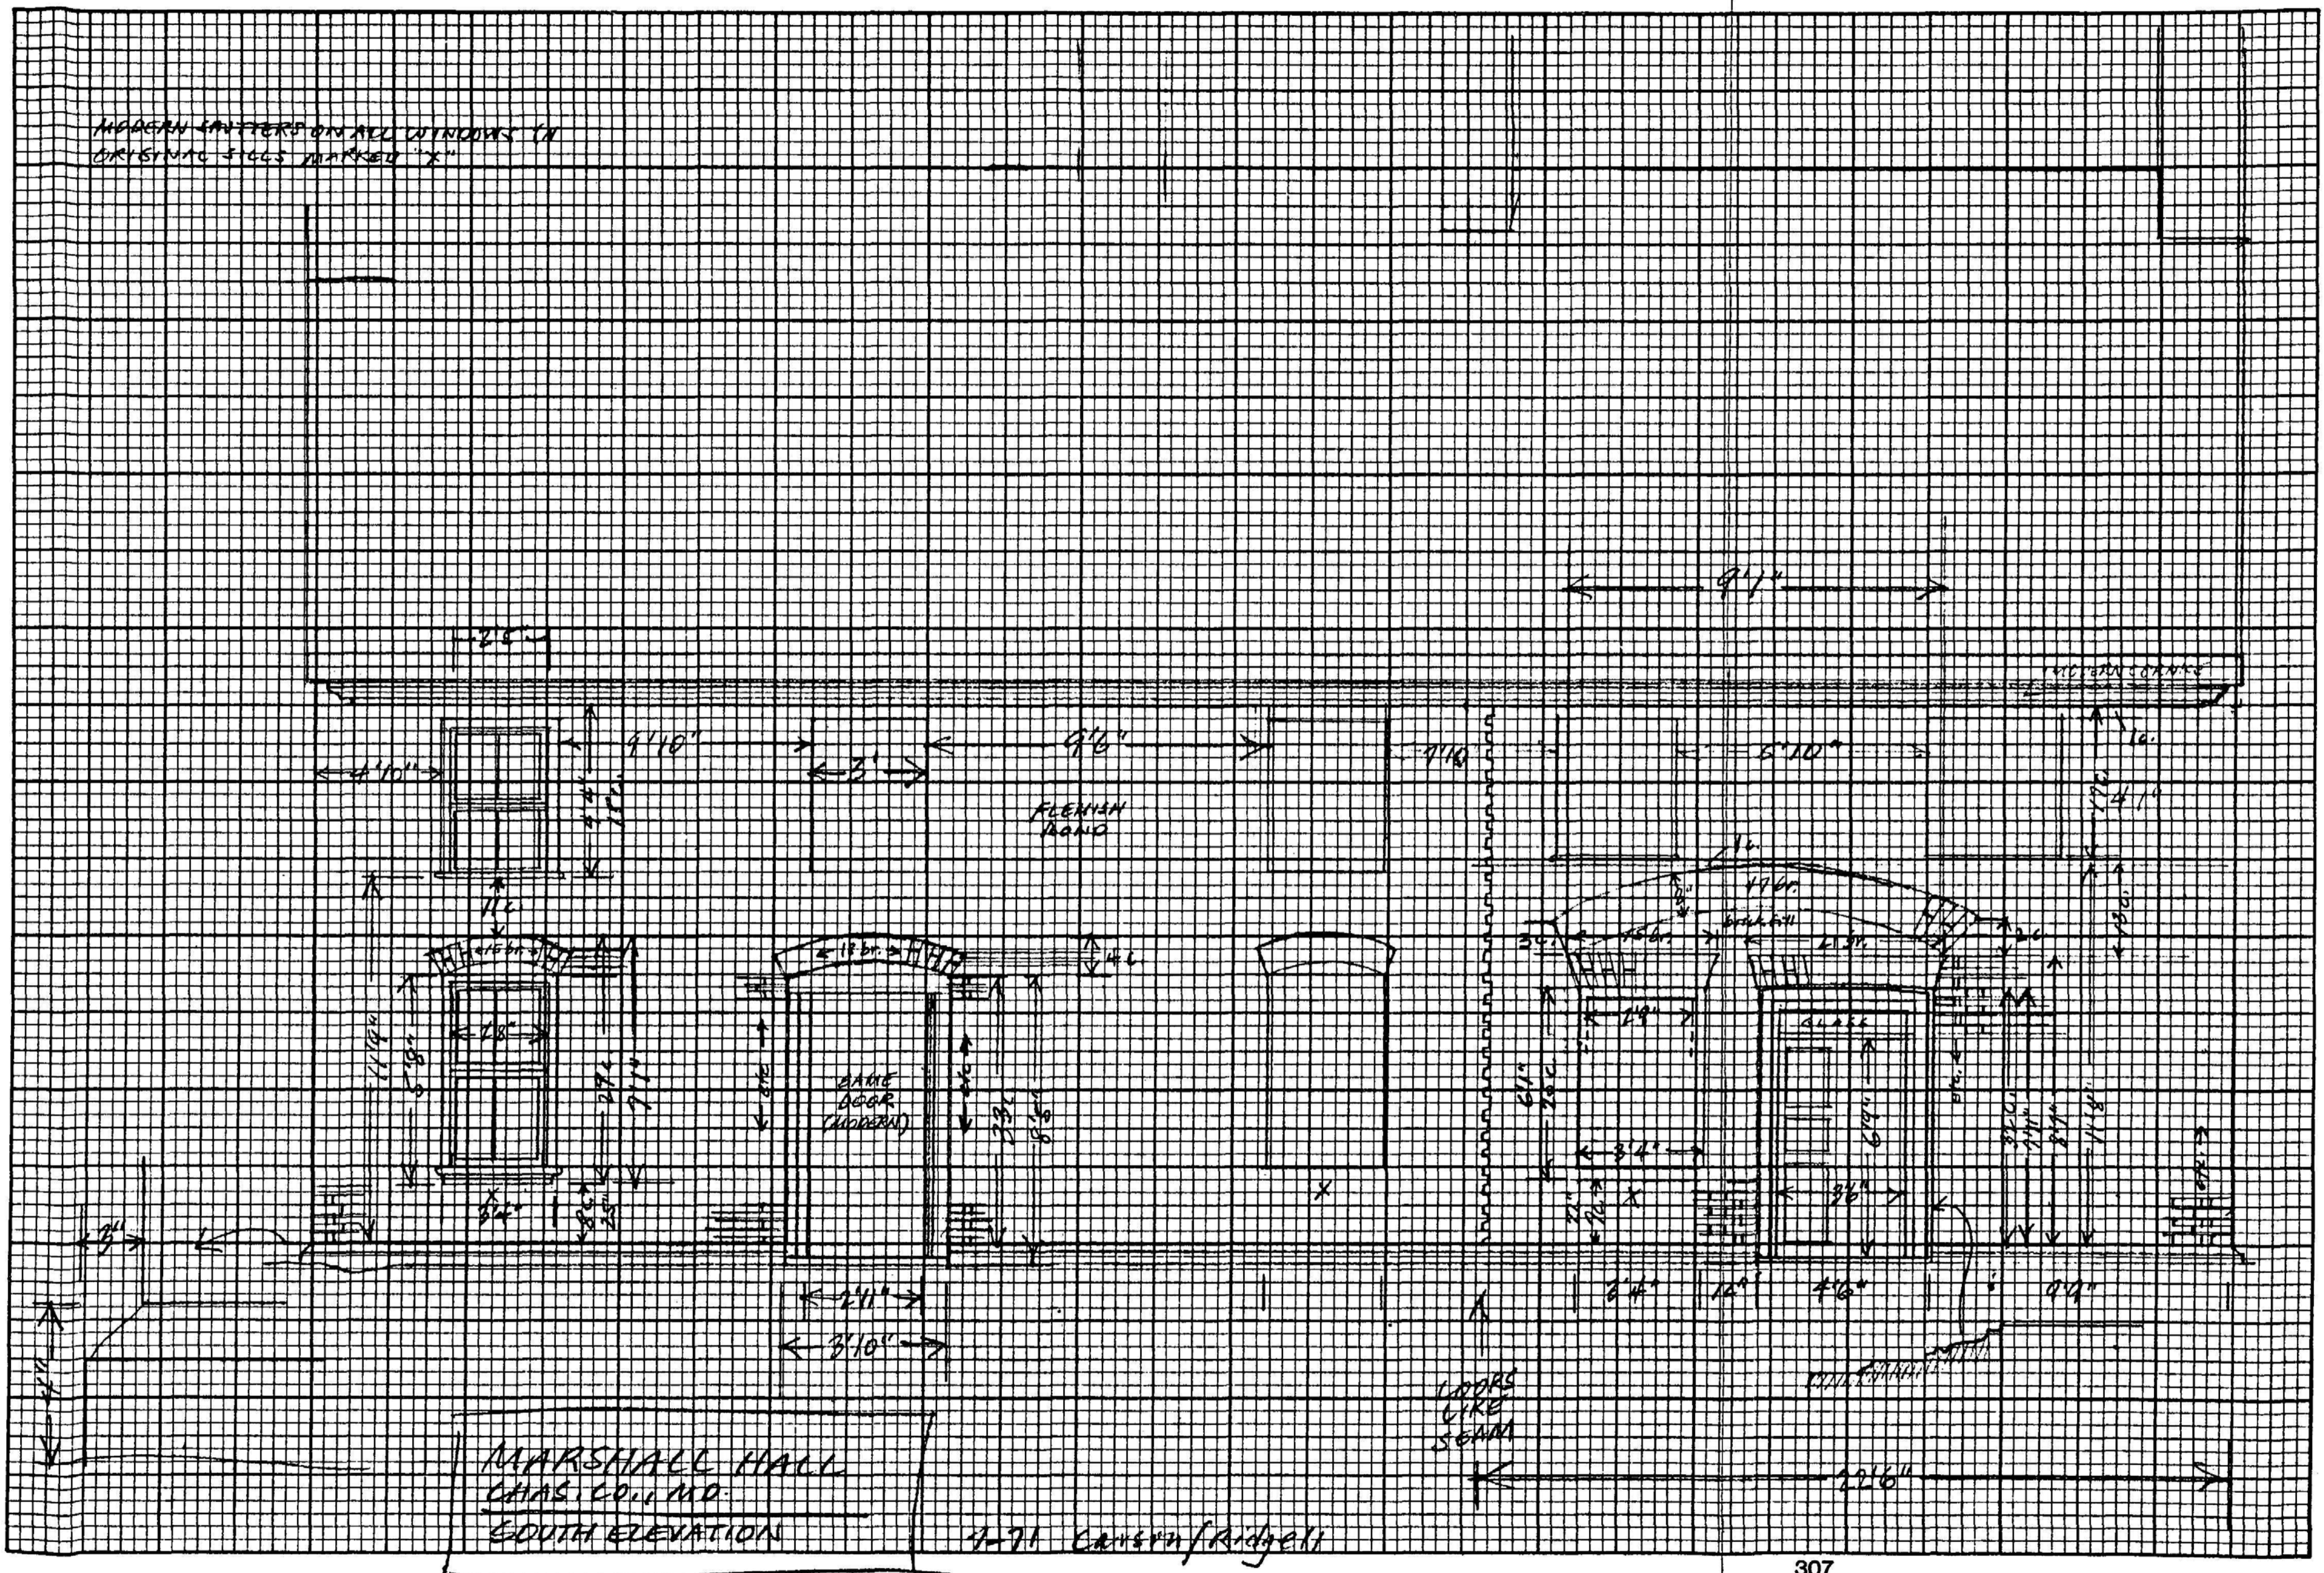
MARSHALL HALL
CHAS. CO., MD.
SOUTH ELEVATION

MODERN SHUTTERS ON ALL WINDOWS IN
ORIGINAL SILLS MARKED "X"

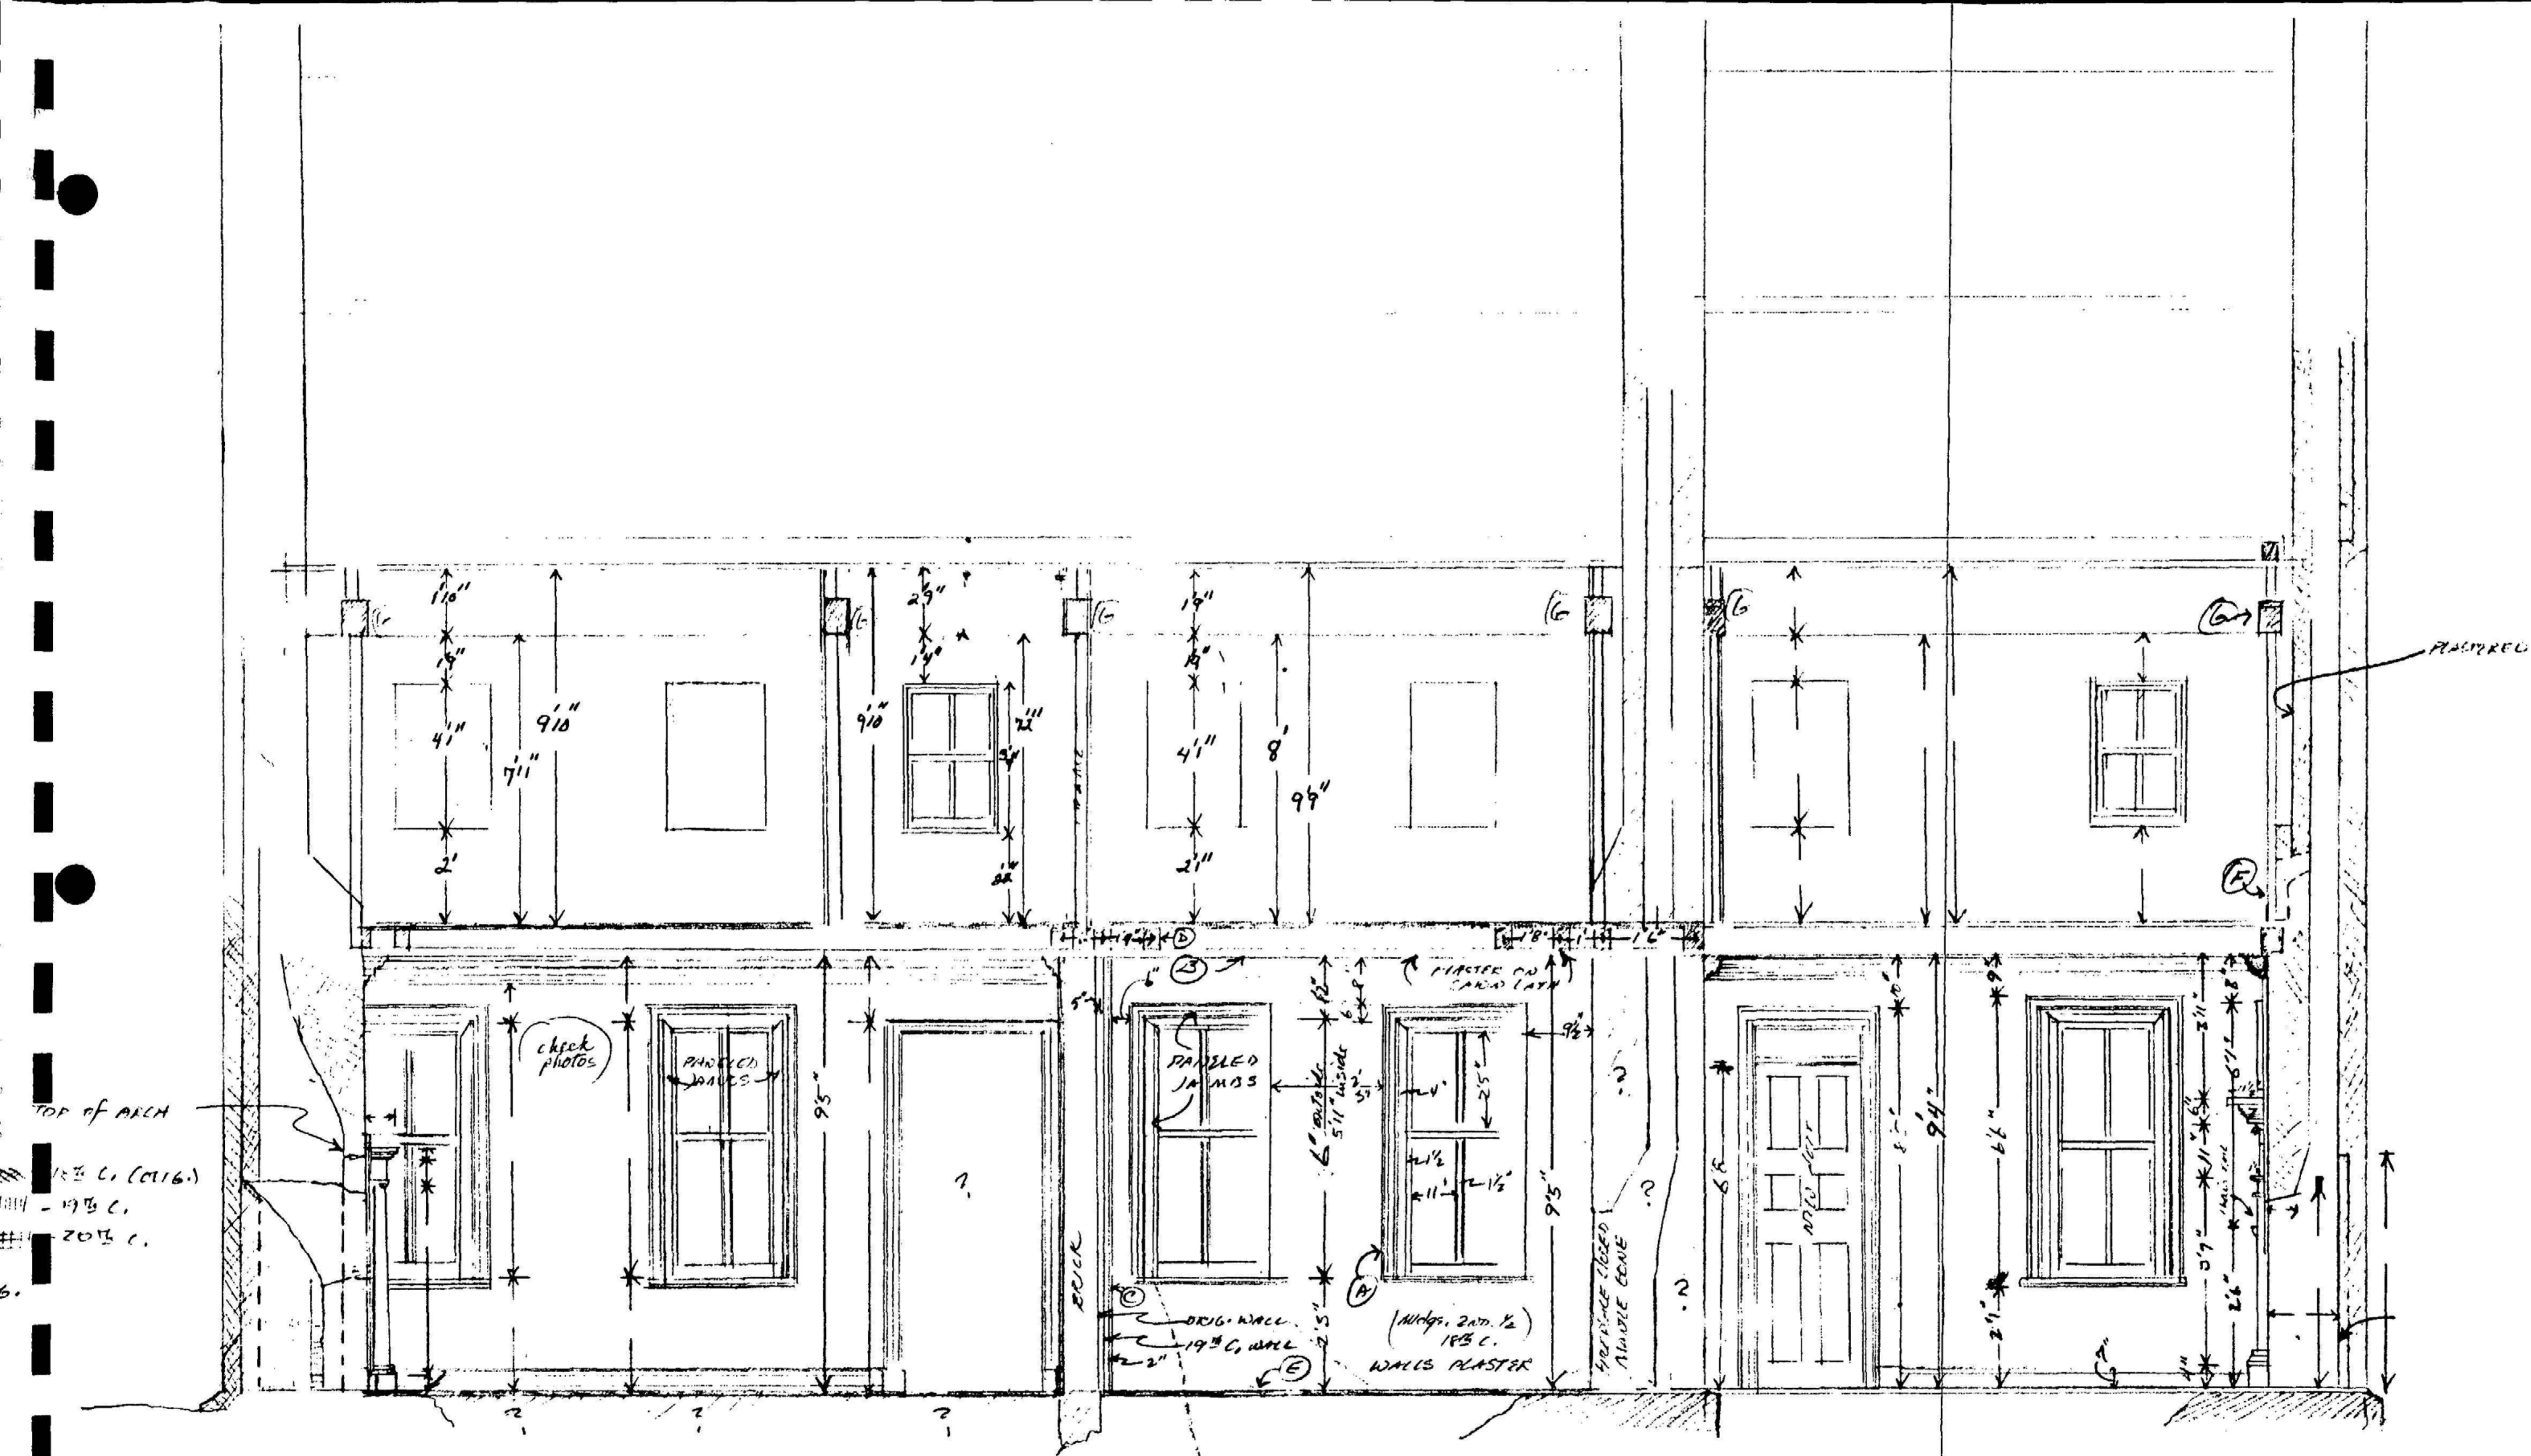
MARSHALL HALL
 Lat. Cross
 RIDING
 9/11

- (B) NO PLACE of CORNICE LEAVING BEEN IN THIS ROOM.
- (C) 2nd WALL - PLASTER, ROVEN LATH, CUT NAILS
- (D) JOIST - 5 1/2" x 4"
- (E) 17044. VRY. SM. FIREPLACE
- (G) JOIST SIDES PROJ INTO ROOM/HALL, ETC.
