historic structure report

architectural data section

SPRINGFIELD ARMORY

NATIONAL HISTORIC SITE/MASSACHUSETTS

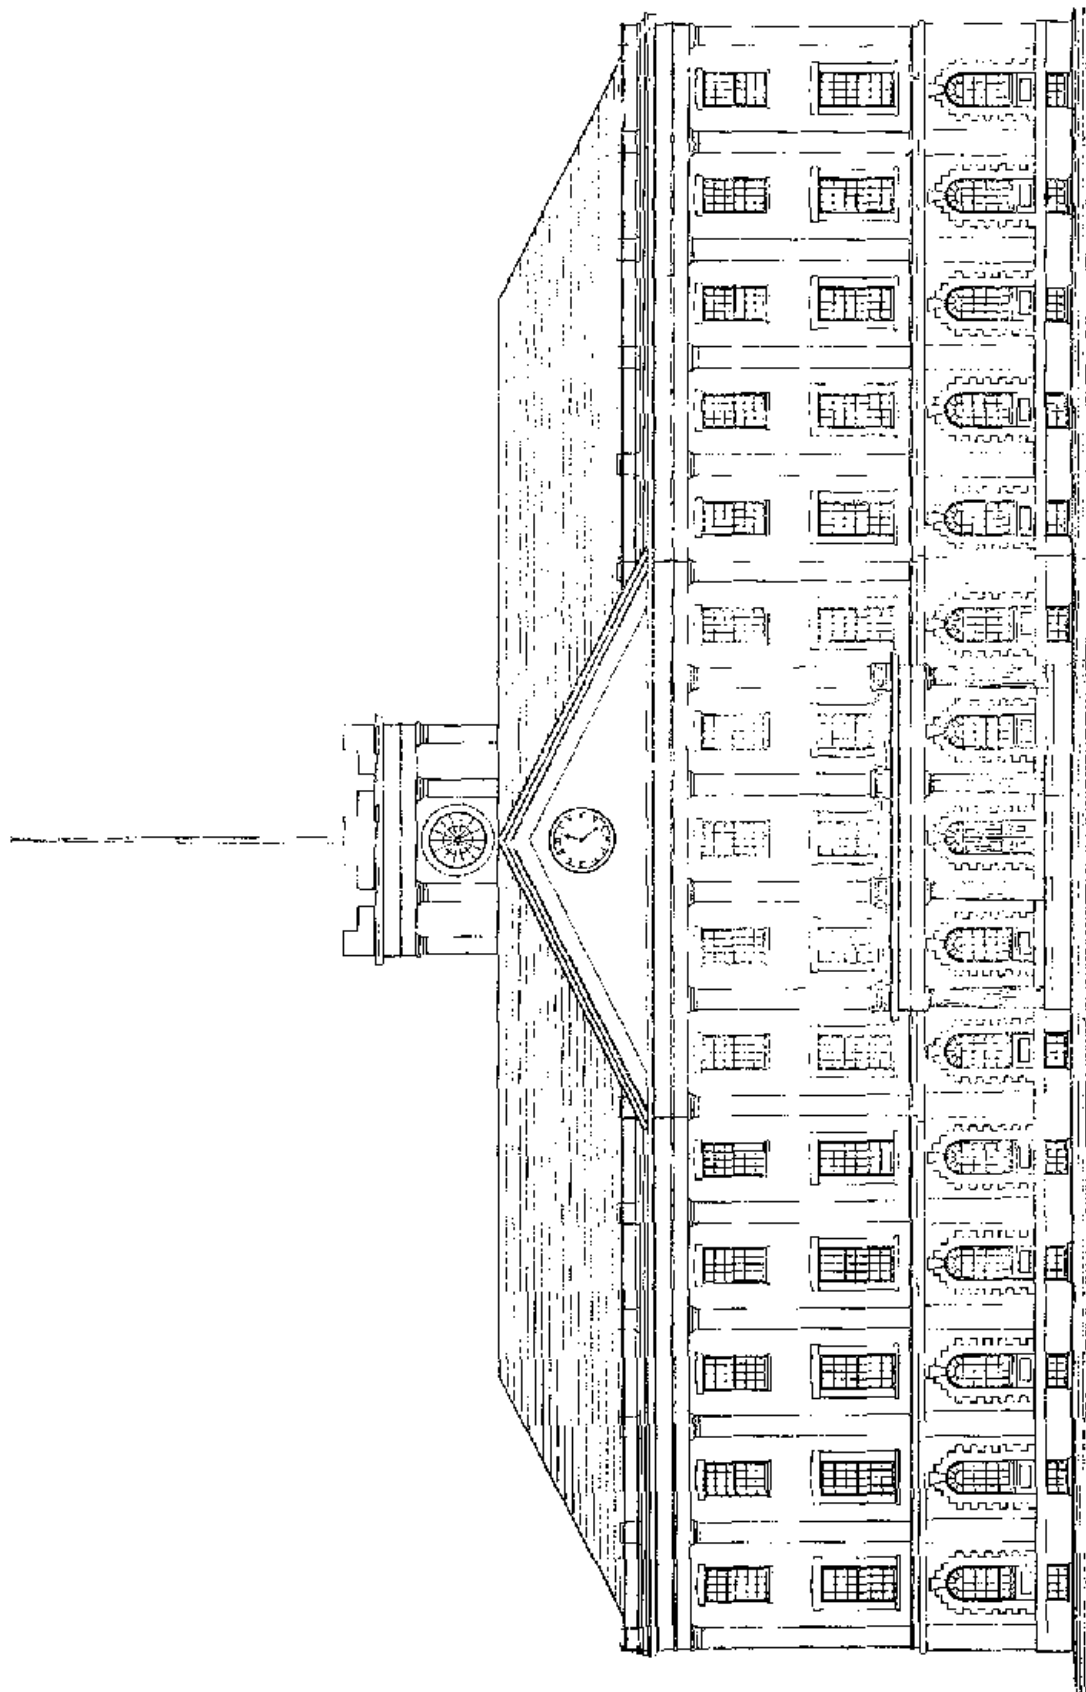
Illustration 3

Undated elevation drawings show details differing from those of the building. A portico is shown on the west side, for which physical evidence cannot be found.⁹ The third floor windows are shown with a pedimented lintel, whereas the actual lintels are flat. At second floor windows, the drawing shows the projecting brick jamb portions of the architrave starting at the window sill rather than at the stone stringcourse.¹⁰ Whether the drawing was done in error or was done prior to construction of the building is not known.

Arsenal, View from West, Note One-Story Doric Portico, apparently not constructed
U. S. Armory, Installation Facilities Office, NPS Park Files

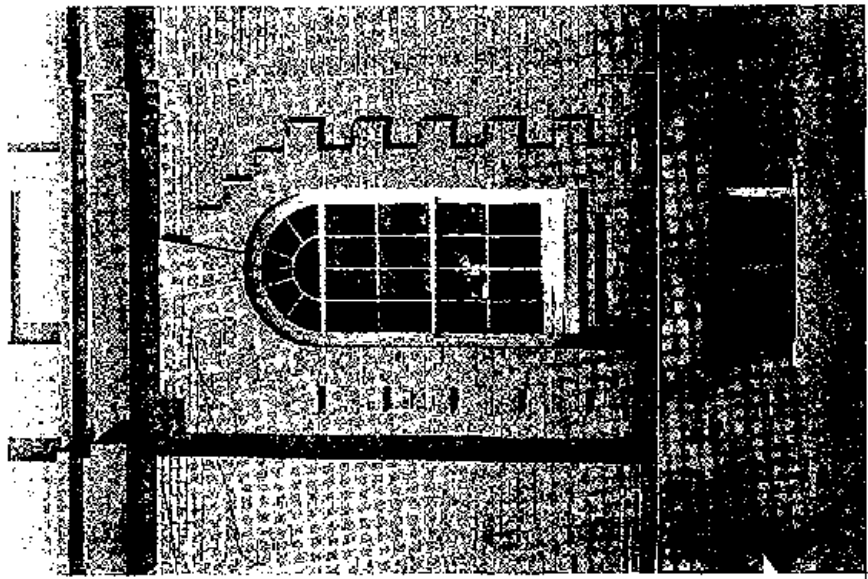
Illustration 20
Arsenal
First Floor Window (Typical)

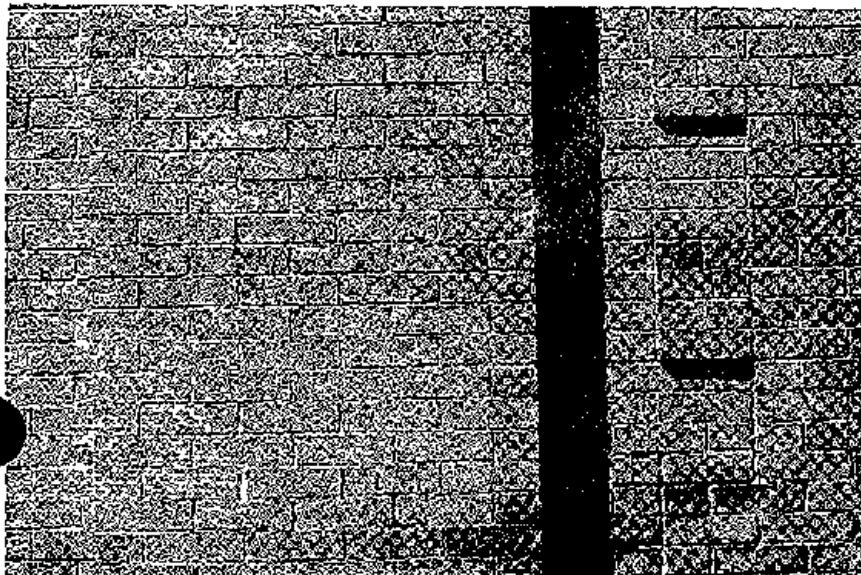
About 1937 the paint was removed by sandblasting.¹⁶ This removed the hard, protective surface of the brick, exposing voids within the material. Though the increased porosity should have made the brick much more susceptible to water penetration and damage, little evidence of increased deterioration can be noted. The sandblasting also removed the surface of the mortar joints. The joints were probably tooled flush to provide a smooth appearance when the walls were painted.

Illustration 23
Arsenal, Tower
East Side
Sandblasted Brick Surface

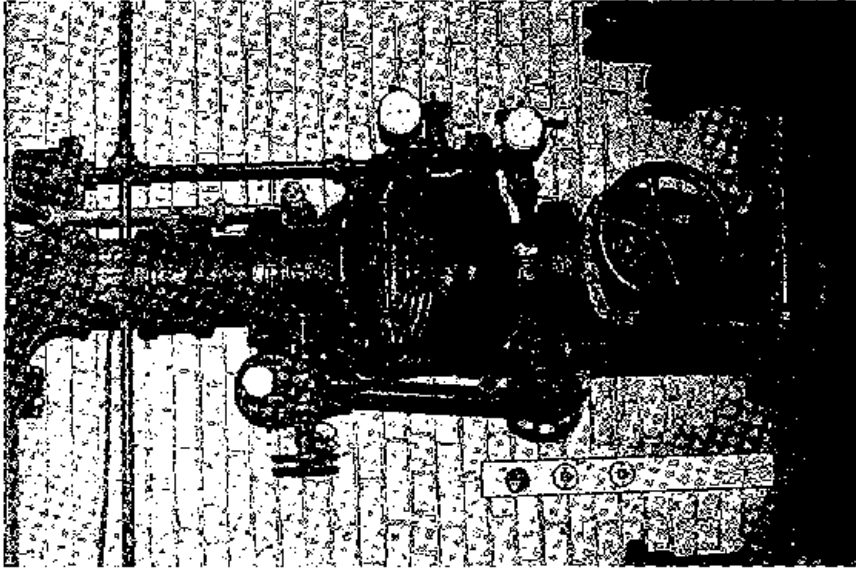
Illustration 31
Arsenal
Basement
Sprinkler System Piping
and Valves

The existing dry-pipe fire suppression system should be retained. Supplementary systems, perhaps Halon, may be desired in special functional areas, e.g., document storage. Retention of the existing system would require storage and display systems to provide protection of artifacts from water damage while maintaining fire suppression capability. Final suppression decisions will be made when final building use and space allocations are determined during preliminary design for the adaptive use of the structure.

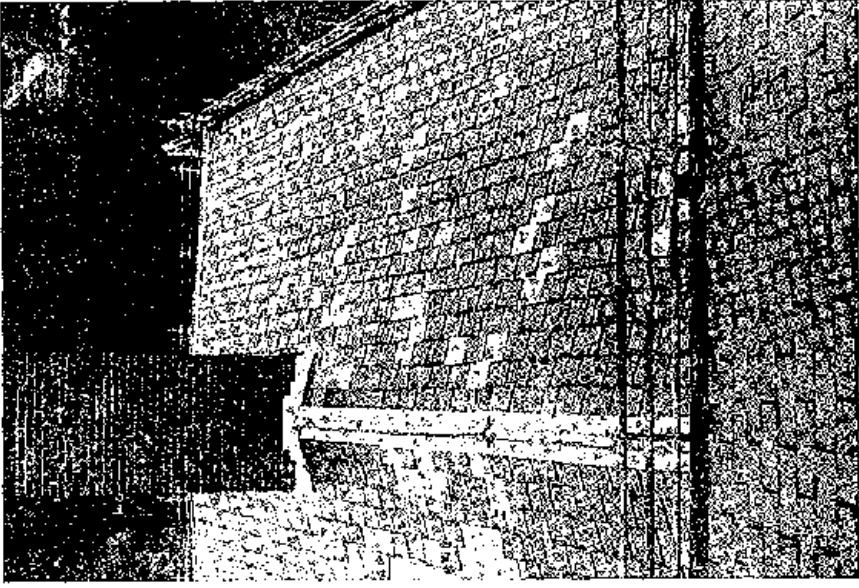
Illustration 73
C. O.'s House
Wing Roof from Main House
Note: Light-colored slates
indicate repairs

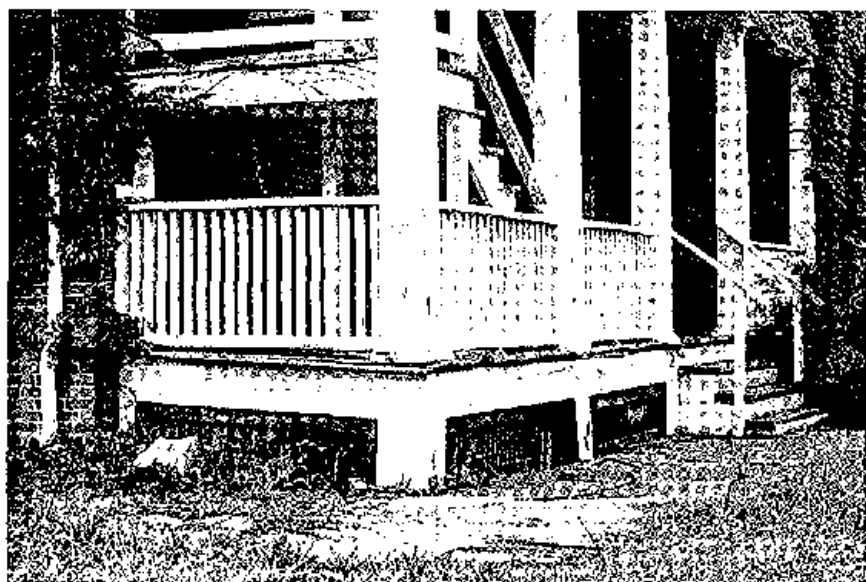
Illustration 107
Building 10
Northeast Porch

Although a later addition, the second floor portion of the side porch was constructed with the same post and railing detailing as the original. The roof line of the original porch can be seen along the brick walls of the house. The stair between first and second levels is of later, simpler detailing and could have been added later than the second level of the porch. Additional evidence of this is seen on the brick wall at the stair opening. The original ceiling and roof lines can be seen and between these a paint stain at the later second floor line. Lack of maintenance has brought about deterioration of the porch.

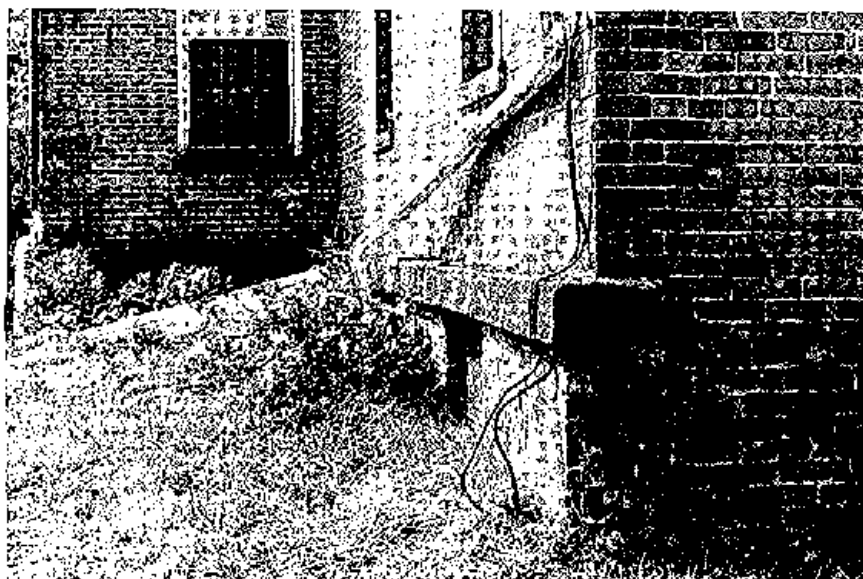
Illustration 108
Building 10
Water Table, Southeast Corner

Some downspouts on the north side of the house are missing, others are deteriorated. These conditions cause flooding of the walls with water or splash onto the top of the stone water table, resulting in mortar erosion and the walls being penetrated with moisture.

Above the stone water table, the original brickwork of the walls is in good condition, even though the hard smooth surface was removed when the building was sandblasted to remove the paint. This paint removal was probably done during the 1930s, possibly earlier. The sandblasting greatly increased the permeability of the brick walls, although they have withstood at least 40 years of weathering remarkably well.

Replace existing and missing copper downspouts.

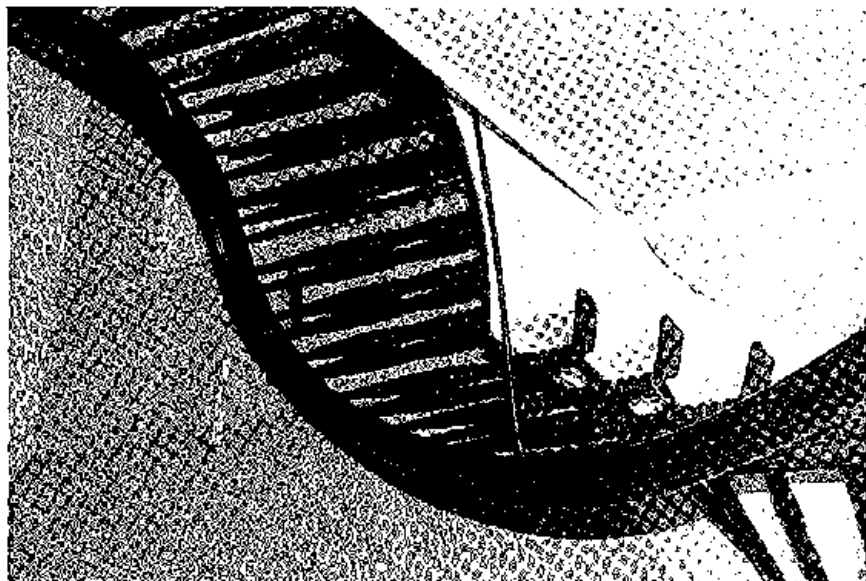
Illustration 112
Building 10
Main Stair

The original stairway to the second floor changes from a straight run to a quarter circle turn at the upper end.¹⁵ The beautifully curved wood handrail, the turned wood balusters, and the wood newel post are in good condition.

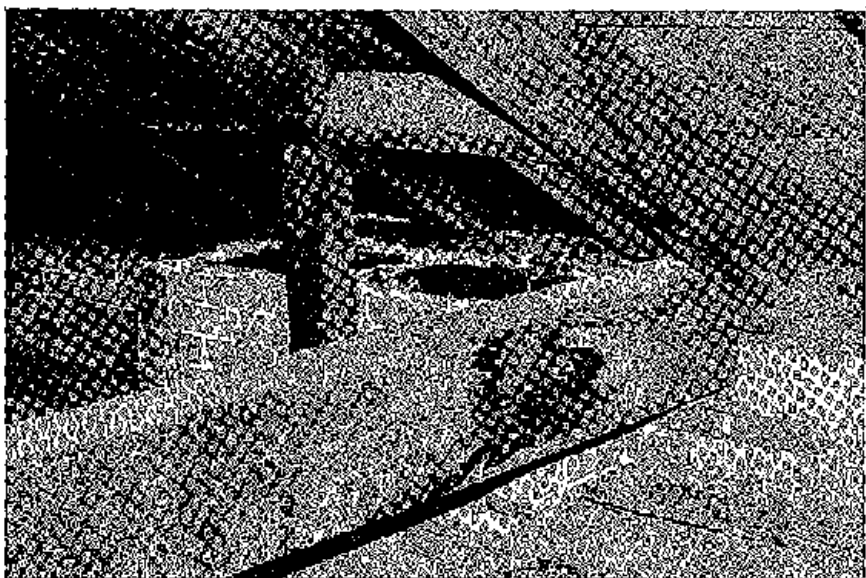
Illustration 113
Building 10
Attic Framing

The roof framing is in good condition, however, the knee braces at the center of the main roof were removed.

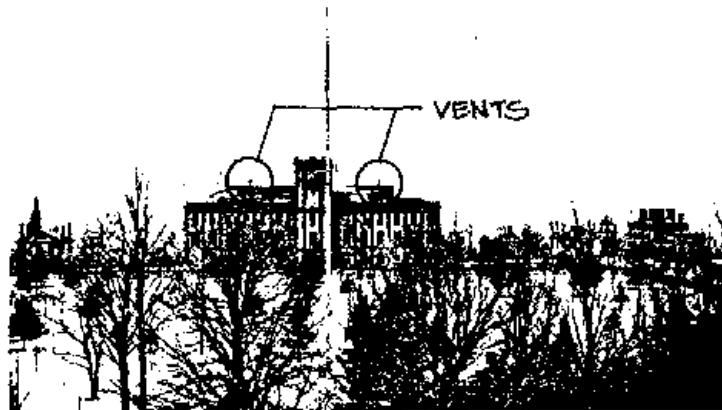
Figure 9: Main Arsenal, ca. 1880. Note location of roof vents. (Photo from the Historic Structure Report, historical data/base map, p. 69, courtesy of the Springfield City Library.)

exterior historic appearance, accomodation of a chimney or vent presents a design problem. Roof vents could be located as shown in the 1880 photo (Figure 9). Combustion air supply would be obtained through louvers installed in an existing basement window.

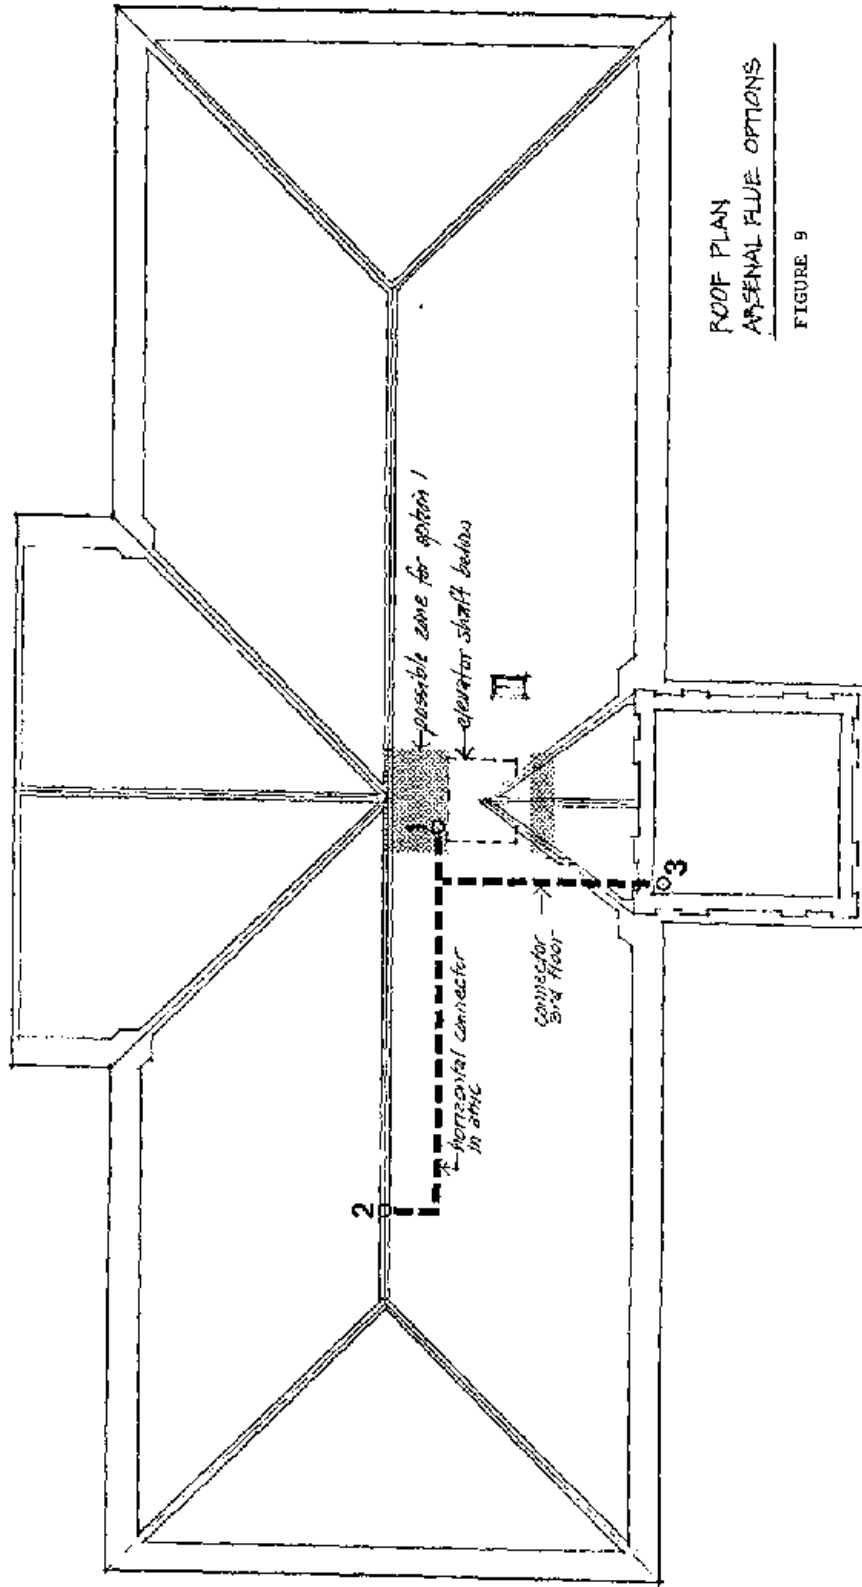
FIGURE 9

ROOF PLAN
 ARSENAL FLUE OPTIONS

Above the third floor there are three possible ways to route the chimney to minimize its visual impact (Figs. 9, 10, 11, 12). The flue could emerge through the roof behind the clock tower, where it would be hidden from front and rear and only be marginally visible when viewed from the side (option 1). An alternative vent location was identified in the Building Systems Analysis. An old photo, ca 1880, shows that at that time the Arsenal had a pair of vents penetrating the ridge line. The flue could be shunted over within the attic to emerge at location 2, reproducing a vent. The exact location of the vents can be identified by a patch in the roof sheathing and a gap in the ridge beam. The second pipe would be reproduced for symmetry, and could eventually serve some other purpose, such as toilet exhaust.

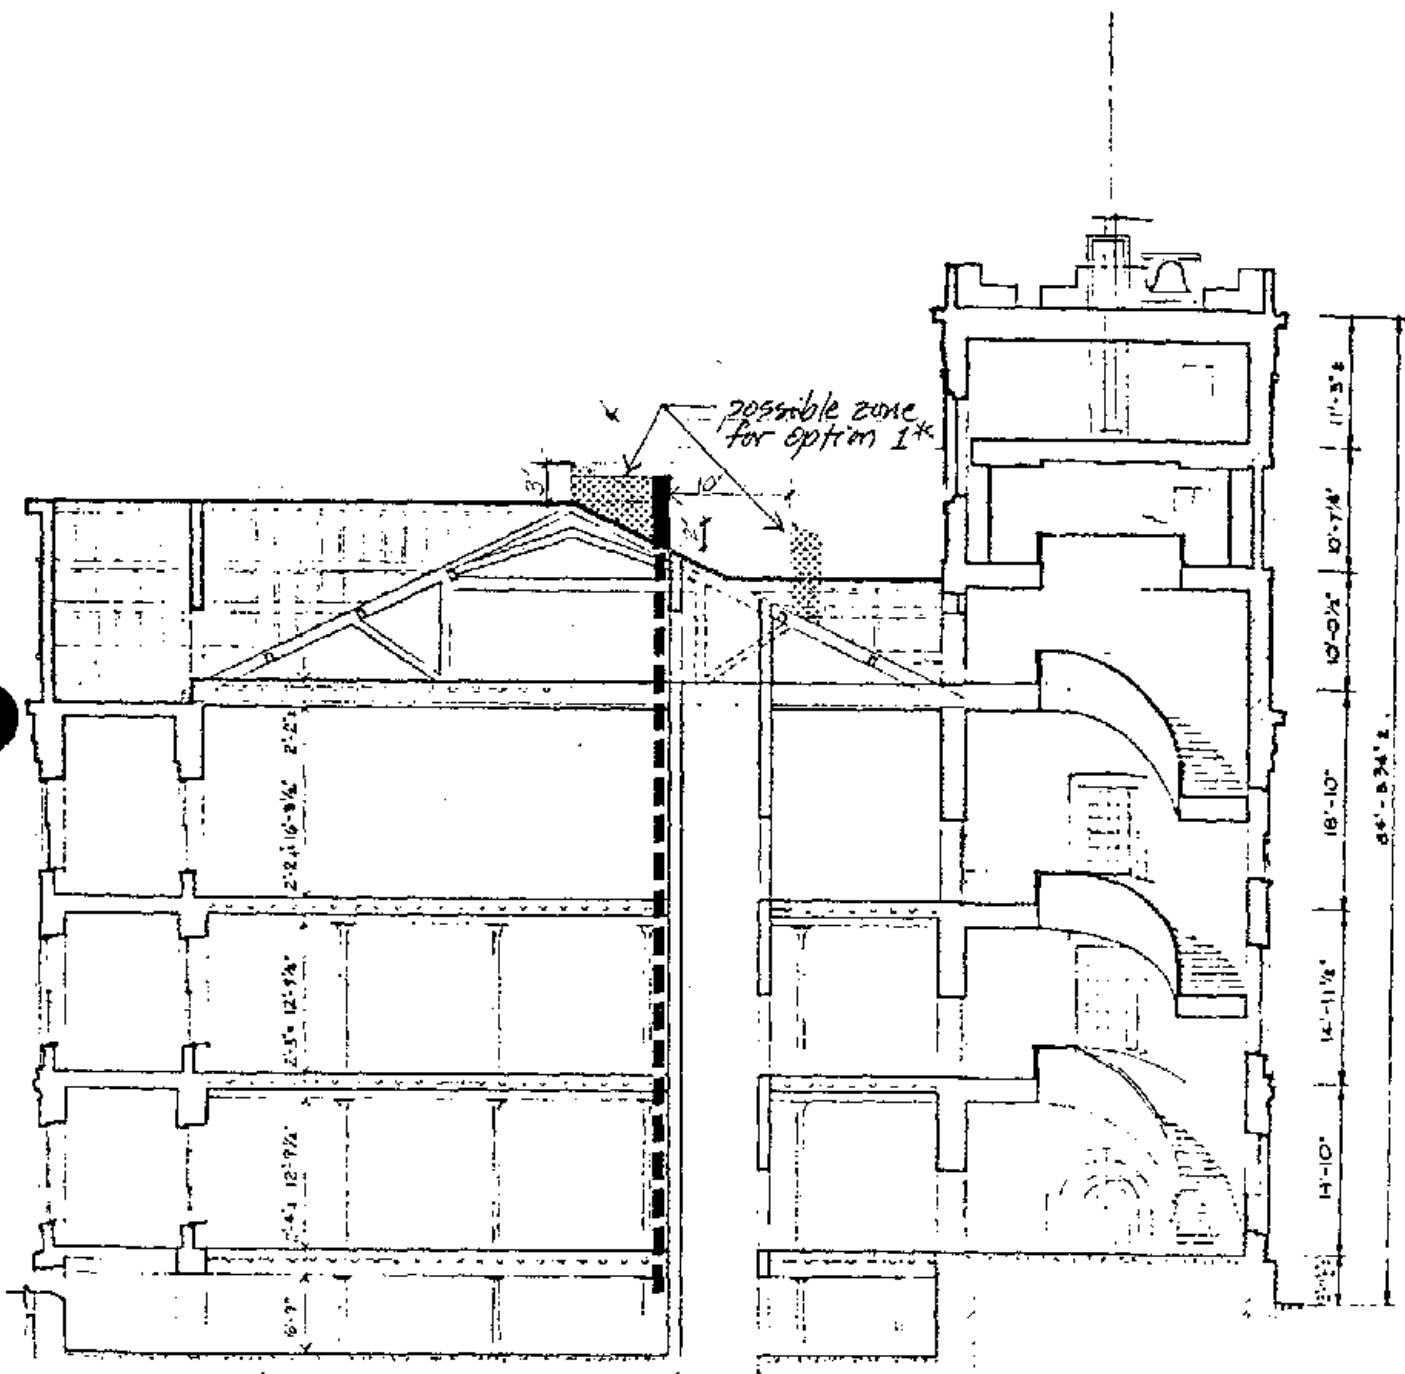
FIGURE 10

*chimney must be at least 3' high and 2' higher than any roof within 10'

ARSENAL SECTION
FLUE OPTION 1

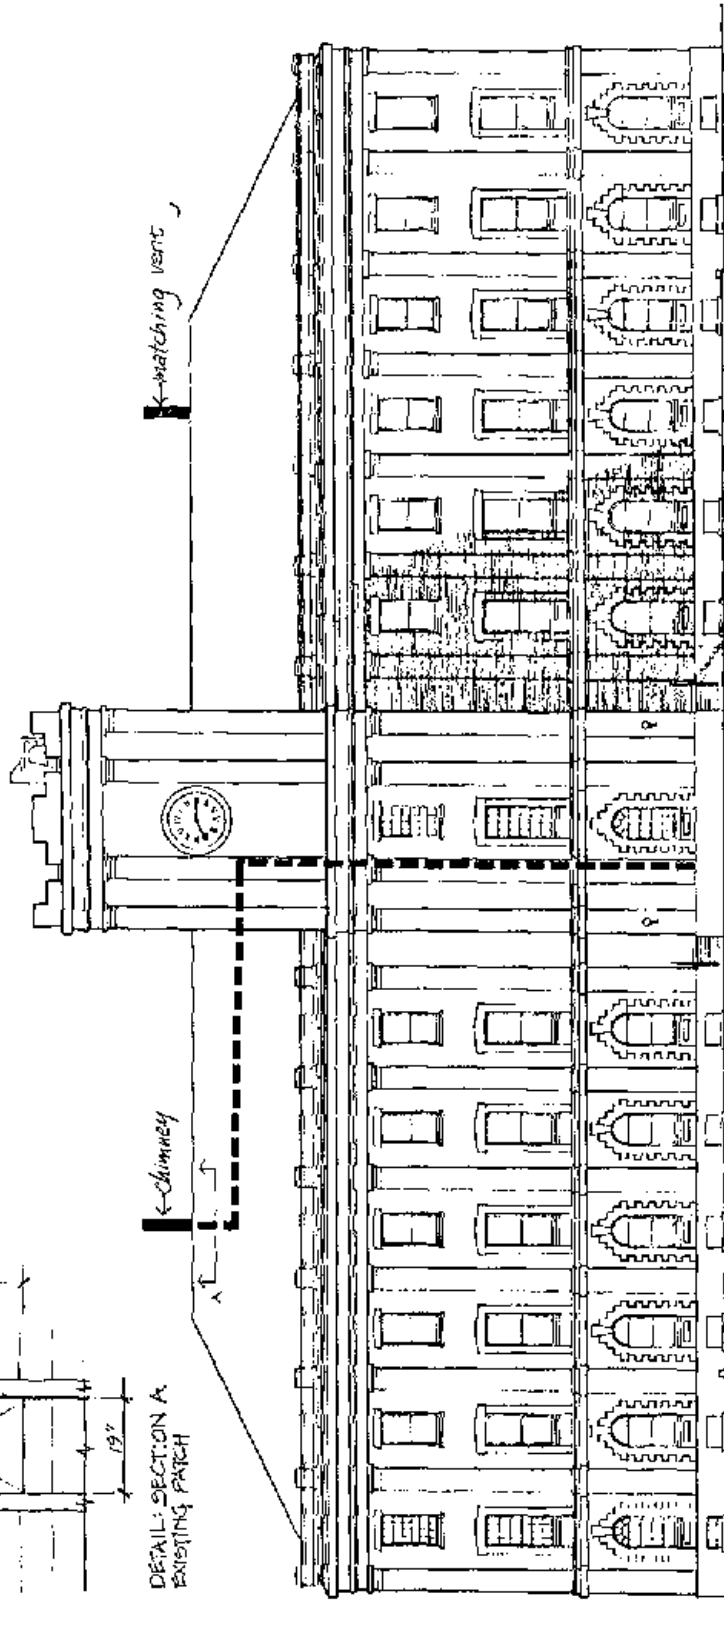
FIGURE 11

ARSENAL FRONT ELEVATION
FLUE OPTION 2

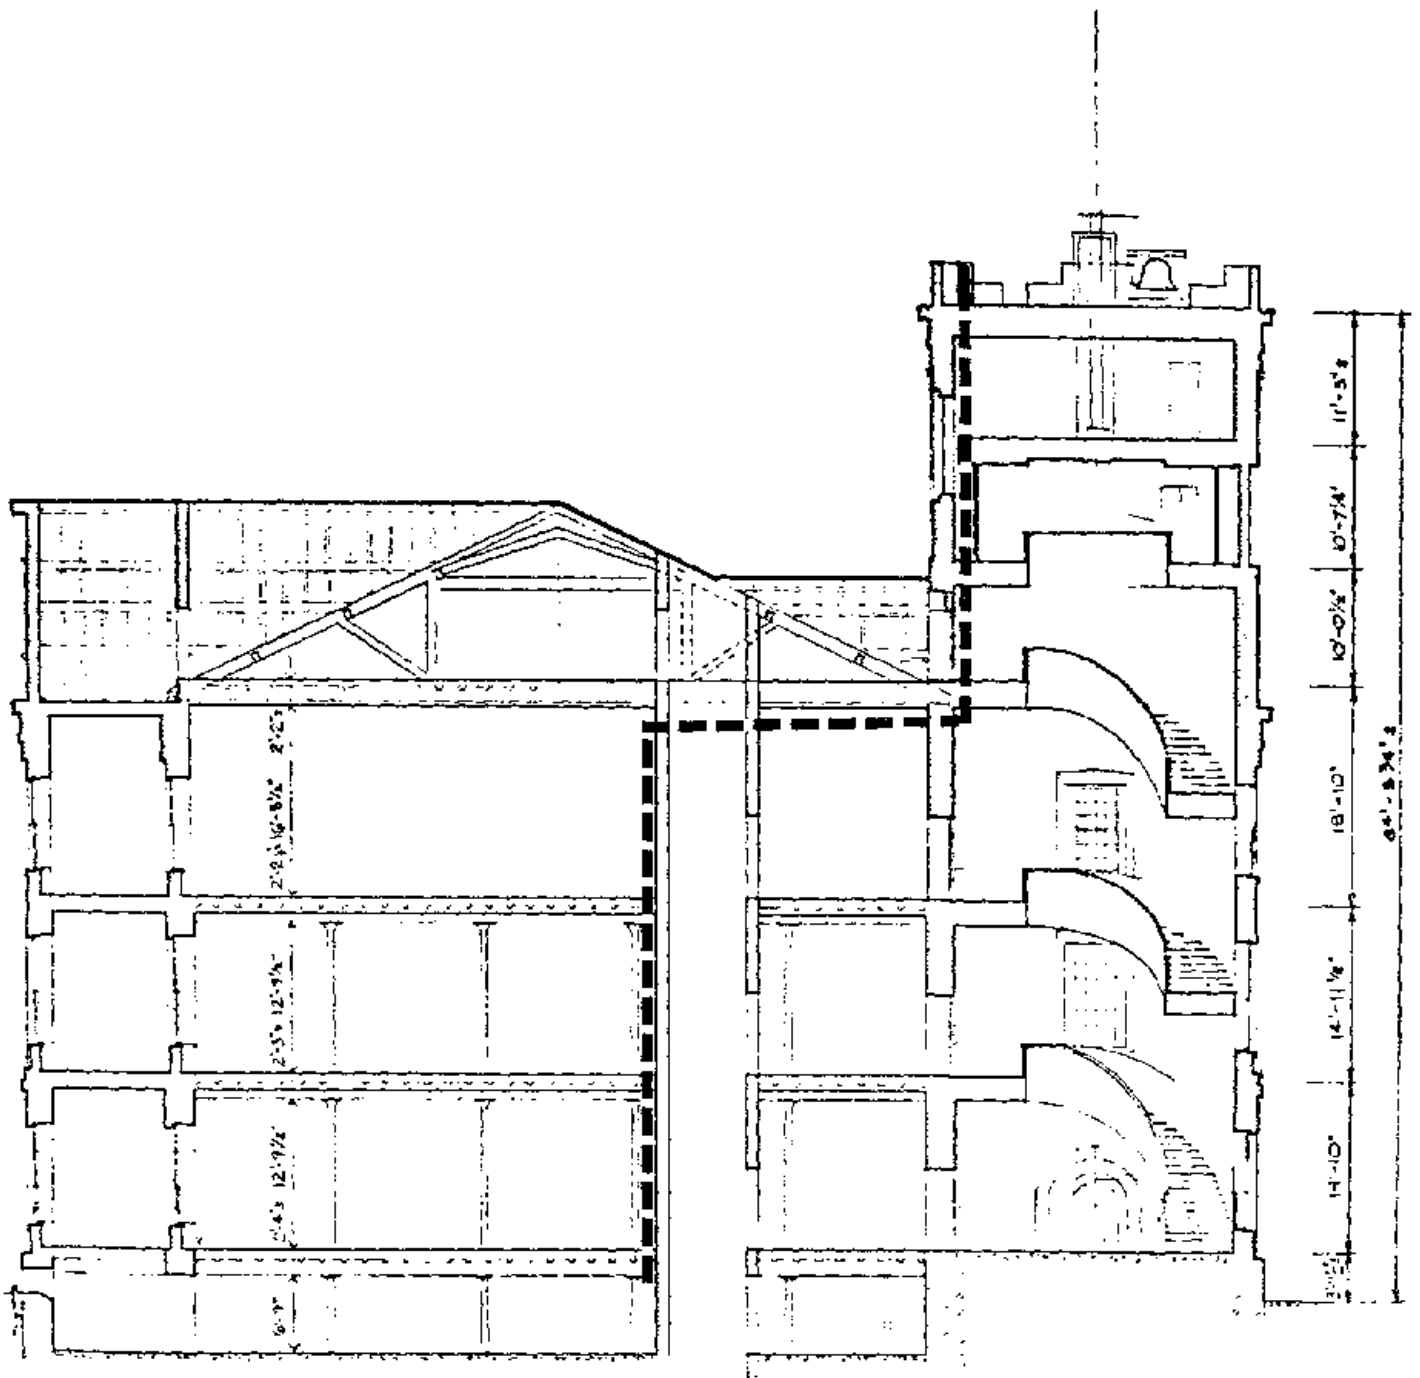
FIGURE 12

ARSENAL SECTION
FLUE OPTION 3

A third possibility is to carry the flue to the tower and have it emerge at the southeast corner of the tower roof (option 3). The roof framing makes this very difficult to do within the attic, but it could be done simply below the third floor ceiling. Option 3 requires breaching the masonry tower wall with a hole big enough to pass a 20" diameter pipe and cutting holes in two additional (tower) floors.

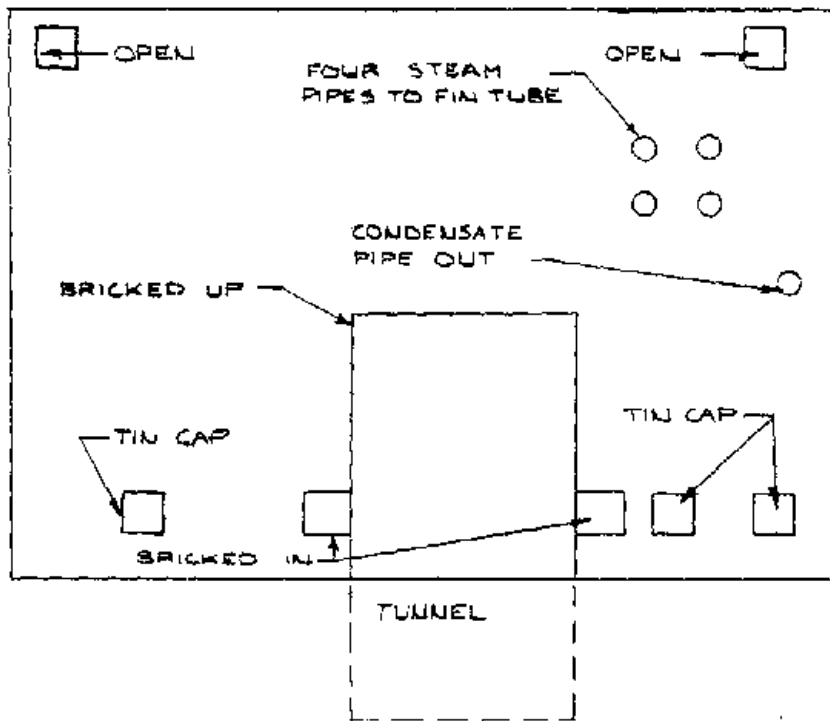
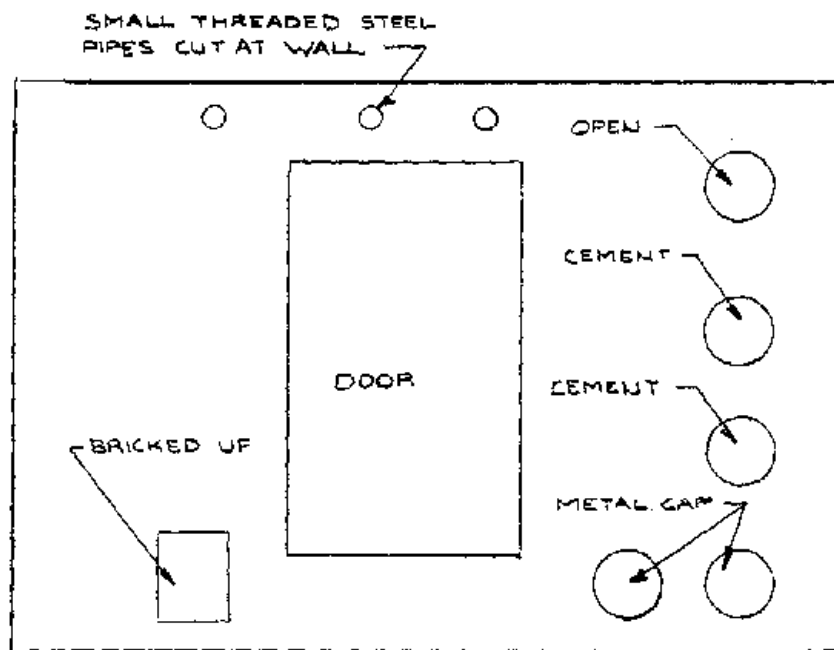
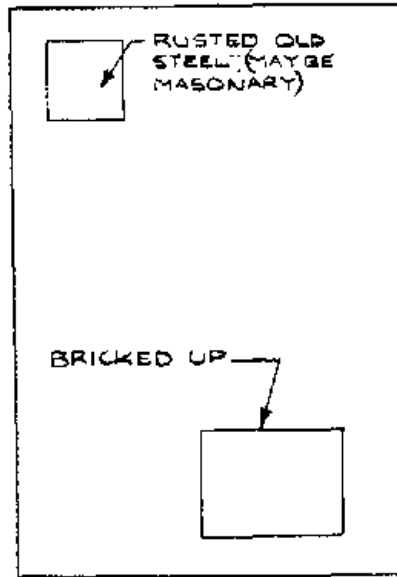
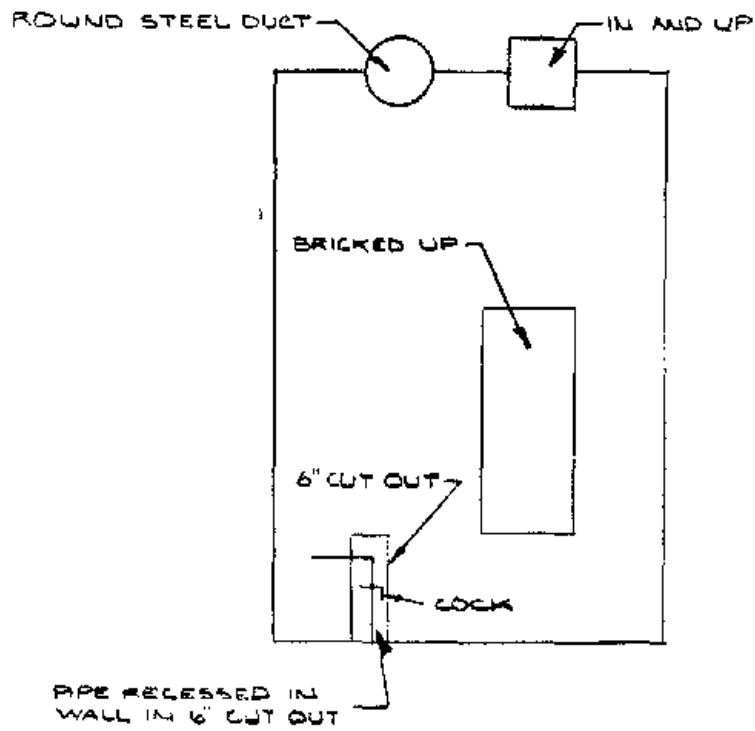
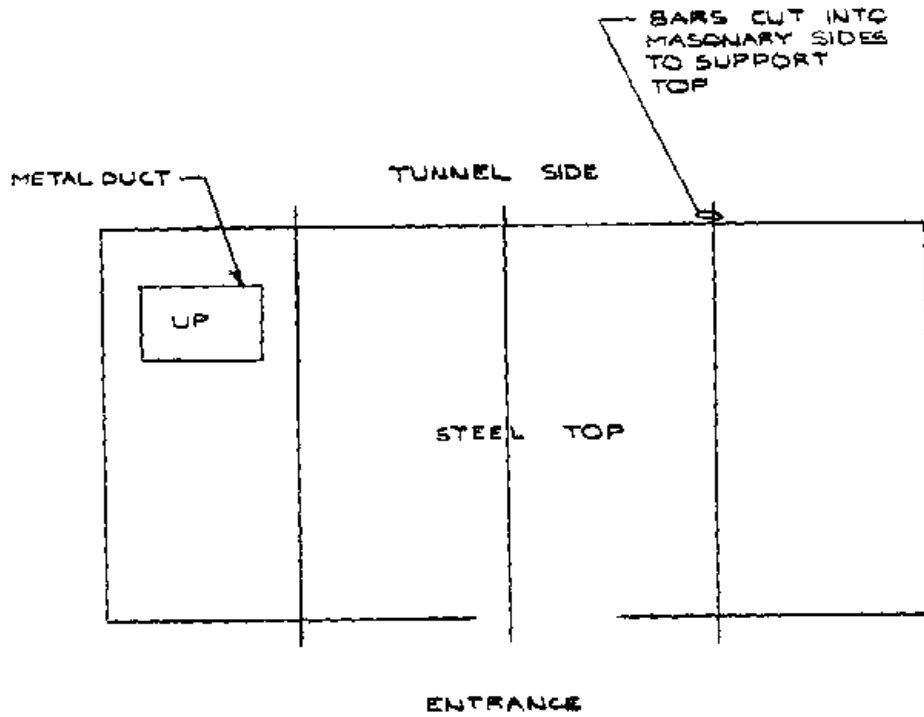
Details of the unique south heating chamber are shown in Figures 8-13.

This chamber has a total of 19 flue openings, twelve of which are capped or bricked over. Only one opening (still in use) exists in the top plate; the remainder are in the walls of the chamber. Some of these openings are low in the walls of the chamber and therefore useless for gravity heating. The purpose of these openings is still uncertain. It can be conjectured that these formed part of a return system, discussed later.
