100% SUBMITTAL
November, 1995

HISTORIC STRUCTURES REPORT

LACKAWANNA HERITAGE VALLEY TROLLEY MUSEUM

Silk Mill Building
Steamtown National Historic Site

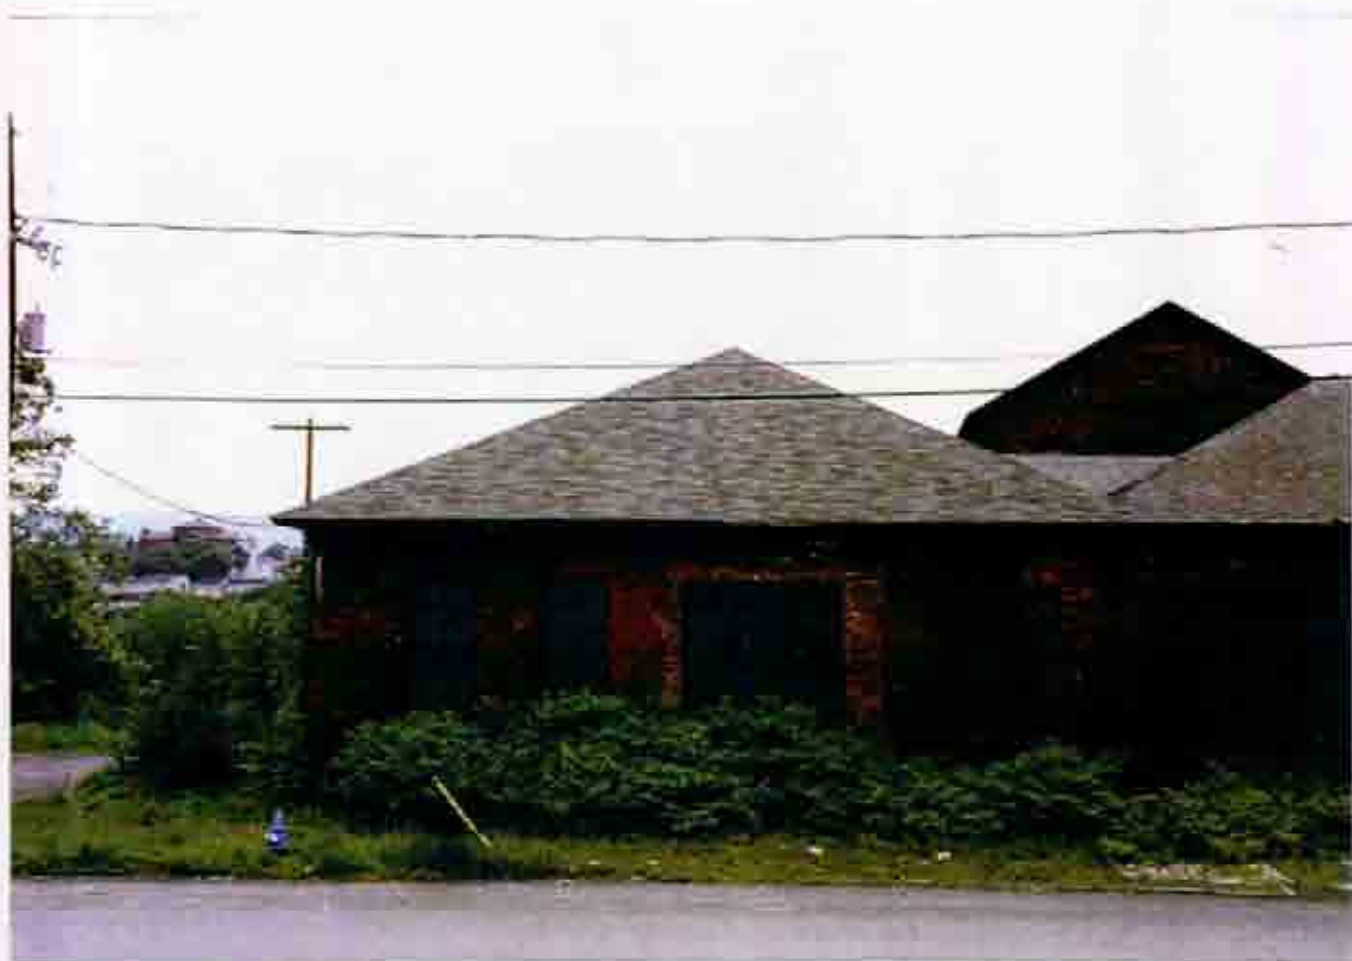
Figure 3.2

The west and east sides of the parapet wall between the eastern two story area of Bay 4 and its western 1-1/2 story area are in poor condition with severe joint deterioration and spalling, broken and missing brick. The top of the parapet wall is a rowlock brick coping showing minor signs of deterioration. See Figures 3.2, 3.8 and 3.14.

Detail of brick parapet on Pattern Shop; note that there are no butt joints or lines of demarcation to suggest anything other than that the building was originally constructed in this configuration.

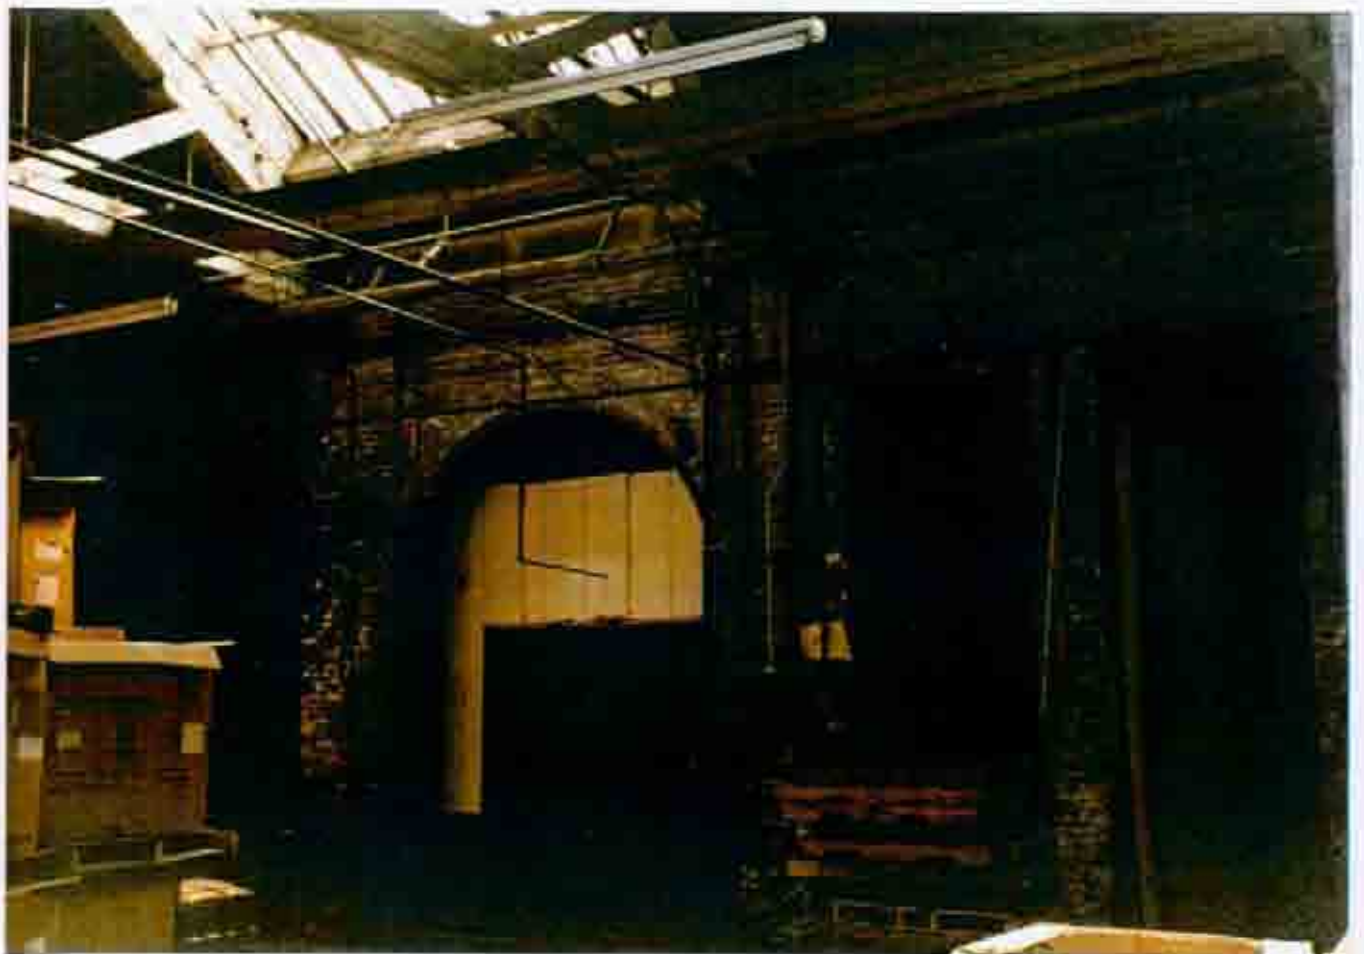
Figure 3.3

Curiously, the second floor masonry openings of Bays 2 and 4 contain wood double hung windows, which suggests that the steel windows of the first floor are later alterations. See Figure 3.14. The flat arch head types appear in the perimeter walls of Bays 1, 2 and 4, while the flat head type are confined to east elevation of Bays 2 and 3 where clear signs that the original flat arch masonry openings were changed to accommodate flat head window units are visible. The east elevations of Bays 1 and 2 contain later alterations, but with a slight variation - two/three flat head steel units tied together with steel mullions to form larger masonry openings. See Figure 3.3. The units in the masonry openings along the south, west and north

Detail of east elevation of Machine Shop (Bay 1), showing original large door opening that has since been partially closed in.

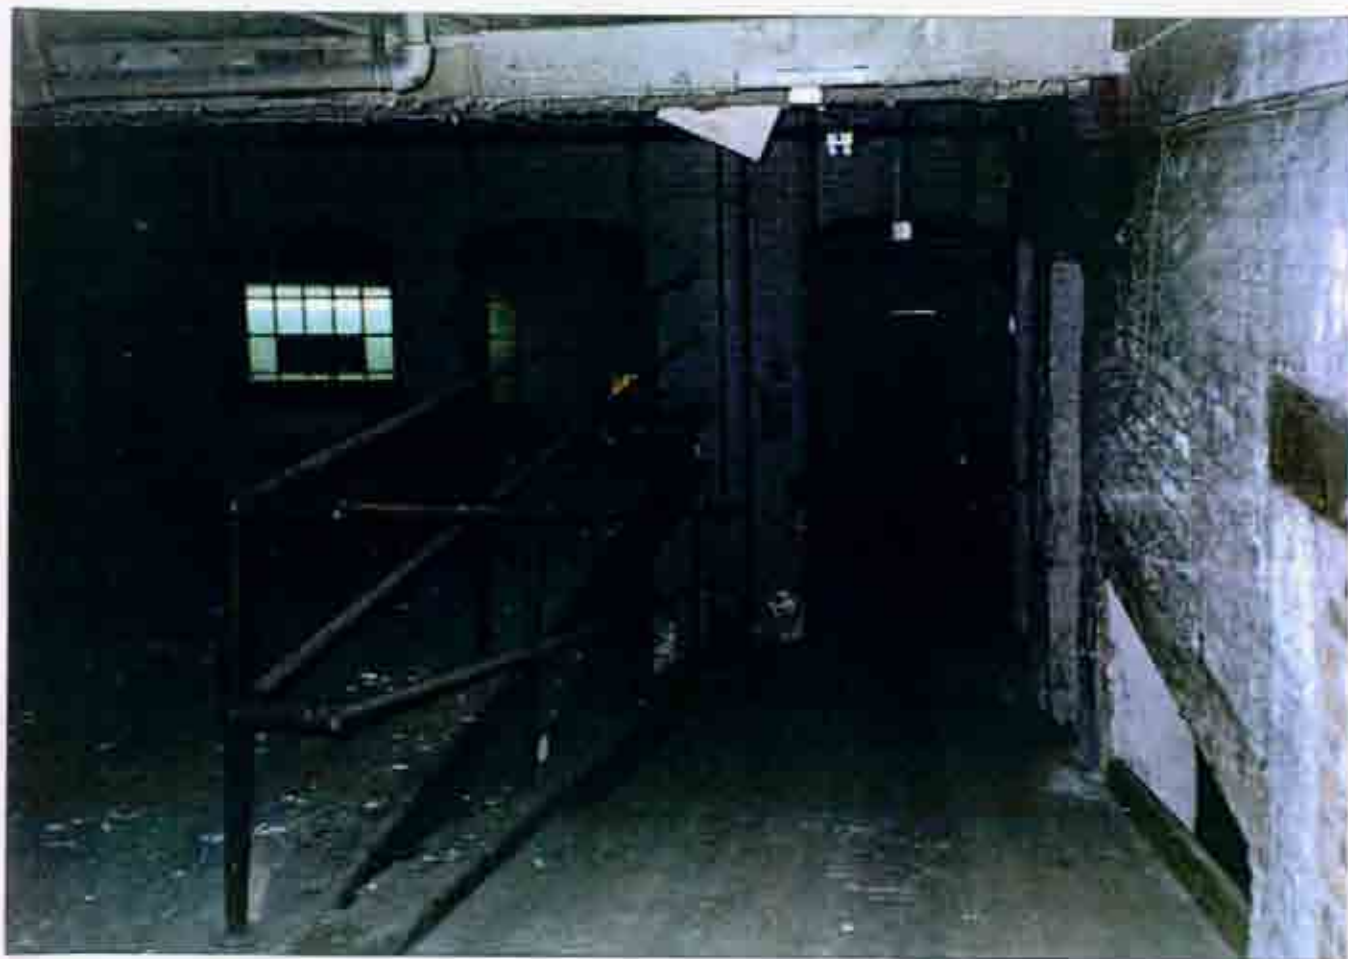
Figure 3.16

A mezzanine level at 9'-10" above first floor level was added inside the structure in Bays 1 and 2. This framing is composed of 3x12 wood joists at 16" centers spanning to steel beams. These beams are supported by wood posts, independent of the brick columns supporting the roof trusses above. See Figure 3.16. A ramp up to this level starts in Bay 3 and finishes in Bay 2. See Figure 3.17.

Detail of the mezzanine installed in Bay 1; this view looks north at windows that once looked out toward Bay 4, but were closed in when Bay 2 was added.
