VICKSBURG NATIONAL MILITARY PARK
SHIRLEY HOUSE

HISTORIC STRUCTURE REPORT

2004
Historic Structure Report
SHIRLEY HOUSE
Vicksburg National Military Park
Vicksburg, Mississippi
LCS#: 001362

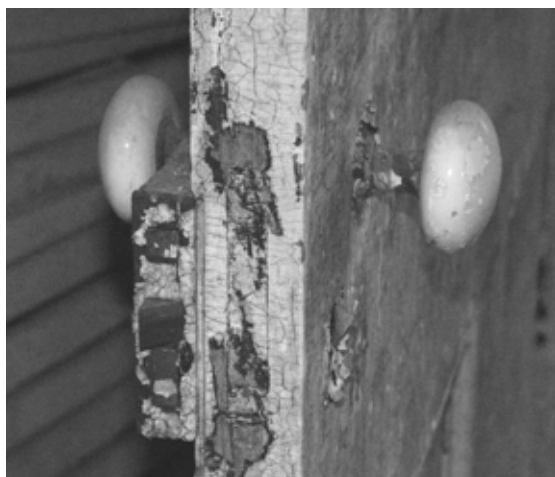
Figure 47 View of typical original rim lock and porcelain knobs. NPS SERO 2001

Hardware: A few of the original door hinges, rim locks, and door knobs remain in the building, but most have been lost. Typically, white porcelain knobs would have been used at primary doors while dark mineral knobs would have been used at closets and other secondary locations. Metal knobs characterize the hardware that replaced missing elements in 1902.
