CAPE LOOKOUT NATIONAL SEASHORE
GUTHRIE- OGILVIE HOUSE

HISTORIC STRUCTURE REPORT

**Historical Architecture, Cultural Resources Division
Southeast Regional Office
National Park Service**

2004

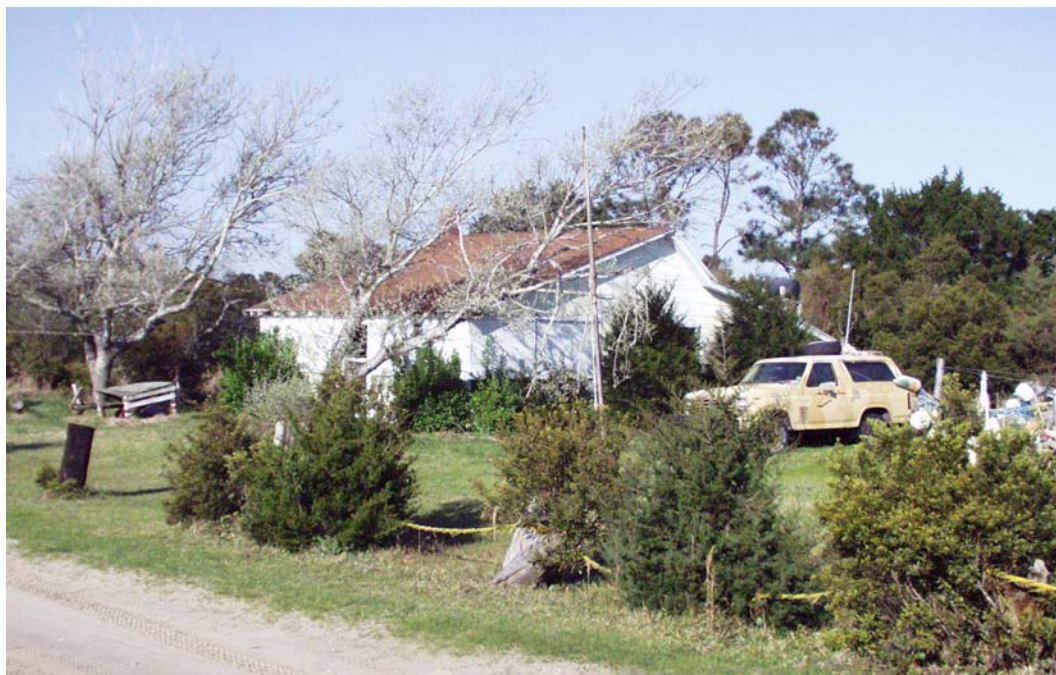
Figure 15 View to west of Guthrie-Ogilvie House. (NPS-SERO-CR, 2003)

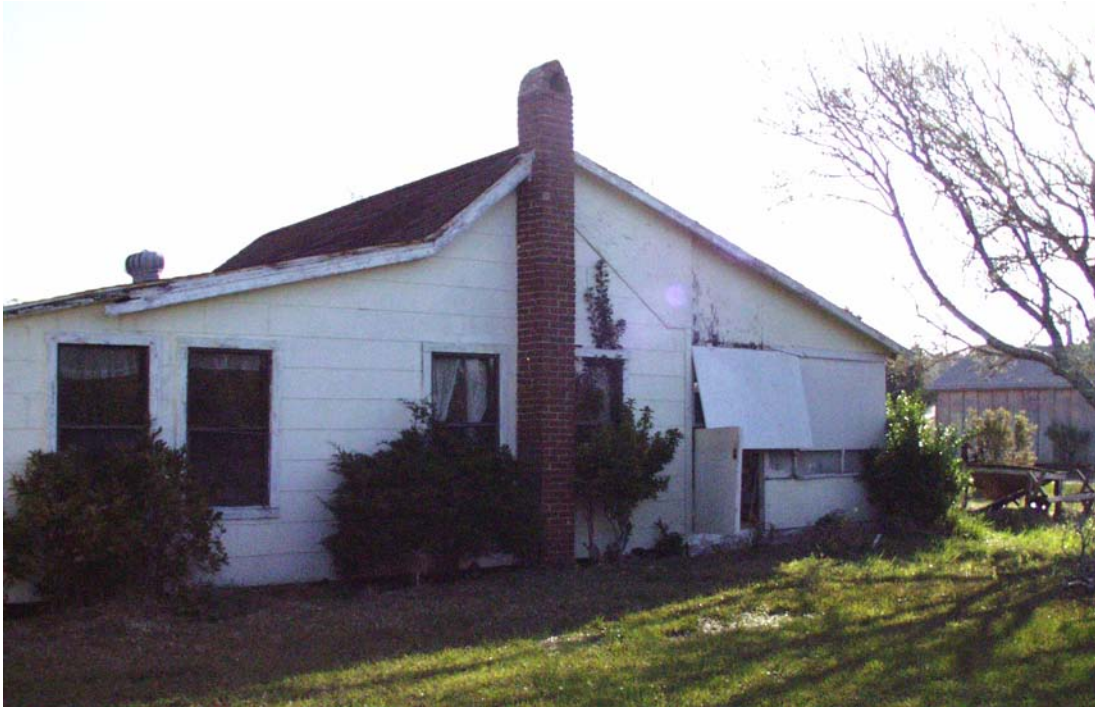
Figure 17 View east of house. (NPS-SERO-CR, 2003)

A wood- framed, plywood- covered storage building, constructed since 1977, is located a few feet west of the house, and there is a water tank elevated on a wood frame at the rear of the house. The condition of both structures is only fair.

- Clear crawl space beneath house of all trash and debris.
- Remove storage building and elevated water tank.
- Follow recommendations of Cultural Landscape Report in determining additional treatment of the surrounding landscape.

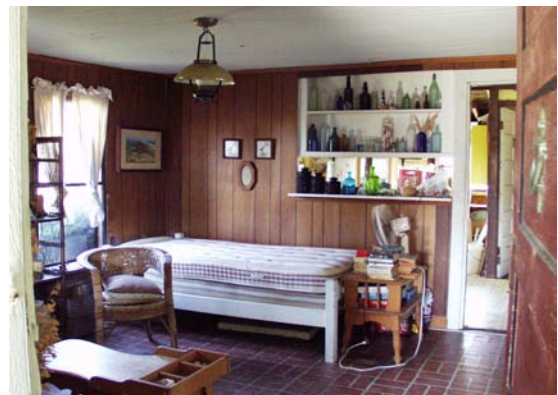
Figure 28 View to west in Room 100. (NPS-SERO-CR, 2003)

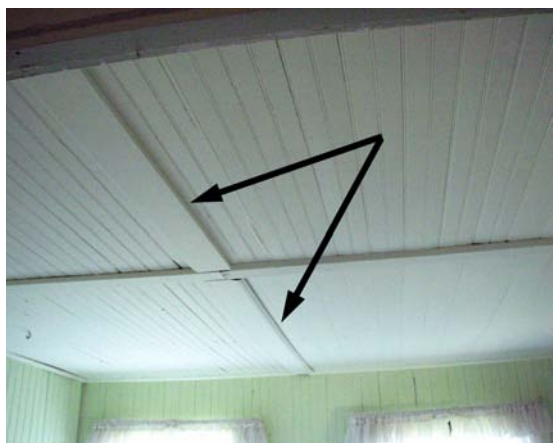
Figure 30 View of ceiling in Room 101, with arrows indicating location of wall that originally divided the space. (NPS-SERO-CR, 2003)

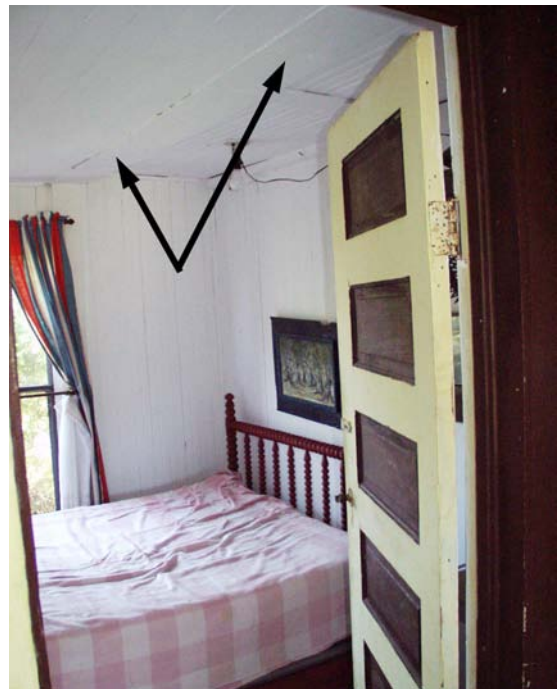
Figure 32 View east in Room 102, with arrows indicating line of wall that was relocated to create this room. (NPS-SERO-CR, 2003)

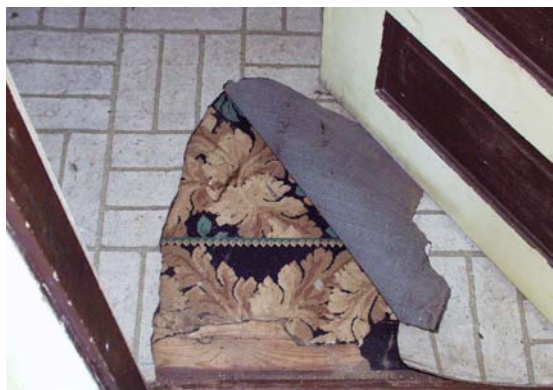
Figure 33 View of linoleum-type floor-covering underneath modern vinyl in Room 102. (NPS-SERO-CR, 2003)

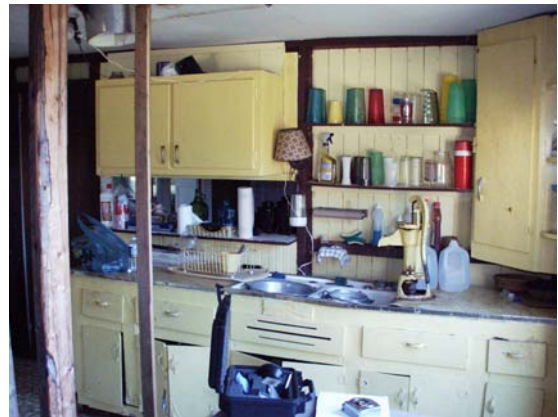
Figure 36 View of kitchen counter and cabinets in Room 103. (NPS-SERO-CR, 2003)

about 5'- 7" along the outside wall, there is no finish material on the ceiling at all. Significant water damage has occurred to the ceiling at the rear of the room, and removal of the separating wall between the two rooms weakened the

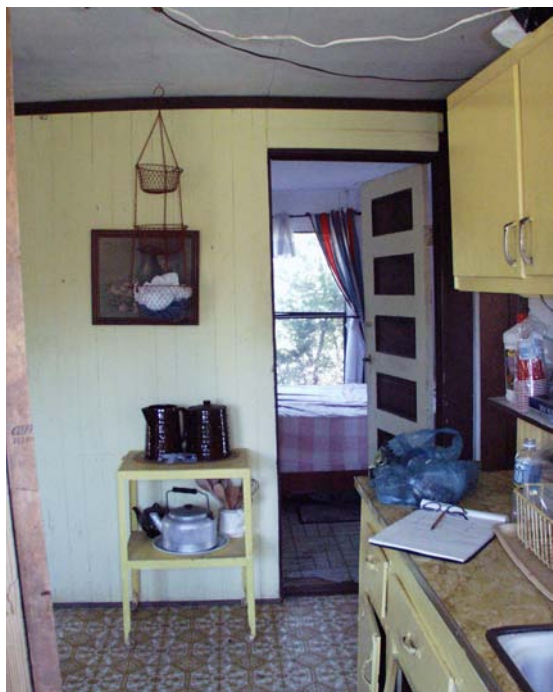
Figure 37 View northeast in Room 103. (NPS-SERO-CR, 2003)

- Reconstruct missing wall and repair framing in Room 103.
- As piers are replaced, inspect and repair sills and floor joists as necessary.
- Where feasible, improve connections of framing members to reduce the possibility of significant damage from high winds.
- Augment floor framing with added support beams as necessary.
- Remove addition to front porch and restore historic porch enclosure.
- Restore original roof line.

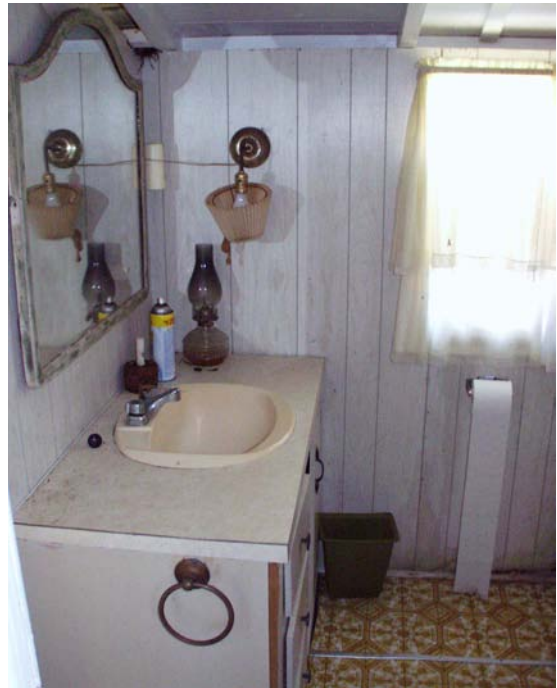
Walls: The southwest and the southeast walls of the original porch were finished with vertical, 3- 1/2"- wide, tongue- and- groove boards, like those used elsewhere on the exterior. Parts of these and all of the other walls, which historically had no interior finishes, are now covered with sheets of modern plywood paneling.

Figure 39 View northwest of bathroom. (NPS-SERO-CR, 2003)

- Remove existing front porch and reconstruct historic front porch.
- Remove bathroom, partition, and enclosure from back porch and restore historic porch.
- Preserve shutters at northeast side of back porch and use as model for replicating missing shutters.

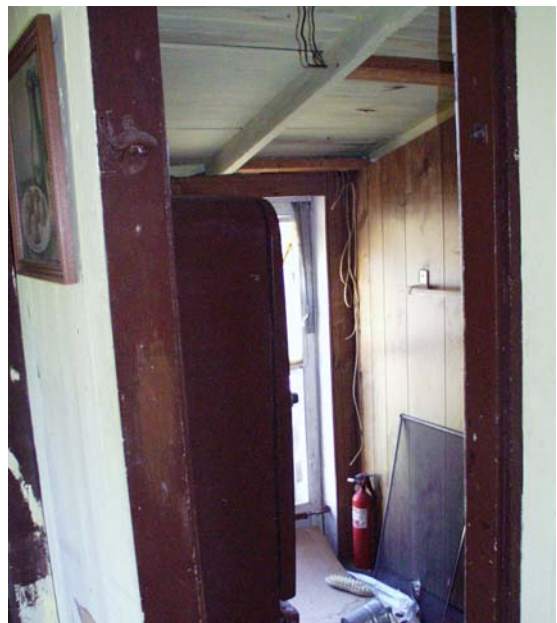
Figure 40 View to north of Room 105. (NPS-SERO-CR, 2003)

Doors and Windows: The back door, which is 2'- 8" by 5- 4", is a metal storm door that has

been broken by vandals. The door to the bathroom is a modern hollow- core, flush door, 2'- 0" by 6'- 7". The bathroom window opening is a modern creation and is covered by a storm window.
