Presidio Gate, Broadway Gate and Vicinity

Cultural Landscape Report

Presidio of San Francisco

October 1996

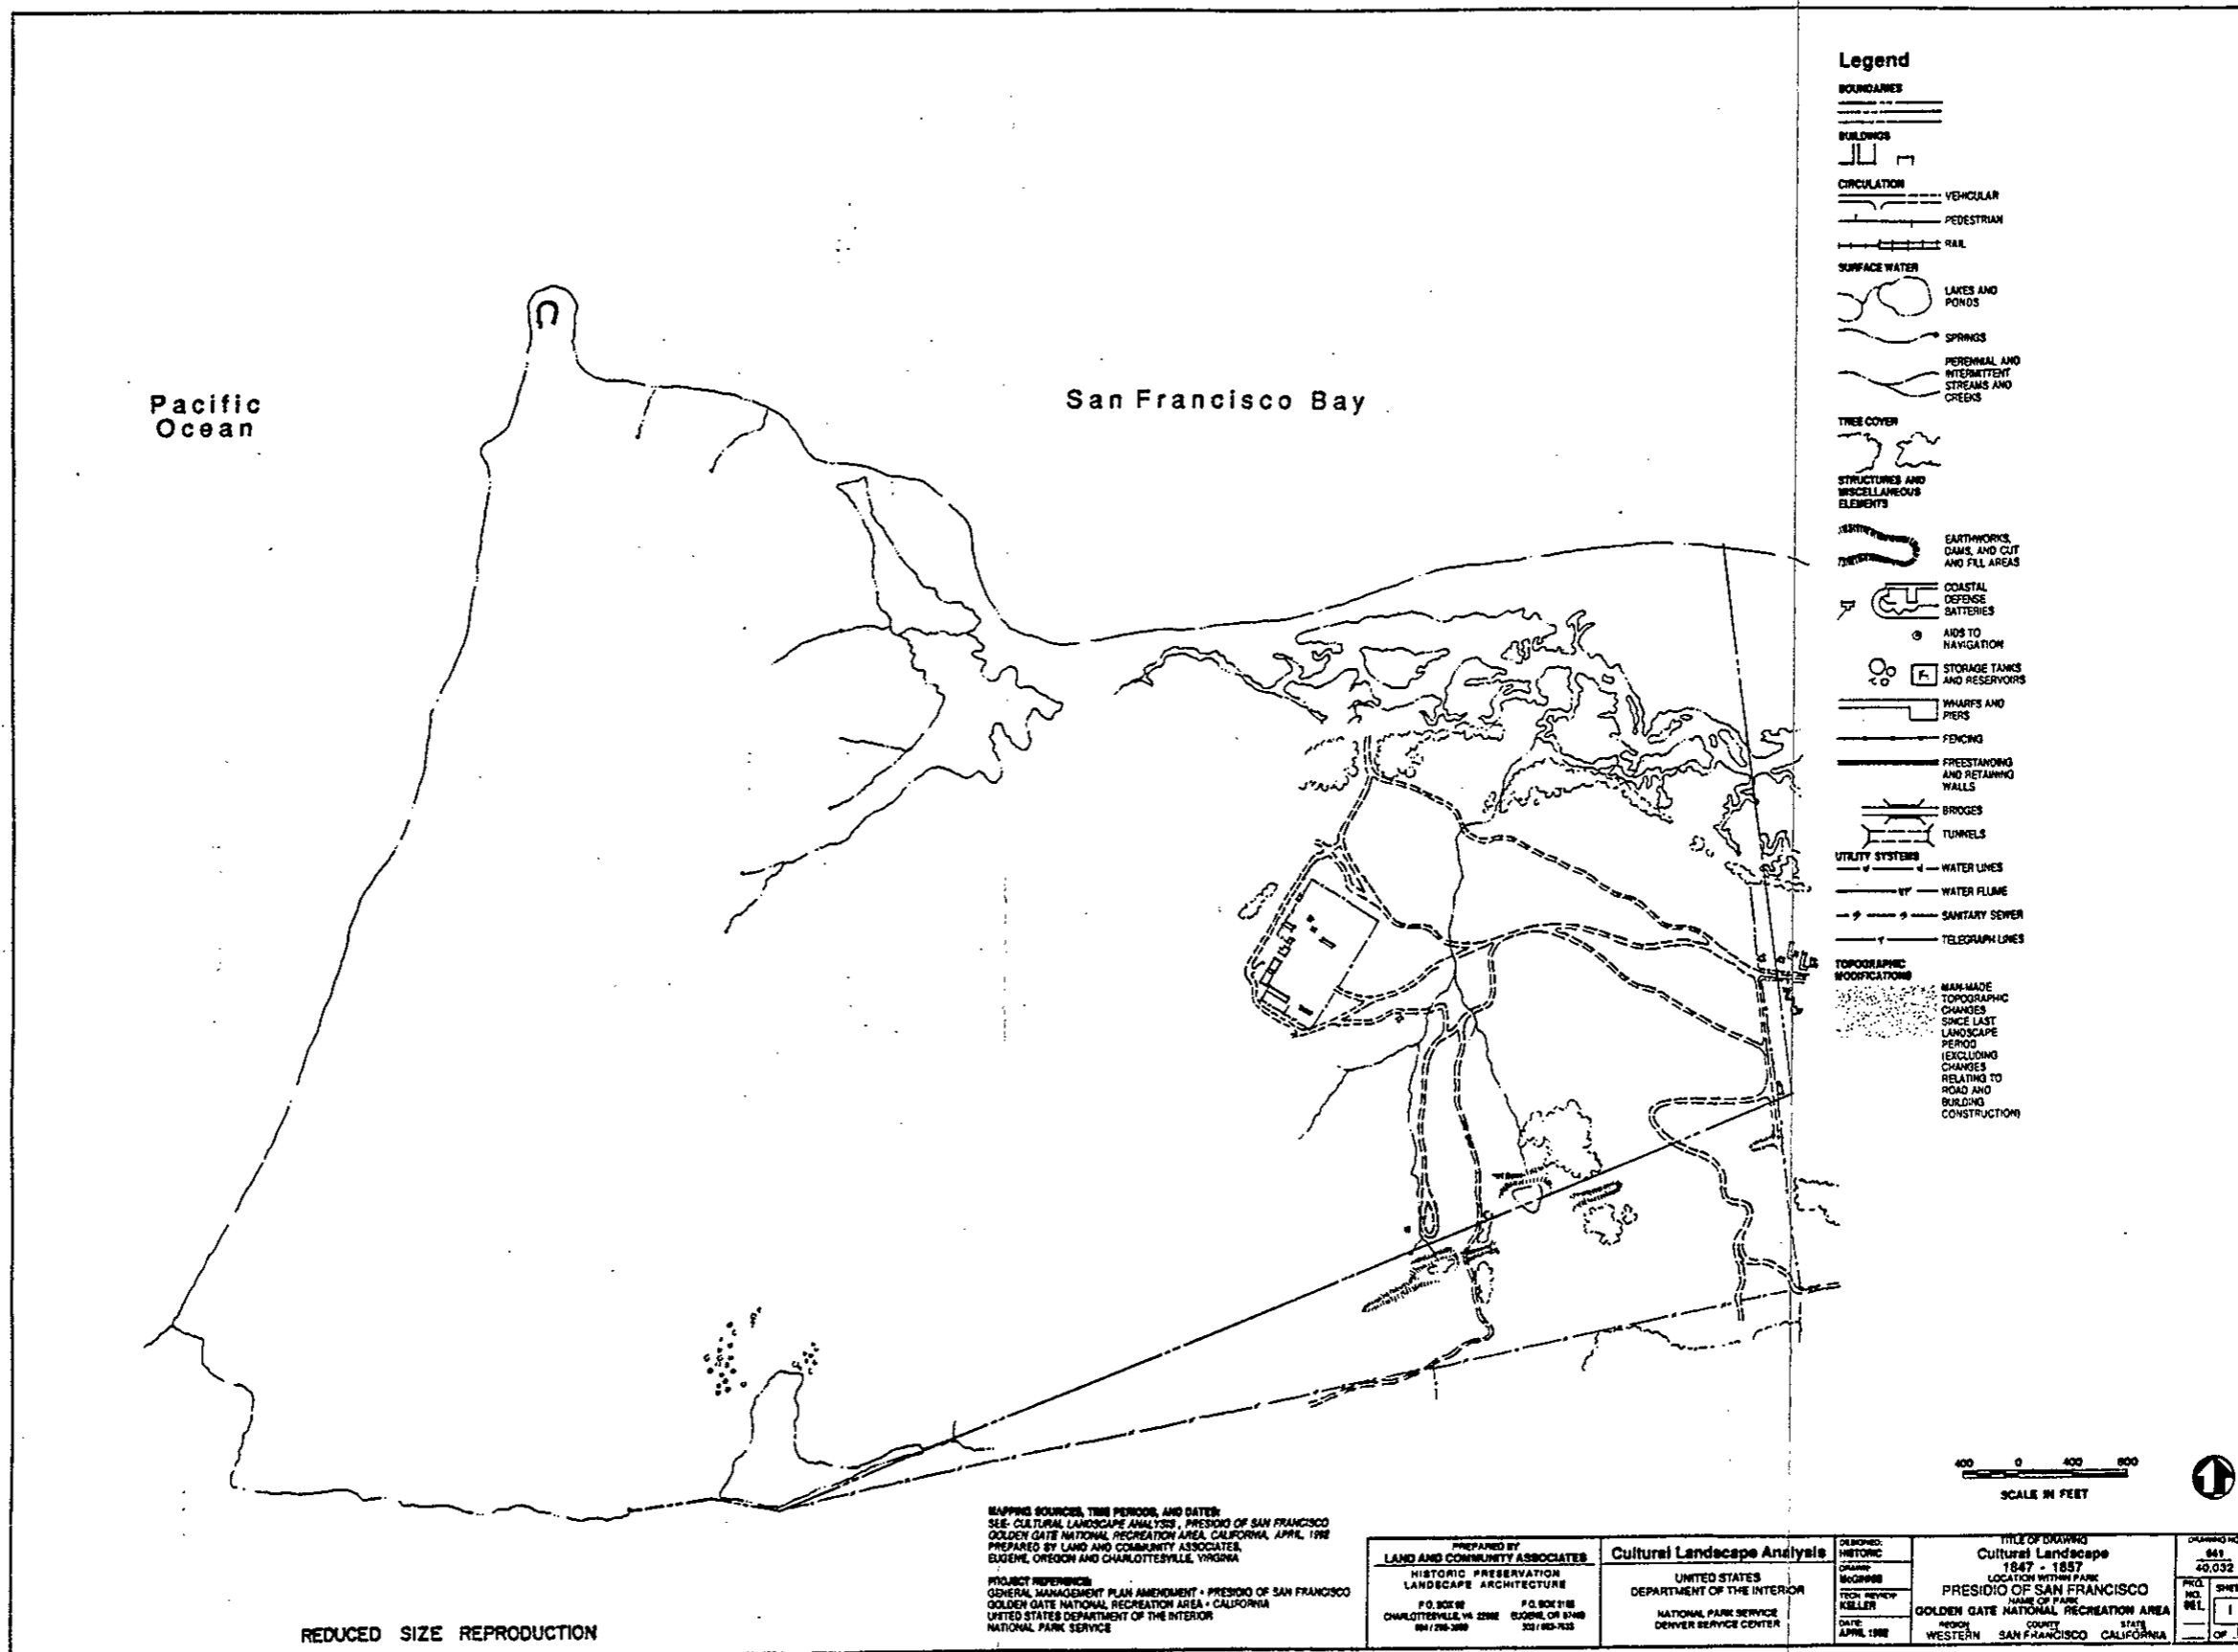
Figure 7 - 1847-1857 map of the Presidio

- * 1847 - Figure 7 Presidio Boulevard is unnamed and appears as an informal trail.
- * 1895 - Figure 8 Presidio Boulevard, West Pacific Avenue and Lovers Lane are clearly identified in present day locations.
- * 1907 - Figure 9 Broadway Street is shown in present day location, Shafter Road (including connection to Presidio Boulevard), and Liggett Avenue are shown.

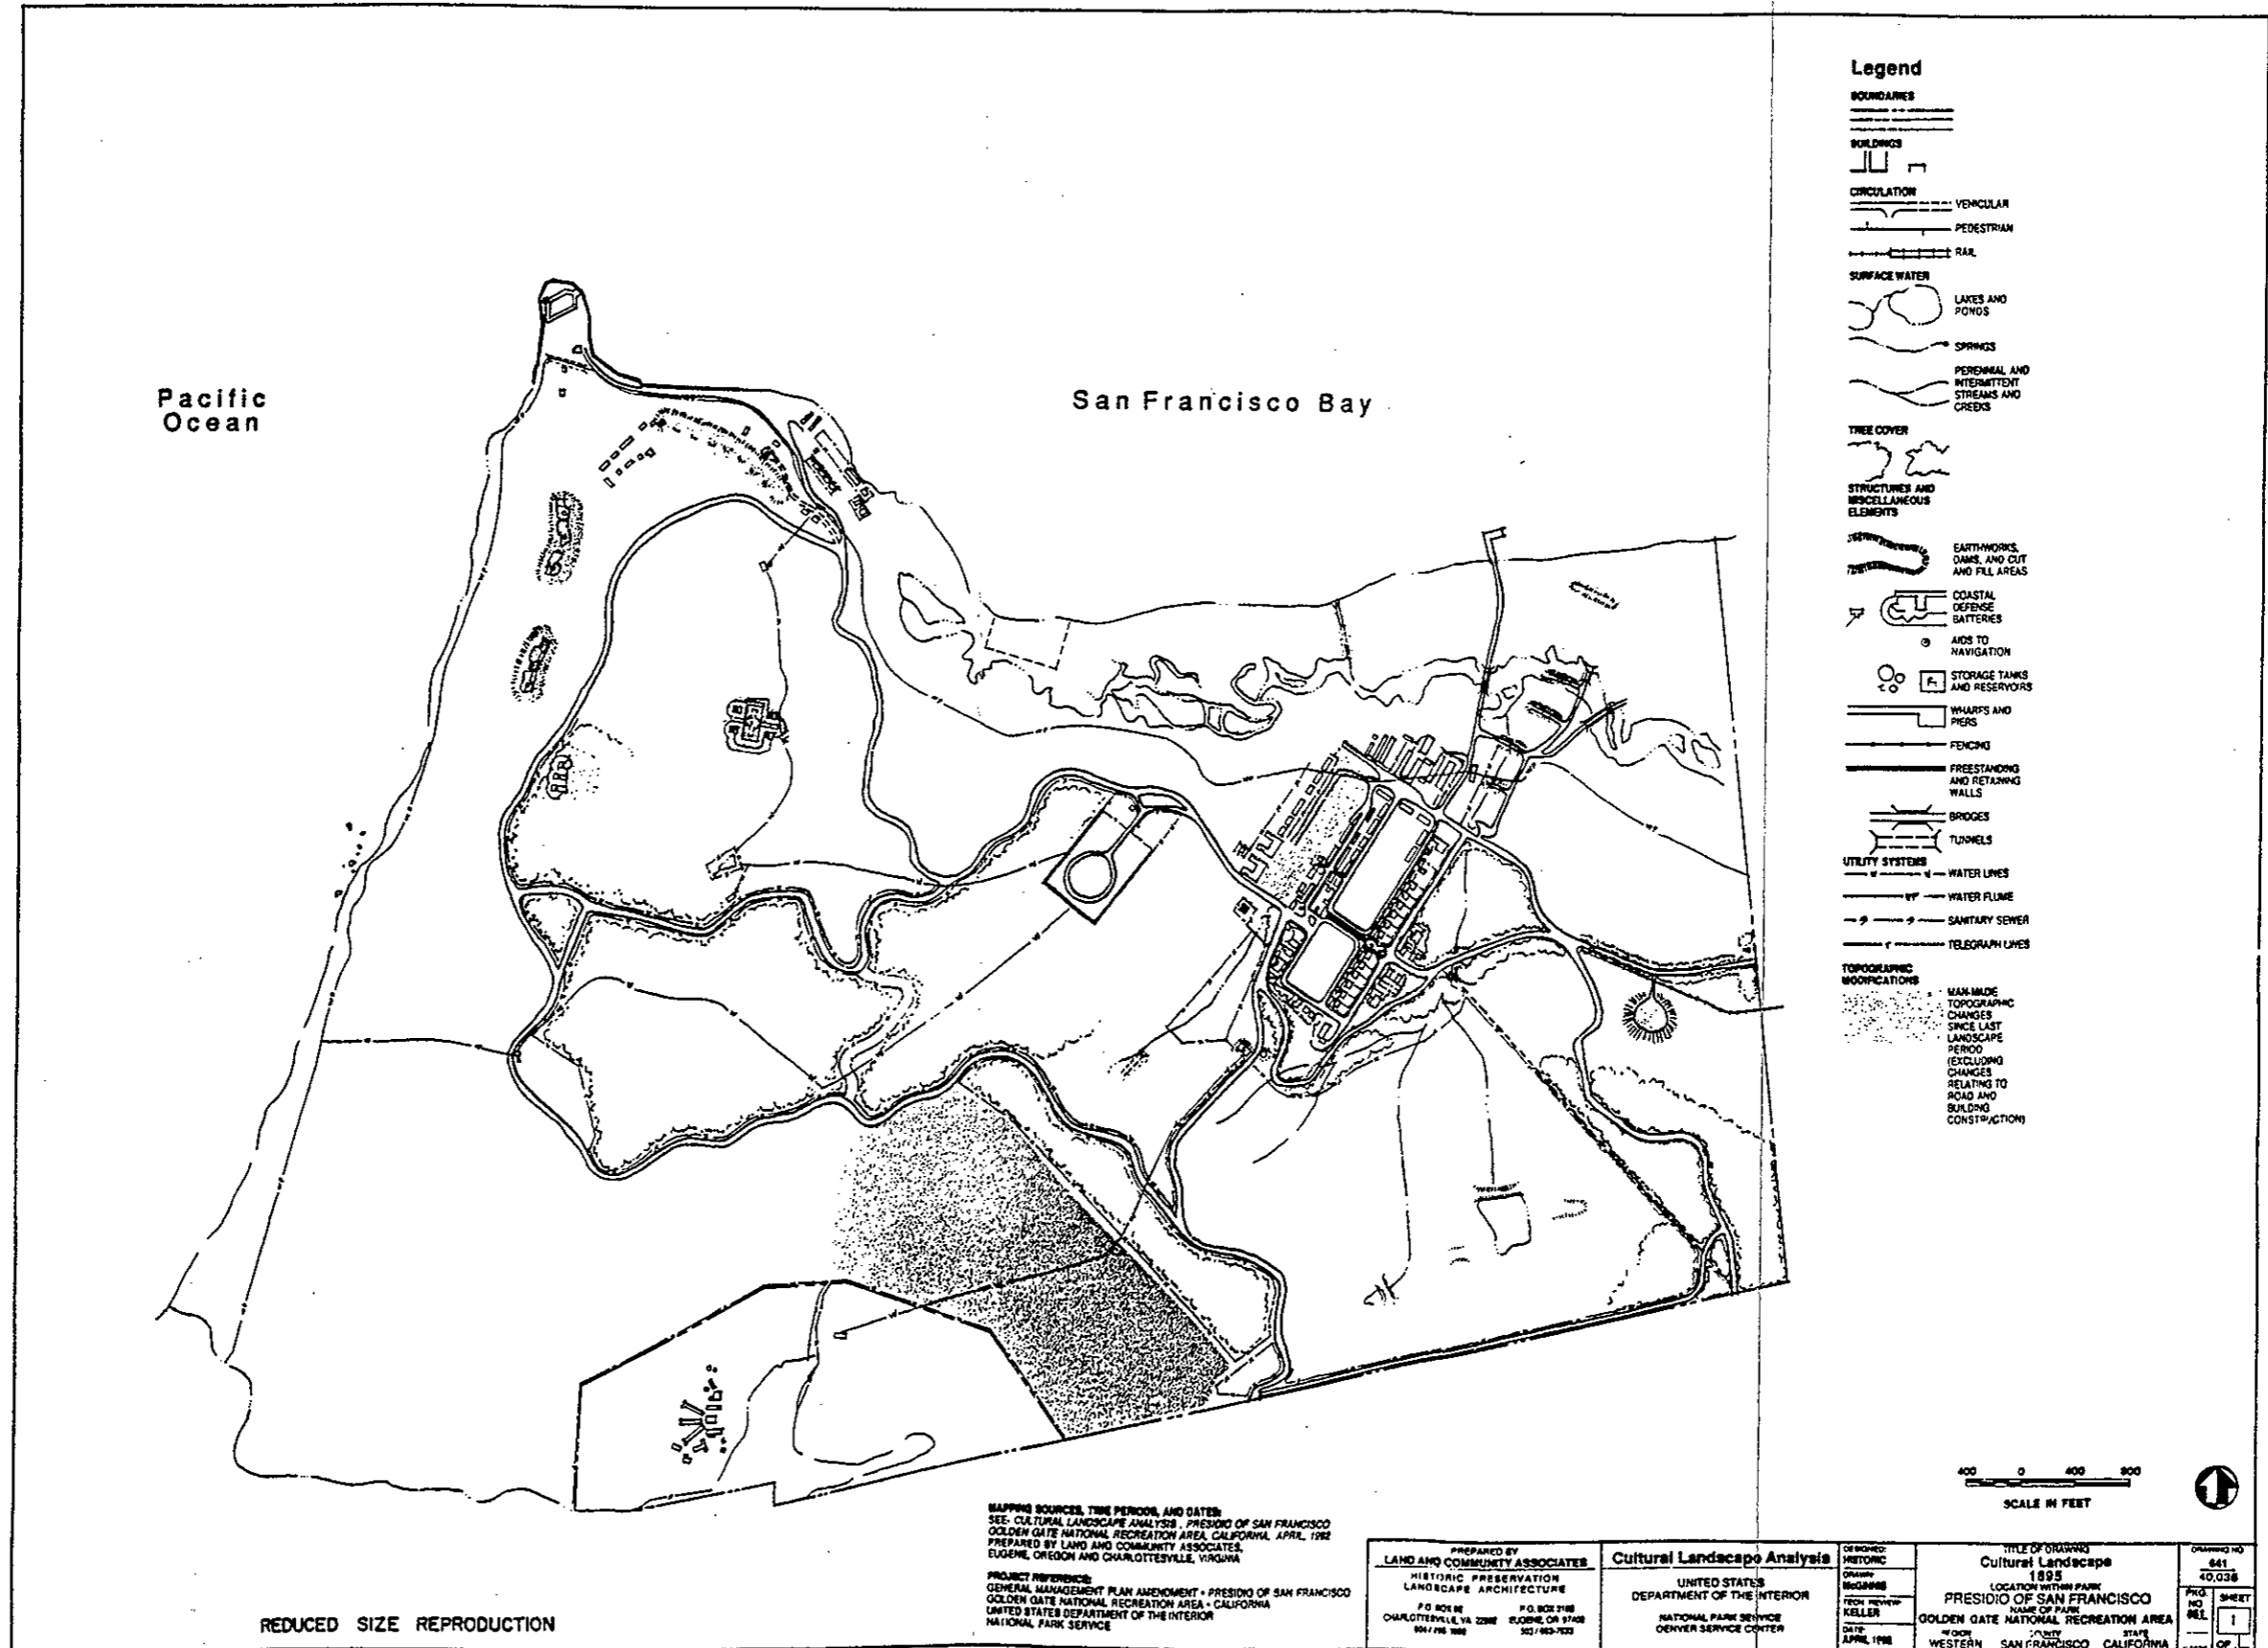
Figure 8 - 1895 map of the Presidio

West Pacific Avenue is a paved 22' wide connection between Arguello Boulevard and Presidio Boulevard. The avenue shows on maps as early as 1895, figure 8. The intersection with Presidio Blvd. has poor sight distance for vehicles turning onto Presidio Blvd. from W. Pacific Ave. Due to steep slope of intersection and stand of mature trees on the southwest corner. The side slopes along the north side of W. Pacific between Presidio Blvd. and Lovers Lane are eroded due to steepness of the slope and pedestrian crossing.

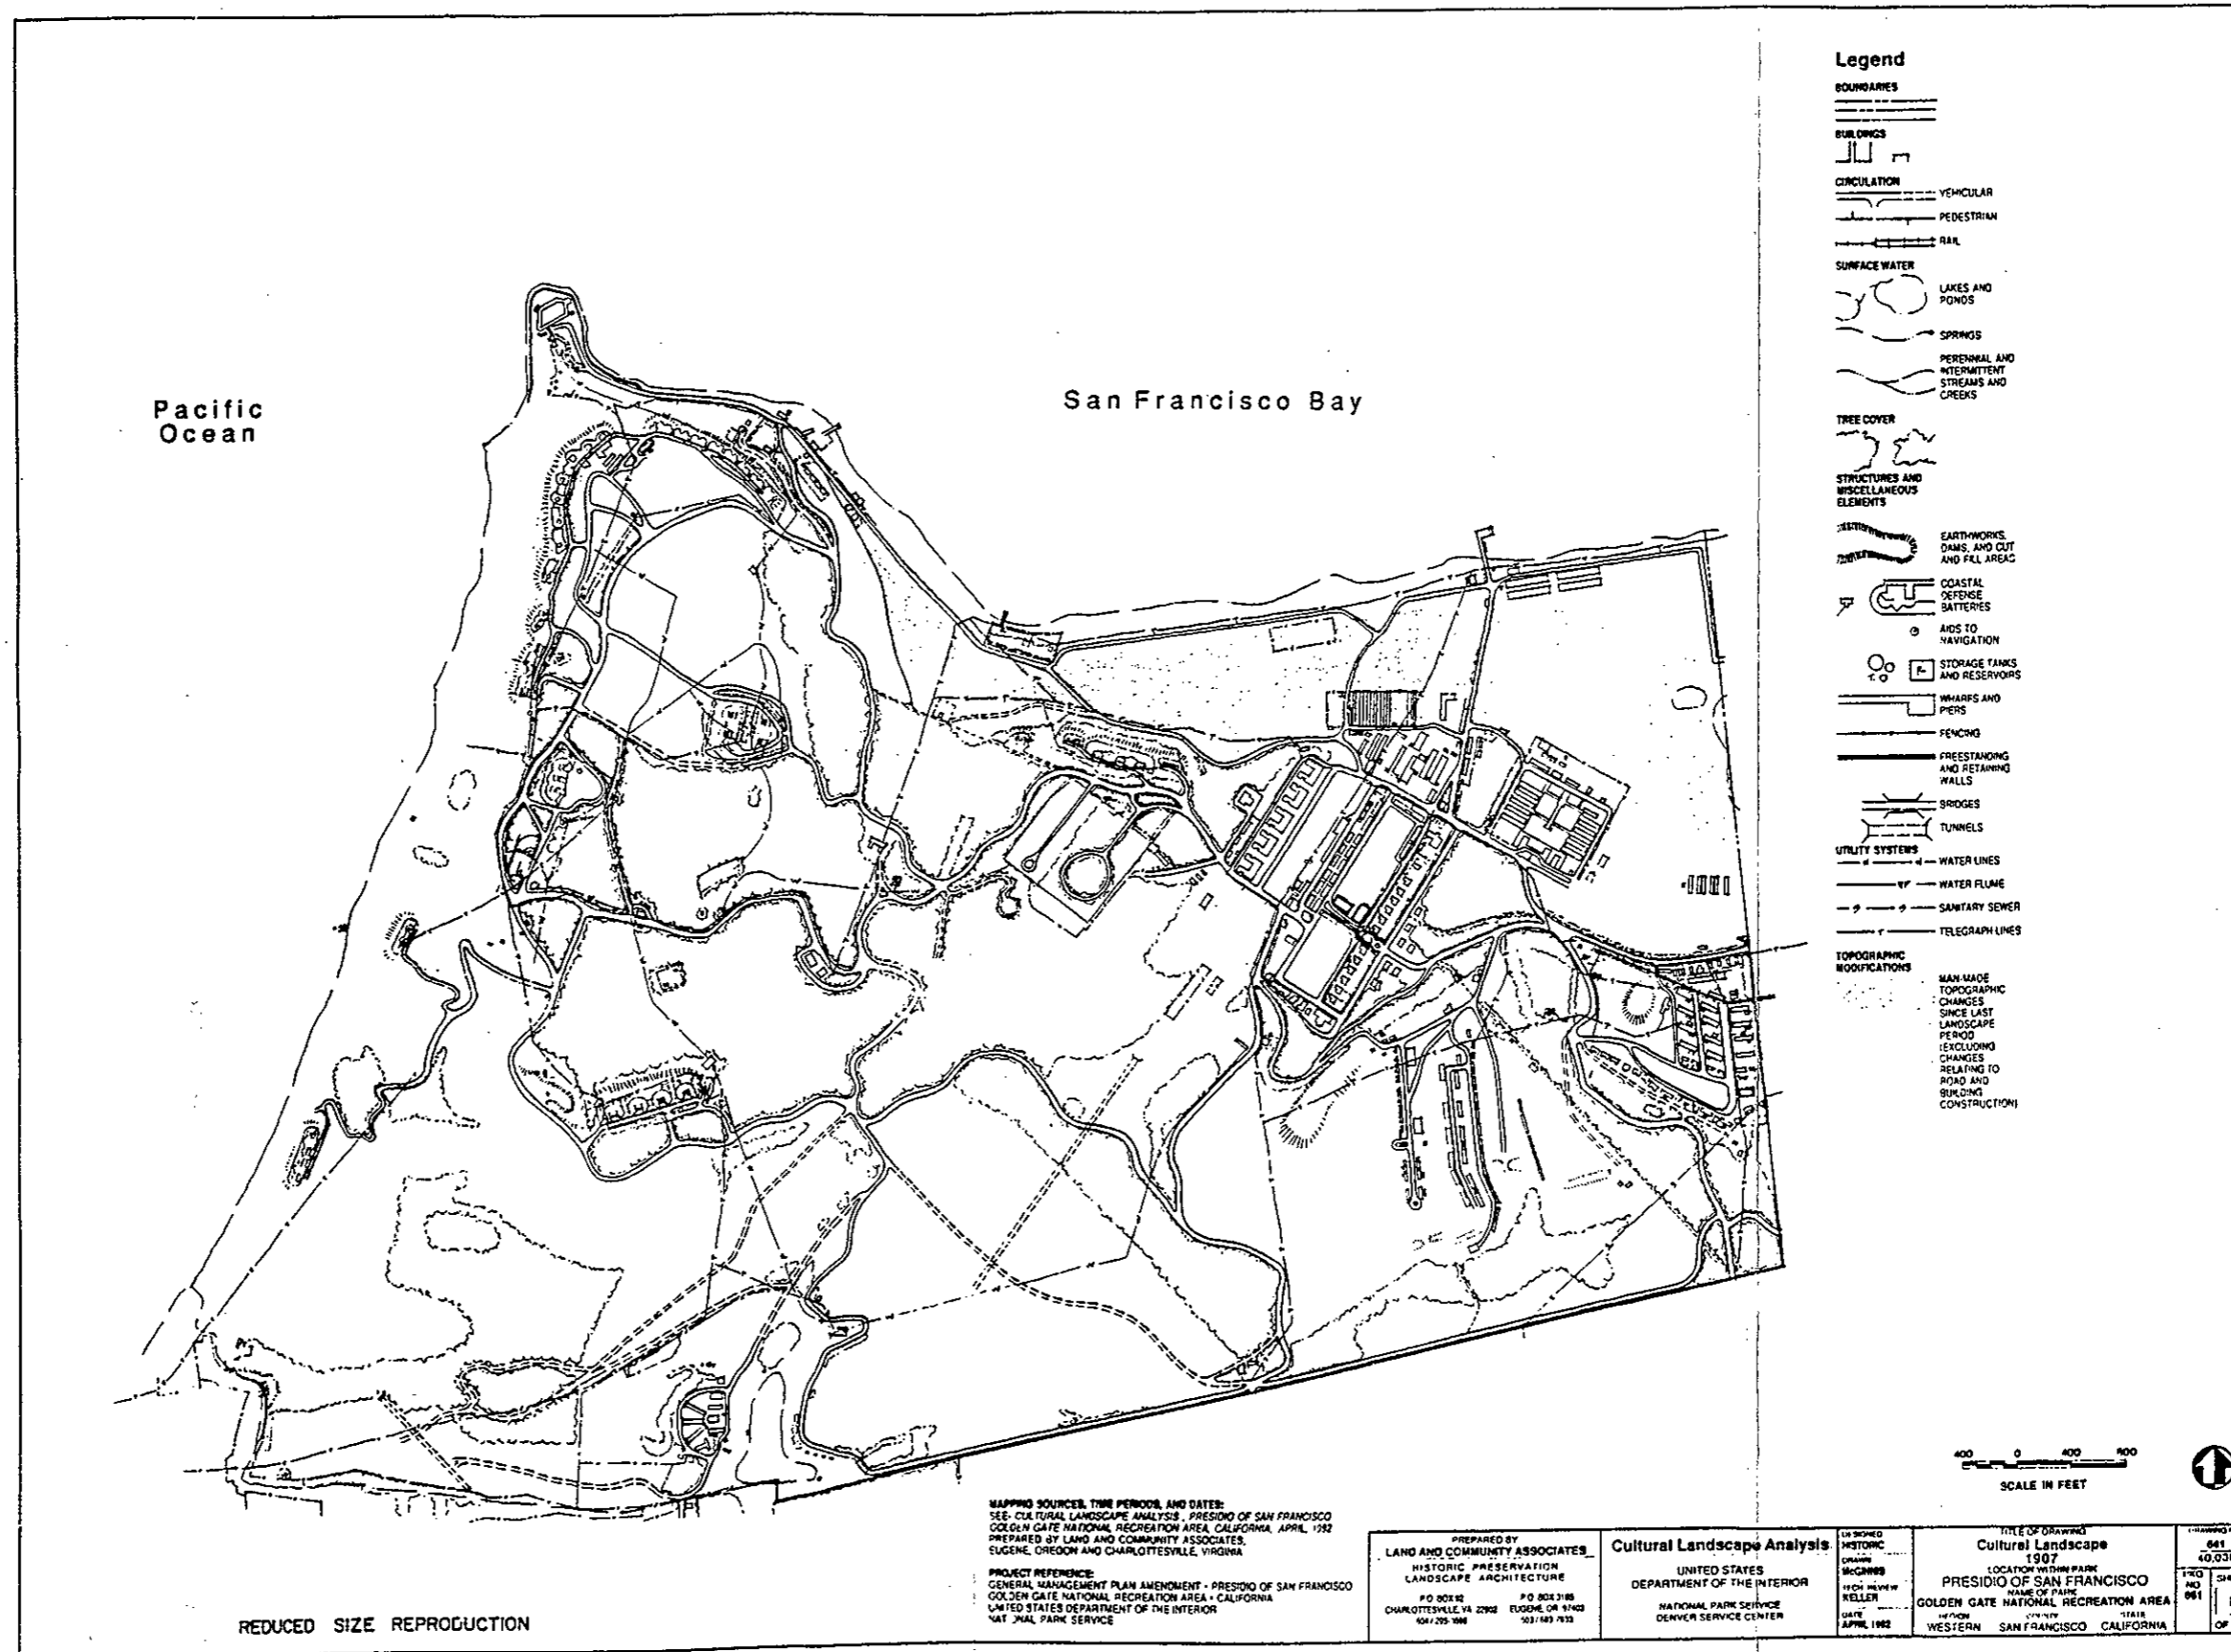
Figure 9 - 1907 map of the Presidio

Broadway Street is closed to vehicular traffic, the street is used by pedestrians and bicyclists, the street is shown on the 1907 map of the Presidio, figure 9. The street is approximately 20' wide and has a wide parking pull-off northwest of the Broadway Gate. A non-historic pipe gate blocks the entrance at Presidio Boulevard.
