Steam Schooner  
**WAPAMA**  
 HISTORIC STRUCTURE REPORT  
 1986

Steam Schooner  
**WAPAMA**  
HISTORIC STRUCTURE REPORT

1986

**Tri-Coastal Marine, Inc.  
(White Elephant Management)  
2104 Strand, Galveston, Texas, 77550**

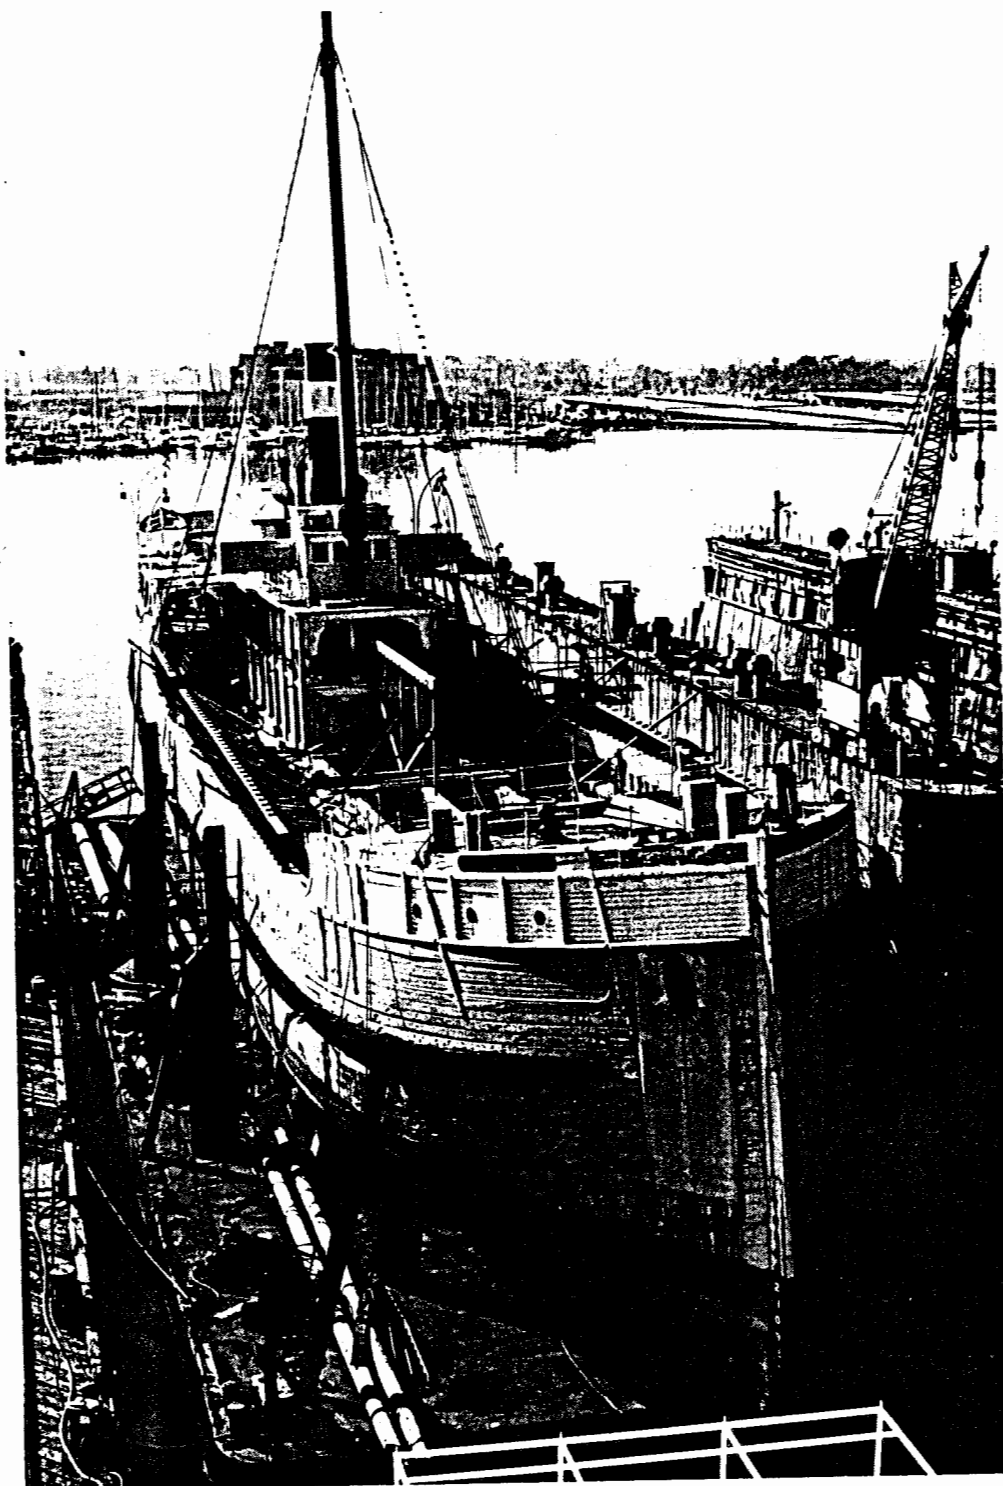
Fig. 9. WAPAMA at Pacific Drydock, December, 1885. Weather cover over main deck in process of installation.

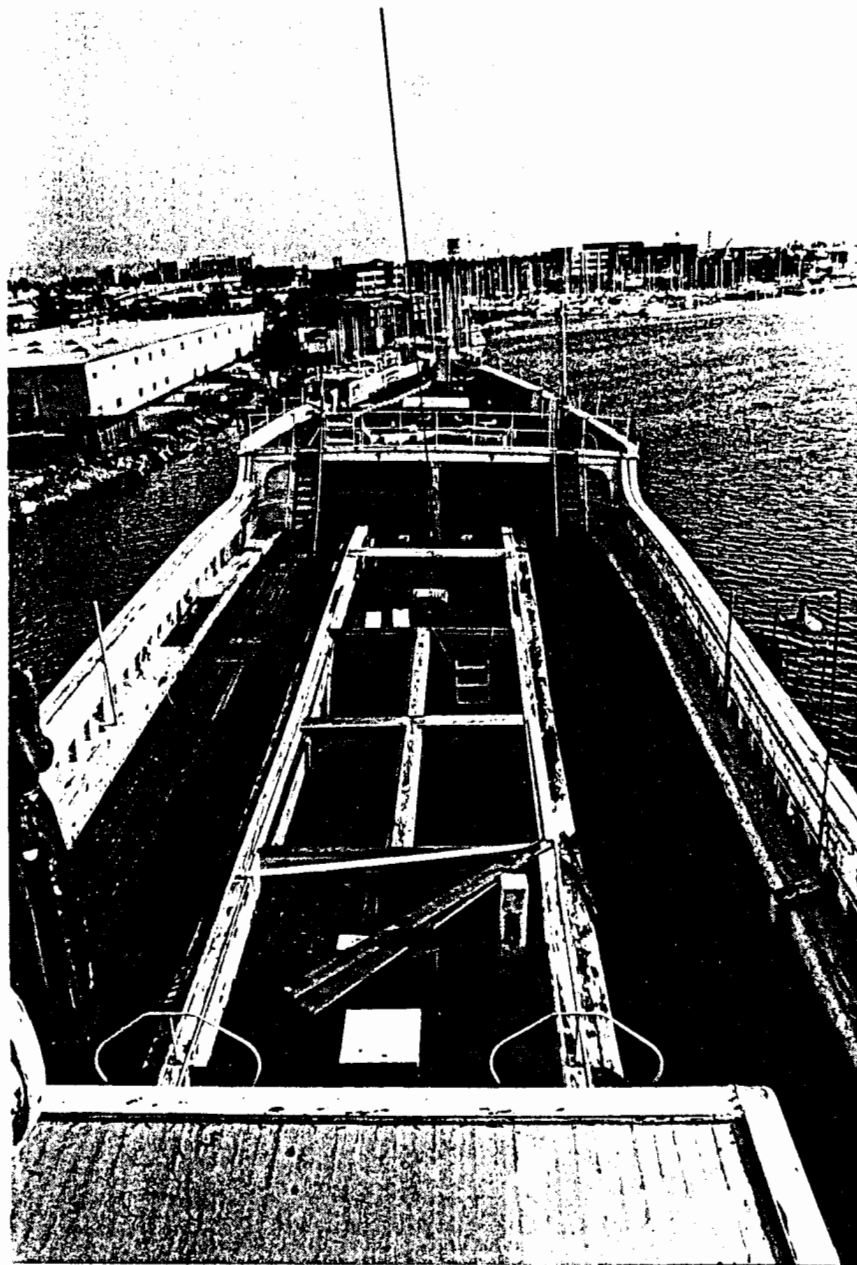
Fig. 11. View of main deck from top of wheel house. This deck is presently covered by roof structure. --Photo, TCM

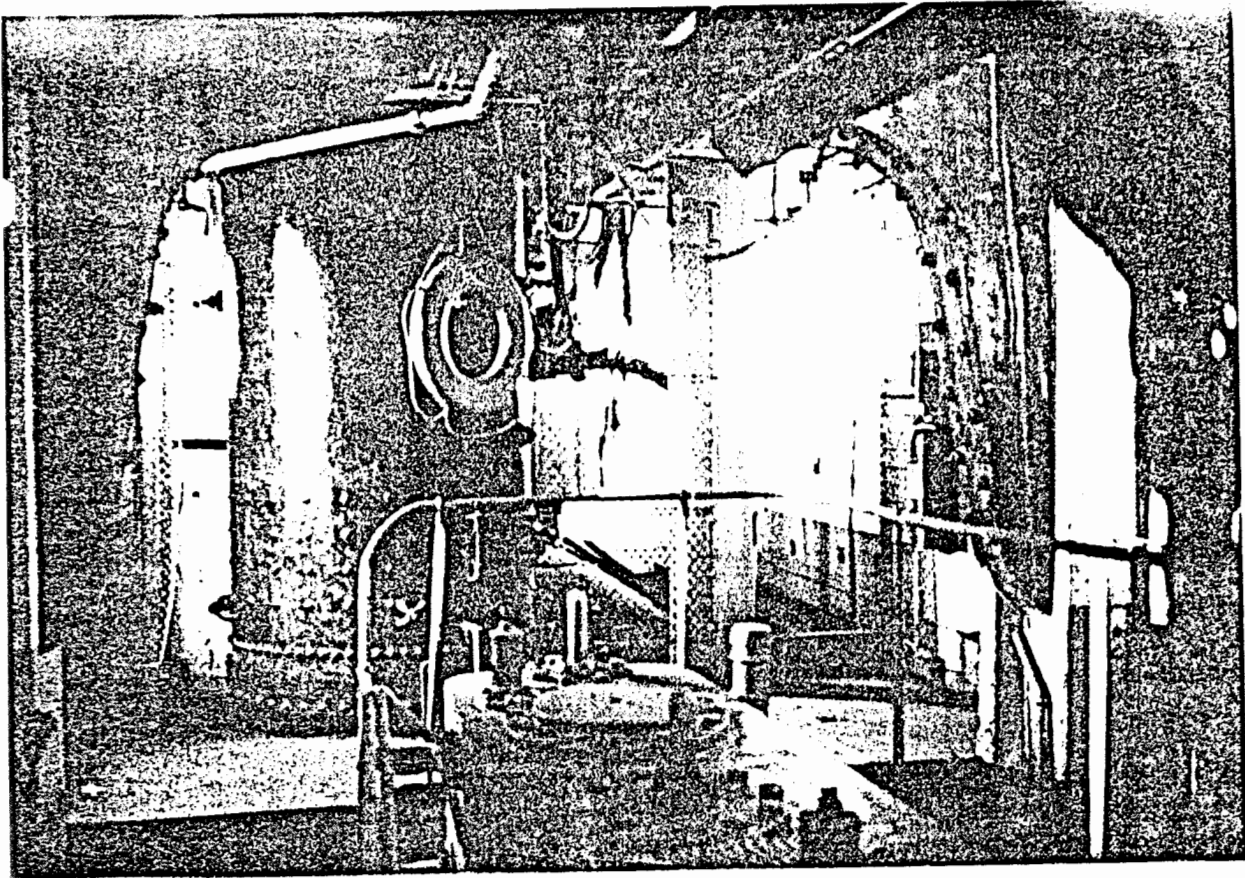
Fig. 14. Main deck engine flat, looking forward. Steam chest is in center foreground, donkey boiler past it to the left. Ventilators port and stbd, and stbd side of boiler breeching visible beyond. Note heavy knees port and stbd.

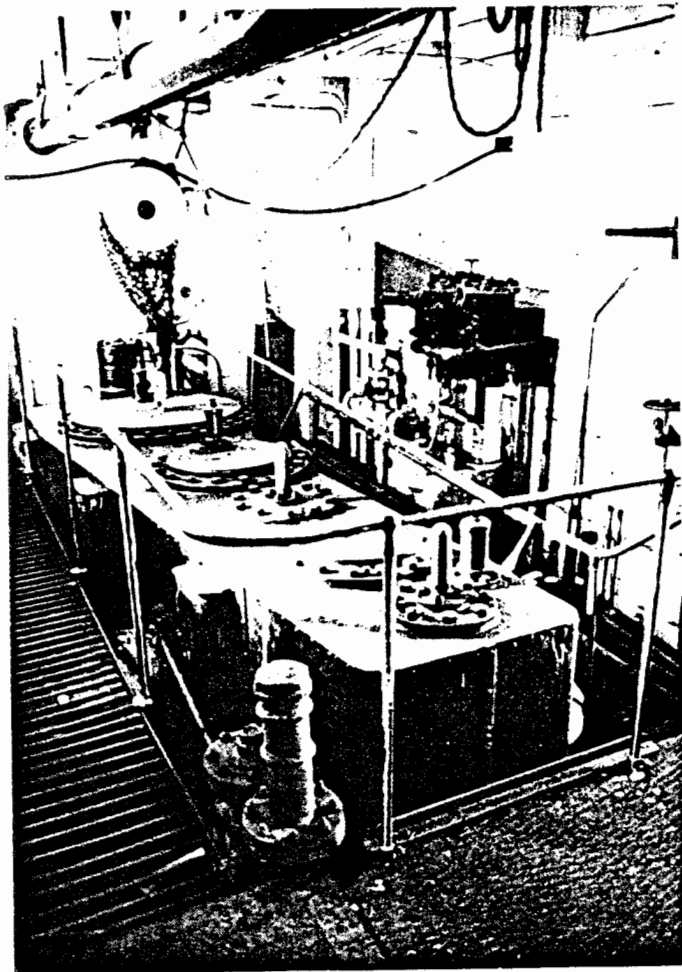
Fig. 15. Main deck engine flat, looking aft. Top of engine, steam chest, is enclosed by pipe rail.

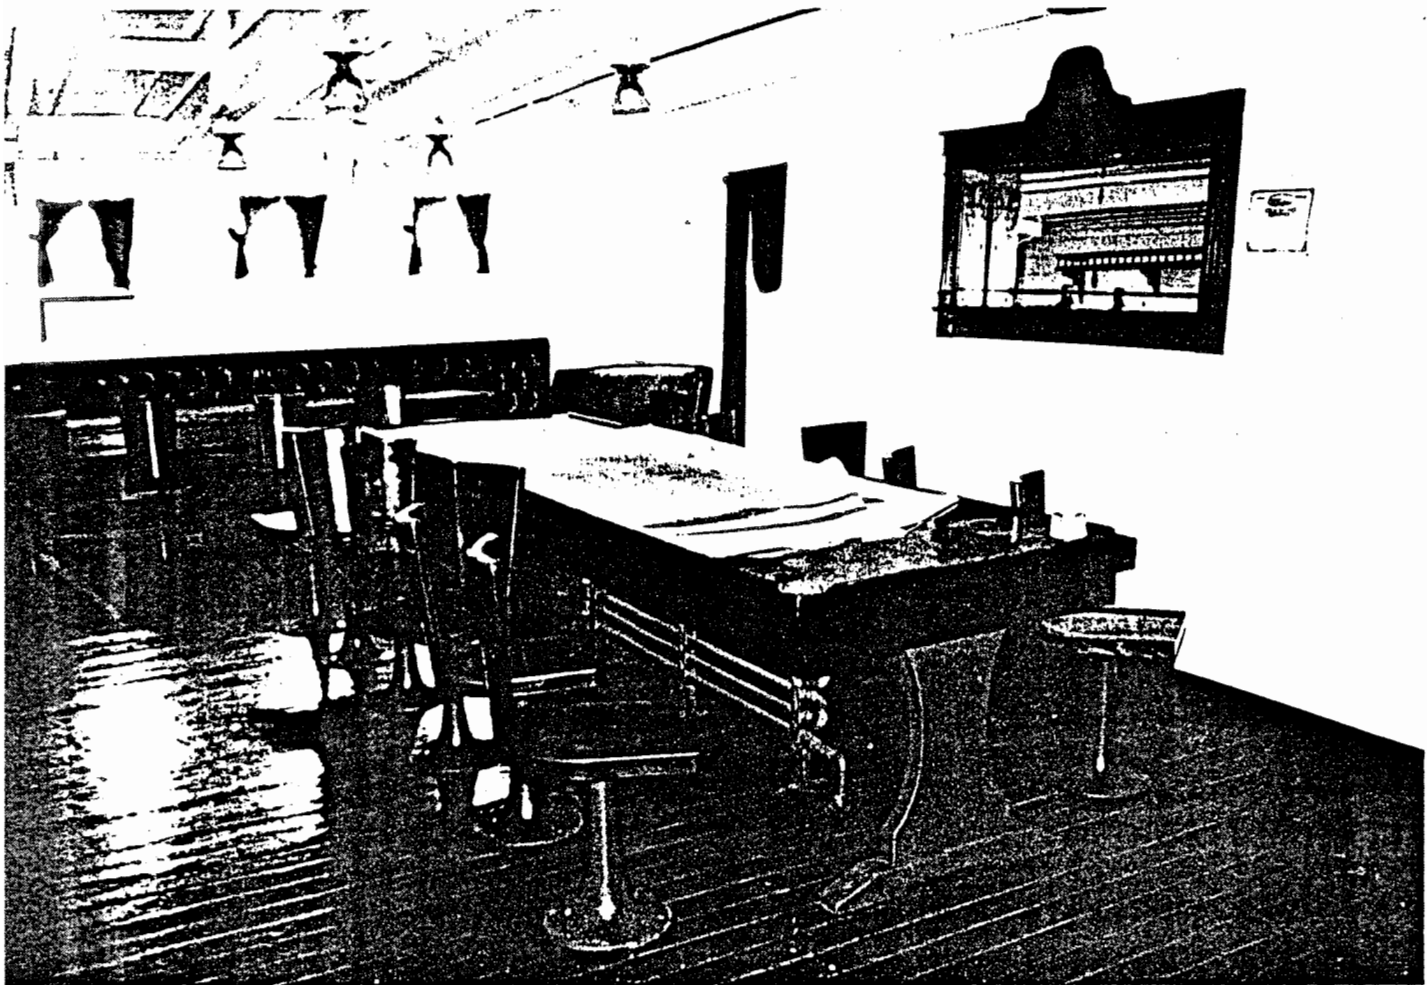
Fig. 16. Dining saloon, looking aft and to stbd. Note fixed seating, radiator under thwartships table. Curtained doorway in aft bulkhead leads to former passenger cabin and steward's accommodation. --Photo, TCM

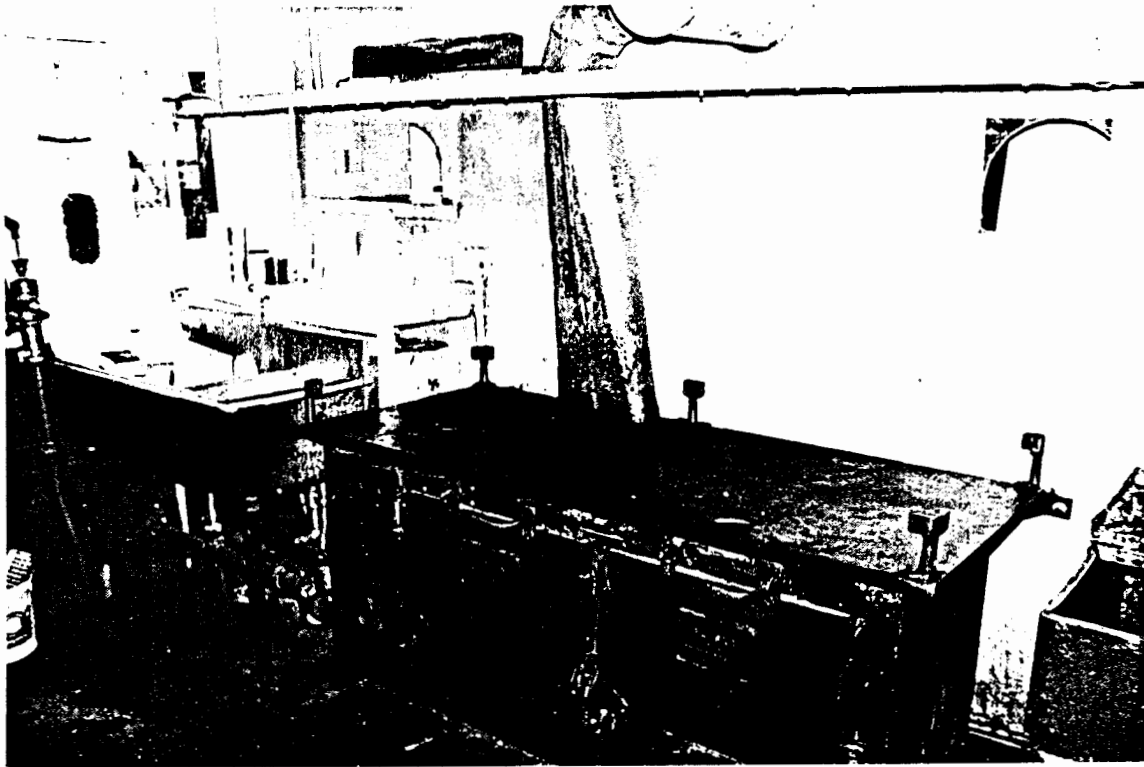
Fig. 17. Galley looking fwd. Stove pipe pierces steel blkhd into engine room fwd.

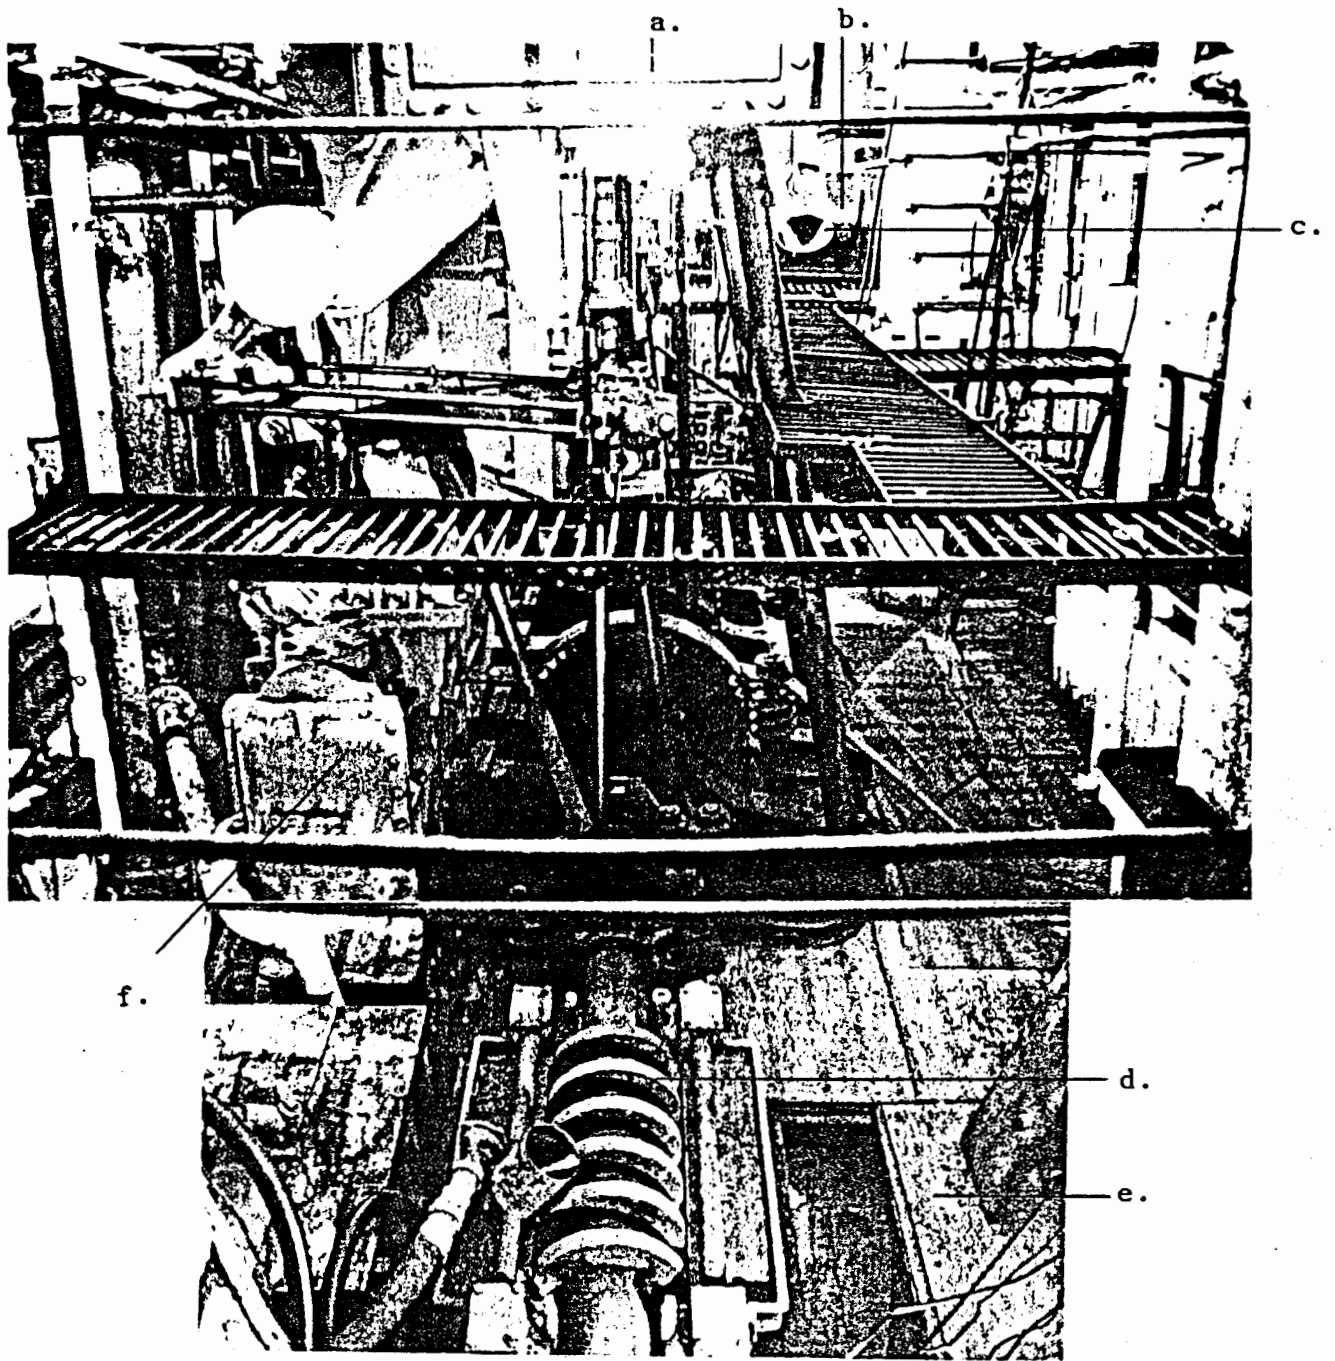
Most major internal members: keelsons, ceiling, frames, and deck beams and knees are in generally worse condition in the engine/boiler room than in the cargo hold. Probable causes for this are reduced ventilation and limited access for maintenance. The alternate heating and cooling of the compartment over the years the vessel was in operation may also have contributed to the rot and surface deterioration seen throughout. As in other areas, rainwater seepage is seen throughout the engine room.

The hull has suffered damage due to a fire in way of the starboard fuel tank. In this area, frames 61 to 63, eight ceiling strakes have been almost completely burned away, frames are damaged, and the fuel tank foundation timber is burned and decaying. Much of the ceiling below the turn-of-bilge could not be inspected due to limited access in way of the fuel tanks, boilers, and machinery flats. Where inspection was possible, these strakes appeared much like those in the cargo hold, with extensive rot, and nail sickness around fastenings.

The upper ceiling strakes and clamps, and the underside of the main deck are suffering from severe surface deterioration, primarily in way of the fuel tanks. This deterioration, which appears as a "fraying" of the surface grain, is thought to be non-fungal in nature. All three clamps and the upper three ceiling strakes are generally rotten behind the hanging knees from frame 56 to 67 on the port side, and from frame 51 to 63 on the starboard side. Areas of advanced rot were also seen in the lower ceiling strakes at the aft bulkhead, port and starboard.

Fig. 21. Engine room, looking fwd. (Composite photo)  
 a. steam chest. b. stbd steam drum c. bottom of ventilator  
 d. thrust bearing e. engine room flat f. condenser

The engine room presents a challenge for both preservation and interpretation. This compartment is presently considered unsafe, even for volunteers and crew. The first priority should be to correct safety deficiencies in order to begin preservation work. A major program of documentation and removal of wasted machinery and piping should be undertaken before further collapse prevents proper recording of these artifacts.

Preservation of the wood structure should begin with weatherproofing. This can be achieved in the short term by addition of covers over the decks and fidley above. Even if freshwater is stopped, drying will be slow due to the poor ventilation here. The drying process can be speeded up by selective use of forced air ventilation. Even so, ongoing decay will likely necessitate some repair, and possibly renewal, of deck beams and stanchions.

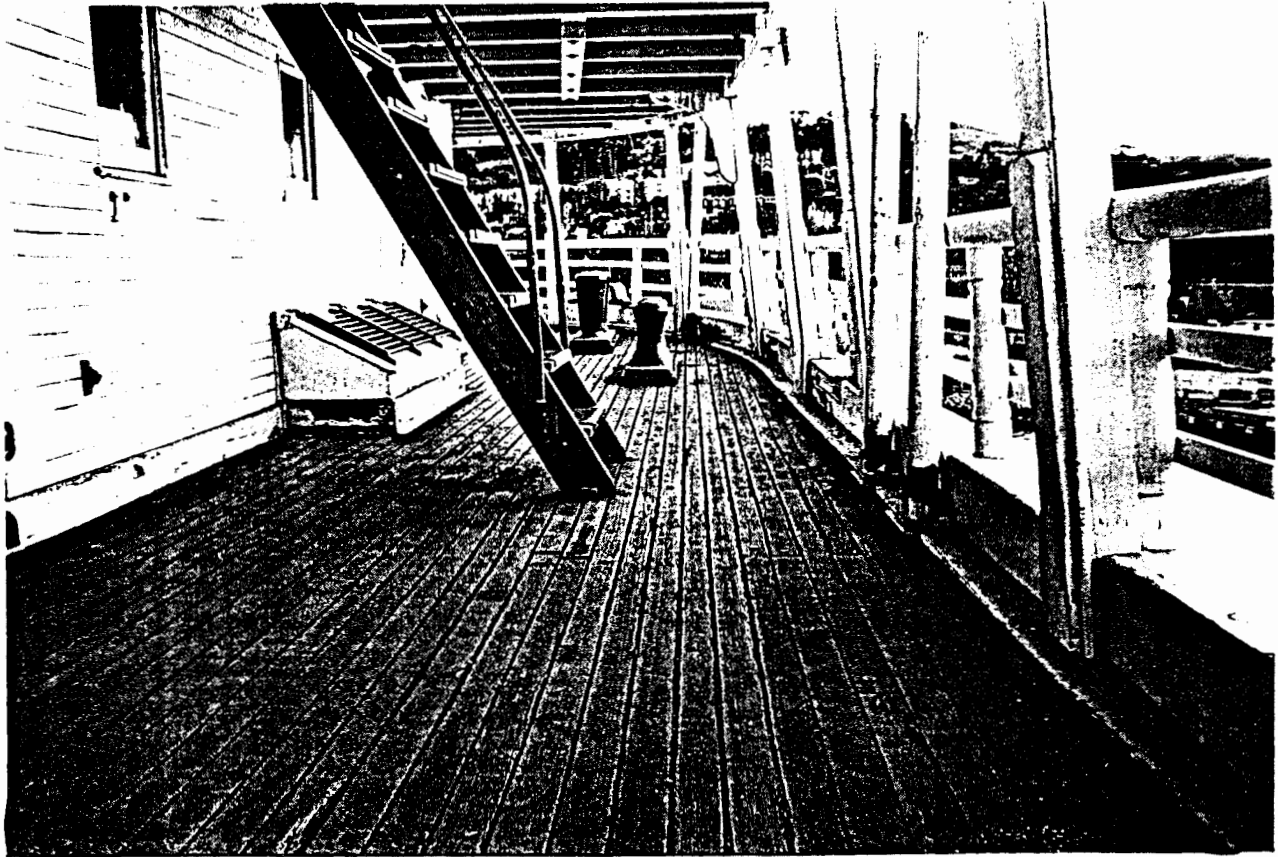
The worst deterioration seen in the cabin deck is found in the exposed exterior areas, particularly on the port side, from the poop bulkhead to the stern. Here, the solid bulwark timber is severely rotten and disintegrated over a distance of 24 feet, from the port quarter chock to the stern. The port covering boards are rotten variously with the worst area at the quarter. The poop bulkhead covering board is rotten at the port outboard end. The cap of the raised bulwark, forward of the poop bulkhead on the port side, is rotten variously from frame 64 to 70. Localized areas of rot are seen in the deck planking near the deck edge on the port quarter, and around bitts and skylights.

Four of the turned pillars supporting the boat deck on the port side, number 2, 3, 4 and 5 counting from the poop bulkhead, are rotten at the bases and structurally unsound. The aftermost of the port side davits is adrift at the base and presents a hazard.

Fig. 24. Cabin deck, port side, looking aft.

The boat deck should be temporarily shored in way of the rotten pillars on the port side, until the pillars can be repaired. Loose davits should be secured or removed. The severe rot seen in the fidley will require attention. This structure is a prime candidate for rebuilding because of its role in supporting the weight of the stack in the original manner.

The leaking deck could be rewalked with minimum plank renewals, though this alone would not prevent rainwater seepage into the accommodations areas. The severe deterioration along the port side of the deck will necessitate at least partial renewal in order to achieve this. In the short term, the addition of weather covers over the fidley trunk on the boat deck, and side curtains around the exposed areas of the cabin deck will do much to keep water out and slow the ongoing deterioration.

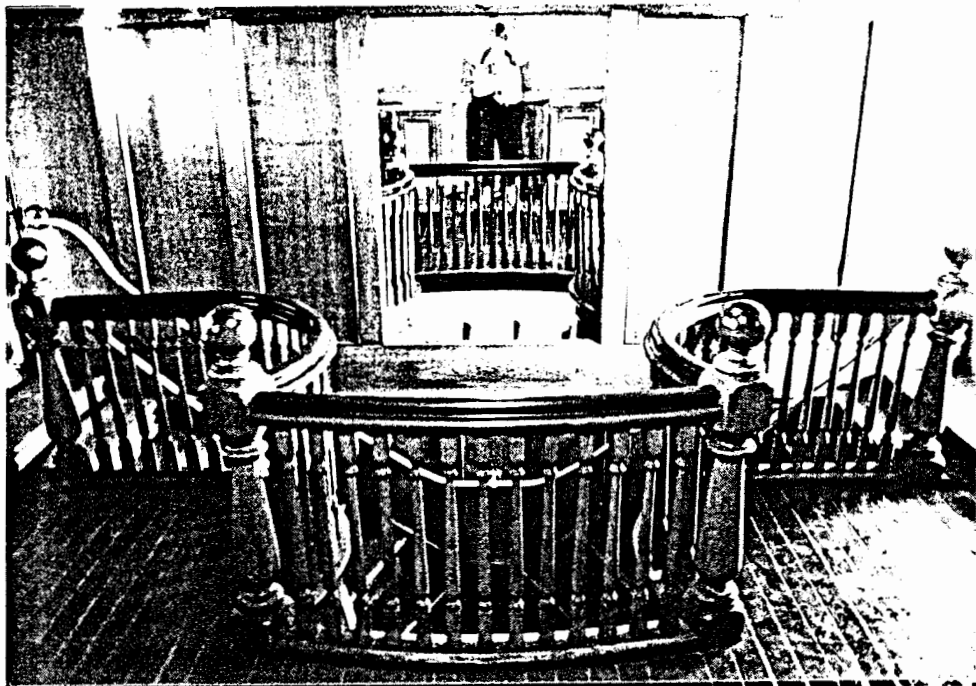
Fig. 25. Social hall, looking forward. Mirror is on bulkhead to smoking room, railing over double staircase down to dining saloon.

The social hall is in good condition and quite presentable, though oak paneling has been removed from the tops of the settees to the wainscotting, and the nickelodeon or piano has been removed. The smoking room (doors #8 and #9), heads (doors #14, #16 and #17), and cabin #12 are basically sound, but in need of ventilation

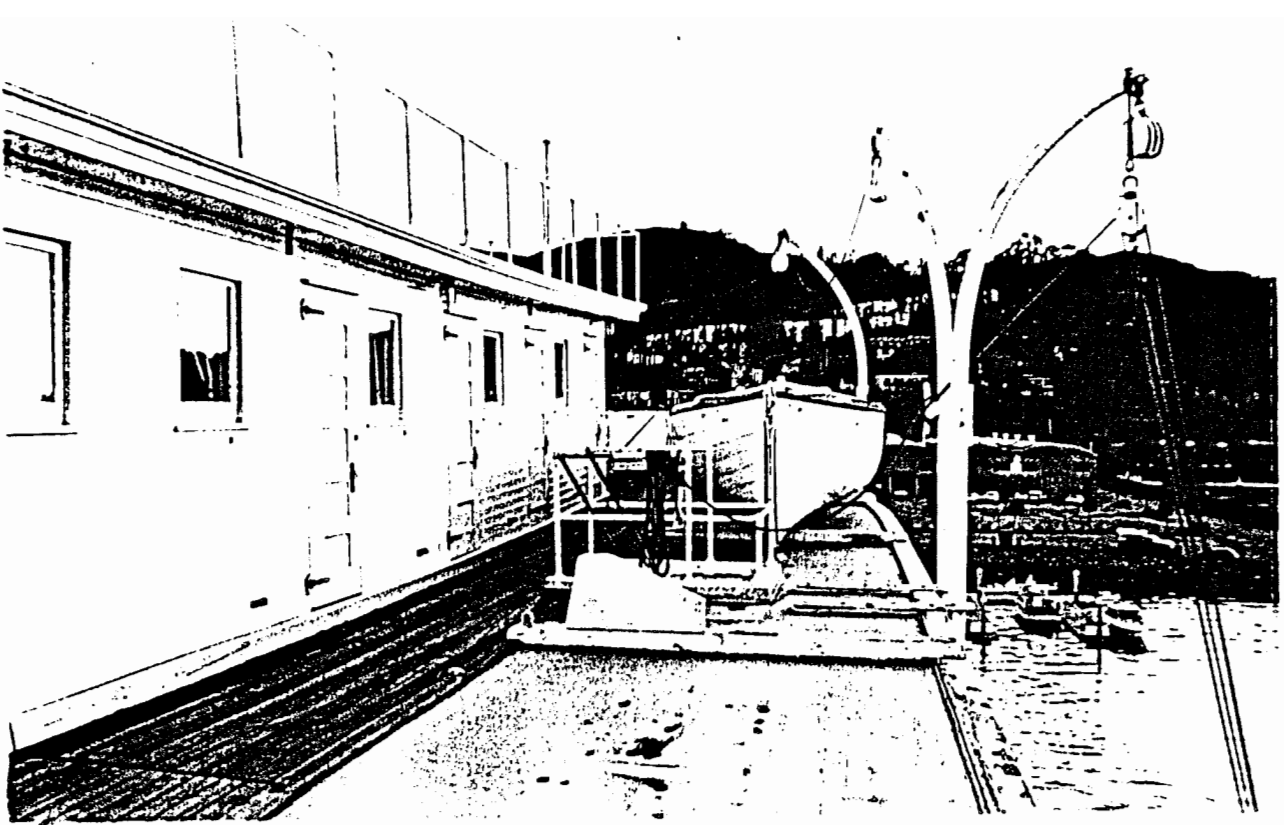
The boat deck is in generally good condition, primarily due to the extensive rebuild undertaken in the early 1960s. Although the deterioration seen on this deck is relatively minor, it appears to be advancing at a rapid rate, a result of improper drainage of rainwater. Drainage has become a problem because the WAPAMA is not trimmed by the stern, as she was when afloat. This means that the scuppers and drains are no longer at the lowest points in the deck and house tops, and standing water results. This water eventually seeps down into the structure and the rot process begins.

Most boat deck beams and decking are in good condition, with the exception of an area at the starboard deck edge between frames 58 and 61, in way of the fidley trunk. Here the deck edge stringer, two deck beams and outer deck planks are rotten due to poor drainage.

Torn areas are seen in the canvas deck covering, forward of the pilot house and in several areas near the deck edge. The quarter-round molding at the covering boards is soft or rotten throughout. The covering boards themselves are generally sound, except for the rot seen around the port access ladder deck opening.

Fig. 27. View of boat deck, port side, looking aft.

The boat deck area should be considered a preservation priority because of the relatively intact state of the structure. The ongoing deterioration, due to rainwater seepage, will eventually result in costly repairs or loss of structure. The most effective means of preventing this would be to place a weather cover over the entire deck. If this cannot be done, individual covers should be placed over the pilot/chart house, fidley trunk, and boat deck house. In addition, areas of torn canvas decking should be repaired, and standing water eliminated by installation of scuppers. The two lifeboats should be covered or removed to protective storage. The two transom boats should also be protected, even if rebuilding or replication is planned.

Although the boat deck is presentable for public display at this time, access should be limited until the weakened support pillars on the port side (noted in section Cabin Deck) are repaired or reinforced.

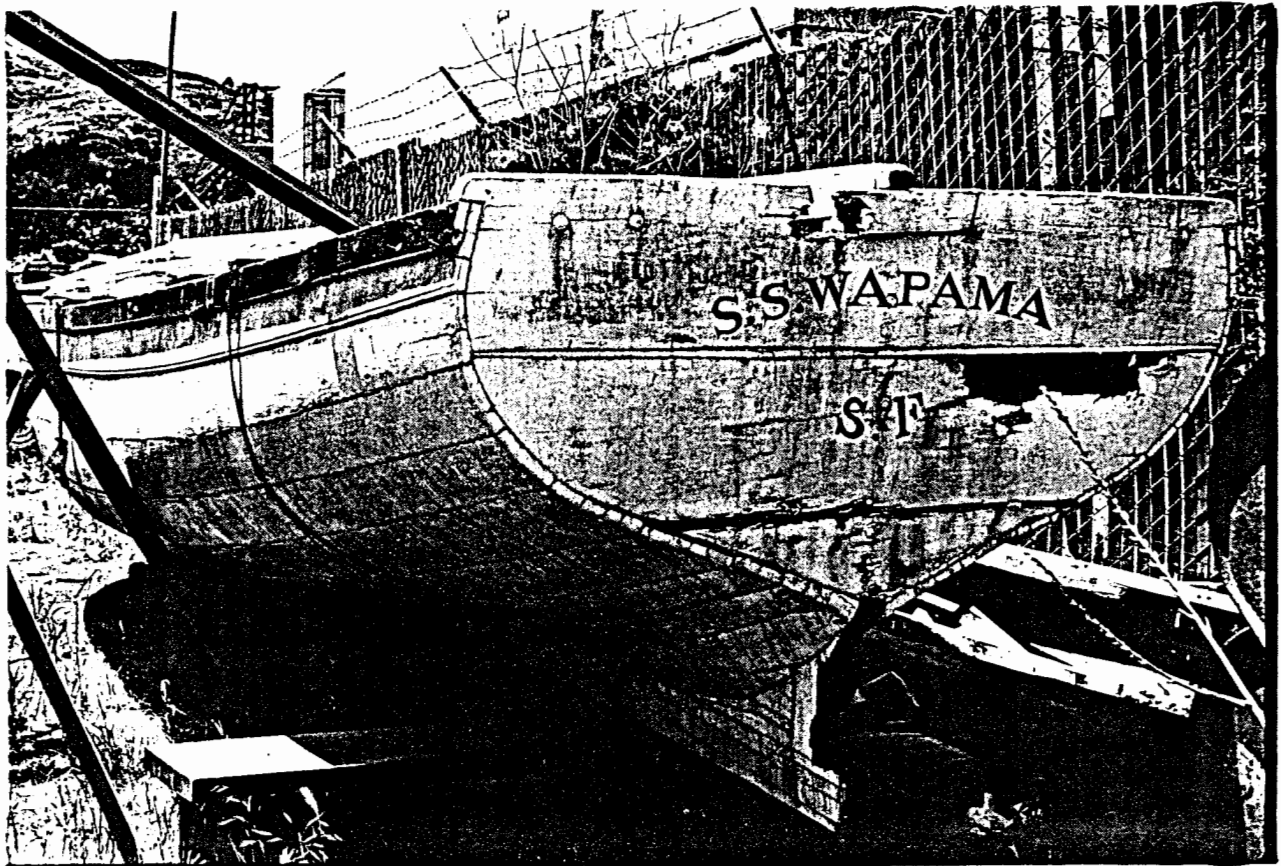
Fig. 28. Transom stern launch removed to shore. --TCM

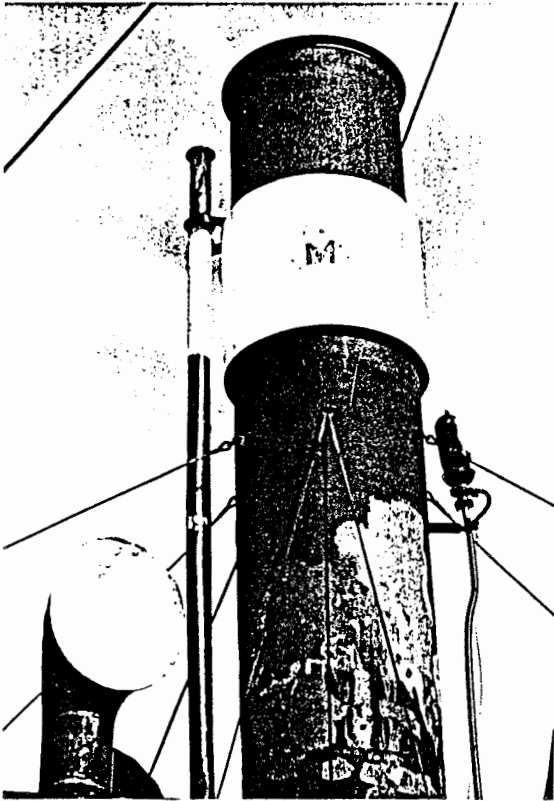
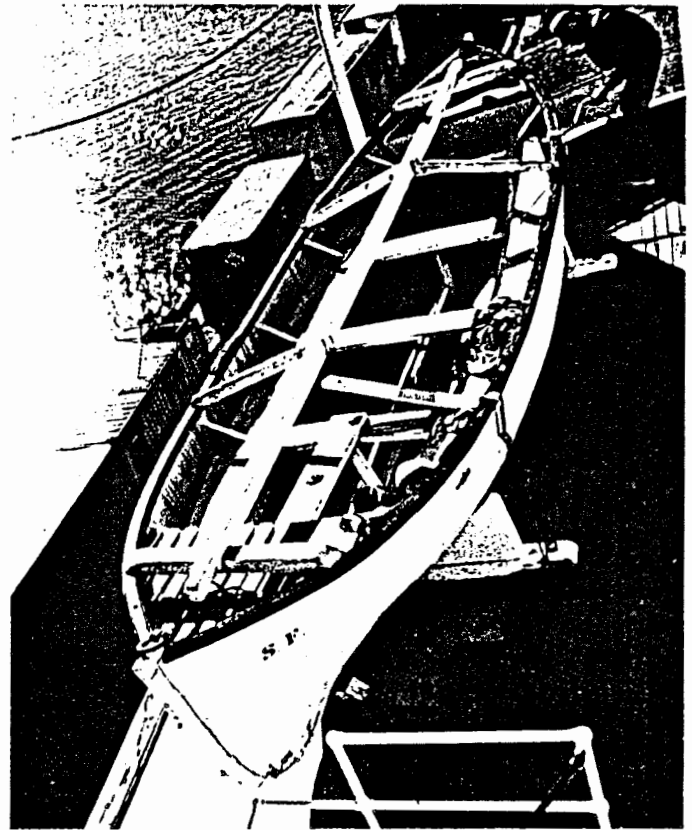
The steel fidley trunk has rusted through in local pits on the top, and active corrosion is seen on the ventilators. The stack above the fidley trunk is in good condition, though the iron pipes running up the aft side of the stack are corroded and coming adrift. The stack stay wires show signs of corrosion but are considered adequate for the time being.

Fig. 29. Stack.

Fig. 30. Steel double-ender in place.

Fig. 31. Steel fidley trunk. Note covered deadlights over portholes.

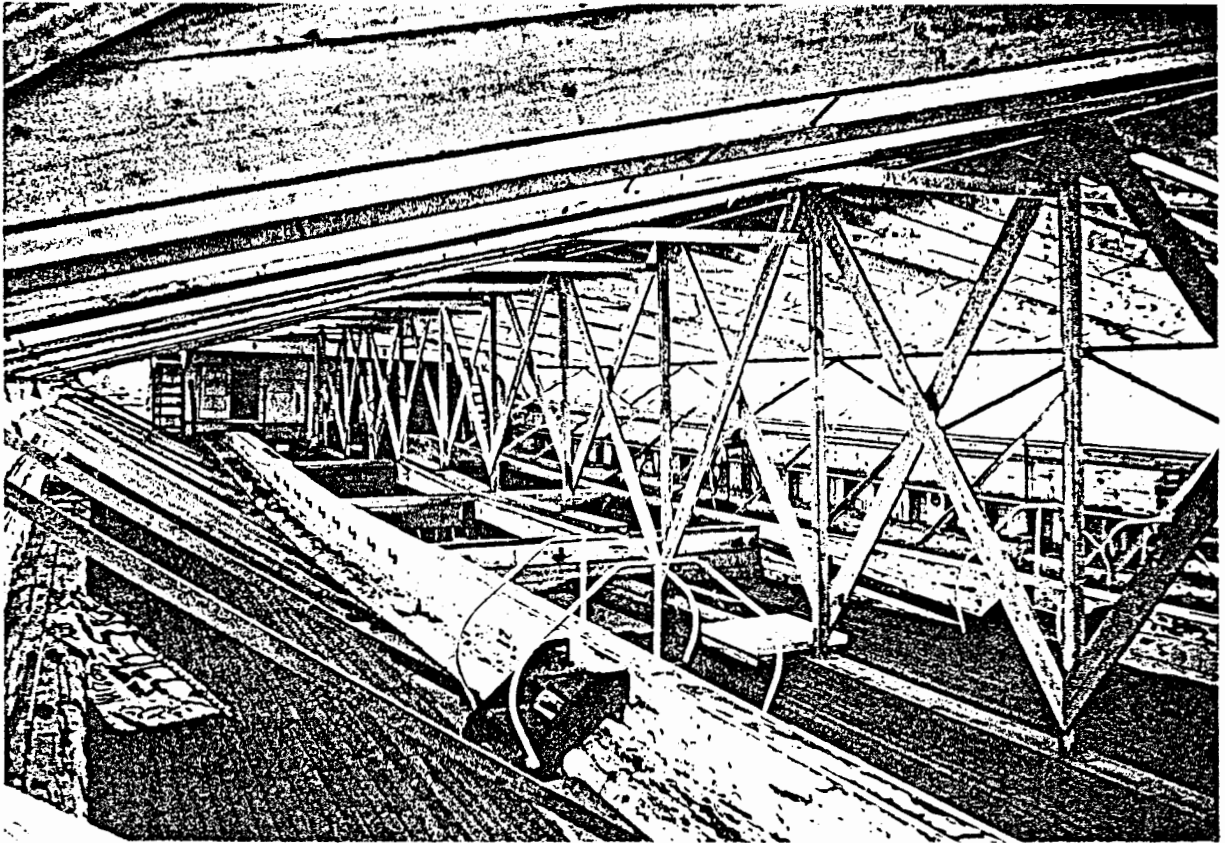
The present cover is a good start but provides only limited protection to the main deck and forecastle head, and none for the rest of the ship. The cover, as it is now, has very little overhang and even a slight angle of wind driven rain will soak the decks and pass on to the interior of the ship. In addition, protection should be provided for the porous topsides as well as the superstructure aft. This protection would be neither expensive nor difficult to achieve if use is made of reinforced plastic sheeting held in tension by a simple frame.

Fig. 49. Present cover over main deck. (1986)

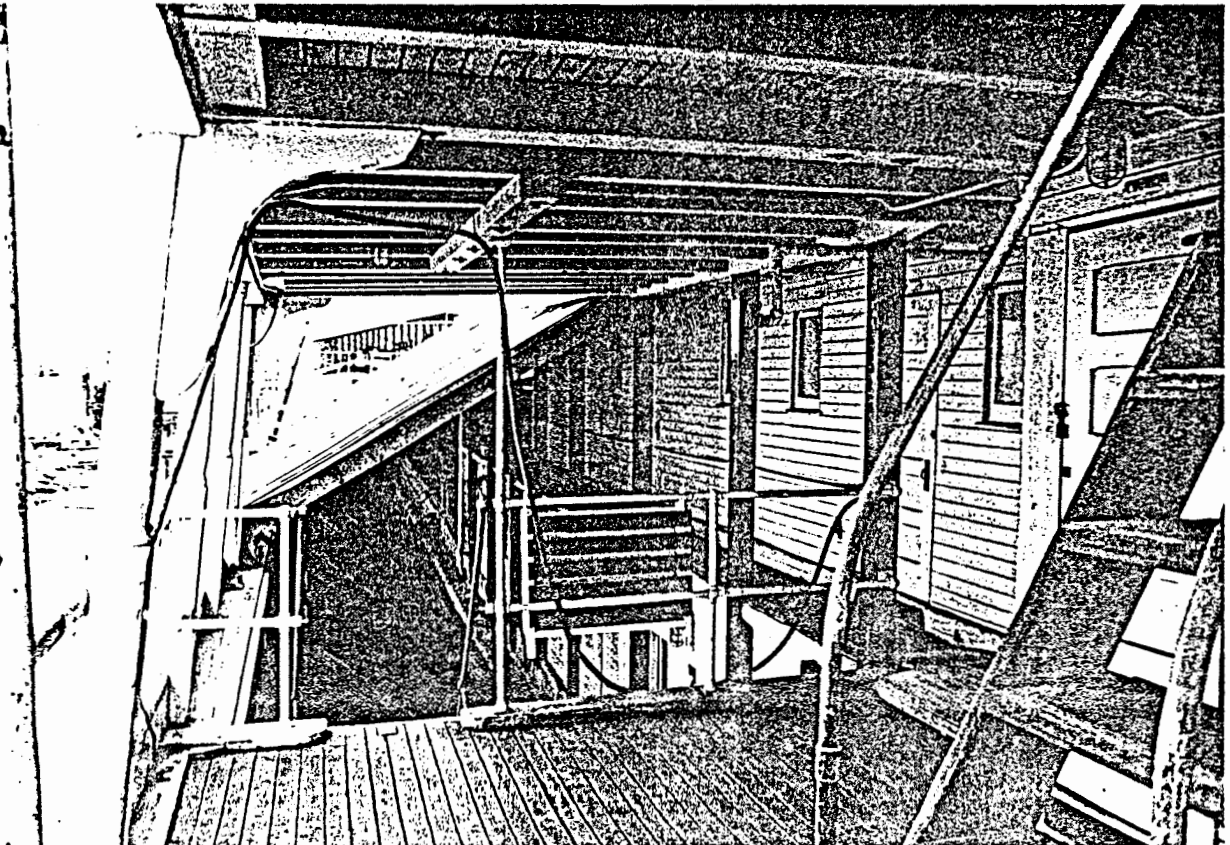
Fig. 50. View forward, port side, from cabin deck, showing compromised visitor circulation and sight lines.

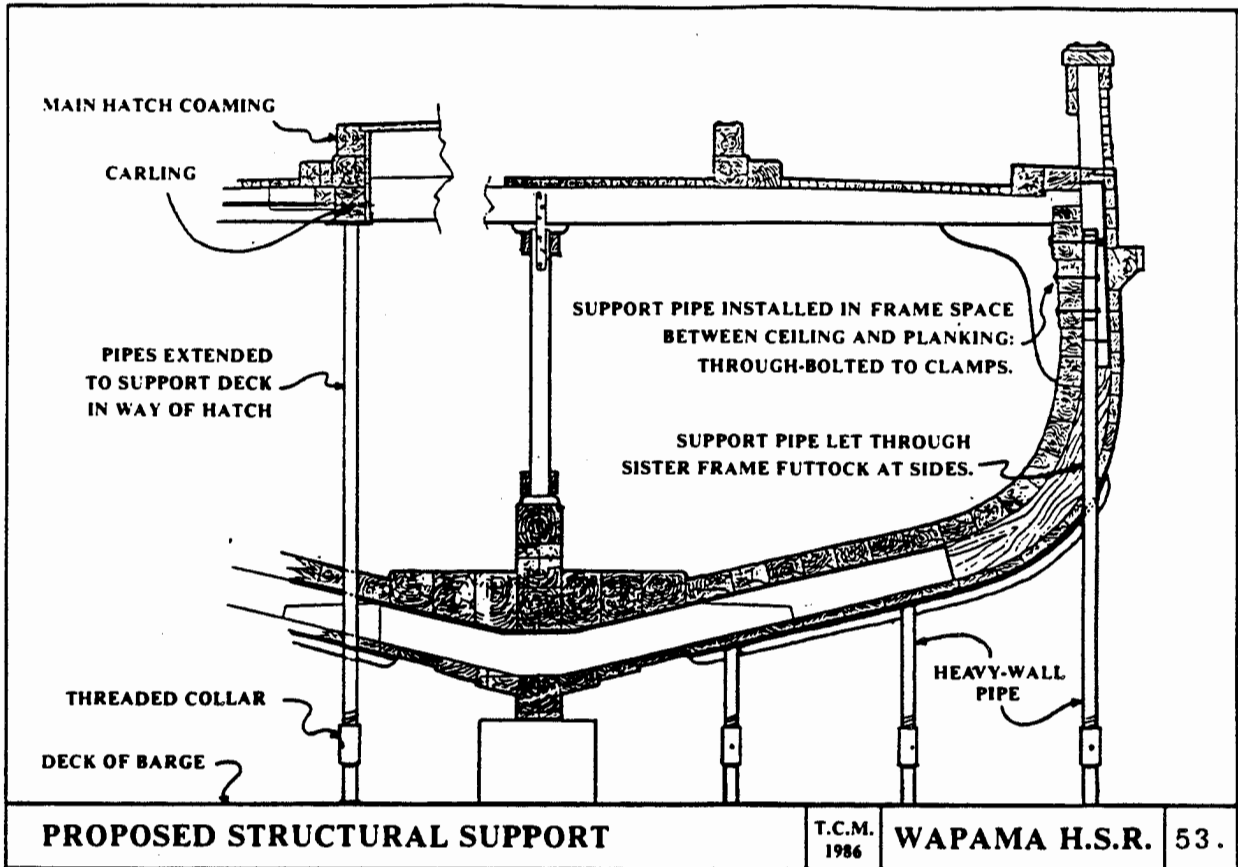
Ships are designed to be supported evenly and continuously by water. When out of water for prolonged periods of time and supported on only a few points, their own weight works very much against them. Therefore an optimum support system for the WAPAMA would simulate the support of water by providing multiple points of support rather than a few concentrated areas such as her present bilge blocking system.

Another design criteria for a permanent support system should be unobtrusiveness for the sake of interpretation. The added support should block or distract viewing of hull form as little as possible. Designing a system that is visually minimal and structurally adequate will require an engineering effort beyond the scope of this report. A suggested concept for such a system is given in figure 53.

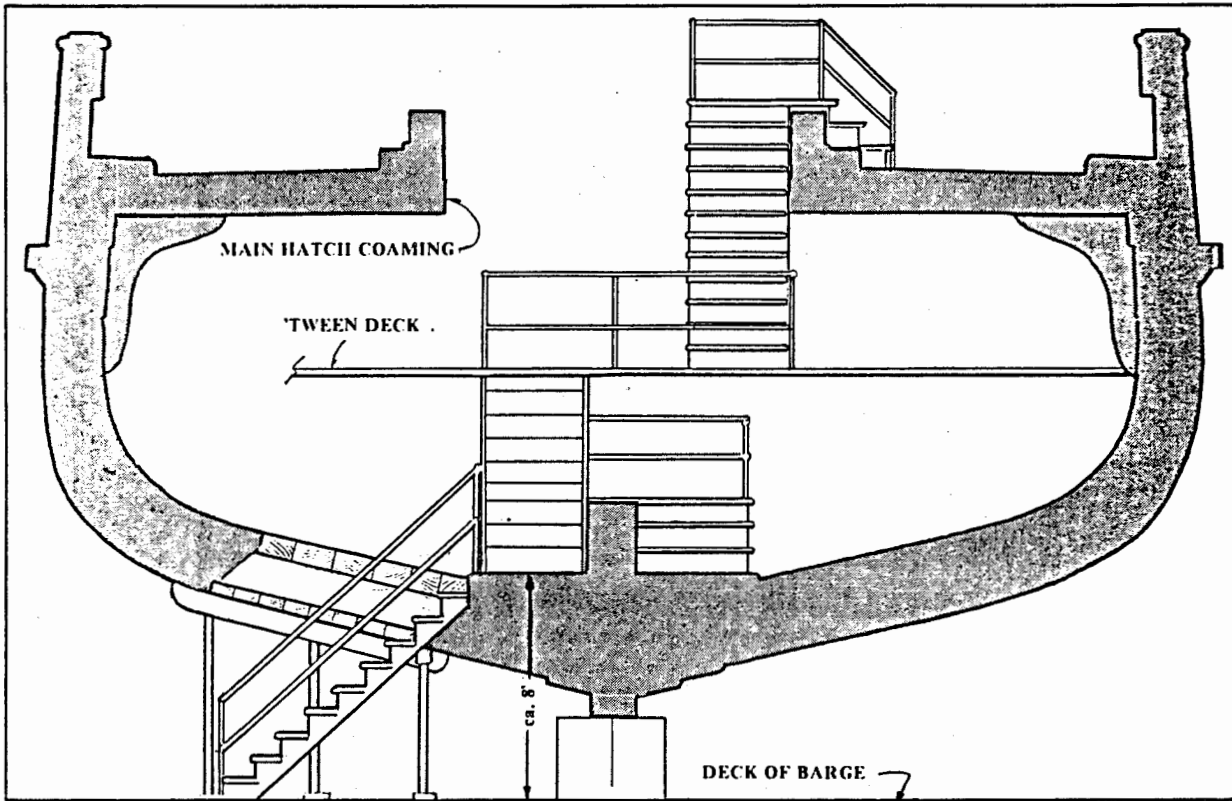
PROPOSED HOLD AND MAINDECK ACCESS

The main deck is now high above the visitors as they stand on the barge. A climb up the narrow outside stairway is required in order to reach this deck. A visit the hold requires a steep climb down again, and again back up. To alleviate this problem, it is proposed that a 7 foot square access be opened in the bottom of the hull, in way of the main hatch. (see fig. 56 and 57). The visit then begins with a dramatic view of the wooden expanse of the ship's bottom, goes through a cross-section view of the structure of the bottom, and enters several steps up into the vast curving hall that is the ship's hold. Another comfortable stairway would then lead to the main deck by way of the 'tweendeck and main hatch.
