# HISTORIC STRUCTURE REPORT

## JAMES MORSE HOUSE LINCOLN HOME NATIONAL HISTORIC SITE SPRINGFIELD, ILLINOIS

HISTORICAL DATA SECTION  
ARCHITECTURAL DATA SECTION  
EXTERIOR RESTORATION PROPOSAL

HISTORICAL ARCHITECT ALAN W. O'BRIGHT  
OFFICE OF PLANNING AND RESOURCE PRESERVATION  
DIVISION OF CULTURAL RESOURCES MANAGEMENT  
NATIONAL PARK SERVICE  
UNITED STATES DEPARTMENT OF THE INTERIOR  
OMAHA, NEBRASKA

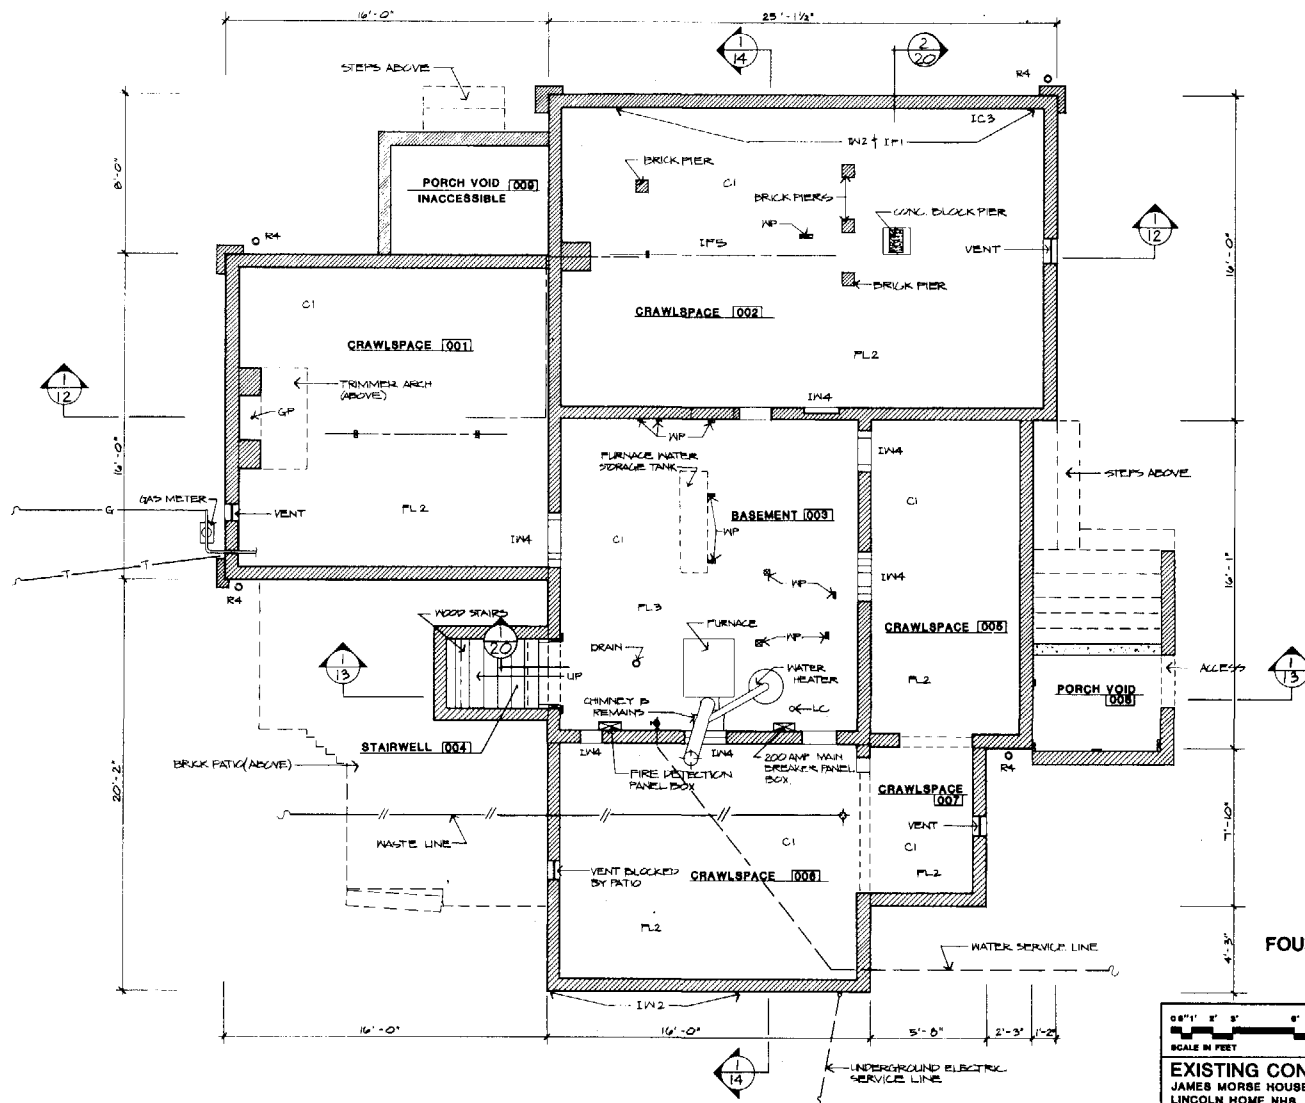
FOUNDATION PLAN

The existing red brick foundations are in no immediate danger of collapse. Although there are no major cracks or signs of settlement, areas of deterioration exist. Single course, triple wythe brick footings exist beneath all foundation walls which are all double wythe. (See Detail 2/20, p. 74). The damp condition of the soil and age have decayed the mortar joints, especially in the full cellar area. The mortar joints at the sill header course have failed in many places, especially along the south and north walls of Crawlspace 002. Some of the bricks have partially slipped out from beneath the wood mud sill (see Figure No. 12). Two top courses of foundation brick were removed

at the north wall of Crawlspace 002, and a 4- by 4-inch wood member inserted beneath the mud sill as replacement for the brick. Apparently the brick deteriorated so badly this work was performed to halt the settlement of the entire north wall of the building. Many openings were punched through interior foundations to run utility lines and to gain access to crawlspace areas, adding more stress on the supporting brick walls.

Chimney B, once engaged to the foundation wall, was broken from the wall, leaving only one wythe of support. Most of the foundation walls are at or just below grade, making them vulnerable to ground movement caused by freezing and water absorption in the soil. Some areas in the crawlspaces were constructed at grade, and are not accessible for inspection.

Pargetting was troweled to all exposed surfaces of the foundation at the exterior. The mortar is very hard and is virtually impossible to remove without severely damaging the brick and mortar joints. Some has spalled at the exterior southwest corner of Crawlspace 006 due to an unrepaired downspout and freeze-thaw cycles. The mortar bonded so well that whole bricks have fallen out with sheets of the mortar still clinging (see Figure No. 13).

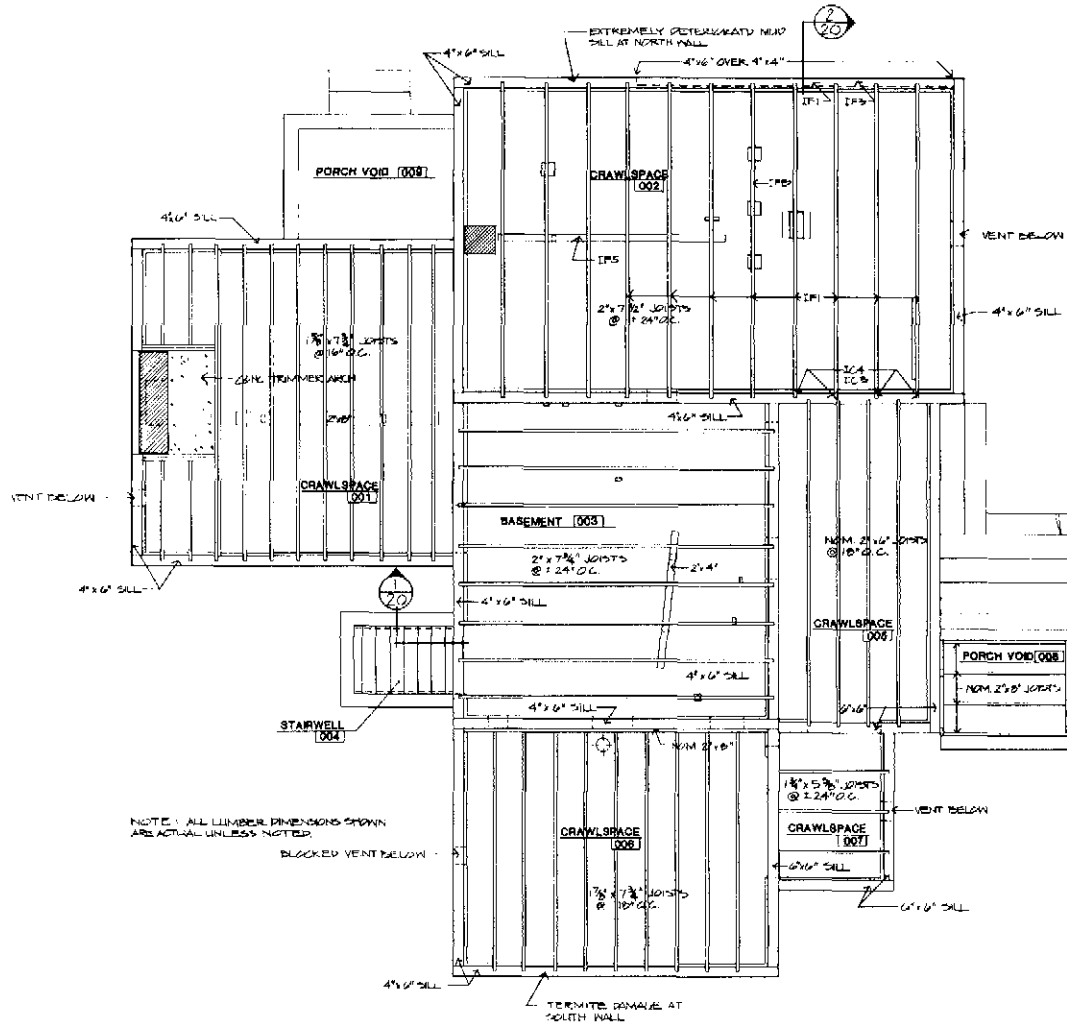
<p>SCALE IN FEET</p>	PREPARED DESIGNED CHECKED DATE	DRAWING NO. 449 80017
	EXISTING CONDITIONS JAMES MORSE HOUSE HS-9 LINCOLN HOME NHS	SHEET 21 OF 27

BLOCKED VENT BELOW

Termite damaged or rotted sills and plates should be completely replaced and secured with adjacent members. Areas of deterioration are described in the existing conditions drawings. Deteriorated or missing studs should be replaced or supplemented as required when uncovered. Headers should be placed above all windows and doors where none exist, where existing headers are insufficient, or where new doors and windows are being installed.
