MAURICE STEPHENS HOUSE (SITE OF HUNTINGTON'S QUARTERS)

Valley Forge National Historical Park

HISTORIC STRUCTURE REPORT

February 2008

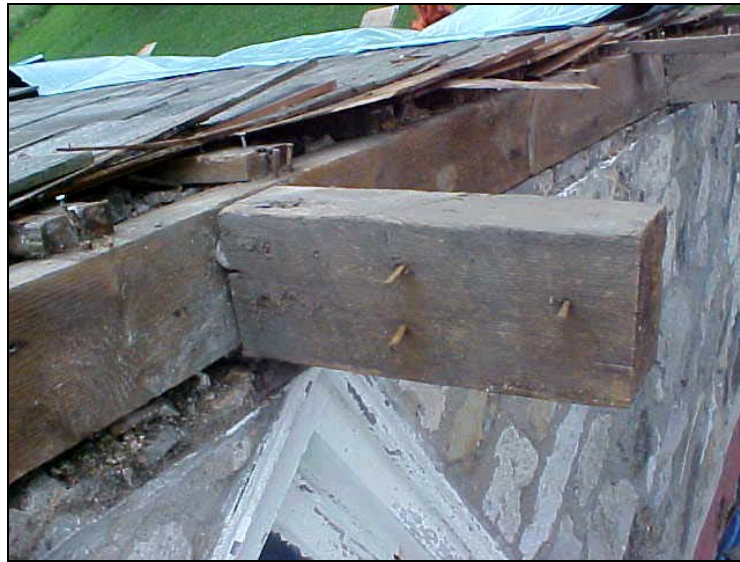
The box cornice, moldings, and reeded frieze boards were nailed to the ends of the attic joists, which extended through the masonry wall and the plate upon which these joists rested. As Dodd pointed out in his report, the cornice as originally constructed terminated at the gable walls, and probably only had flush board returns on the gable ends. Investigation of the eaves by park Historical Architect Tim Long confirmed Dodd's supposition, finding that the outlookers upon which the larger existing eaves were constructed were mortised through the end rafter pairs at a later date, and nailed with "modern" machine cut nails probably produced after 1840.

Figure 11. Nonoriginal eave extension, or "outlooker," mortised into original gable end rafter (2004 photograph).

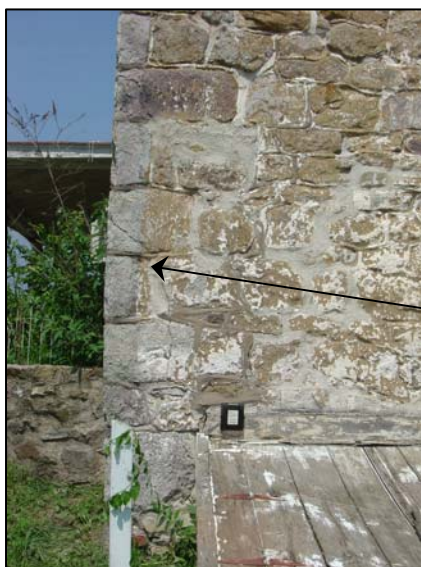
There are several repointing campaigns visible in the main block of the house. However, a remnant of the building's earliest mortar joints was discovered after the south porch was removed, revealing a stucco finish coat and behind that the ridge (or crown) pointing of the original construction campaign. The pointing mortar was rich in lime, and white to light pink in color, with little aggregate. The joint was finished with a crisp, convex, v- shape. Thus, the original appearance of the building seems to have been exposed fieldstone with finely pointed mortar joints. A subsequent repointing may be represented by a bed- joint found at the southeast corner of the main house (fig. 13). Its mortar is similar to the original, but it contains more aggregate, and its convex v- shape is of lower profile (fig. 14).³

Figure 13. Early v- shaped mortar joint extant at the southeast corner, main house (2004 photograph).

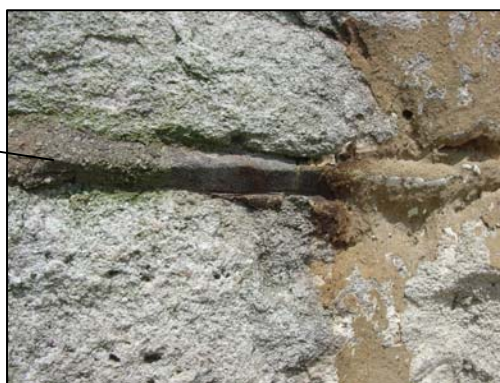
Figure 14. Detail of early v- shaped mortar joint.

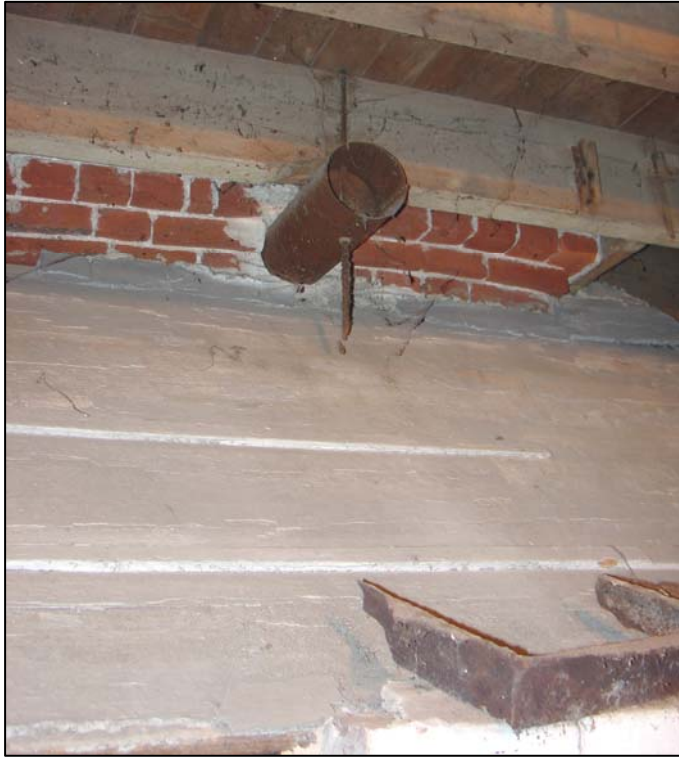
The efficiency of the coal- burning inserts seems to have been enhanced by a duct- and- damper system that regulated the flow of air to their fires. Round ducts in the chimneys bases (fig. 17) carried air to the first- story fireboxes. Dampers within the ducts were activated by long rods that ran up through the first floor, connecting to handles set in the two brick hearths just in front of the lip of the inserts (fig. 18). Rotating the handles would control the air supply to the inserts, producing either a hotter or cooler burning of the fires within them.

Figure 17. Duct with damper in Room 002 (south basement). The damper was controlled by a rod attached to a handle set into the hearth of the first- story fireplace above.

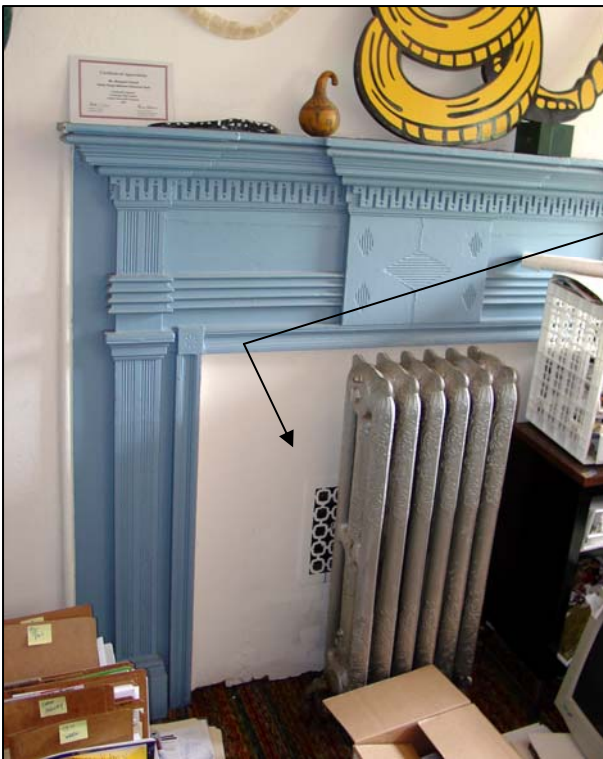
Circa 1900, during the Todd period, a system of central heating was installed.⁸ This is based on the existence of a furnace flue in the east chimney, and on a hot- air register set into the infilled firebox in Room 202 (fig. 19). Dodd says that the addition of the flue was part of a larger reworking of the chimney stack at the first- story level. The large kitchen fireplace in the ell was made shallower; this created enough room to add a shallow fireplace facing into the original kitchen, and the new furnace flue. It is not known what effect this work had on the fireplace above it, in the southeast bedroom. The firebox is currently covered with a board.

Figure 19. Heat register set into closed firebox of Room 202. Interestingly, this photograph shows all three generations of the house's heating system, including the original fire place, the late 19th- century hot- air register system, and the 20th- century radiator system.

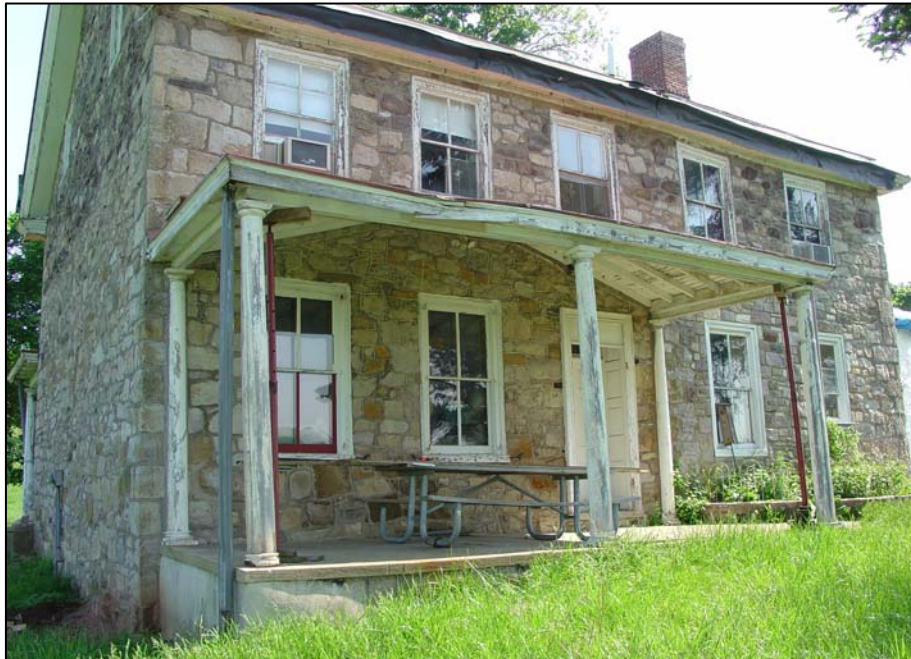
The 1919 photograph of the building also reveals that by that year, the porch on the north side of the house had been rehabilitated, with the original columns (seen in figure 3, dated 1902) having been replaced with Tuscan- order columns. The same type of columns was introduced at the south porch (fig. 20), presumably at about the same time. The stone retaining wall around the berm was in place by now, and the south porch of the ell was enclosed.

Figure 20. Front porch of house, added ca.1860- 1880, and modified with Tuscan- order columns ca. 1902- 1919.

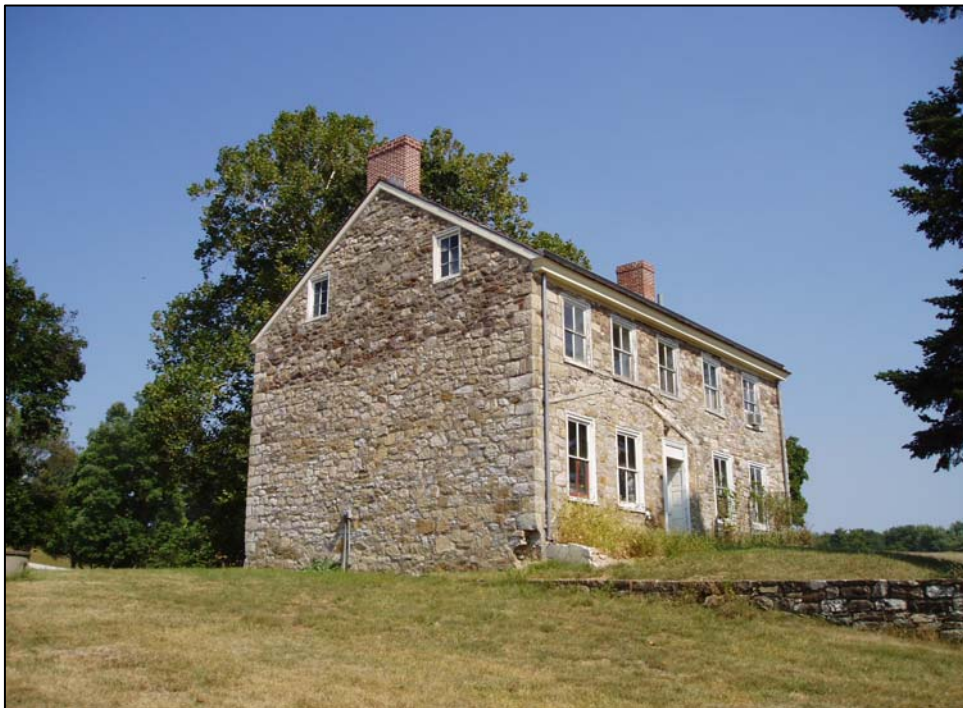
Figure 24. South and west elevations of the main house.

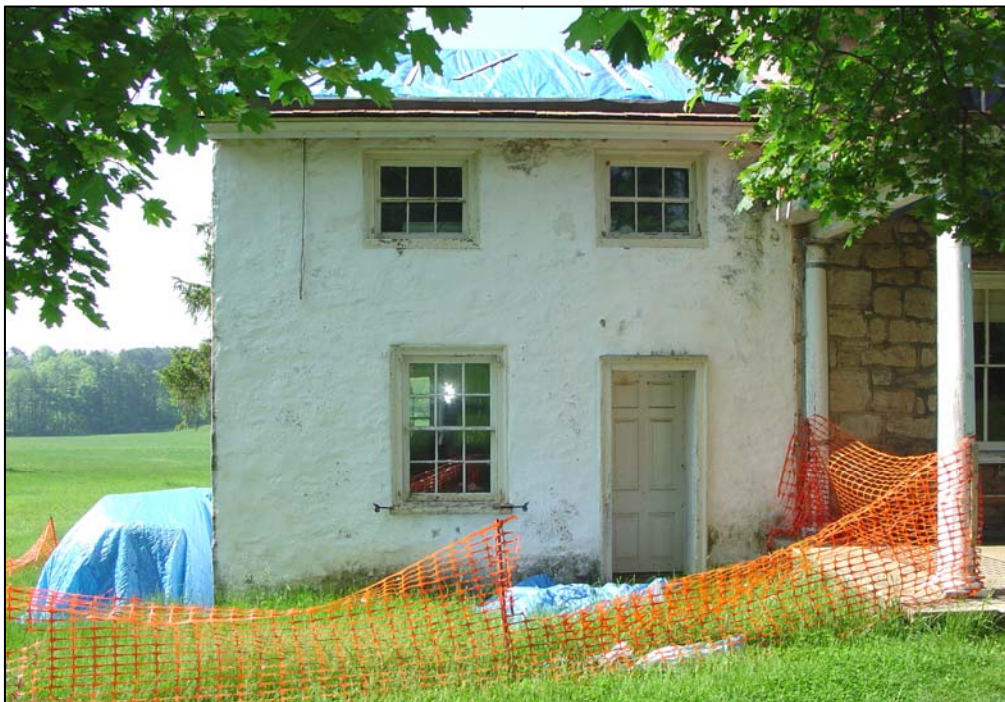
Figure 28. North elevation of the ell during reroofing in 2004.

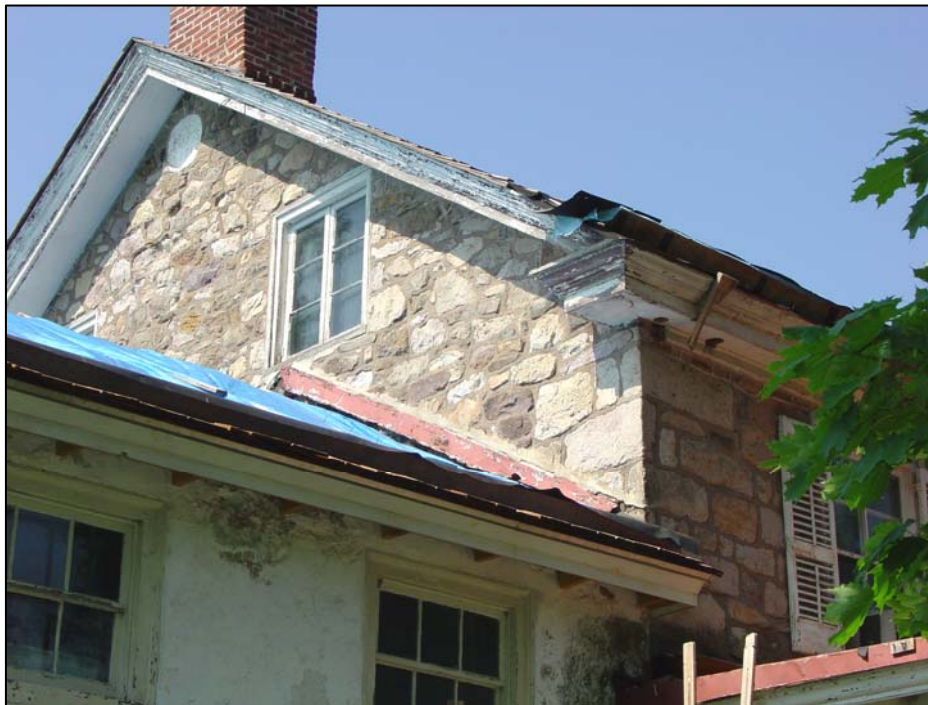
Figure 30. Main house, east end, detail of extended cornice and return.
(Photograph taken in 2004.)

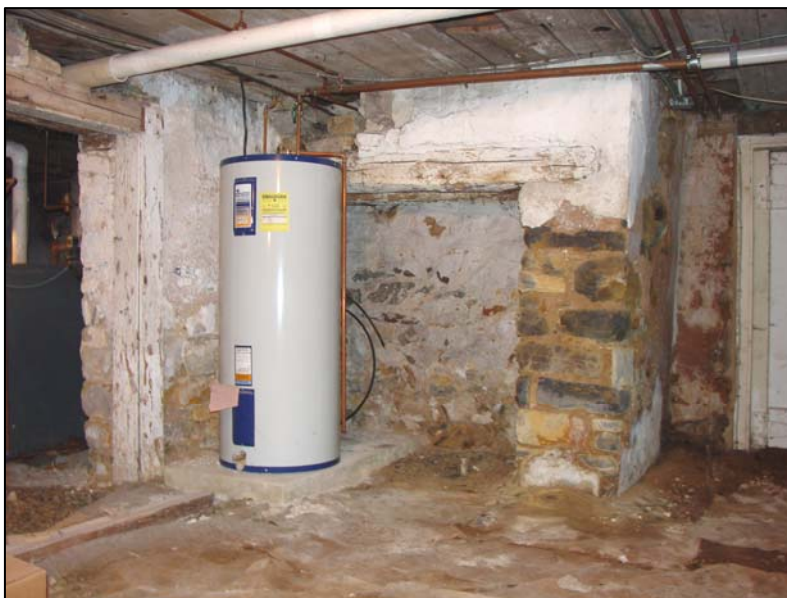
Figure 34. Room 002 (south basement), east wall, south portion of the original chimney, showing how the base was partially infilled to allow the creation of a large fireplace in the added ell.

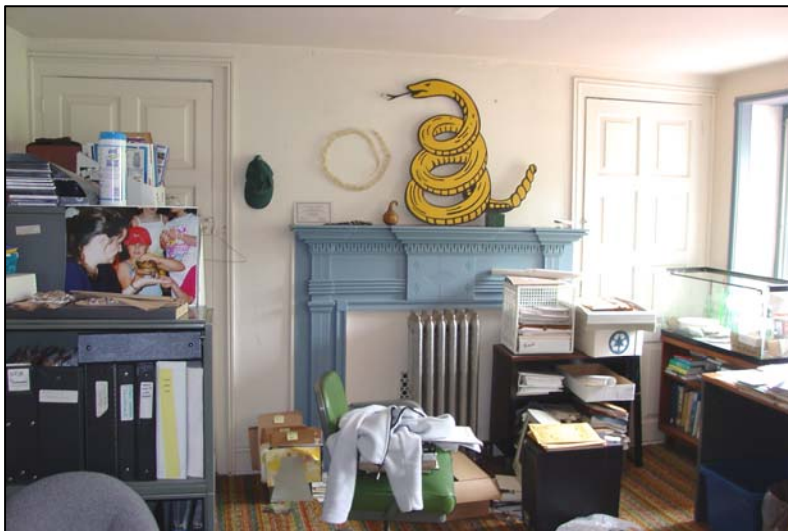
- Fireplace: One, at the west wall. The original mantel measures $68\frac{1}{4}$ inches wide by $55\frac{3}{4}$ inches high, with chip- carving around the firebox opening, which measures 43 inches wide by 37 inches high.⁶ The firebox has been infilled, and has a heating grille and later radiator.

Figure 64. Room 202 (northwest bedroom), west wall, showing the fireplace and the shallow closets flanking it.

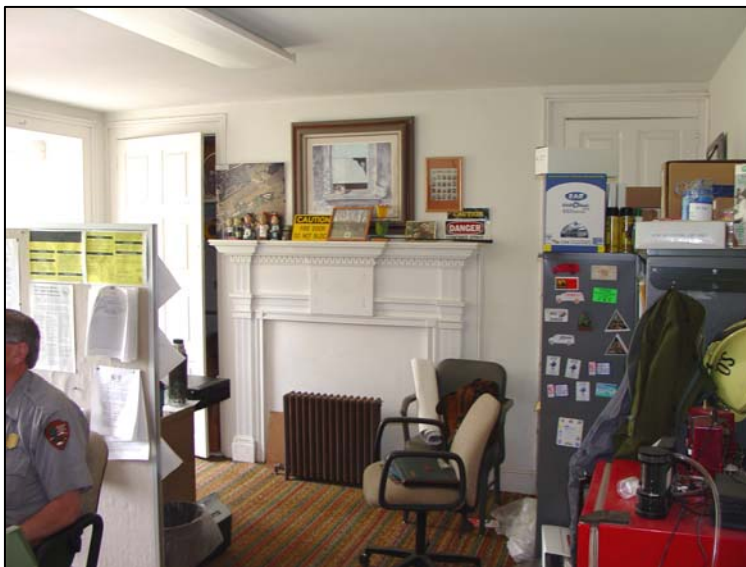
- Fireplace: One, at the west wall. The original mantel measures $69\frac{3}{4}$ inches wide by 59 inches high. The firebox measures $43\frac{5}{8}$ inches wide by $39\frac{1}{4}$ inches high;⁷ it has been infilled, and has a stovepipe- like hole covered by a later radiator.

Figure 67. Room 203 (southwest bedroom), west wall, showing the fireplace and the shallow closets flanking it.

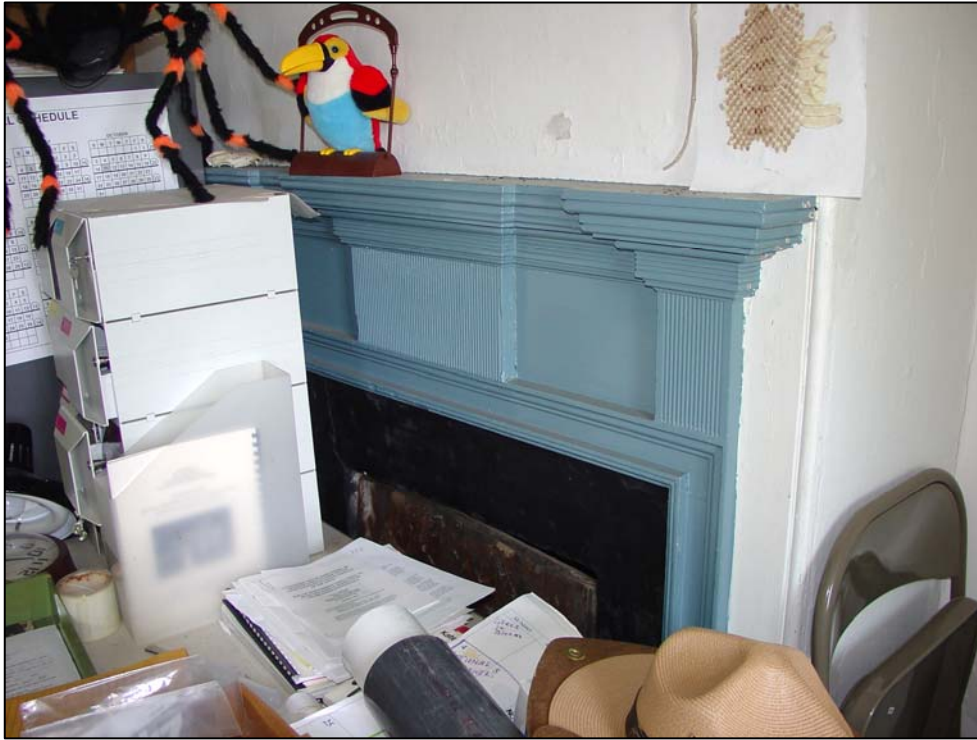
- Fireplace: One, at the east wall. The original mantel measures $54\frac{3}{4}$ by $52\frac{1}{4}$ inches, with chip- carving and reeding around the firebox opening, which measures $39\frac{3}{4}$ inches by $37\frac{1}{4}$ inches. The firebox has been infilled, and has a heating grille in it.

Figure 79. Room 206 (southeast bedroom), east wall, showing fireplace mantle.

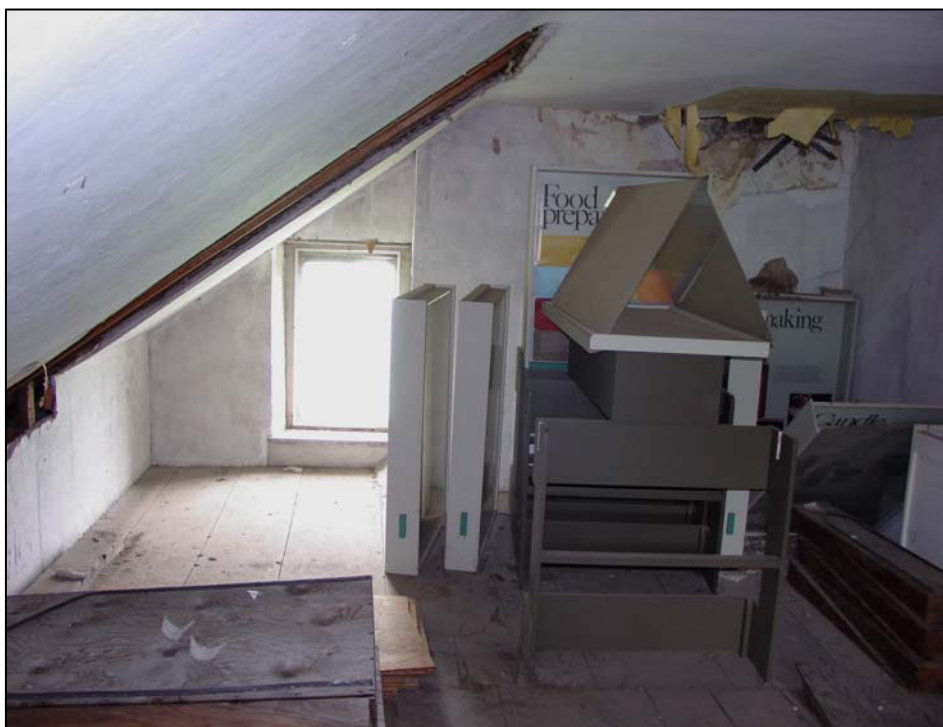
Figure 89. Room 302 (center attic room), west wall, showing dormer infill, casement sashes, and chimney.

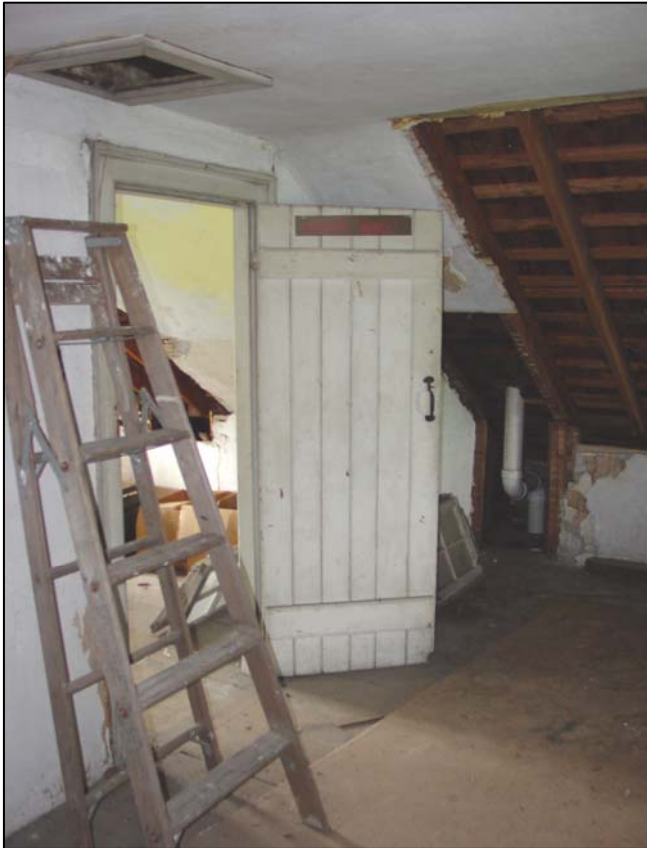
Figure 90. Room 302 (center attic room), southeast corner, showing the doorway to Room 301 (east attic room), with a board- and- batten door. Also shown is the ceiling scuttle to the attic, and an area of ceiling disturbed by the addition of an early 20th- century dormer (removed in 1978).

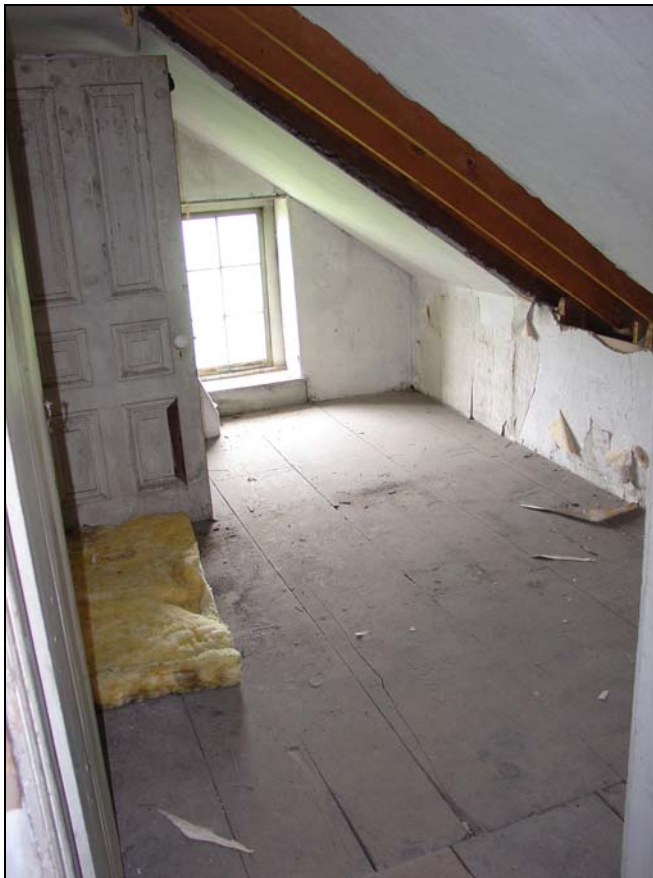
Figure 91. Room 303 (northwest attic room), looking west. At right is an area of ceiling disturbed by the addition of an early 20th- century dormer (removed in 1978). (Note: the door at the right side of the photograph is being stored in the room and is not part of the space.)
