HISTORIC STRUCTURE REPORT

WASHINGTON MONUMENT AND ASSOCIATED STRUCTURES

VOLUME I – WASHINGTON MONUMENT

PREPARED BY
John Milner Associates, Inc.

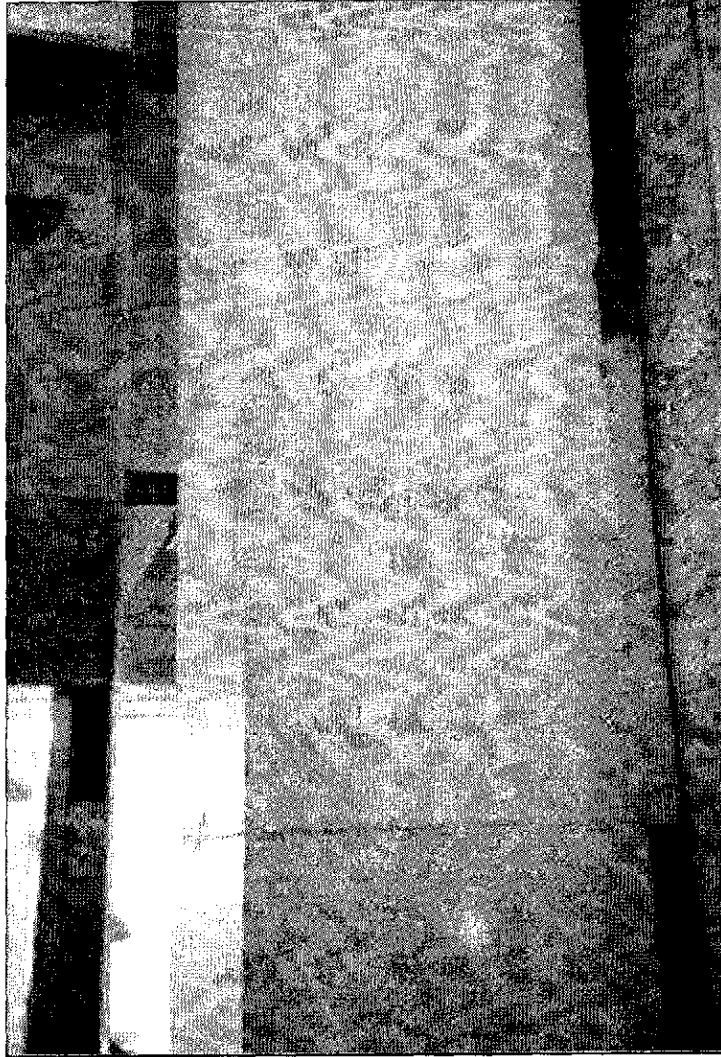
historic graffiti adorn the marble. Carved into the marble surface are several characters, a profile of George Washington, and the date 1861 (see figure 4.29).

Figure 4.29: East elevator lobby, view to the east, showing the south door surround with historic graffiti.

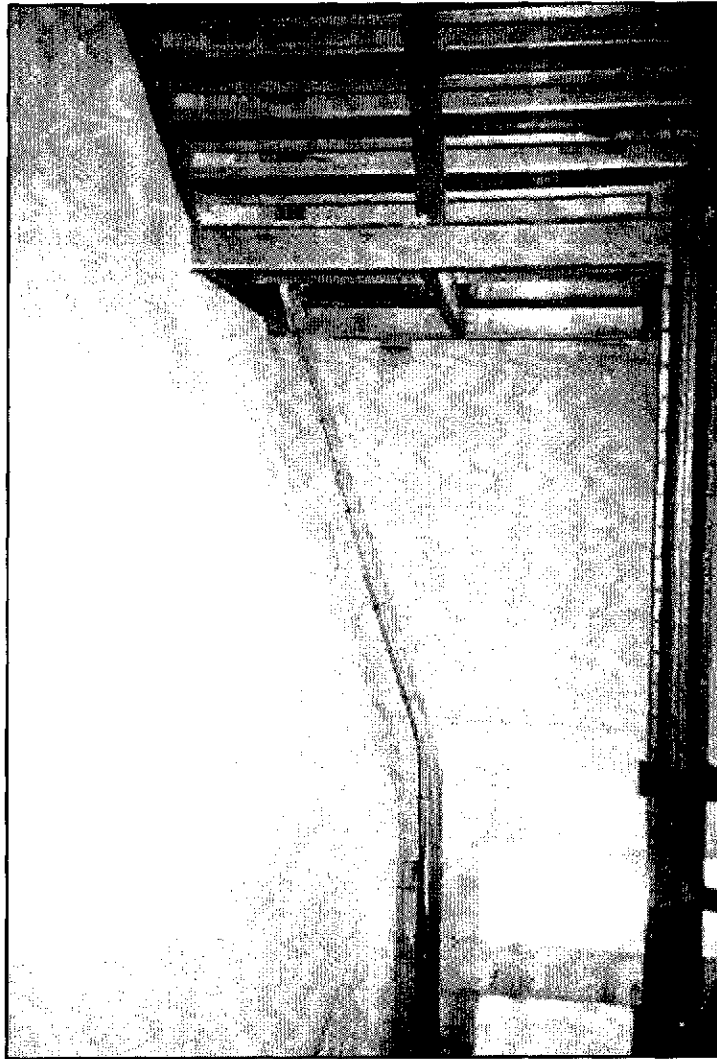
Efflorescence was noted accumulating at masonry joints from the 150- to 410-foot levels. The presence of efflorescence indicates that water is moving through the masonry joints and is evaporating on the interior, leaving behind dissolved salts on the interior of the shaft (see figure 5.14). While efflorescence was found on all elevations, it was more often noted on the east and northwest interior elevations.⁵ The efflorescence is not severe and does not indicate an unacceptable level of moisture movement within the masonry.

Figure 5.14: Washington Monument, interior, central shaft, efflorescence.

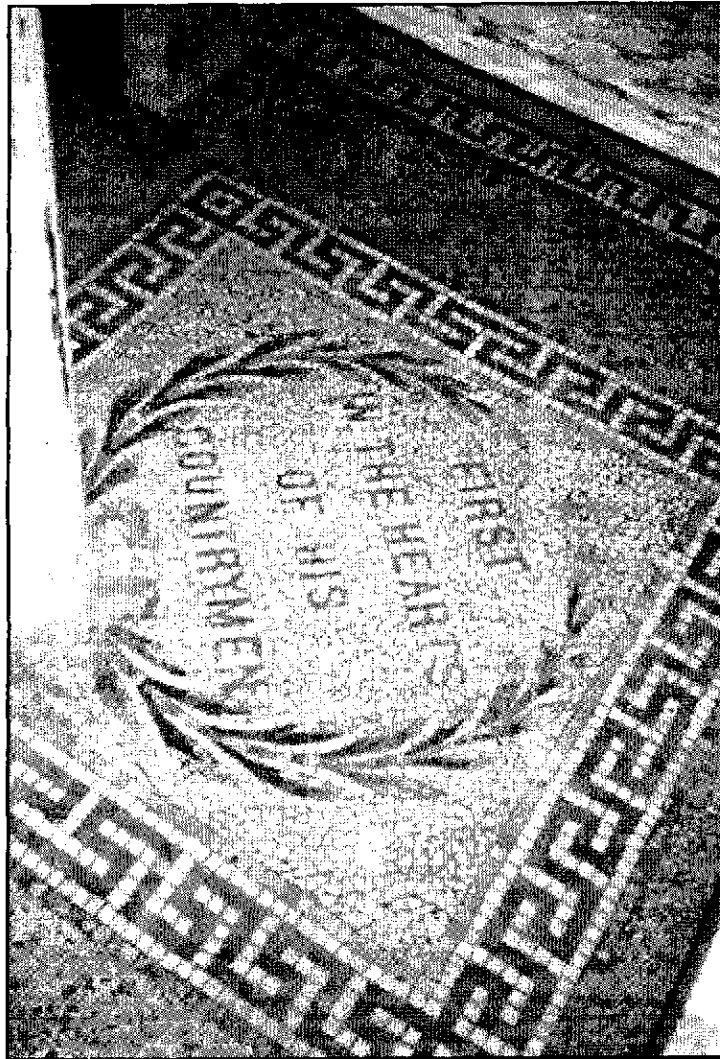
Figure 5.19: Washington Monument, interior, central shaft and stairwell, loss in terrazzo floor at 310-foot level.

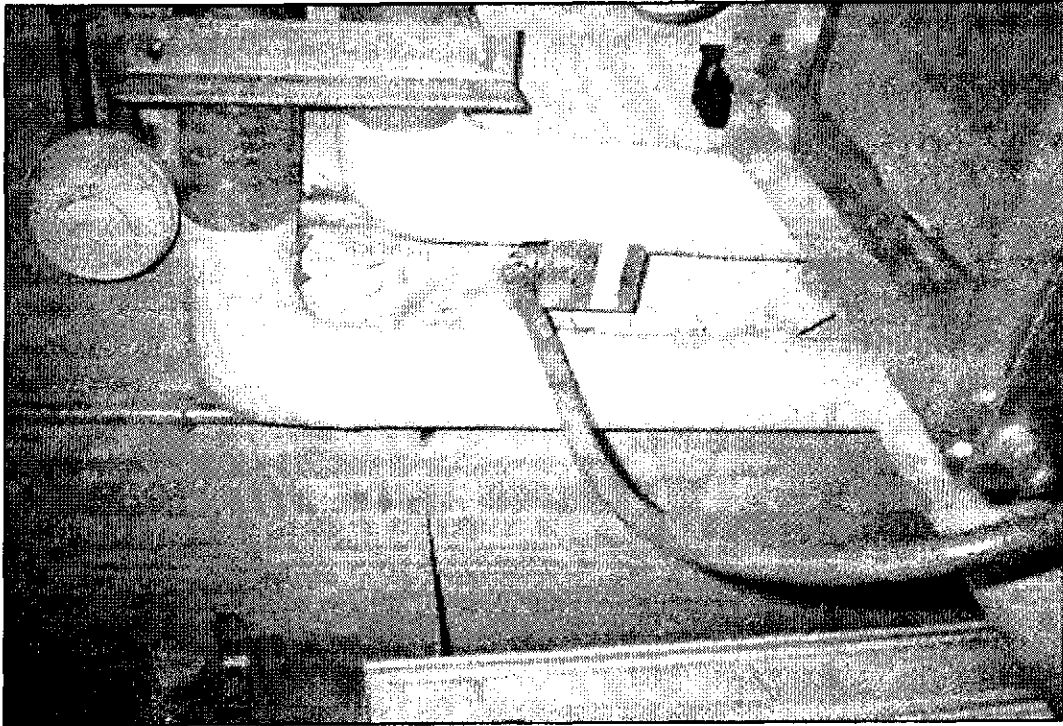
The concrete steps at the entrance are spalled, cracked, and delaminating, particularly near the top of the entrance. Stalactites of efflorescence have formed at the concrete covering the western end of the entrance area, indicating considerable water movement through the masonry. Rust staining on the concrete in this area indicates that concrete reinforcing bar is actively corroding. The ceiling structure in this area should be investigated and appropriate repair methods undertaken in order to halt ongoing deterioration. The cement plaster on the brick masonry at the entrance steps is cracked with large areas of loss. Efflorescence is forming at the cracks. In some areas, large accretions of efflorescence have accumulated (see figure 5.21). It is recommended that the deteriorated cement plaster be completely removed. The source of water infiltration, whether from the open grate above or from the surrounding earth, should be investigated prior to replacing the plaster. Appropriate remedial measures should be taken, including installation of flashing, new drainage, and/or below-grade waterproofing, as deemed necessary.

Figure 5.21: Washington Monument, Bunker 1, interior, entrance area, looking east at south wall.
