FINAL REPORT

JUNE 2004

WASHINGTON MONUMENT AND
ASSOCIATED STRUCTURES

VOLUME III – SURVEY LODGE

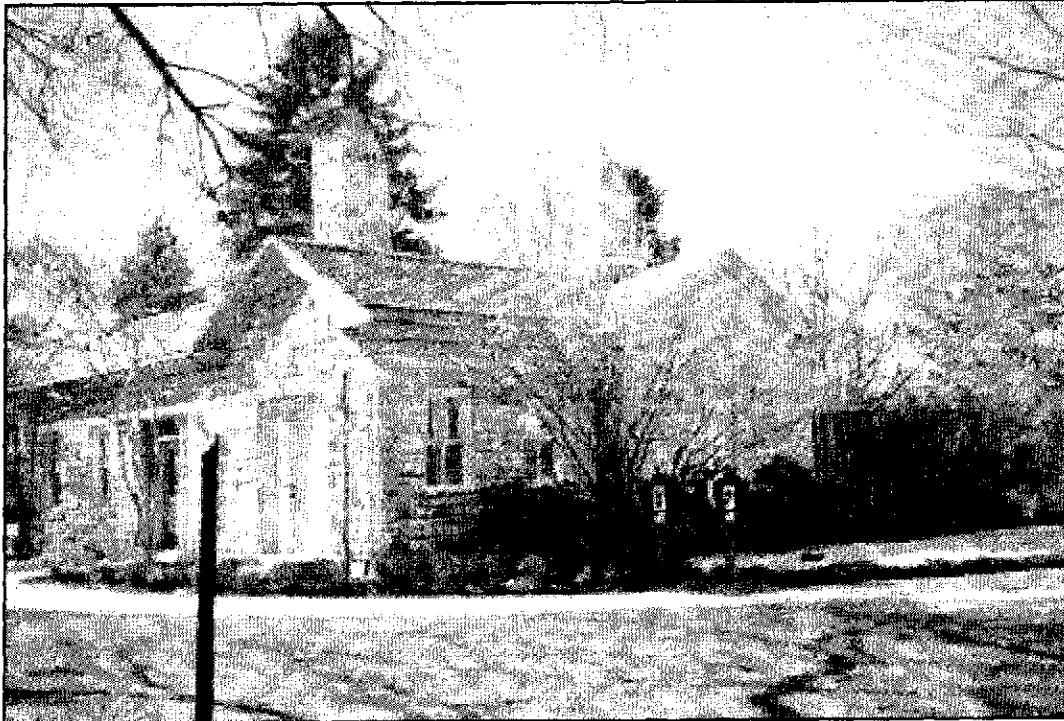
Figure 4.14: Alternating-board wood fence is scribed to stone building wall, view to southwest.

The utility shed to the northwest of the Survey Lodge is in good condition, and only requires maintenance-level repairs to ensure its longevity. The alternating-board wood fence that encloses the shed is supporting biological growth in isolated areas, and there are approximately two vertical boards missing. The interior steel structure of the shed has small areas of paint failure and resulting rust bloom. The concrete paving is heavily soiled and should be cleaned. As this paving also serves as a portion of the staff break-room and north storage-room roofs, its deterioration can be a major source of water infiltration in these spaces, and it should be maintained free of debris at all times. The corrugated galvanized steel roof deck is littered with branches and foliage, which hold standing water long after other roof areas are dry. The K-type hanging gutters of the roof are also clogged with debris and contain standing water (see figure 5.16). All of these surfaces should be routinely cleaned to assure adequate drainage and to lengthen the life of the roof deck. Ferrous fasteners on the roof deck have begun to rust, and the gutters and downspouts reveal the beginnings of paint failure. Any rust staining on the roof deck or gutters should be contained to prevent any impact on Survey Lodge building elements.

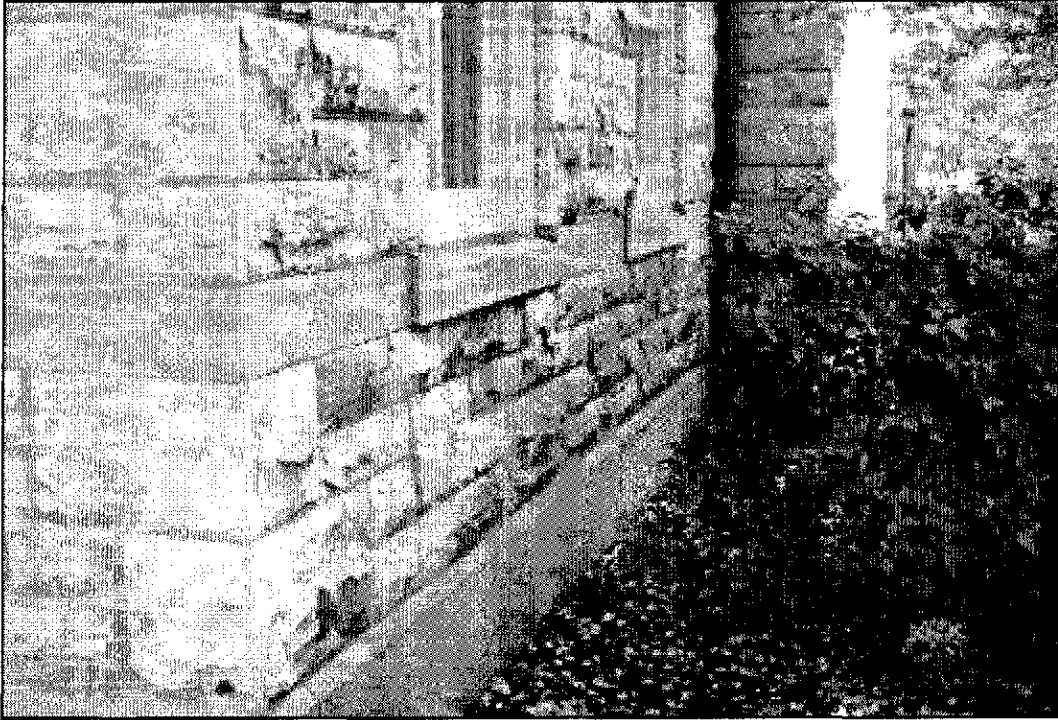
dot the northwest elevation and should be removed to prevent further rust stains and possible masonry cracking. All of the masonry openings have lines of paint around their perimeters where over-painting has occurred at window frames. Paint spatters are also visible on window sills and on the masonry under each of the façade's four windows. Each masonry opening is further characterized by a series of ¼-inch- to ½-inch-diameter holes where security-screen fasteners have been removed. In some cases these holes have been filled with sealant, but in most instances the fastener anchors are still in place (see figure 5.11). These anchors should be removed and the holes filled with a cementitious mortar.

Figure 5.11: Lower sash of double-hung wood window with granite sill, northwest elevation. Note the line of paint at the masonry opening, drips of paint on the granite sill, and the remains of an anchor from a previously removed security screen.

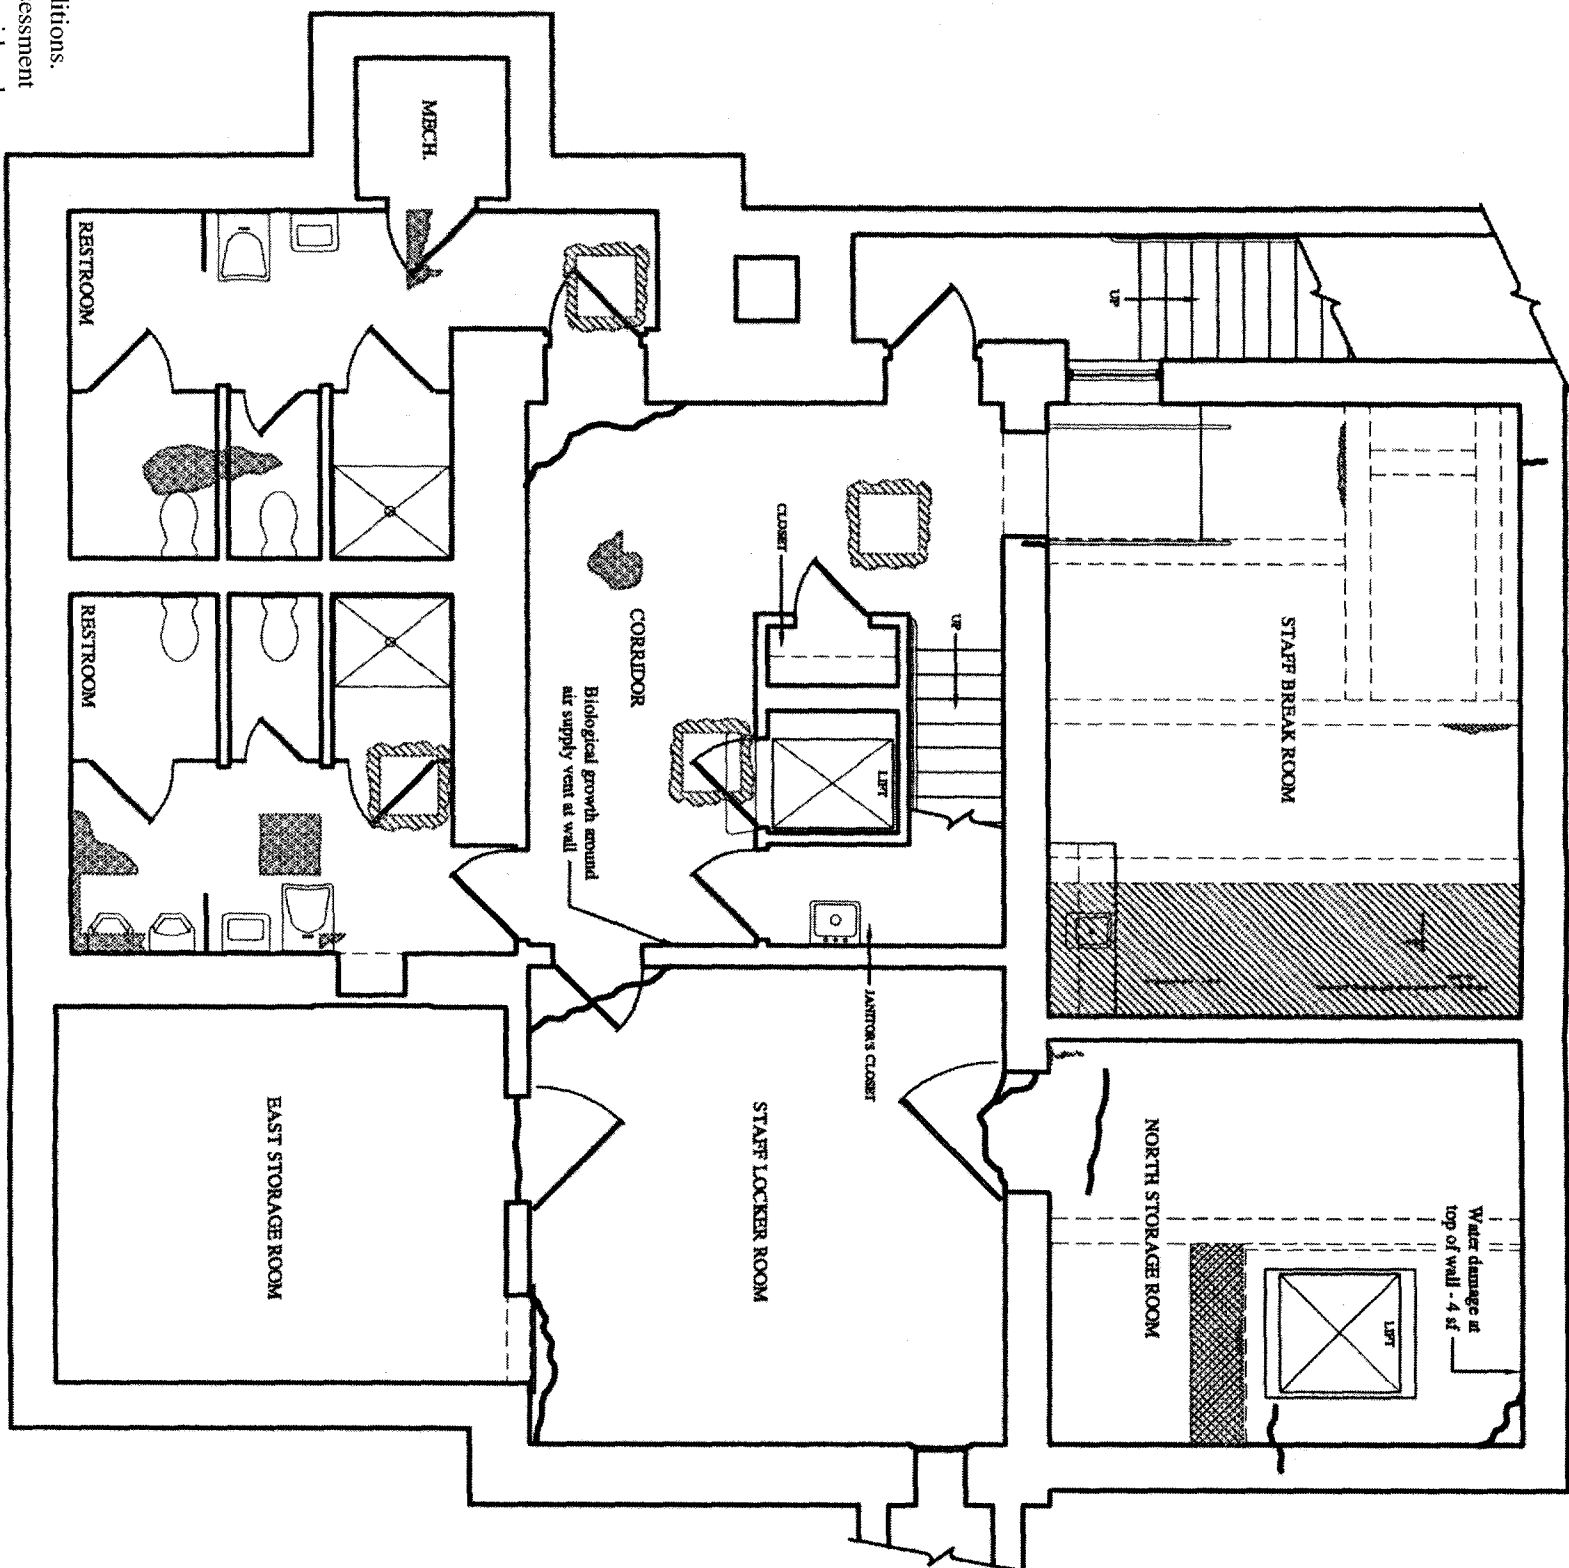
Condition assessment drawings for the first floor and basement have been prepared to visually represent areas of more serious damage (see figures 5.17 and 5.18). Damage represented on these drawings includes severe paint failure, biological growth, and water damage on ceiling surfaces, as well as concrete cracking in walls and floors. Water damage shown may be the result of active leaks in the building envelope or condensation on hidden pipes or ducts (see figure 5.19). Severe paint deterioration on ceiling surfaces, such as flaking or bubbling, may also be a direct result of water infiltration (see figure 5.20). All of these areas should be

Figure 5.17: First floor plan conditions. Drawing is provided for conditions assessment information only and should not be considered an accurate measured drawing.
