NATIONAL AERONAUTICS AND SPACE ADMINISTRATION

APOLLO 13 MISSION REPORT

SEPTEMBER 1970

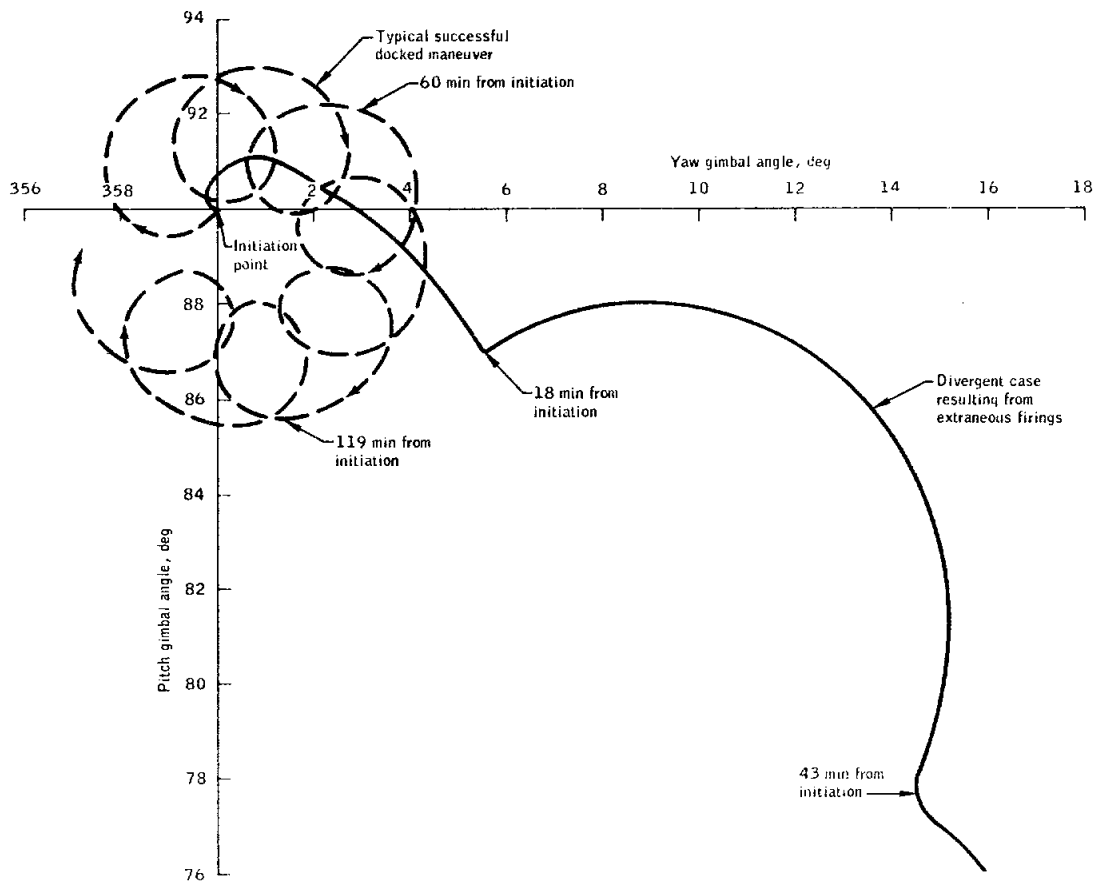
Figure 5.6-1.- Comparison of early translunar maneuver to establish a passive thermal control mode.

firing could have been avoided procedurally by disabling all engines before doing any control system switching. The passive thermal control mode attempted at 32:21:49 is compared with a typical case in figure 5.6-1, which shows the adverse effects of two extraneous firings. All subsequent passive thermal control modes using the command and service module were established normally.

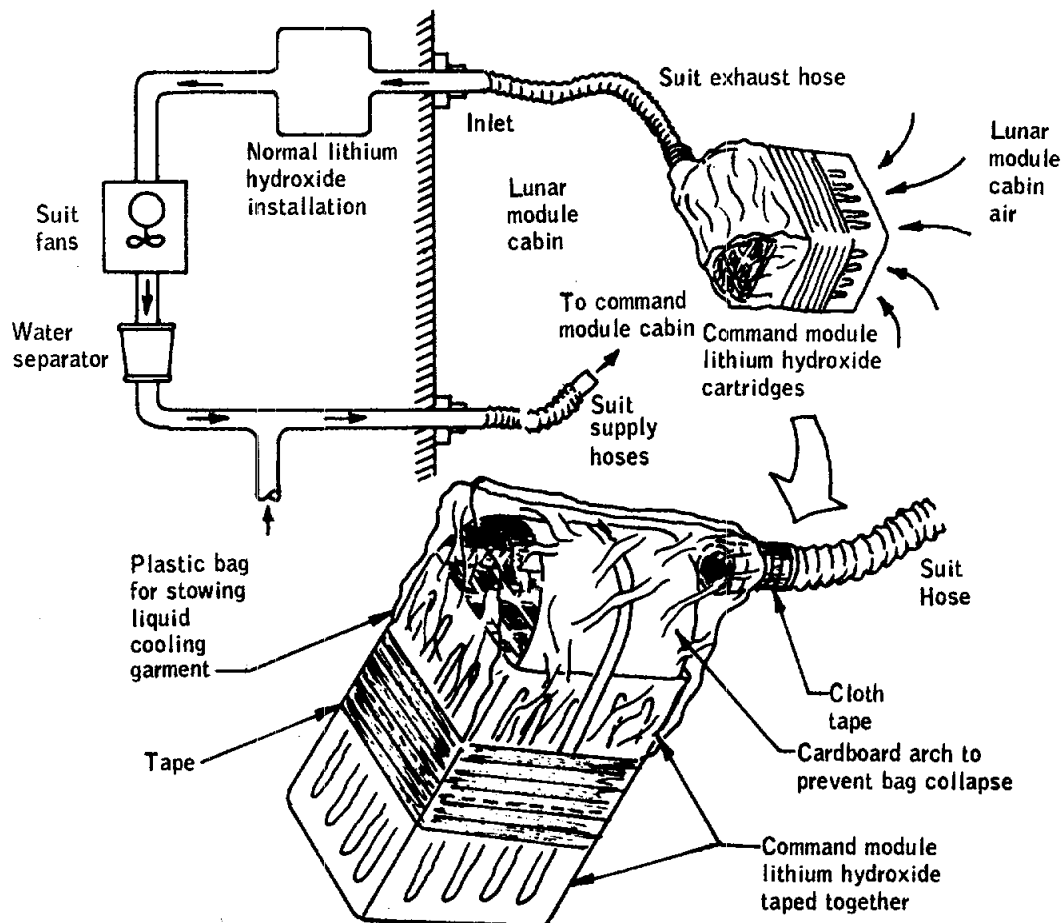
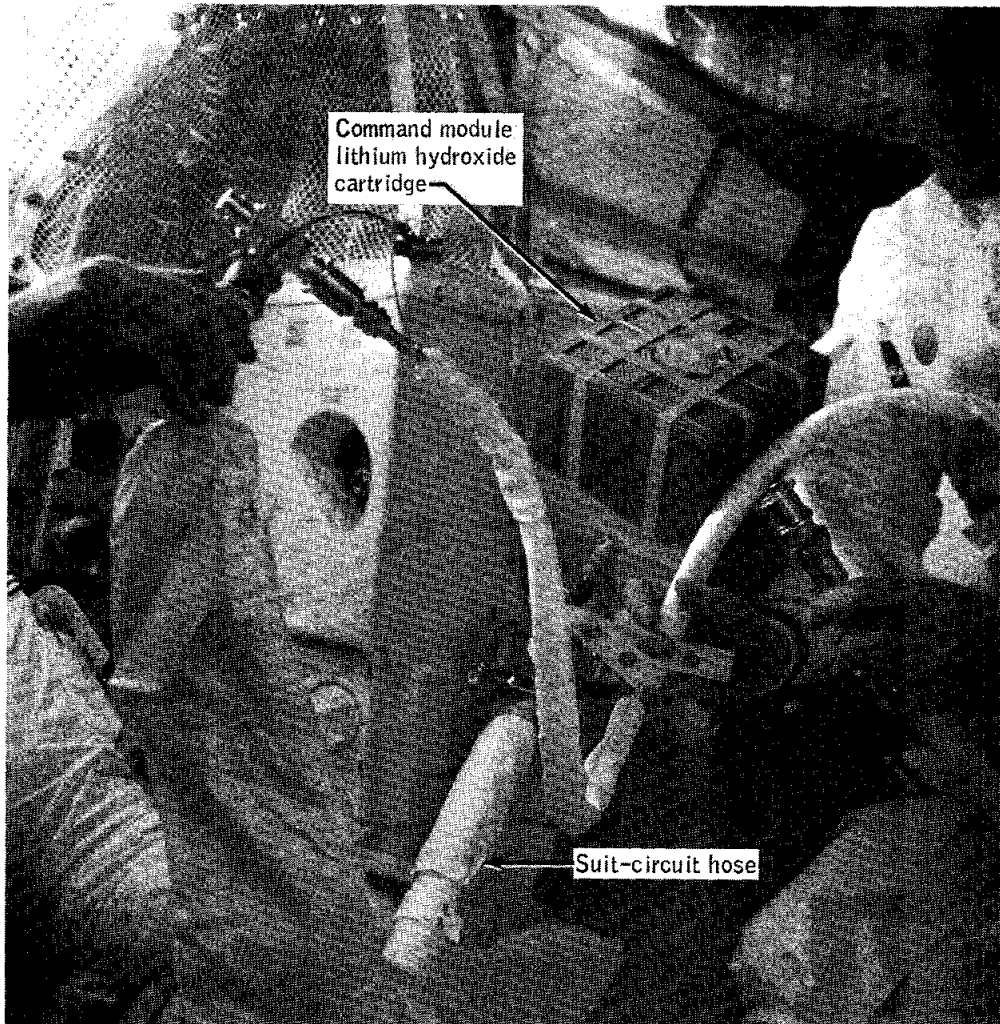
Figure 6.7-1.- Supplemental carbon dioxide removal system.

It became apparent that there were insufficient lithium hydroxide cartridges in the lunar module to support the abort mission, even with allowable carbon dioxide levels extended to a partial pressure of 15 mm Hg. With ground instructions, a system was constructed which attached a command module lithium hydroxide cartridge to each of two lunar module suit hoses. The Commander's remaining hose was placed in the tunnel area to provide fresh oxygen to the command module, while the Lunar Module Pilot's remaining hose was positioned in the lunar module environmental control area. At a later time, a second cartridge was added in series to the cartridges initially installed, as shown in figure 6.7-1. In each case, the drop in carbon dioxide levels reported by the ground showed satisfactory operation of this improvised carbon dioxide removal system.

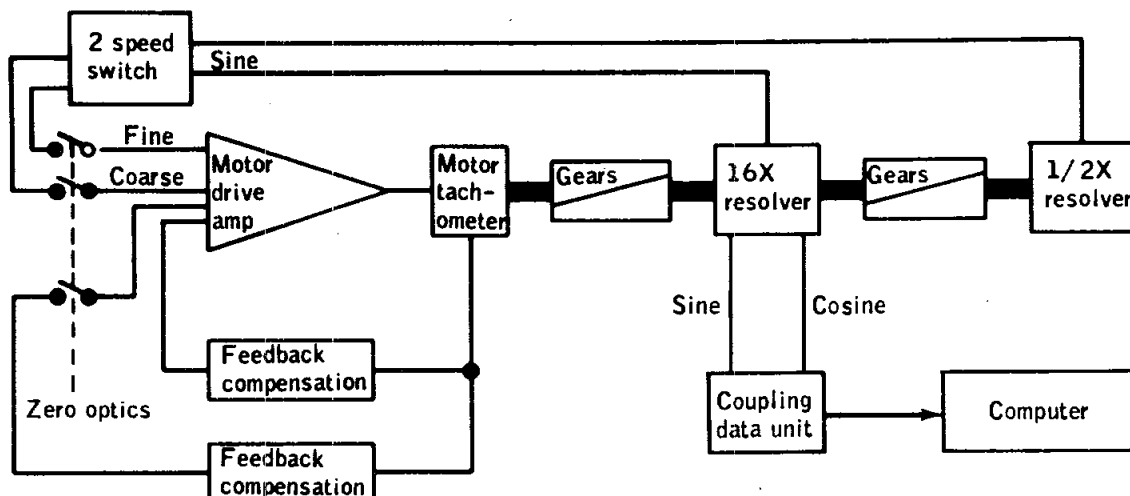
Figure 14-2.- Zero optics mode circuitry.

A simplified schematic of the optics shaft servo loop mechanization is shown in figure 14-2. In the zero optics mode, the sine outputs of

the half-speed and 16-speed resolvers are routed through a coarse/fine switching network to the motor drive amplifier and are used to null the system. Rate feedback from the motor tachometer is routed to the drive amplifier through a compensation network which removes any bias in the signal. When the zero optics mode is selected, the coupling-data-unit counter and the computer register which contains the shaft angle are zeroed for 15 seconds and then released to follow the 16-speed resolver. The half-speed resolver, the fine/coarse switching network, and the tachometer feedback compensation are used only in the zero optics mode.

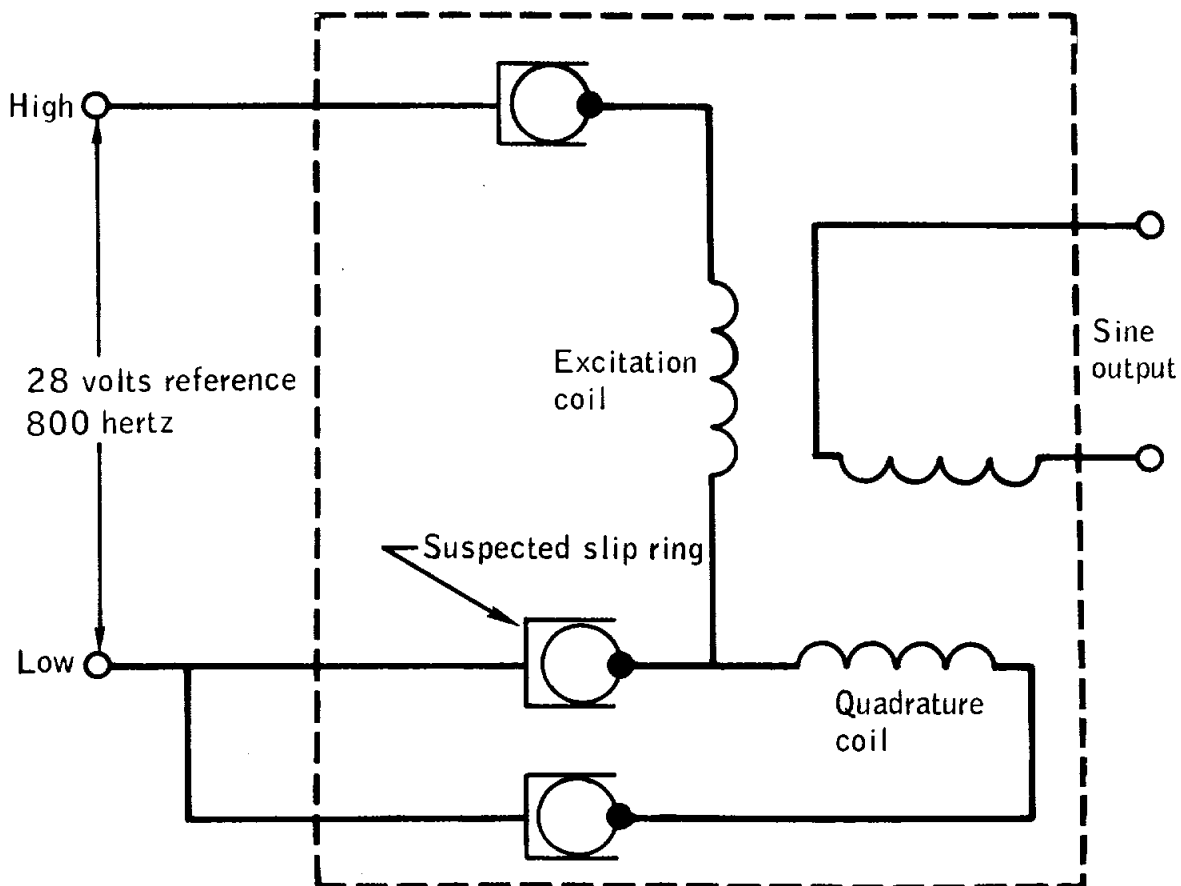
Figure 14-4.- One-half speed resolver.

The most likely candidate is the half-speed resolver, which is used only for the shaft axis and only to provide an unambiguous zero reference. The reference voltage is applied to the rotor through slip rings (fig. 14-3), connected as shown in figure 14-4. If any resistance is present in the common ground path through the slip ring, a portion of the reference voltage will appear across the quadrature winding and induce a finite output (different than zero). Zero output is equivalent to zero degrees in shaft rotation.

Simulated changes in slip ring impedance were made on the half-speed resolver in the shaft loop (fig. 14-4). An impedance of 50 ohms produced an offset of approximately plus 0.5 degree in sextant shaft angle. The trunnion loop does not use this type of resolver or connection.

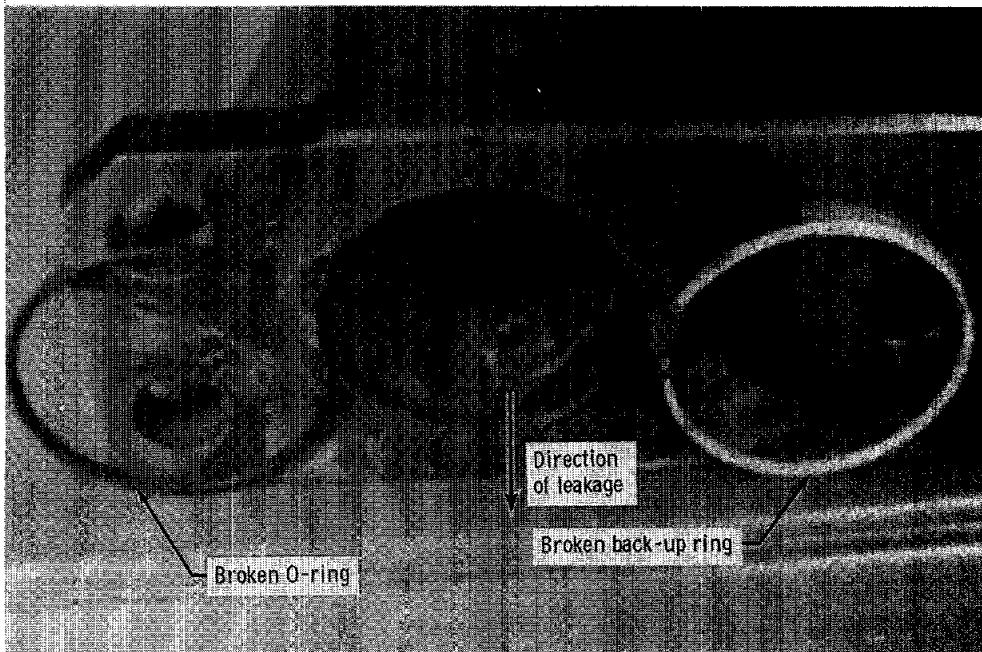
Figure 14-9.- Plenum side of breech-plenum interface.

During postflight inspection, it was discovered that propellant gas had leaked from the gusset-4 breech assembly, which is a part of the apex cover jettison system (fig. 14-7). A hole was burned through the aluminum gusset cover plate (fig. 14-8), and the fiberglass pilot parachute mortar cover on the parachute side of the gusset was charred but not penetrated. The leakage occurred at the breech-plenum interface (fig. 14-9). The breech and plenum are bolted male and female parts which are sealed with a large O-ring backed up with a Teflon ring, as shown in figure 14-7. During operation, the breech pressure reaches approximately 14 000 psi and the gas temperature exceeds 2000° F. The O-ring and backup ring were burned through and the metal parts were eroded by the hot gas at the leak path. The system is completely redundant in that either thruster system will effect apex cover jettison. No evidence of gas leakage existed on the previous firings of 56 units.

sheet (fig. 14-10) will be applied to the interior of the breech plenum area on future spacecraft. The protection provided by the polyimide has been proof-tested by firing the assembly without the O-ring, simulating a worst-case condition.

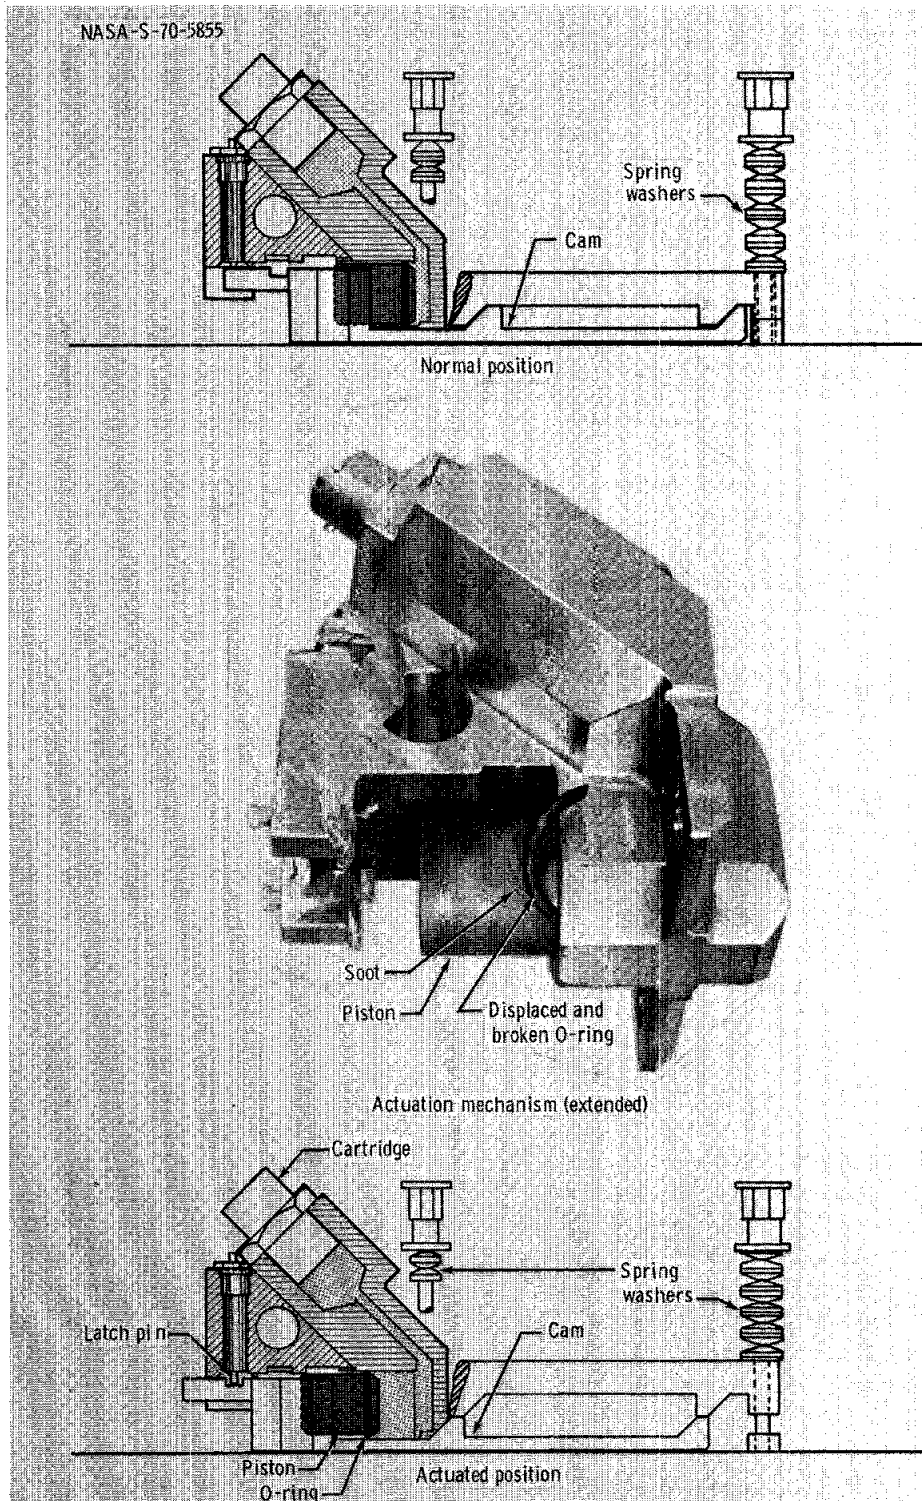
Figure 14-13.- Circuit interrupter.

During postflight inspection of the command module, propellant gas was noted to have escaped from the left-hand electrical circuit interrupter, mounted in the lower equipment bay, and deposited soot on adjacent equipment. The right-hand circuit interrupter showed no evidence of a gas leakage. The removed breech, showing the displaced O-ring and crushed attenuator block, is shown in figure 14-13.

The two interrupters open the electrical circuits about 30 milliseconds before the wires are severed by the command module/service module umbilical guillotine. As illustrated in the figure, a cam fork is moved by a piston, which is operated by propellant gas from redundant cartridges, to function a lift plate. Motion of this plate disconnects the male and female portions of electrical connectors located, respectively, in the lift plate and in the base plate of the interrupter. At the completion of the stroke, the fork is brought to rest by impacting and crushing an aluminum block mounted on the interrupter housing.

The worse-case tolerance buildup is when the fork contacts the attenuator block and the piston O-ring is 0.075 inch from entering the chamfer in the breech assembly. The O-ring enters this chamfer when the block has been crushed about 94 percent, at which point an O-ring displacement and accompanying gas escape could be expected. The factors which affect the degree of attenuator crushing are generally uncontrollable within narrow limits and include:

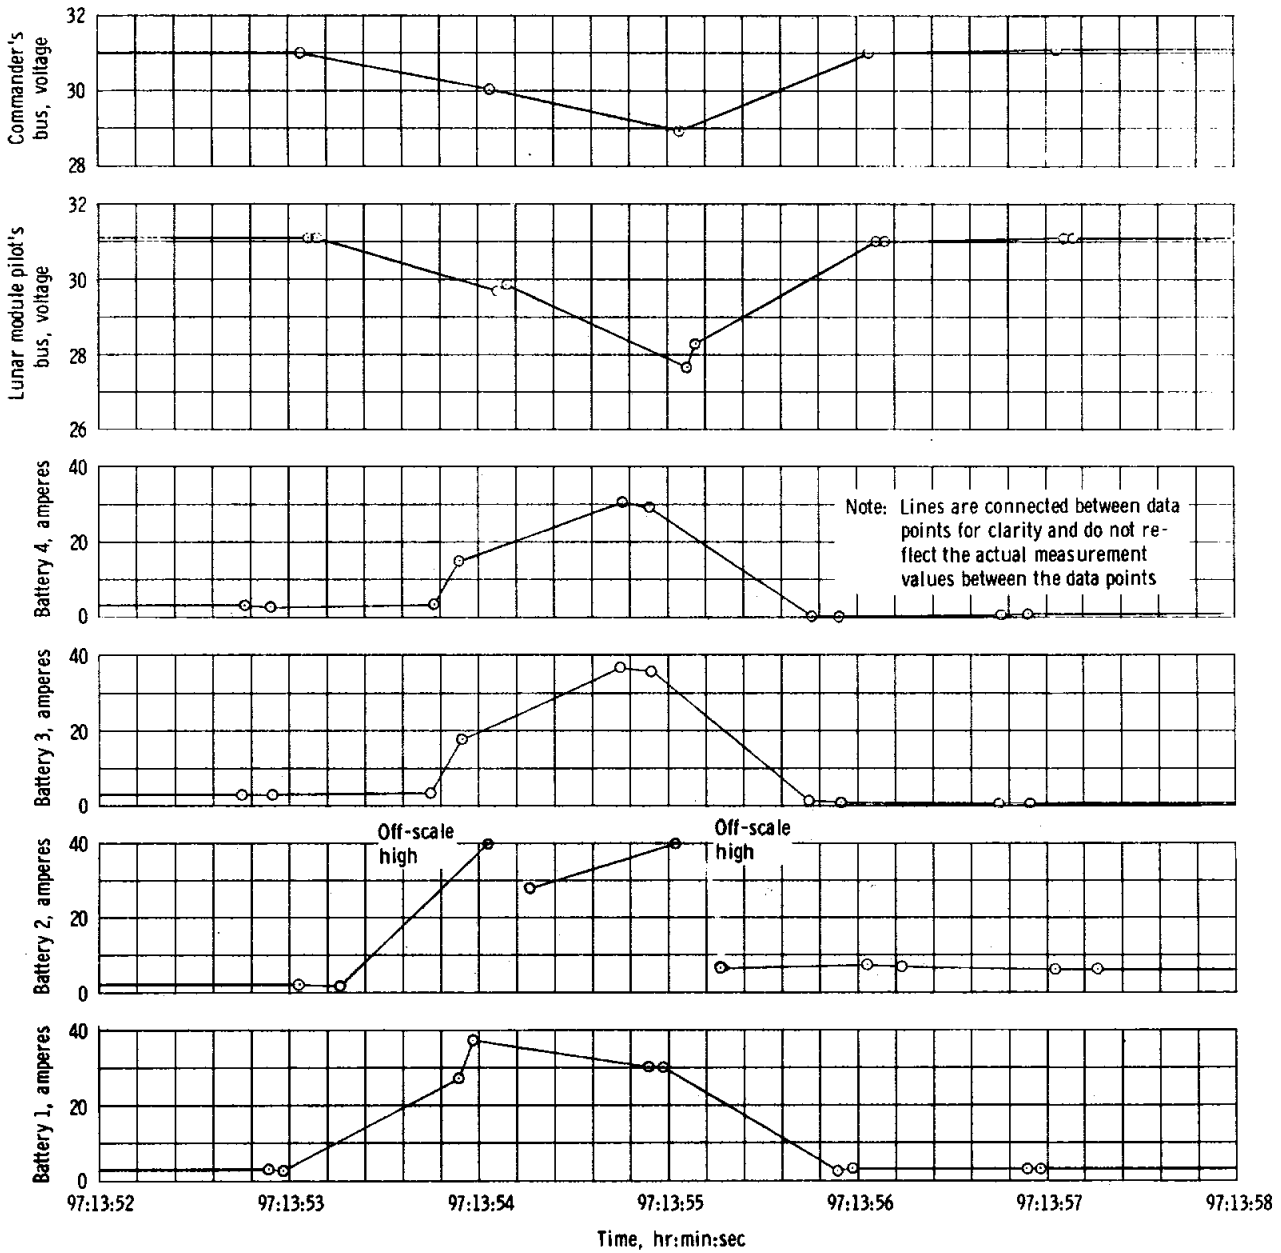
Figure 14-16.- Battery electrical transients.

At 97 hours 14 minutes, the crew reported a thumping noise and snowflakes venting from quadrant 4 of the lunar module descent stage (fig. 14-15). All four descent batteries experienced current transients at 97:13:53 for about 2 seconds, with corresponding drops in dc bus voltage (fig. 14-16). Also, the water glycol pressure differential for the heat transport system decreased momentarily, indicating that the glycol pump momentarily slowed down.

The thumping noise occurred at about the same time as the current spikes. The current spikes show that a momentary short circuit existed in the Lunar-Module-Pilot side of the dc electrical system, which includes descent batteries 1 and 2 (fig. 14-16). The current surge was not of sufficient duration either to open the balance-load cross-tie circuit breakers, to display a reverse current indication, or to trip a battery-off relay as a result of an overcurrent condition.

The data show that descent battery 2 experienced at least a 60-ampere current surge. This condition could have been a reverse current into the battery, since the instrumentation system does not indicate the direction of current. Immediately after the current surges, battery 1 current returned to its original value while battery 2 provided about 80 percent of the total current load. After sustaining a surge load, the battery terminal voltage normally increases for a short period of time. Since battery 2 experienced the highest surge, it should have temporarily assumed the most load. Within 10 minutes all batteries were properly sharing the current load, and no subsequent abnormal performance was observed. At 99:51:09, battery 2 gave an indication of a battery malfunction, discussed in more detail in the next section.

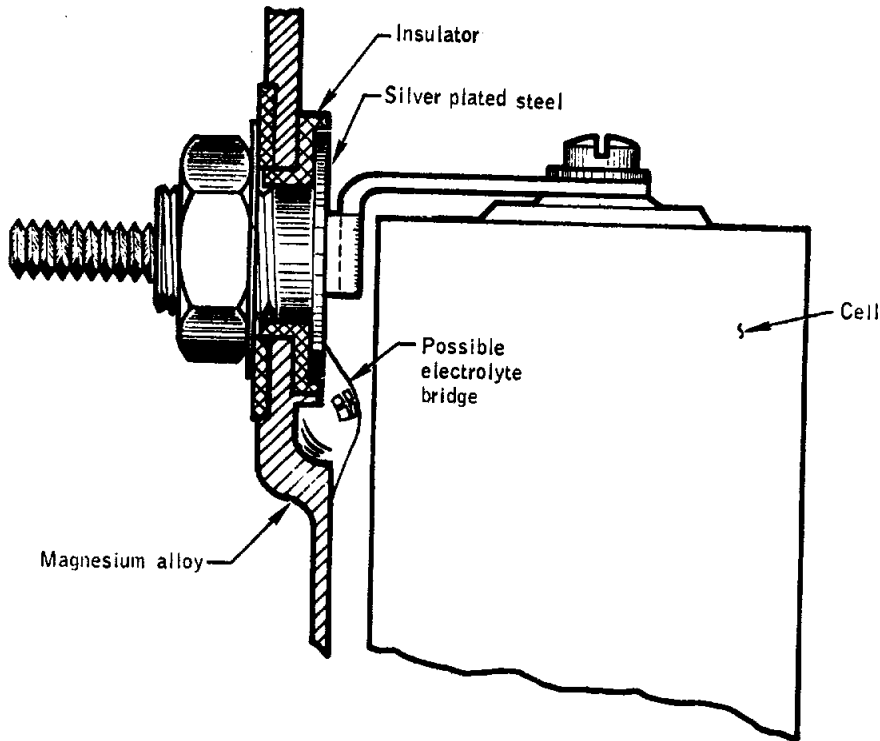
Figure 14-17.- Descent battery terminal configuration.

Evidence indicates that battery 2 may have experienced an electrical fault of some type. The most probable condition is electrolyte leaking from one or more cells and bridging the high-voltage or low-voltage terminal to the battery case (fig. 14-17). This bridging results in water electrolysis and subsequent ignition of the hydrogen and oxygen so generated. The accompanying "explosion" would then blow off or rupture the seal of the battery lid and cause both a thump and venting of the free liquids in the battery case, resulting in "snowflakes."

- a. Electrolyte can leak past the Teflon retention screens installed in each cell to prevent leakage.
- b. The descent battery cells contain an excessive amount of free electrolyte.
- c. The potting does not adhere to the battery case, consequently, any free electrolyte can readily penetrate the interface between the potting and the case and bridge between the terminals and case.
- d. Once an electrolyte bridge is formed, electrolysis will produce hydrogen and oxygen gas.
- e. A bridge at the positive terminal can produce a current surge of as much as 150 amperes.

For Apollo 14 and subsequent missions, the descent batteries will be modified to minimize the hazards associated with electrolyte leakage.

The battery potting will be improved to prevent electrolyte bridging between the battery terminals and case. These improvements include coating the inside of the battery case with epoxy paint before the battery is assembled and changing the potting material used at the ends of the case to a material which has better adhesion characteristics. Also, the cell chimneys will be manifolded together and to the case vent-valve with plastic tubing.

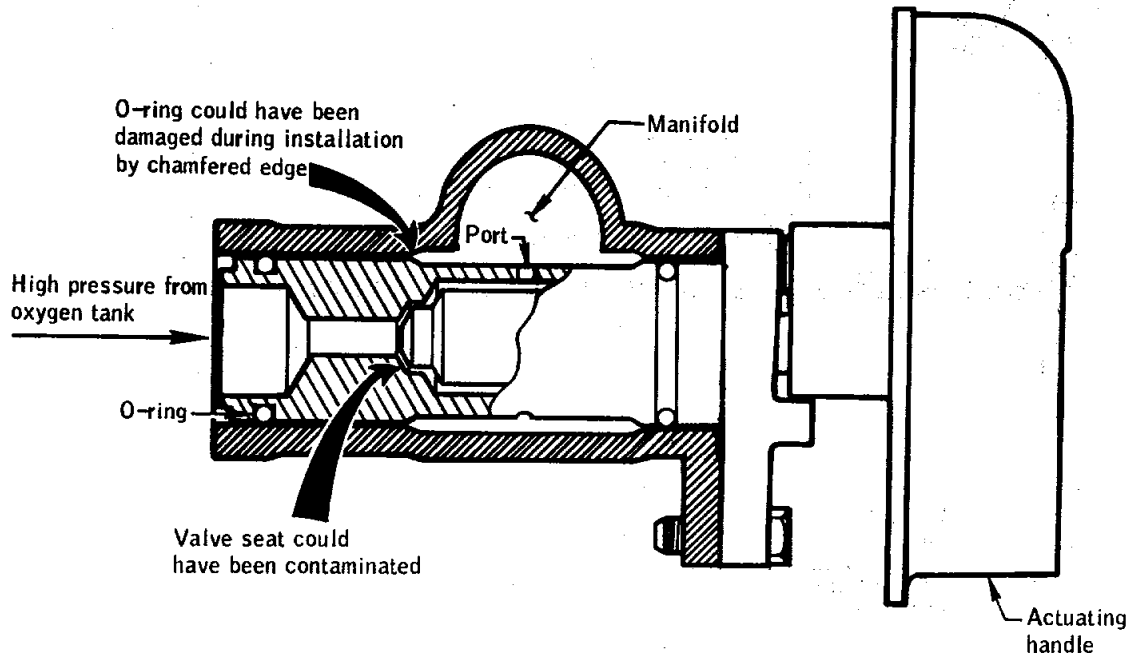
Figure 14-20.- Ascent stage tank shutoff valve.

The internal portion of three valves of this type had been replaced previously on the spacecraft because of excessive leakage through the ascent oxygen tank 1 shutoff valve. In one valve, a rolled O-ring

(fig. 14-20) caused the leakage. When the valve is installed, the forward O-ring can be rolled and damaged when it passes the manifold port. In the other two valves, the cause was not identified and was assumed to be contamination.

The production tolerances of the valve and bore were examined to determine if a tolerance buildup problem existed. The manufacturer's specification to which the valve was designed requires that the O-ring be subjected to a compression of between 0.0115 and 0.0225 inch, whereas the O-ring supplier recommends between 0.011 and 0.017 inch. The added

compression allowed in the valve design would aggravate the tendency for the O-ring to roll during valve assembly.

Leak tests previously performed on the valve were inadequate, in that only reverse leakage at high pressure was determined. For future vehicles, forward and reverse leakage at both high and low pressures will be measured to detect any defective valves.
