NATIONAL AERONAUTICS AND SPACE ADMINISTRATION

APOLLO 8 MISSION REPORT

MANNED SPACECRAFT CENTER
HOUSTON, TEXAS
FEBRUARY 1969

Mission Evaluation Team

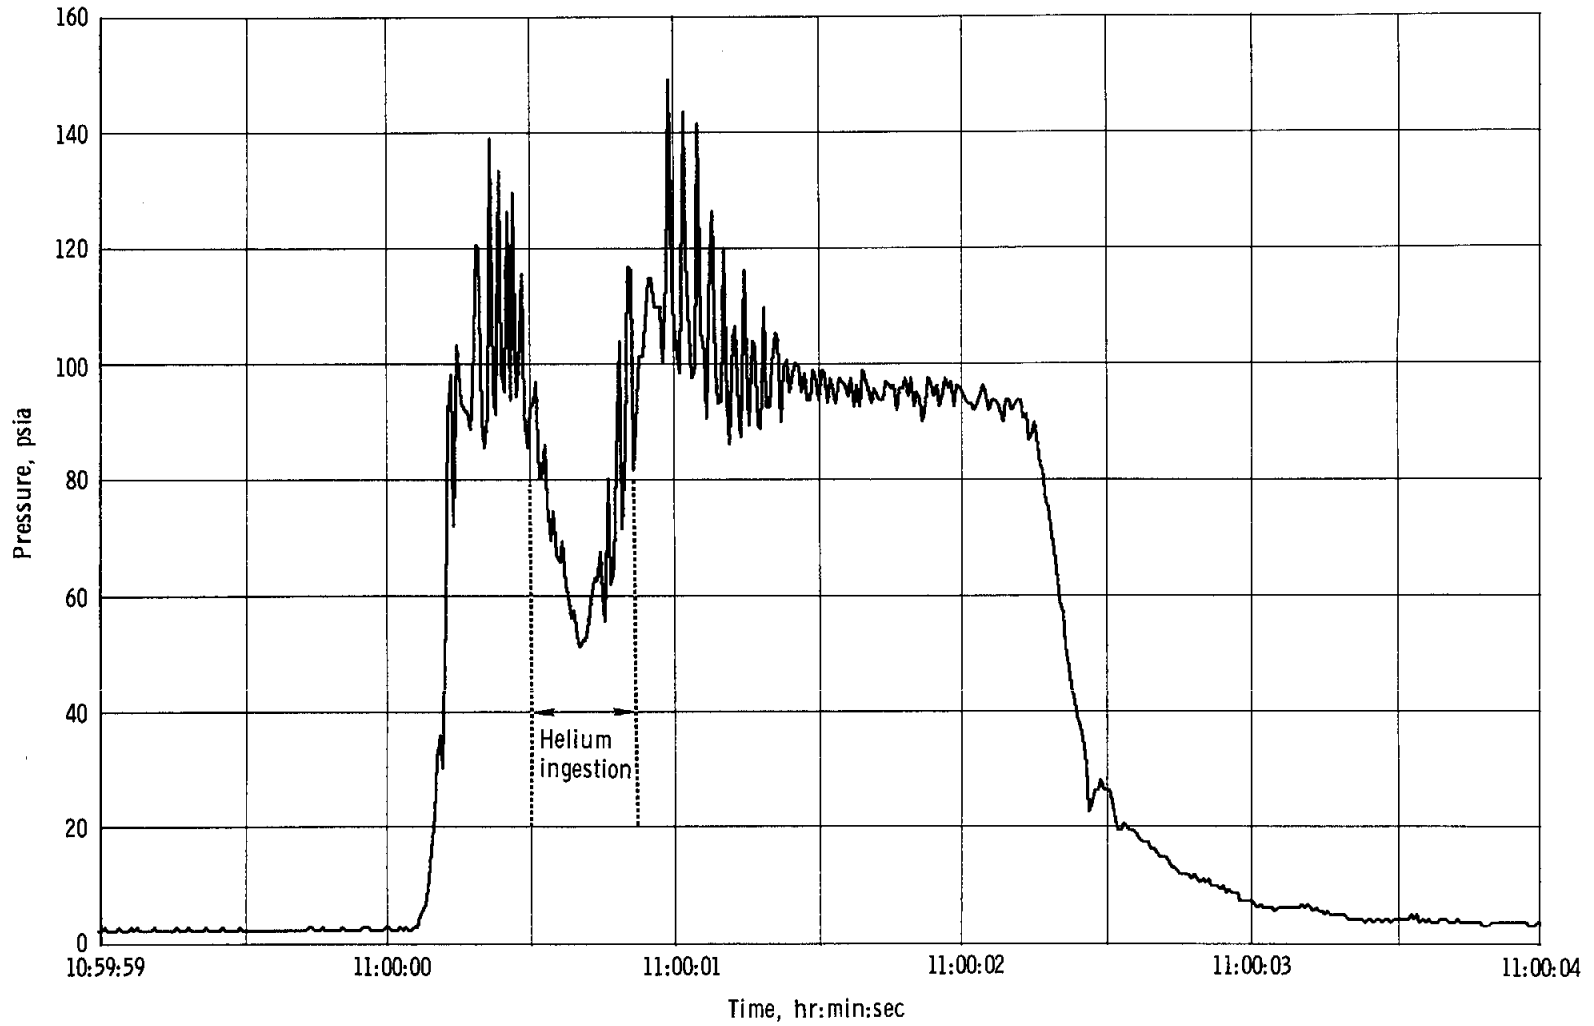
Figure 6.11-1. - Chamber pressure during first service propulsion maneuver.

A momentary drop in chamber pressure (fig. 6.11-1) was observed at the start of the first maneuver; this drop is attributed to the presence of a helium bubble in the oxidizer feed line. The trapped helium resulted from an inadequate engine-oxidizer bleed during preflight servicing. Comparable chamber pressure traces were obtained during a spacecraft ground test when the bleed procedure was also improperly conducted and during the AS-202 mission, during which the second service propulsion maneuver also exhibited helium ingestion. Chamber pressure characteristics were normal for the remaining three maneuvers. Bleed procedures have been changed in future spacecraft to preclude recurrence of trapped helium in the lines.

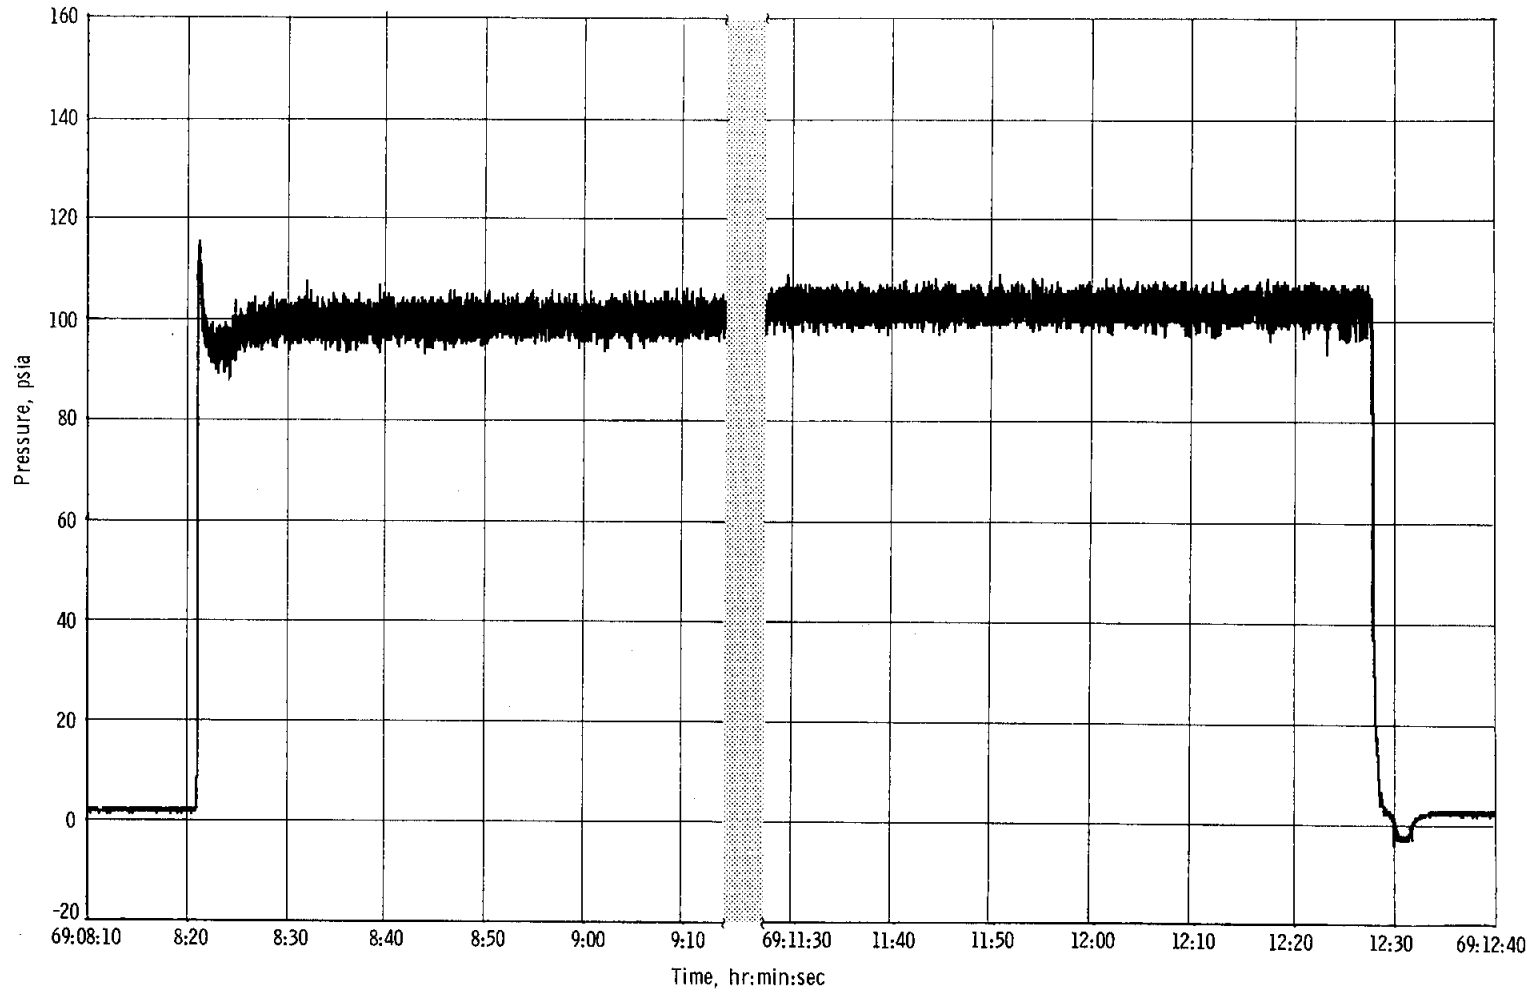
Figure 6.11-2. - Chamber pressure during second service propulsion maneuver.

Table 6.11-II presents the measured steady-state pressures at representative time periods for the first and final service propulsion maneuvers. These pressures indicate satisfactory engine operation. The data from the lunar orbit circularization maneuver indicate normal system operation. The measured chamber pressure profiles for the first, second, and fourth service propulsion maneuvers are shown in figures 6.11-1, 6.11-2, and 6.11-3, respectively.

The engine firings for the lunar orbit insertion and the transearth injection maneuvers were longer than planned by approximately 4.9 and 5.7 seconds, respectively, to achieve the required velocity change. The lower thrust caused by the decreased tank pressures can account for the increased firing times.

During all four service propulsion maneuvers, the measured oxidizer interface pressure was approximately 8 psi lower than expected. The oxidizer interface pressure reading was such that malfunctioning instrumentation is very unlikely because the measured pressures were valid for no-flow conditions. Analysis of the flight data confirm that the interface pressure could not be low by 8 psi. For example, the lunar orbit insertion maneuver would have been 10 seconds longer had the indicated pressure been valid for this sensor location, immediately upstream of the flow orifice. A measurement port, located immediately downstream of the flow orifice at

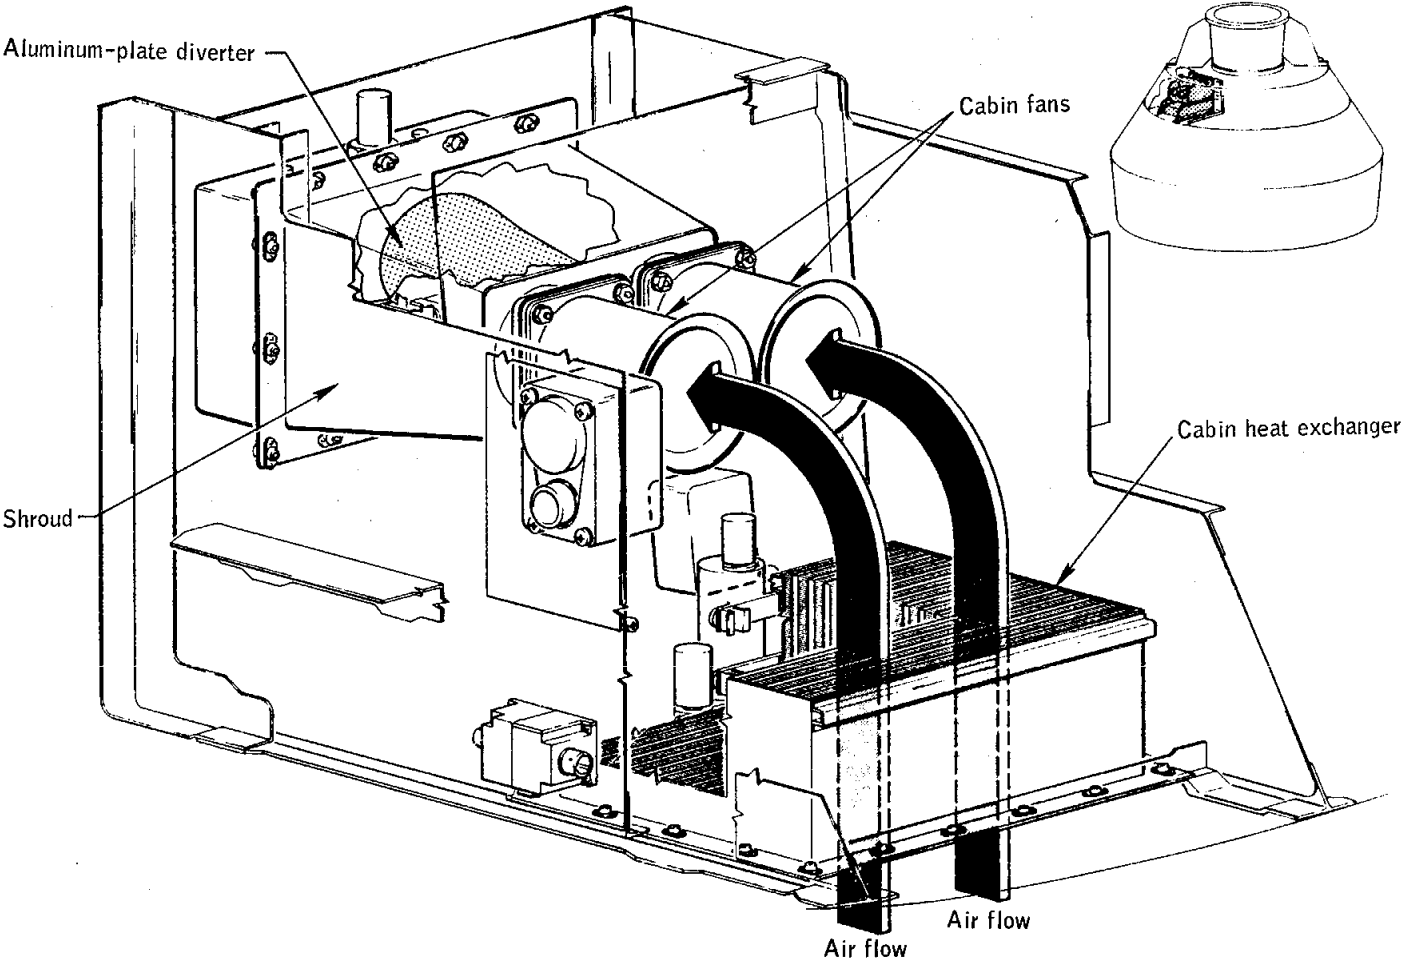
During the sixth day of the mission, the cabin fans (fig. 12-3) were momentarily turned on, and the crew reported that both were noisy.

No blade or bearing damage was detected, and the blades moved smoothly and stopped slowly. No loose objects were found in the plenum chamber and none of the blades were nicked; loose objects and nicked blades on spacecraft 101 (Apollo 7) produced objectionable noise on that flight.

Figure 12-3.- Cabin fan installation.

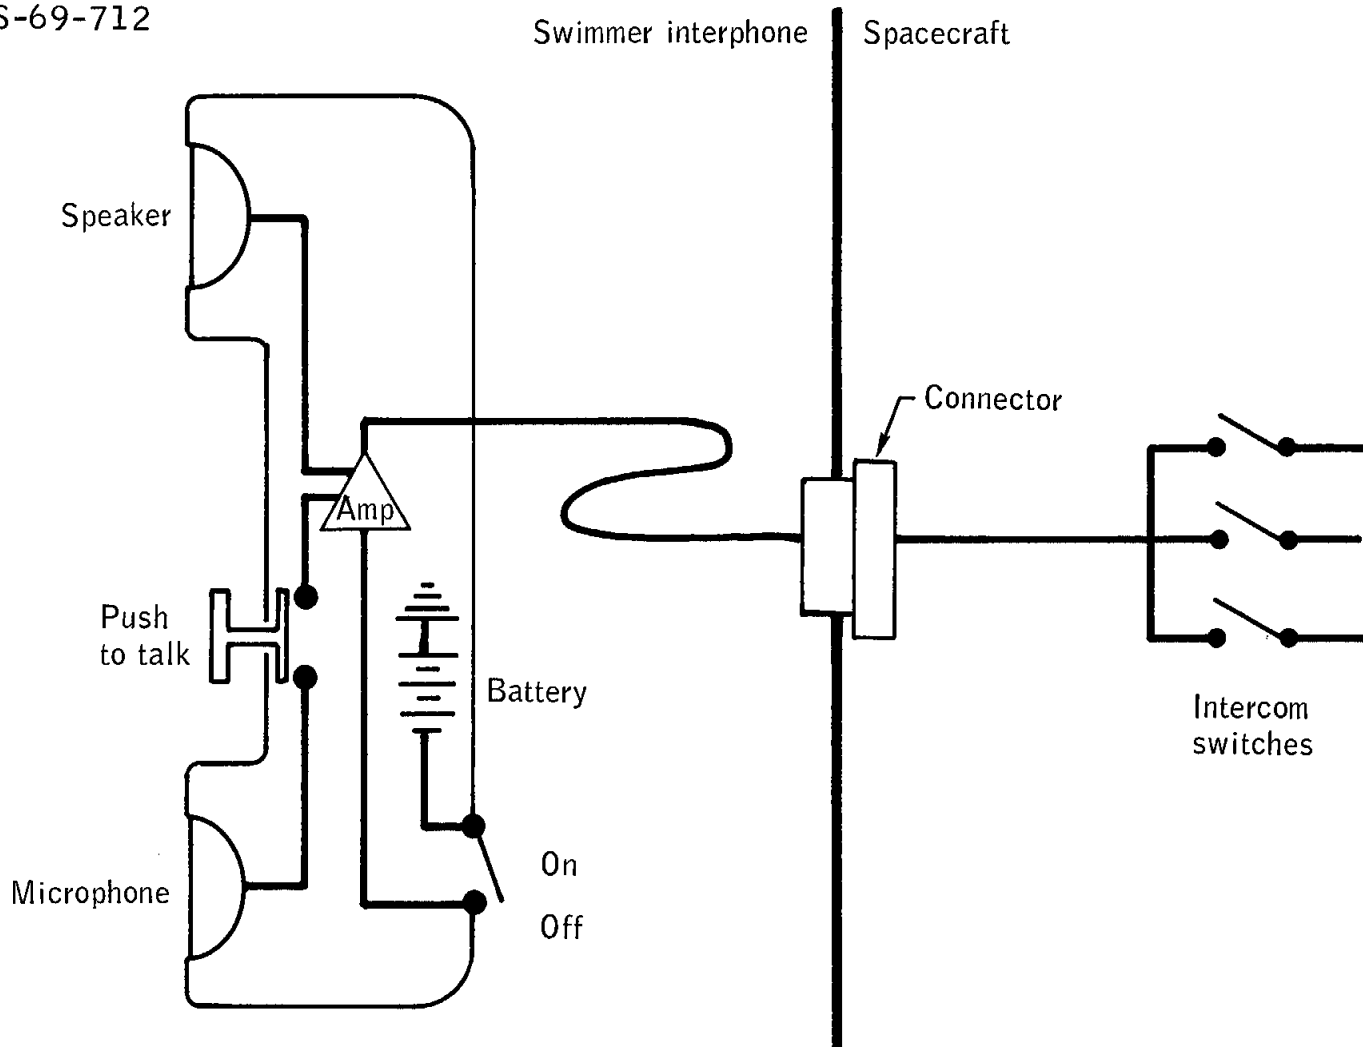
During recovery operations, the swimmers were unable to communicate with the crew via the intercommunications system. The crew reported that the spacecraft intercom switches were in the proper position. As shown in figure 12-6, the swimmer interphone, which plugs into the spacecraft, has a push-to-talk switch and an ON-OFF switch.

Figure 12-6.- Swimmer interphone.

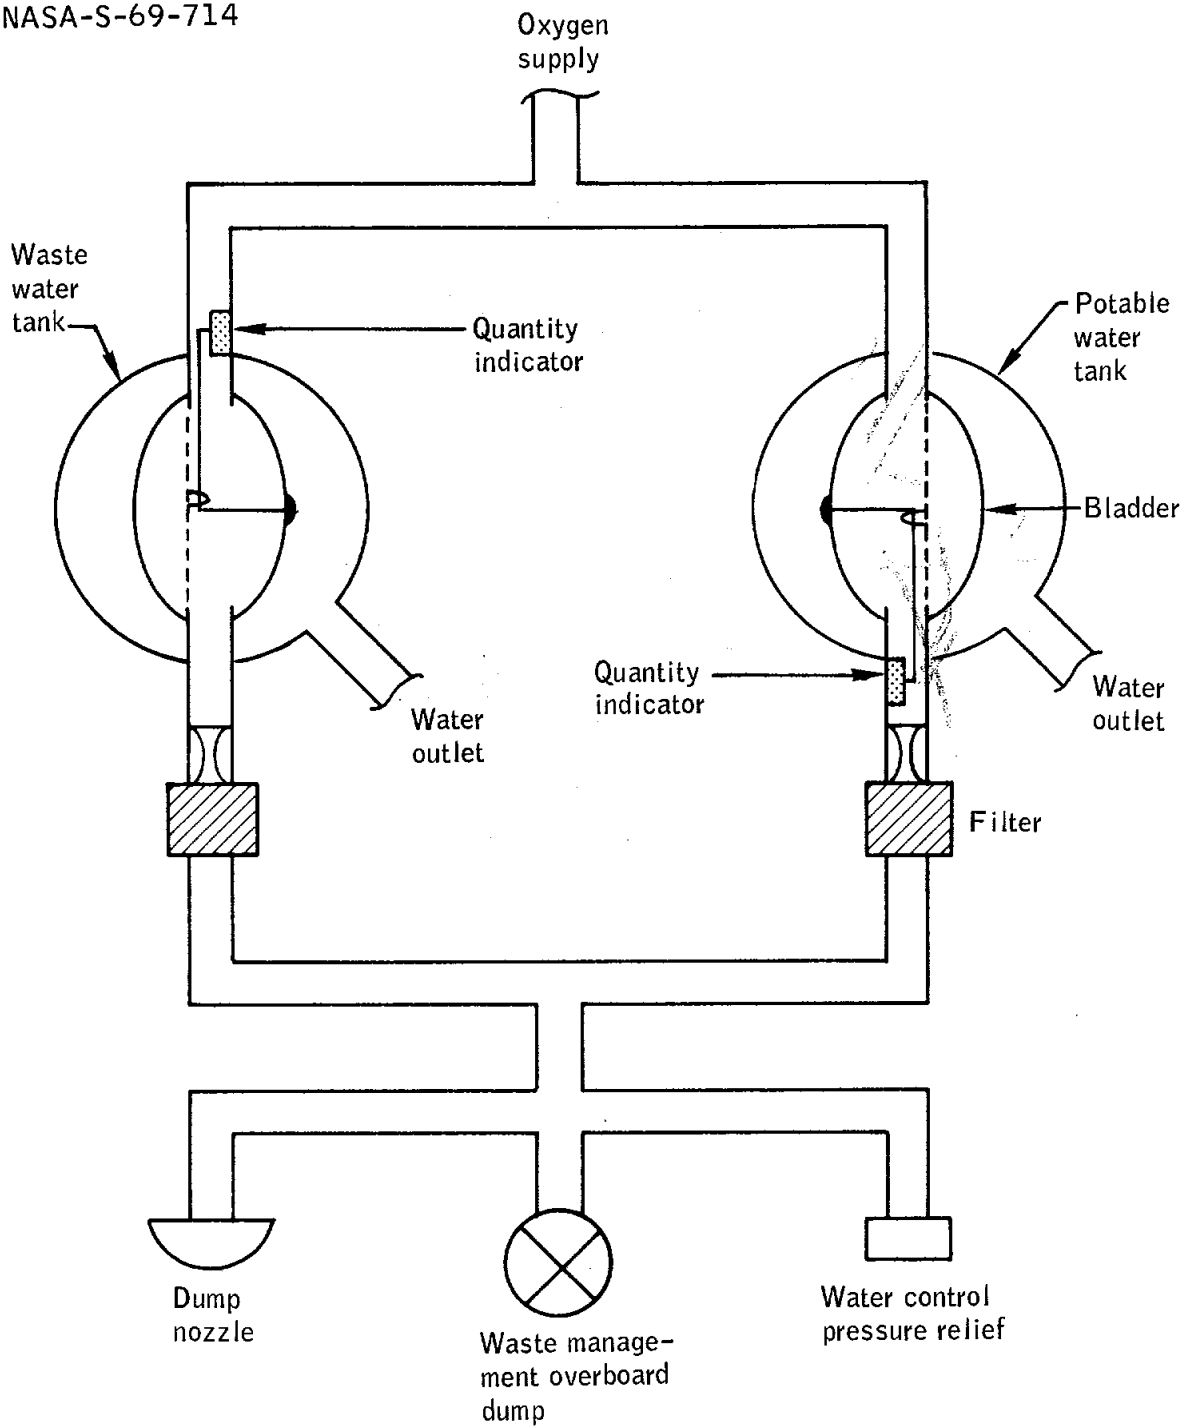
Figure 12-8.- Water tank pressurization system.
