**CO Migration from Trench Blasting in Amherst, New York**  
by Marcia L. Harris and Richard J. Mainiero

The New York State Department of Transportation recently commenced highway widening and drainage improvement projects in Clarence and Amherst, NY. Drainage improvements including the installation of storm sewer lines required excavation to a depth of 2.5 m (8.2 ft).

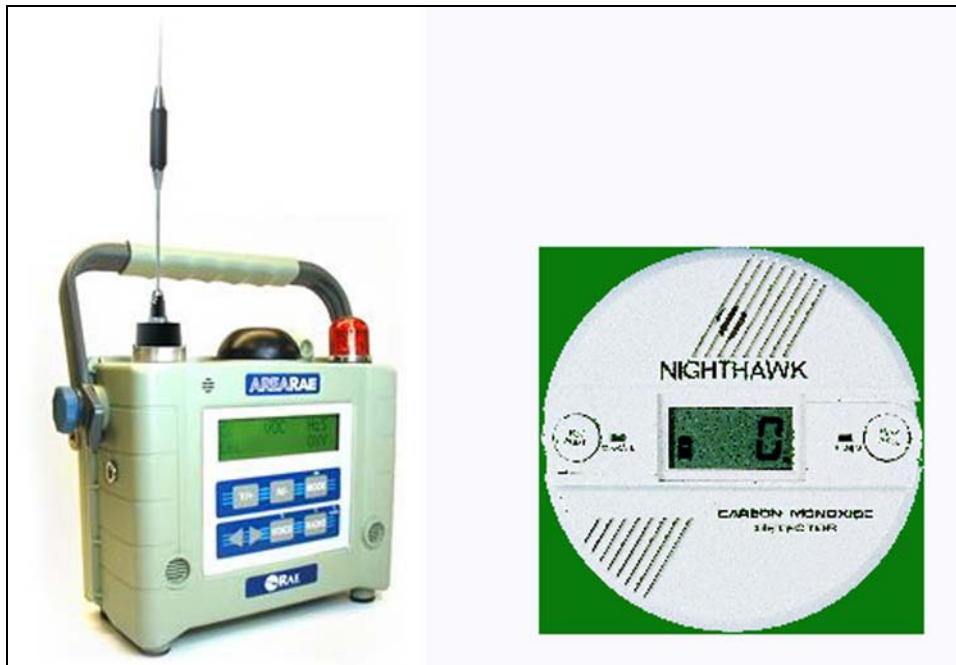
The first occurrence of CO on this project, took place August 27, 2002, see Figure 1, and was attributed to an automobile running in the garage. The first definite sign that CO was migrating from the blasting occurred on August 28, 2002, when 213 ppm was recorded in a basement. This incidence was followed by two occurrences of elevated CO recorded on September 12. In the first instance, the CO alarm located in the basement adjacent to a crack in the foundation alarmed when the concentration of CO peaked at 67 ppm. In the second instance on September 12, a resident living just beyond 100 meters from the blasting area contacted the EIC to report their own CO monitor had been periodically alarming. They initially disregarded the alarm. An investigation disclosed that CO was present in an unlined sewage ejection pit in the basement at 90 ppm. This appeared to be the avenue by which the CO entered the home. No other source of CO was identified.

**Figure 1 - Area blasted during August and September, 2002. Pad and Base indicate whether the corresponding home is built on a pad (slab) or has a basement. The dates and the number of blast holes are indicated. Each blast hole was loaded with three to four pounds of ANFO.**
