## **Atmospheric Hazards**

### **Solvents**

## **FACE 85-09: Worker in Vermont Dies in 20,000 Gallon Gasoline Bulk Tank While Wearing Closed Circuit SCBA**

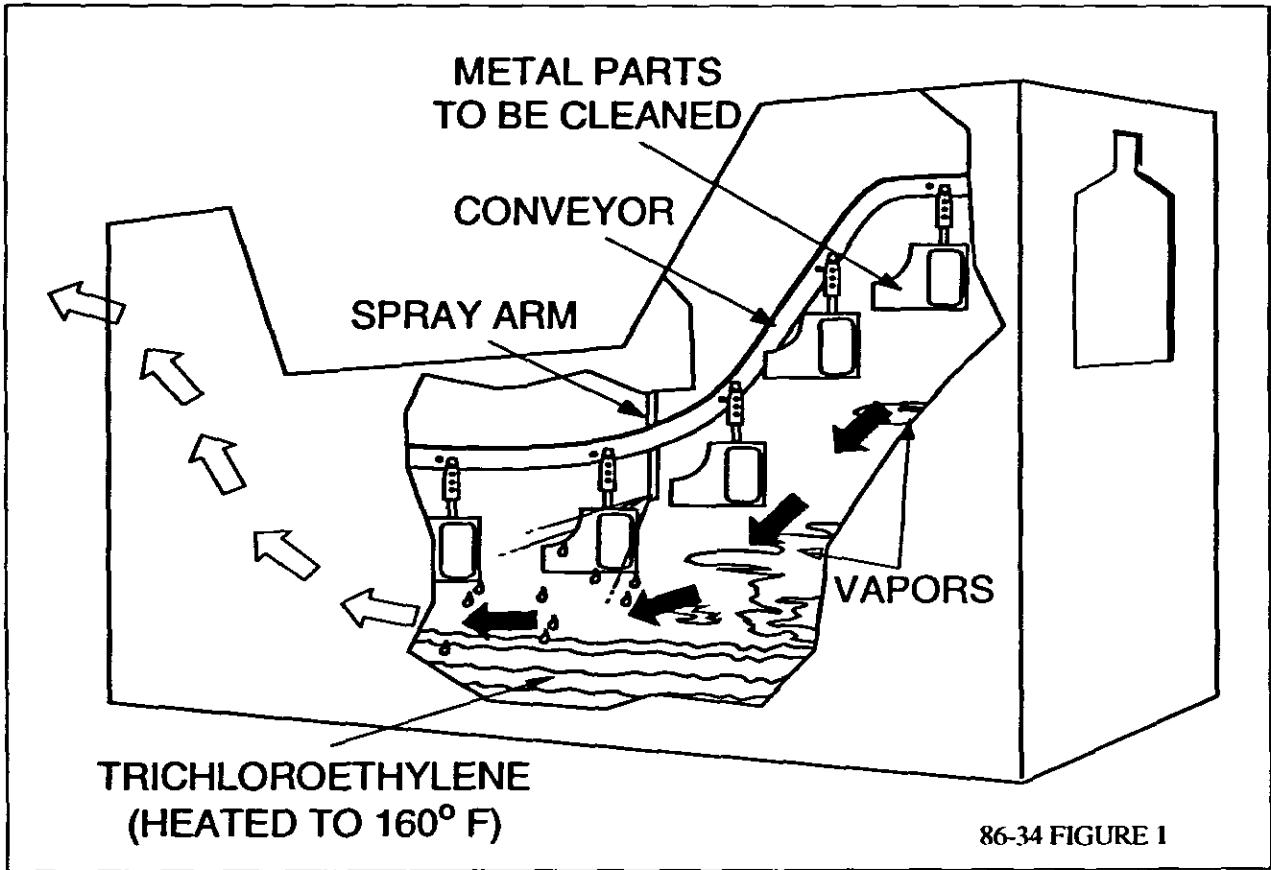
Since there were no witnesses to what happened, and all three workers died, the following scenario was developed: The men were found at approximately 7:30 p.m. by a relative who had stopped by to see what was the problem. The tank is cleaned out on Saturday morning and the three men were still there at 7:30 that evening. The relative found all three men in the degreaser tank, unresponsive. He immediately called the fire department for help. The fire department and police department responded to the call and the men were removed from the tank. One was dead when removed, one died a few hours later at a local hospital, and one remained critical until July 17, 1986, when he died without regaining consciousness. Two police officers were also hospitalized with chemical burns.
