## **Appendix L: Metallurgical Analysis of PCCV Liner Tears**

## **Metallurgical Analysis of PCCV Liner Tears**

K. H. Eckelmeyer, J. A. VanDenAvyle, A. C. Kilgo, and L. D. Lambert

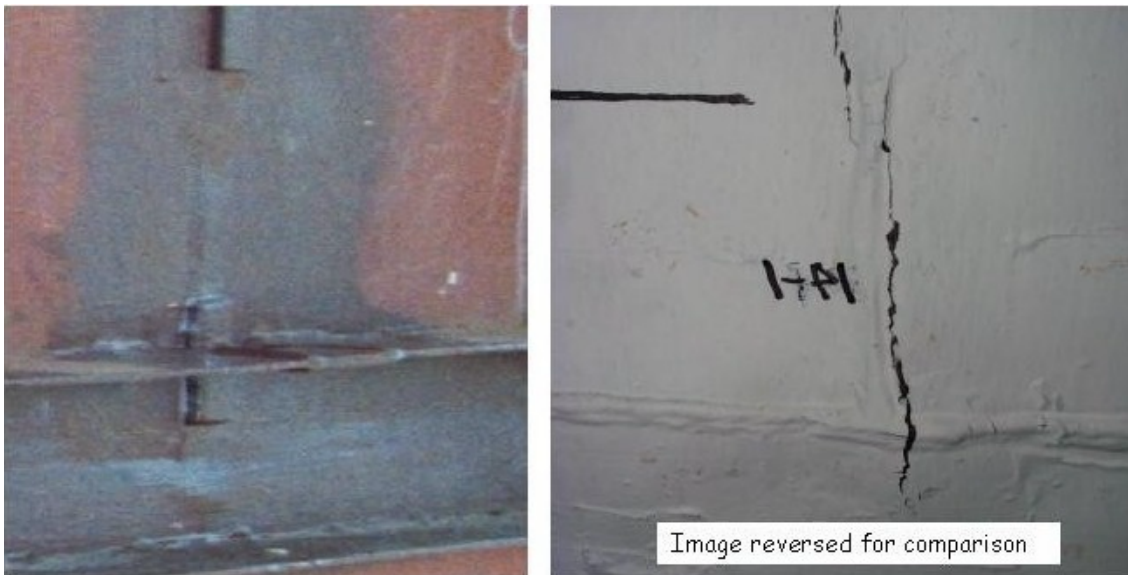
Figure 2. Photographs showing region of tear #1 from outside of liner (left) (prior to concrete placement) and inside of liner (right) (prior to removal of paint). The tear occurred under the wide segment of back-up bar near the top of the left-hand photograph, on the side closest to the anchor.

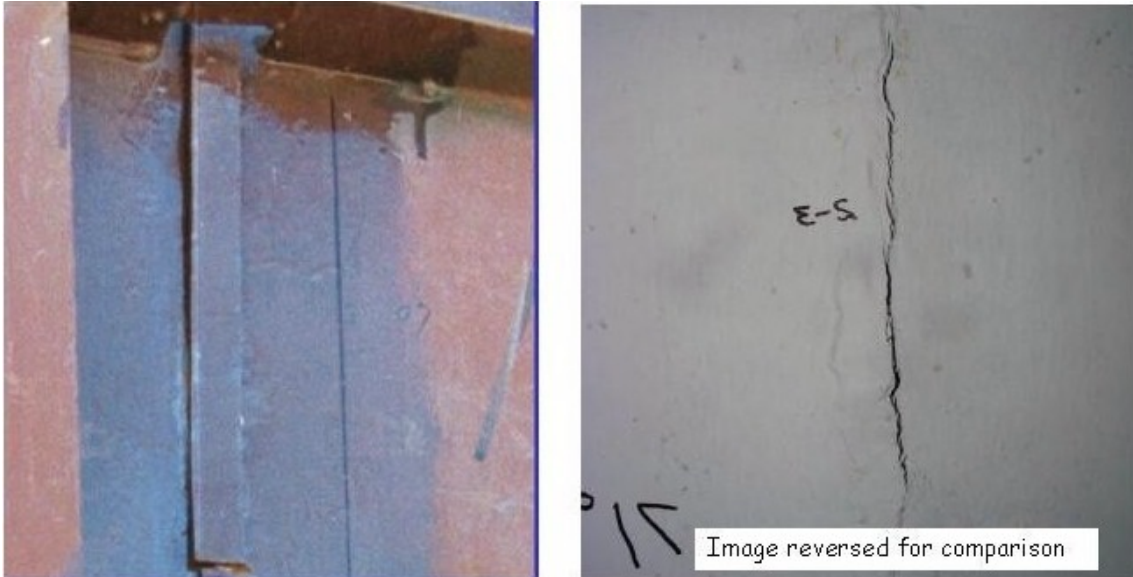
Figure 3. Photographs showing region of tear #2-3 from outside of liner (left) (prior to concrete placement) and inside of liner (right) (prior to removal of paint).

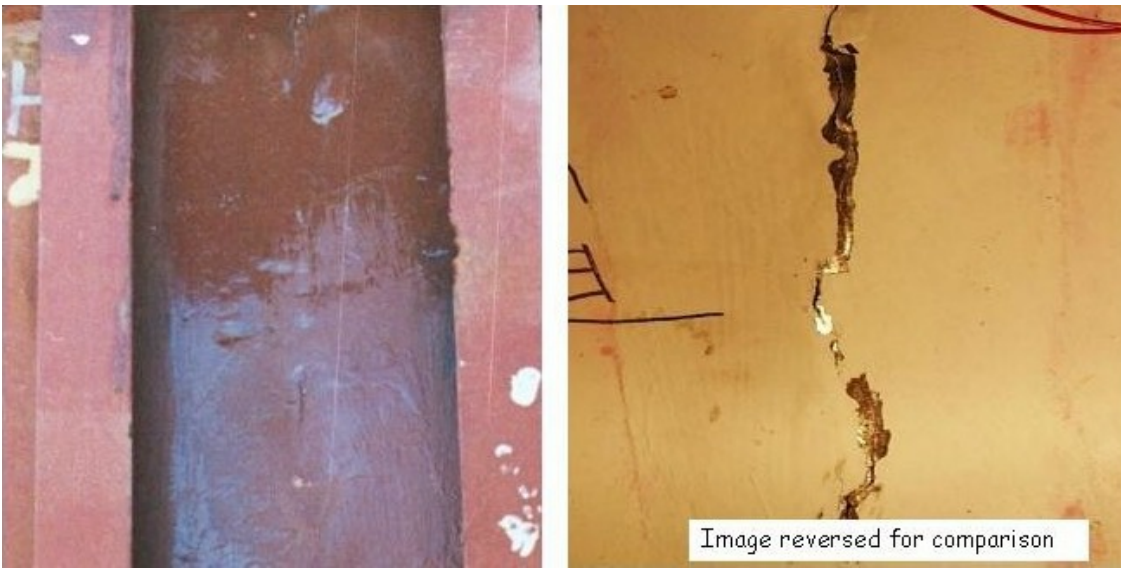
Figure 4. Photographs showing region of tear #4-1 from outside of liner (left) (prior to concrete placement) and inside of liner (right) (prior to removal of paint). Separate tears began of opposite sides of the weld, eventually growing together through the fusion zone.

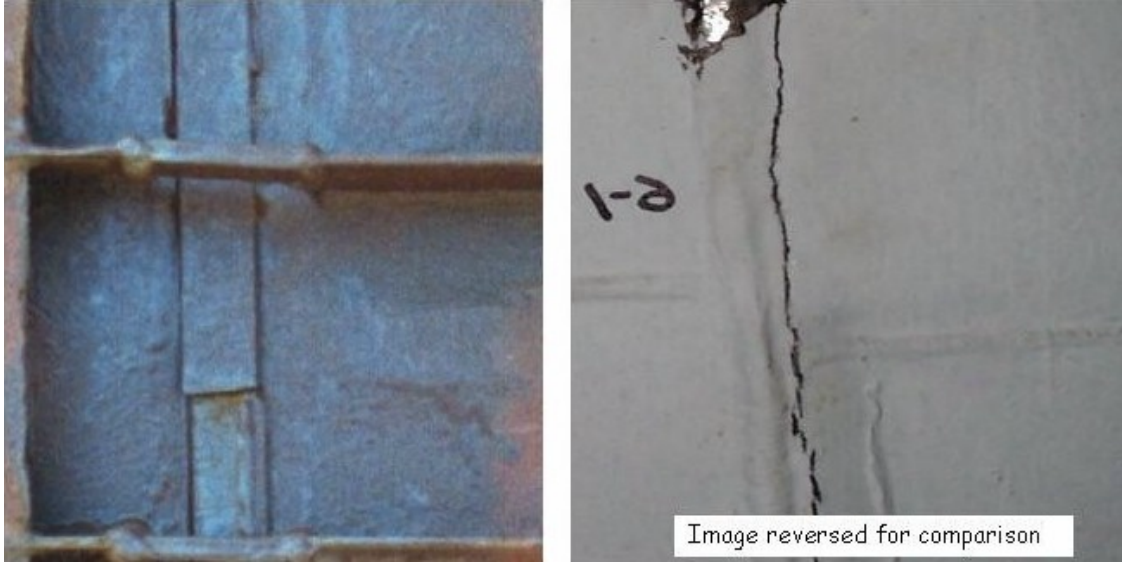
Figure 5. Photographs showing region of tear #6-1 from outside of liner (left) (prior to concrete placement) and inside of liner (right) (prior to removal of paint). Tear #6-2 was along the same vertical weld, but distant from the horizontal weld and associated horizontal stiffeners.

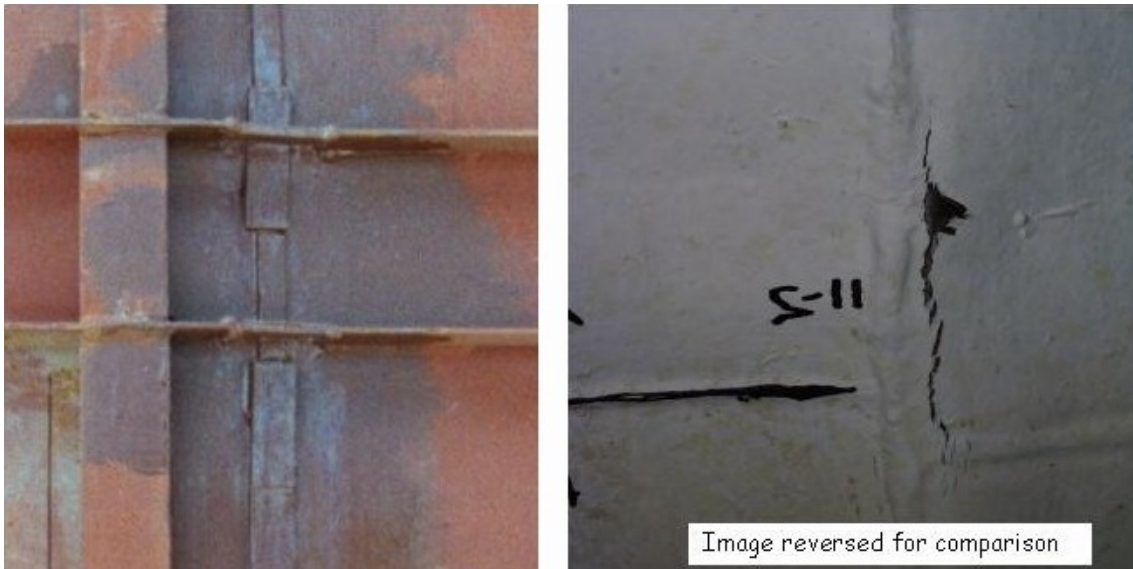
Figure 6. Photographs showing region of tear #11-2 from outside of liner (left) (prior to concrete placement) and inside of liner (right) (prior to removal of paint). Tear #11-1 was along the same vertical weld, but distant from the horizontal weld and associated horizontal stiffeners. Tears #11-1 and 11-2 were along the same vertical weld as tears #6-1 and 6-2.

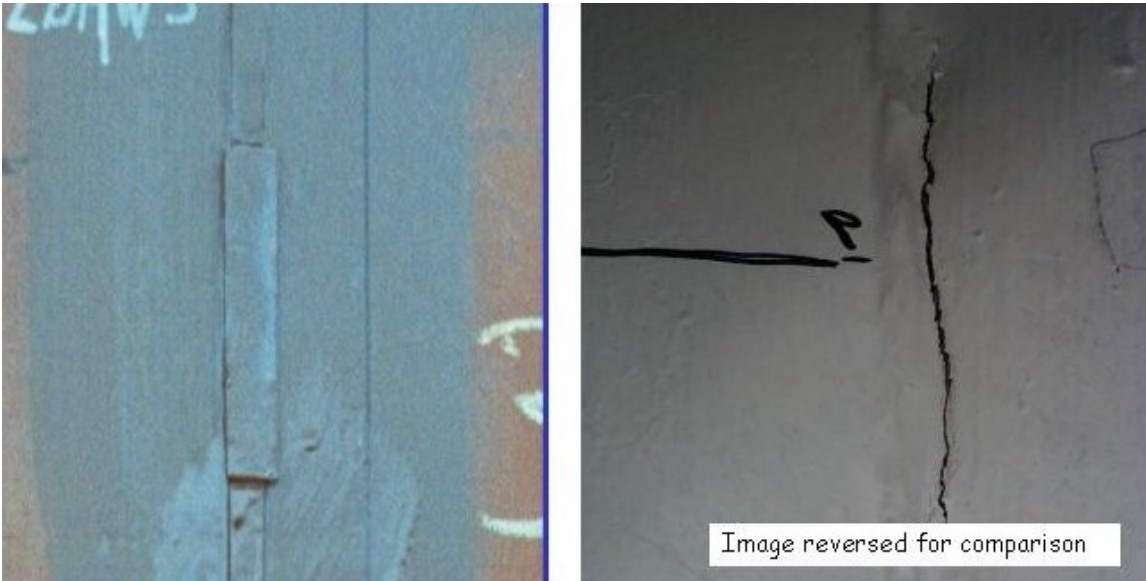
Tear #9: This tear is described in Tables 1 and 6, and pictured in Figures 8, 27, 58 and 76. It represented a typical repair welded joint far from either anchors or horizontal stiffeners. In other respects it was similar to tear #6-2, one where a narrow band of thinning resulted from heavy grinding adjacent to the back-up bar, and where numerous back-up segments indicated a series of repairs at various heights along a vertical field weld. Metallographic examination revealed no unusual microstructural features. While this sample showed the greatest discrepancy in percent grinding estimated by different methods, all methods indicated that sufficient grinding had been done to cause substantial strain localization and ductile tearing when the structure was tested. Approximately 40 to 45% thinning appears to have been done by grinding based on two of the three estimation methods.

Figure 8. Photographs showing region of tear #9 from outside of liner (left) (prior to concrete placement) and inside of liner (right) (prior to removal of paint).

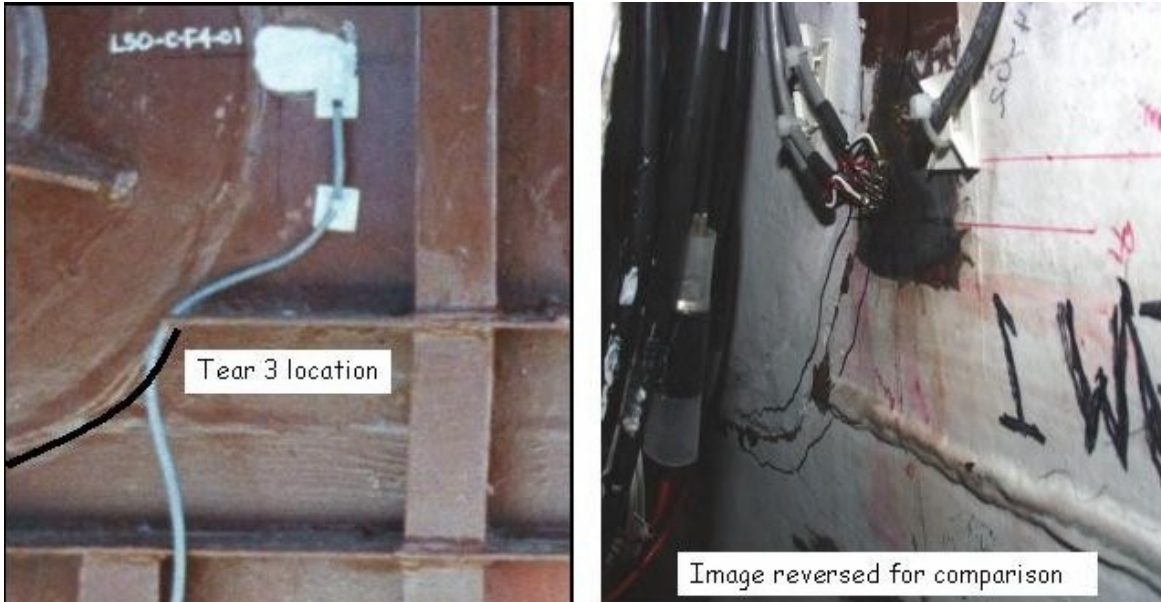
Tears #3 and 5-1: These tears are described in Table 2 and pictured in Figures 13 and 14. They occurred along opposite ends of the feedwater penetration transition weld, i.e., in areas that were mirror images of one another. No metallographic samples were taken from these regions because their locations made removal difficult and because repair would be difficult in the event a decision was made to retest the structure. The fact that tear #3 was substantially larger than tear #5-1 may have resulted from more extensive grinding and weld repair on this end of the transition. On the other hand, it could also have been exacerbated by a difference in horizontal stiffener terminations revealed by the back-side photographs. At #3 the horizontal stiffener ends very close to the transition weld (within 1 cm – see Figure 13), creating a very limited length of low stiffness, hence a region of potentially very high strain localization. At #5-1 the horizontal stiffener ends much farther from the transition weld (~10 cm – see Figure 14), thus providing a longer length of low stiffness over which the local strain could distribute, (i.e., lower strain localization).

Figure 13. Photographs showing region of tear #3 from outside of liner (left) (prior to concrete placement) and inside of liner (right) (prior to removal of paint).

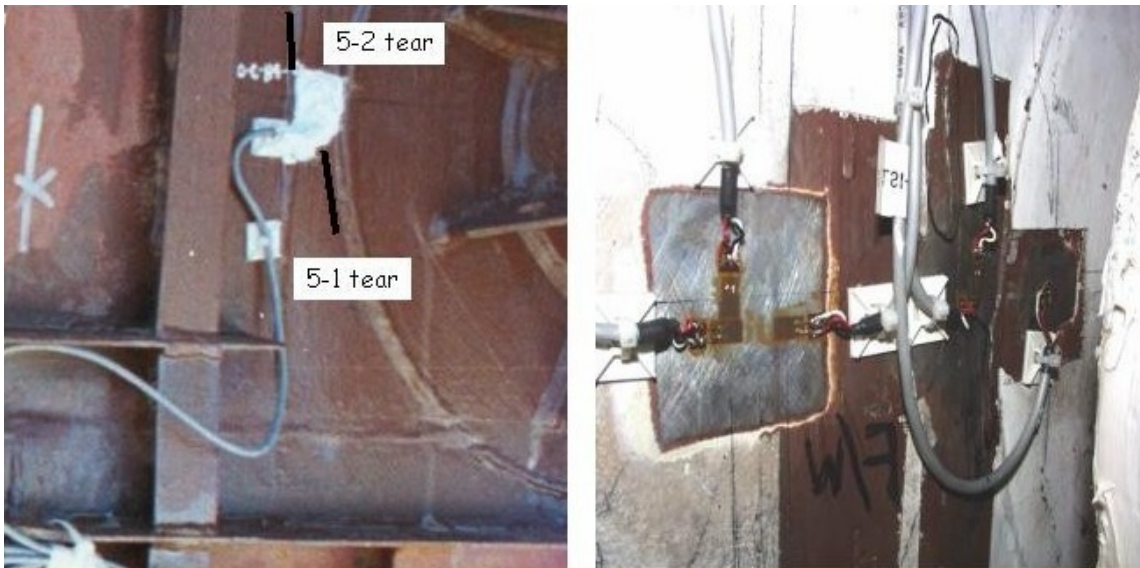
Tear #5-2: This tear occurred along a vertical weld slightly above #5-1. No metallographic samples were taken for the same reasons mentioned above. However, the back-side photographs (Figures 13 and 14) revealed a significant difference between the region in which tear #5-2 occurred and the corresponding mirror image region at the opposite end of the feedwater penetration transition. At one end there was a vertical weld in the high strain region between the nearest concrete anchor and the stiff feedwater

Figure 14. Photographs showing region of tear #5 from outside of liner (left) (prior to concrete placement) and inside of liner (right) (prior to removal of paint).

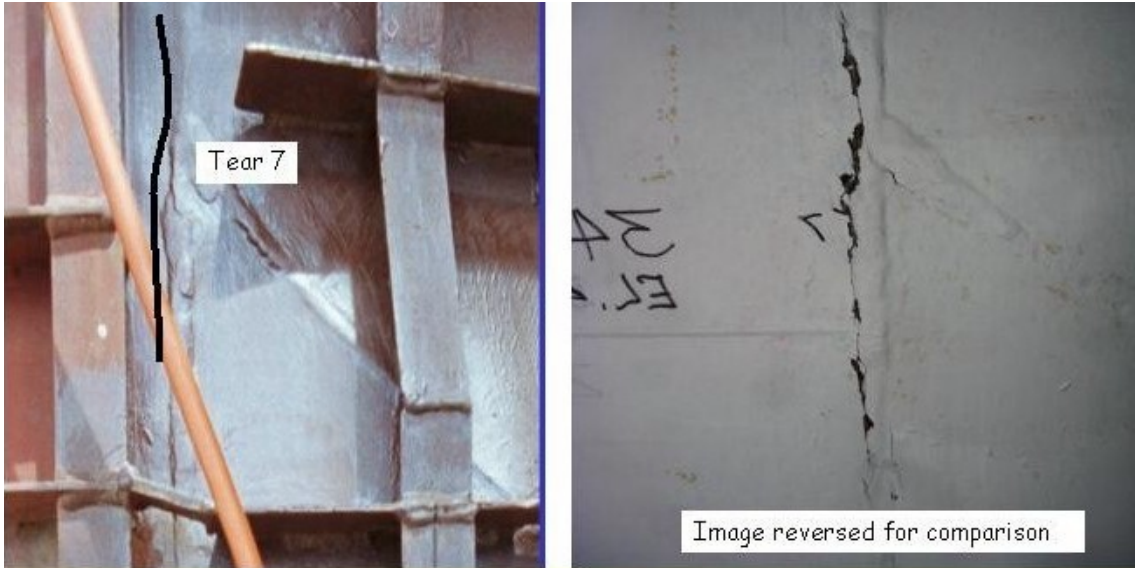
Tears #7 and 15: These tears occurred near the lower and upper corners of the equipment hatch transition joint, respectively. They are described in Tables 2 and 7, and pictured in Figures 15, 16, 32, 33, 60, 61, 79, 80 and 81. Acoustic monitoring suggested that initial tearing occurred in the vicinity of this transition joint. While this transition represented a region where complex stresses and high local strains were expected, liner thinning resulting from grinding done in association with repair welding was also substantial in the areas of these tears: 25% to 30% at tear #7 and ~ 50% at tear #15. This thinning undoubtedly exacerbated plastic strain localization and tearing in these areas, however, it is likely that high strains at this transition also contributed to tearing. No unusual microstructural features were observed in the vicinities of these tears.

Figure 15. Photographs showing region of tear #7 from outside of liner (left) (prior to concrete placement) and inside of liner (right) (prior to removal of paint).

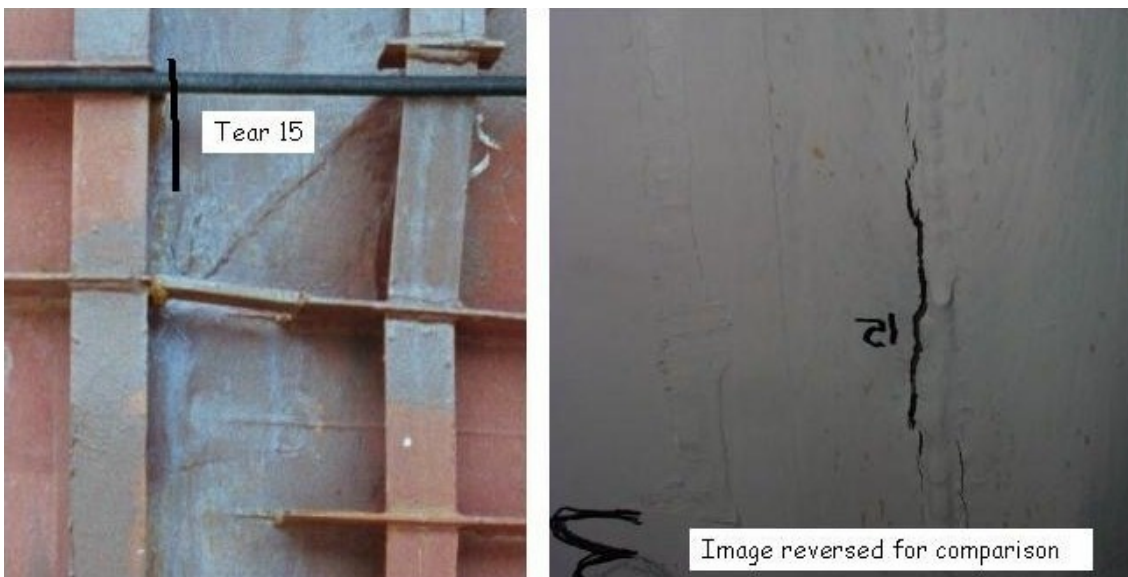
Figure 16. Photographs showing region of tear #15 from outside of liner (left) (prior to concrete placement) and inside of liner (right) (prior to removal of paint).

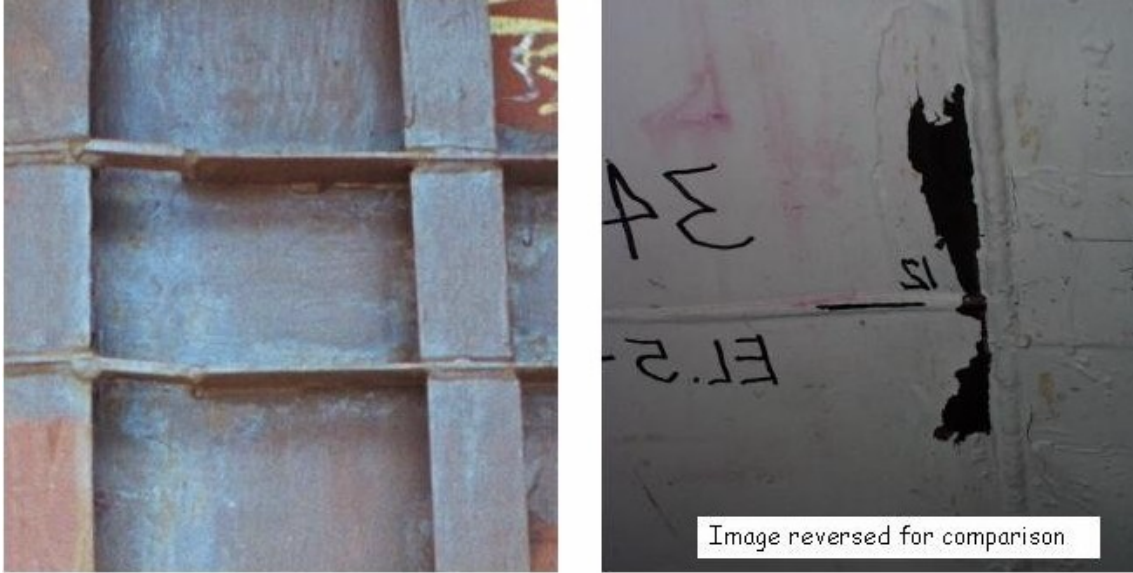
Tears #12 and 13: These tears also occurred along the equipment hatch transition joint, but near its midpoint, rather than the corners. They are described in Tables 2 and 7, and pictured in Figures 17, 18, 34, 35, 62, 63, 64, 82 and 83. Both formed near horizontal field welds and the associated “rat-hole” discontinuities in horizontal stiffeners, although back-side photographs indicated that patches were welded in between the adjoining stiffener segments, minimizing strain localization in these regions (unless the welds at the ends of these patches failed). Evidence of ~30% thinning from grinding was found at tear #13.

The extent of thinning from grinding was much less clear in the vicinity of tear #12. Little evidence of grinding or weld repair was macroscopically apparent on either the front or back side. Consistent with this, ultrasonic thickness measurements indicated ~22% thinning approximately 5 mm adjacent to this tear (Figure 34), only slightly greater than the amount expected based on cross-sections of the tensile samples (Figures 45 to 48). Consistent with this, metallographic observation of the portion on the side of the tear where the ultrasonic measurements had been made indicated only a small amount of grinding, ~10%. However, the opposite side (adjacent to the weld fusion zone) showed a different and thinner section at the tear location, suggesting ~27% reduction by grinding. Microstructural observation of the weld failed to unequivocally reveal whether a repair weld had been made in this area. The fusion zone was wider (~8 mm) than most initial welds, suggesting that a repair had been made. But no evidence remained of the previous weld – perhaps the initial fusion zone had been completely ground out prior to repair or the repair weld had completely consumed it – this was observed in several other areas where it was macroscopically apparent that repair welds *had been* made. Tear #12 may be the one most likely to represent a “true structural effect”, i.e., to not have resulted from excessive grinding, backing bar abnormalities, or weld defects. However, there is a substantial degree of uncertainty regarding the amount of thinning from grinding in the vicinity of this tear.

Figure 17. Photographs showing region of tear #12 from outside of liner (left) (prior to concrete placement) and inside of liner (right) (prior to removal of paint).

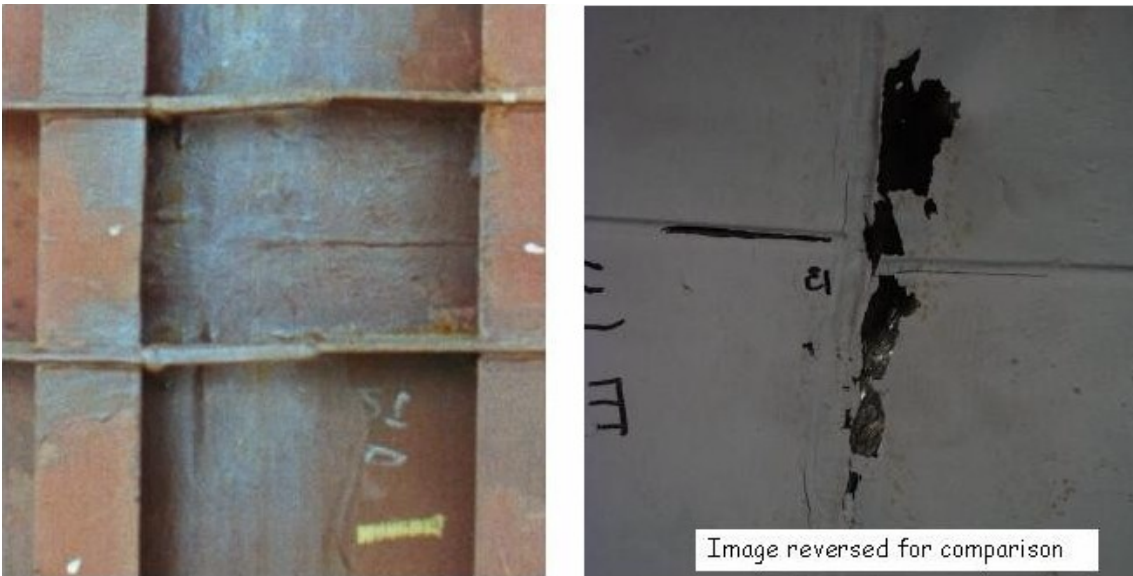
Figure 18. Photographs showing region of tear #13 from outside of liner (left) (prior to concrete placement) and inside of liner (right) (prior to removal of paint).

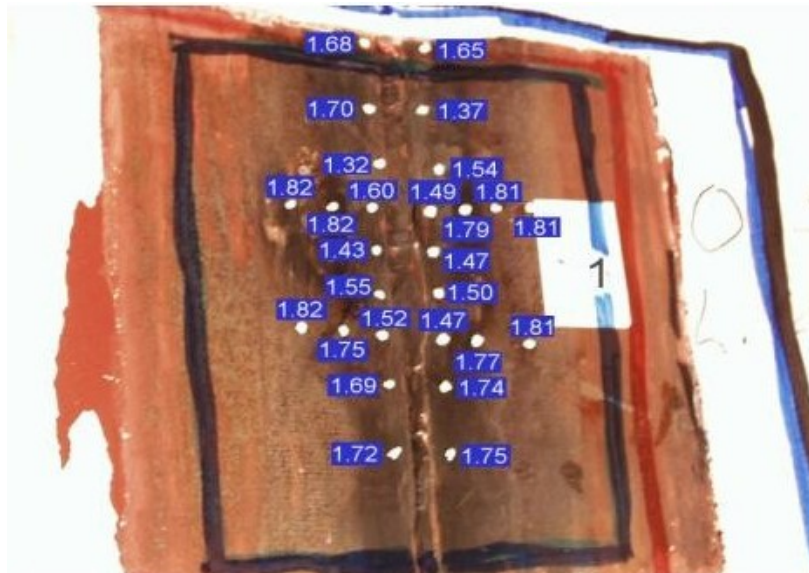
Figure 19. Liner thicknesses (in millimeters) measured ultrasonically in the vicinity of tear #1.

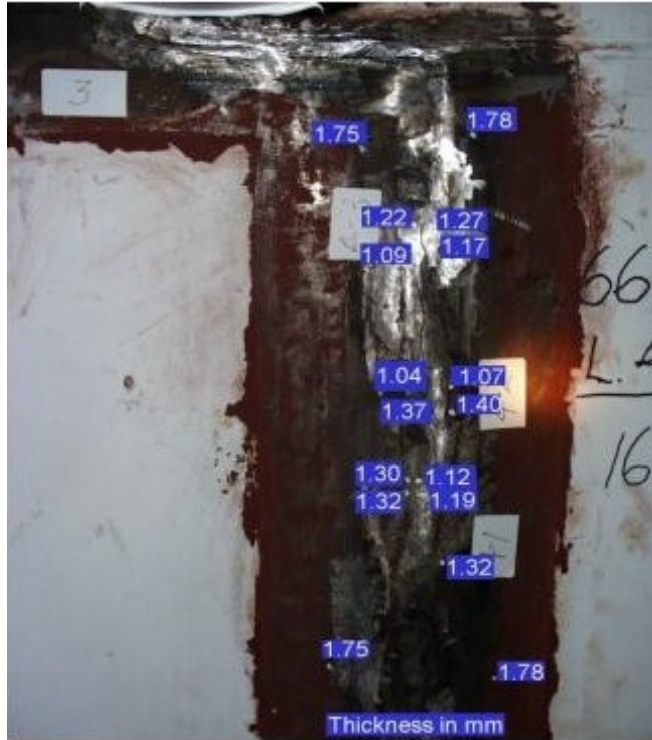
Figure 21. Liner thicknesses (in millimeters) measured ultrasonically in the vicinity of tear #4 (4-1, 4-2, and 4-3).

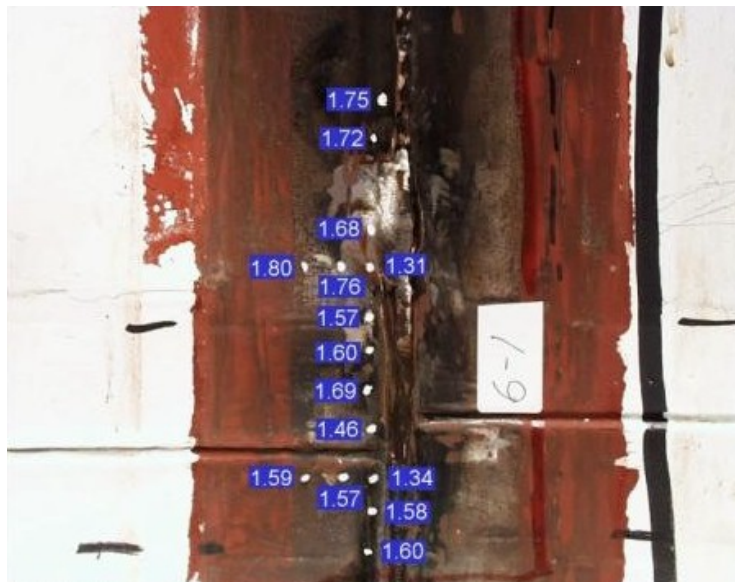
Figure 22. Liner thicknesses (in millimeters) measured ultrasonically in the vicinity of tear #6-1.

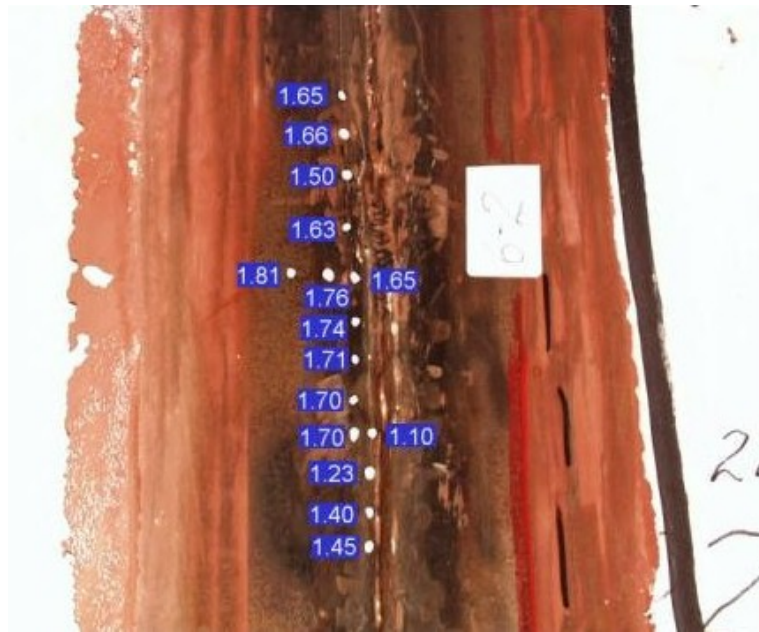
Figure 23. Liner thicknesses (in millimeters) measured ultrasonically in the vicinity of tear #6-2.

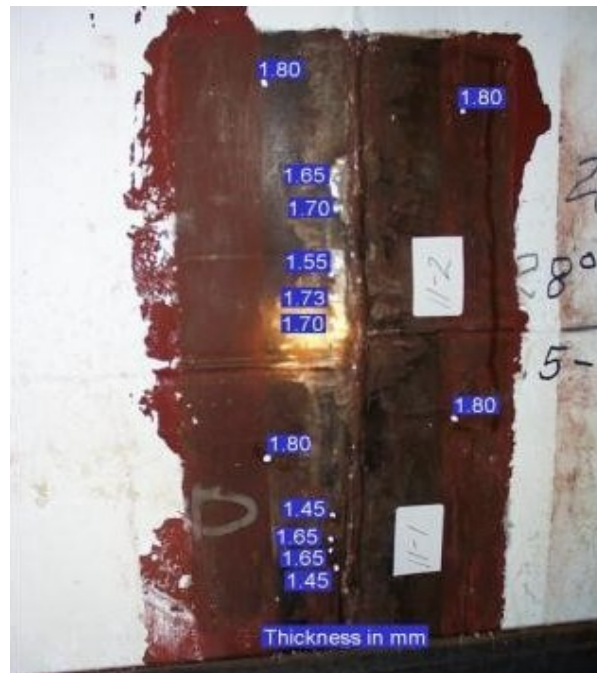
Figure 24. Liner thicknesses (in millimeters) measured ultrasonically in the vicinity of tear #11 (11-1 and 11-2).

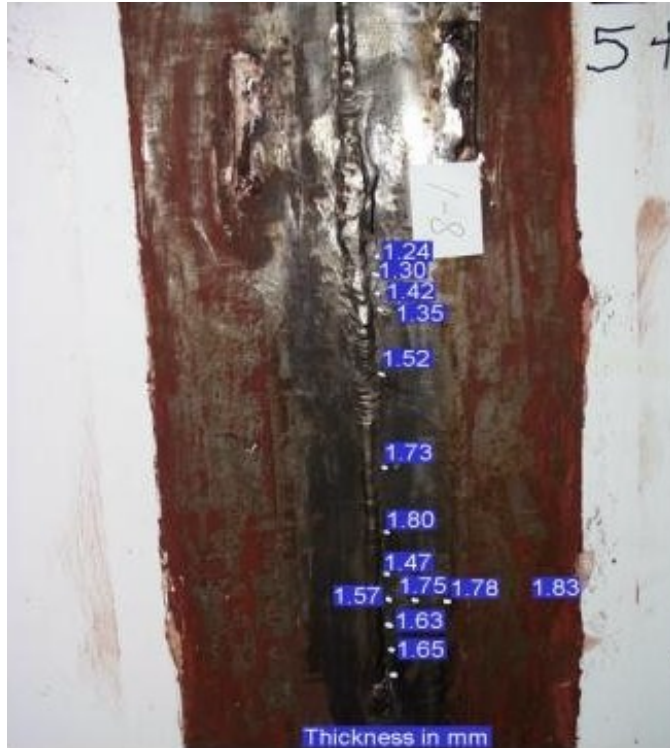
Tear #8-1: This tear is described in Tables 1 and 6, and pictured in Figures 7, 25, 56 and 78. It represented a tear that occurred in an area where a segment of back-up bar had been left missing during repair welding. This may have exacerbated strain localization in this region, but the estimated 30% grinding reduction of liner thickness observed in this area was, by itself, likely sufficient to cause severe plastic strain localization and subsequent ductile tearing.

Figure 25. Liner thicknesses (in millimeters) measured ultrasonically in the vicinity of tear #8-1.

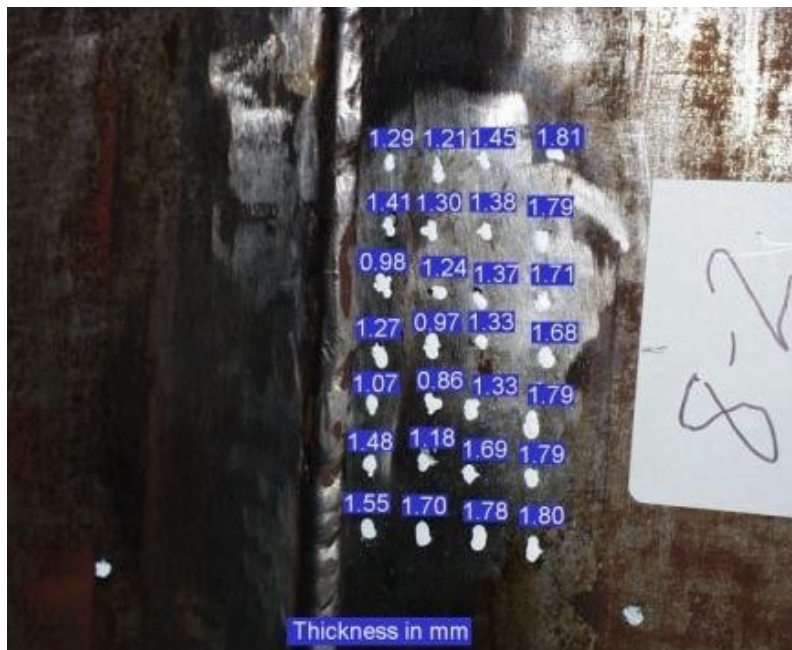
Tear #8-2: Tear #8-2 is described in Table 1 and 6, and pictured in Figures 26, 57 and 75. It was unique in that it occurred relatively distant from the weld in an area where macroscopic examination revealed evidence of substantial grinding (Figure 26), but no apparent repair weld. Metallographic examination revealed, however, that at least two repair welds had been made adjacent to the vertical joint, apparently to repair an inadvertent “grind-through” made in association with repairs on the main weld. Following repair of this “grind-through”, the weld bead of this repair had been ground off from both front and back sides, leaving no obvious evidence of this defect having been made or repaired. However, this grinding reduced the wall thickness in the repaired “grind-through” area by approximately 60%, resulting in severe localization of plastic deformation culminating in ductile tearing when the structure was tested.

Figure 26. Liner thicknesses (in millimeters) measured ultrasonically in the vicinity of tear #8-2. Note the extensive grinding extending distant from main weld.

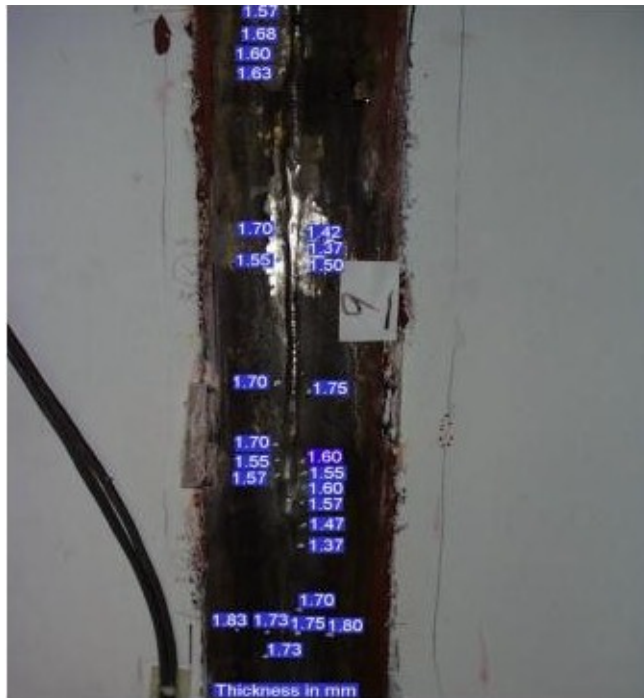
Figure 27. Liner thicknesses (in millimeters) measured ultrasonically in the vicinity of tear #9.

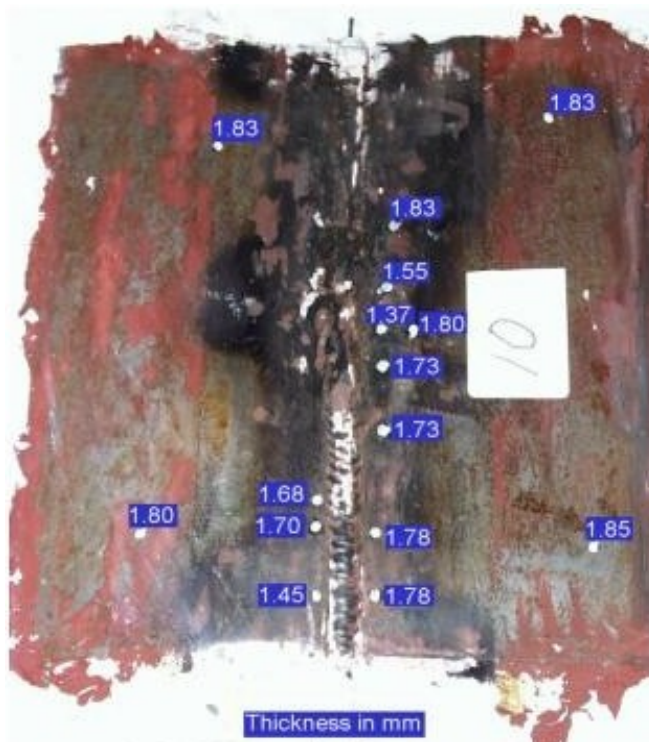
Figure 28. Liner thicknesses (in millimeters) measured ultrasonically in the vicinity of tear #10.

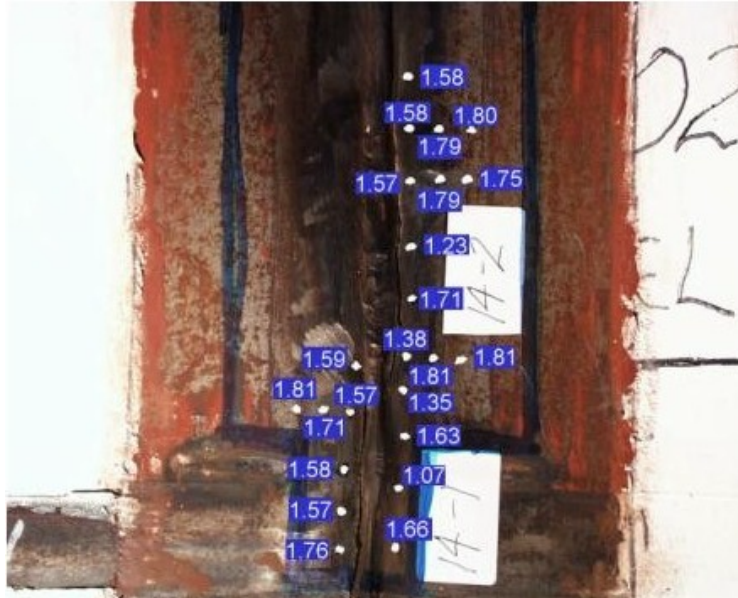
Figure 29. Liner thicknesses (in millimeters) measured ultrasonically in the vicinity of tear #14 (14-1 and 14-2).

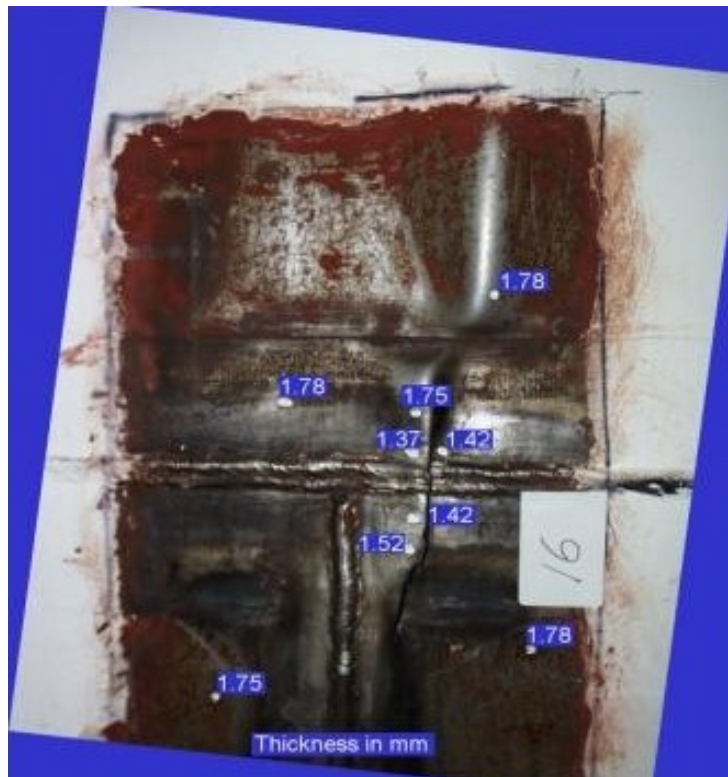
Figure 30. Liner thicknesses (in millimeters) measured ultrasonically in the vicinity of tear #16. Note distance of tear from vertical weld and extensive buckling above tear.

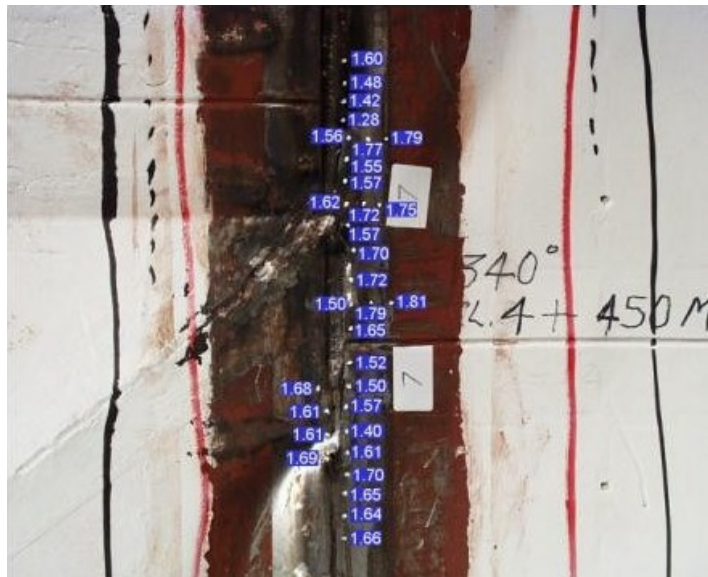
Figure 32. Liner thicknesses (in millimeters) measured ultrasonically in the vicinity of tear #7.

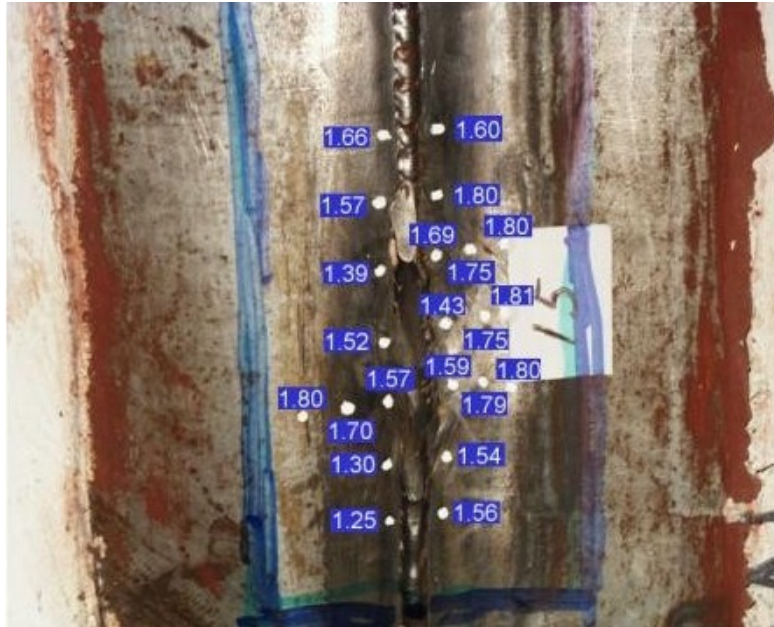
Figure 33. Liner thicknesses (in millimeters) measured ultrasonically in the vicinity of tear #15.

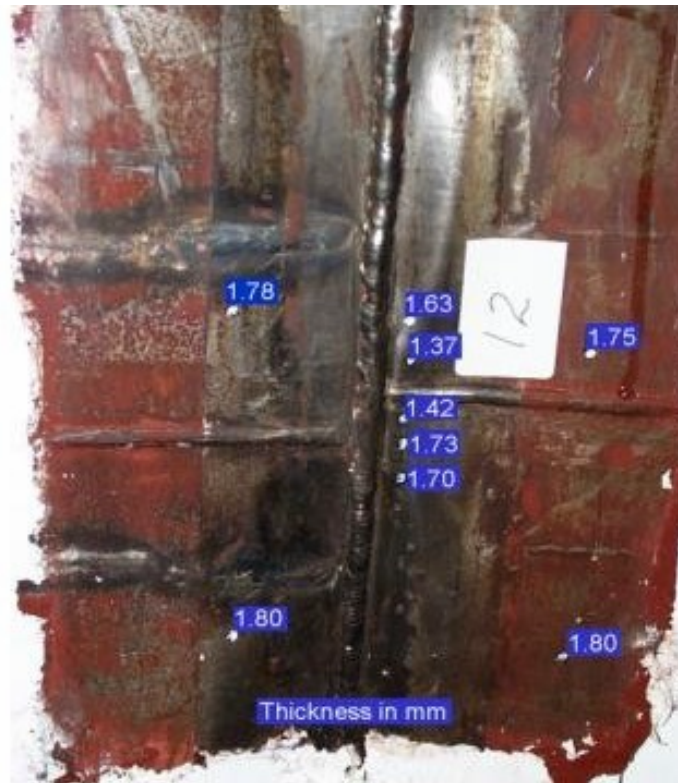
Figure 34. Liner thicknesses (in millimeters) measured ultrasonically in the vicinity of tear #12.

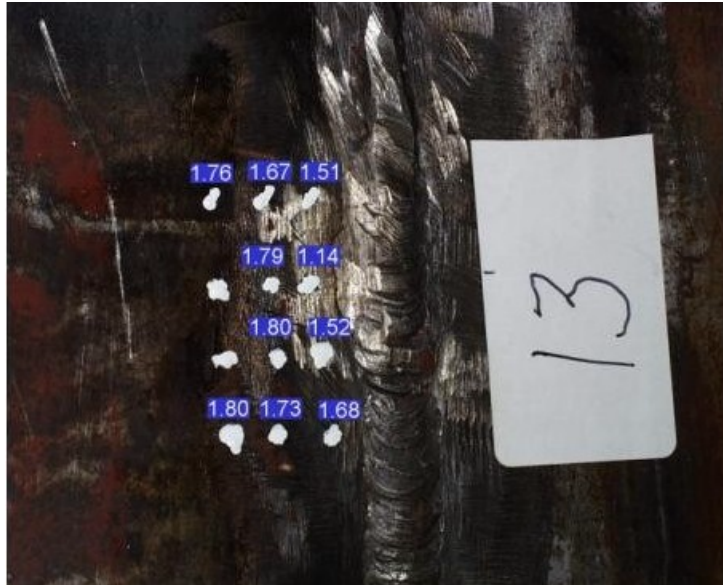
Figure 35. Liner thicknesses (in millimeters) measured ultrasonically in the vicinity of tear #13.

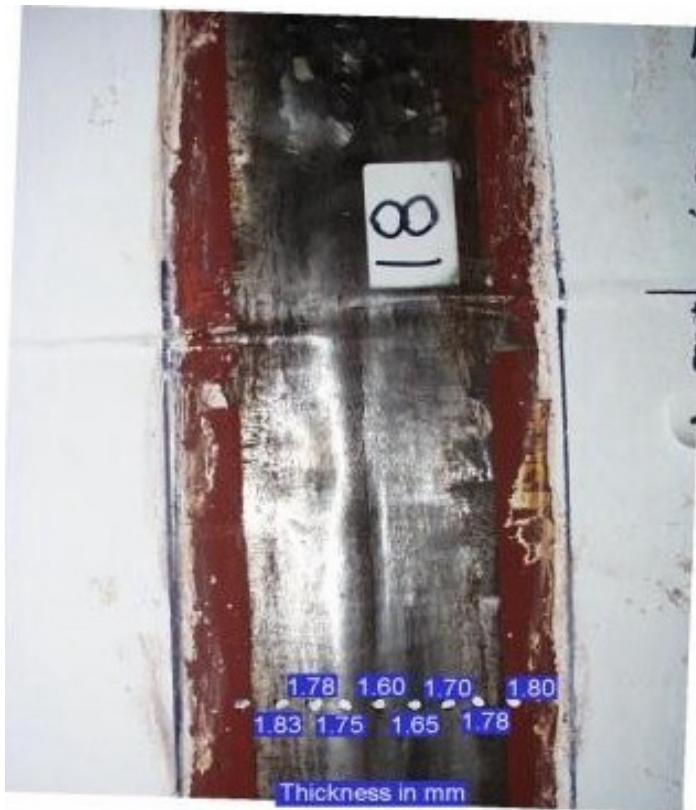
Region #18-1 and 18-2: The observations made in these areas are described in Table 8 and pictured in Figures 36, 85, 86, 89 and 90. The cross-section of #18-1 (Figure 89) showed that a modest amount of localized plastic deformation had occurred adjacent to the weld on both sides of the fusion zone. The greatest amount of deformation thinning occurred in the HAZ near the fusion line (13% on one side, 9% on the other side – note that these amounts of thinning are consistent with the ultrasonic thickness measurements, shown in Figure 36). Approximately 5% thinning was uniformly observed over a ~15 mm wide band in the adjacent base metal. Thinning then tapered out gradually to zero over the next ~15 mm. The amount of thinning in the HAZ is in the vicinity of the 12% to 13% required for the onset of necking, as was determined from analysis of the welded tensile samples. However, considerable additional local deformation would be required before tearing would be expected to occur. Consistent with this, no evidence of void formation or shear banding, which would be indicative of incipient failure, was observed.

Figure 36. Liner thicknesses (in millimeters) measured ultrasonically in region #18. Buckling and “orange-peel” evidence of substantial plastic deformation, but no tearing, was apparent in this area.

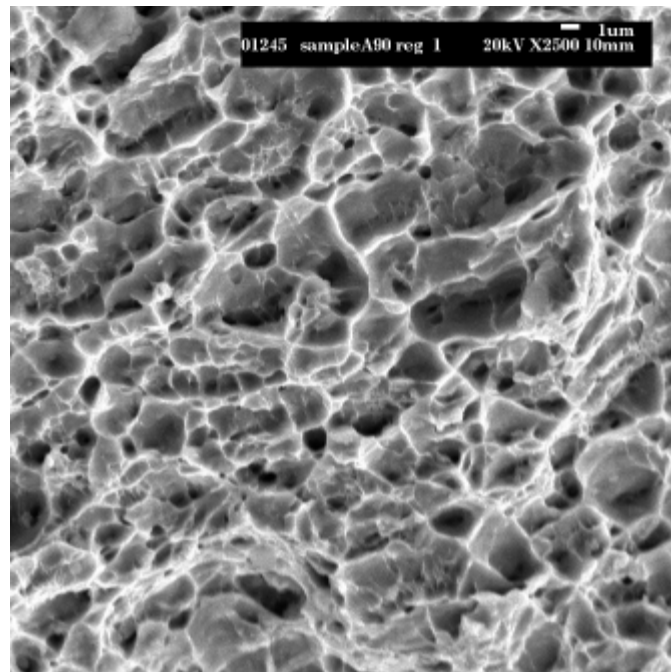
Figure 43. Scanning electron micrograph of fracture surface from welded tensile sample with lack of fusion defect. The location pictured is away from the weld defect, here deformation and fracture occurred in the heat affected zone. Failure here also occurred by ductile rupture.

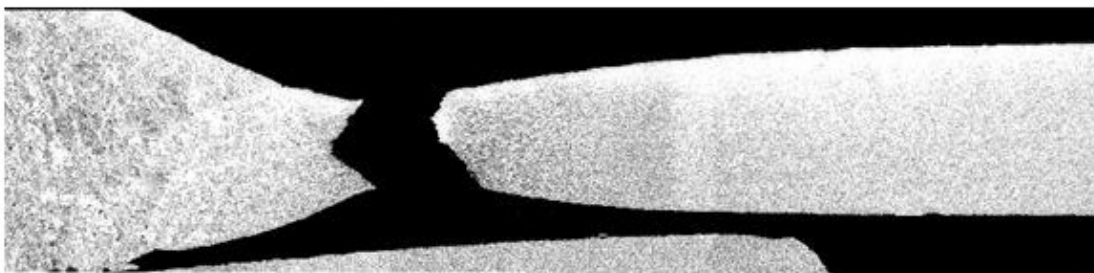
Figure 46. Metallographic cross-section of tensile sample from practice weld panel in area without substantial offset between plates (Sample B-2). This sample broke along the fusion line at an apparent lack of fusion defect. Cross-section is not through defect, but through a sound region adjacent to the defect where ductile tearing occurred.

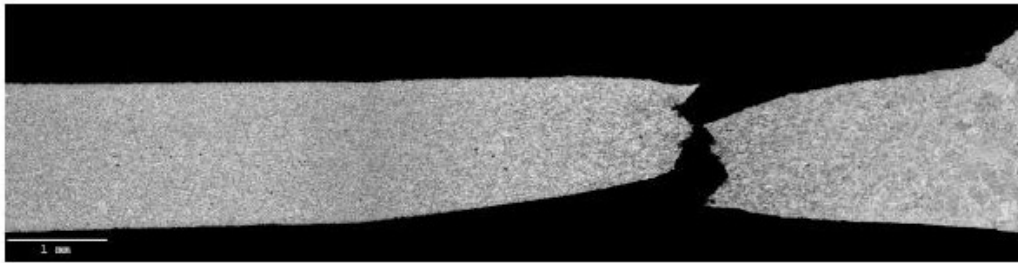
Figure 47. Metallographic cross-section of tensile sample from practice weld panel in area with substantial offset between plates (Sample C-1).

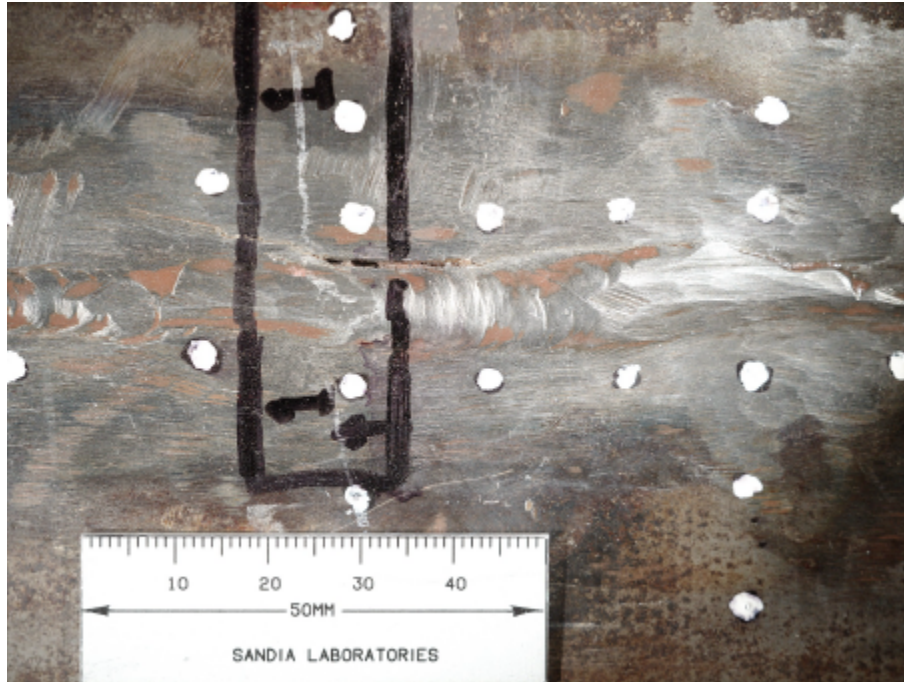
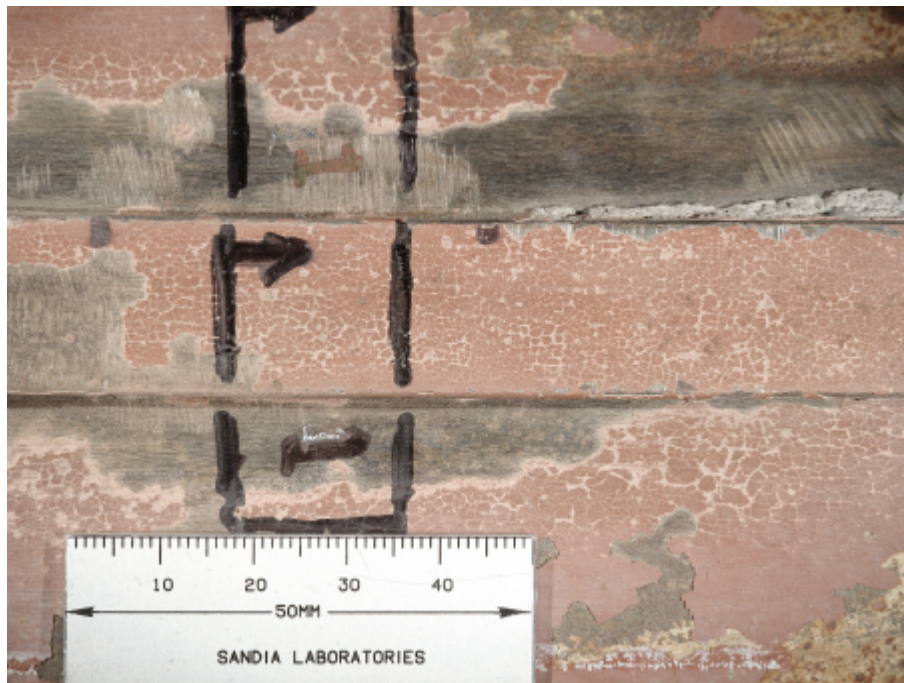
Figure 49. Details of inside (top) and outside (bottom) liner features in region of tear #1 metallographic cross-section (arrows begin at plane of section and indicate view direction).
