## **Appendix L: Metallurgical Analysis of PCCV Liner Tears**

## **Metallurgical Analysis of PCCV Liner Tears**

K. H. Eckelmeyer, J. A. VanDenAvyle, A. C. Kilgo, and L. D. Lambert

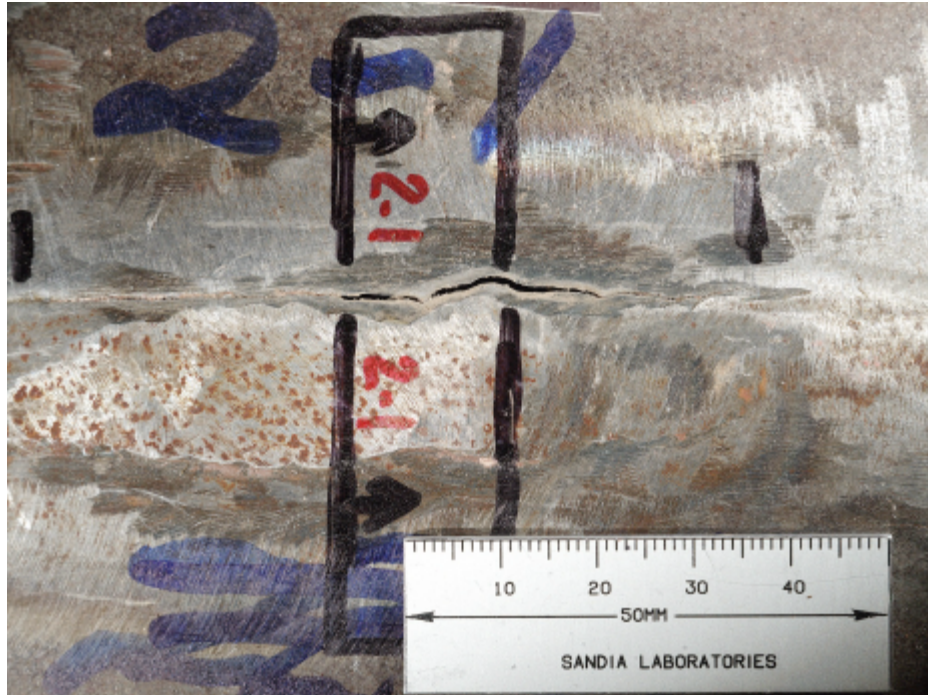
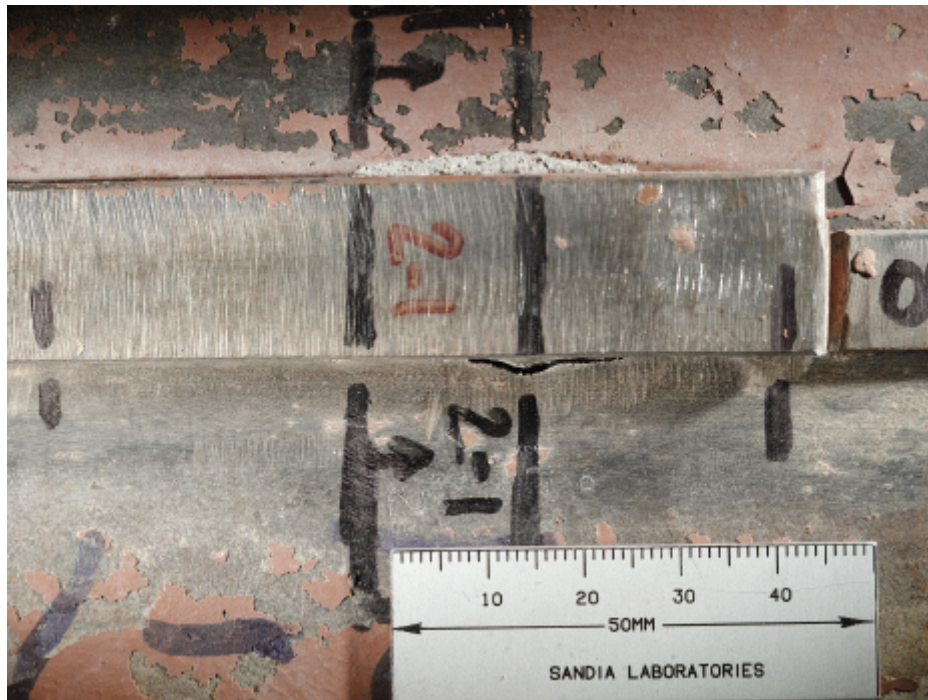
Tears #2-1, 2-2, 2-3: These tears are described in Tables 1 and 6, and pictured in Figures 3, 20, 50, 51, 52, 68, 69 and 70. They occurred along a vertical field weld that had undergone numerous overlapping repairs. The repeated repair welding resulted in a band as wide as 3 cm consisting largely of weld metal, much of which had been re-austenitized and recrystallized from the heat associated with subsequent welds. Extensive grinding was visually apparent over a broad area on either side of the tears (Figures 20, 50, 51 and 52). Immediately adjacent to tear #2-1 a small section of plate remained attached to the massive weld bead (Figure 68), permitting direct measurement of the residual thickness after grinding, as illustrated in Figure 84. Sufficiently continuous banding was apparent in #2-2 and #2-3 to permit grinding reduction to be estimated from the tapering of the ground surface with respect to these bands. In all three cases the amounts of grinding inferred by the three different methods were in reasonable agreement with one another,

Figure 50. Details of inside (top) and outside (bottom) liner features in region of tear #2-1 metallographic cross-section (arrows begin at plane of section and indicate view direction).

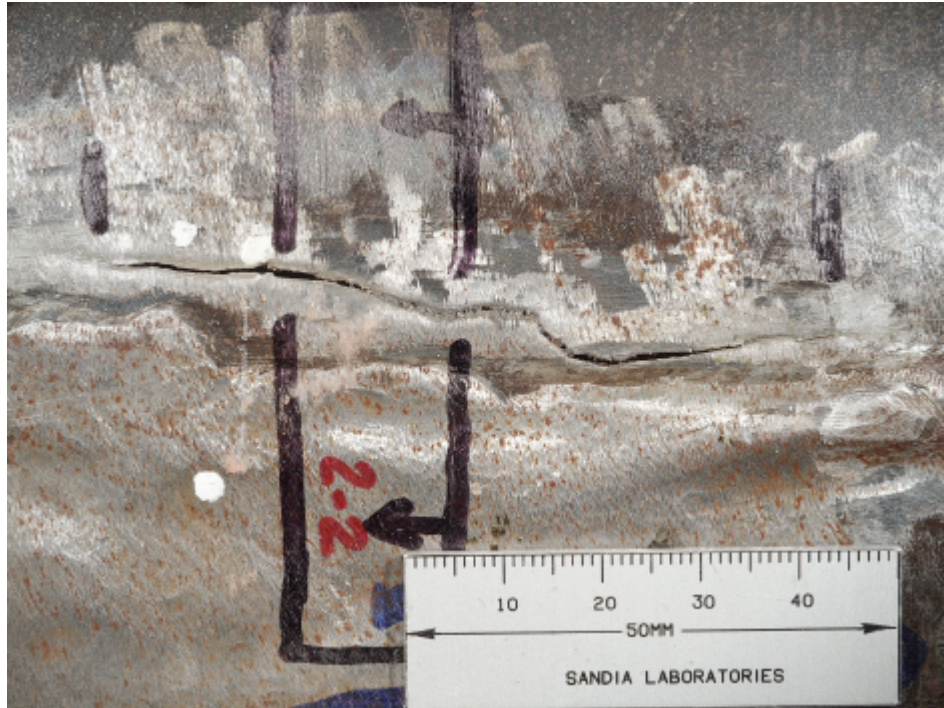
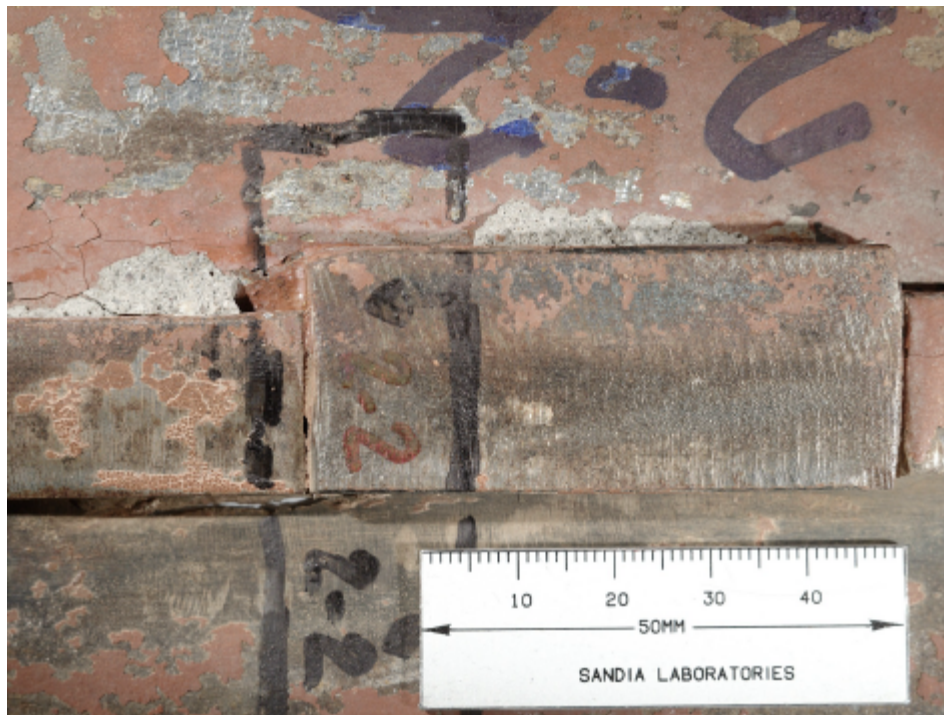
Figure 51. Details of inside (top) and outside (bottom) liner features in region of tear #2-2 metallographic cross-section (arrows begin at plane of section and indicate view direction).

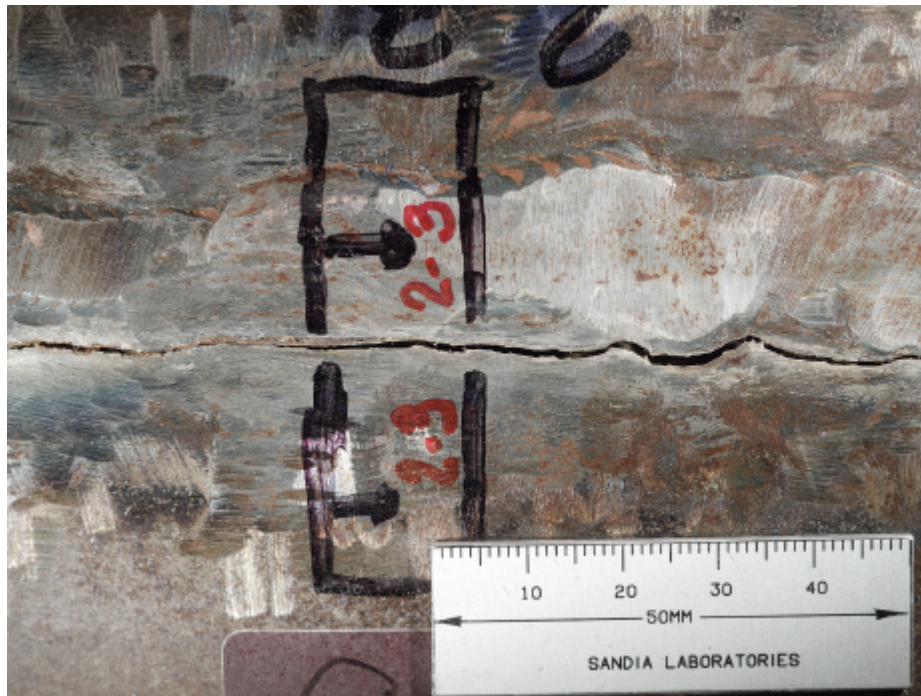
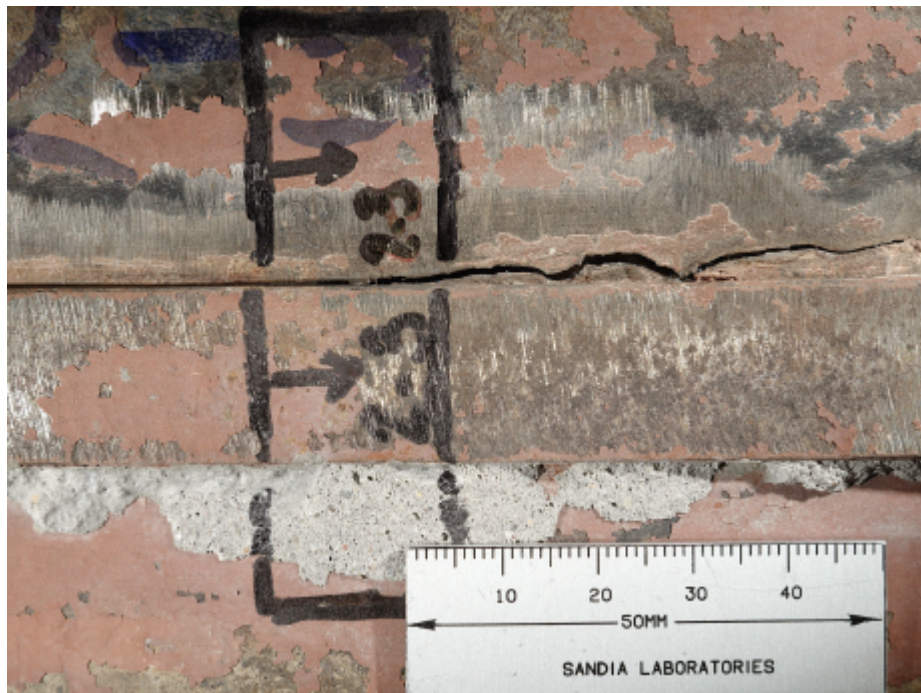
Figure 52. Details of inside (top) and outside (bottom) liner features in region of tear #2-3 metallographic cross-section (arrows begin at plane of section and indicate view direction).

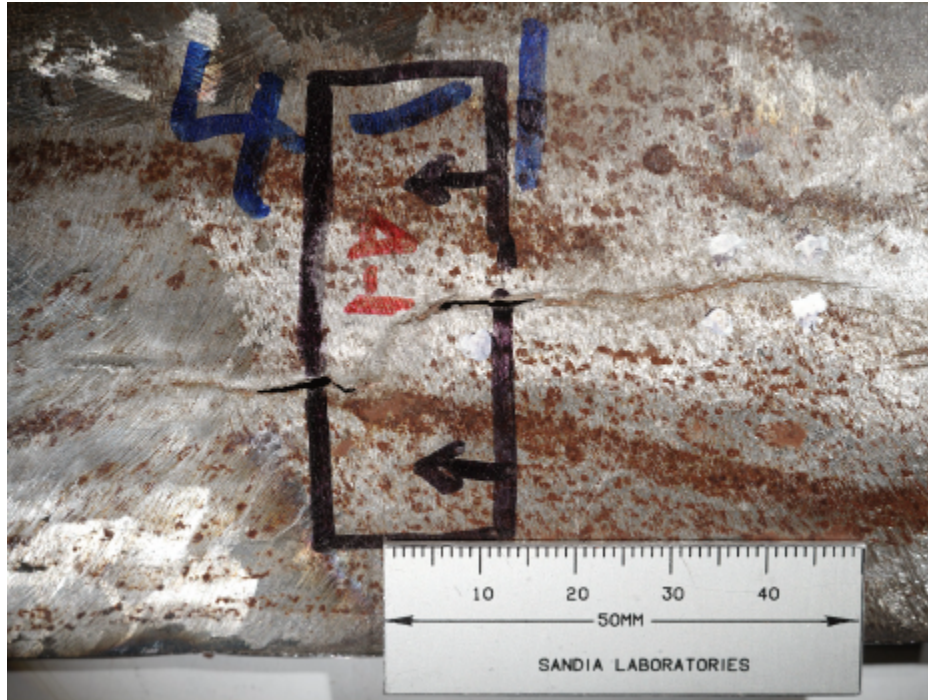
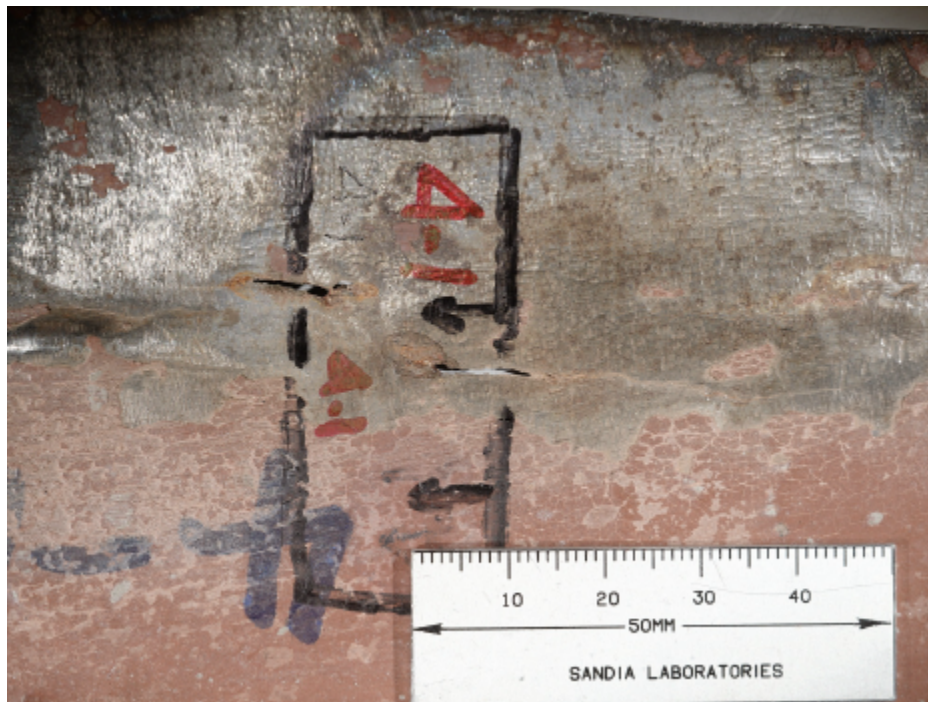
Figure 53. Details of inside (top) and outside (bottom) liner features in region of tear #4-1 metallographic cross-section (arrows begin at plane of section and indicate view direction).

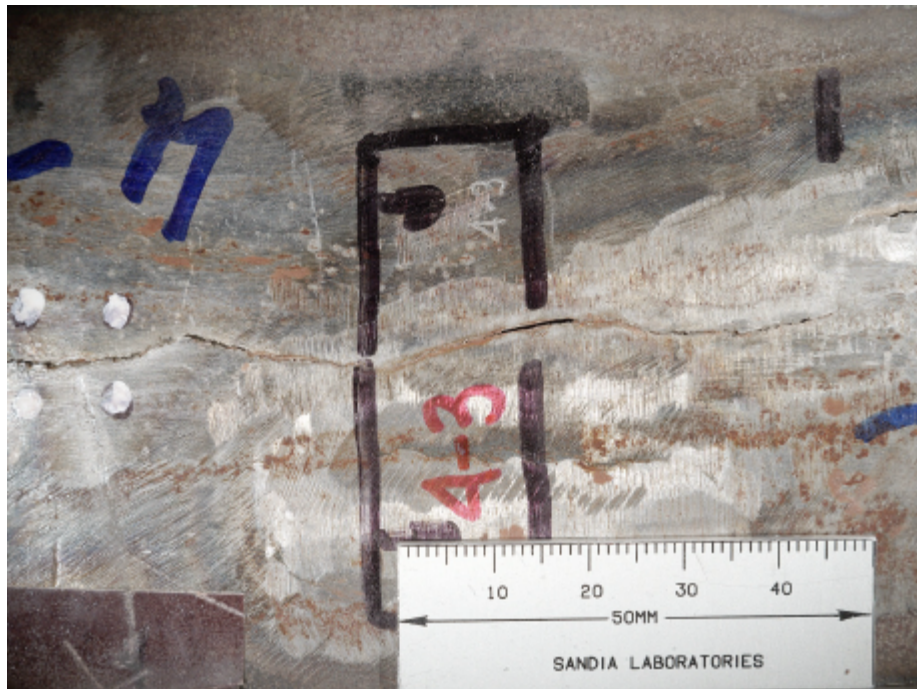
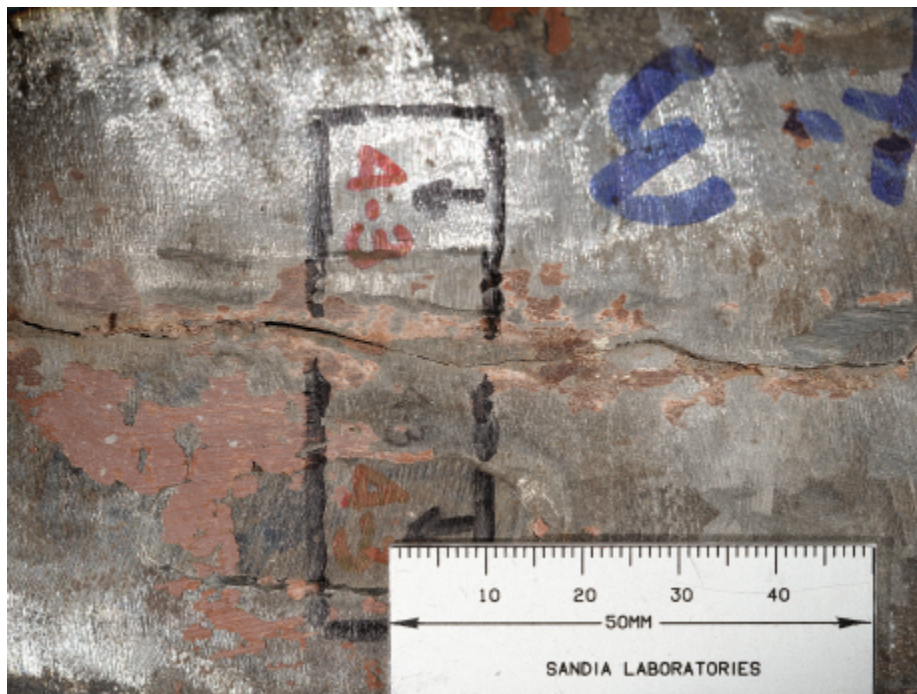
Figure 54. Details of inside (top) and outside (bottom) liner features in region of tear #4-3 metallographic cross-section (arrows begin at plane of section and indicate view direction).

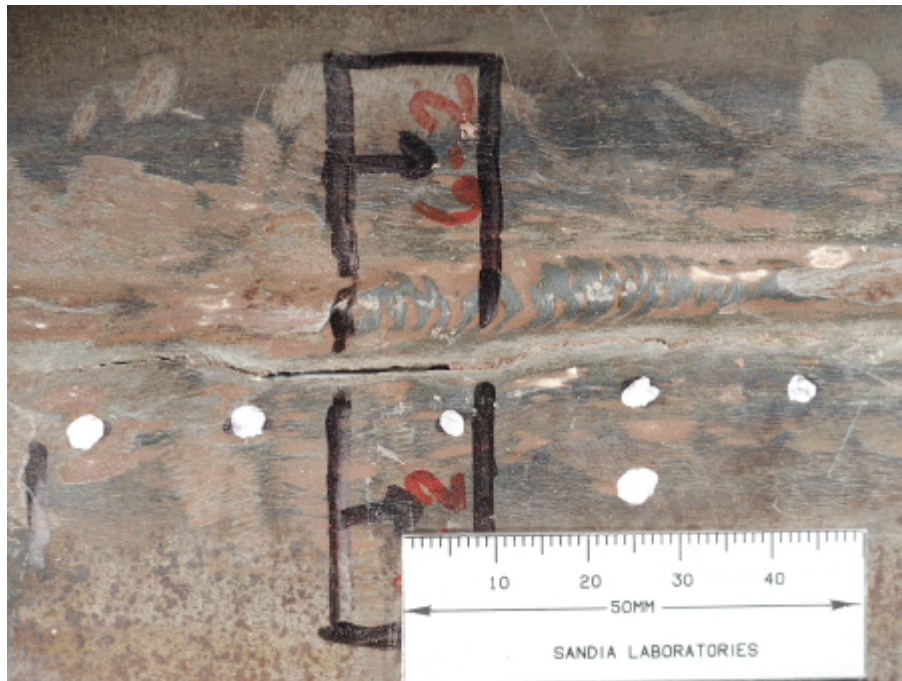
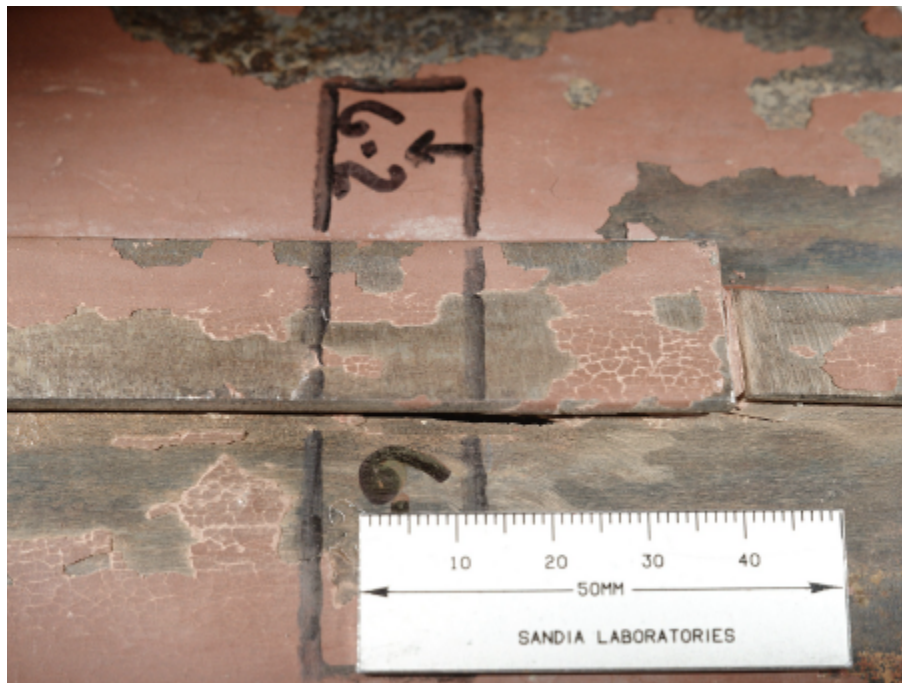
Figure 55. Details of inside (top) and outside (bottom) liner features in region of tear #6-2 metallographic cross-section (arrows begin at plane of section and indicate view direction).

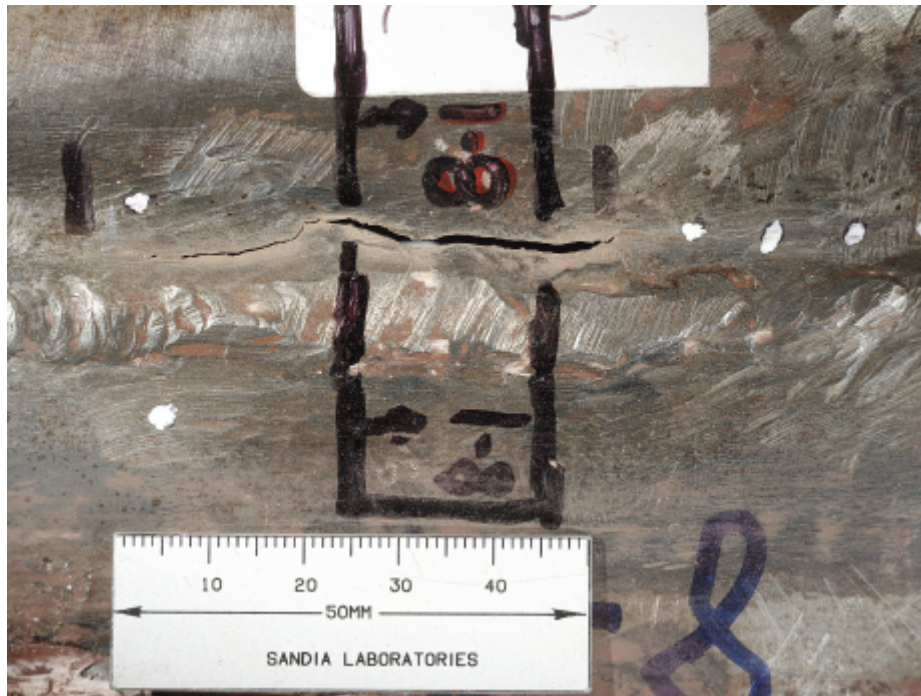
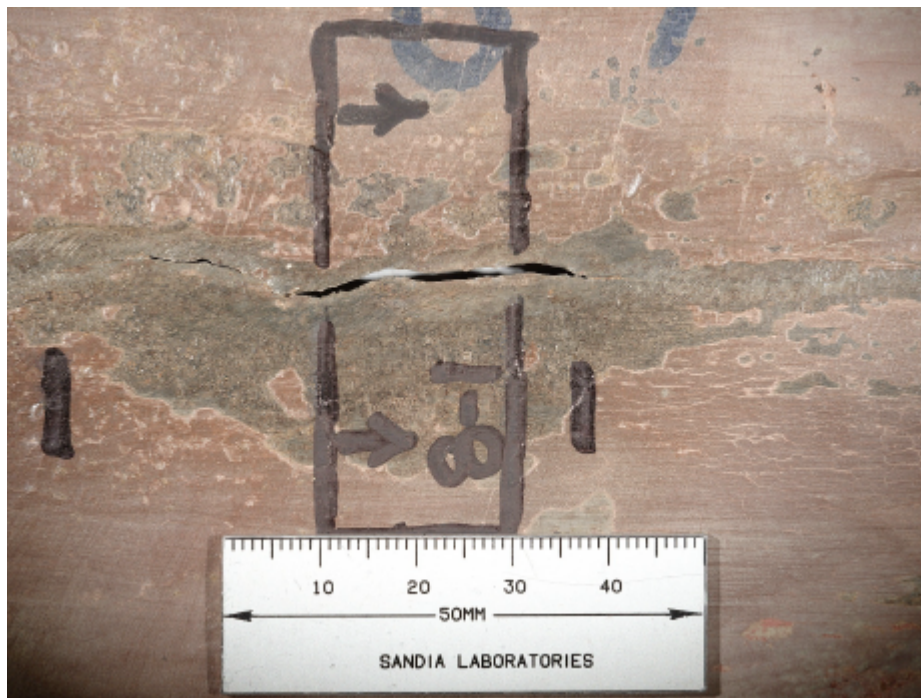
Figure 56. Details of inside (top) and outside (bottom) liner features in region of tear #8-1 metallographic cross-section (arrows begin at plane of section and indicate view direction).

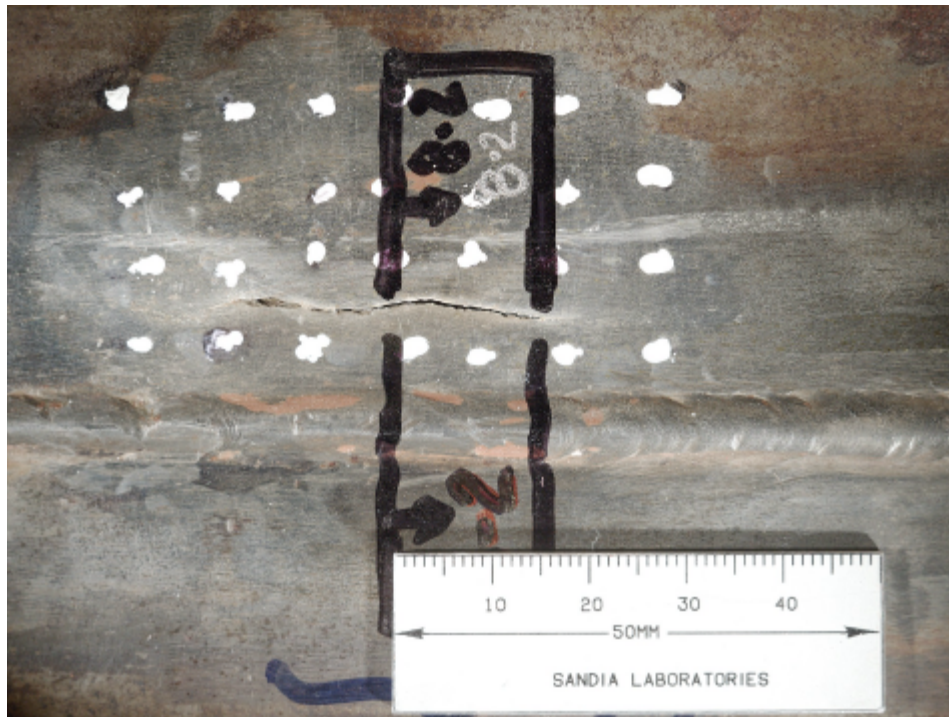
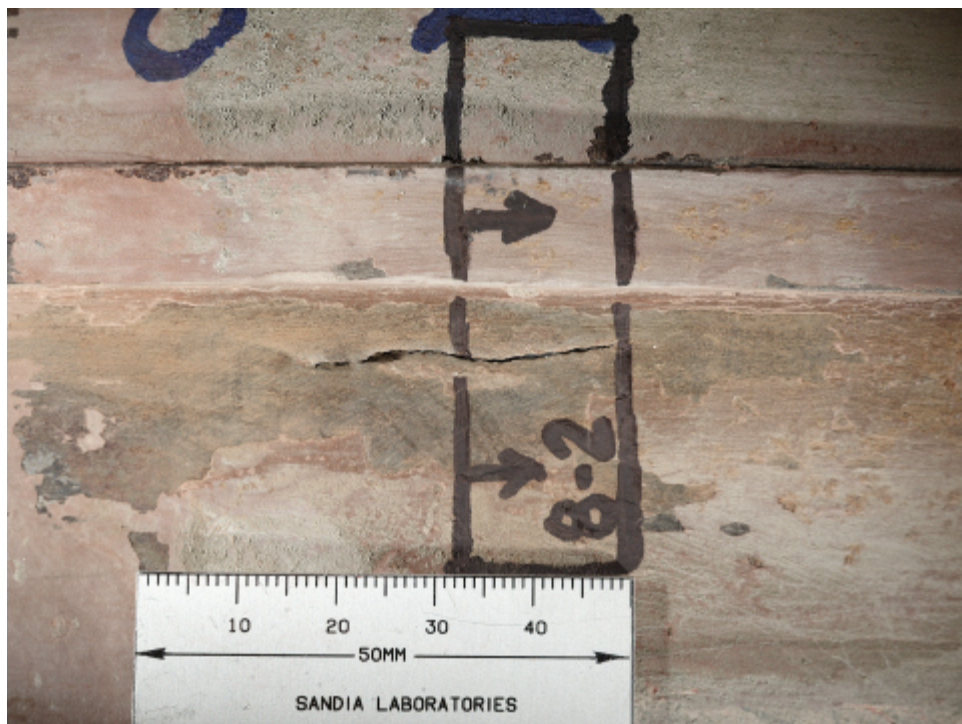
Figure 57. Details of inside (top) and outside (bottom) liner features in region of tear #8-2 metallographic cross-section (arrows begin at plane of section and indicate view direction).

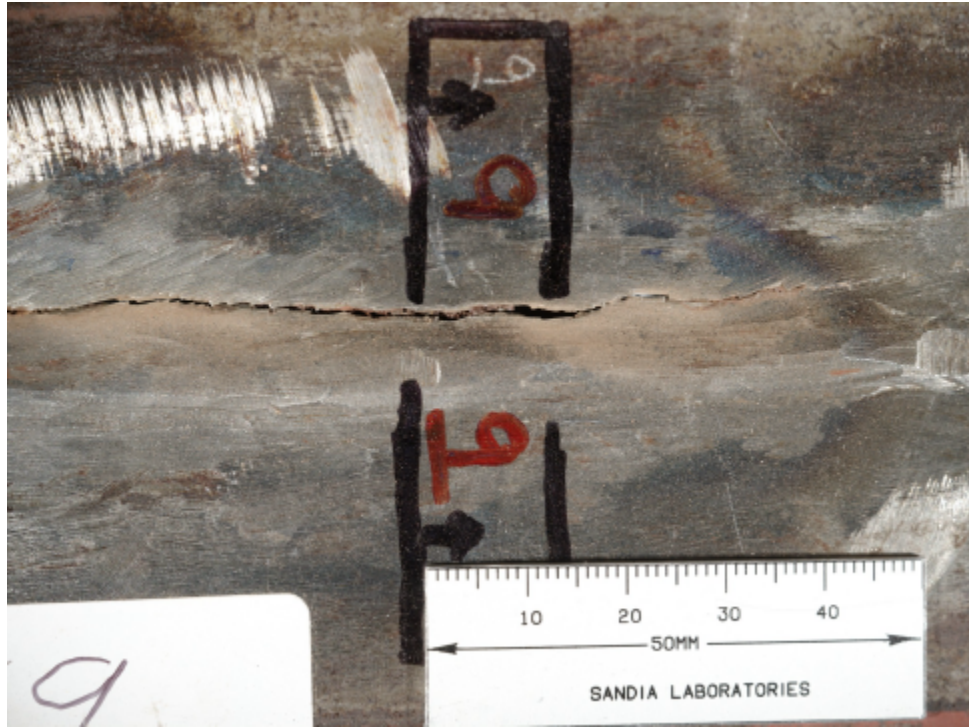
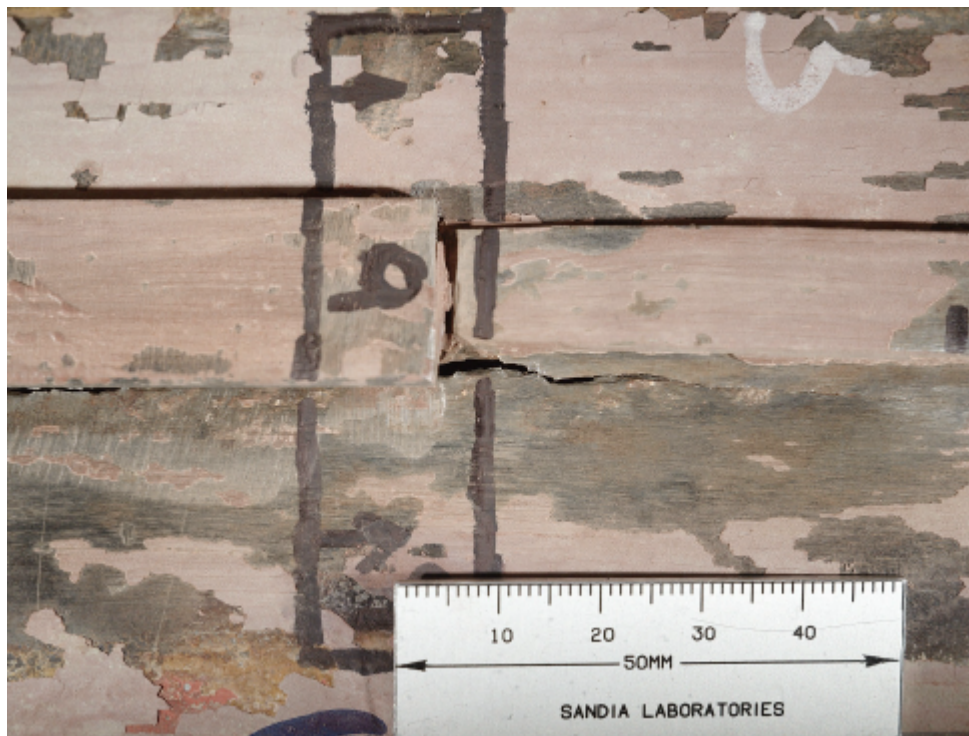
Figure 58. Details of inside (top) and outside (bottom) liner features in region of tear #9 metallographic cross-section (arrows begin at plane of section and indicate view direction).

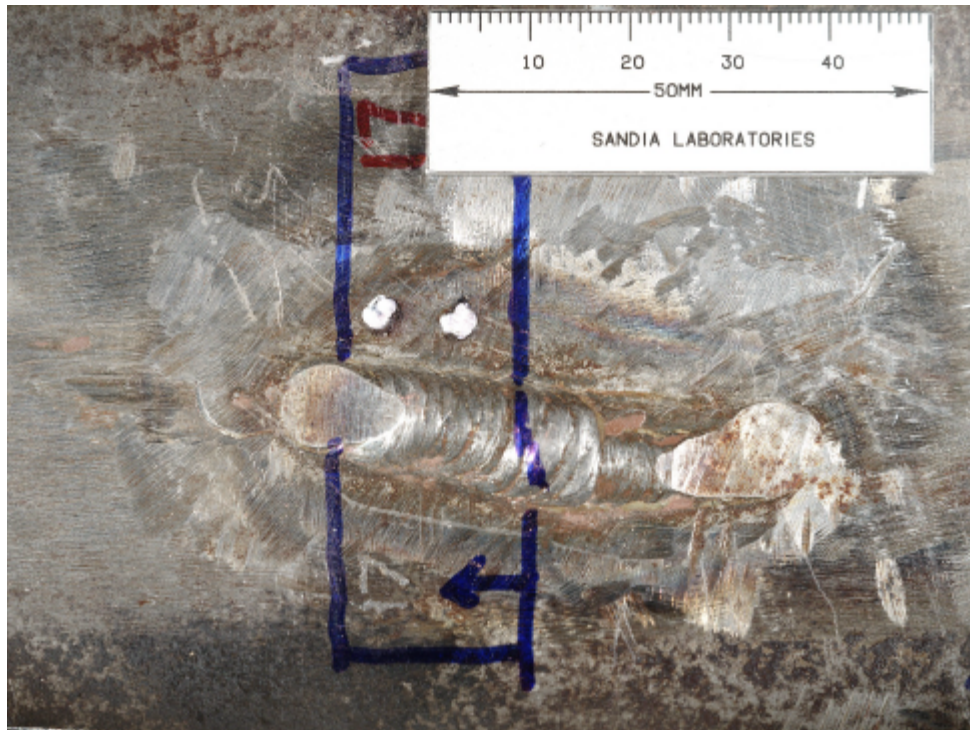
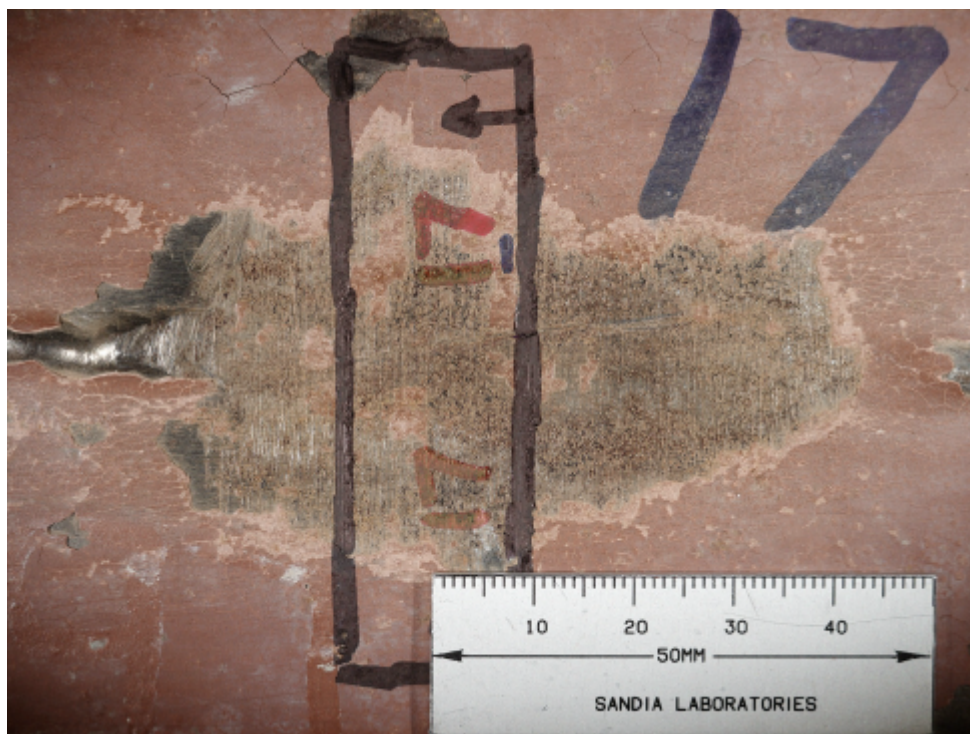
Figure 59. Details of inside (top) and outside (bottom) liner features in region of tear #17 metallographic cross-section (arrows begin at plane of section and indicate view direction).

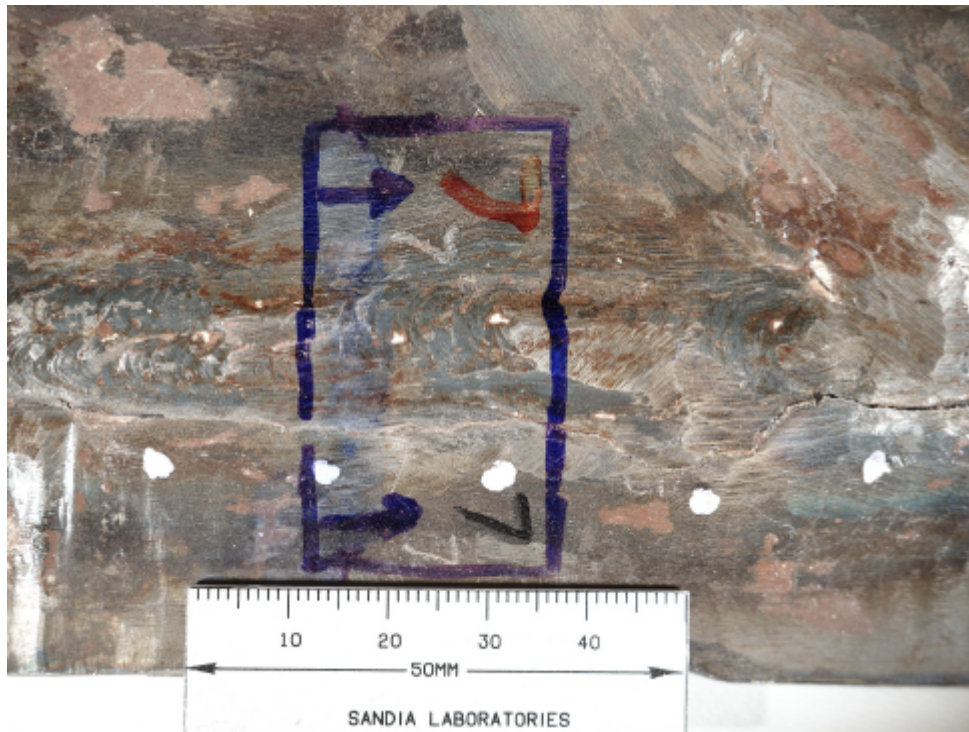
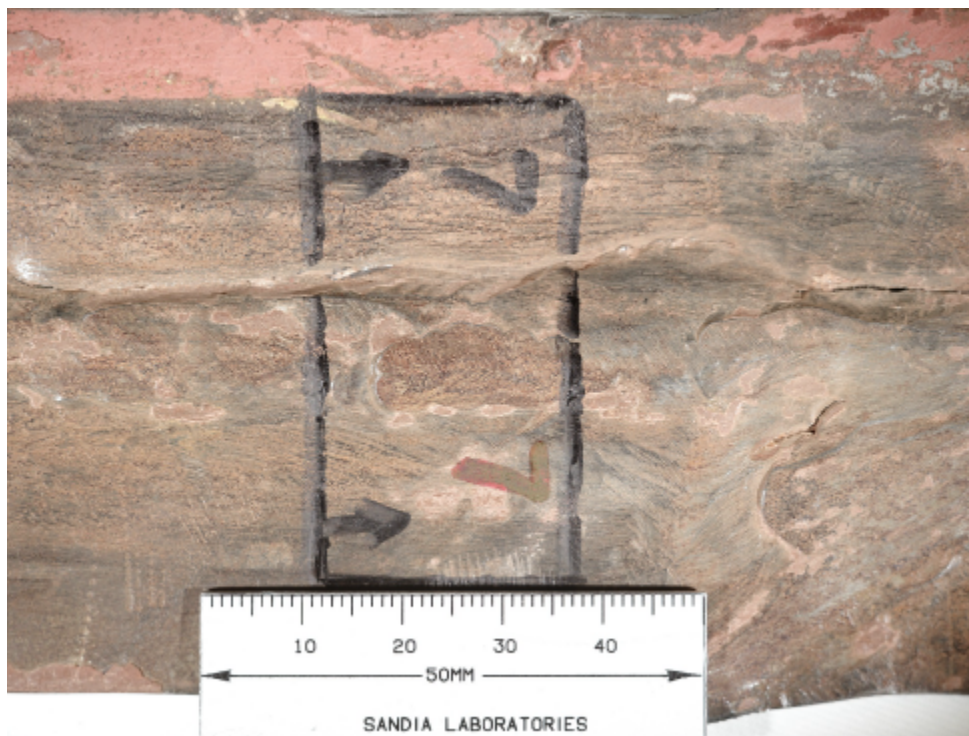
Figure 60. Details of inside (top) and outside (bottom) liner features in region of tear #7 metallographic cross-section (arrows begin at plane of section and indicate view direction).

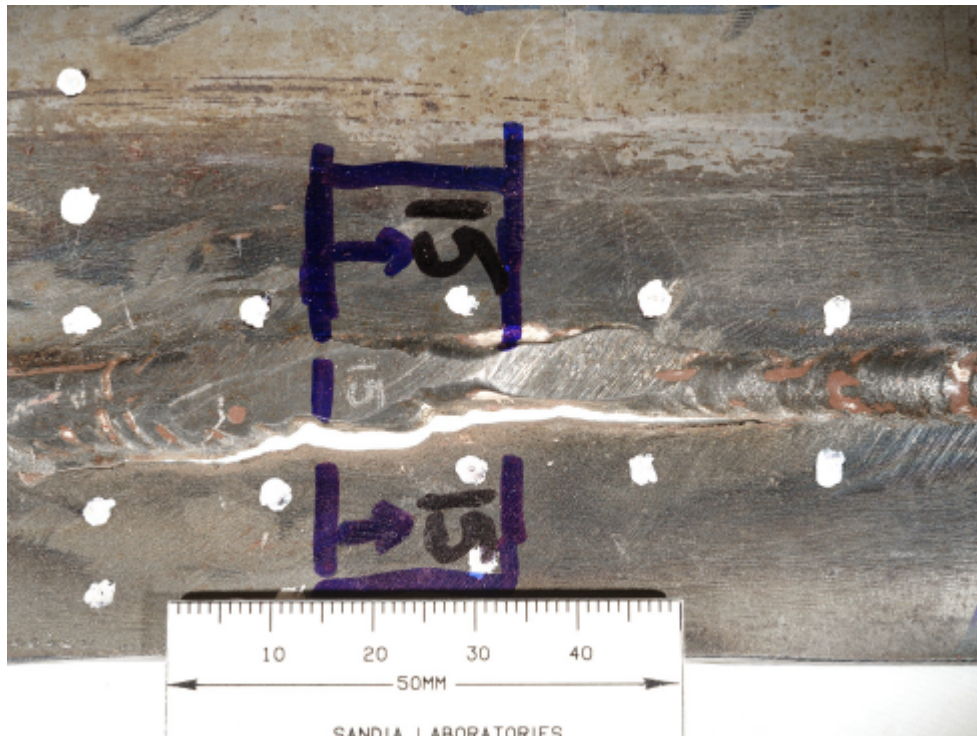
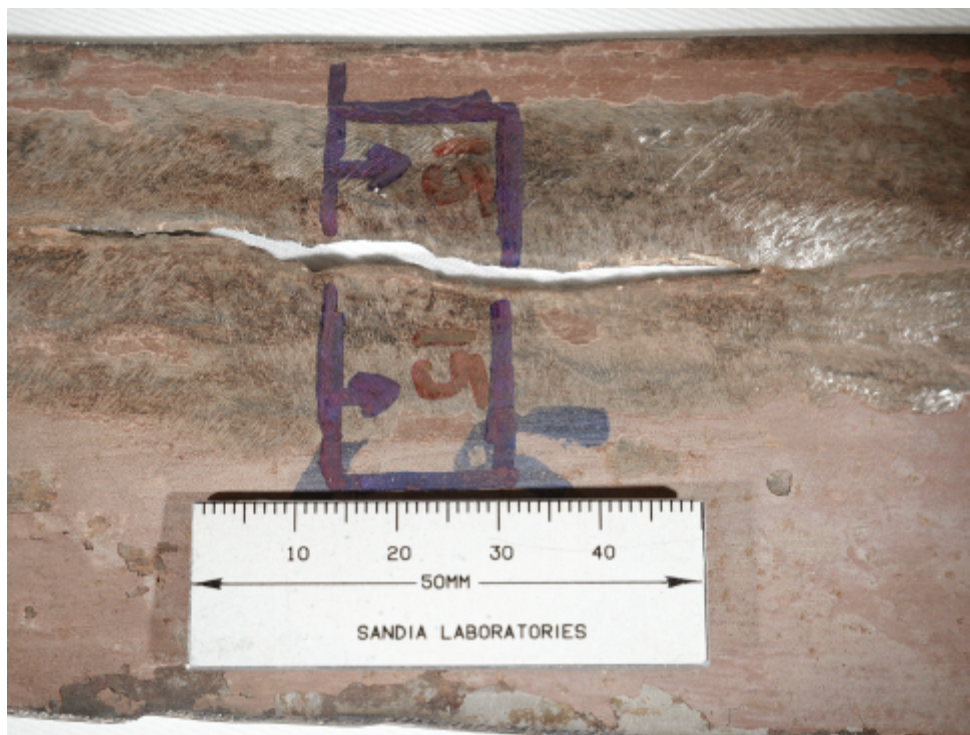
Figure 61. Details of inside (top) and outside (bottom) liner features in region of tear #15 metallographic cross-section (arrows begin at plane of section and indicate view direction).

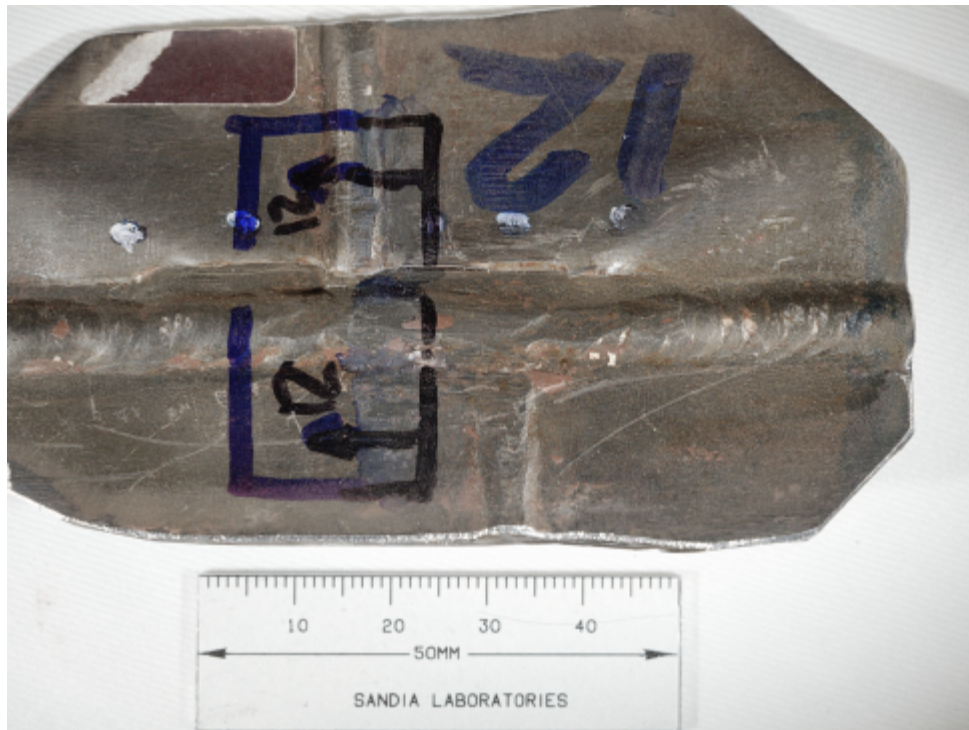
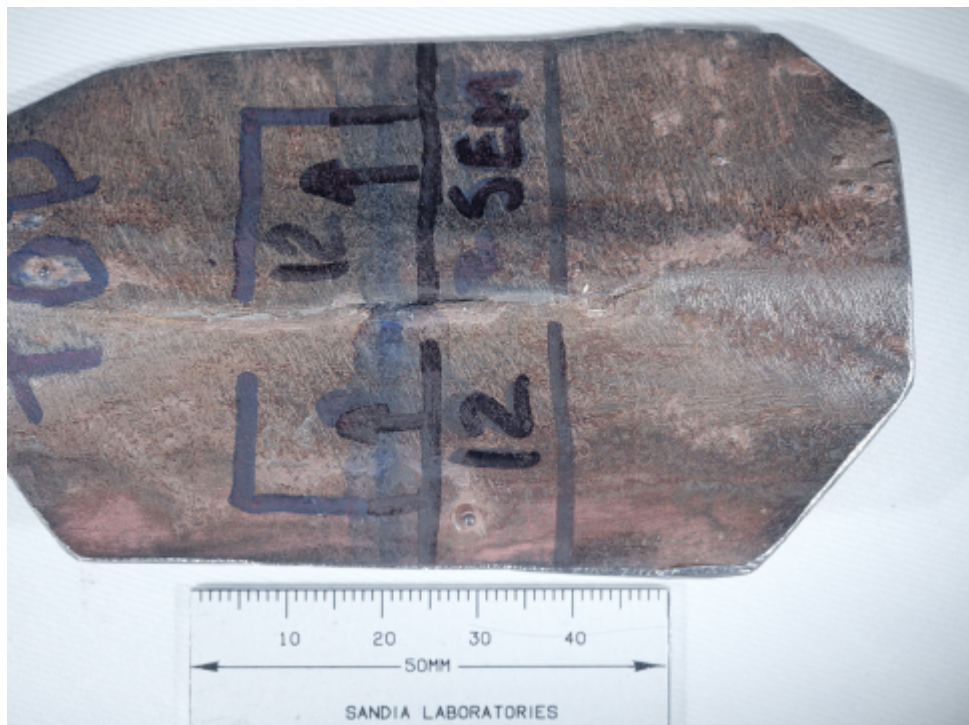
Figure 62. Details of inside (top) and outside (bottom) liner features in region of tear #12 metallographic cross-section (arrows begin at plane of section and indicate view direction). Location of SEM fractographic sample is also shown.

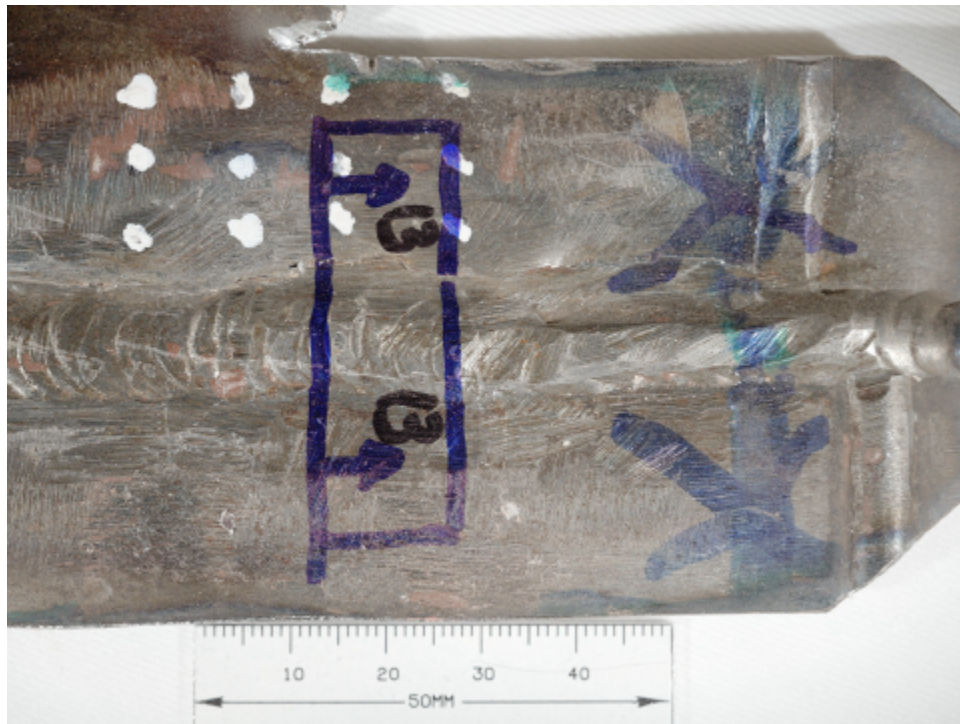
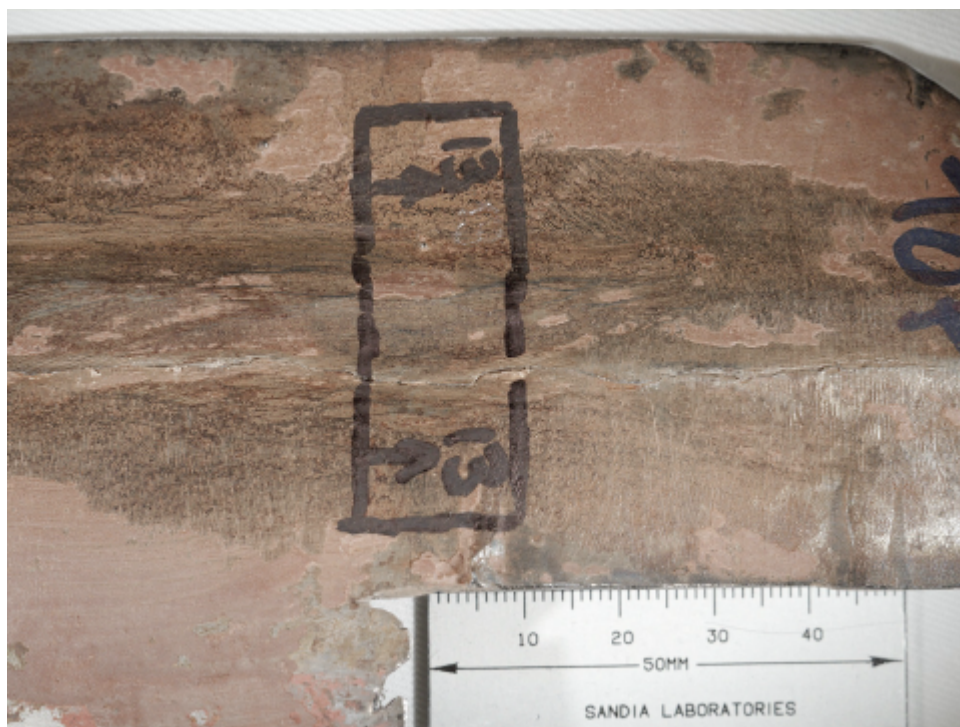
Figure 63. Details of inside (top) and outside (bottom) liner features in region #18-1 metallographic cross-section (arrows begin at plane of section and indicate view direction).

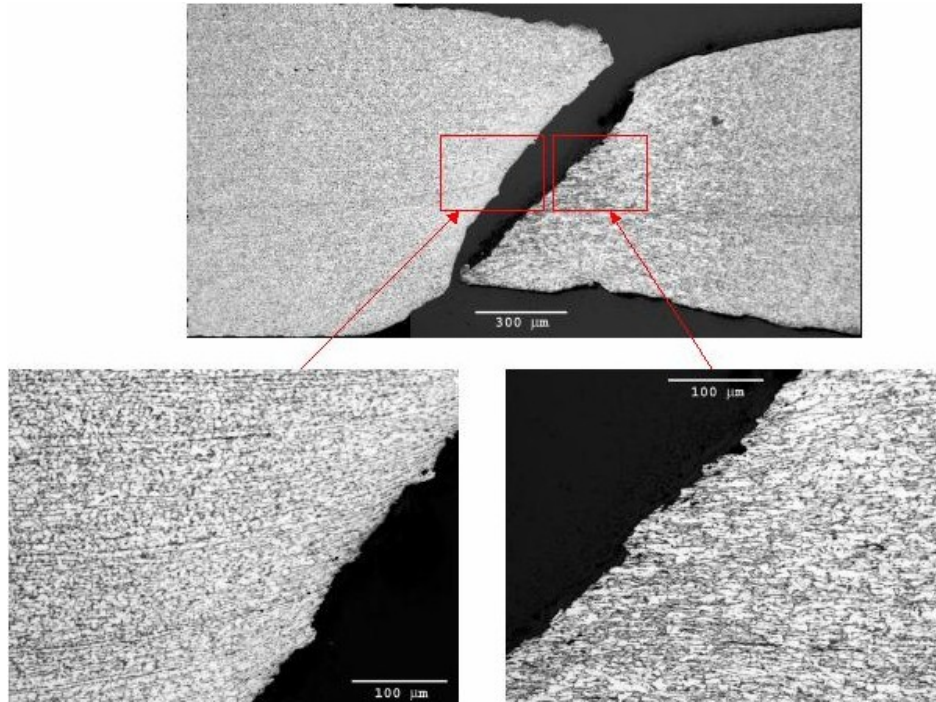
Figure 82. Metallographic cross section of tear #12. Tearing occurred in base metal (or perhaps far out in fine grained portion of heat affected zone). Note that two halves do not match perfectly across tear; this results in uncertainty regarding the amount of grinding done.

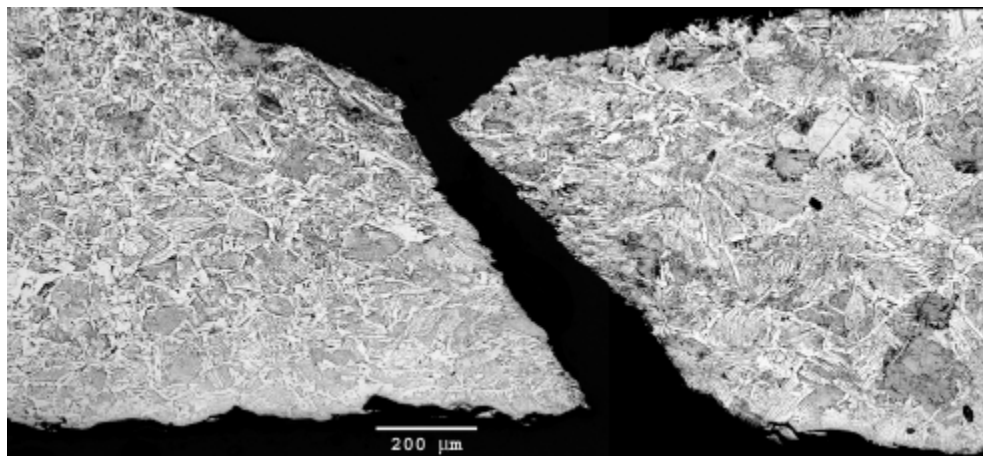
Figure 83. Metallographic cross section of tear #13. Tearing occurred in coarse grained portion of heat affected zone).

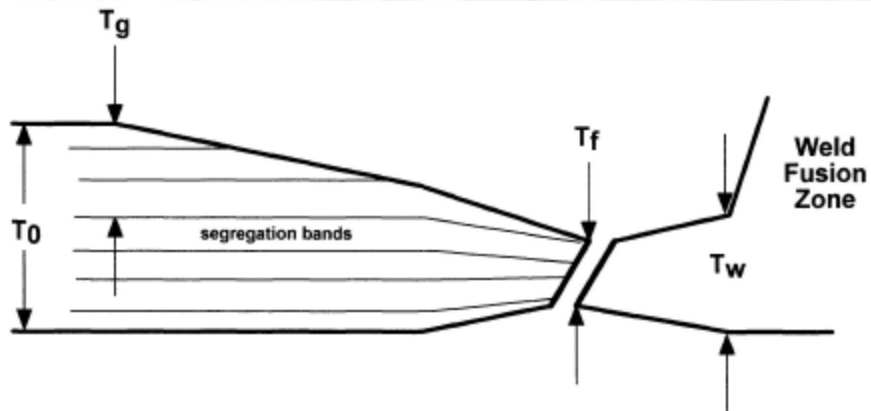
Estimates of the amounts of grinding associated with each tear were obtained based on the previously described knowledge that ~ 49% reduction in thickness occurs due to plastic deformation prior to fracture. The method used is illustrated in Figure 84. The liner thickness at each tear location was measured using a calibrated scale internal to the metallograph. This tear thickness was then divided by 0.51 to obtain the local pre-deformation thickness at/near each tear location. This pre-deformation thickness was subtracted from the initial liner thickness to determine the amount of material removed by prior grinding. Finally, the amount of material removed by grinding was divided by initial liner thickness to determine the percentage of grinding-related thickness reduction associated with each tear initiation site. These results are given in Tables 6 and 7. These percentages of original liner thickness removed by grinding are estimated to be accurate to +/- 5% absolute, i.e., 40% grinding implies 35% to 45%.

Figure 84. Illustration of three methods used to estimate extent of liner thickness reduction due to grinding from metallographic cross sections.
