## **Appendix L: Metallurgical Analysis of PCCV Liner Tears**

## **Metallurgical Analysis of PCCV Liner Tears**

K. H. Eckelmeyer, J. A. VanDenAvyle, A. C. Kilgo, and L. D. Lambert

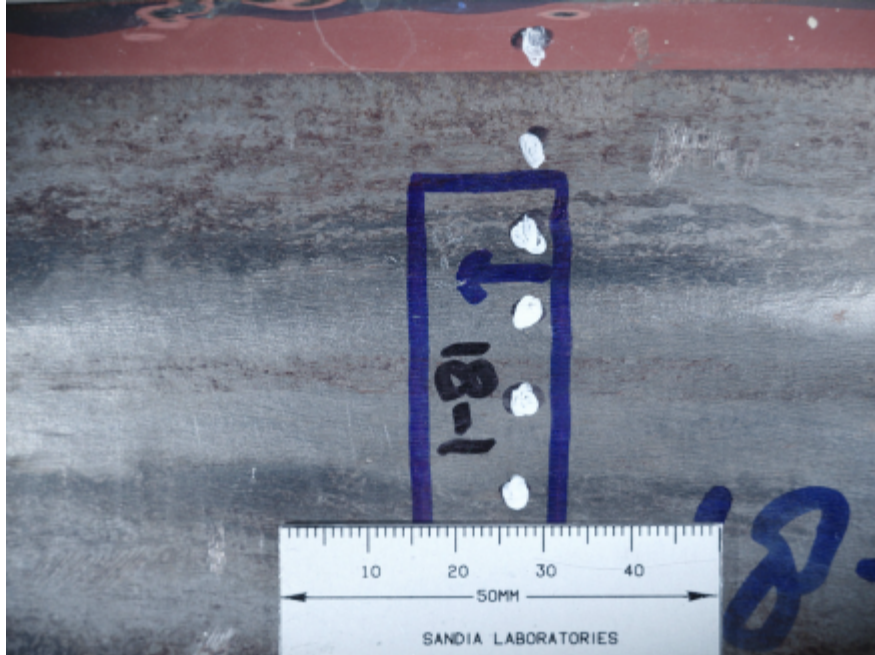
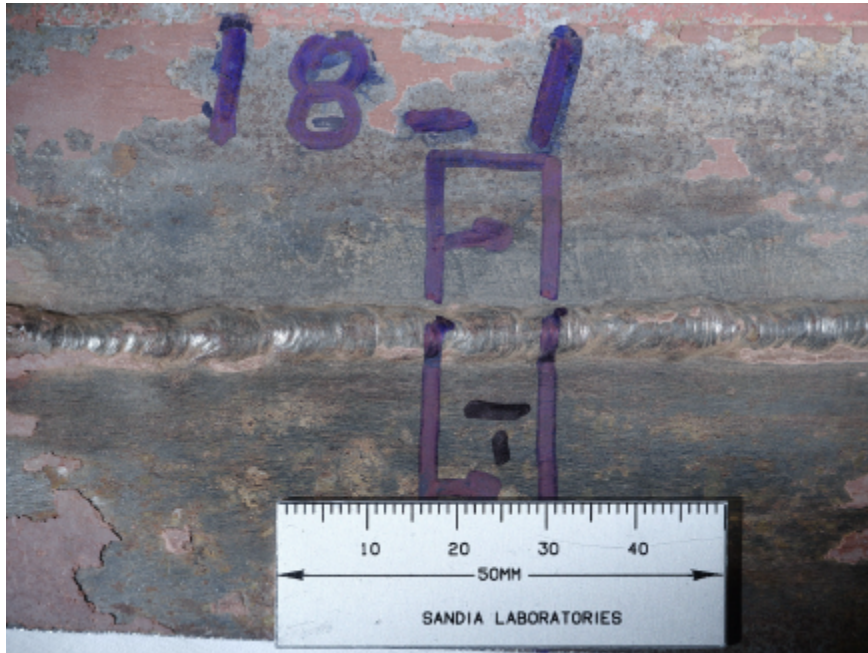
In addition to the tear regions, metallographic cross-sections were also taken from several regions where there was evidence of substantial localized plastic deformation, but where no tearing had occurred. Samples 18-1 and 18-2 were across a vertical field weld that exhibited substantial buckling and “orange peel” evidence of localized plasticity. This weld was in the region between the equipment hatch transition and the air lock, where the largest amounts of buckling and tearing were observed. It had been initially made and subsequently repaired from the front side (inside of the liner), but no back-up bar had apparently been used in making either the initial or repair weld. 18-2 contained a single isolated repair weld and a modest amount of associated grinding, while 18-1 was a nearby region with no apparent grinding or repair weld. Samples 24-1 and 24-2 represented a region with no apparent grinding or repair welds, but where the highest liner strains were recorded by strain gauges during the test (~7% strain). This weld was near the edge of a buttress, where substantial buckling was observed. 24-2 was taken near the intersection of horizontal and vertical field welds within a “rat-hole” region in a horizontal stiffener. 24-1 was along the same vertical field weld, but above the horizontal weld and stiffener. The locations where these samples were taken and surrounding details are shown in Figures 85 to 88. Metallographic observations made on these samples are shown in Figures 89 to 92 and summarized in Table 8.

Figure 85. Details of inside (top) and outside (bottom) liner features in region #18-1 metallographic cross-section (arrows begin at plane of section and indicate view direction).

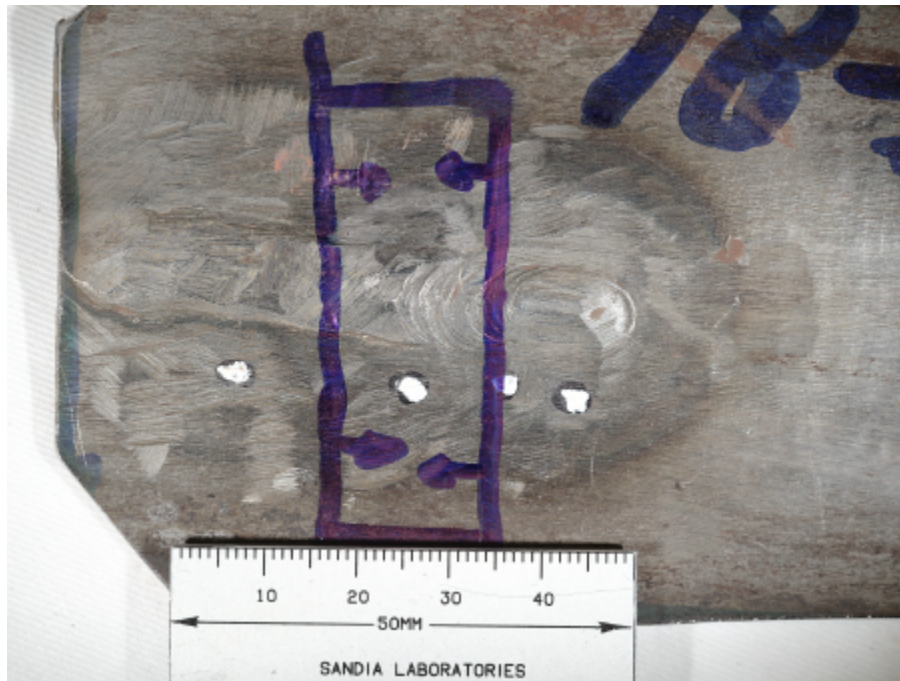
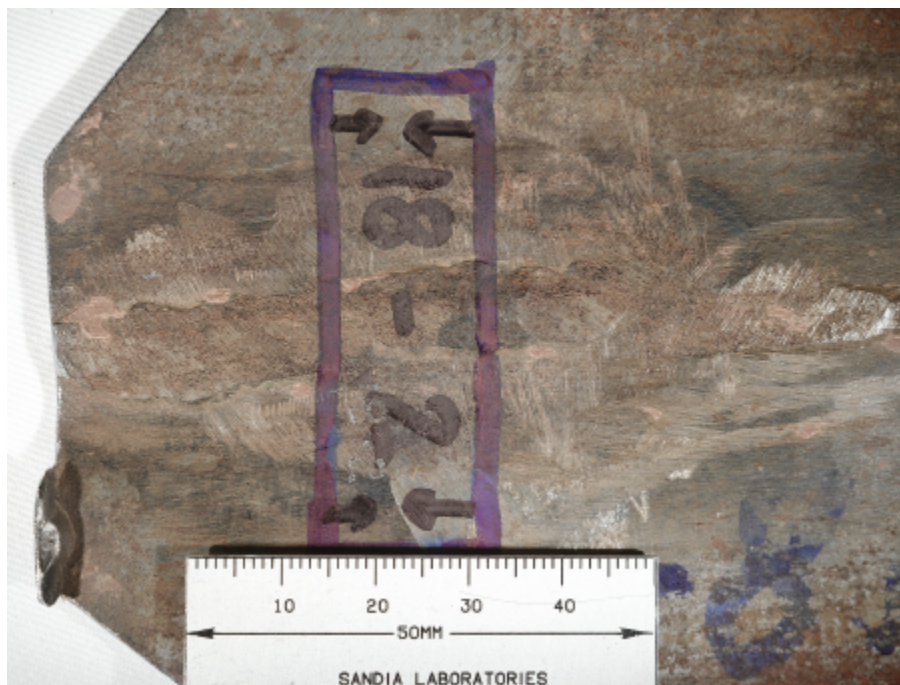
Figure 86. Details of inside (top) and outside (bottom) liner features in region #18-2 metallographic cross-section (arrows begin at plane of section and indicate view direction).

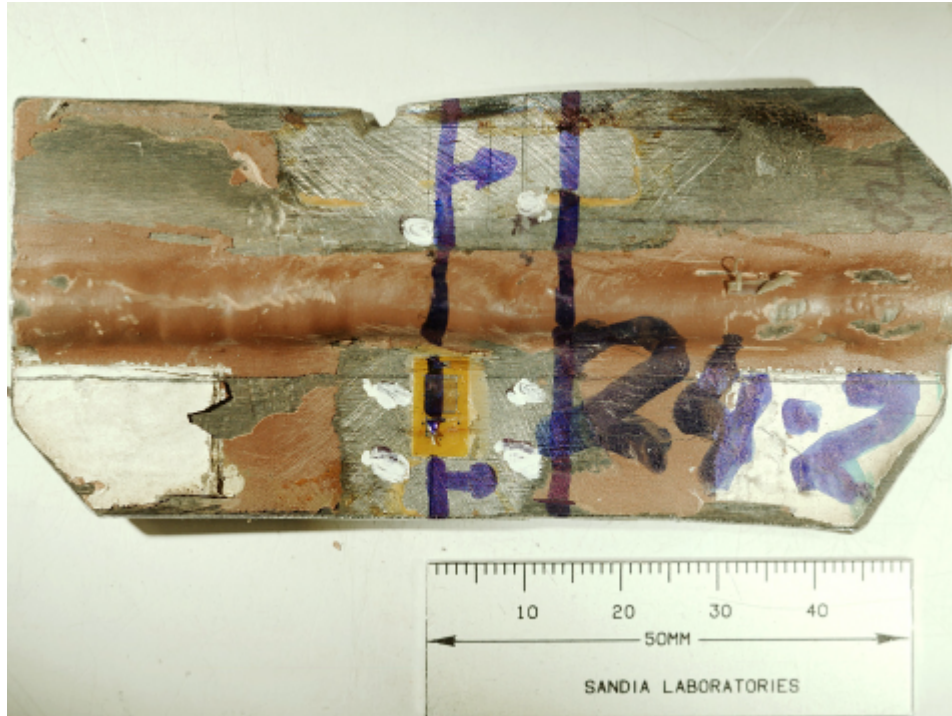
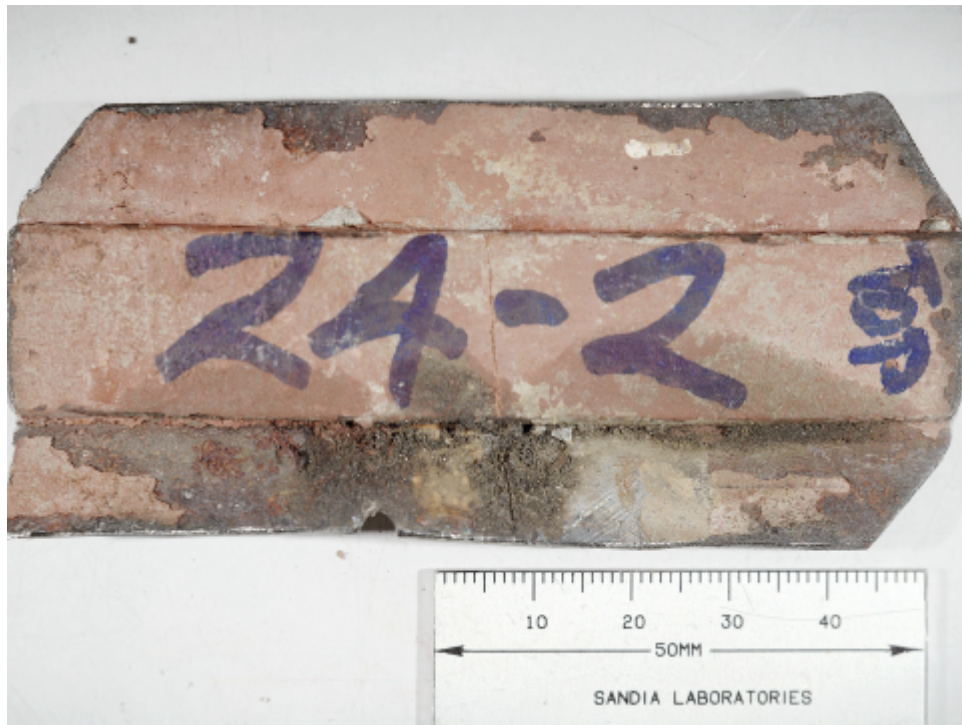
Regions #24-1 and 24-2: These regions are described in Table 8 and pictured in Figures 87, 88, 91 and 92. Sample #24-2 was taken in the “rat-hole” region immediately between the ends of the bridged horizontal stiffeners. This sample was sharply bent, attesting to the complexity of the stresses in this region. The sample exhibited a maximum of at least 20% thickness reduction on one side of the weld and ~14% thickness reduction on the opposite side of the weld (Figure 91). Presumably, the strain gauge in this area recorded only 7% strain because it was not co-located with the point of peak local strain. Thicknesses change rapidly with position in this region, implying much lower strains within several millimeters of the point of maximum thickness reduction.

Figure 88. Details of inside (front) and outside (back) liner features in region #24-1 metallographic cross-section (arrows begin at plane of section and indicate view direction).

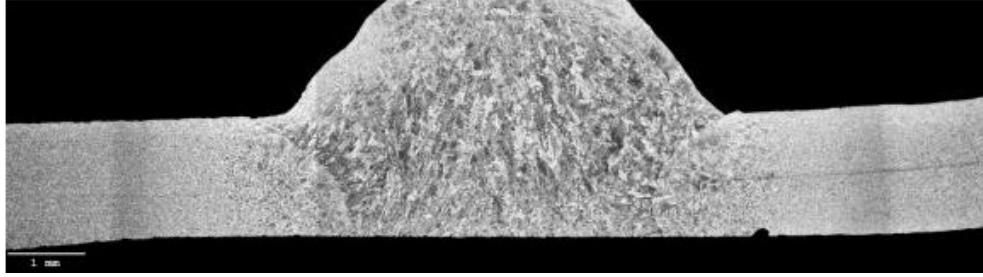
Region #18-1 and 18-2: The observations made in these areas are described in Table 8 and pictured in Figures 36, 85, 86, 89 and 90. The cross-section of #18-1 (Figure 89) showed that a modest amount of localized plastic deformation had occurred adjacent to the weld on both sides of the fusion zone. The greatest amount of deformation thinning occurred in the HAZ near the fusion line (13% on one side, 9% on the other side – note that these amounts of thinning are consistent with the ultrasonic thickness measurements, shown in Figure 36). Approximately 5% thinning was uniformly observed over a ~15 mm wide band in the adjacent base metal. Thinning then tapered out gradually to zero over the next ~15 mm. The amount of thinning in the HAZ is in the vicinity of the 12% to 13% required for the onset of necking, as was determined from analysis of the welded tensile samples. However, considerable additional local deformation would be required before tearing would be expected to occur. Consistent with this, no evidence of void formation or shear banding, which would be indicative of incipient failure, was observed.

Figure 89. Metallographic cross section of region #18-1. Plastic deformation, but no tearing, occurred in this region. No evidence of repair welding or substantial grinding was found in this area.

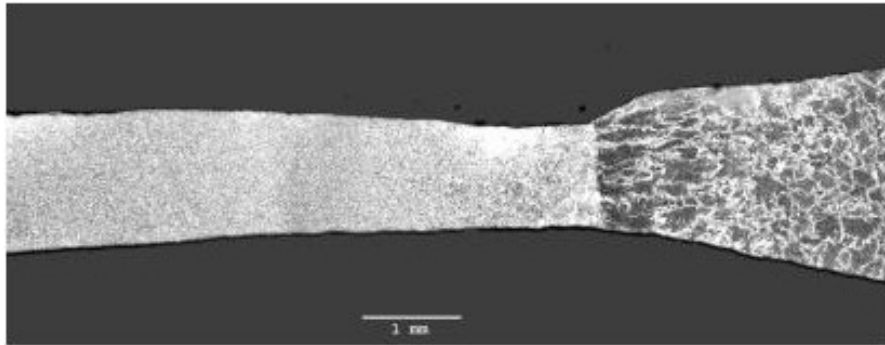
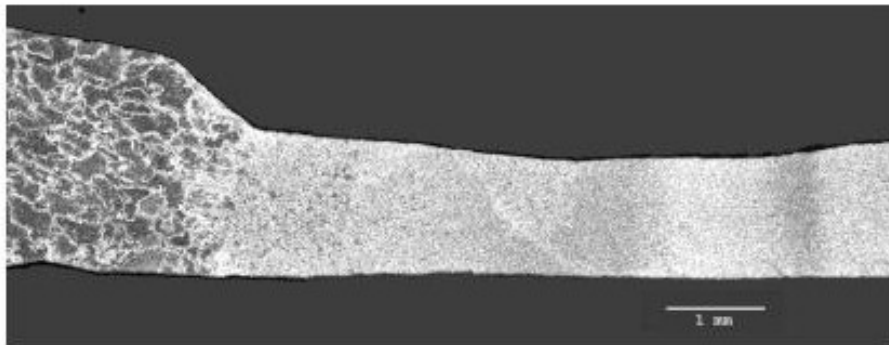
The cross-section of #18-2 revealed substantially more thinning, 42% on one side of the weld and 31% on the other side (Figure 90). However, it was clear that a substantial, but not quantifiable, amount of this thinning was due to prior grinding, rather than simply to plastic deformation during testing. While considerably higher levels of localized plastic deformation would be expected in these previously ground areas, no evidence of substantial necking or incipient tearing was apparent. This suggests that, while necking may *begin* after only 12% to 13% local thinning, considerably more localized deformation must be accommodated prior to the onset of tearing.

Figure 90. Metallographic cross section of region #18-2. Plastic deformation, but no tearing, occurred in this region. Evidence of repair welding and an undetermined amount of grinding was found in this area.

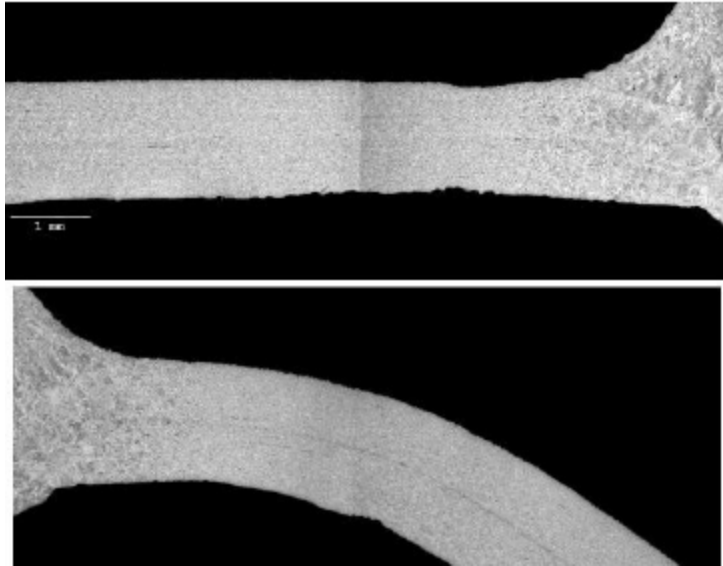
Figure 91. Metallographic cross section of region #24-2, where strain gauges recorded local strain of approximately 7%. No evidence of repair welding or substantial grinding was found in this area. Detailed observation of the surface “depressions” to the left of the weld suggested that they may correspond to surface defects in the plate. In particular, the bottom depression was filled with non-metallic particles, perhaps rolled-in oxide (too dark to be visible on this photo). These depressions may also correspond to the early stages of necking.

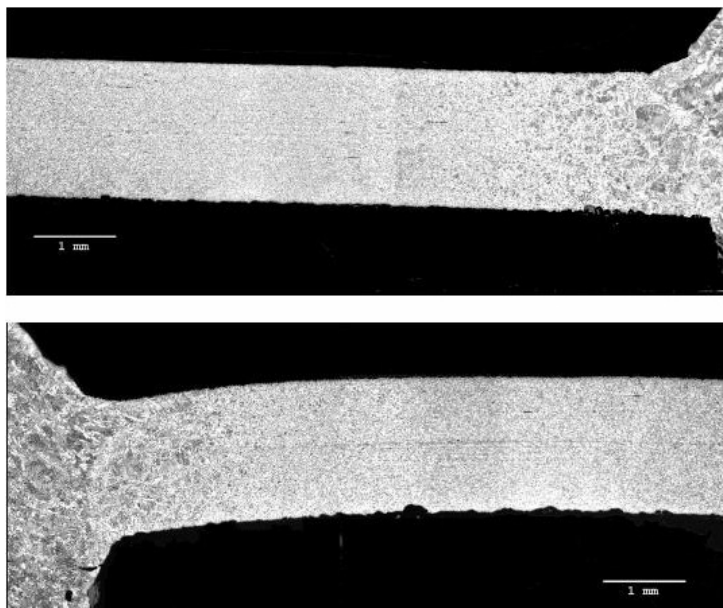
Figure 92. Metallographic cross section of region #24-1. Plastic deformation, but no tearing, occurred in this region. No evidence of repair welding or substantial grinding was found in this area.
