5. TESTING

5.1 Test Planning

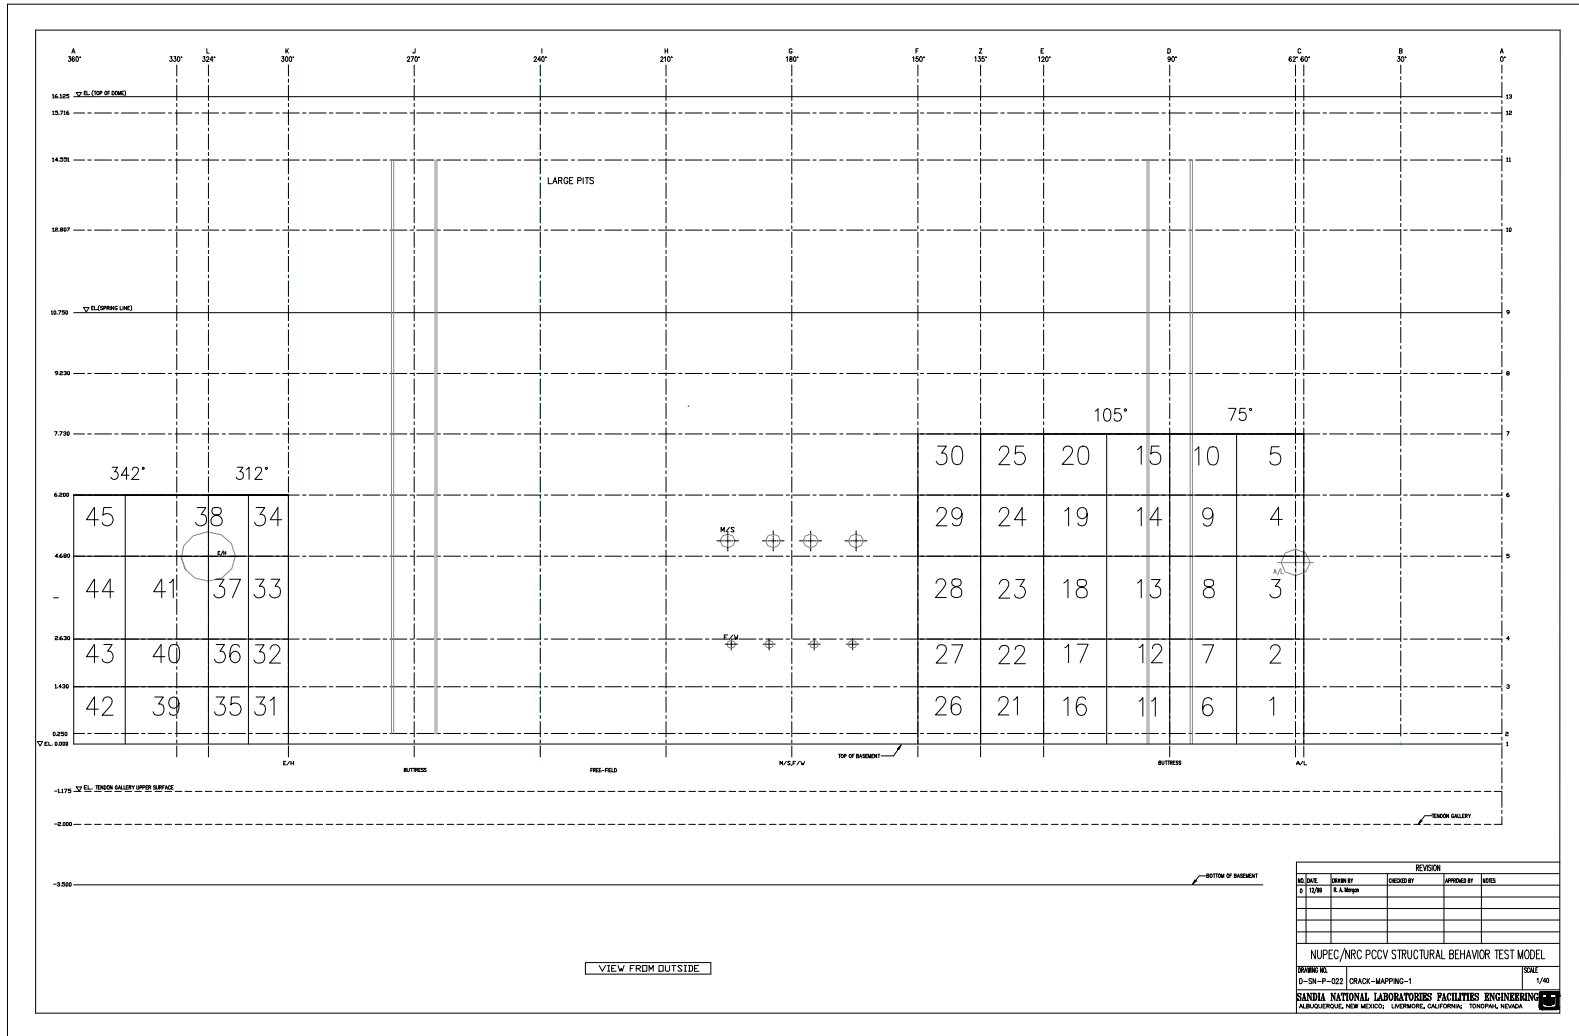
Figure 5.8 Concrete Crack Map Grid

- The entire surface of the cylinder was mapped for cracks prior to the test; however, crack widths were not measured. No crack mapping was performed during the SIT. After the SIT, additional cracks within selected areas of the cylinder wall were identified but the widths were not measured. The crack map grid is shown in Figure 5.8
- Model strains were measured primarily using the gages mounted directly to the rebar and liner. Only a limited number of concrete strains were measured directly.
- Displacements were measured at all specified locations with the exception of the points around the largest penetration (i.e. the E/H)

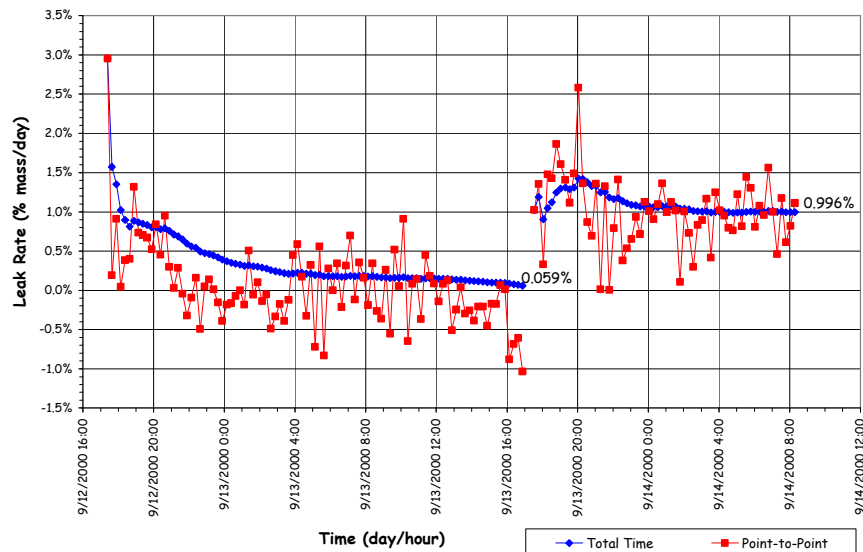
Figure 5.9 Integrated Leak Rate Test Leak Rates

The ILRT for the PCCV model was a hybrid of these procedures. The ILRT pressure, P_{ILRT} , was $0.9 P_d$ (0.35 MPa or 51.2 psig) based on JEAC 4203 and the Absolute Method for a Type A Test per ANSI/ANS N56.9 (Section 5.0) was followed. After depressurizing from the P_{SIT} to P_{ILRT} , the model was held at P_{ILRT} for approximately one hour to allow the model atmosphere to stabilize before the start of the leakage rate test. The ILRT commenced after all stabilization criteria were achieved and the duration of the test was “sufficient to enable adequate data to be accumulated and statistically analyzed so that a leakage rate ... can be accurately determined” but no less than 24 hours. Data was collected at least once every hour. The measured leakage rate at P_{ILRT} , L_{tm} , was determined using both the (a) total time analysis and (b) point-to-point analysis techniques. The nominal atmospheric pressure at the elevation of the test site (verified by checking the Sandia Photovoltaics Weather Station reading) was used for leak rate calculations. The calculated leak rate after 24 hours at $0.9 P_d$, was 0.059% mass/day.

After the ILRT was completed, the model was initially depressurized by venting through the 1mm orifice plate, calibrated for a leak rate of 1% mass/day. After approximately 16 hours, a stable leak rate of 0.996% mass per day was calculated, again confirming the accuracy of the leak rate instrumentation.

The calculated leak rates during and after the ILRT are shown in Figure 5.9.

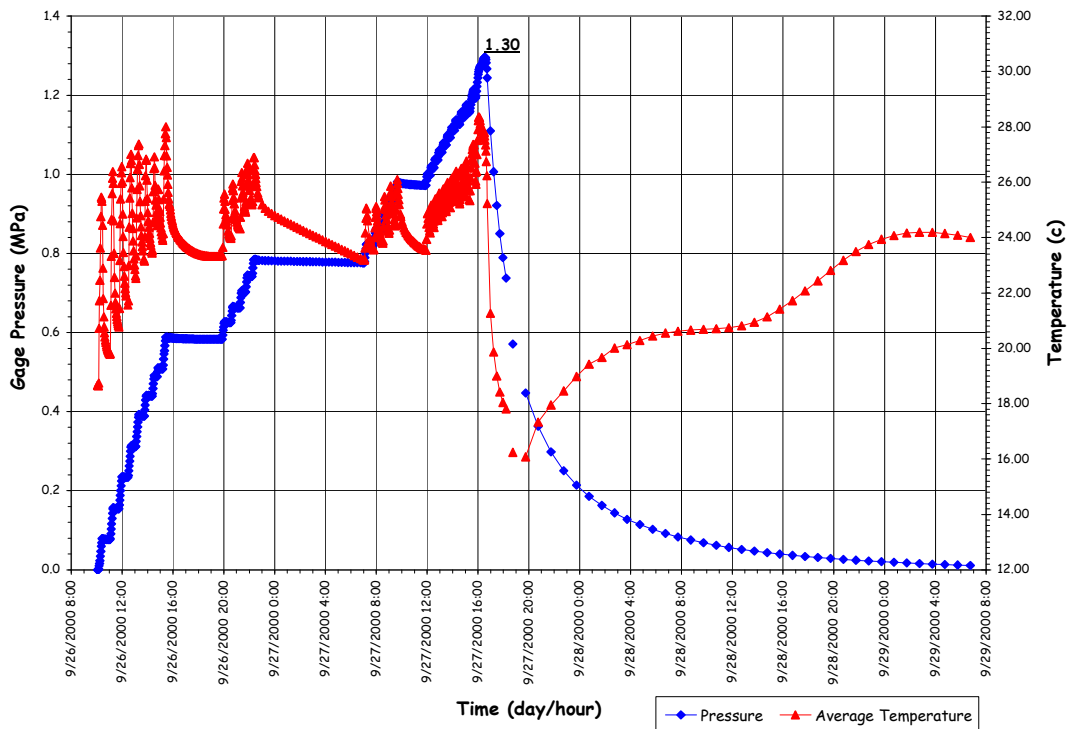
Figure 5.15 Limit State Test Pressure and Average Temperature

The pressure and average temperature time histories during the LST, including depressurization, are plotted in Figure 5.15. The LST followed the planned pressurization sequence up to the point where the model began leaking.

Pressurization of the model continued in increments of approximately $0.1P_d$ until a pressure of $2.0P_d$ ($8.0 \text{ kg}_f/\text{cm}^2$ or 113.8 psig) was reached at approximately 11:00 PM. At this pressure the model was again isolated to perform a planned leak check. This leak check was also planned to be held for 8 hours to allow the test team to partially stand down for a rest period. A ‘skeleton crew’ consisting of the TC, Data Acquisition System Operator (DO), and Nitrogen Supply Operator (NO) continued to monitor the response of the model and all other systems until approximately 7:00 AM on September 27. This pressure hold and leak check was also selected below the lower bound prediction for the onset of structural yielding (i.e. yielding of the rebar or tendons) to ensure the model would remain relatively stable during this period. After approximately eight hours, the calculated leak rate was 0.003%, i.e., essentially zero. This confirmed the interpretation of the leak check results at $1.5 P_d$ and also demonstrated the greater accuracy of the leak rate results when the model is thermally stable.

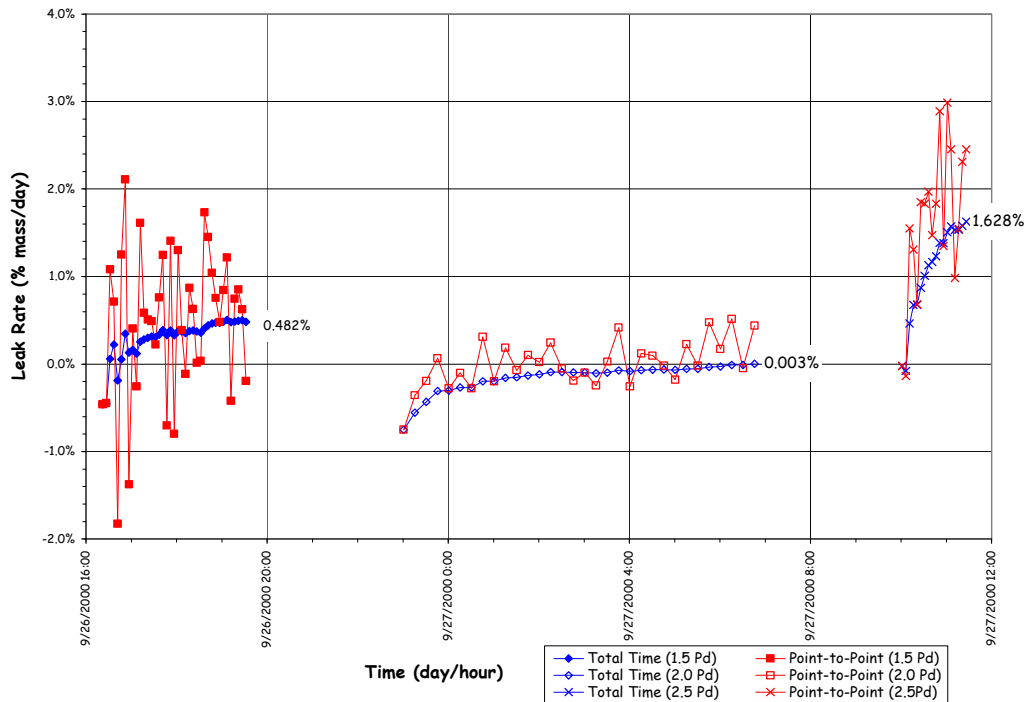
Figure 5.16 LST Calculated Leak Rates at 1.5, 2.0 and $2.5 P_d$

Initially, the model pressurization sequence matched the pressurization steps followed for the SIT to allow for comparison of the model response to two identical cycles of loading. The gage stability criteria used during the SIT (i.e. Equation 5.1) was also applied during the LST. Pressurization continued in increments of approximately $0.2P_d$ until a pressure of $1.5 P_d$ ($6.0 \text{ kg}_f/\text{cm}^2$ or 85.3 psig) was reached at approximately 4:30 PM. At this pressure, the first planned leak check was conducted by isolating the model and monitoring the temperature and pressure. After approximately three hours, a leak rate of 0.48% mass/day was calculated. Considering previous experience from the ILRT, which

demonstrated that thermal expansion of the model during the day yielded apparent leak rates in this range, the results were interpreted to indicate that the PCCV model was leak-tight.

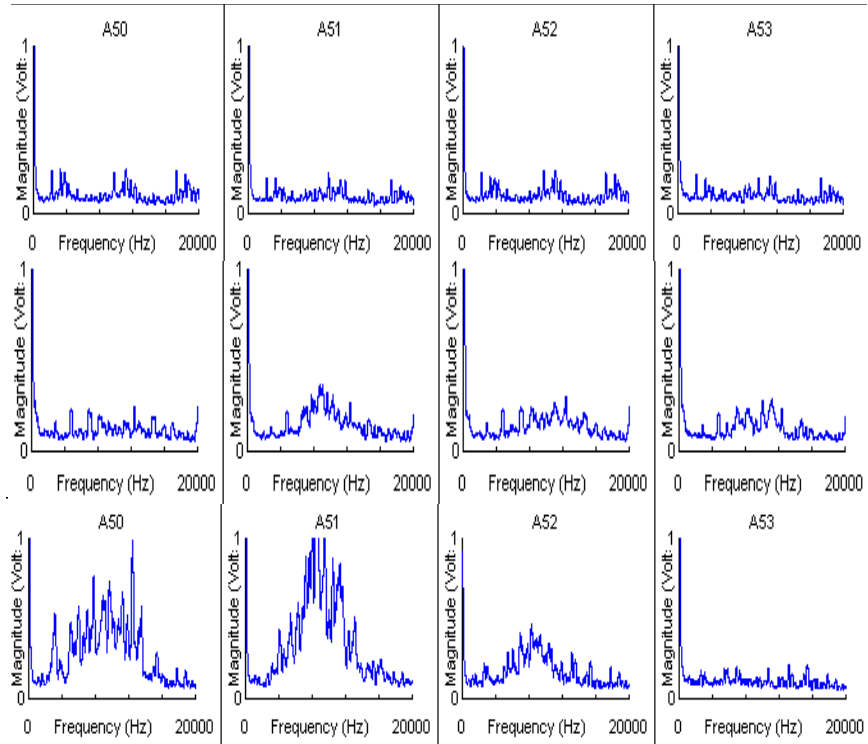
Figure 5.17 Internal Acoustic Sensor Signals at the E/H

Pressurization of the model resumed at 7:00 AM in increments of $0.1P_d$, with increasing dwell time between pressure steps (~30 minutes) required to meet the gage stability criteria. As the pressure was increased to the next planned leak check at $2.5P_d$, liner strain gages in the vicinity of the E/H (LSI-C-K5-12) began registering rapidly increasing strains in excess of 1%. At $2.4P_d$, the acoustic system operator (AO) reported hearing a change in the acoustic output which might indicate that “something had happened.” At approximately 10:00 AM at a pressure of $2.5P_d$ ($10.0 \text{ kg}_f/\text{cm}^2$ or 142.2 psig), the model was isolated for the third planned leak check. After approximately 1-1/2 hours, a fairly stable leak rate of 1.628% mass per day was calculated. The leak rate calculations at 1.5, 2.0, and $2.5P_d$ are plotted in Figure 5.16. Coupled with the acoustic data that continued to confirm some new event had occurred, it became clear that the model was leaking, most likely from a tear in the liner in the vicinity of the E/H. Plots of the output of the four internal acoustic sensors surrounding the E/H at 2.3, 2.4, and $2.5 P_d$ are shown in Figure 5.17.

After consulting with NUPEC and the NRC, the TC concluded that the model had functionally failed between 2.4 and $2.5 P_d$ and directed a change in the pressurization plan. Since the model was leaking, the next goal was to pressurize the model as high as possible to collect data on the inelastic response of the structure and to observe, if possible, a structural failure mode. Pressurization continued in increments of $0.05 P_d$, as planned. However, the gage stability criteria was abandoned and the hold time at each pressure step was reduced to less than 10 minutes.

The complete reports from the Acoustic System Operator, Pure Technologies, are provided in Appendix K. As stated in Section 3.2.8, the objectives for the acoustic system were to detect tendon or rebar breaks, concrete cracking or crushing, and liner tearing/leakage. The acoustic system response data, which helped to identify when the PCCV model began leaking, was described in Section 5.2.2 (see Figure 5.17).

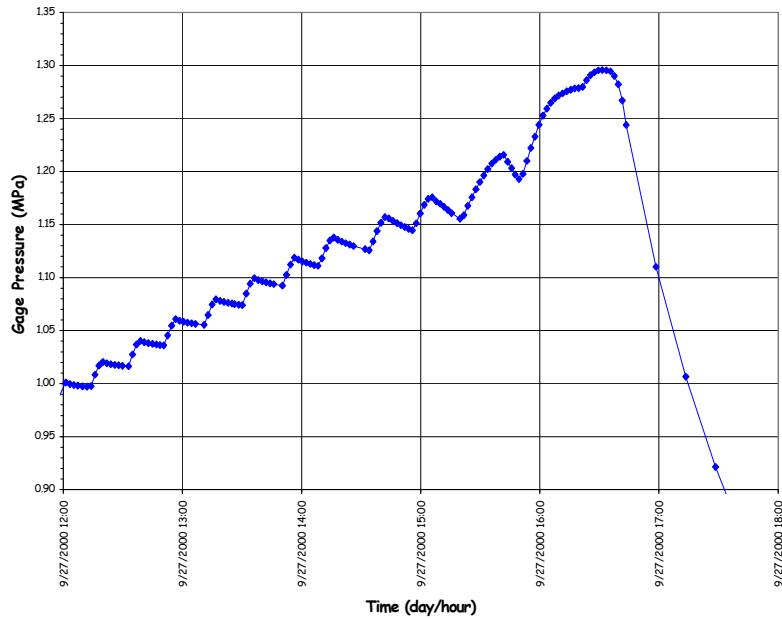
Figure 5.18 LST Pressure Time History, 2.5 to 3.3 Pa

The PCCV model was pressurized to approximately $3.0P_d$, with increasing evidence of leakage and increasing liner strains. At $3.0P_d$, it became increasingly difficult to pressurize the model, and the nitrogen flow rate was increased to 99 std.m³/min (3500 scfm). At this flow rate, the pressure in the model was increase to $3.1P_d$. However, the pressure dropped steadily after reaching this pressure. The leak rate at this point was estimated to be 100%.

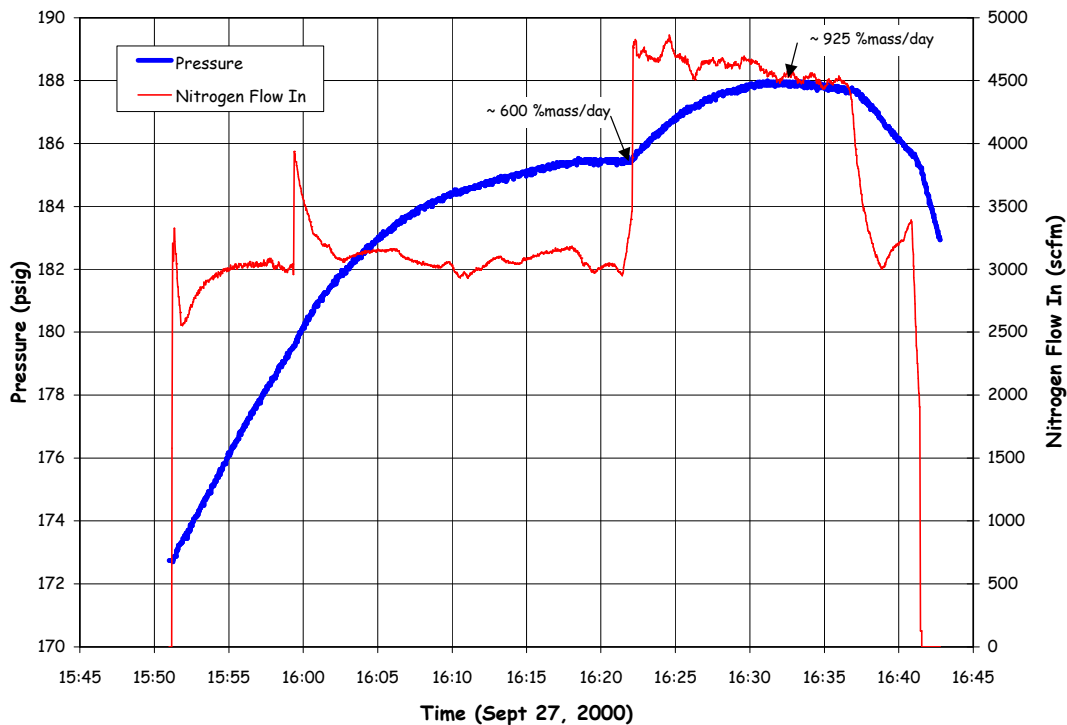
Figure 5.19 LST Pressure and Flow Rates at Maximum Pressure

The nitrogen flow rate was increased to the maximum capacity of the pressurization system, 142 std.m³/min (5000 scfm), and the pressure was increased to slightly over $3.3 P_d$ before the leak rate exceeded the capacity of the pressurization system. The pressure time history and flow rates during the final phase of the test are shown in Figures 5.18 and 5.19. Since it was no longer possible to increase the pressure in the model and the supply of nitrogen was nearly exhausted, the TC decided to begin terminating the test.

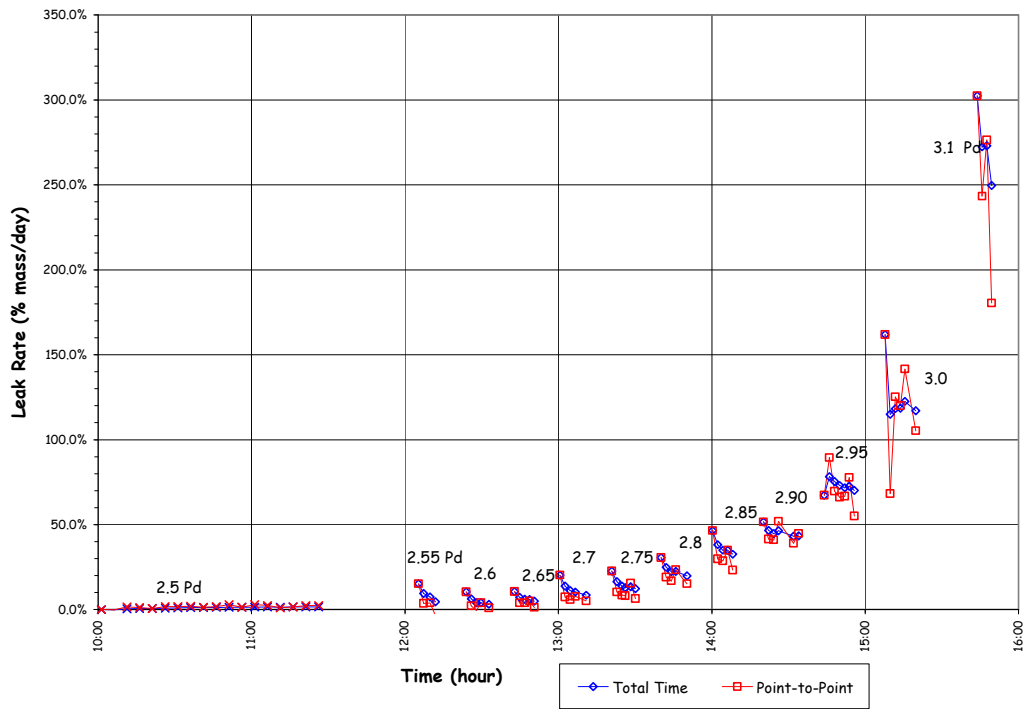
Figure 5-20. LST - Estimated Leak Rates (2.5-3.1 P_d)

The isolation valve was closed and the model was allowed to depressurize on its own. The terminal leak rate was estimated to be on the order of 900% mass/day. (The maximum flow rate of nitrogen, 5000 scfm, is equivalent to a leak rate of 1000% mass/day.) Estimated leak rates during the final pressurization and depressurization phases are shown in Figures 5.20 and 5.21.

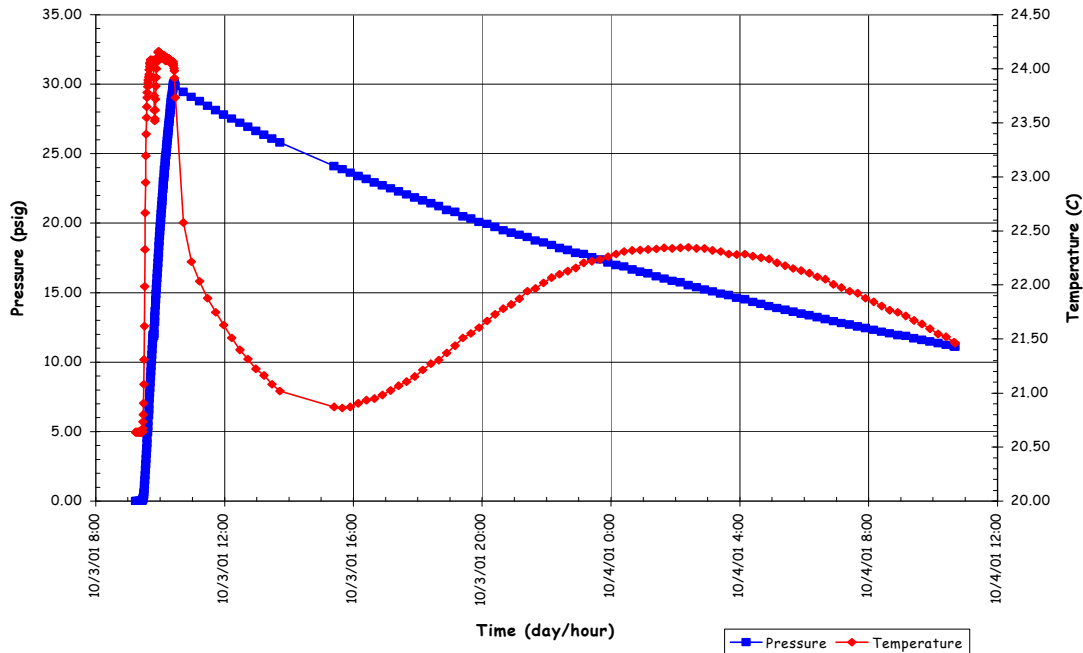
Figure 5.27 Pre-SFMT Leak Test Pressure and Temperature

After completing the installation and all test-readiness checks, the E/H cover was installed and sealed. A low pressure pneumatic test was conducted to check for leaks on October 3, 2001. The pressure and temperature time histories for the leak test are shown in Figure 5.27. The leak test began at approximately 09:30 and a leak was detected (via the acoustic system) at approximately 0.2 Pd (~12 psig). Pressure was increased to the target pressure of 0.5Pd (30 psig), at which time the vessel was isolated and monitored for a 24-hour leak test. The acoustic system (multiple sensors) continued to output signals consistent with a leak in the model and several potential leak locations were identified.

Once the model was deemed stable, the nitrogen supply was isolated and a close inspection of the model was conducted. Through a combination of visual/auditory inspection, hand-held acoustic monitoring, and the application of soap-water solution, a number of locations were discovered where nitrogen gas was leaking from the model.

- The largest apparent leak was from a crack on the left-hand side of the 90-degree buttruss at an elevation of approximately 6 m (20') above the top of the basemat (Level 6 in the cardinal coordinate system). This leak was the first detected by the acoustic system and was immediately confirmed during the close-up inspection.

- Secondary leaks, identified by the acoustic system, were confirmed at 150 degrees/3 and 6 m (10 and 20') and 210 degrees/4.5 m (15'). These leaks appeared to be through previously existing cracks in the concrete. The leak at 150 degrees was along the horizontal construction joints between C1, C2, and C3 as well as along a vertical crack extending between C2 and C3. The leak at 210 degrees also appeared to be through a previous crack.

These results indicated that, in spite of the manufacturer's quality control procedures coupled with detailed visual inspection (individual locations that appeared suspect were also sealed with silicone sealant prior to closing the model), the sprayed-on liner was not impermeable. Once the gas escaped through the sprayed-on and steel liners, it migrated between the steel and concrete until it found an exit path. The pressure did not appear high enough to tear the sprayed-on liner when a leak was first detected.

Based on these results, it was concluded that the leak was most likely due to a pre-existing hole(s) in the sprayed on liner which did not increase (or decrease) significantly during pressurization or during the leak test. (The equivalent orifice size reduced from about 6 mm (0.25") at 2.1 kg_f/cm² (30 psi) to 5 mm (0.20") at 0.8 kg_f/cm² (12 psi), based on the calculated leak rates.) As a result, the SFMT could be conducted without repairing the sprayed-on liner while maintaining a reasonable chance that the leak would not grow significantly and overwhelm the capacity of the pressurization system. (Nevertheless, during an unscheduled one-month postponement of the SFMT, the surface was retested with a 'spark-tester,' and a few small holes were discovered and sealed. The model was then resealed and readied for filling with water.)

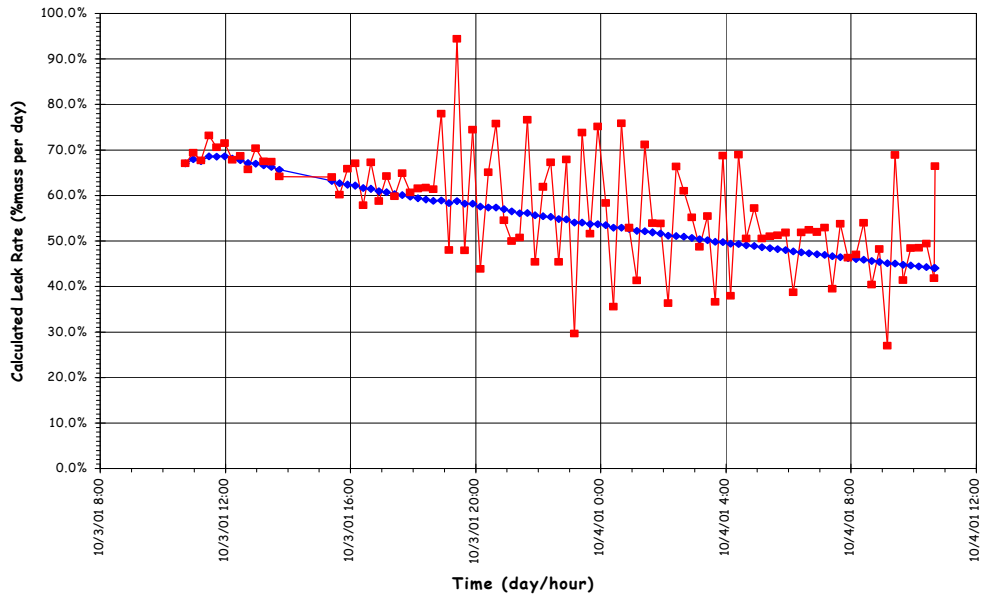
Figure 5.28 Pre-SFMT Leak Rate Test

The calculated leak rate, shown in Figure 5.28, was initially 70% mass/day at the maximum pressure of 2.1 kg_f/cm² (psi) decaying to 45% at 0.77 kg_f/cm² (11 psi) over 24 hours. The sound levels as detected by the SoundPrint system (shown in Figure 5.29), which are roughly proportional to the rate of gas escaping, indicated a stable leak rate that was, to a large extent, independent of the pressure.

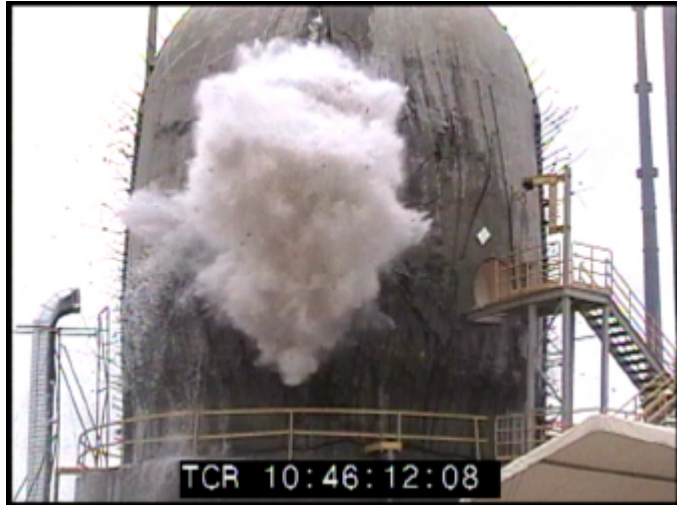
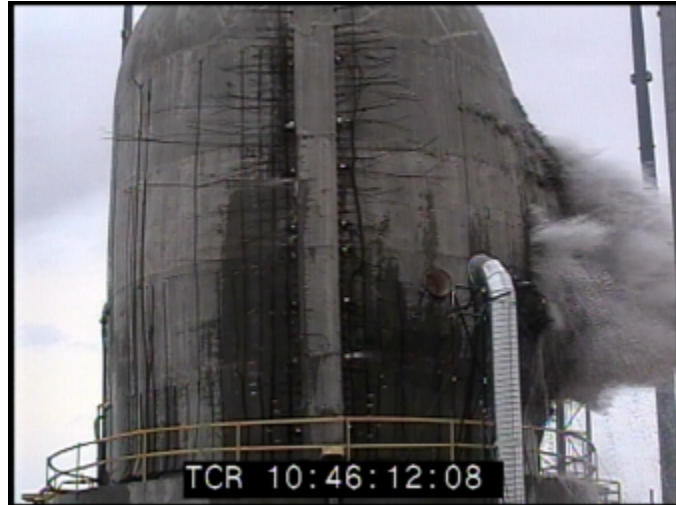
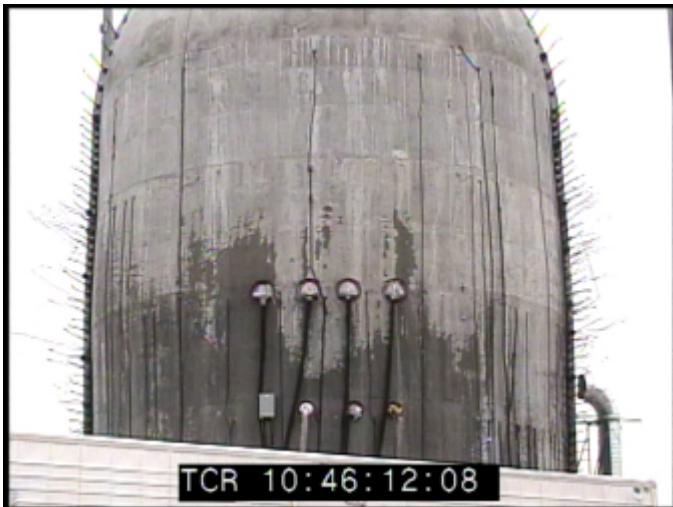
Figure 5.34 SFMT: Rupture of the PCCV Model

Pressurization of the model continued until a second spray of water was observed and suddenly, at 10:46:12.3, at an effective pressure of $3.63 P_d$ (1.42 MPa or 206.4 psig), the PCCV model ruptured violently at ~ 6 degrees azimuth near the mid-height of the cylinder. The rupture propagated vertically in both directions and then radiated circumferentially about 2 m above the top of the basemat, shearing off the cylinder wall. The dome and cylinder wall then came to rest on the instrumentation frame, which apparently prevented the model from toppling over. The entire collapse was over in slightly more than one second. The entire SFMT, including the sequence of rupture and collapse, was recorded by the digital video cameras. A short movie (.mpg) file showing the rupture of the model is included on the enclosed data CD. The moment of rupture is shown from all four angles in Figure 5.34. The video recorded failure of the tendons, including ejection of tendon anchors. The condition of the model after the SFMT is shown in Figure 5.35.

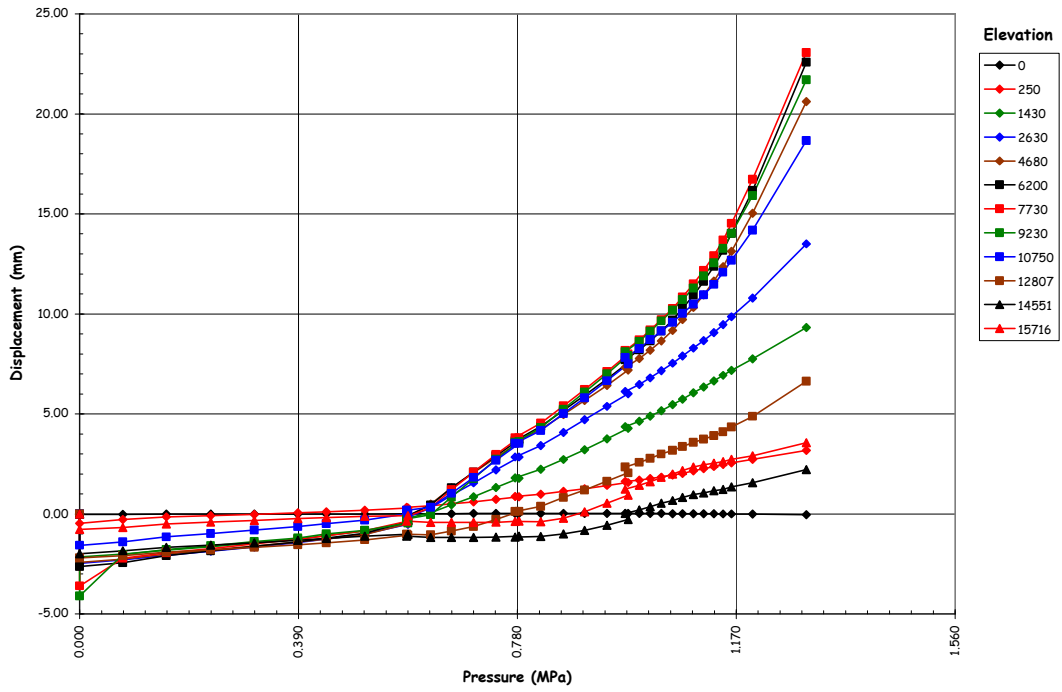
Figure 5.39 LST - Radial Displacement at Azimuth 135 degrees

The radial displacement of the model at the cardinal elevations along Azimuth 135 degrees, selected to represent the ‘free-field’ or axisymmetric response of the model, is shown in Figure 5.39. This plot illustrates several features of the response data that should be noted. The initial values (i.e. at P=0) reflect the inside surface motion of the liner between March 3rd and the start of the LST, thereby reflecting the influence of prestressing, changes in ambient temperature, creep, etc. The response due to pressure alone is the reported displacement minus the displacement at the start of the LST (i.e., at P=0 on 10:03 a.m., 26 September, 2000).

The initial data also suggests that the liner most likely separated from the concrete wall at some locations, as evidenced by the relatively large displacements that occurred during the first pressure step. At these locations, the first increment of pressure ‘pushed’ the liner back into contact with the concrete surface. This behavior can also be observed in the SFT and SIT/ILRT data, including a restoration of the gap after depressurization. The liner separation is most likely a result of differential thermal expansion and prestressing, resulting in compressive stresses that may have bowed or slightly buckled the liner.

The response remains essentially elastic up to 1.3 to 1.5 P_d, after overcoming the prestress (~1.2 P_d) and tensile cracking of the concrete. It is interesting to note that even though drying and shrinkage cracks were present prior to pressure testing, the onset of generalized concrete tensile cracking is quite distinct. Beyond 1.5 P_d to approximately 2 to 2.5 P_d, the response is still linear, although the loss of concrete tensile stiffness is quite distinct. Beyond 2.5 P_d, the response becomes increasingly nonlinear, particularly in the mid-section of the cylinder, as the model exhibits generalized yielding in the hoop direction.

The data also exhibits some apparent discontinuities at 1.5, 2.0, and 2.5 P_d. These apparent discontinuities coincide with the leak checks of the model and reflect, primarily, the response to changes in ambient thermal conditions over the time the model was isolated. The jump in displacement at 2.5P_d, however, most likely includes creep effects, since the temperature was stable over the relatively short (1-1/2 hour) hold at this pressure.

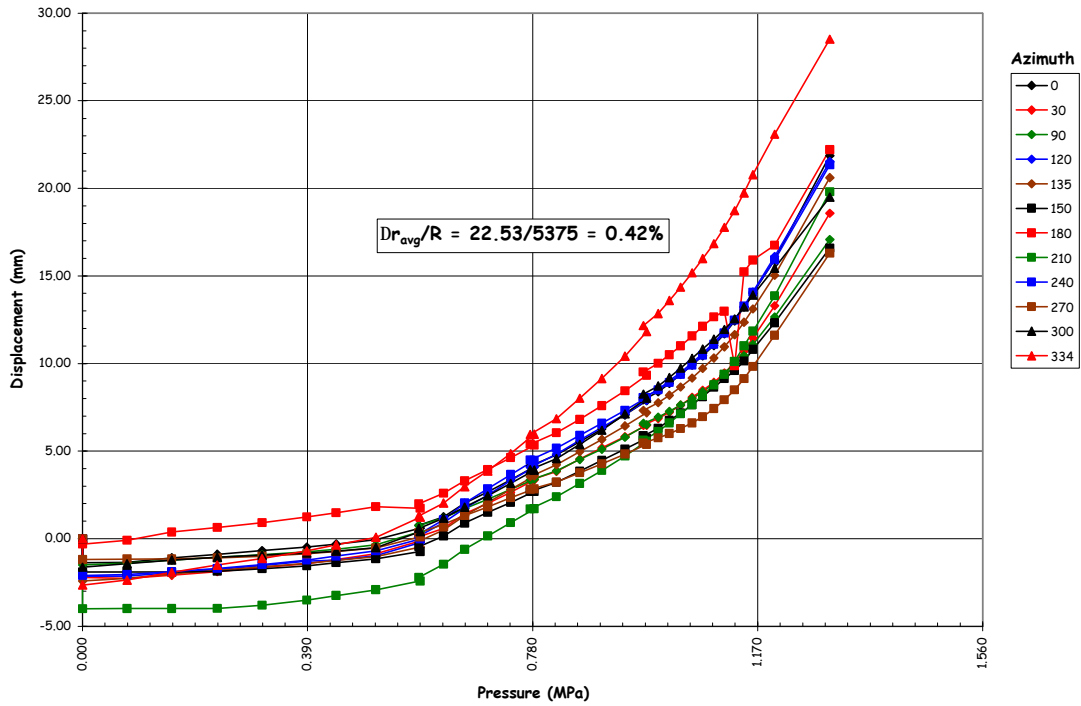
Figure 5.41 LST-Radial Displacement (DOR) at EL 4680

Figure 5.41 compares the displacement response as a function of Azimuth at elev. 4680, nominally the mid-height of the cylinder and the centerline of the E/H, A/L, and M/S penetrations. Ignoring some variation in initial conditions, reflecting some ‘out-of-roundness’ following prestressing, the response is fairly uniform, i.e. axisymmetric, except at 324 degrees, where largest deflections were already noted to occur. Averaging the radial deformation due to pressure yields a nominal average hoop strain of 0.42% at the peak pressure 3.3P_d. Similarly, the average hoop strain at 2.5P_d, coinciding with the onset of liner tearing and leakage, was 0.18%.

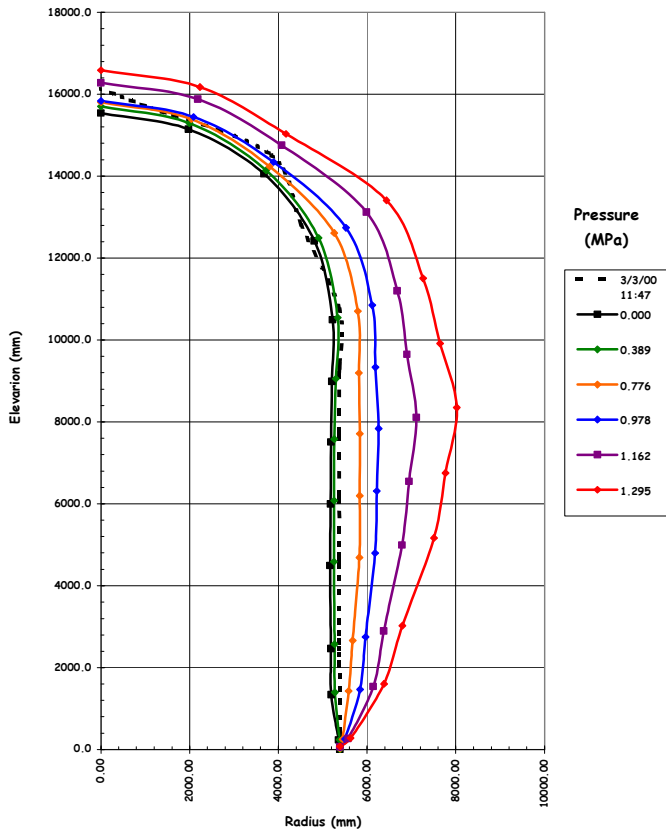
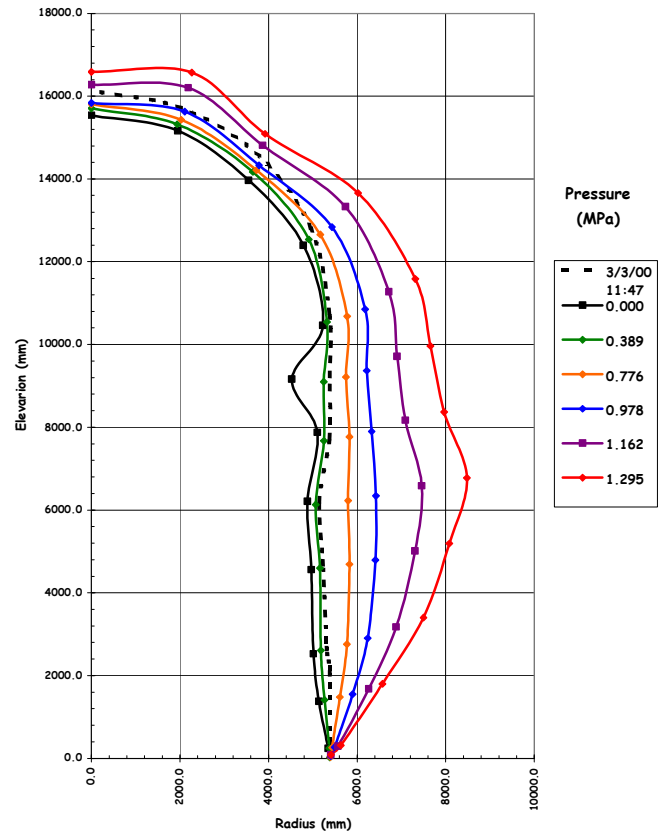
Figure 5.44 LST - Deformation at Azimuth 240 degrees and 324 degrees (I and L) × 100

- The unusual deformation patten in the dome at 135 degrees and 324 degrees coincides with the regions where the East-West and North-South sets of vertical tendons overlap with the hoop tendons in the dome, where higher prestressing forces are present than in other regions of the dome.
- The initial buckling of the liner at Azimuth 324 degrees, elev. 9230 is clearly shown in Figure 5.44.

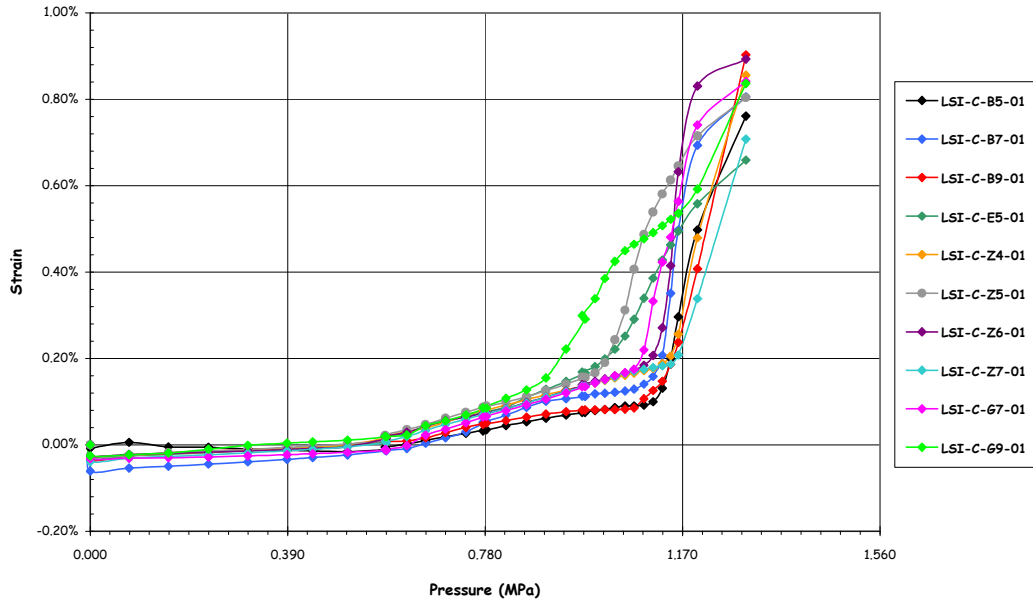
Figure 5.46 LST – Free-Field Liner Hoop Strains

Figure 5.46 shows all the free-field liner hoop strain gages that exceeded 0.5% at the end of the test. It is interesting to note that up to 2.5 Pd, the free-field liner strain hoop strains were almost all below 0.2%, which compares favorably with the average hoop strain computed from the displacements, 0.18%.

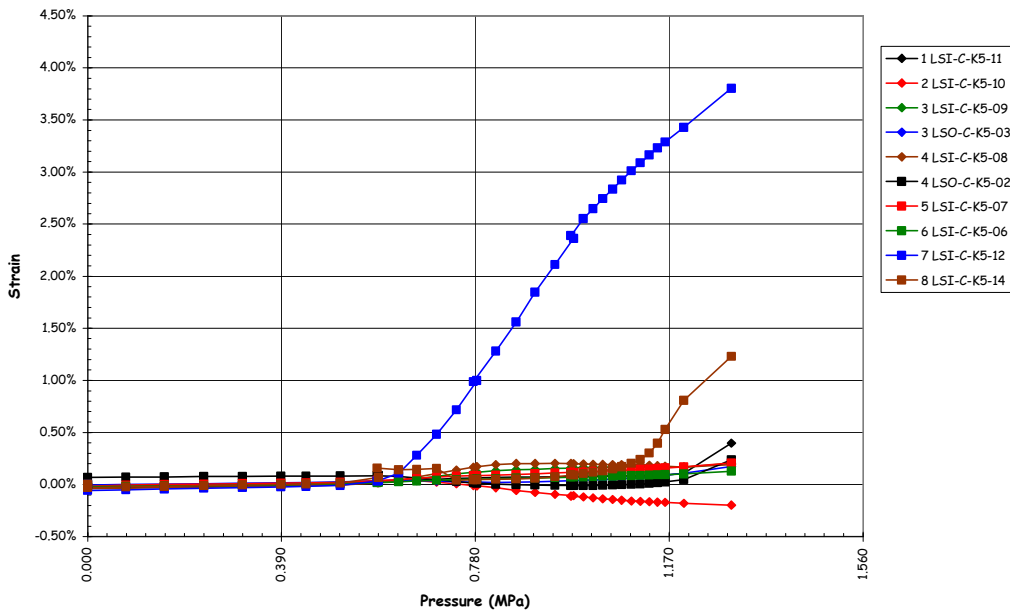
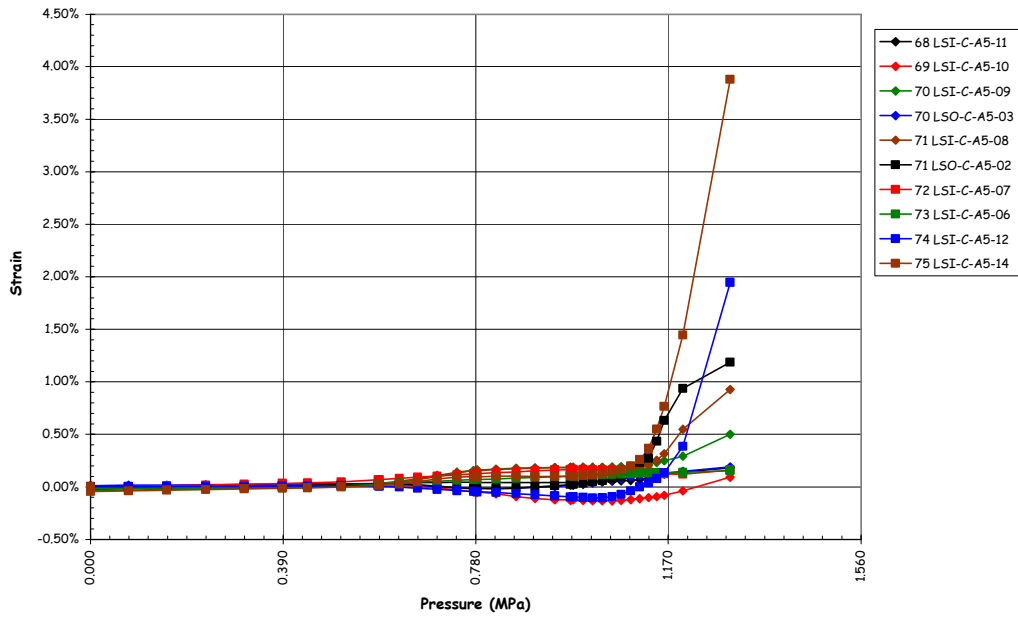
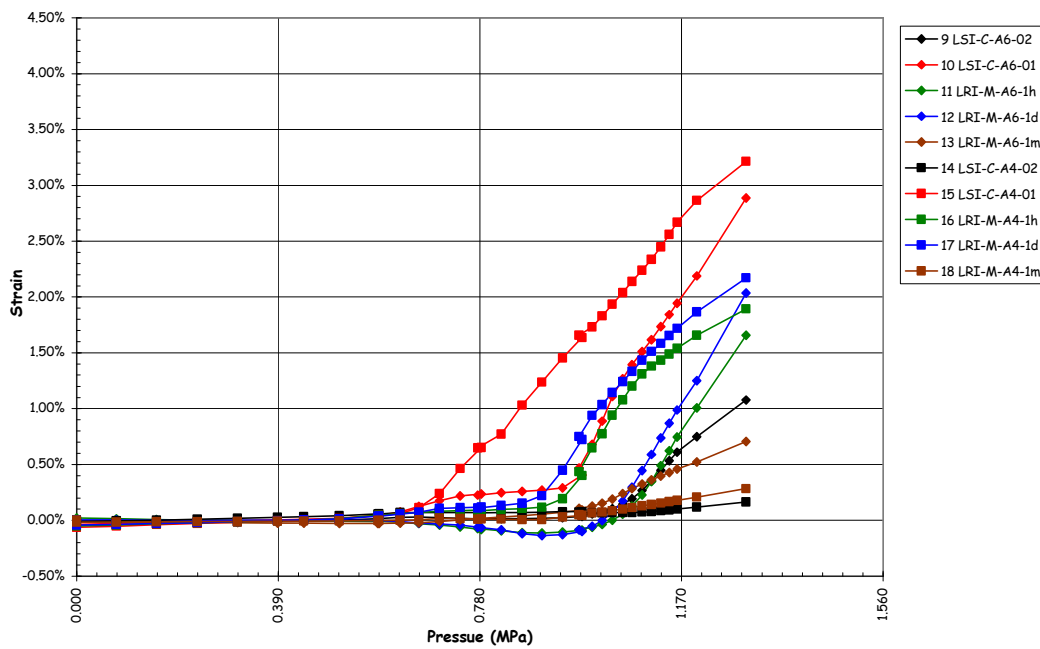
The strains at the middle of the ‘left’ (#1-8) and right (#68-75) edges of the embossment are shown in Figures 5.49 and 5.50. The strains at the upper and lower ‘left’ corners are shown in Figure 5.51. With the exception of gage #7, the strains at the mid-sides of the embossment are all very small until global yielding of the model occurs just below $3P_d$. At the corners, however, liner strains begin increasing earlier, with gage #10 showing increasing strains beginning at $1.5P_d$, while most of the other gages show significant increases beginning at $2.5P_d$, when liner tearing was believed to

have occurred. At first glance, it appears unfortunate that the liner tore on the opposite side from the strain gages (pretest analyses suggested the highest strains would occur on the 'left' side). However, it has been found that strain gages near tears often see lower strains than would be expected, since the tear acts as a strain relief mechanism. While it is apparent that the strains on the 'right' side were higher, it is unlikely that gages at those locations would have recorded higher strains than those on the left side. This is demonstrated by comparing gages #7 on the left and its mirror image, #74, on the right.

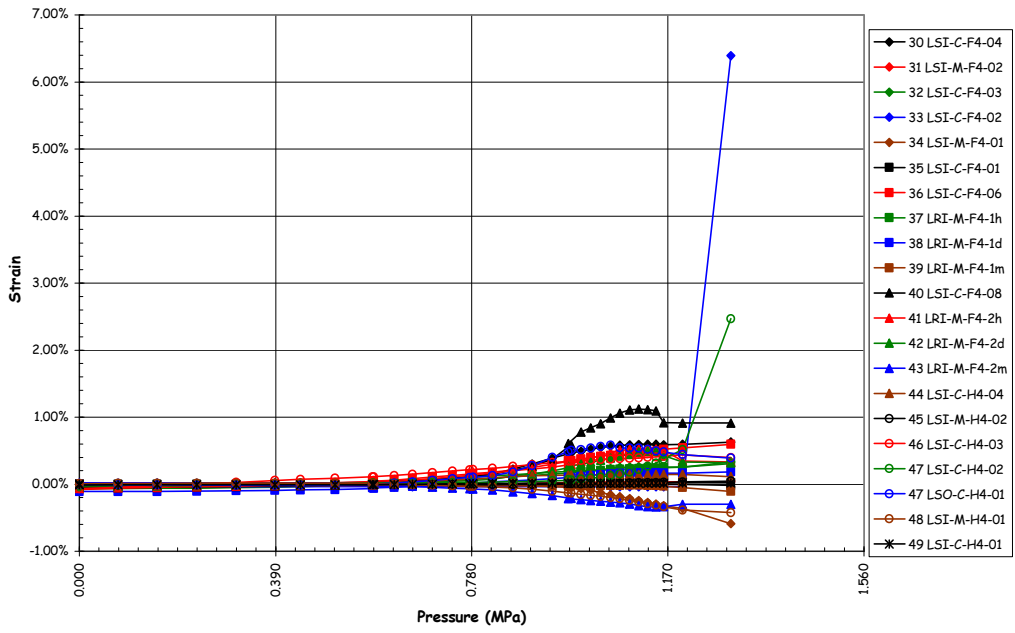
Figure 5.53 Liner Strains (DOR) at F/W (F=Ref. D-SN-P-220)

Several large tears occurred at each end of the F/W penetration, beginning at the weld between the thickened insert plate and the liner; however, no tears occurred at the M/S penetration event, though the free-field hoop strains at the M/S are higher since it is closer to the mid-height of the cylinder. There are a number of reasons why this occurred, primarily liner fabrication issues discussed in Section 5.3.2.2. It is interesting to note that even though the strain gages at the F/W penetration were located near the tear (see Figure 5.54), measured strains were relatively low until the very end of the LST, when some strains increased very rapidly. This might indicate that a tear in the vicinity of a strain gage can act as a strain relief mechanism on the surrounding material. The 'jump' in the strain near the end of the test may also be due to material distortion in the vicinity of the tear as the tear propagated. On the other hand, the strains recorded at the M/S penetration begin to climb rapidly at 2.0 to $2.5 P_d$, reaching values as high as 4.5% without resulting in any liner tearing. Detailed inspections of this location did not reveal any evidence of the fabrication problems that were present at the F/W penetration.

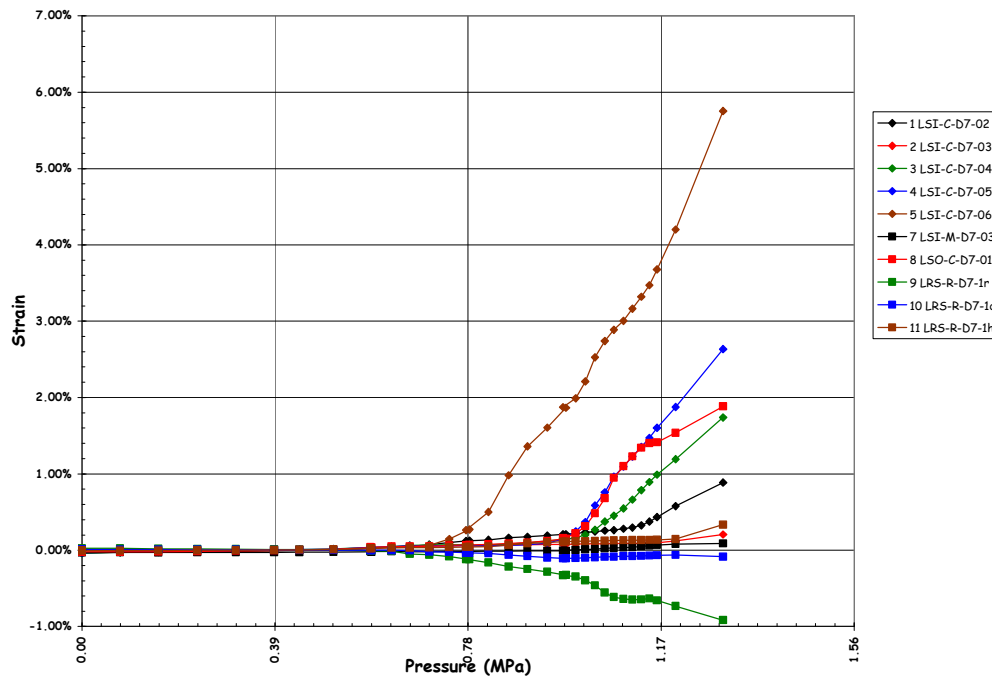
Figure 5.56 Liner Strains (DOR) at D7 Anchor Detail (Ref. R-SN-P-209, a.4)

The interior strain gages at D7 are also shown after the LST in Figure 5.56. The arrangement of these gages is shown on Drawing D-SN-P-209, Detail a.4 (Appendix E). Strains begin increasing between 2.0 and 2.5Pd, reaching a maximum of 5.7% at the maximum pressure. Nevertheless, the liner did not tear. A subsequent comparison of this detail to similar rathole details that did tear, but were not instrumented, revealed a lack of any weld repairs, which was not true of the other locations. This detail appears to demonstrate that the liner is capable of undergoing significant local strain without tearing in the absence of any other factors that might degrade the liner.

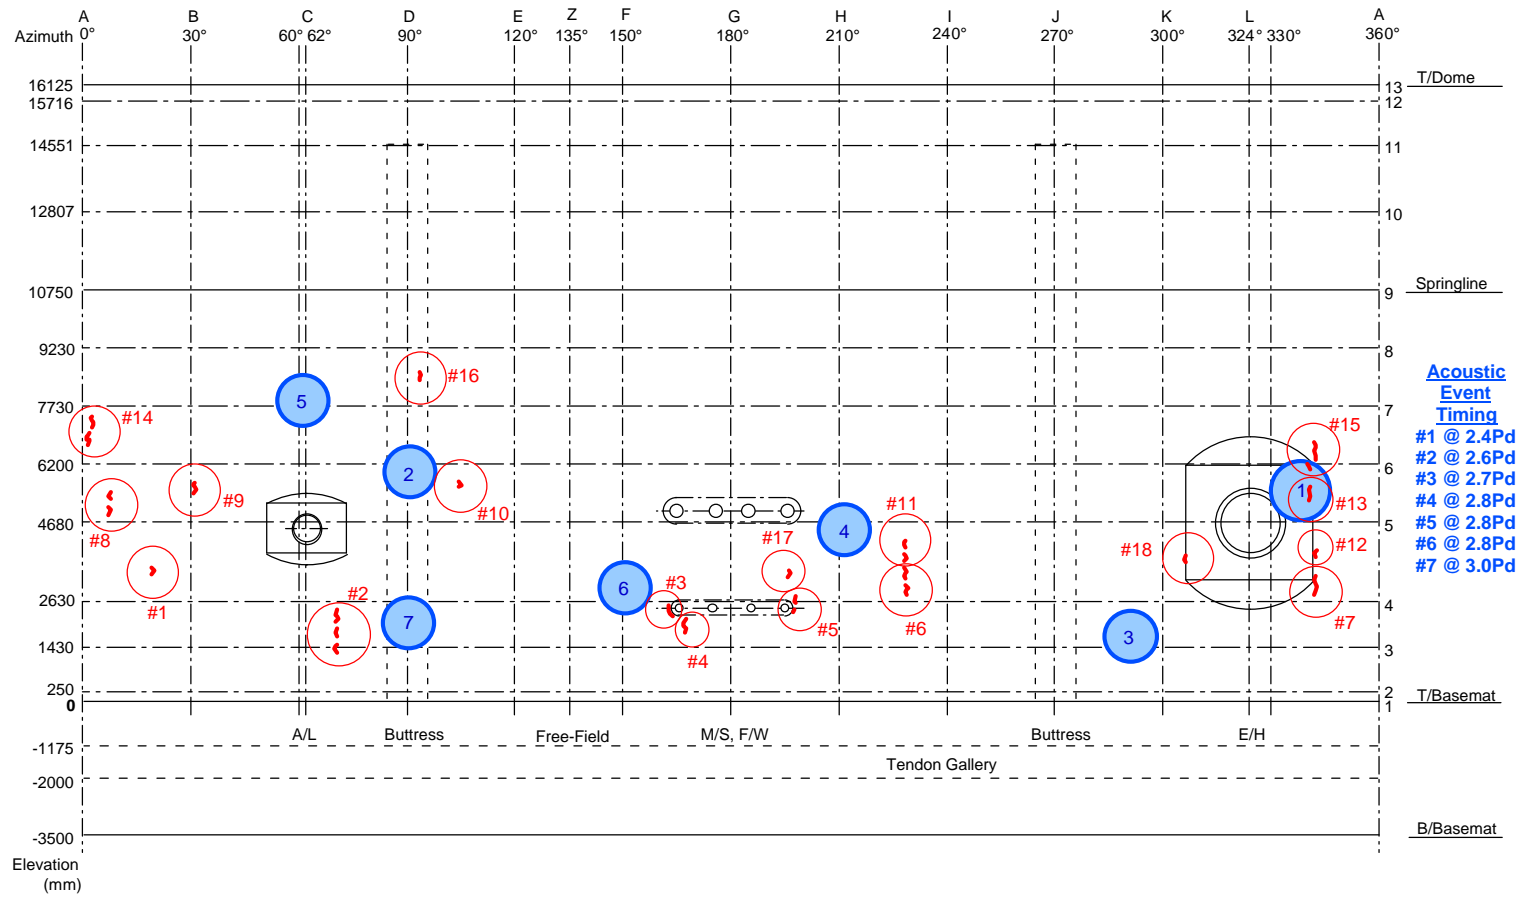
Figure 5.78 Liner Tears and Acoustic Event Locations

The acoustic events, later associated with the sound of the nitrogen gas escaping through the liner tears, are superimposed on the tear map in Figure 5.78, along with the approximate pressure levels when these events were first detected. The first tearing event appears to be clearly associated with the tears along the edge of the E/H embossment (#7, #12, #13, and #15), although it is arguable which of these occurred first. The other acoustic tearing events cannot be as clearly identified with any specific tear or tears, and, near the end of the test, it may have been difficult to distinguish the separate 'tearing' events from each other since gas continued to escape through each tear after it occurred.
