5. TESTING

5.1 Test Planning

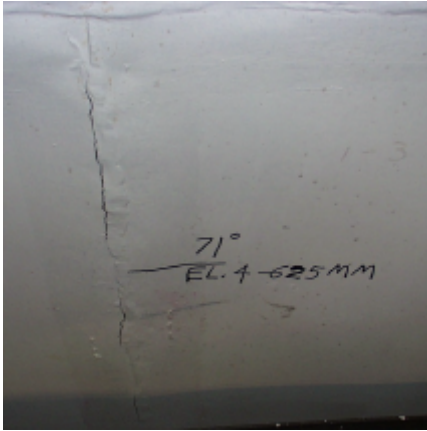
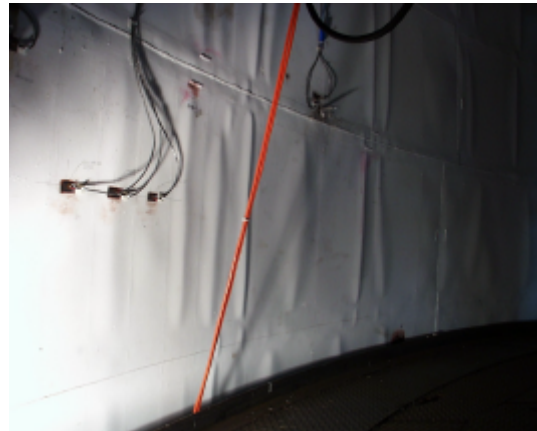
Figure 5.79 Post-LST Liner Tear (#2) and Liner Buckling

A typical liner tear (#2) as it appeared during the initial inspection is shown in Figure 5.79. In addition to the liner tears, a pattern of buckling appeared throughout the middle section of the cylinder wall. The buckling pattern, also illustrated in Figure 5.79, is believed to have occurred during depressurization, when the permanently stretched liner could not accommodate the elastic recovery of the cylinder wall.

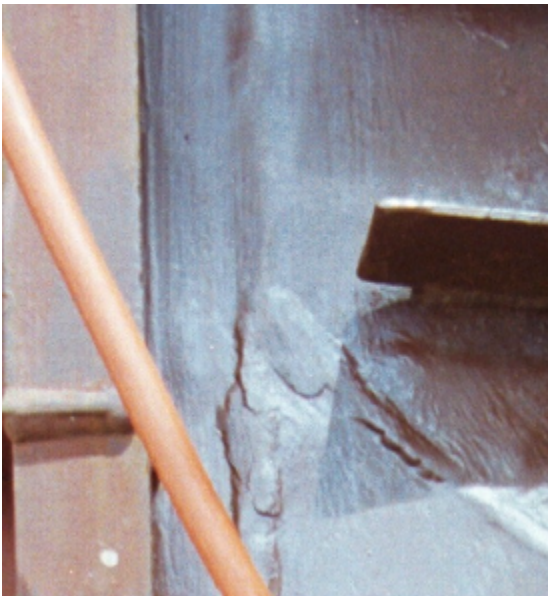
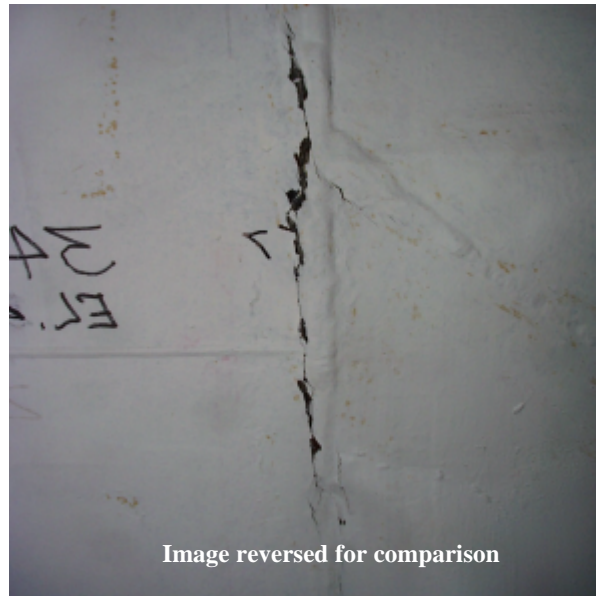
Figure 5.80 Tear #7 at E/H

After the initial inspection of the liner, a more methodical inspection was undertaken. Each tear was photographed and matched with photographs of the 'backside' of the liner before the concrete was placed. (One early program decision was to photograph the entire length of every field weld made during the fabrication of the liner. While this was a very time-consuming and painstaking task, the benefit obtained in understanding the causes of the liner tearing was worth the effort.) A sample of the pre-LST exterior condition compared to the post-LST interior condition for Tears #7, #12, #13 and #15 at the E/H, #2 at a free-field weld seam, and #16 at a 'rathole' detail are shown in Figures 5.80 to 5.85.

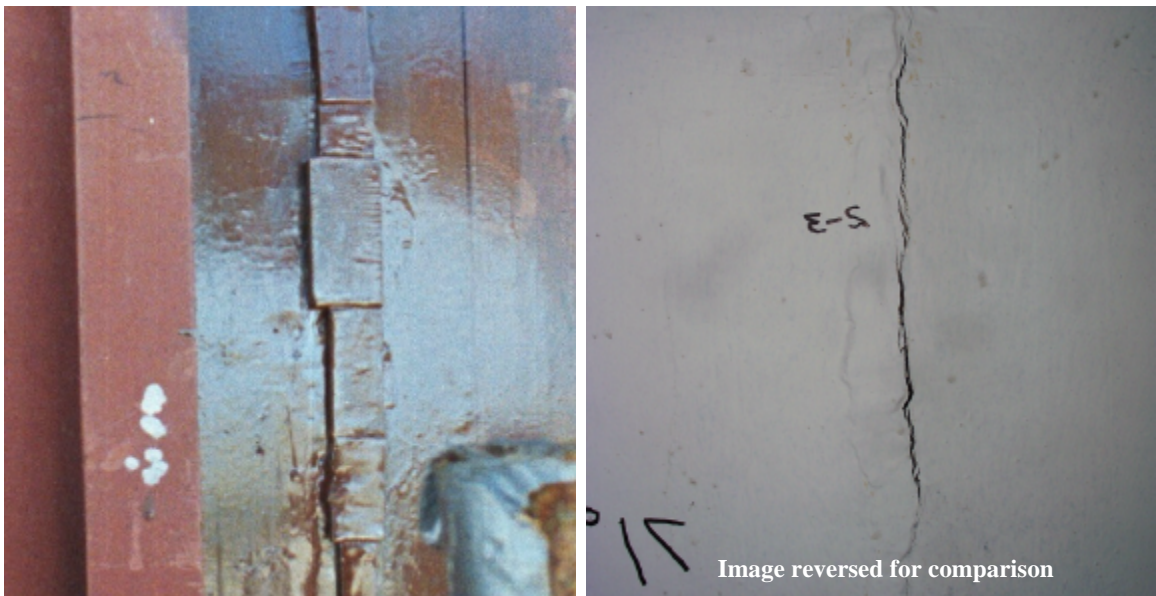
Figure 5.84 Tear #2, Free-Field

1. Nearly all of the tears occurred in areas where the liner thickness was reduced ~25% or more by grinding done in association with repair welding. Extensive localized plastic deformation culminating in ductile tearing occurred in these thinned areas as the structure was being tested. This appears to have been the most prevalent cause of liner failure.

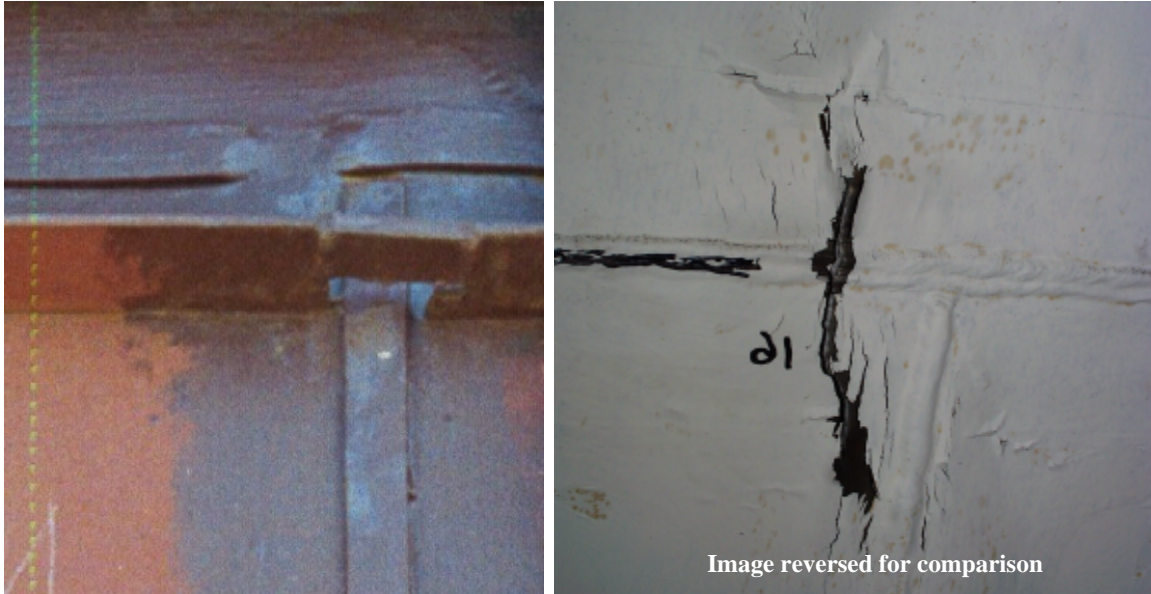
Figure 5.85 Tear #16 at Rathole Detail

5. Geometric features may also have contributed to the formation of some tears. These include structural transitions, such as those at the feedwater penetration and the equipment hatch transition boundaries, discontinuities in horizontal stiffeners, and discontinuities in weld back-up bars. A missing segment in a horizontal back-up bar appears to have been primarily responsible for one tear (#16).

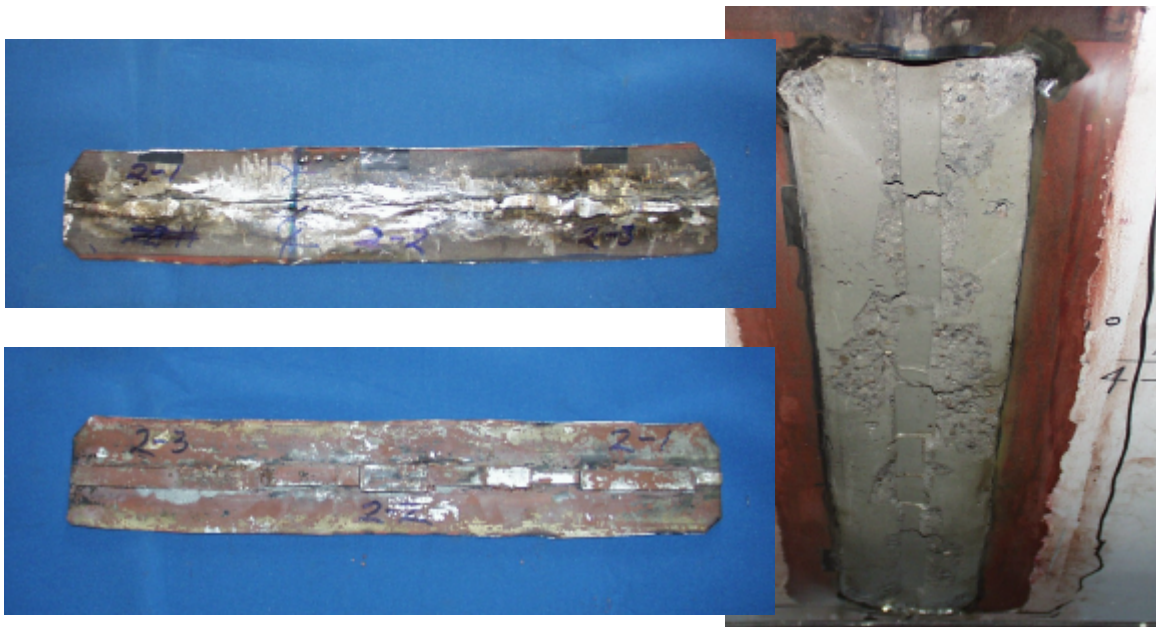
Figure 5.87 Liner Specimen at Tear #2

1. In-situ examination:
 - a. In addition to the visual/photographic records, ultrasonic thickness measurements were made at each tear location and at several baseline locations where tears did not occur.
2. Destructive examination:
 - a. Twenty-five liner specimens were removed from the model (see Figures 5.87 and 5.88).
 - b. Eighteen of the liner specimens were subjected to metallographic analysis.
 - c. Sample weld specimens were subjected to metallographic analysis.
 - d. After the liner specimens were examined by SNL, the unused portions were sent to NUPEC for further examination. The results of NUPEC's examination have been reported separately.

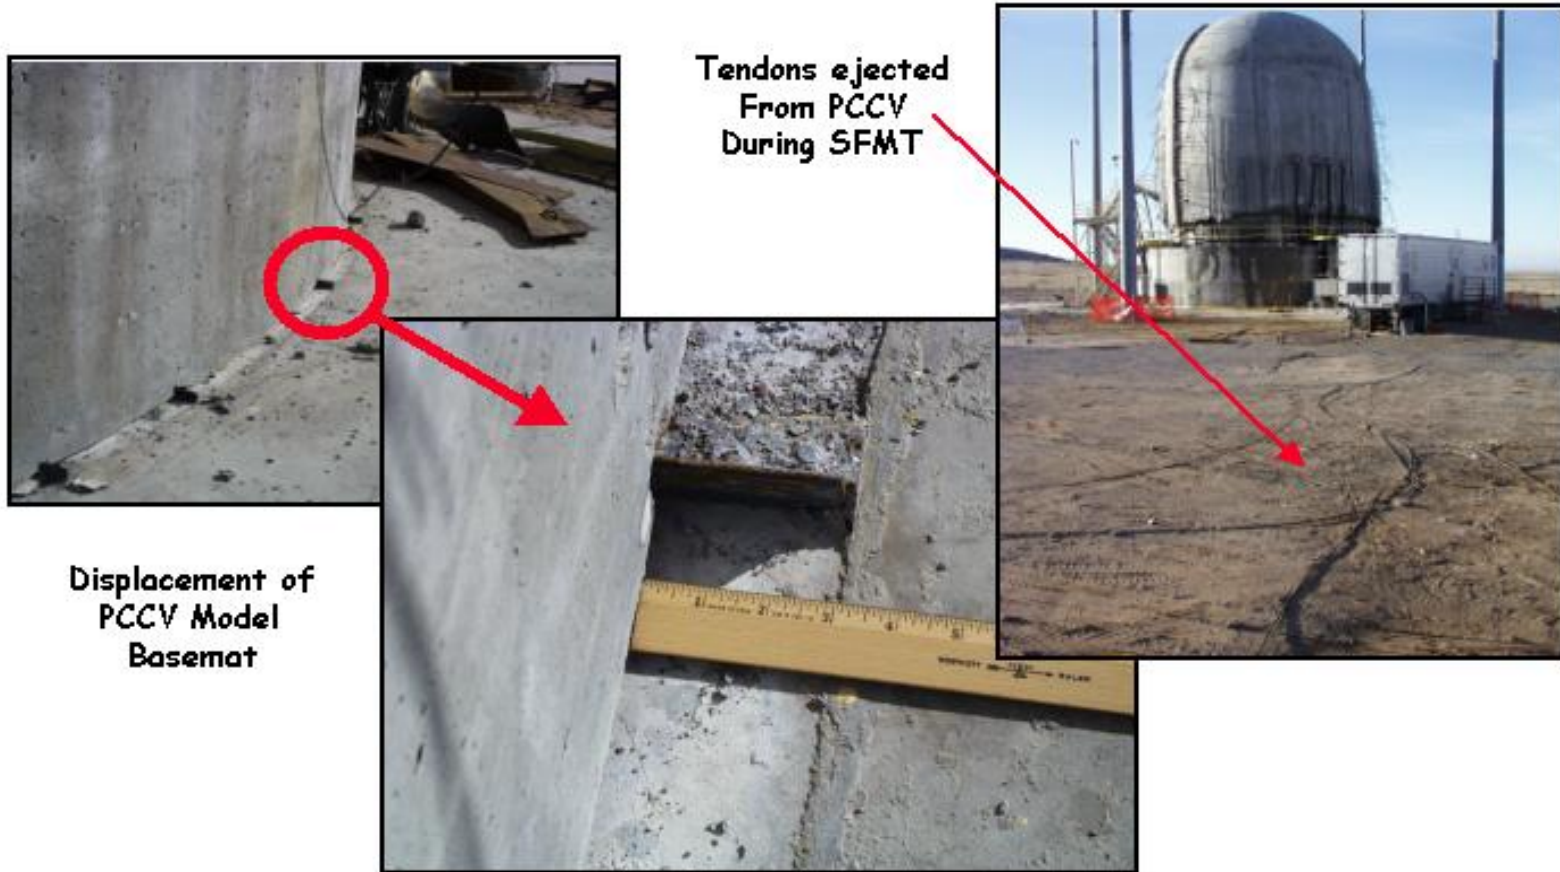
Figure 5.124 SFMT – Model Displacements

The position of the model after the SFMT was also noted. Figure 5.124 shows that the model displaced approximately 3" horizontally and tipped in the opposite direction of the rupture. Six tendons were completely ejected from the model and the final location of major pieces of debris were mapped on the site plan, as shown in Figure 5.125. The location of the debris was not only due to the initial rupture, but also by the flow of 350,000 gallons of water escaping from the model.

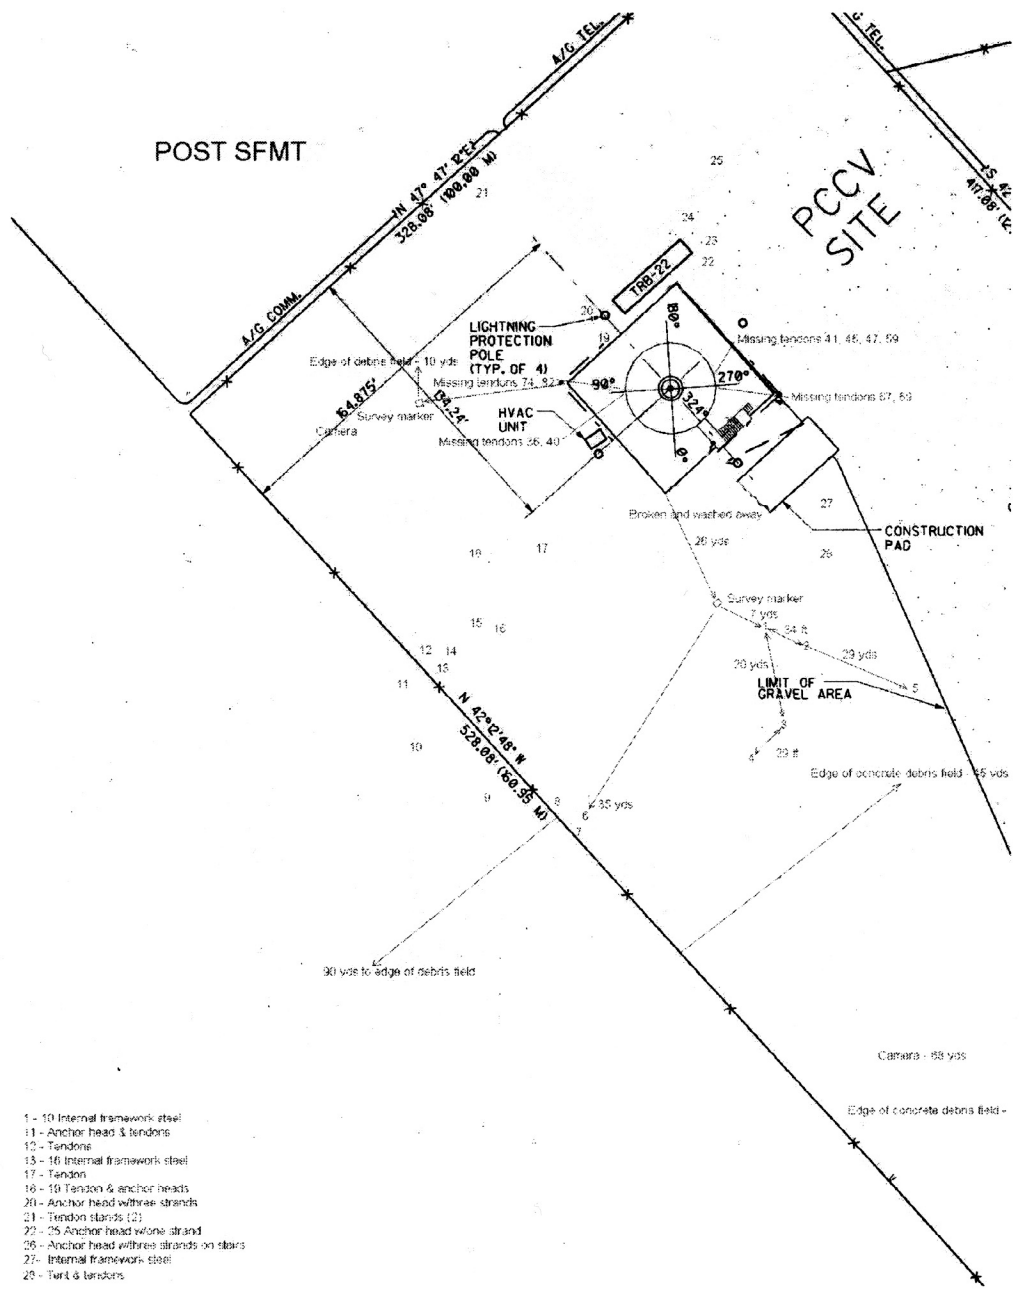
Figure 5.125 SFMT – Debris Map

- 1 - 10 Internal framework steel
- 11 - Anchor head & tendons
- 12 - Tendone
- 13 - 16 Internal framework steel
- 17 - Tendon
- 18 - 19 Tendon & anchor heads
- 20 - Anchor head with two strands
- 21 - Tendon stands (2)
- 22 - 25 Anchor head w/one strand
- 26 - Anchor head with three strands on stairs
- 27 - Internal framework steel
- 28 - Tank & tendons
