# **Assessment of Structural Flood-Control Measures on Alluvial Fans**

October 1993

Hydrologic Engineering Center  
US Army Corps of Engineers  
609 Second Street  
Davis, CA 95616-4687  
(916) 756-1104

Federal Insurance Administration  
Federal Emergency Management Agency  
500 C Street, SW  
Washington, D.C. 20472

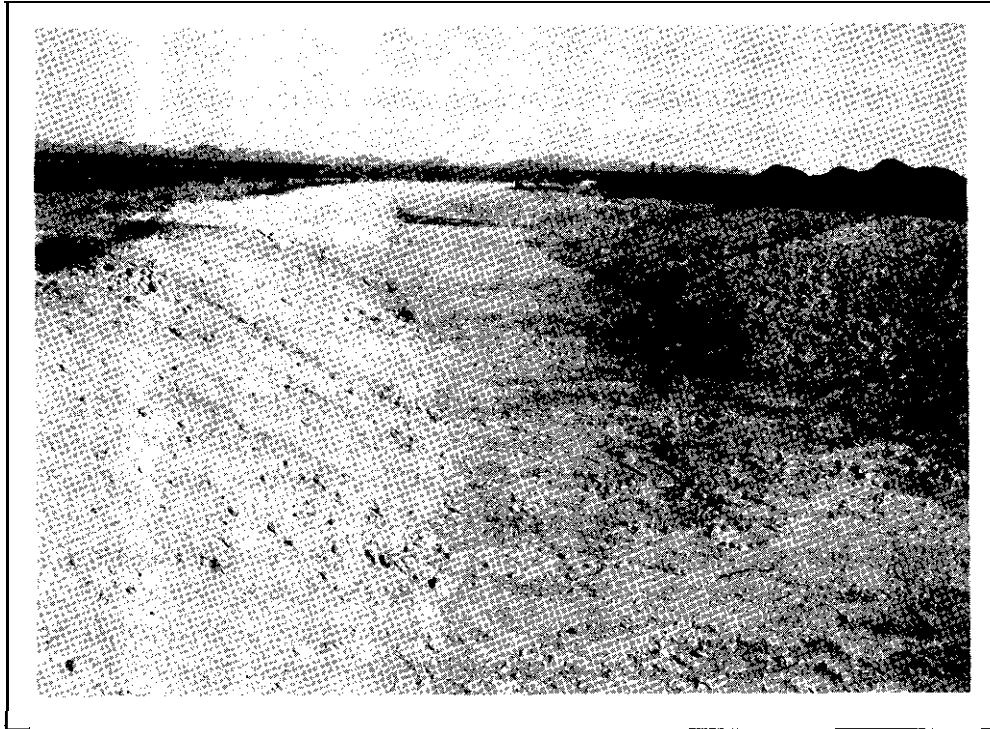
Figure 2-3 Lined Diversion Channel, Looking Upstream Toward FRS

Saddleback Floodwater Diversion Channel is a 4.73-mile-long channel that takes the principal spillway outflow from Saddleback Flood Retention Structure (FRS). Approximately 1,900 feet of the channel from the FRS to the Courthouse (McDowell Road) bridge is lined with grouted rock riprap, shown in Figure 2-3. Downstream from the bridge, the unlined channel intercepts drainage from an 8.6-square-mile area across an alluvial fan. There are four grouted rock drop structures to maintain grade and to reduce velocity within the channel. The diversion channel outflow is a natural alluvial wash in an undeveloped area. The diversion protects agricultural development adjacent

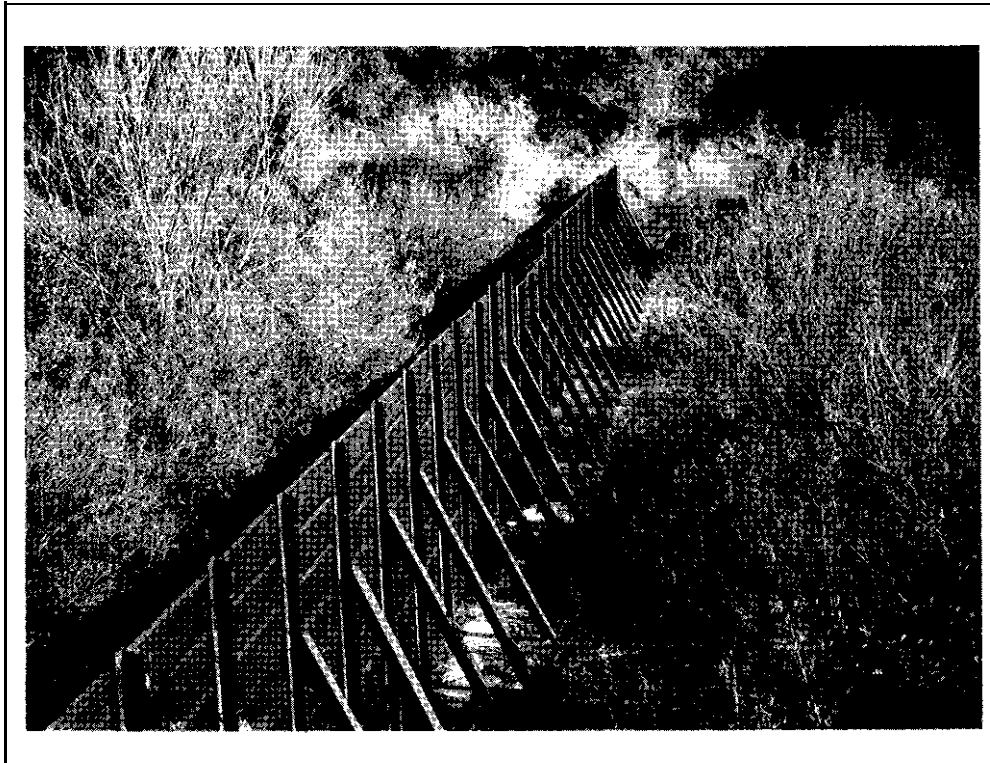
Figure 3-1 Debris Barrier Wall in Southern California

temporary protection while protective natural vegetation is re-established in a burned watershed (lasting 3 to 5 years), in practice, they have proven to be quite durable. Examples of filled and unfilled fire barriers in good condition up to 15 years old are found in the San Gabriel Mountains near Glendora, California. Figure 3-1 shows a typical Southern California debris barrier wall.

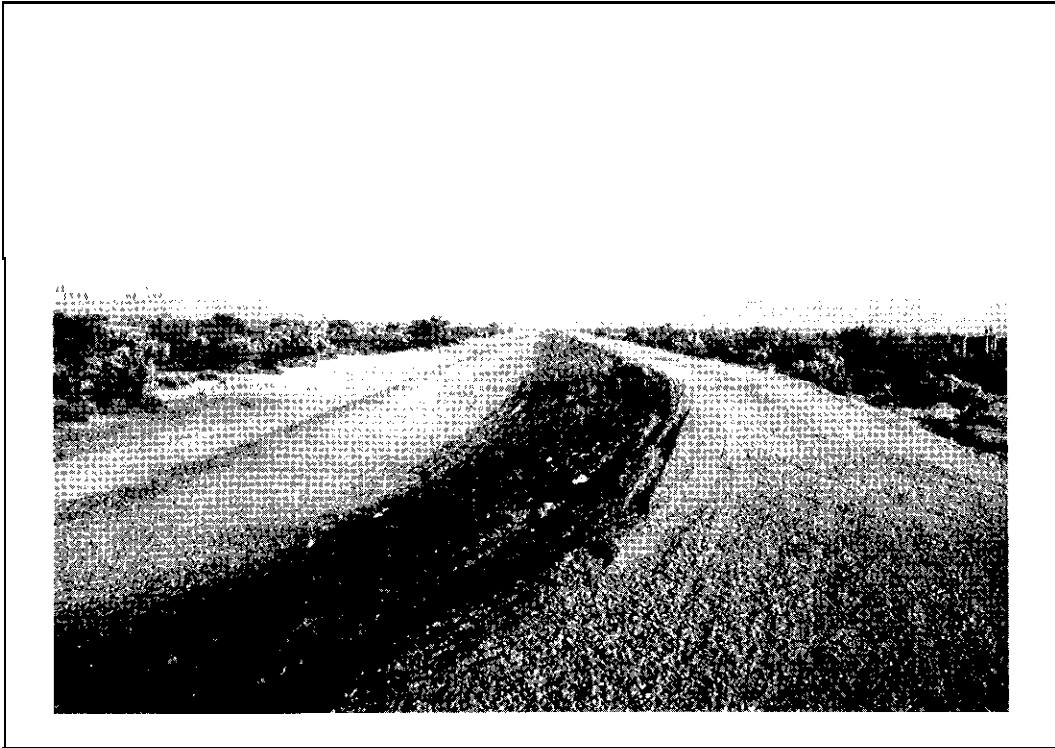
Figure 3-4 Pass Mtn. Diversion Dam, Mesa, Arizona (Flow trapped on left diverted upward in picture.)

The SCS has developed several Debris/Flood Detention basins in Arizona. A review of the flood experience at Saddle Back Diversion indicated that the Flood-Reduction Structure (FRS) performed well (Chapter 2). This project and the Buckhorn Mesa Watershed flood-diversion and retention structures near Mesa, Arizona (SCS, 1984), are long, earthen, levee-like structures across the fan, capturing runoff from a portion of an alluvial fan. The Buckhorn-Mesa project also uses the levee, shown in Figure 3-4, to divert alluvial fan flow to the FRS. These structures would only be practical where there is sufficient open space to provide for flood inundation during flood events. Because these are dry dams, there is a potential for open-space land use within the storage zone of the reservoir.

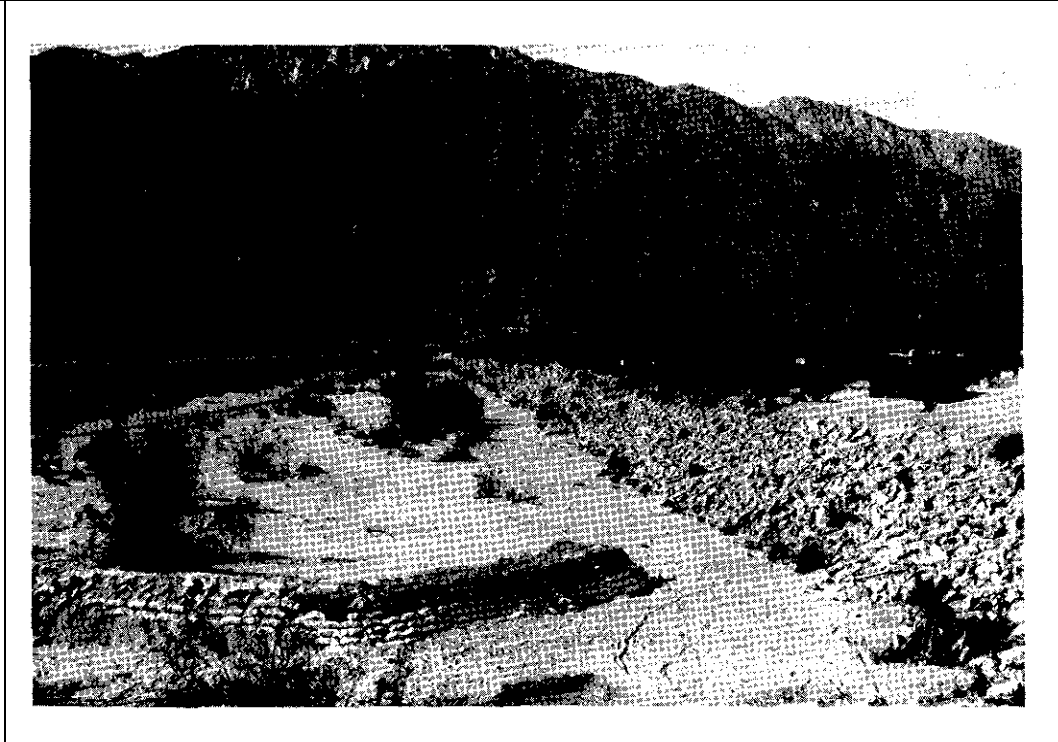
Figure 3-8 Tahquitz Creek, looking upstream from Sunrise Bridge, Palm Springs, California

Rock riprap is often used to maintain alluvial channels, especially when high velocities are expected. Figure 3-8 shows a section of Tahquitz Creek with riprap bank protection. The series of flood reports from Southern California (Sections 2.1 to 2.3) describe several causes for riprap failure; however, two, (1) toe failure due to undermining or movement, and (2) riprap failure caused by impinging flow from lateral inflow or poor channel alignment, seem to be the predominant causes of failure.

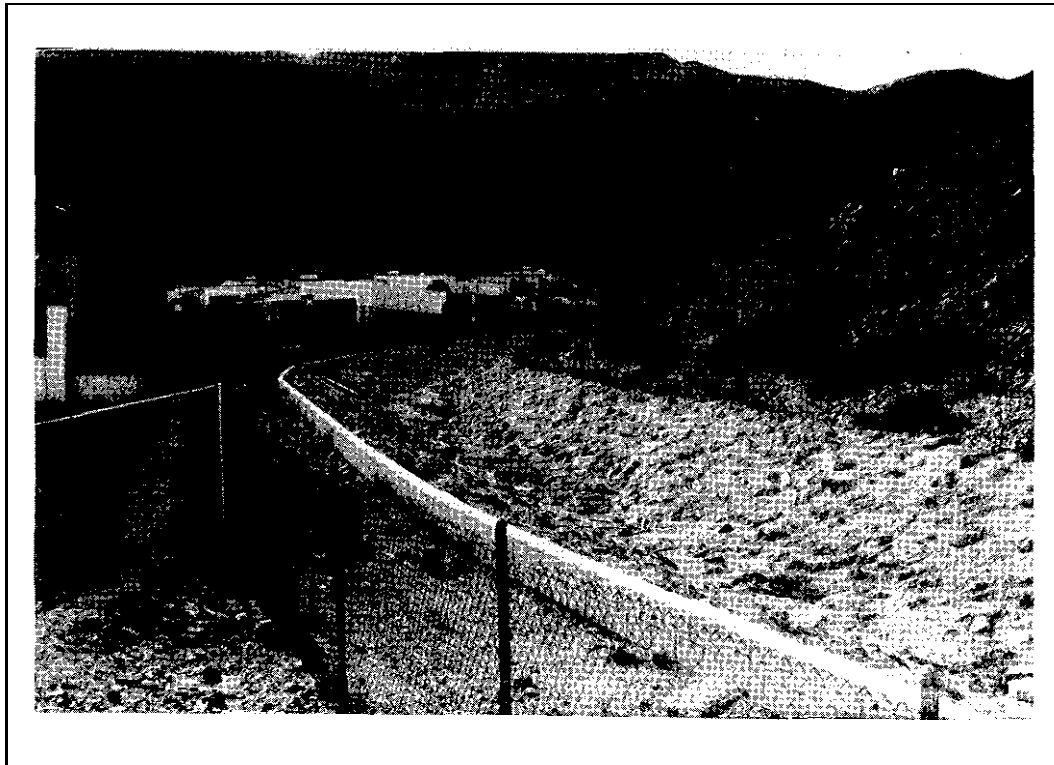
Figure 3-12 Low Concrete Wall on Outside Bend of Magnesia Canyon Channel, Rancho Mirage, California

Generally, the levees associated with the reviewed flood-control channels have been small portions of the improved flood-control channels. No floodwalls were reviewed during this investigation. Figure 3-12 shows a low concrete wall on the outside bend of West Magnesia Canyon Channel at Rancho Mirage. The channel is protected with gunite-rock riprap.
