THE APOLLO 13 ACCIDENT

HEARINGS
BEFORE THE
COMMITTEE ON
SCIENCE AND ASTRONAUTICS
U.S. HOUSE OF REPRESENTATIVES
NINETY-FIRST CONGRESS
SECOND SESSION

JUNE 16, 1970

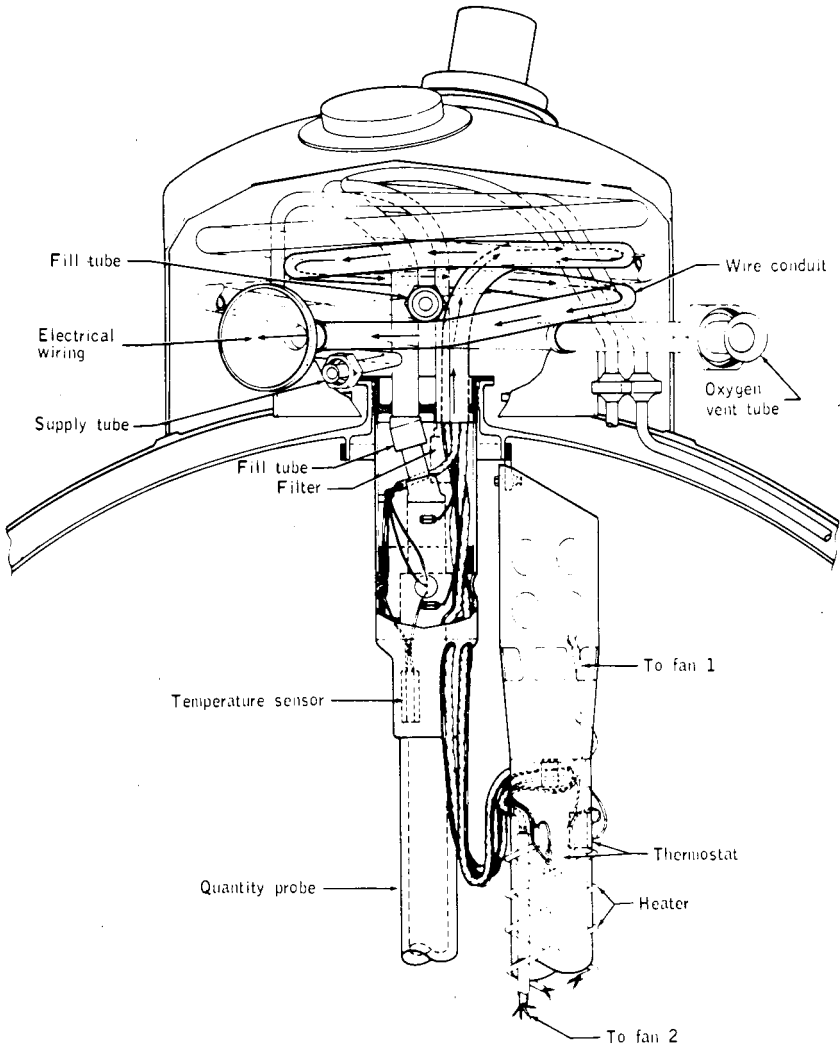
Figure 4-2.- Oxygen tank wiring and lines.

As shown in Slide 9, each heater coil is protected with a thermostatic switch, mounted on the heater tube, which is intended to open the heater circuit when it senses a temperature of 80° F. As I will point out later in tracing the Board's conclusions as to the cause of the accident, when the heaters were powered from a 65 volt DC supply at KSC during an improvised detanking procedure, these thermostatic switches, because they were rated at only 30 V DC, could not prevent an overheating condition of the heaters and the associated wiring. Tests conducted for the Board indicate that the heater tube assembly was probably heated to a temperature of as much as 1000° F during this detanking procedure.

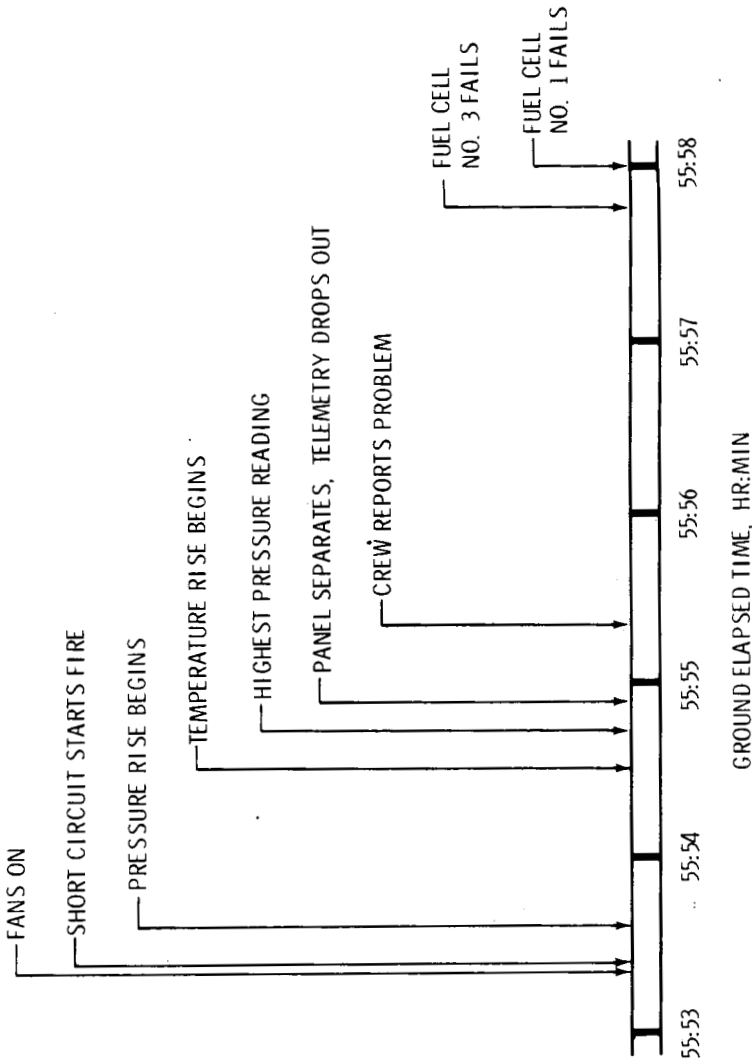
slide 12

The evidence points strongly to an electrical short circuit with arcing as the initiating event. Near the end of the 55th hour of flight, about 2.7 seconds after the fans were turned on in the SM oxygen tanks, an 11.1 ampere current spike and simultaneously a voltage drop spike were recorded in the spacecraft electrical system. Immediately thereafter current drawn from the fuel cells decreased by an amount consistent with the loss of power to one fan. No other changes in spacecraft power were being made at the time. No power was on the heaters in the tanks at the time and the quantity gage and temperature sensor are very low power devices. The next anomalous event recorded was the beginning of a pressure rise in oxygen tank #2, 13 seconds later. Such a time lag is possible with low level combustion at the time. These facts point to the likelihood that an electrical short circuit with arcing occurred in the fan motor on its leads to initiate the accident sequence. The energy available from the short circuit is estimated to have been at least 10 to 20 joules. Tests conducted during this investigation have shown that this energy is more than adequate to ignite Teflon wire insulation of the type contained within the tank.

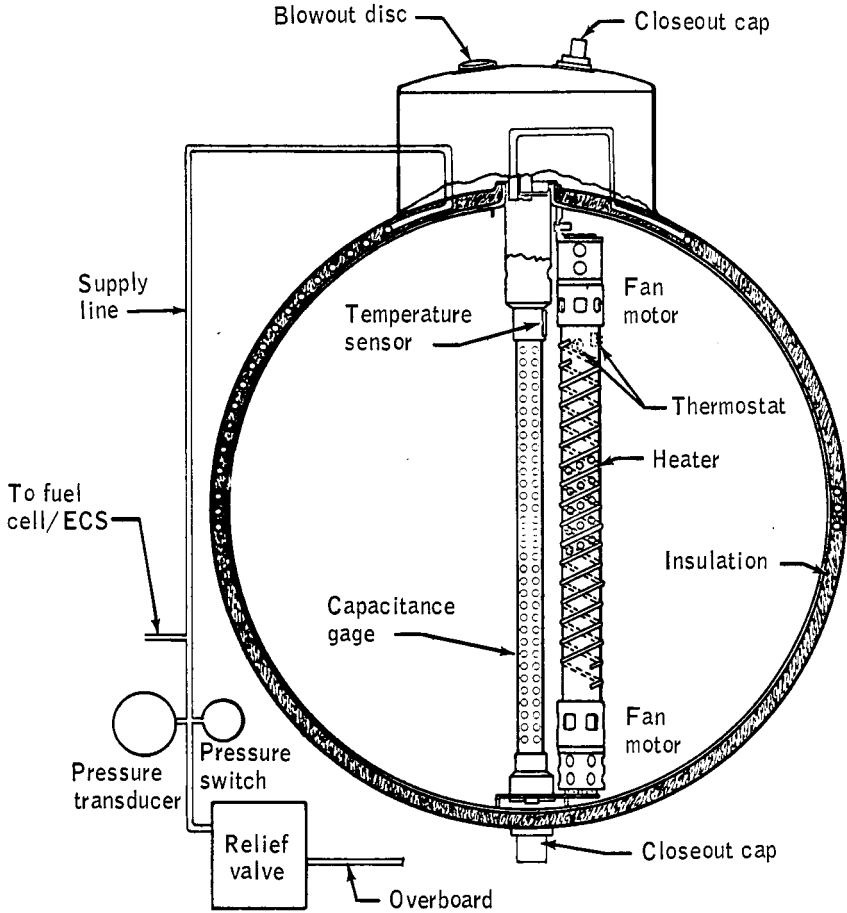
Figure 4-1.- Oxygen tank no. 2 internal components.

As the simplified drawing in figure 4-1 indicates, each oxygen tank has an outer shell and an inner shell, arranged to provide a vacuum space to reduce heat leak, and a dome enclosing paths into the tank for transmission of fluids and electrical power and signals. The space between the shells and the space in the dome are filled with insulating materials. Mounted in the tank are two tubular assemblies. One, called the heater tube, contains two thermostatically protected heater coils and two small fans driven by 1800 rpm motors to stir the tank contents. The other, called the quantity probe, consists of an upper section which supports a cylindrical capacitance gage used to measure electrically the quantity of fluid in the tank. The inner cylinder of this probe serves both as a fill and drain tube and as one plate of the capacitance gage. In addition, a temperature sensor is mounted on the outside of the quantity probe near the head. Wiring for the gage, the temperature sensor, the fan motors, and the heaters passes through the head of the quantity probe to a conduit in the dome. From there the wiring runs to a connector which ties it electrically to the appropriate external circuits in the CSM. The routing of wiring and lines from the tank through the dome is shown in figure 4-2.

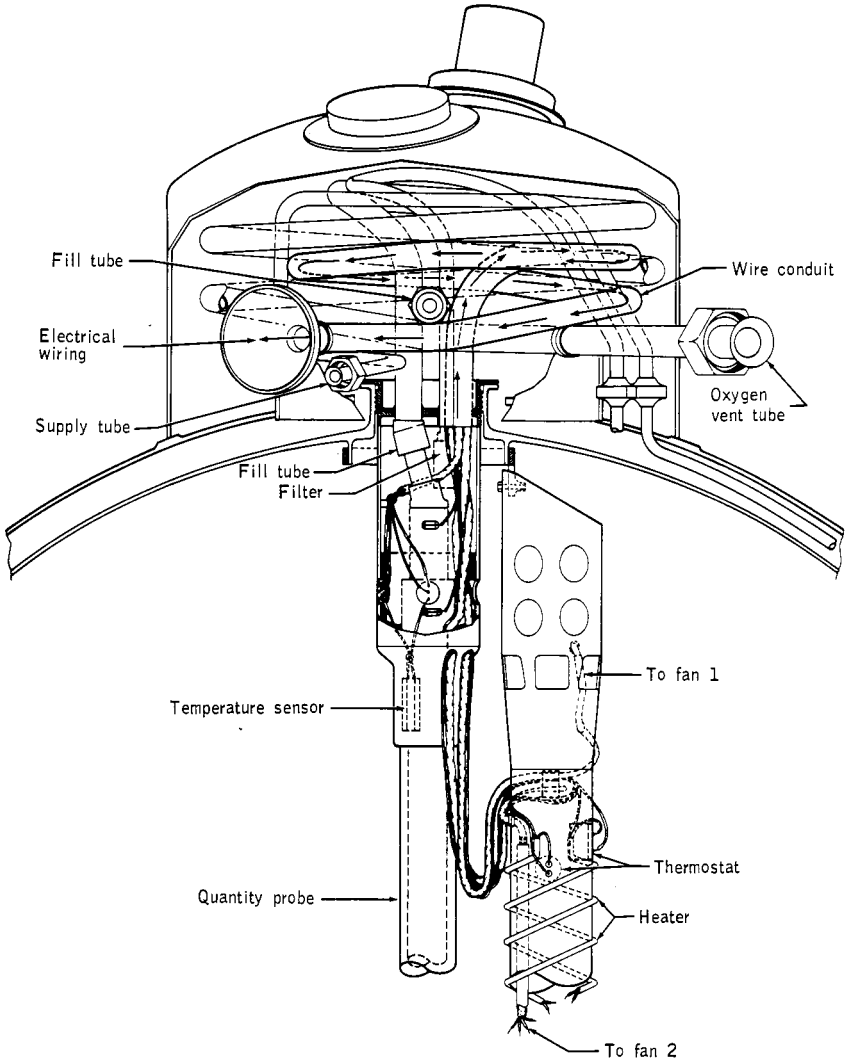
Figure 4-2.- Oxygen tank wiring and lines.

As shown in figure 4-2, the fill line from the exterior of the SM enters the oxygen tank and connects to the inner cylinder of the capacitance gage through a coupling of two Teflon adapters or sleeves and a short length of Inconel tubing. The dimensions and tolerances selected are such that if "worst case" variations in an actual system were to occur, the coupling might not reach from the fill line to the gage cylinder (fig. 4-3). Thus, the variations might be such that a very loose fit would result.

As noted earlier in this chapter, and shown in figure 4-2, each heater is protected with a thermostatic switch, mounted on the heater tube, which is intended to open the heater circuit when it senses a temperature of 80° F. In tests conducted at MSC since the accident, however, it was found that the switches failed to open when the heaters were powered from a 65 V dc supply similar to the power used at KSC during the detanking sequence. Subsequent investigations have shown that the thermostatic switches used, while rated as satisfactory for the 28 V dc spacecraft power supply, could not open properly at 65 V dc. Qualification and test procedures for the heater assemblies and switches do not at any time test the capability of the switches to open while under full current conditions. A review of the voltage recordings made during the detanking at KSC indicates that, in fact, the switches did not open when the temperature indication from within the tank rose past 80° F. Further tests have shown that the temperatures on the heater tube may have reached as much as 1000° F during the detanking. This temperature will cause serious damage to adjacent Teflon insulation, and such damage almost certainly occurred.

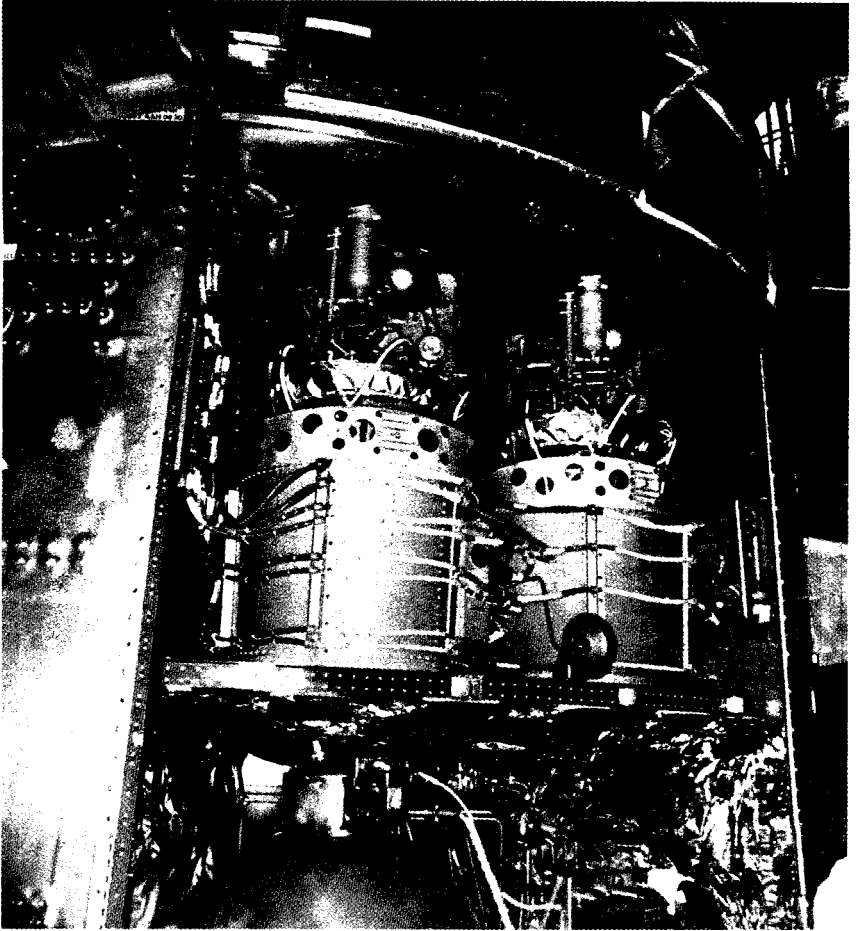
Figure 4-5.- Fuel cells shelf.

of the Apollo 13 service module (SM 109) at the North American Rockwell plant prior to shipment to KSC. Figure 4-5 shows the fuel cell shelf, with fuel cell 1 on the right, fuel cell 3 on the left, and fuel cell 2 behind cells 1 and 3. The top of oxygen tank no. 2 can be seen at the lower left. Figure 4-6 shows the oxygen tank shelf, with oxygen tank no. 2 at left center. Figure 4-7 shows the hydrogen tank shelf with hydrogen tank no. 1 on top and hydrogen tank no. 2 below. The bottom of the oxygen shelf shows some of the oxygen system instrumentation and wiring, largely covered by insulation. Figure 4-8 is a photograph of the bay 4 panel, which was missing from the service module after the accident.

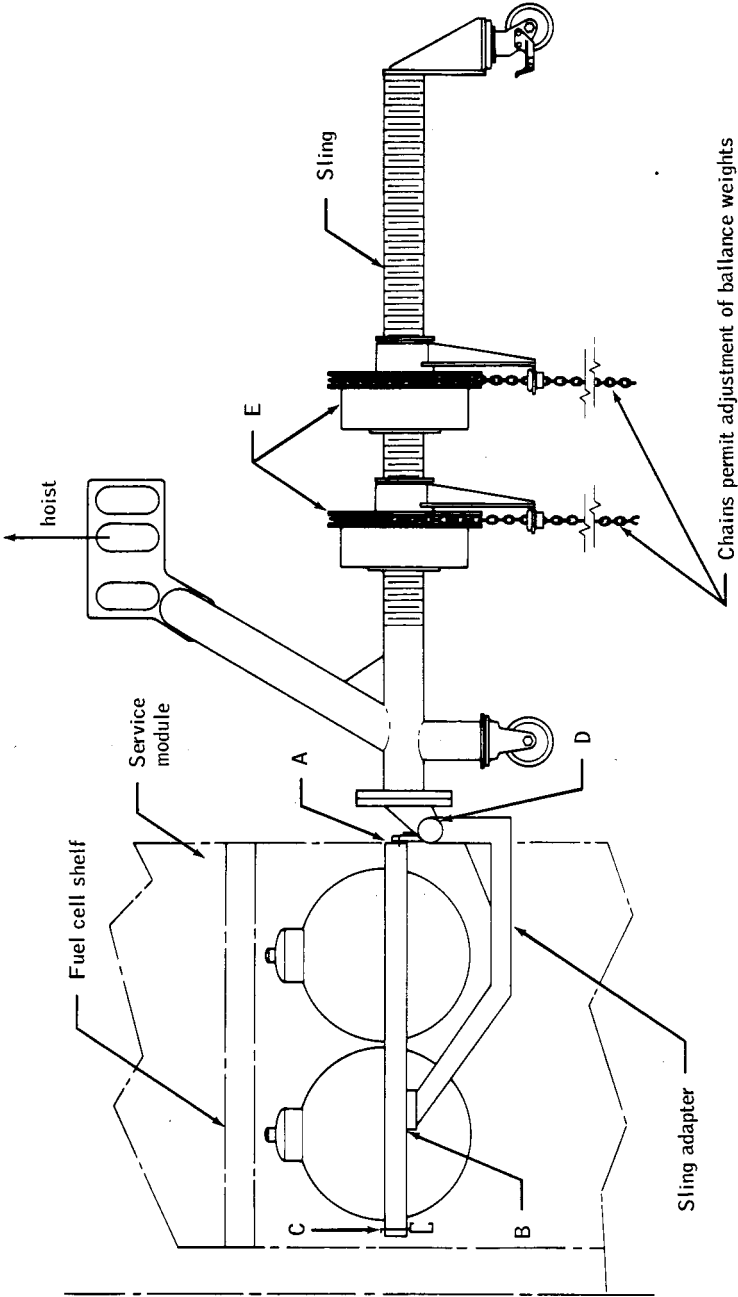
Figure 4-9.- Hoist and sling arrangement - oxygen shelf.

The oxygen shelf was removed in the manner shown in figure 4-9. After various lines and wires were disconnected and bolts which hold the shelf in the SM were removed, a fixture suspended from a crane was placed under the shelf and used to lift the shelf and extract it from bay 4. One shelf bolt was mistakenly left in place during the initial attempt to remove the shelf; and as a consequence, after the front of the shelf was raised about 2 inches, the fixture broke, allowing the shelf to drop back into place. Photographs of the underside of the fuel cell shelf in SM 106 indicate that the closeout cap on the dome of oxygen tank no. 2 may have struck the underside of that shelf during this incident. At the time, however, it was believed that the oxygen shelf had simply dropped back into place and an analysis was performed to calculate the forces resulting from a drop of 2 inches. It now seems likely that the shelf was first accelerated upward and then dropped.

calculated assuming a 2-inch drop only. The probability of tank damage from this incident, therefore, is now considered to be rather low, although it is possible that a loosely fitting fill tube could have been displaced by the event.

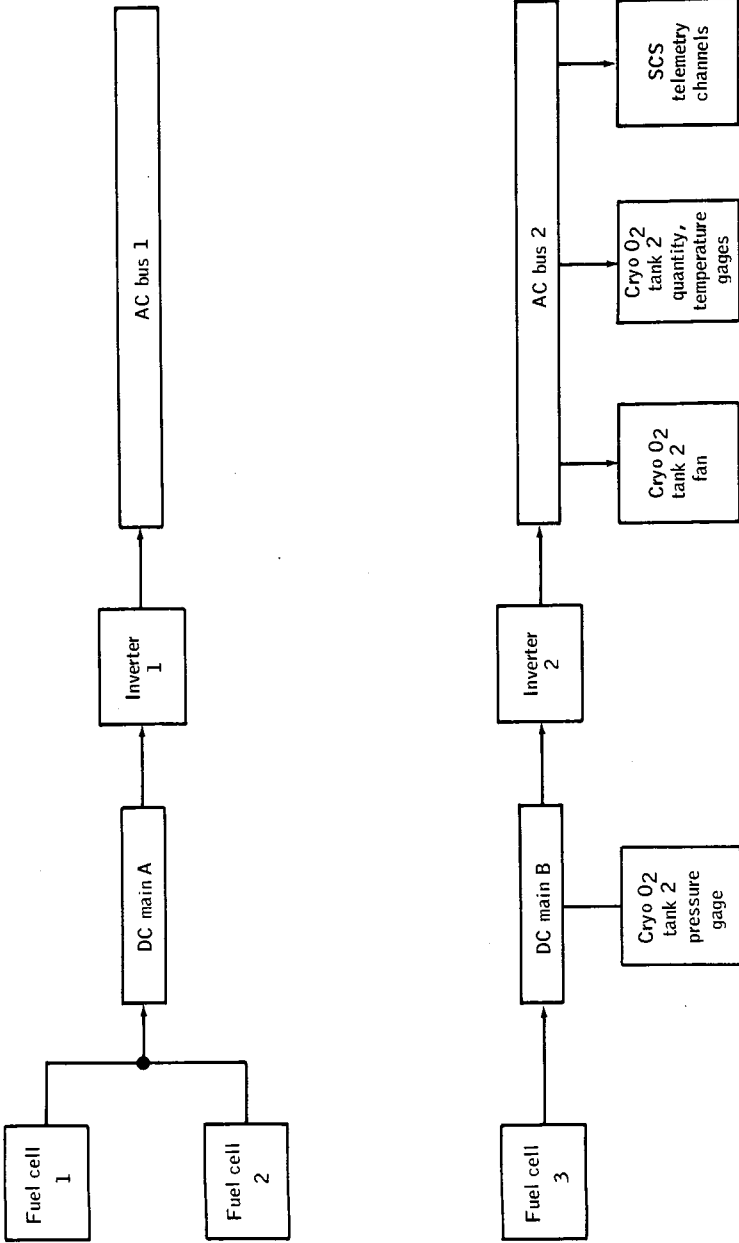
Figure 4-12.- Electrical configuration at 55:54:53 g.e.t.

The failure of oxygen tank no. 2 and consequent removal of the bay 4 panel produced a shock which closed valves in the oxygen supply lines to fuel cells 1 and 3. These fuel cells ceased to provide power in about 3 minutes, when the supply of oxygen between the closed valves and the cells was depleted. Fuel cell 2 continued to power ac bus 1 through dc main bus A, but the failure of fuel cell 3 left dc main bus B and ac bus 2 unpowered (see fig. 4-12). The oxygen tank no. 2 temperature and quantity gages were connected to ac bus 2 at the time of the accident. Thus, these parameters could not be read once fuel cell 3 failed at 55:57:44 until power was applied to ac bus 2 from main bus A.
