**Investigation of Flash Explosion and Injuries
South Timbalier Block 151, Production Platform
OCS 00463
June 15, 2002**

Gulf of Mexico
Off the Louisiana Coast

U.S. Department of the Interior
Minerals Management Service
Gulf of Mexico OCS Regional Office

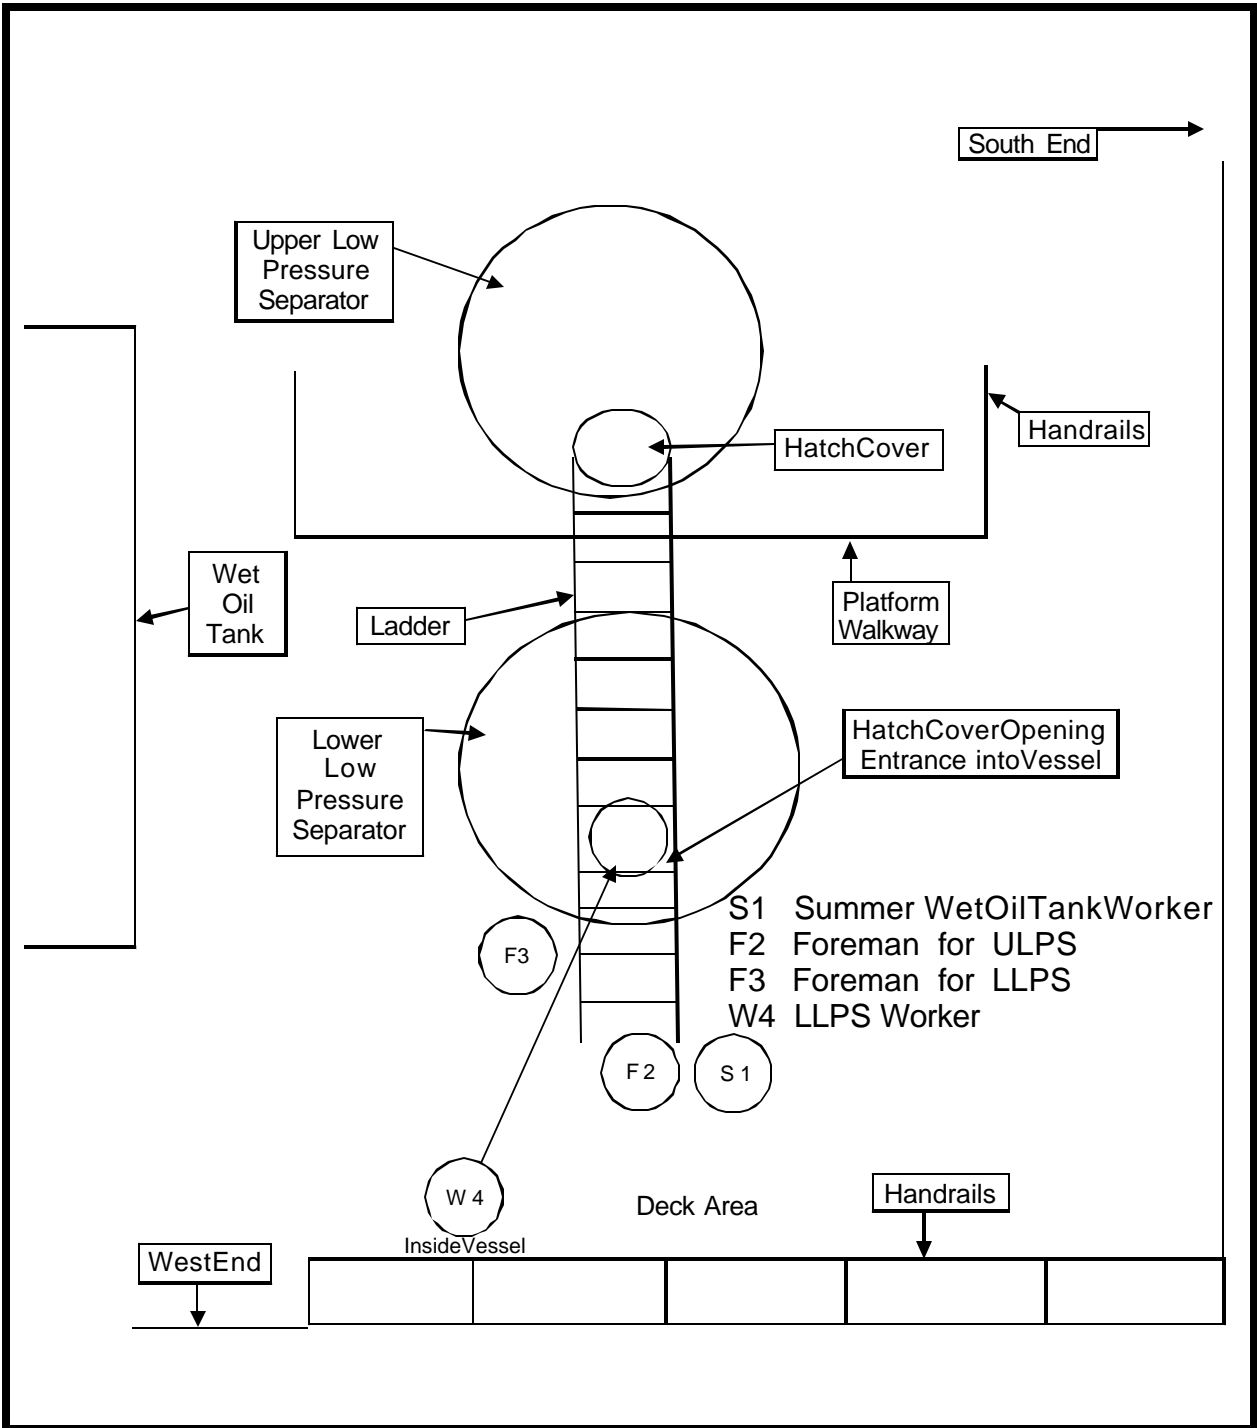
Diagram, ULPS and LLPS and Position of Crew at the Time of Flash Explosion

The foreman for the upper low pressure separator was burned by the direct force of the flash explosion and most likely suffered punctures from being thrown into equipment or barriers or possibly from being hit by flying debris.

The crew member who was blown into the water was propelled by the blast into the fence, springing the fencing material outward and breaking any plastic ties holding the fencing to the rail frame. This most likely allowed him to fall through the gap created at the bottom of the fencing possibly adding additional injuries to the burns from the direct blast and other injuries sustained from bodily impact with barriers or debris.

1. Even without proper venting, the failure to open both vents of the vessel prior to initiating operations within it possibly contributed to the injuries by channeling the blast out of a single exit, thus increasing the force of the flash explosion. The presence of a second exit point for the blast would possibly have reduced the severity of the force that was directed into the workers outside the tank.
