NATIONAL AERONAUTICS AND SPACE ADMINISTRATION

APOLLO 15 MISSION REPORT

MSC-05161

NATIONAL AERONAUTICS AND SPACE ADMINISTRATION
MANNED SPACECRAFT CENTER
HOUSTON, TEXAS
December 1971

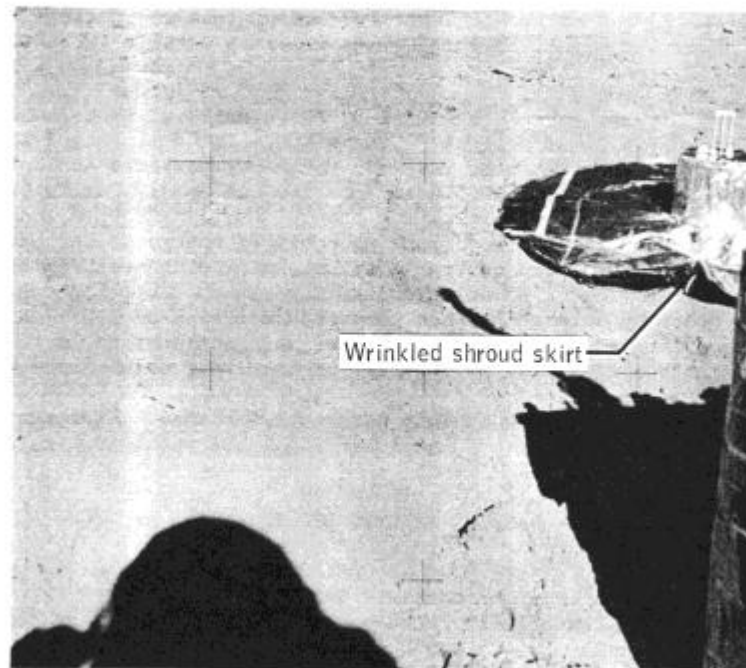
Figure 4-4.- Passive seismic experiment deployment.

The passive seismic experiment was deployed approximately 2.7 meters (9 feet) west of the experiment package central station and has functioned well since its initial activation on July 31, 1971. One deviation from nominal operation has occurred. The instrument internal temperature fell below the predicted 126 F as the Apollo 15 site entered the first lunar night. This will not detrimentally affect the operation of the instrument except that degradation of gravity tidal data from the experiment is expected. Photographs of the instrument show the shroud skirt to be raised up at several places (fig. 4-4). Heat loss due to the uneven shroud accounts for the low night temperature.

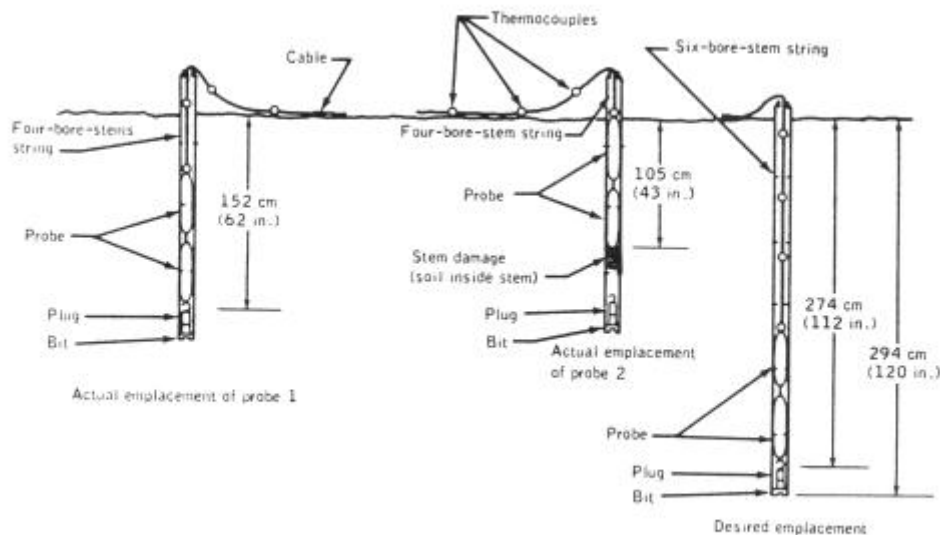
Figure 4-6.- Heat flow experiment bore-stem and probe emplacement.

The performance of the drill power-head and the core stem was good. However, full depth penetration with the bore stems was a problem and extraction of the core stems from the hole was difficult (see sec. 14.4.1). The two bore stem holes were drilled to a depth of about 172 centimeters (70 inches) instead of the desired 294 centimeters (120 inches), with one of the bore stem strings probably sustaining damage at a point slightly above the first joint [about 105 centimeters (43 inches) below the surface] (see fig. 4-6).

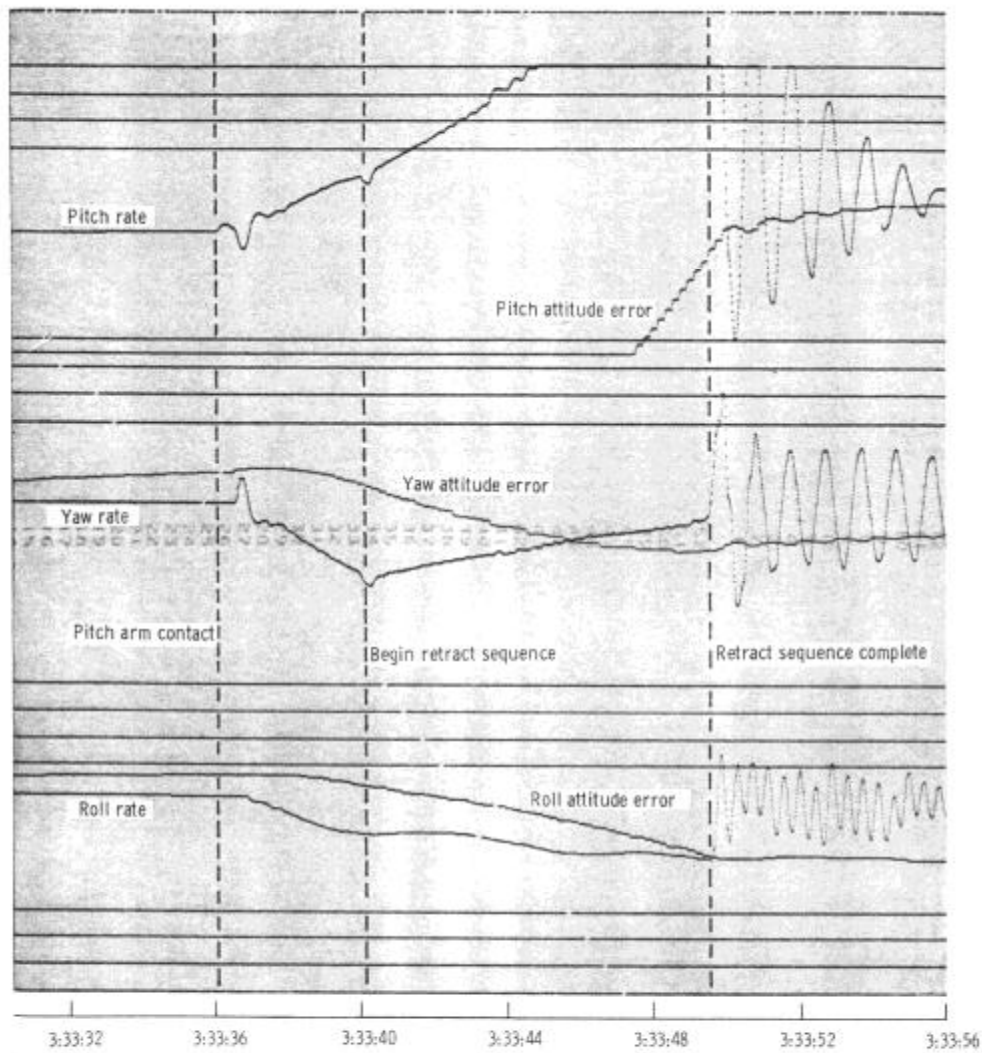
Figure 6-1. - Rate and attitude error data during transposition and docking sequence,

docking sequence, the digital autopilot control mode was changed from "attitude hold" to "free" while a plus-X translation was being commanded in order to secure a positive capture latch indication. The body rates induced by contact and the plus-X thrusting were not nulled and resulted in misalignment angles of minus 1-1.0, plus 2.2, and plus 1.6 degrees in pitch, yaw and roll at the start of the retract sequence (see fig. 6-1). The resultant misalignment caused a greater-than-normal structural loading in the docking interface (see sec. 7.1).

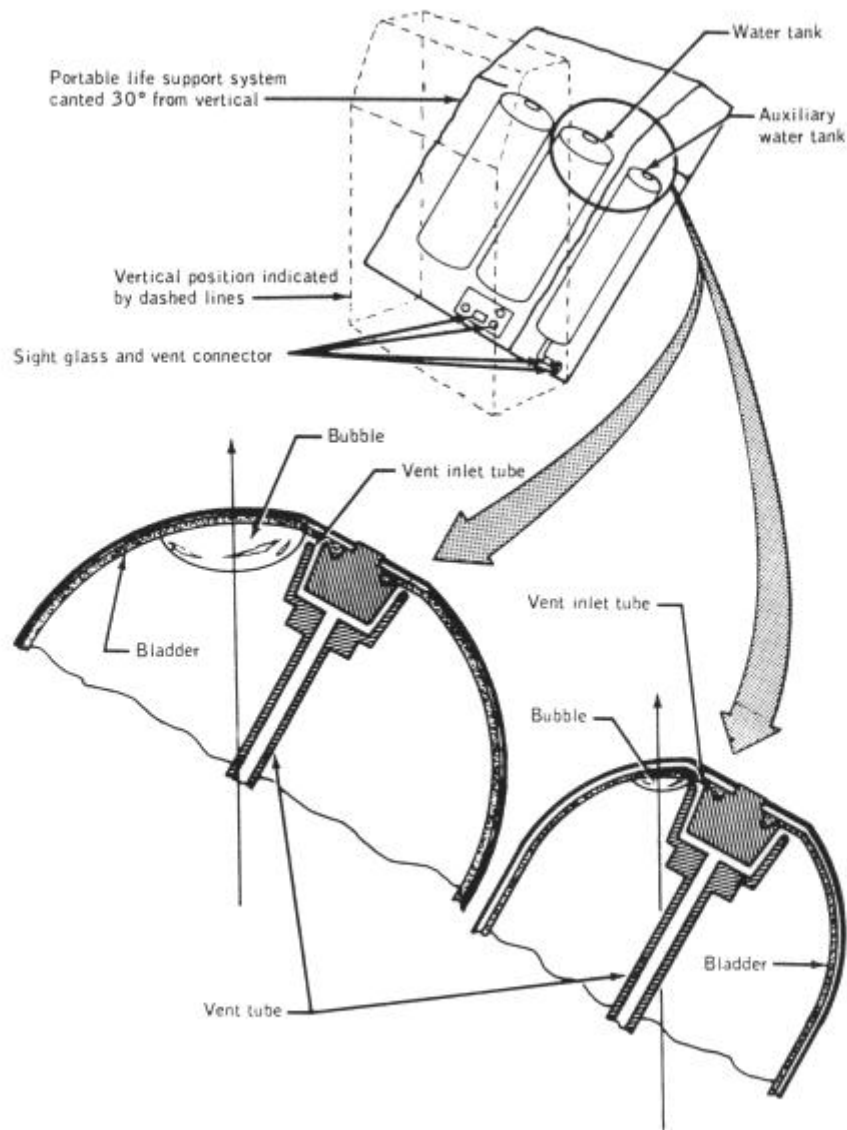
Figure 8-1.- Effect of tilt during water recharge

Checkout of the Commander's portable life support system prior to the first extravehicular activity was normal. Portable life support system startup for the Lunar Module Pilot was normal until the feedwater was turned on. The feedwater pressure increased faster and higher than expected. A warning tone and, a short time later, a vent flow flag was activated. The trouble was traced to a gas bubble trapped in the feedwater bladder during charging by the flight crew (**Fig. 8-1, Fig. 8-1, Con't.**). The gas bubble caused high feedwater pressure. Until the feedwater pressure had decayed to the suit pressure level, the condensate stowage volume was blocked by the feedwater bladder. This resulted in the water separator becoming saturated and allowing droplets of water to be carried over to the fan. This can reduce the fan speed, thereby activating the vent flow flag. Data confirmed the presence of current spikes which are a characteristic of water droplets hitting the fan.

Subsequent to recharging the portable life support systems after the first extravehicular activity, the problem associated with the Lunar Module Pilot's water separator was found to have resulted from filling the portable life support system at a 30-degree tilt, and the unit was recharged thereafter while in the proper upright position.

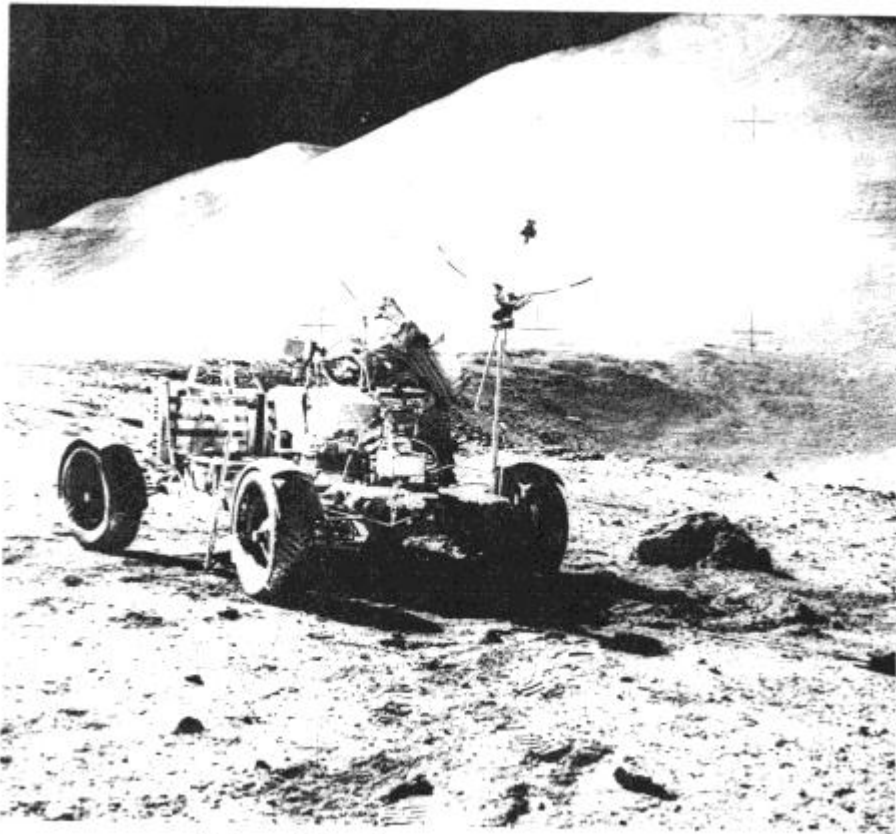
Figure 8-2.- Lunar roving vehicle.

The lunar roving vehicle (**Fig. 8-2**) performed well during the mission. During the three lunar surface extravehicular activities, the vehicle traveled 27.9 kilometers (15.1 miles) during 3 hours and 8 minutes of driving at an average speed of 9.2 kilometers (4.97 miles) per hour. A total of approximately 52 ampere-hours was consumed. Navigation errors were within expected tolerances with small distance errors and no apparent gyro drift. The combined wander and wheel slip factor was within predicted limits.

The front-wheel steering was inoperative during the first extravehicular activity, but operated normally for the second and third extravehicular activities. Simultaneous front- and rear-wheel steering was found to be more sensitive than desired, and difficulties were experienced with the seat belts; but overall, the crew was very pleased with the vehicle's performance, particularly, the speed and hill-climbing capability.

Both walking hinge latches were found unlatched during the predeployment inspection and were easily reset. Televised deployment operations showed that, when the deployment tapes were pulled, the vehicle bounced on the lunar surface in a manner similar to that seen during preflight 1/6-weight vehicle deployment tests. The orientation of the lunar module (6.9 degrees pitch up and 8.6 degrees roll to the left, resulting in a tilt of 11 degrees) required an additional hard pull on the deployment cable by the Lunar Module Pilot after all four wheels had contacted the surface. Two of the chassis hinge lock pins required additional pressure to seat them properly. (This possibility had been anticipated and corrective action was incorporated in the checklist.) The deployment saddle and the Velcro seat tie-down were difficult to release. The initial failure of the saddle to release was partially attributed to the vehicle's having been moved sideways on the surface before saddle release was attempted.

During preparations for the first traverse, the front wheels did not respond to steering commands. The Commander changed busses and observed the ammeter closely to find out if power was being applied to the front wheels in response to steering commands. No response was seen. He then tried, without success, to manually force the front wheels to turn. The front wheel steering remained inoperative, thus the rear wheels were used for steering during the first traverse (see sec. 14.6-3). Little difficulty was experienced in driving, except that attempts to avoid nearby objects resulted in the rear wheels sliding into small craters and objects that the driver was trying to avoid. In at least one slide, the vehicle rotated through 180 degrees.

During checkout of the vehicle for the second traverse, the crew cycled the forward steering power switch and circuit breaker, and found that the front wheel steering operated normally. In starting the second traverse, the Commander first tried dual steering. Then, after the dual steering was found to be very sensitive, he tried front-wheel-only steering. However, this mode was discontinued because the rear wheels tended to wander. (It had been decided not to lock the rear wheels mechanically because of the prior problem with the front wheels.) Therefore, the dual steering mode was used for the remainder of the second traverse and the entire third traverse.

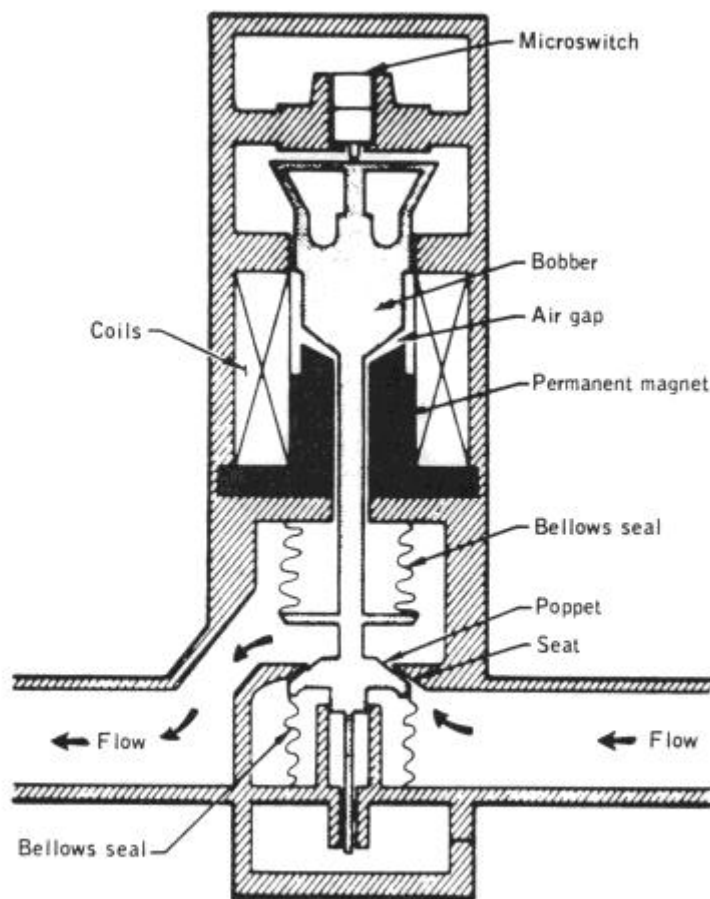
Figure 14-1.- Cross section of reaction control system isolation valve.

This type of valve (a magnetic latching valve, shown in **Fig. 14-1**) has, in previous missions, closed as a result of pyrotechnic shocks. Ground tests have shown that the valve will close at a shock level of approximately 80g sustained for 8 to 10 milliseconds. There were no indications of shock levels of the magnitude required to close the valve during launch.

Testing has shown that if a reversed voltage of 28 volts is applied to the valve, the latching voltage will drop to a point where the valve will no longer remain latched (magnet completely degaussed). In addition, at lower voltages with reversed polarity, the magnet would become partially degaussed.

During acceptance testing of one valve for command and service module 117, the latching voltage had changed from approximately 13 volts to 3 volts. Additional testing of the spacecraft 117 valve verified the low voltage condition. Additionally, the valve stroke was proper, thereby eliminating contamination as a possible cause of the problem. During the test, the valve was disconnected from spacecraft power (28 volts) and was being supplied power through a variable power supply (approximately 20 volts, maximum, applied to the valve). The valve was most likely subjected to a reversed polarity at a voltage level which would partially degauss the magnet. This may have been the cause of the valve closures during Apollo 15 launch phase.

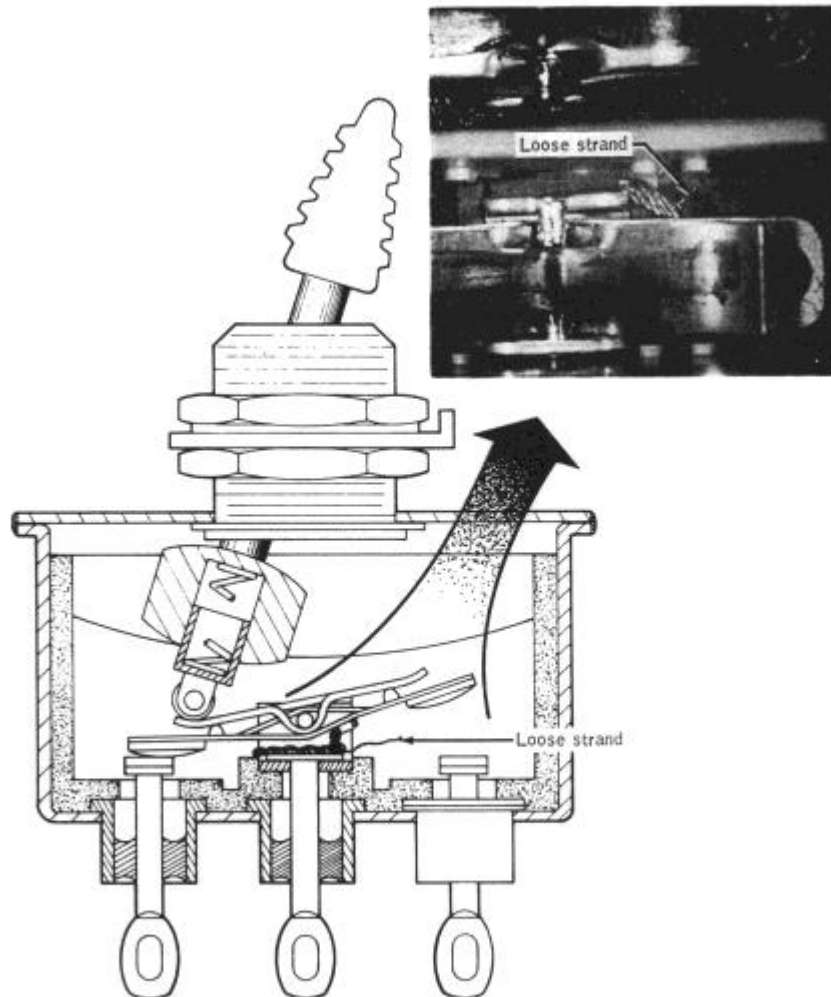
Figure 14-4.- Service propulsion system delta-V thrust switch.

The short was isolated to the system A delta-V thrust switch which was found to be intermittently shorted to ground (**Fig. 14-3**).

The delta-V thrust switch (**Fig. 14-4**) was shorted to ground both before and after removal of panel 1 from the command module during postflight testing. After a change in panel position, the short-to-ground disappeared. The switch was then removed from the panel and X-rayed. The X-rays showed a wire strand extending from the braid strap which was thought to have caused the grounding problem. After switch dissection, an internal inspection verified that a strand extended from the braid strap; however, it did not appear to be long enough to cause a ground at any point within the switch (**Fig. 14-4**). The bracket assemblies (pivot brackets, pigtail braids, and movable contacts) and the plastic liner were removed from the switch. Microscopic examination revealed that a

wire strand (approximately 0.055 inch long) was present on the flange on terminal 2 (Fig. 14-5). The strand appeared to be attached, but was later moved quite easily.

Switches required for crew safety and mission success for Apollo 17 which had not been screened according to the aforementioned procedures will also be replaced. In addition, two science utility power switches are to be disabled and stowed, and two circuit breakers are to be added to provide series protection for the command and service module/lunar module final separation function.

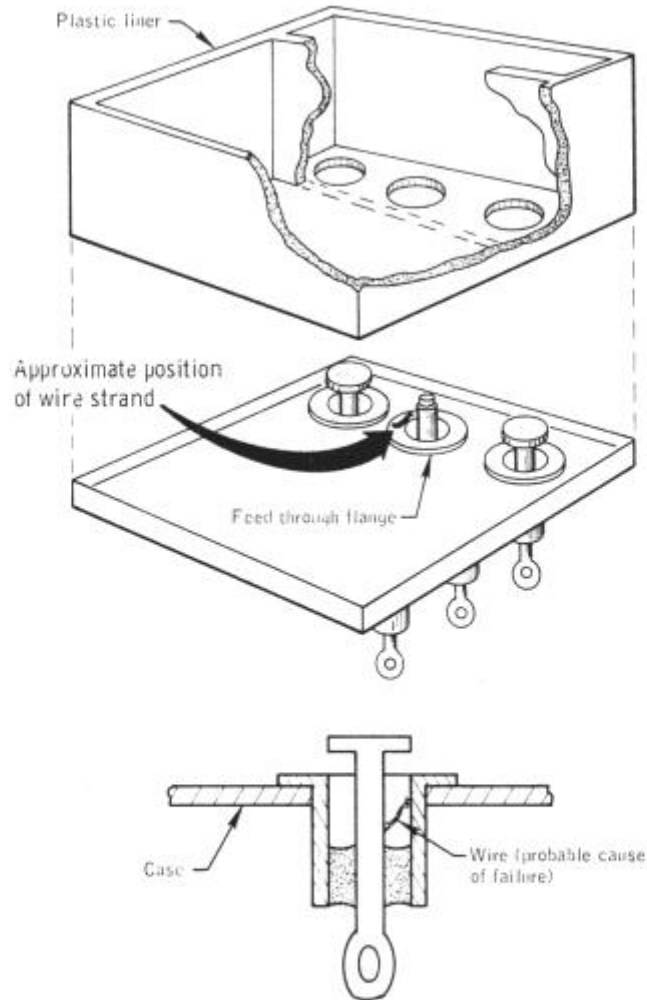
Figure 14-5.- Disassembled service propulsion system thrust switch.

The bottom of the plastic case liner was examined, and showed no evidence of a scratch or deformation conforming to the shape of the wire strand. A sample wire strand was placed on a feed-through flange of a scrap switch unit, and the plastic case liner was pressed on as would occur during normal switch assembly. When the scrap switch was disassembled an indentation in the plastic case liner was readily apparent. This test indicated that the strand could not have been trapped between the case liner and the flange surface; therefore, it is postulated that it might have been enclosed in the cavity of feed-through terminal 2 (Fig. 14-5). The maximum clearance between the interior of

the feed-through terminal wall and the terminal itself is 0.040 inch. A 0.055-inch-long wire strand could easily have bridged this distance, and yet is short enough to move quite freely within the feed-through terminal cavity. In fact, the strand subsequently fell into the cavity. Examination of the strand and cavity wall showed evidence of arcing. The strand could not be detected on the X-rays because that area was obscured by other poles in the switch.

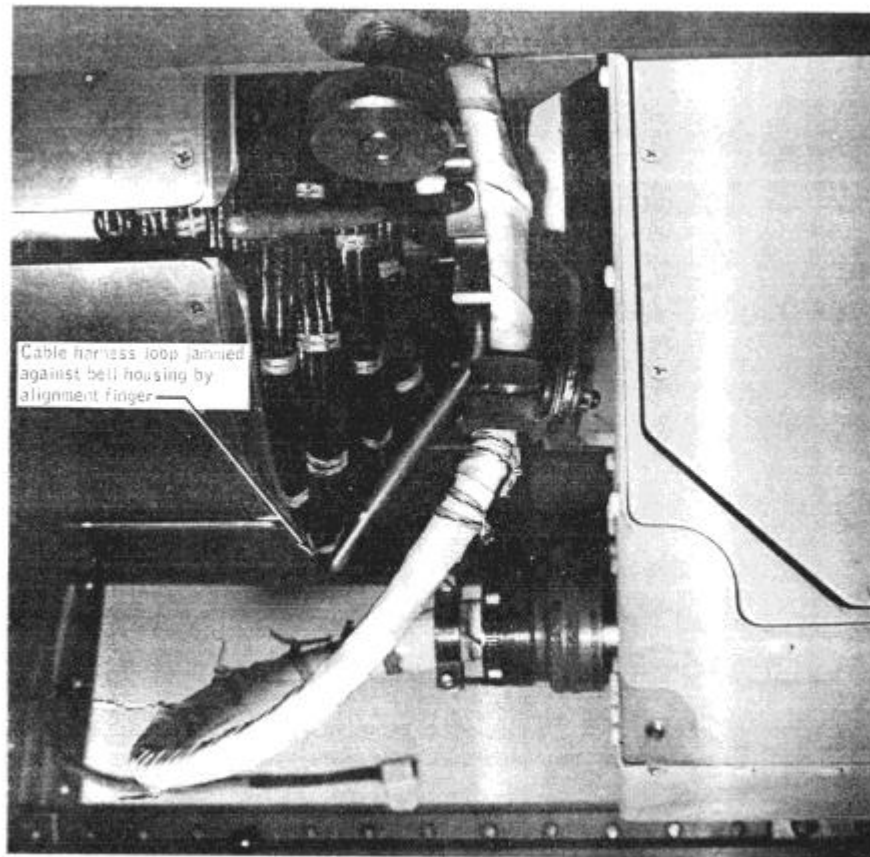
Figure 14-8.- Side view of mass spectrometer deployment mechanism (experiment attached).

An inflight test of the Apollo 15 boom indicated that the problem was a function of temperature. Testing and examination of the Apollo 16 spacecraft showed that the failure was possibly caused by pinching of the cable harness during the last several inches of boom retraction. The cable could have been pinched between the bell housing and rear H-frame bearing (**Fig. 14-7**), or a cable harness loop was jammed by a boom alignment finger against the bell housing (**Fig. 14-8**).

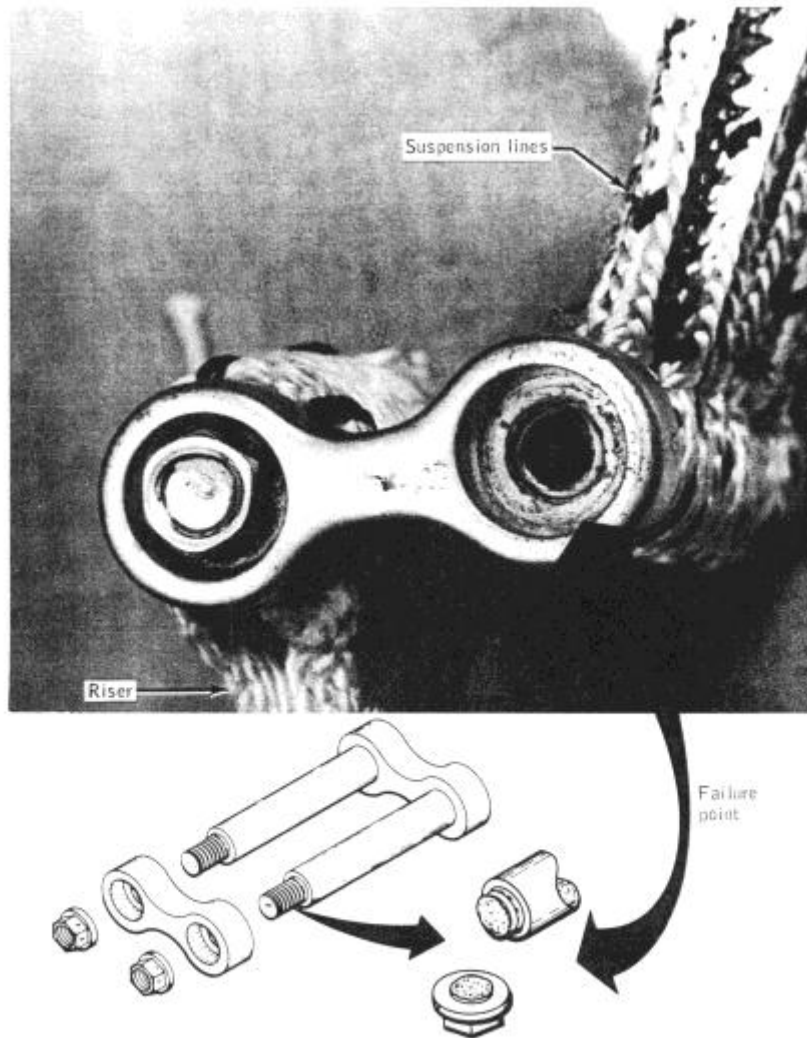
Figure 14-12.- Main parachute connector link failure.

A broken riser/suspension line connector link which was found on the recovered parachute (**Fig. 14-12**).

Onboard and photographic data indicate that the forward heat shield - was about 720 feet below the spacecraft at the time of the failure. The failed link on the recovered parachute implies the possibility of a similar occurrence on the failed parachute. Based on parachute tow tests, however, more than one link would have had to fail to duplicate the flight problem. The two possible causes have been identified as hydrogen embrittlement or stress corrosion.

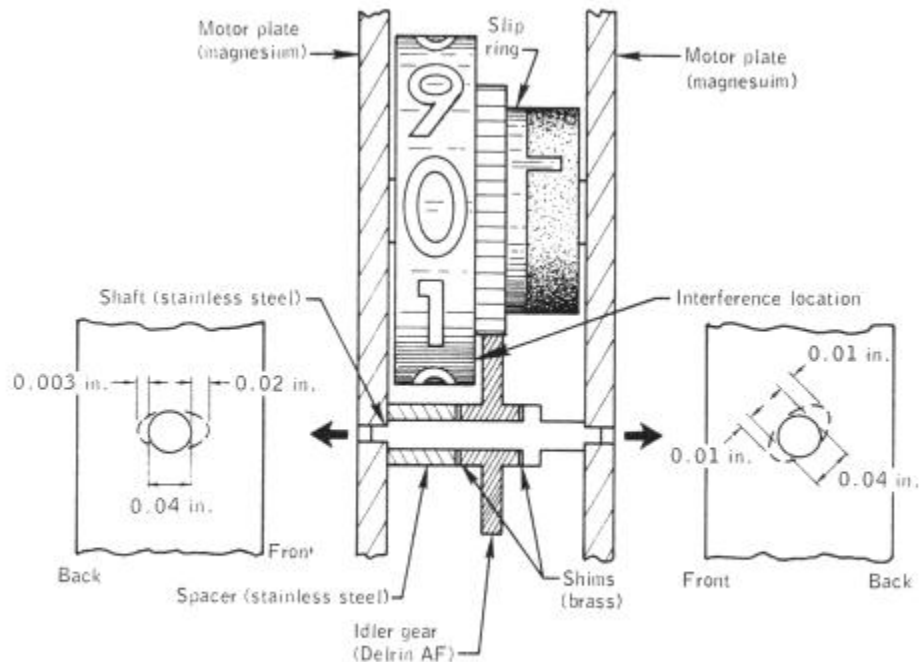
Figure 14-17.- Digital event timer mechanism.

The seconds digit of the digital event timer, located on panel 1, became obscured by a powder-like substance that formed on the inside of the glass. Postflight analysis of the unit disclosed that the substance on the window was paint which had been scraped from the number wheel by the idler gear. The idler gear is free to rotate on the shaft (**Fig. 14-16**); however, the design allows the stainless-steel shaft to also rotate. The stainless steel shaft bearing points are in the magnesium motor plate and the shaft rotation wears away the softer magnesium material.

Inspection of the unit showed that the magnesium bearing points had been elongated as shown in **Fig. 14-17**. Torque from the stepping motor applied to the idler gear not only resulted in rotation of the shaft but also caused the shaft to tilt (**Fig. 14-17**). The wearing eventually allowed the shaft to tilt sufficiently to cause the gear to rub against the number wheel. When the timer counted down, the motor torque threw the gear teeth into the front edge of the counter wheel. Testing indicates that this bearing hole elongation occurs after approximately 500 hours running time (specification life is 1400 hours).

A review of the history of the unit shows that it was built in 1966. Prior to installation in Apollo 15, the unit was modified because of failures on other timers. Brass shims (fig. 14-17) were installed to prevent the idler gear from rubbing on the number wheel.

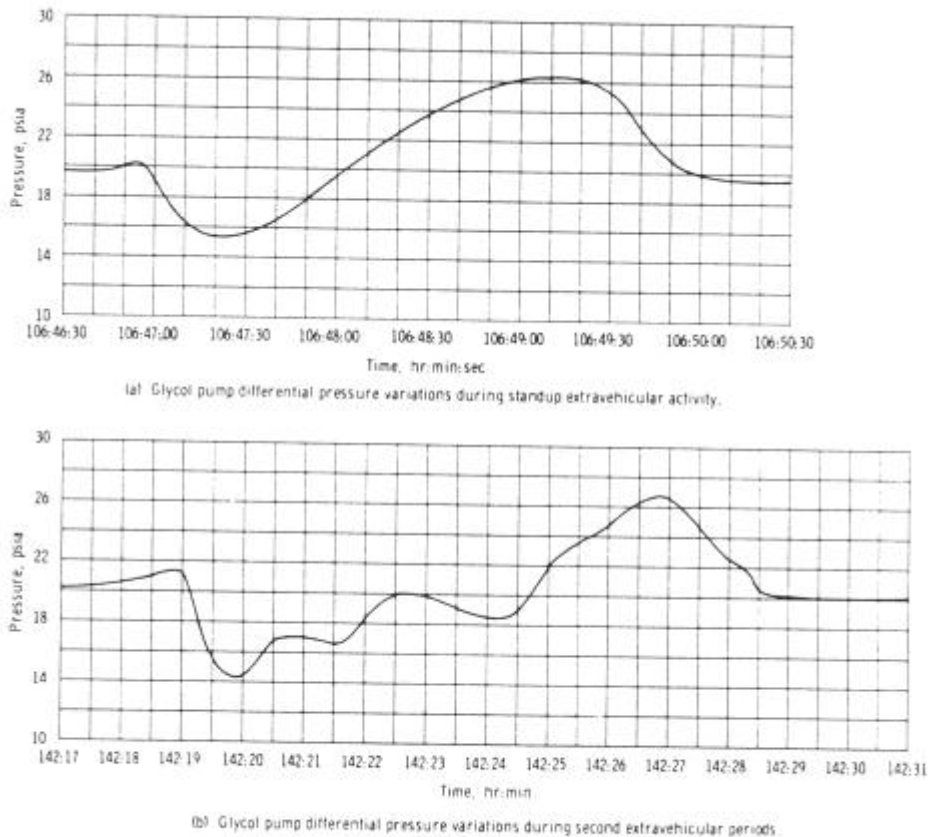
Figure 14-24.- Glycol pump differential pressure variations during extravehicular periods.

Variations were noted in the water/glycol pump differential pressure shortly after the cabin depressurizations for the standup extravehicular activity and the second extravehicular activity. The variations were similar on both occasions. The pressure differential decreased from about 20 psid (normal) to about 15 psid, then increased to about 27 psid and returned to normal (**Fig. 14-24**).

The total times for the cycles were 3 minutes during the standup extravehicular activity and 10 minutes during the second extravehicular activity. The pump discharge pressure remained relatively stable throughout both periods. If pressure fluctuations had taken place in the heat transport system, both the pump discharge pressure and differential pressure should have varied together.

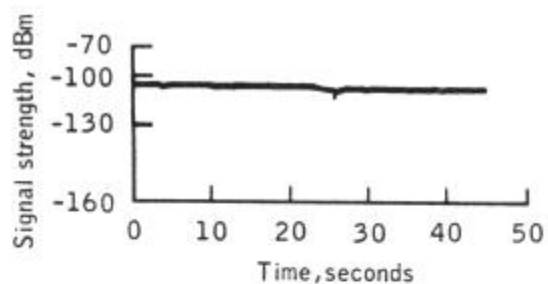
(a) 100 hours 21 minutes

Random oscillations occurred while the steerable antenna was in the auto-track mode. The oscillations were small, and damped without losing auto-track capability (**Fig. 14-29**). The three times when the oscillations became divergent are shown in **Fig. 14-30**.

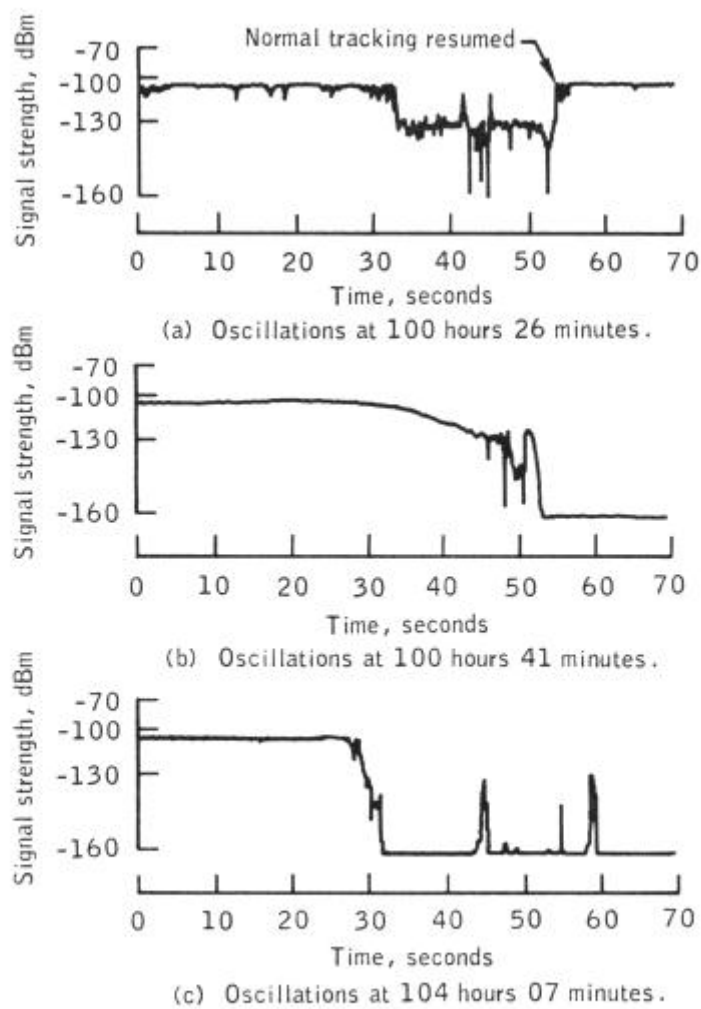
Figure 14-30.- Received signal strength plots associated with divergent antenna oscillations.

100:26 (revolution 12): This divergence occurred prior to separation and was not caused by vehicle blockage or reflections from the command and service module structure.

104:07 (revolution 14): Earth look angles for this time period indicate that the antenna was clear of any vehicle blockage.

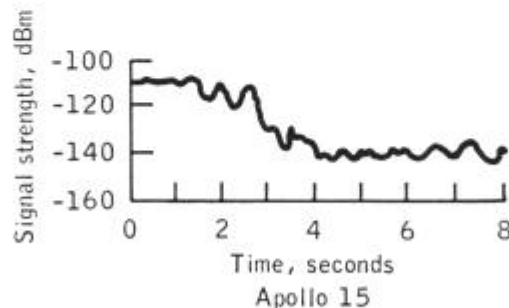
Figure 14-31.- Ground-received signal strength showing spacecraft antenna oscillation characteristics.

All oscillations indicated characteristics similar to the conditions experienced on Apollo 14 (Fig. 14-31). After Apollo 14, one of the prime candidates considered as a possible cause was incidental amplitude modulation on the uplink signal. A monitor capable of detecting very small values of incidental amplitude modulation was installed at the Manned Space Flight Network Madrid site for Apollo 15. The data from this monitor indicated that no amplitude modulation existed on the uplink at the frequencies critical to antenna stability during the problem times. Consequently, incidental amplitude modulation has been eliminated as a possible cause of the antenna oscillations, and the problem must be in the spacecraft.

There are two possible causes of the problem in the spacecraft. The first is that electrical interference generated in some other spacecraft equipment is coupled into the antenna tracking loop. A test performed on the Apollo 16 lunar module showed that no significant noise is coupled into the tracking loop during operation of any other spacecraft equipment in the ground environment. The second is that temperature or temperature gradients cause an intermittent condition in the antenna which results in the oscillations. The acceptance tests of the antennas do not include operation over the entire range of environmental temperatures; therefore, a special test is being conducted on a flight spare antenna to determine its capability to operate over the entire range of temperatures and gradients.

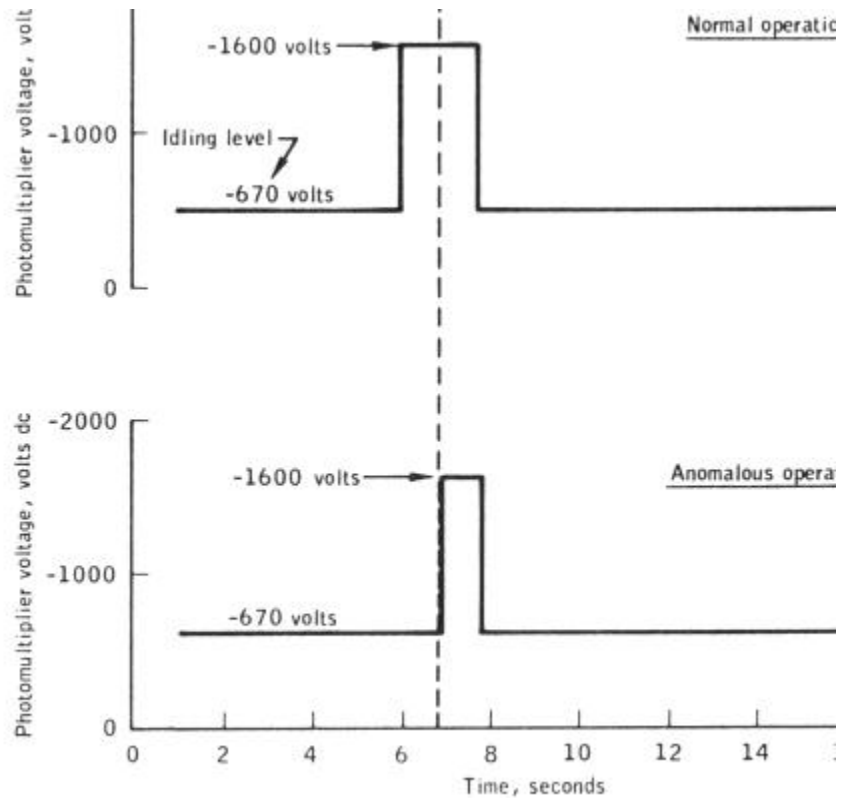
Figure 14-37.- Comparison of photomultiplier power supply volt.

The laser altimeter exhibited two anomalous conditions during the mission:

- a. Altitude data became intermittent after revolution 24 as the result of a decrease in the laser output power.
- b. Beginning with revolution 38, the photomultiplier tube high-voltage power supply was held in the idling (minimum-voltage level) mode until after the laser fired, thereby causing the receiver to miss the return pulse from the lunar surface (**Fig. 14-37**). No altitude data were obtained after this anomaly occurred.

The photomultiplier tube power supply anomaly was duplicated when a relay which had been removed from a flight unit because it had an audible "buzz" was installed in the prototype altimeter. The relay serves no function in flight, but is a safety precaution for ground personnel working on the altimeter (**Fig. 14-38**). The relay contacts close when the altimeter is turned off, discharging the high voltage stored in the pulse forming network capacitors.

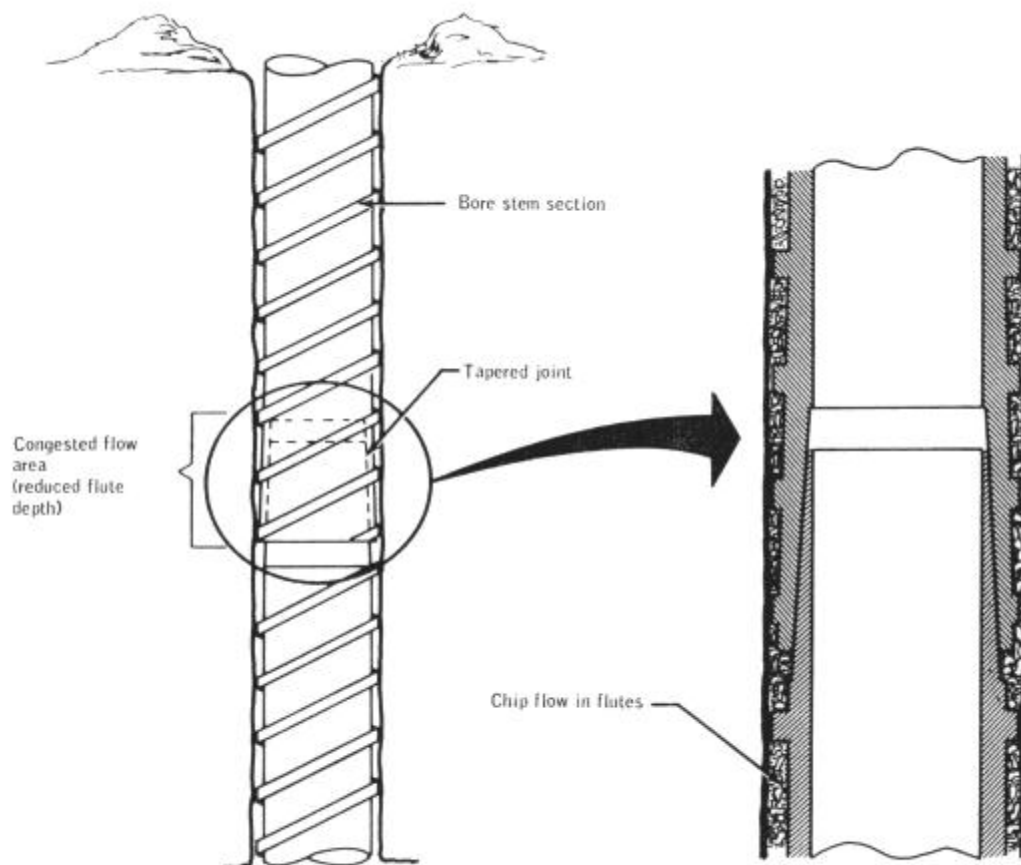
Figure 14-41.- Congestion at bore stem joints.

Although the average penetration rate for the two bore stem holes was reasonable (approximately 120 inches per minute for hole 1, and 18 inches per minute for hole 2), it was necessary to stop both holes at approximately 60 percent of the depth desired.

The bore stem sections are made of a fiberglass and boron filament laminate, chosen for its optimum thermal characteristics as a casing for the heat flow experiment probe. The sections are approximately 21 inches long with tapered male and female joints. One-inch double-thread spiral lead flutes are provided on the exterior surface to transport the soil chips from the drilled hole to the surface. The depth of the flutes is 0.050 inch for about 18 inches, but the flutes almost disappear at the joint area where the wall thickness must follow the taper of the joint (**Fig. 14-41**). As a result, the volume of chip flow to the surface is slowed considerably in looser soil formations, and stalled by the packing of the chips in high-density formations.

In order to reduce the time required, prevent damage to bore stems, and increase the probability of attaining the full depth, the following modifications and corrective actions are being implemented:

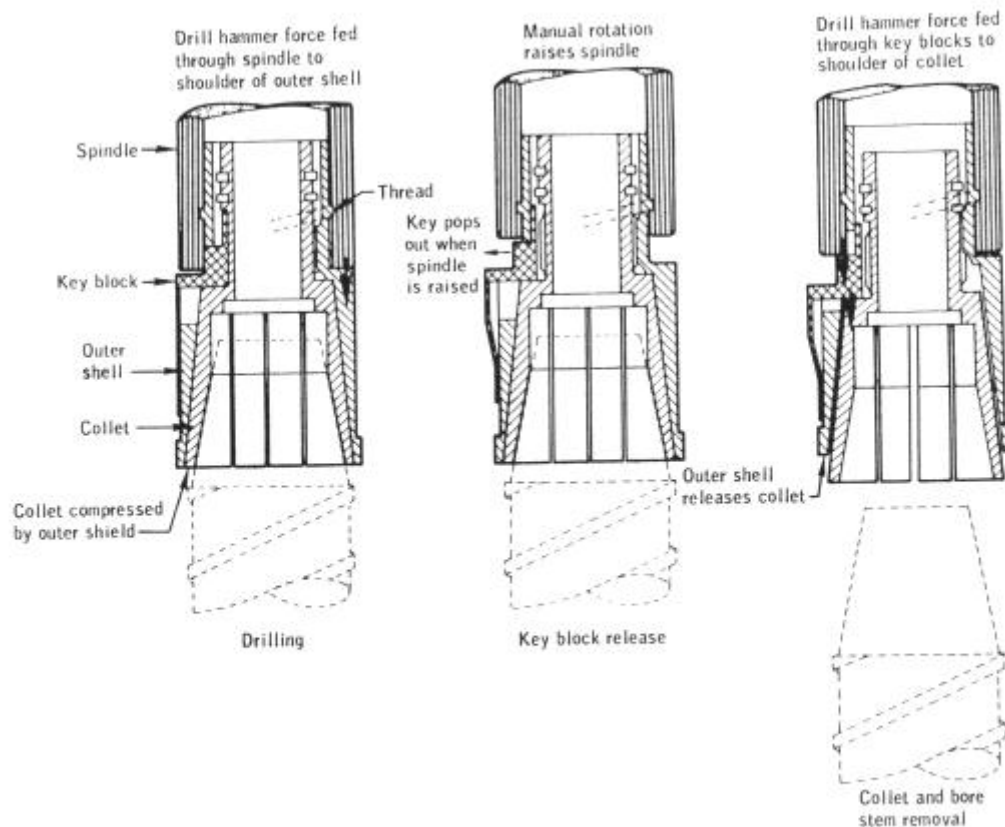
Figure 14-42.- Release of bore stem from drill.

Difficulty in releasing bore stems from drill adapter

Use of the normal procedure for releasing the lunar surface drill head from the bore stems was hampered by the bore stems turning freely in the lunar soil.

In the bore stem drilling position, the key blocks are restrained inside, and the spindle drives against the shoulder of the adapter outer shell (**Fig. 14-42**). The operational sequence to release the bore stem from the adapter includes the following steps:

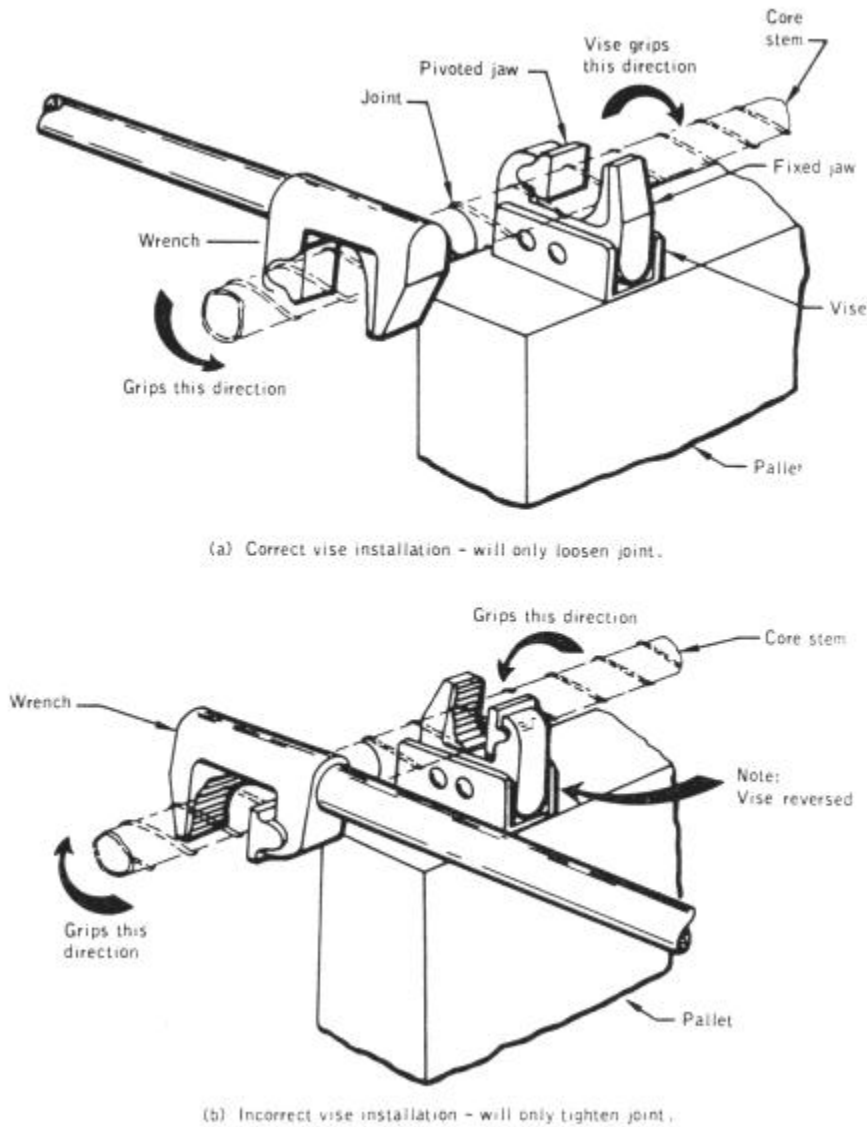
As mounted, the vise would hold the core stem so that the joint could be tightened by rotating the wrench on the adjoining section. However, the vise would not hold in the opposite direction so that the joint could be loosened and separated (**Fig. 14-44**). Working on the inboard side of the vise, the core stem could have been held properly for loosening; however, there is insufficient clearance on the inboard side of the vise for

wrench rotation, and the distance to the other side of the lunar roving vehicle is greater than the length of a core stem section.

Figure 14-44.- Installation of core stem vise on rover pallet.

The installation drawing of the vise was in error and has been corrected to assure correct orientation of the vise for Apollo 16. The training vise was installed backward from the erroneous drawing, but correct for loosening the stems.

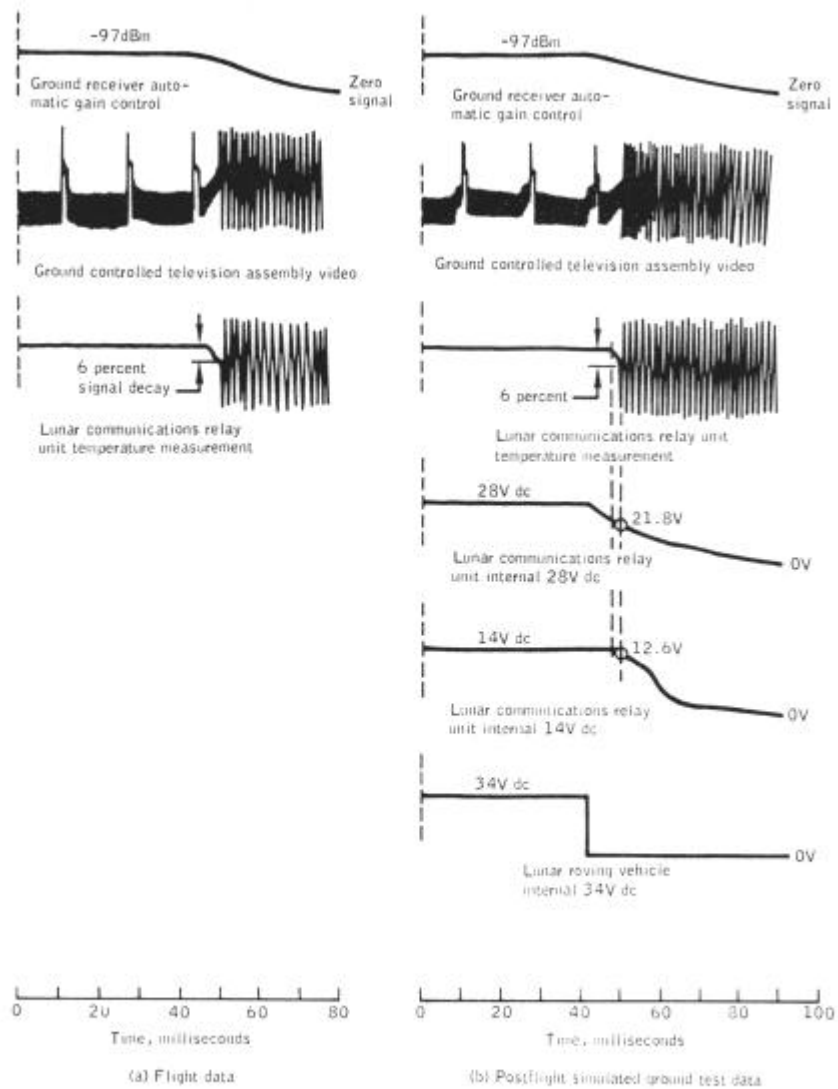
The flight data (**Fig. 14-49**) shows that the automatic gain control measurement began to fall followed by the video signal decay. This was followed by the decay of the lunar communications relay unit temperature measurement. The RF signal level then decreased below the ground receiver is threshold as indicated by complete signal loss. The overall loss of the downlink signal within 5 milliseconds is indicative of 28-volt d-c power loss. Decay of the temperature measurement is indicative of 16.5 volt d-c power loss. The lunar communications relay unit dc-to-dc converter (**Fig. 14-48**) supplies both the 28-volt and 16.5-volt d-c power. To verify loss of 16.5-volt power, an uplink voice signal was transmitted to key the VHF transmitter on. No signal was received on the Stanford 150-foot VHF antenna which indicates that the VHF transmitter, powered from 16.5 volts dc, was inoperative.

Figure 14-49.- Comparison of signal deterioration characteristics.

In laboratory tests, the fault which duplicated the flight data was the opening of the lunar roving vehicle power line prior to the 440-microfarad capacitor (figs. 14-48 and 14-49). The tests show that the decay time of the lunar communications relay unit 28-volt and 14-volt power is increased by discharging the 440-microfarad capacitor. Other induced faults resulted in shorter power decay times, affecting the received signal accordingly. The temperature measurement output (see thermistor in fig. 14-48) is proportional to the decay in 14-volt power. Consequently, the 6-percent decay of the flight temperature measurement corresponds to a 1.4-volt decay. This characteristic was duplicated when the lunar roving vehicle power line was opened. The 28-volt power decayed to 21.8

volts dc as the 14-volt power decayed to 12.6 volts. The RF transmitter power at this voltage will be decreased by 6.4 dB, and accounts for the total signal loss at this time since the ground receiver would be below its operating threshold.

The lunar roving vehicle power line has a 7.5-ampere circuit breaker forward of the 440-microfarad capacitor (fig. 14-48). Testing a 7.5-ampere circuit breaker under elevated temperatures (1800 F) and at vacuum conditions showed that the current capacity is also dependent on the connecting wire size because the wire provides a heat sink to the circuit breaker thermal element. The rover 7.5-ampere breaker used 20-gage connecting wire. Test results show that the breaker, with 20-gage connecting wire, at elevated temperatures and under vacuum conditions, will trip at 3.3 amperes. This corresponds to the calculated lunar communication relay unit load at the time of power failure.

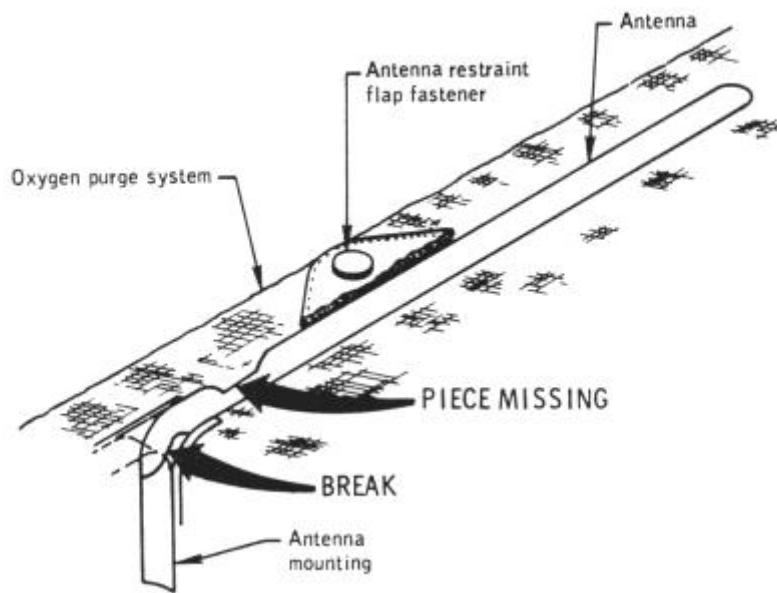
The crew reported that the Lunar Module Pilot's oxygen purge system antenna was broken off near the bottom during communications checkout prior to the second extravehicular activity. Previously, a notch had been observed in the antenna blade (see **Fig. 14-51**).

Antennas broken in training have shown similar flexure breaks. Observation of the notch edges of the returned antenna indicates that the notch started as a partial break in flexure, followed by material being torn out the rest of the way. Test results of the returned antenna indicated that the physical properties of the blade material were satisfactory with no excessive brittleness.

A flap which covers the entire antenna will be added for Apollo 16 to protect the antenna while the oxygen purge system is stowed and during unsuiting after extravehicular activities. The antenna will not be deployed until after egress to prevent it from being damaged inside the cabin or during egress.

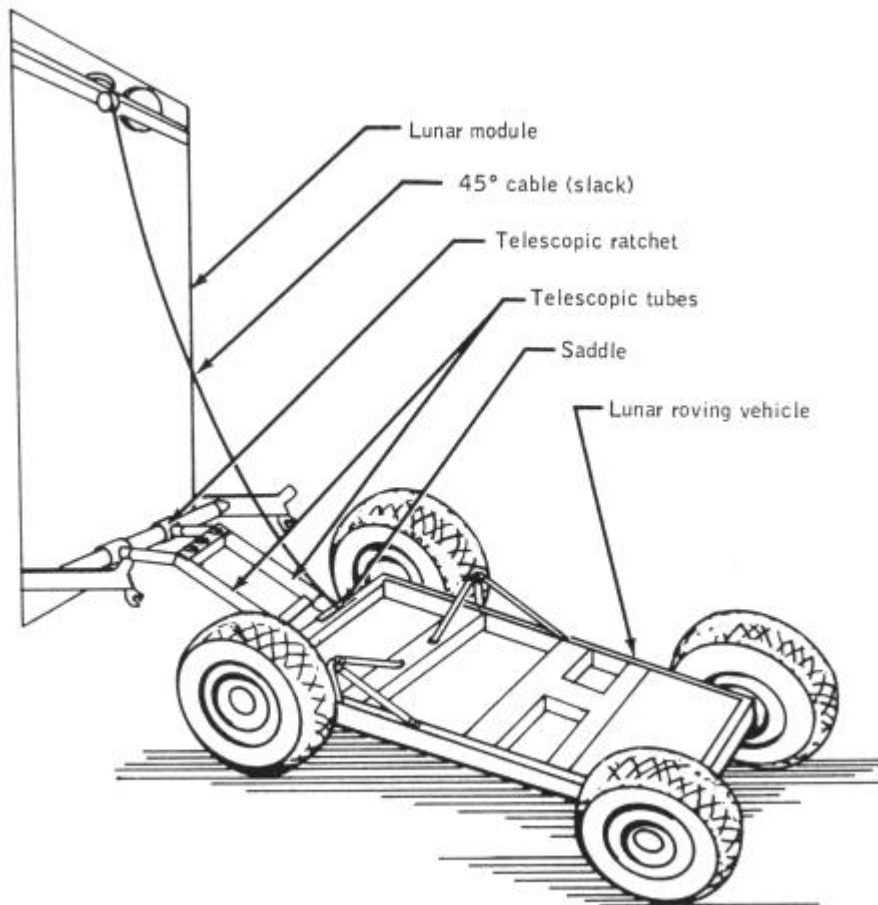
- a. The saddle-to-vehicle connection (**Fig. 14-54**) has close-tolerance interfaces to provide the rigidity required to prevent release-pin distortion and permanent binding. This design requires the vehicle/saddle interface to be completely free of stress to permit easy separation.
- b. The tilt of the lunar module to the rear and sideways, together with an uneven lunar surface, provided some stress preloading of the vehicle/saddle interface. Attempts by the crew to improve the rover position by moving and pulling on it may have aggravated this situation. The crew was aware that the interface had to be free of stress, and when this was accomplished, the saddle separated.

Figure 14-55.- Lunar roving vehicle deployment.

Ground tests have shown that if the partially deployed lunar roving vehicle resting on the surface but not yet detached from the saddle and lunar module, is rolled either to the left or right, the saddle/rover chassis interface will bind. The interface can be released, and the saddle dropped to the ground by one crewman adjusting the roll back to zero while the other taps the saddle with a hand tool. The corrective action is to insure adequate crew training.
