**Investigation of Blowout and Fire,
Platform A, Eugene Island Block 380,
Lease OCS-G 2327, January 24, 1996,
Gulf of Mexico,
Off the Louisiana Coast**

U.S. Department of the Interior
Minerals Management Service
Gulf of Mexico OCS Regional Office

D.J. Griffin
M.J. Saucier
C.J. Schoennagel

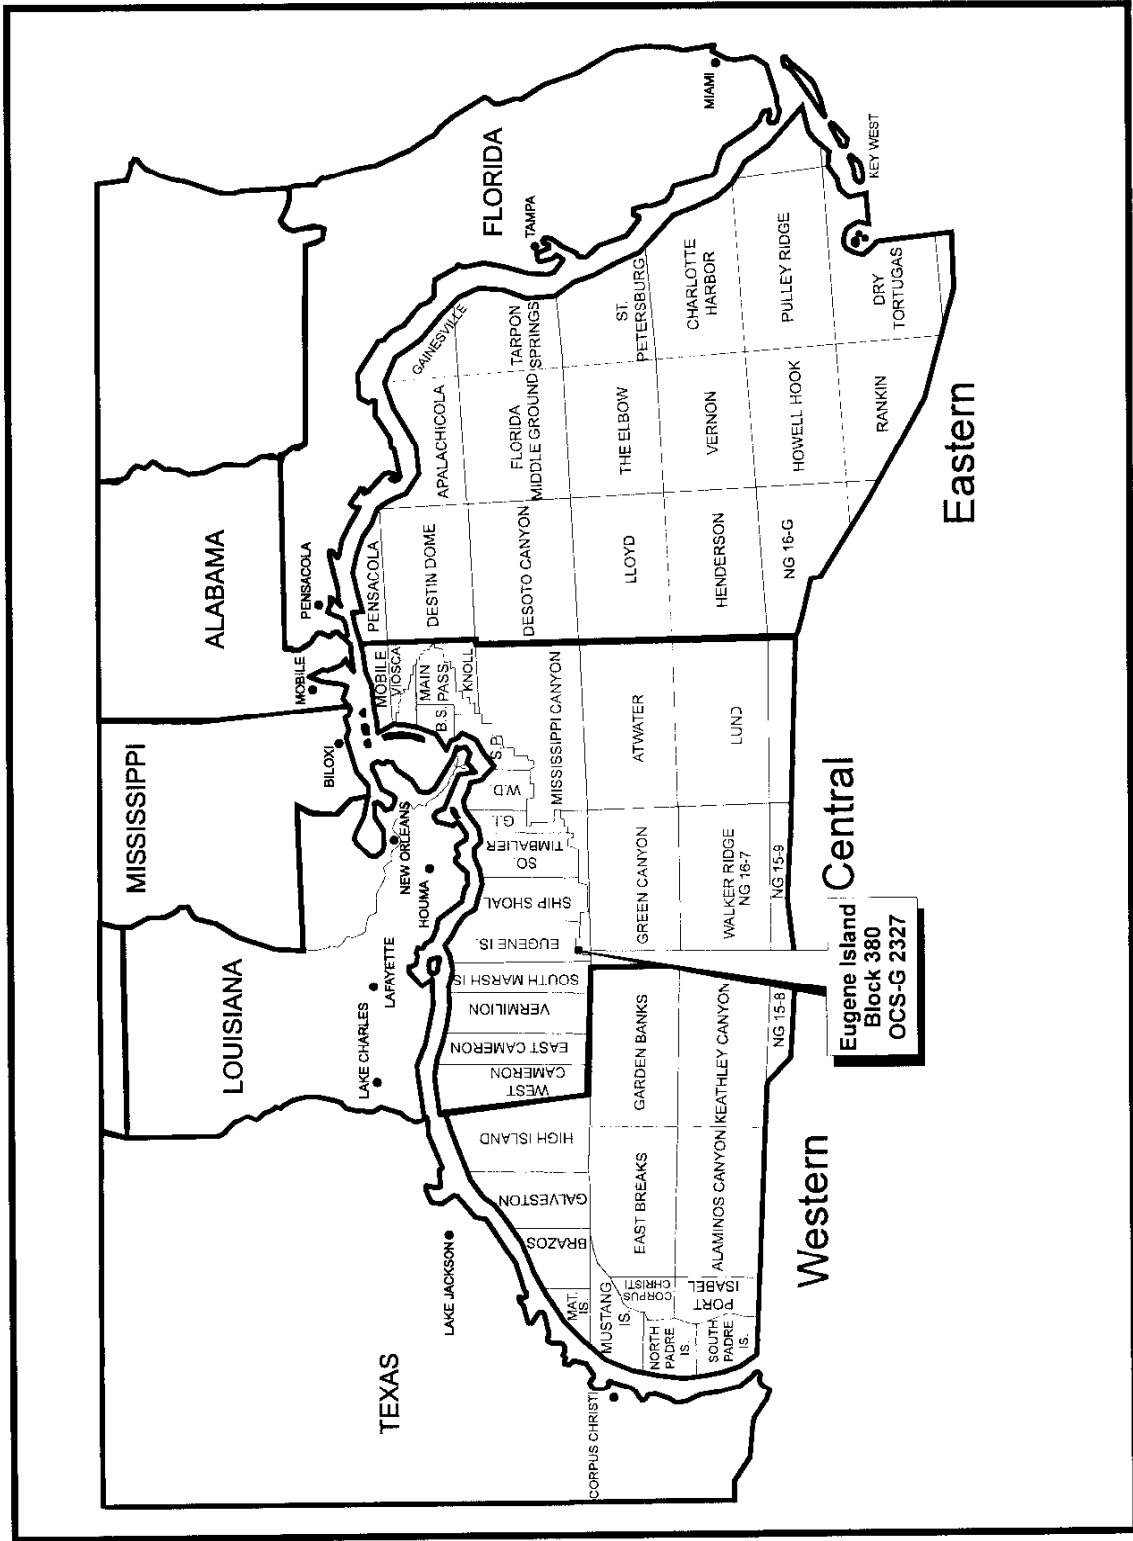
Photographs of scene

The Sundowner 15 rig substructure and derrick were completely destroyed in the blowout and subsequent fire. There was severe damage to other parts of the rig and associated equipment. There was minimal damage to Oryx's Platform A. There was no damage to the other wellheads on the platform. The evacuation of the rig and platform was conducted without incident. There was no pollution as a result of the incident.
