**Investigation of Fall and Fatality
Mississippi Canyon Block 109
August 16, 2000**

**Gulf of Mexico
Off the Louisiana Coast**

Frank Pausina
David Dykes
Charles Griffin

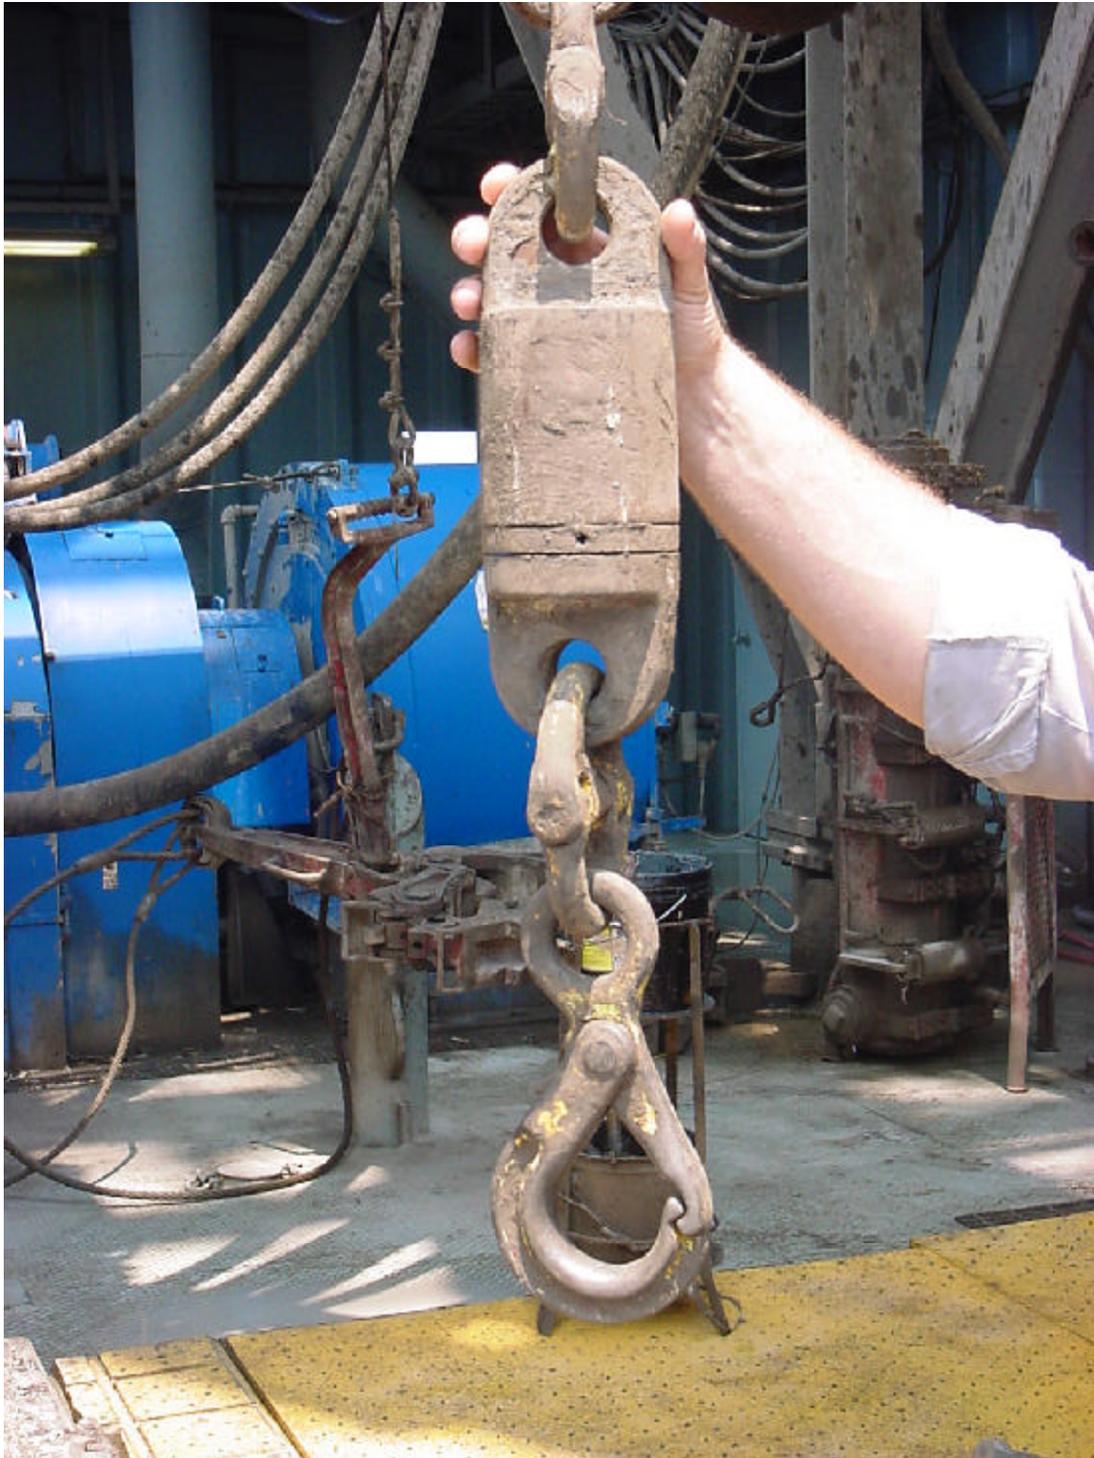
Photograph of Hook Assembly

With the "D" rings in the gap, panel members were unable to physically pull the "D" rings downward from the hook. With the "D" rings in the gap and with the latch release trigger fully depressed, the panel members were still unable to pull the "D" rings downward from the hook. However, with the "D" rings in the gap and with the latch release trigger fully depressed, the "D" rings separated from the hook as soon as the panel members stopped pulling downward on the "D" rings. It should be noted that in both of the above demonstrations with the trigger fully depressed, the trigger was not easily depressed. This indicates that it is possible that the "D" rings can detach from the hook during a personnel lifting operation if the rings are in the latch/hook gap, the trigger is depressed, and the occupant of the chair

- ◆ The failure of H&P's inspection/maintenance program to identify the latch/hook gap as a potential hazard by a more in-depth inspection of the hook.

The panel further recommends that MMS review their regulations and those of other agencies, which do reference personnel lifting, for the purpose of evaluating the possible need to add a specific MMS regulation(s) to 30 CFR 250 regarding the lifting of personnel. Specifically, the evaluation should consider the types of hooks used and the need for fall-arrest systems.
