# Post Mortem Failure Assessment of MODUs During Hurricane Ivan

September 2004

**Minerals Management Service**

**Hurricane Ivan: MODU Investigation & Recommendations Sept 2004**

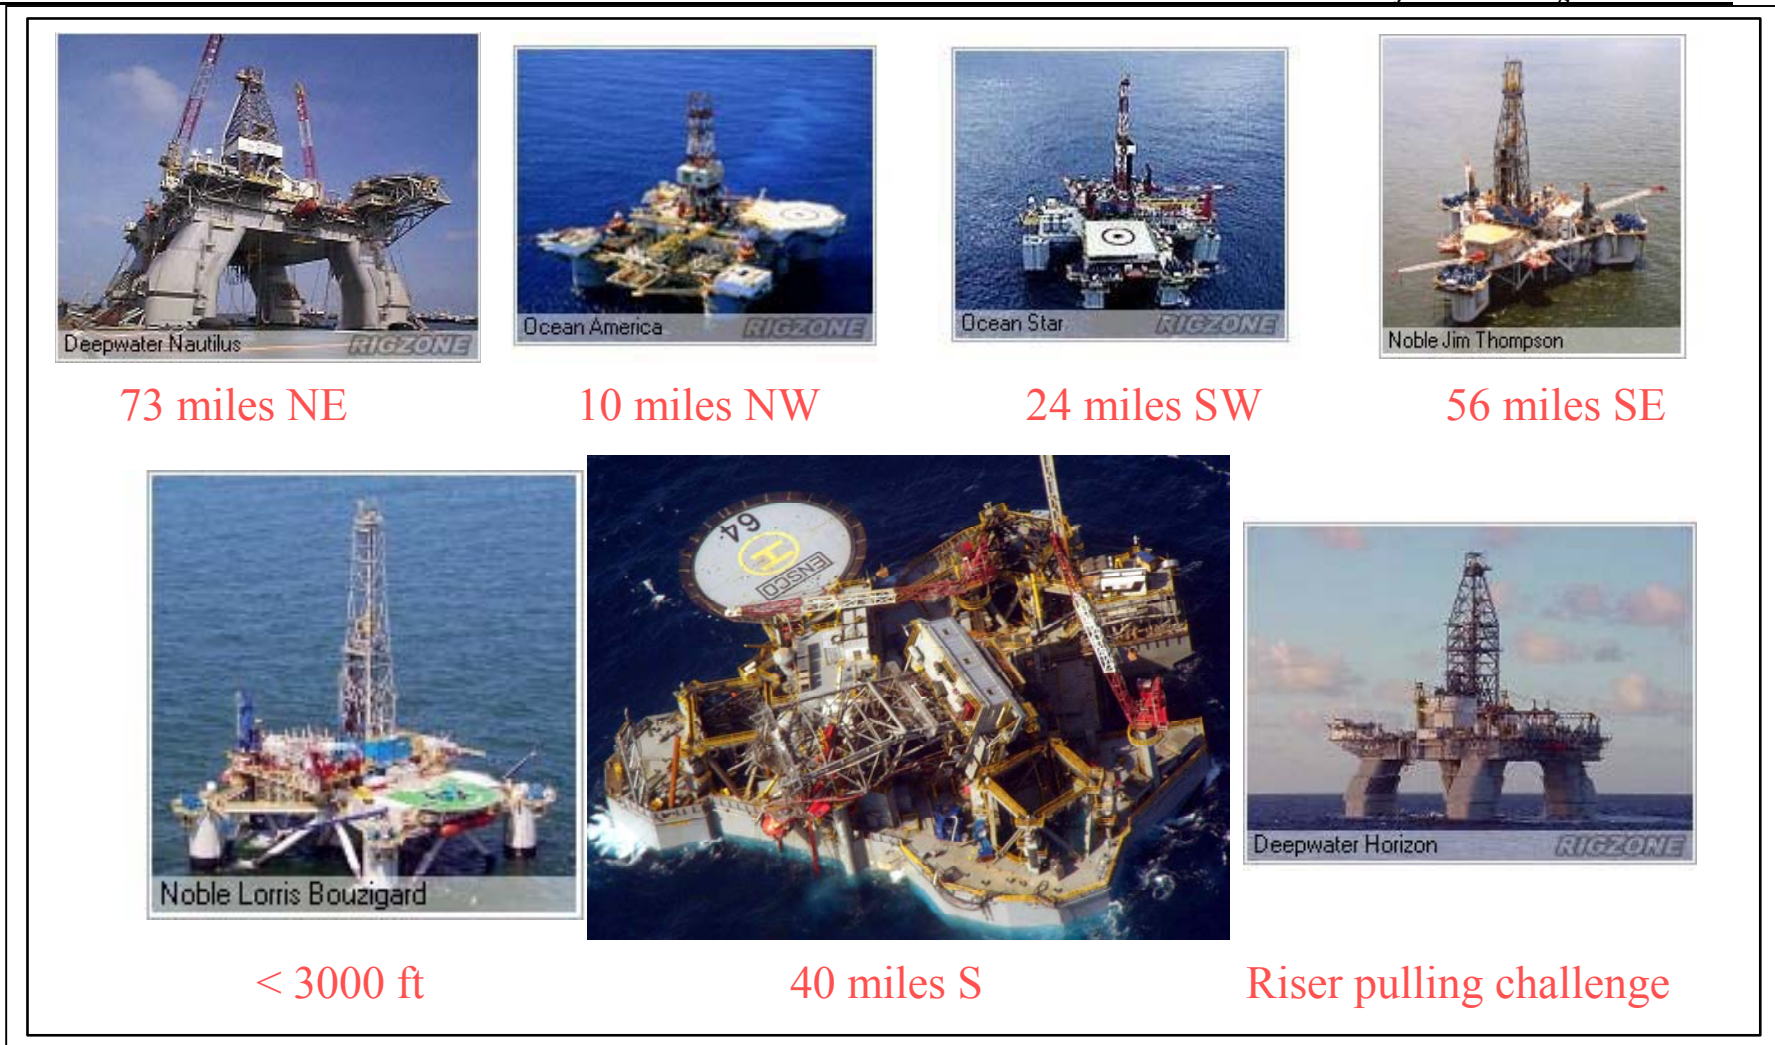
Figure 9: Hurricane Ivan MODU Mooring Issues

Figure 9 shows each of the MODUs that had stationkeeping issues. Note the Deepwater Horizon is self-propelled, and the Ensc 64 is a jackup. The other vessels depicted are semisubmersibles that are moored to their respective locations and where the moorings broke in Hurricane Ivan.

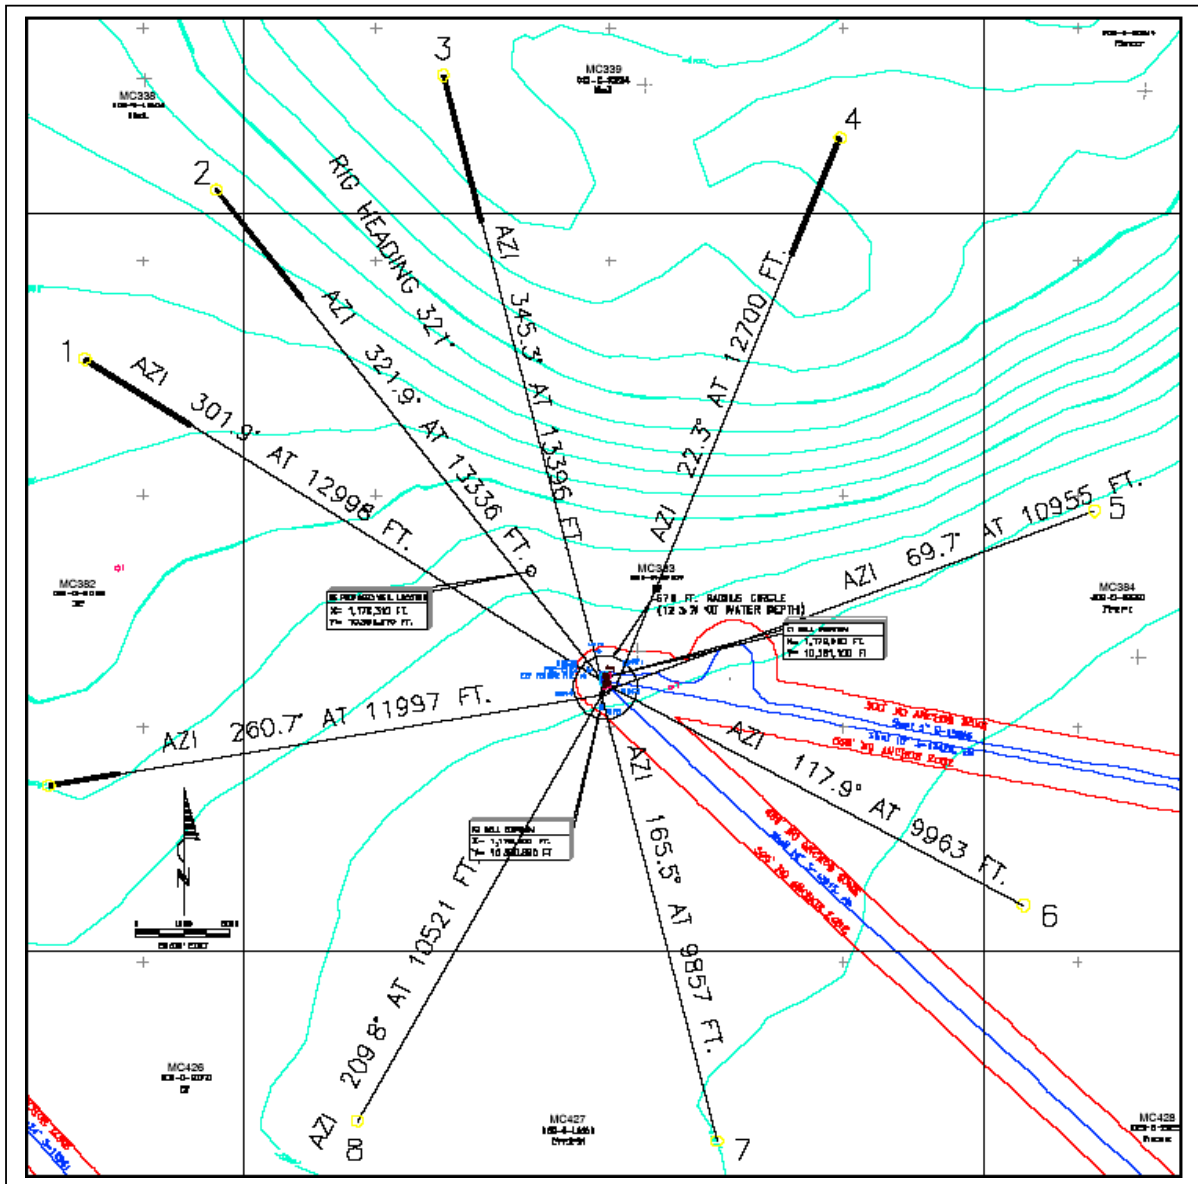
Figure 11: Noble Jim Thompson mooring pattern at MC 383

Figure 11 shows the mooring pattern at MC 383. Points of note are the pipelines. Arrangements of moorings over existing pipelines ensured that #6 would not impact if the hurricane winds came from the south. Different elevations to the north increases the complexity of the mooring design.

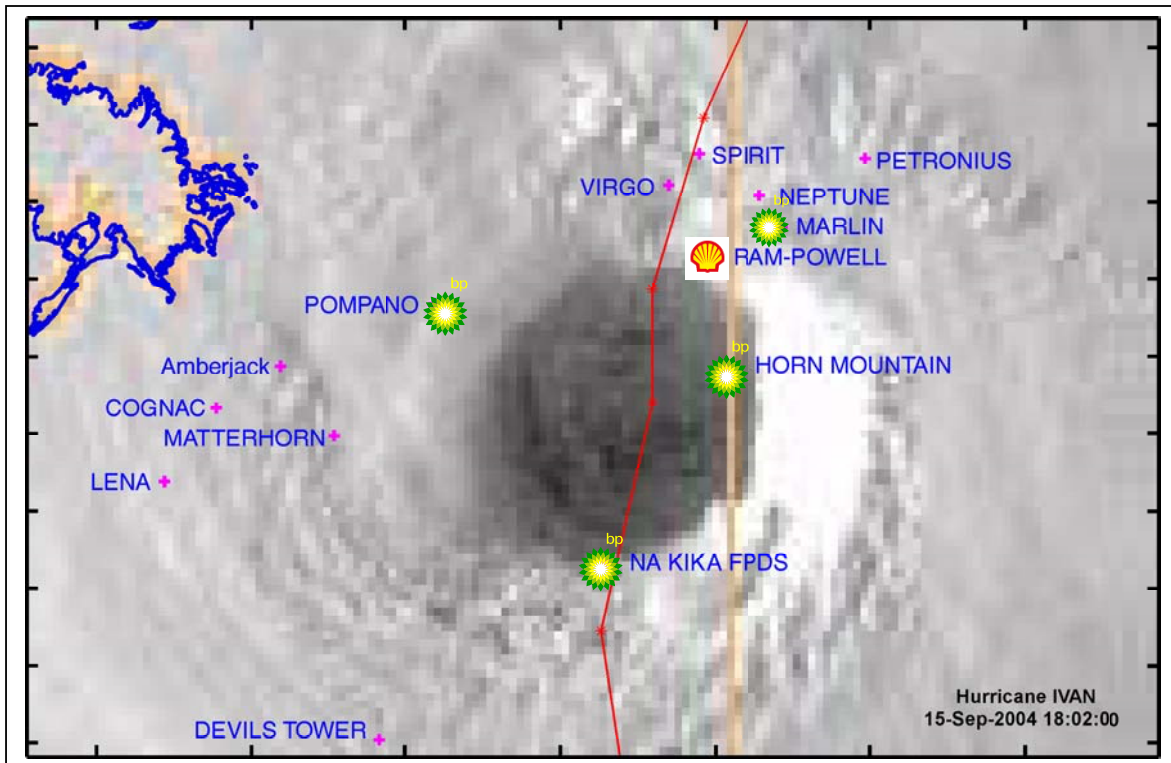
Figure 13 shows the eye of the Hurricane Ivan in relation to the Noble Jim Thompson which was working very close by to the Nakika position.

Once the 3 initial lines #5, #4 and #3 had broken the rig would have moved off location and then put a significant load out-of-plane on the padeyes of the suction piles, for which they are not traditionally designed. This would also be consistent with reported tangling of moorings around the rig after the event (Ref 22).

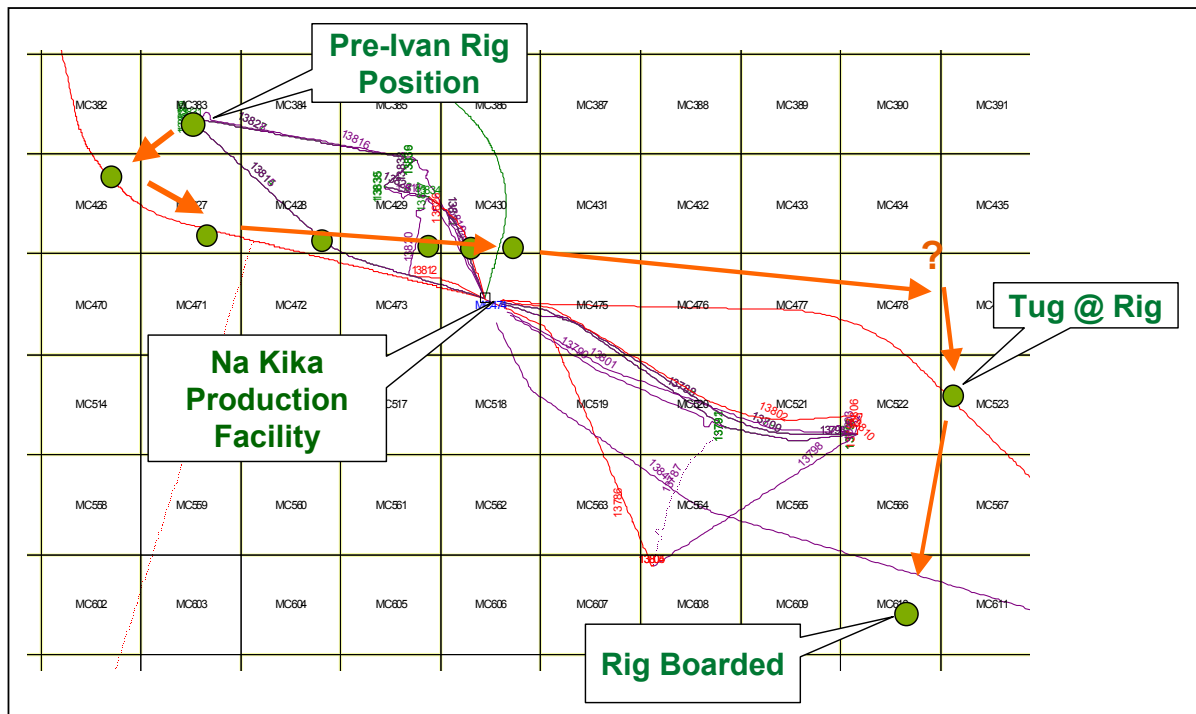
Figure 20: Possible Route of the Noble Jim Thompson after the Hurricane Broke the Moorings.

Figure 20 illustrates a possible route to that the vessel may have followed. The path was based on where mooring components were found, marks in the seafloor or from an indication where wire was drug across pipelines.

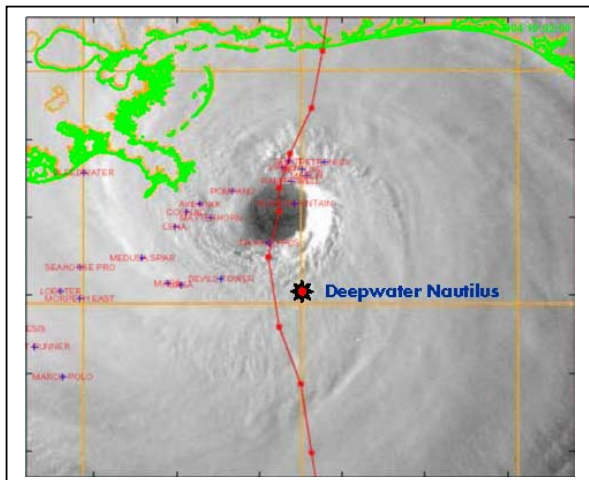
During the storm the eyewall of the hurricane passed directly over the Deepwater Nautilus with

1-min. sustained windspeeds of 111 kts gusting to 130 kts. and generating a maximum wave height of about 87 ft.

Figure 23: Deepwater Nautilus in relation to the eye of the storm and to the other significant production platforms in the area. The Nautilus was 17 miles to the east of the track in the most ferocious part of the storm.

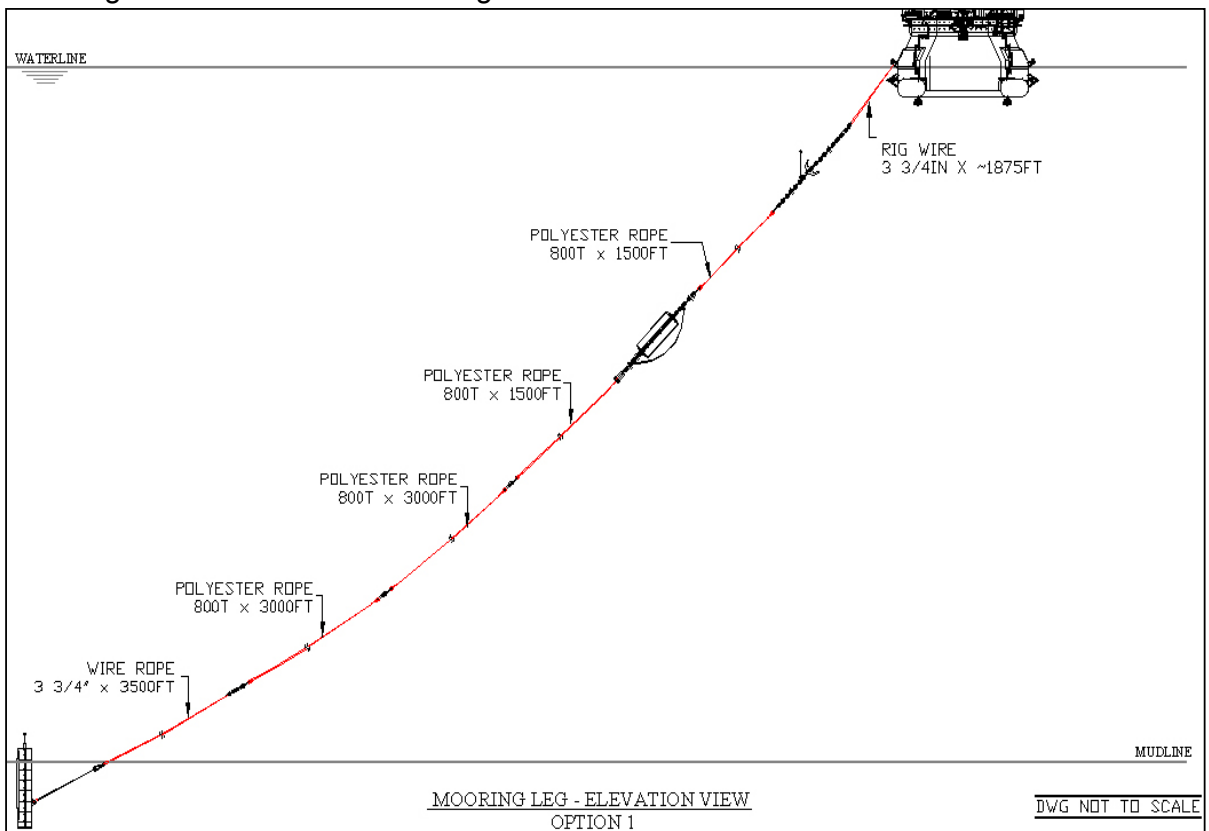
Figure 25: Mooring Line Elevation

Based on the sequence of the breaks and the direction determined by the lines on the seafloor after the incident the break must have occurred close to the time the storm center was on the same latitude as the Nautilus. A break at this time would allow the unit to move north propelled by the northerly winds on the east side of the storm.

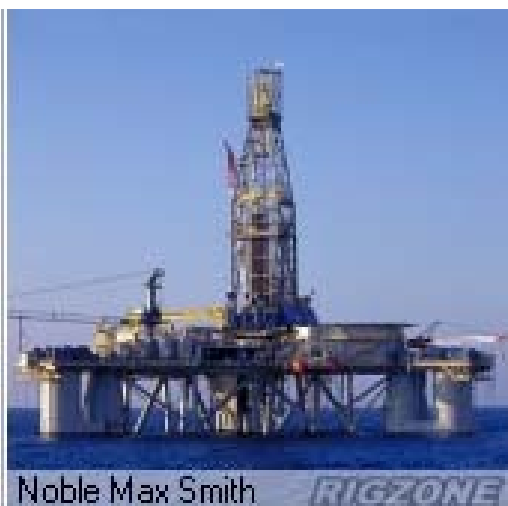
The Noble Max Smith as shown in Figure 8 was approximately 47 miles to the west of the storm. The conditions there were somewhat in excess of the 10-year return period values used in mooring design. The Noble Max Smith had no apparent problem in maintaining location, nor was there any damage.

The item of interest here is that it confirmed for this storm that the required distance from the track before having issues was approximately 50 miles: the extent of the distance to avoid the ferocity of the storm in excess of the current mooring standard.

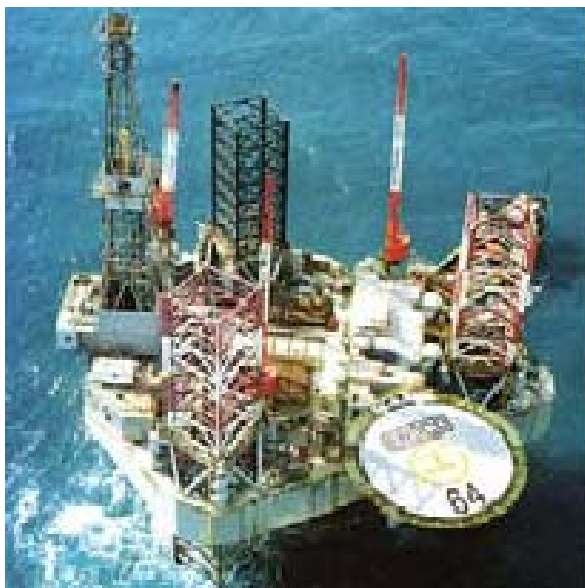
Figure 28: Ensco 64 jacked up on location

*London, Sep 20 -- A press release from Ensco International Corp, dated Dallas Sep 16, states: Ensco International Inc announced today that one of the Company's jackup drilling platforms, Ensco 64 (5451 gt, built 1973, upgraded 2002) was directly in the path of hurricane "Ivan" and has sustained damage. The platform is now afloat in the U.S. Gulf of Mexico approximately 80 miles southeast of Venice, Louisiana. The platform was operating in Main Pass Block 280 for Dominion Exploration and Production Inc, and all personnel had been safely evacuated ahead of the storm. Appropriate regulatory agencies have been notified. A report of visual inspection from a fixed-wing aircraft has indicated Ensco 64 is floating approximately 40 miles south of its drilling location. Company personnel will be deployed to assess the extent of damage and determine appropriate remedial action to secure the platform as soon as practicable. The platform is insured for \$65 million. Unless the rig is declared a total loss, Ensco anticipates the cost of repairs will be recoverable in excess of policy deductibles which are limited to \$5.5 million. The Company also has received a preliminary report from a third-party of damage to the helideck on one of the Company's platform Ensco 25, which was adjacent to the path of the storm. The Company has commenced inspection and re-boarding operations of its Gulf of Mexico rig fleet and is unaware of any further damage at this time.*

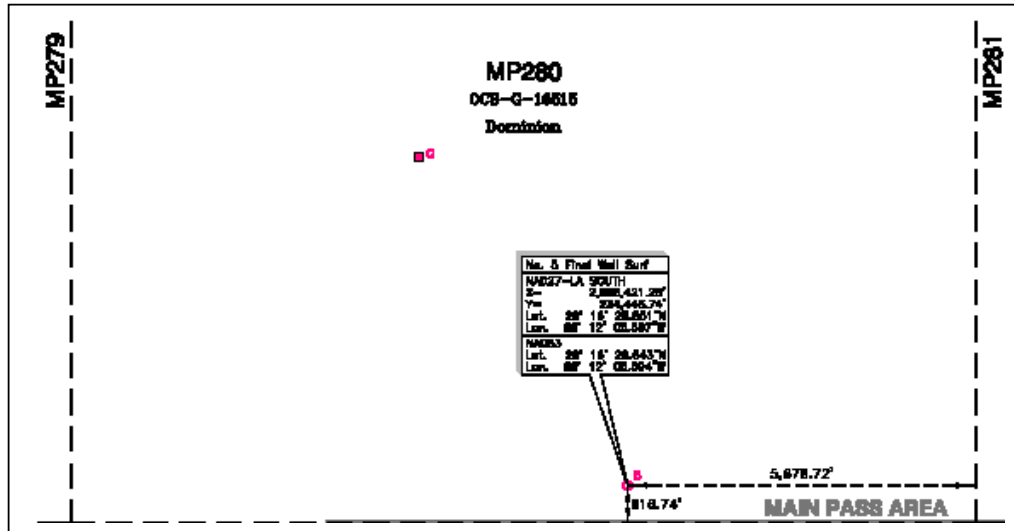
Figure 29: Location in Main Pass 280 Well #5.

The location is shown on the chart below in a waterdepth of 301 feet.

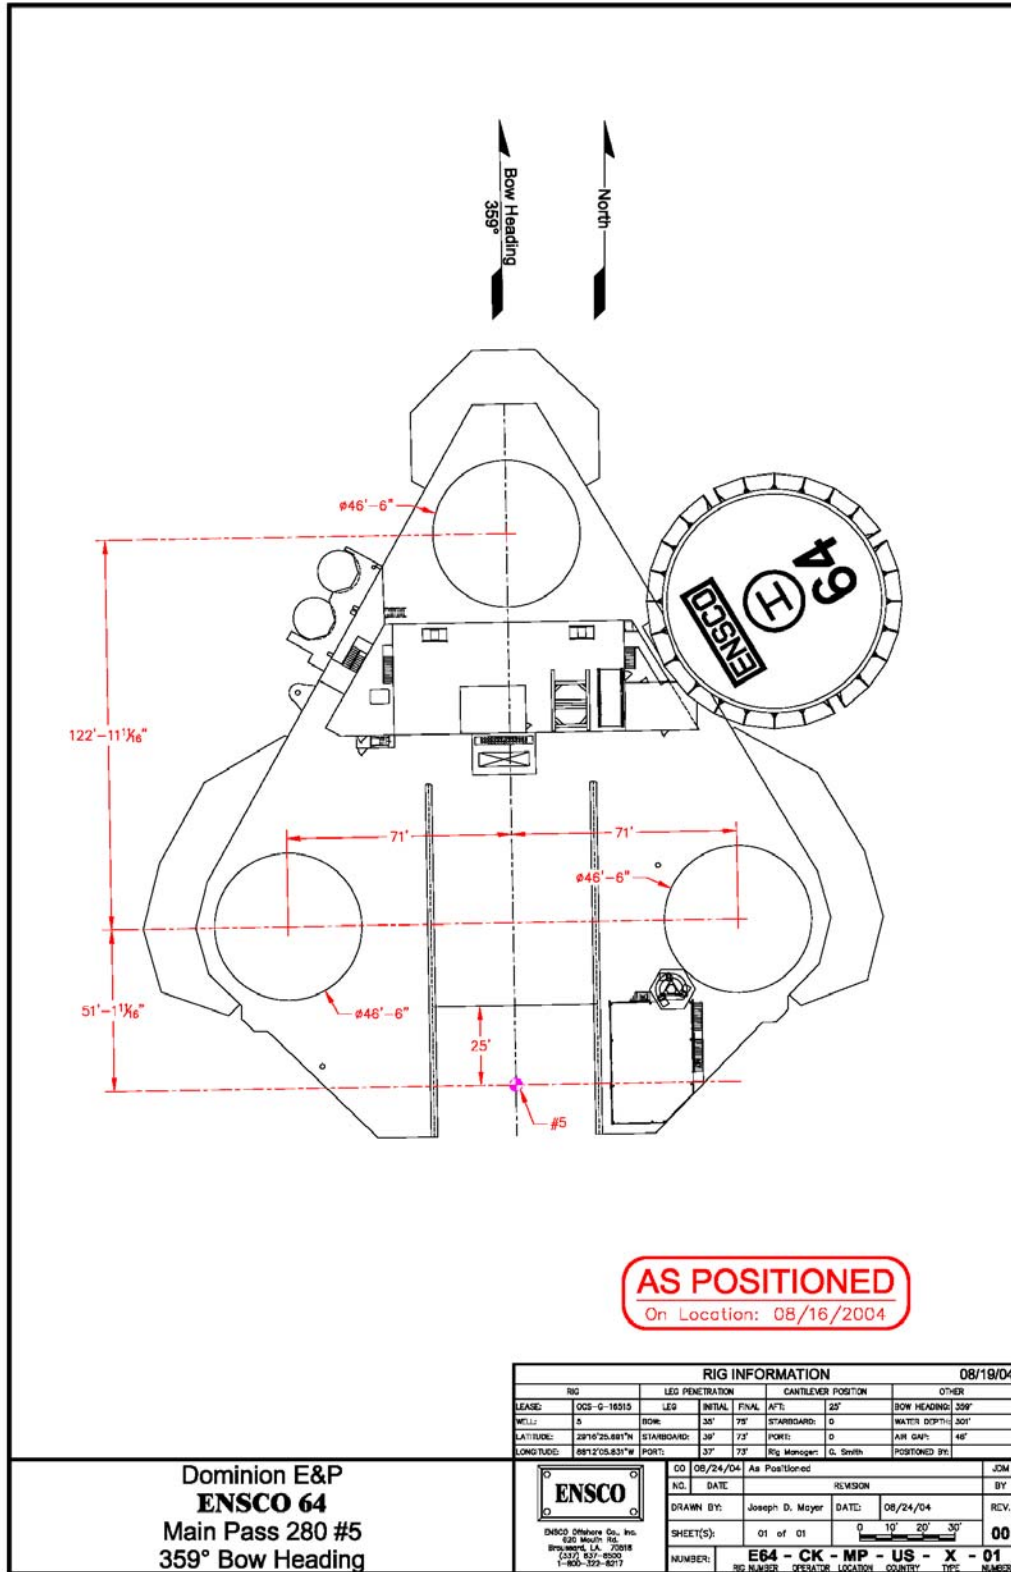
Figure 30: Ensco 64 Arrangements on Location

It had been upgraded to increase the leg length to 477 ft, reinforce the legs, and increase the preload capacity in order to increase the waterdepth capability of the rig. It was at its deepest waterdepth at this location based on the leg penetration. With 75 ft of leg penetration, this location was also on the limits of its leg length with little reserve (a couple of feet), to get higher (as can be seen in Figure 32).

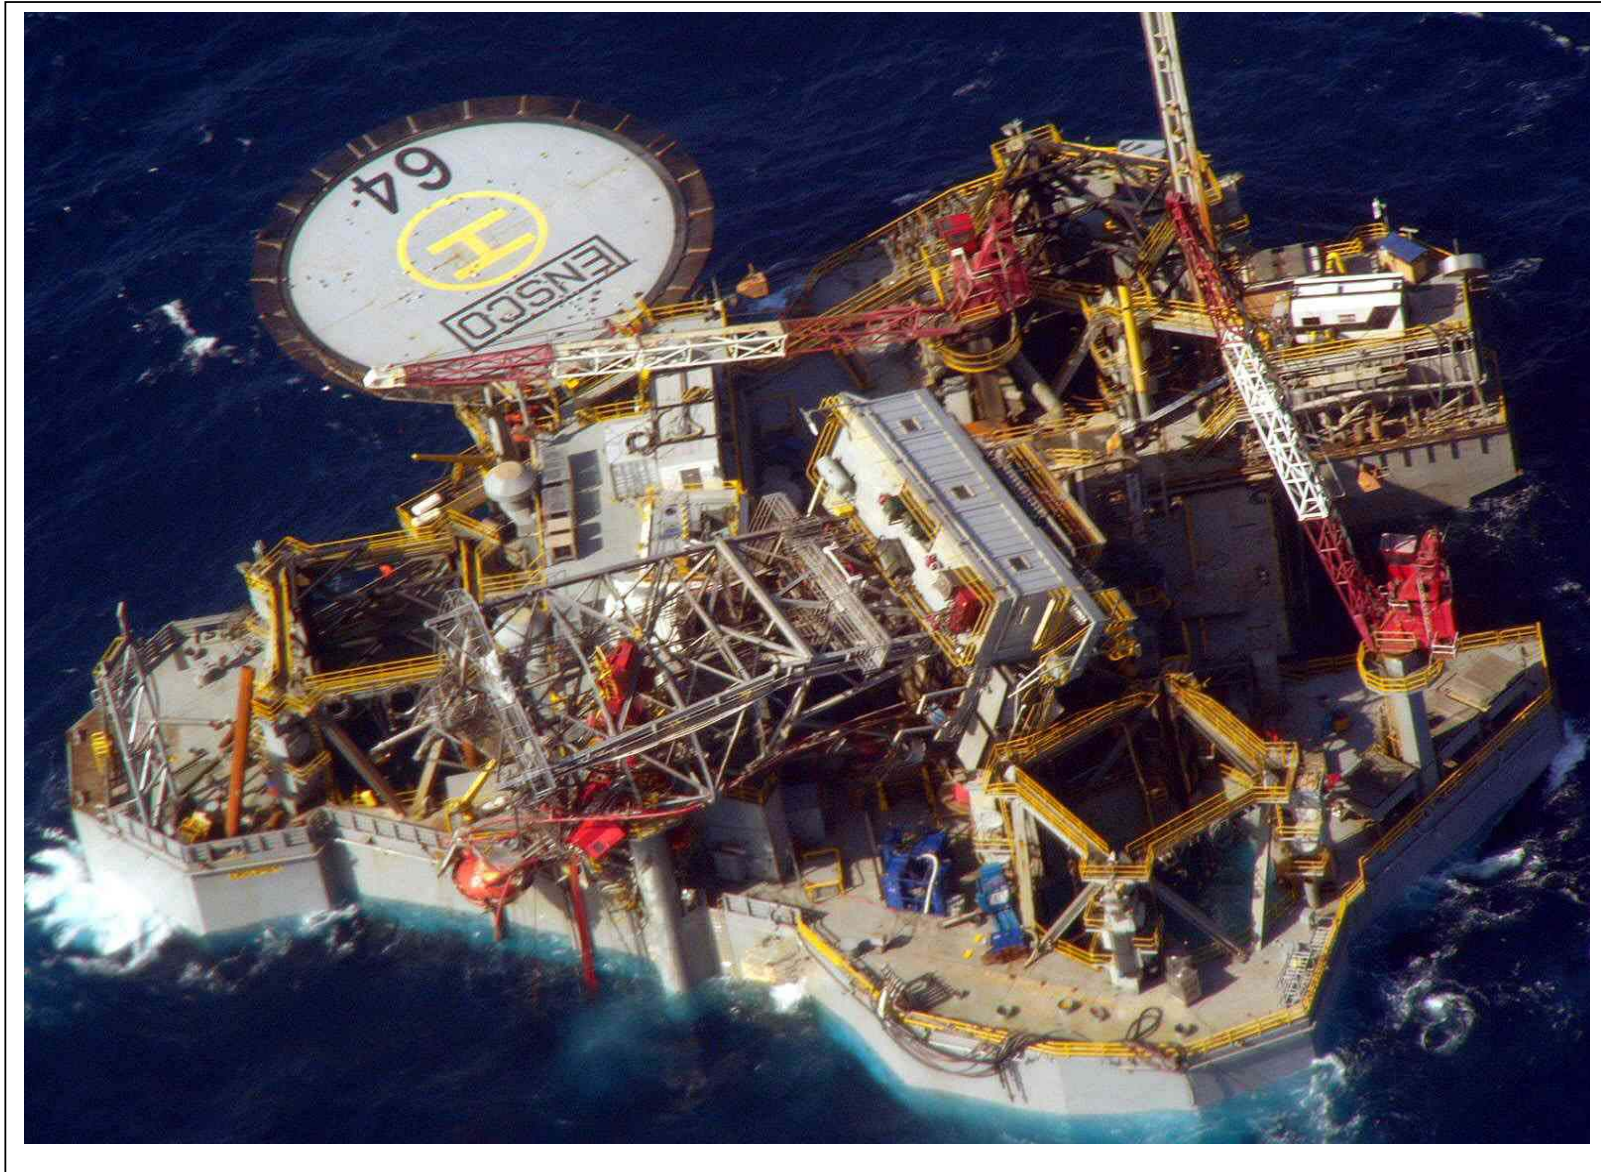
Figure 32 follows:

The wind, wave and current all exceeded the design by a large margin. An increase in current results in a decrease in capability as shown from the operating manual conditions showing the extreme design storms. A 1.5 kt current knocks the capability down by 12 knots of wind and 4 ft of wave. Doubling the current would further decrease the capability significantly. Thus Ivan imposed on the rig forces related to double the design wave height and this would take the jackup well past its ability to stand. Thus even by rare chance the rig did the wave crest impacting the hull bottom, it would be expected to fail regardless, based on normal wind, wave and current conditions as extreme as those of Hurricane Ivan.

The hull drifted off location and Figure 34 shows a photo taken of the unit after it drifted 40 miles south of location. At Main Pass 280, the bottom of the legs were found laid over to the northwest. The legs had to be removed before a drilling rig could be mobilized to attempt well bore salvage. The well was leaning about 16 degrees toward the west from below the mudline for one full joint, which appeared to be straight. The pipe was cut to about 50 ft above the mudline. All casings were collapsed about 6' above a collar on the 2nd joint above the mudline with an angle greater than 90 degrees. The drive pipe deck and tensioner were laying in the mud at the base of the drive pipe.

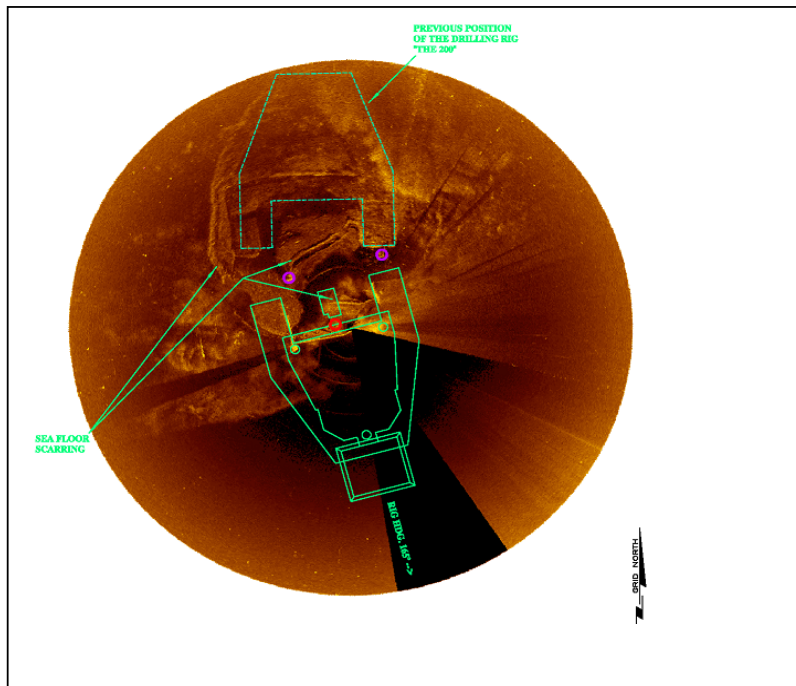
Figure 41: Fugro Chance Inc. Sonar Data on THE 200

THE 200 had no failures, and no issues resulting from a detailed structural inspection. Scour at the forward end of the mat of 6-8 ft and at the stern end of approximately 4 ft was the result of the passage of the storm causing the rig to be relocated for continuation of its work. Figure 41 shows the sonar scan of the area after the passage of the storm and lays out the position that the rig was to be moved to after the storm because of the unevenness of the soil, which had scoured under the mat. Figure 42 shows THE 200 after the storm. Note the effect of the high current on the legs of the unit.
