# Post Mortem Failure Assessment of MODUs During Hurricane Lili

October 2002

**Minerals Management Service**

**MMS Order No.: 0103PO72450**

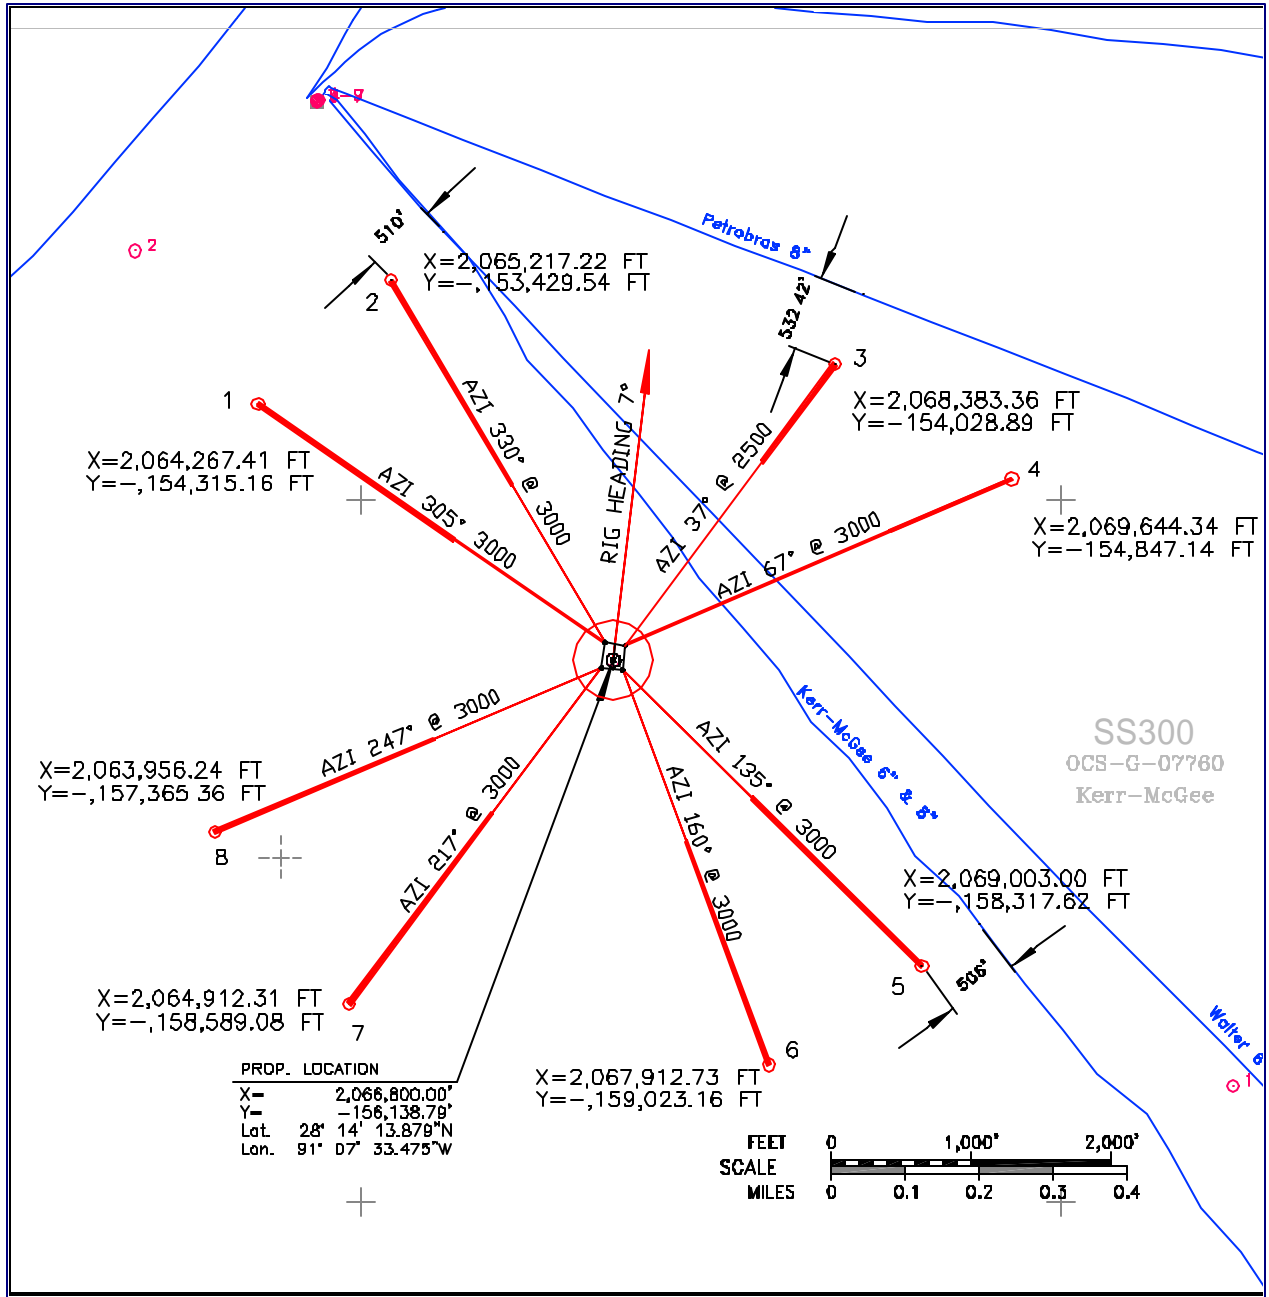
Figure 12: Configuration of mooring lines on Ocean Lexington.

Lines 3 & 4 consisted of

- 500-feet 2-3/4" rig chain
- Chaser Stopper
- 500-feet 3-1/4" wire rope (EEIPS) for line #3 and 1000-feet for line #4
- 50-kip Submersible Buoy on buoy swivel
- 500-feet 3-1/4" wire rope (EEIPS) for line #3 and 1000-feet for line #4
- Inline Pipeline Swivel
- 1500-feet 3-1/4" chain (ORQ or greater)
- 15MT Bruce HHC Anchor

The chain was at the fairlead on legs 3 and 4 and the wire was at the fairlead on the other legs. The pre-layed anchors were Bruce 15 mt. with high holding capacity and because of their characteristics it would have been anticipated they would have minimum drag: the appropriate solution for this site-specific location. The calculated strength of the preset moorings was designed to exceed the strength of the rig mooring components.

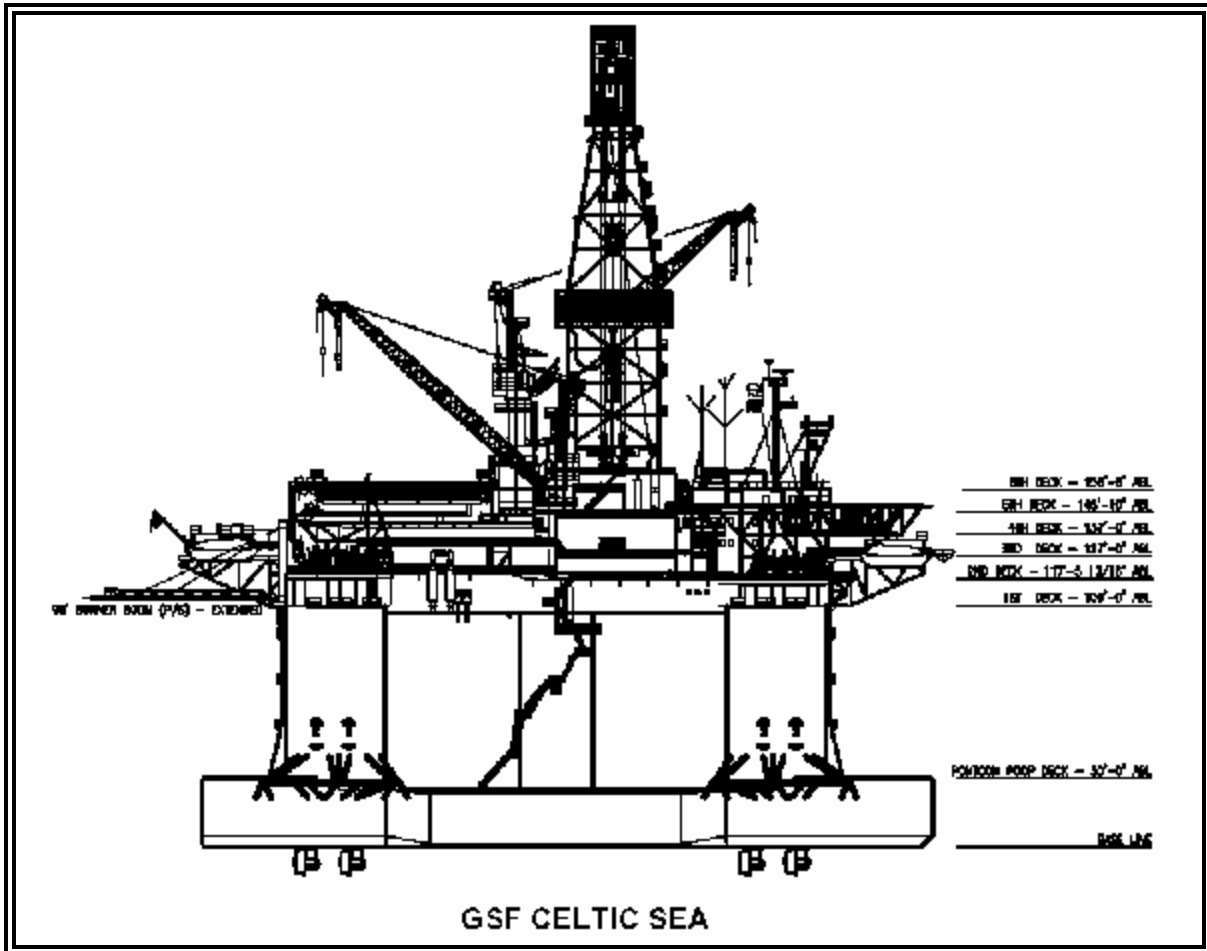
Glomar Celtic Sea reported that 6 of its 8 mooring lines broke in Hurricane Lili but it remained tethered to the seabed. One failure was about 700 ft from the end; the others were in the region of the fairleads. The rig was moored with Stevpris anchors, which moved somewhat on location even though these are high holding power anchors. There was evidence that they reached their maximum limits. There was additionally some minor damage to the accommodation recreation room, which had the deck plates and beams bent upward. This was unexpected and may have resulted from wave run-up on the column. Of the 6 mooring lines that failed, all but one failed near the fairlead. The comparison of anticipated and actual conditions is shown in Table 9.

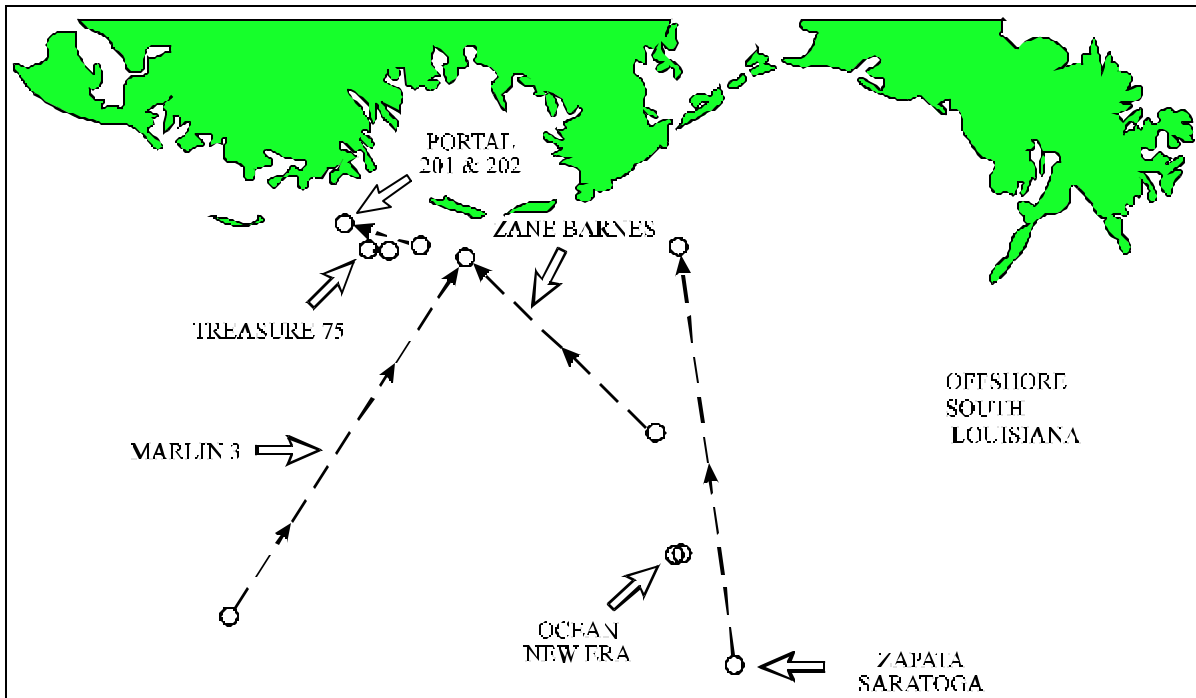
**Figure 15 MODU Movement During Hurricane Andrew**

In hurricane Andrew, three semisubmersible MODUs both experienced damage and inflicted significant damage on surrounding facilities. The Zane Barnes, Zapata Saratoga, and Treasure 75 all moved very significant distance during hurricane Andrew. The storm snapped seven of the semi-submersible drilling unit Saratoga's eight anchor chains and drove the unit some 40 miles to the north. The Zane Barnes broke loose from its eight anchors, drifted northwest some 30 miles, colliding with two platforms and allegedly several pipelines. Treasure 75, was ballasted on the seafloor with four anchors deployed prior to Andrew. By the time Andrew had passed, she had dragged along the bottom for approximately 4 miles and ruptured a large Texaco pipeline spilling 2000 BBL of oil. (Ref. 2). This incident was one of the worst spills during Andrew. The LOOP (Louisiana Offshore Oil Port) 36-inch diameter pipeline narrowly missed being snagged by the dragging anchors of one of these MODUs.

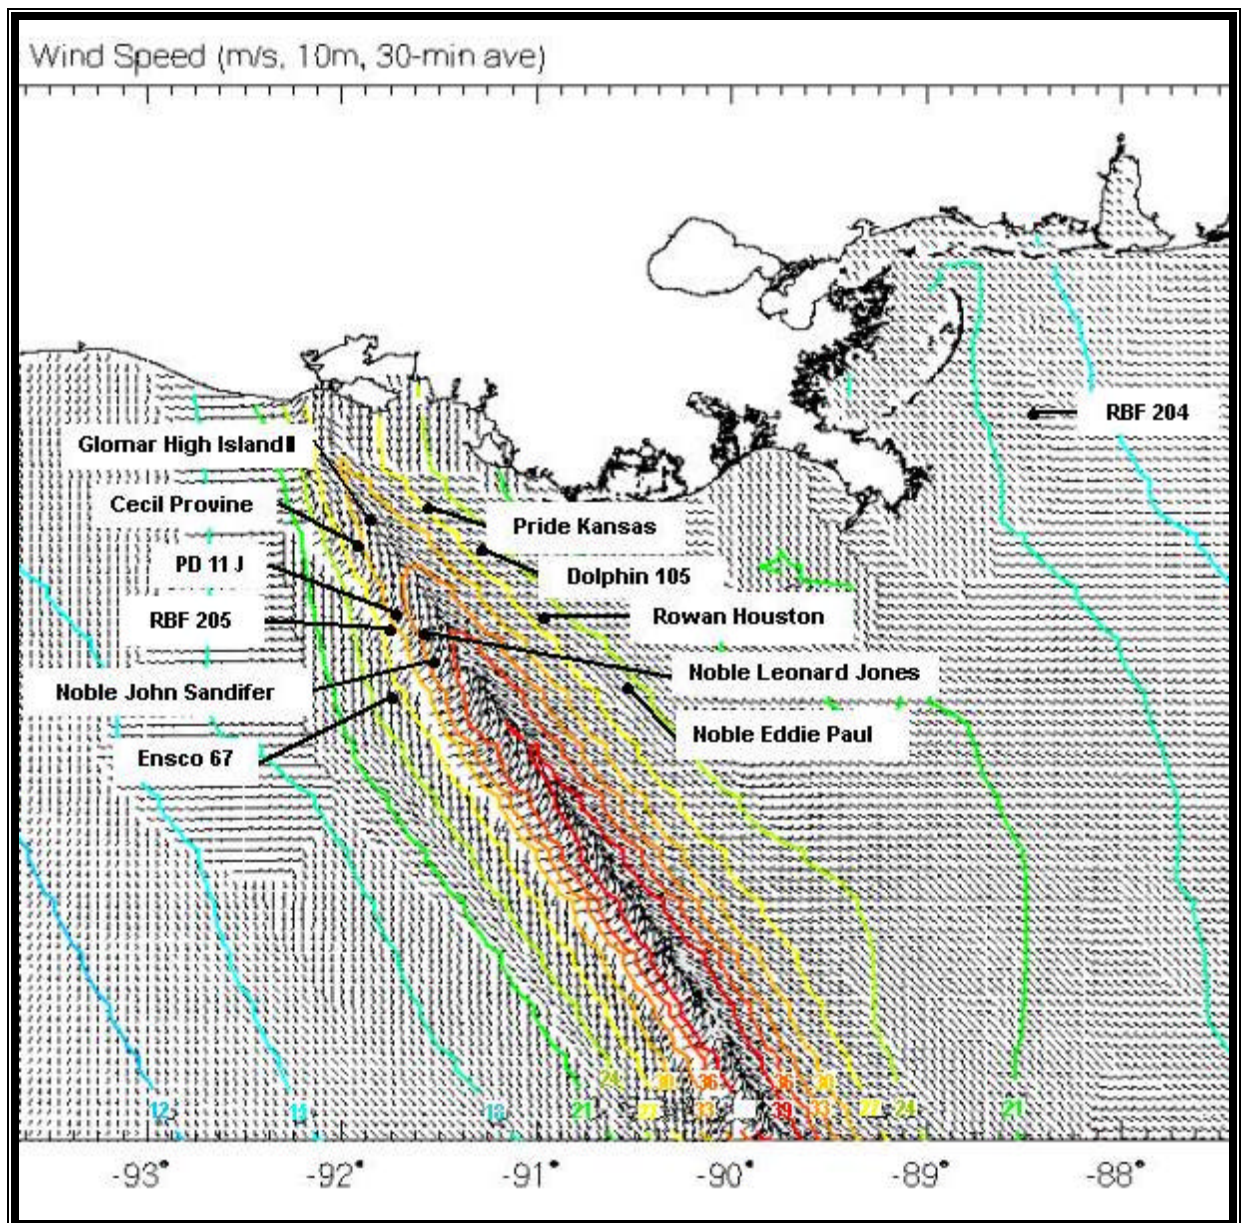
**16 a. Wind Speed**

The various jackups close to the storm are listed together in Table 14 together with a general view of their "likely capability". Figure 16a gives the wind contours, and Figure 16b the wave contours from the Oceanweather Report (Ref 1) with rig locations superimposed. In Table 14, the term "likely capability" is used because no site-specific studies were done to arrive at these numbers. It is a general "experience" number arrived at by engineering judgment from involvement in various analyses over the years. To specifically decide whether the exact weather conditions will affect the site specific location considerable details need to be known about the rig, and its loading during pre-load, variable load, current conditions at the rig as well as the soils data at the prescribed location. This tabulation was used to identify the most likely candidates for further study and to present an overview of "what happened" and was it expected to happen i.e. to see if the general understanding of rig capability resulted in

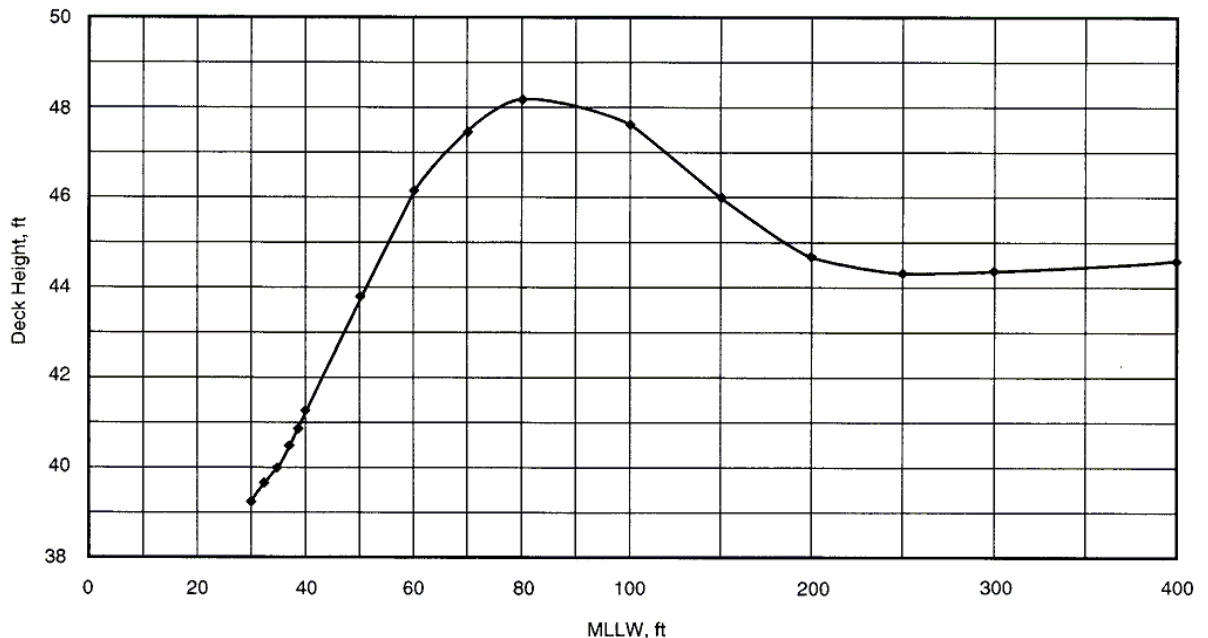
**Figure 20: API Section 17 – Full Population Hurricane Deck Height Criteria**

API RP2A Fig 17.6.2-2b (Figure 20) recommends a minimum deck height for fixed structures as approximately 40 ft for this water depth – the Dolphin 105 was within this recommendation.

- Under the storm hindcast conditions, the deck height used from API (*API RP2A Fig 17.6.2-2b*) would have been insufficient for this unit's expected survival: the API data is based on 100-year full population hurricanes: a higher return storm than is generally used by MODUs.
- Under the storm hindcast conditions, the loads are so much higher than design that the structure was overloaded, primarily legs at the lower guide and at the mat.
- Under the storm hindcast conditions, the rig would have been expected to slide.

It is recommended that the information of deck height experience from this unit be sent to the API RP2A committee for deliberation: since it is clear that *API RP2A Fig 17.6.2-2b* can be a misleading indicator to jackup rig owners who presume that using this deck height for the airgap of their units leaves them in a position of safety.

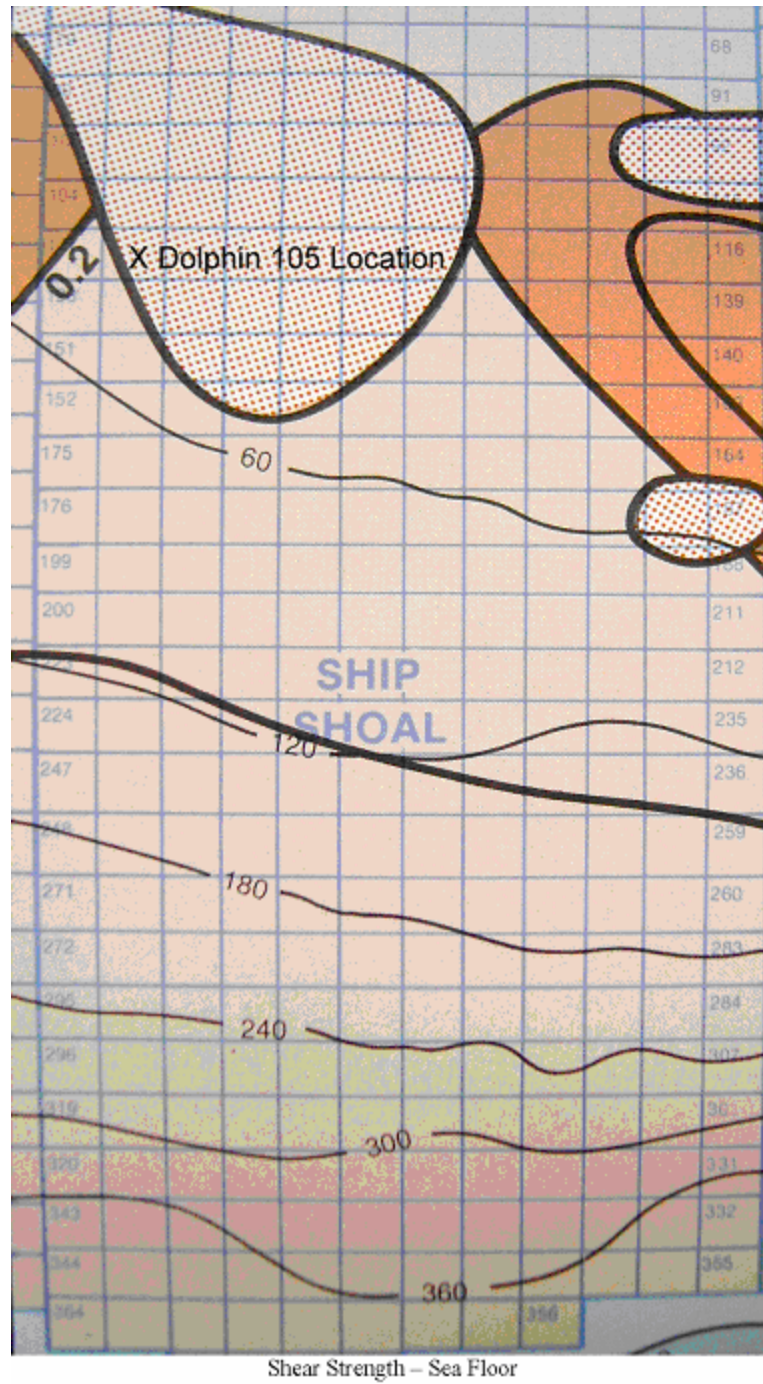
Figure 21: Soil Shear Strength at Dolphin 105 Location

The soil shear strength at the seafloor is shown below. The location is granular material overlying very soft clay. At 10' depth the soil has a cohesive strength of 0.2 ksf and at a depth of 20 ft it has a strength of 0.4 ksf as shown in the diagram below. What is not known is how deep the granular layer is: all we know is that by the 10 ft depth the soils at the location are mapped as soft clay.

The propensity of the rig is to slide on the granular soils. It is most likely this would be exacerbated by potential scour from the breaking wave.

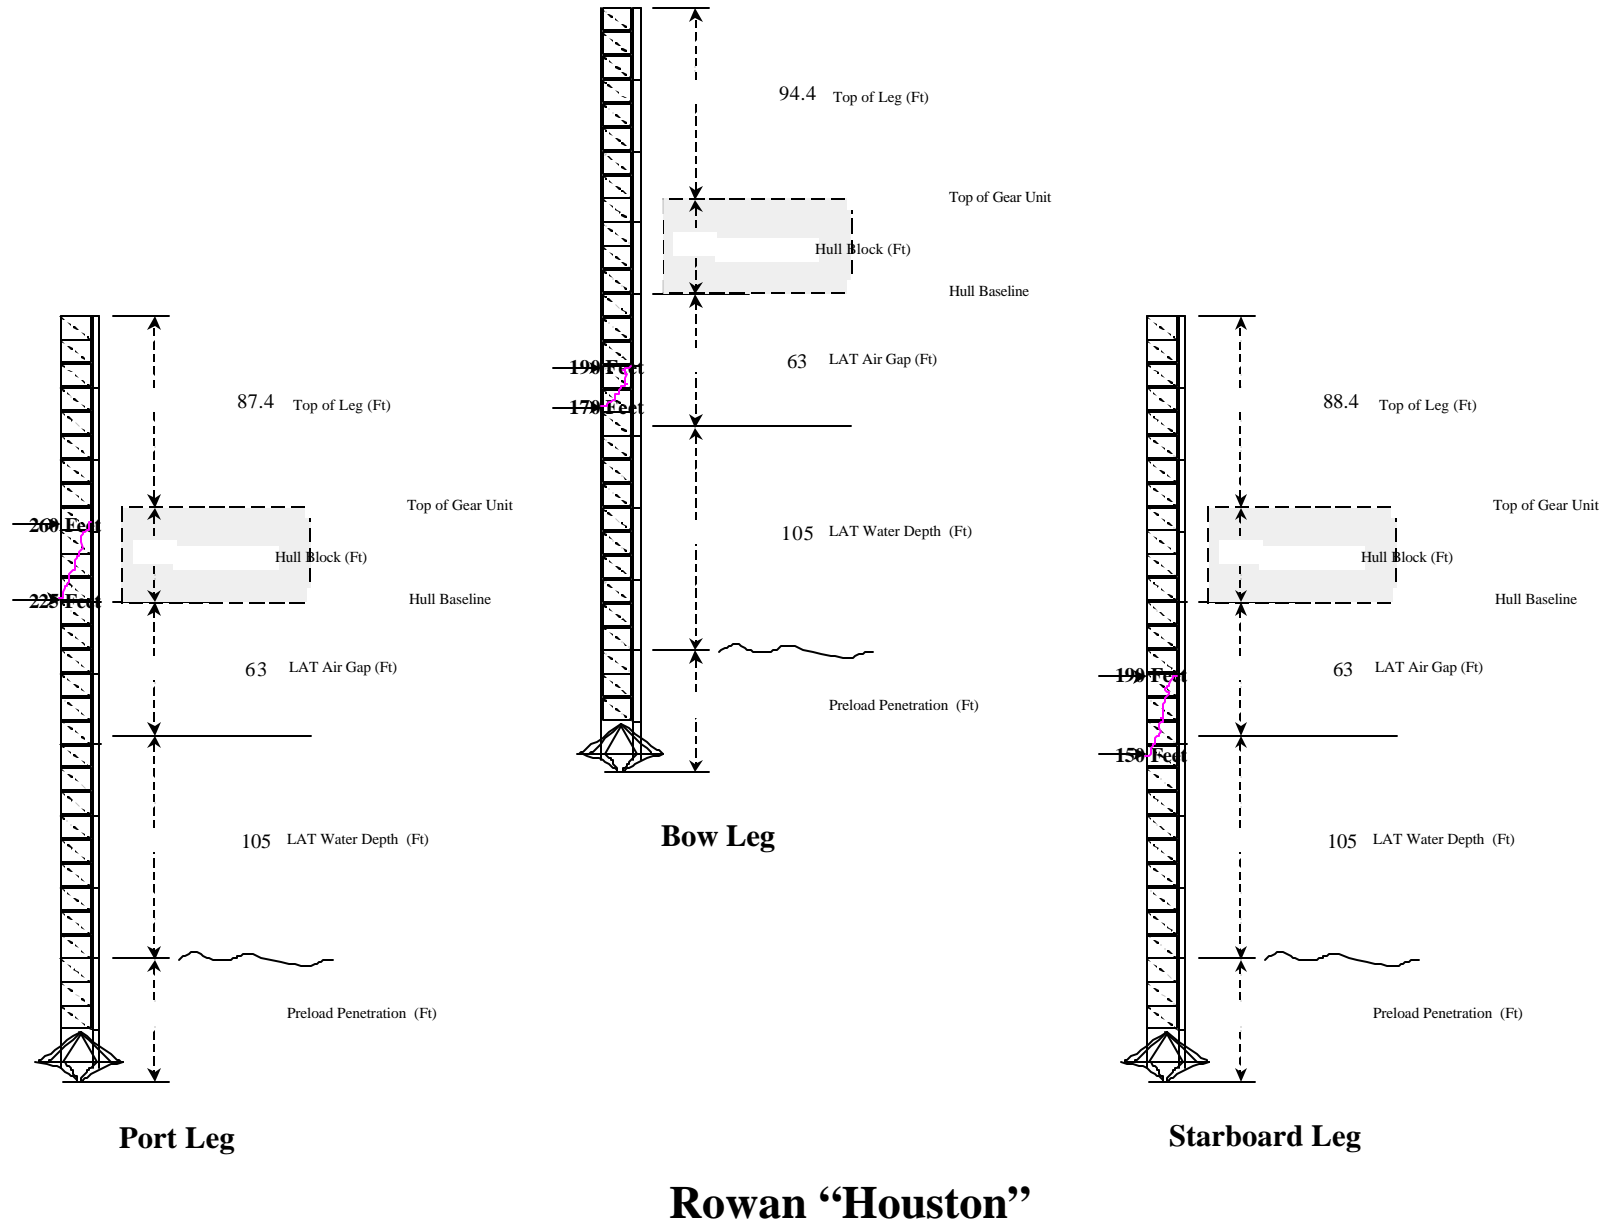
Figure 24: Location Arrangements: Rowan Houston

The Rowan Houston collapsed during the storm. The collapse was to leeward, (starboard). The rig hull drifted off and in the process the substructure slid off the hull and was found on the sea bottom. The hull then drifted off to the north and was found a short distance away. As is often the case with accidents of this type, sorting out the facts and re-constructing the accident is not that easy. While Rowan spent considerable effort to make observations to determine the cause, there are still several possibilities that present themselves: the most likely of which agrees both with Rowan's conclusion, and that of our own independent analysis. The jackup collapsed in a rather unusual way and various impact marks on the leg, at first indicated there may have been an initiating collision event, which in hindsight, turned out not to be the case.

Figure 24 gives an overall view of each of the leg positions based on 105 ft waterdepth and a 63 ft waveheight.

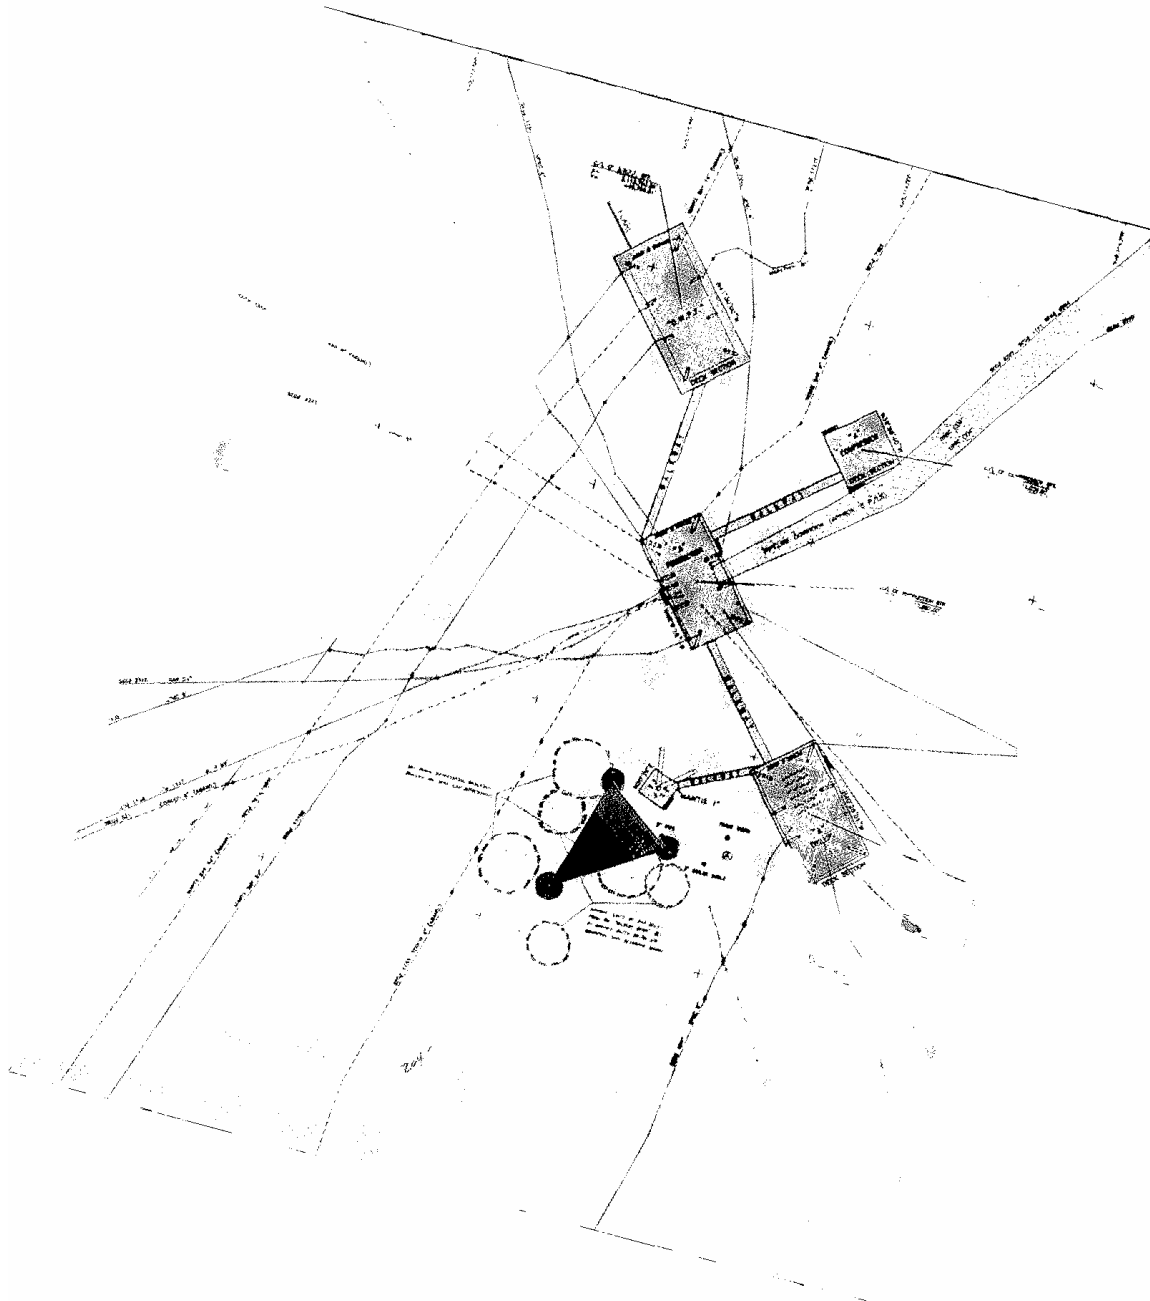
**Figure 26: Location Arrangements Rowan Houston**

The figure above shows Rowan Houston basic leg holes in black and a black triangle is shown between the rig positions (this is not the shape of the Rowan Houston hull). This shows the probable orientation of the unit in relation to other spud can holes (dotted circles), which may have provided interference. The original drawing was constructed, prior to the casualty. The author has superimposed the image of the can

spacing of Rowan Houston on this diagram: at the presumed location and direction. The direction of collapse is toward the top left corner of the page.

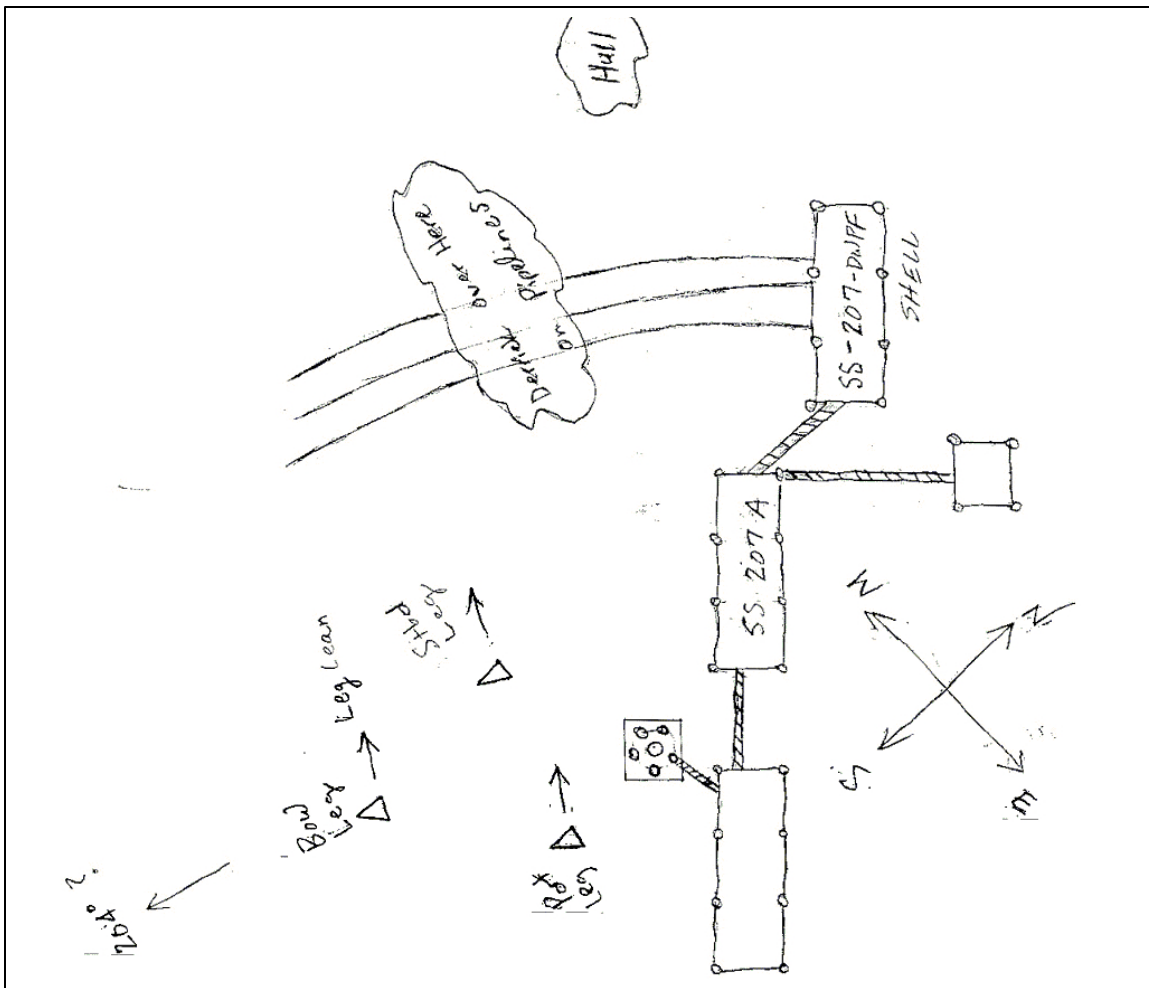
**Figure 27: Location Positions after the Rowan Houston collapse**

The following sketch provides some general idea of where debris may have been found, and the direction that the legs were pointing after the casualty and prior to retrieval.

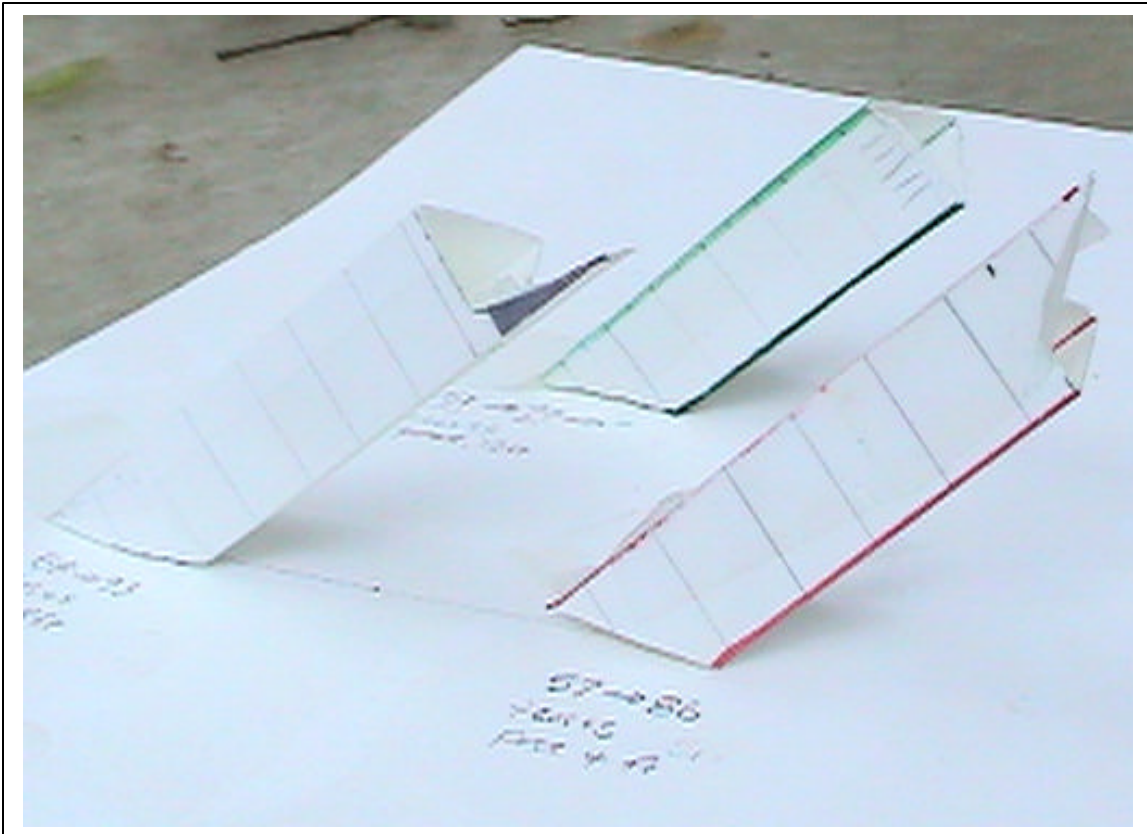
**Figure 30: Small cardboard model of Rowan Houston's Legs**

Figure 30 depicts the situation of the legs on location as surveyed after the incident. While this is a very early model and does not represent the final surveyed position, it was part of the analysis that led to the conclusion that there was no significant definable further penetration of the starboard leg. The divers located a leg depth indicator mark on one chord of each leg: and then moved around to the next chord using the closest horizontal brace as a reference. They then counted horizontal braces down to the mudline (and rack teeth between the lowest visible horizontal brace and the mudline). The penetration depth is then estimated knowing the elevation of the reference brace, the number of horizontal braces below the reference brace, and the number of teeth below the lowest horizontal brace. It was thus possible to use these observations to gain insight into the possible collapse mechanism.

As one example, the starboard leg that had been at 57 ft penetration was observed on average to be reading 86 ft and the leg was on an angle of approximately 45 degrees. If the leg had not penetrated further into the mud, but merely rotated on the tip of the can the reading should be:  $57/\sin 45^{\circ} = 81$  ft. The chord of the leg is approximately  $\frac{1}{2}$  a bay or 6 ft deeper putting the anticipated reading at the chord at 87 ft.

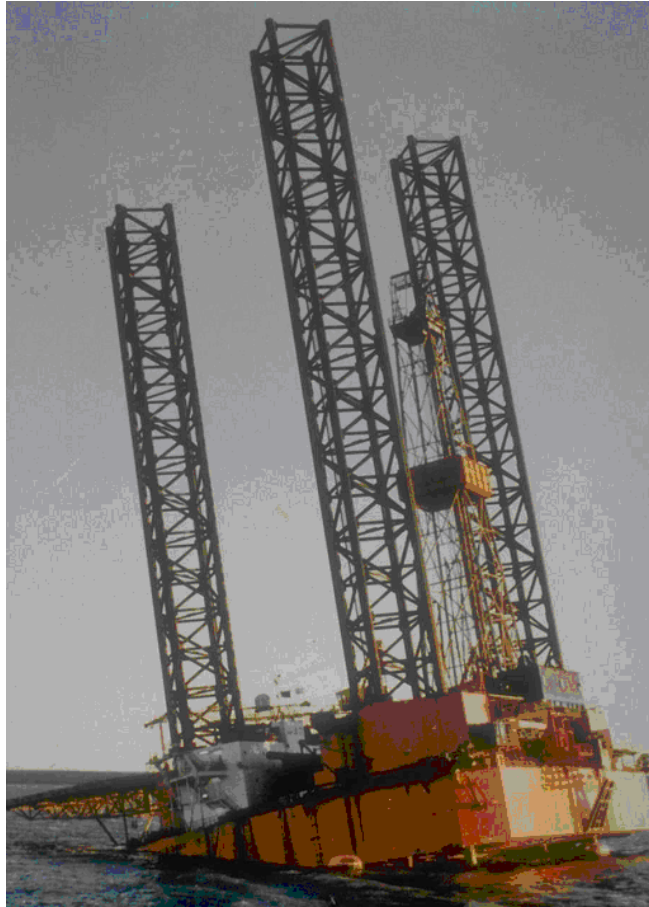
**Figure 36: Rio Colorado rig photo to illustrate the robustness of the Levingston III design to leg settlement.**

The Levingston rig type is very resilient to settlement, and one leg penetrating more than another. As an example of this the photo in Figure 36 shows the Rio

Colorado (same rig type) after a major bow leg settlement offshore Argentina. There was virtually no damage even with this huge uneven penetration (which resulted from a punch-through).

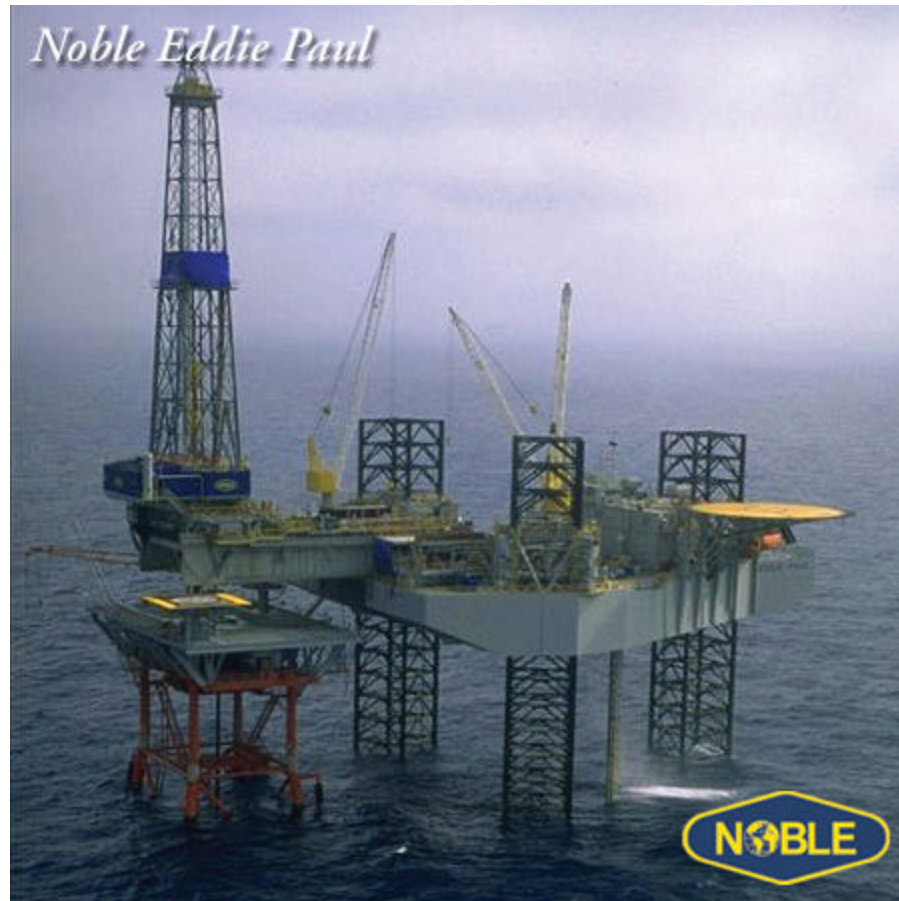
**Figure 37: Noble Eddie Paul**

The Noble Eddie Paul was in 283 ft waterdepth with about 105 ft of leg penetration into the soil. After the storm careful measurements were made. The leeward leg was down by 7 ft, and bow by 2 ft. The rig was reported to have moved 3.8 ft aft toward the platform and about 5.6 ft sideways, rotating about 5 degrees and was down to starboard 1.8 degrees with bow .9 deg high. There was no hull damage. The movement was pronounced enough to cause the rig to have to relocate on the platform in order to reach the wells after the event that were reachable before the event. The rig legs were jettied free and relaxed. The rig was then jacked up and re-preloaded.

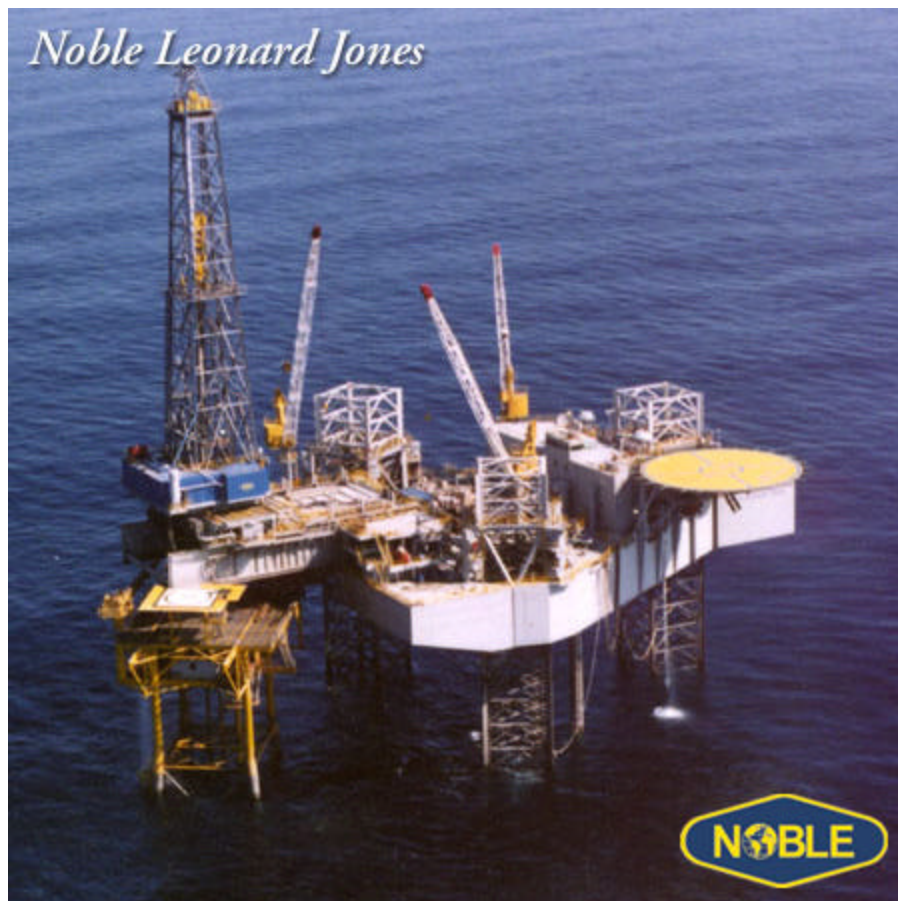
**Figure 38: Noble Leonard Jones**

The Noble Leonard Jones was on location in 184 ft waterdepth with 72 ft of penetration at the time of Hurricane Lili. The starboard leg penetrated an extra 2.5 ft giving a rig inclination of 0.9 degrees to starboard with the bow 0.5 deg. high. The rig moved 3.9 ft aft. Such an incident is not unexpected but shows that the rig may have exceeded the level to which it was preloaded by some small amount. There was no leg or hull damage. The only consequence was that the legs had to be jettied free, and the rig jacked up on the location and preloaded again.

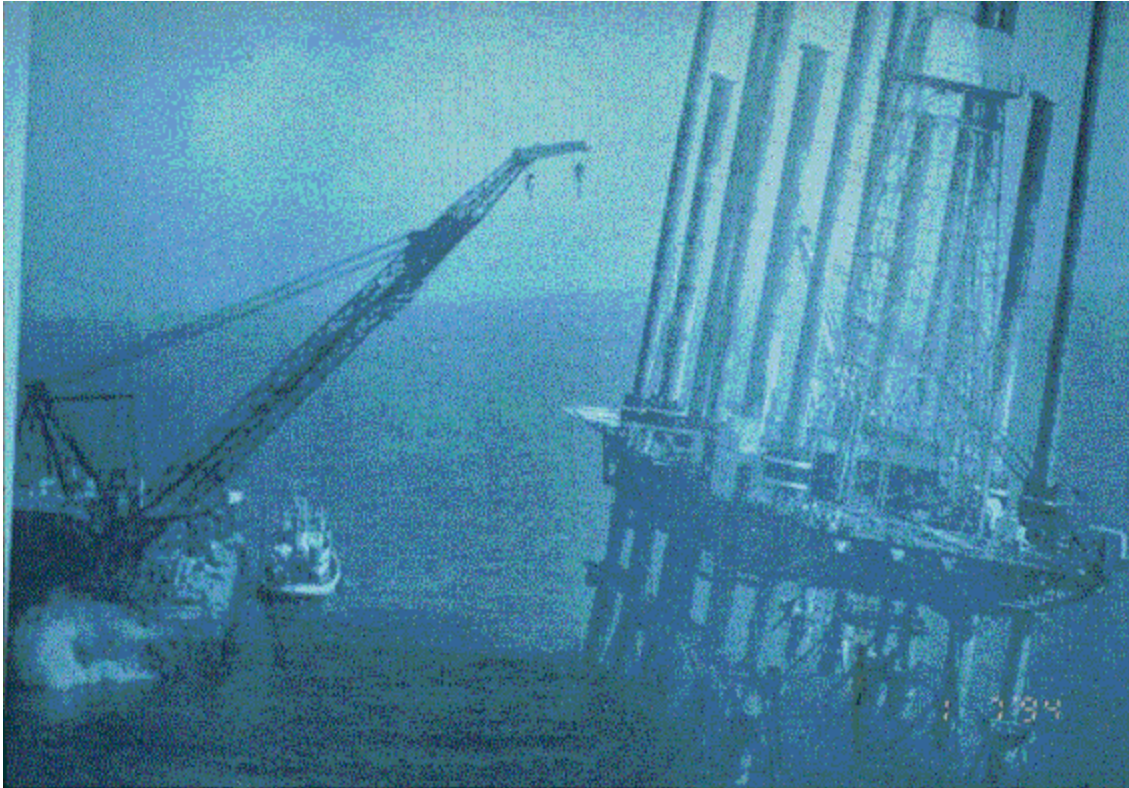
**Figure 41: Mr Gus settled on location – prior to preload requirement**

Settlement either from additional leg penetration or from scour and other “foundation related issues” was not uncustomary, and was not considered to be a failure event. The addition of a preload requirement minimized the risk of further penetration in storms.

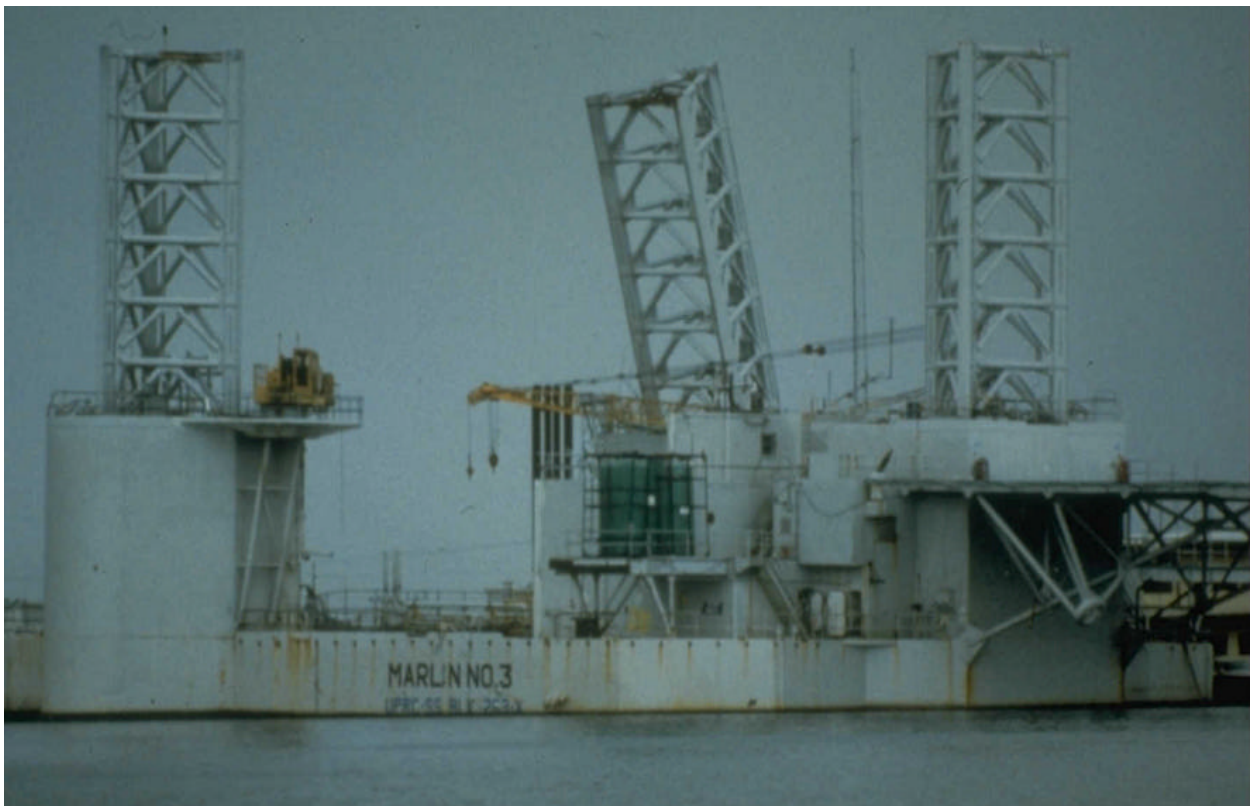
**Figure 46: Marlin 3 After Hurricane Andrew and Prior to Scrapping.**

.Marlin 3 shown in Figure 46, after the incident – was overloaded by the hurricane that exceeded the design criteria – but not by much (Ref 2).

While the Marlin 3 figures concluded that it was above its limitations - there was a strong suspicion that the reason it did not survive arose from the multiple repairs to the trussed legs which had cracked and been troublesome to keep intact over time.

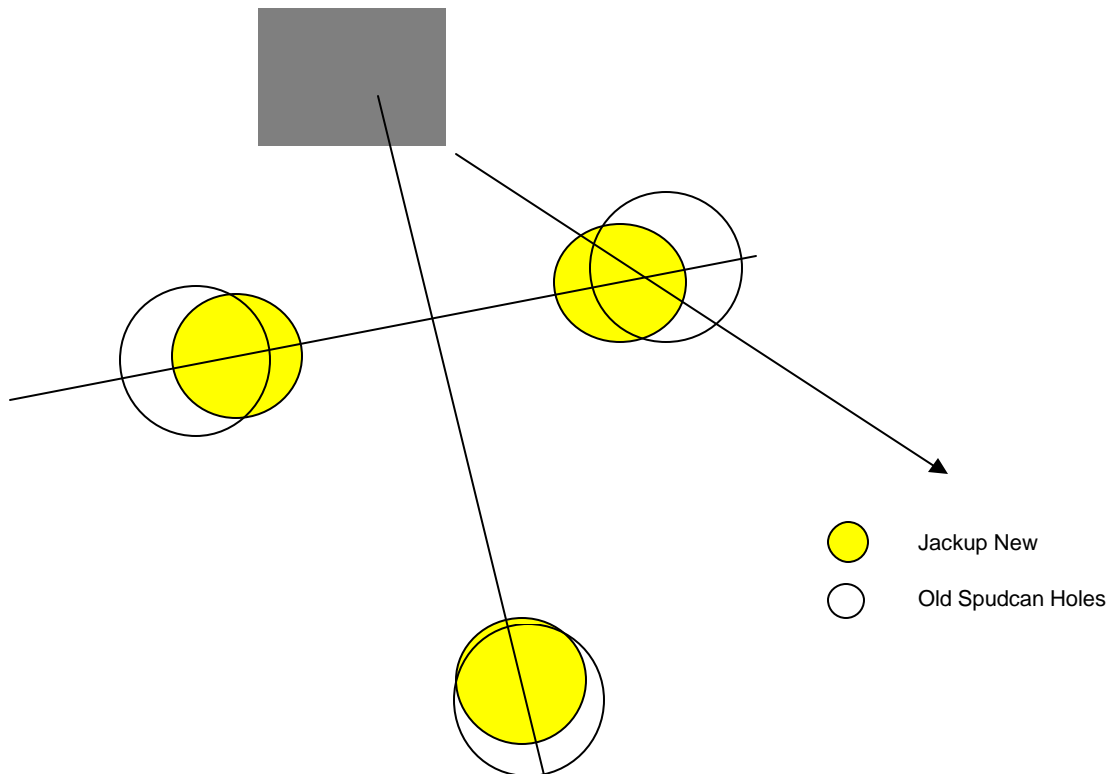
**Figure 48: Spud Can Footprints of Jackup going on location with Old Spudcan Holes, alongside a platform (striped area).**

As can be seen in the Figure 48 above, certain footprints do not match those of rigs, which may have been on location previously. The following illustration Figure 49 shows a variety of popular rig types, some 3 legged and some 4 legged with footprints superimposed. It must also be kept in mind that the average bearing pressure of the spud cans varies considerably also exacerbating the problem. If a spud can with a higher bearing requirement is on the platform ahead of the latest rig then it may turn out that the spud can holes are also deeper than that which would have been appropriate for the later rig. The result of several rig footprints of different size over the same platform gives a visual image of the issue.

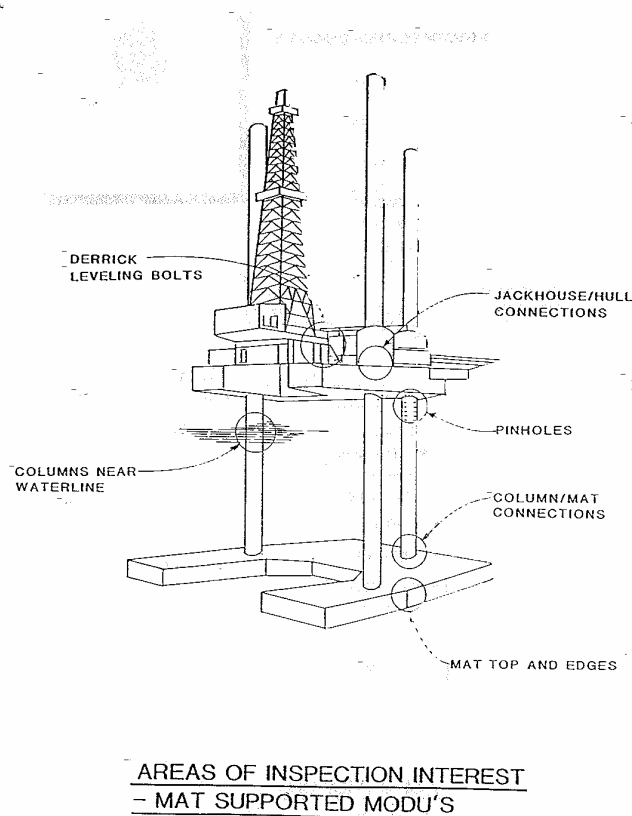
**Figure 54: Mat Supported Rig Areas of Inspection Interest**

Likewise, it is well known for mat-supported rigs that the mat-column connection is a key area, which has caused casualties in the past. This area is generally still recognized as being of importance and we would anticipate that most rig inspectors would today be aware of this: but as the events of the Ranger 1 which caused this issue to be elevated fade from memory – this crack prone area could be an issue in a future incident.

*Mat Rigs – Mat/Column connection issues arose from several rigs experiencing fatigue issues at the connection point. General advice on inspection is to carry out a diligent magnetic particle inspection of the connection points at a minimum at each underwater survey (every 5*

It is thus one of the recommendations from this study that MMS give some consideration to encouraging the industry to develop a guideline of critical areas to inspect on jackups and make this guideline generally available for surveyors and inspectors. It may be that the class societies can be persuaded to cooperate in the writing of this document.
