FY01 Mishaps

Fire Reconnaissance, Huron-Manistee NF July 20, 2001

Cessna U206G

Mission: Aerial Observation Damage: Substantial Injuries: 2 Minor Procurement: CWN NTSB ID: CHI01LA225

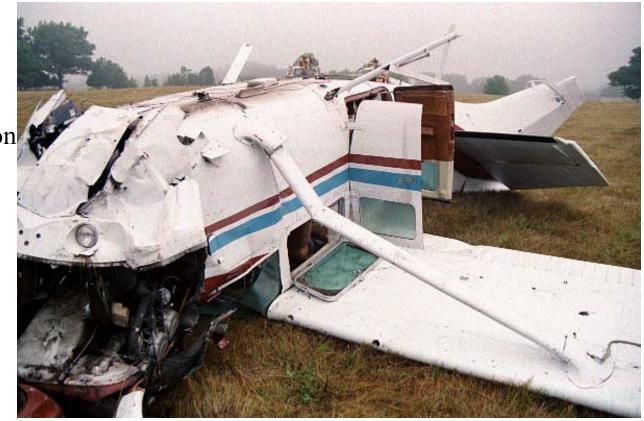
During an aerial observation mission the aircraft failed to respond to the pilots power application. The aircraft was not within gliding distance of an airfield or lake so the pilot maneuvered to land in a field.

The aircraft touched down in a level condition, bounced, then landed hard and flipped on its back.

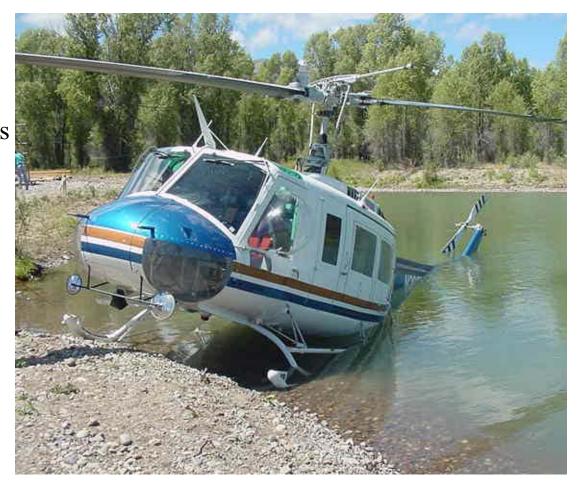
The Bell 205 was operating at a common dipsite when a Bell 212, operating in close proximity, got his long line and bucket tangled in the 205's rotor system.

The 205 pilot did a vertical autorotation to the water, coming to rest with the tail section and part of the fuselage in the pond. The Bell 212 was not damaged.

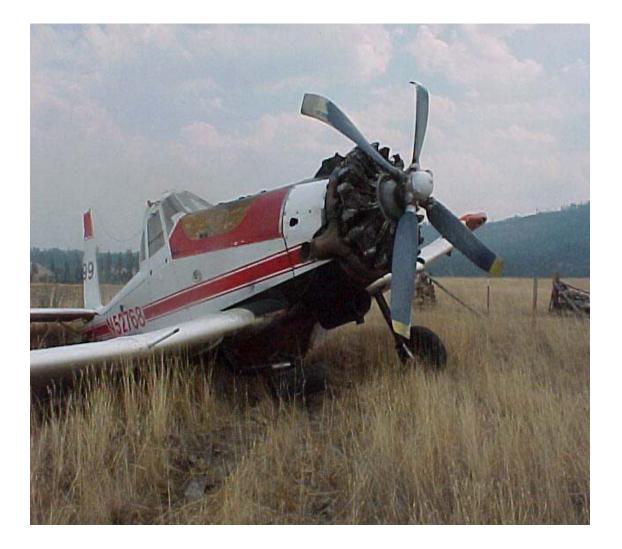
After touch down, witnesses observed the aircraft bouncing, leaving the runway on the east side, moving back across the runway, then spinning after contacting a fence and, coming to rest off the runway on the west side.

The pilot sustained only minor injuries. Assistance quickly arrived to prevent fire.
