FY02 Mishaps

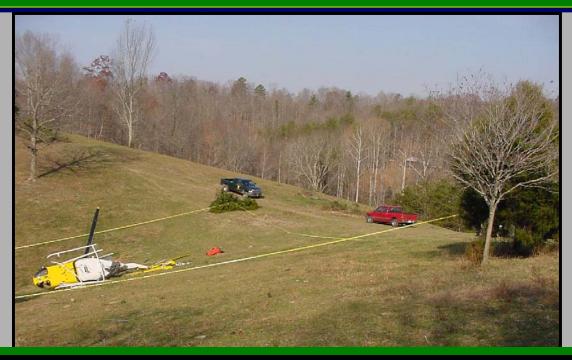
Great Gulf Fire, Daniel Boone NF November 12, 2001

The helicopter was conducting bucket operations when the bucket, which was attached to the cargo hook of the aircraft with a short (approx. 11 ft) lead line, came into contact with the tail rotor of the aircraft.

The pilot received serious injuries and was airlifted to the hospital.

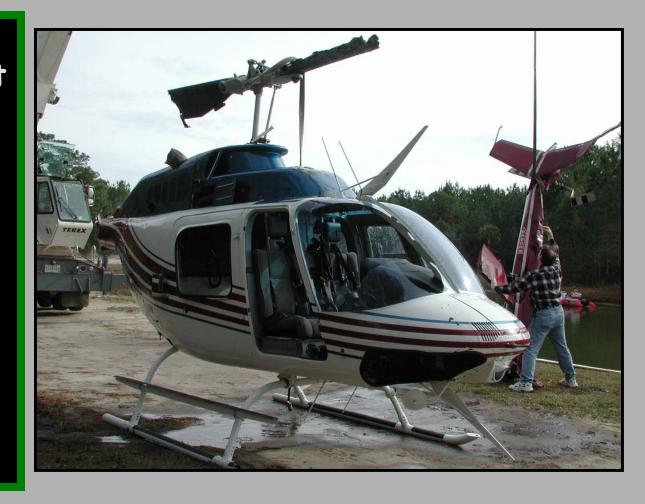
According to the operator, the pilot was attempting a water-dip when the cable slipped over the toe of the skid. As the pilot began a climb from the pond the helicopter rolled right and collided with the water.

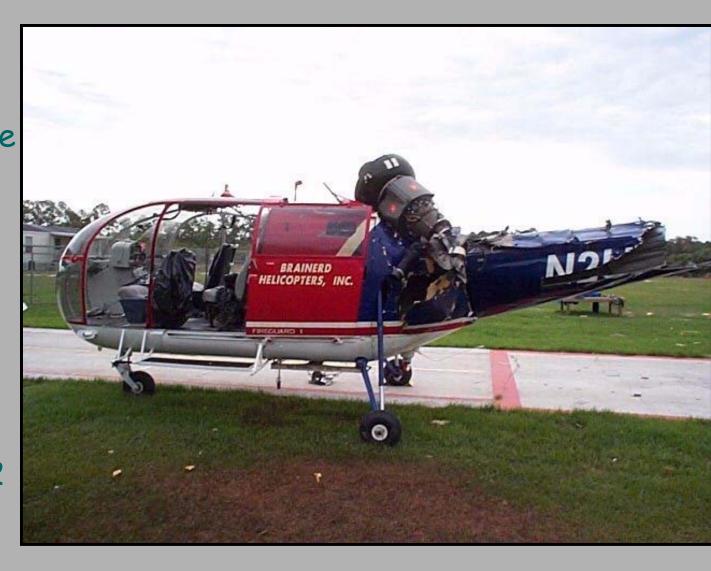
U.S. Forest Service personnel dispatched the helicopter with inoperative brakes for the sole purpose of searching for the possible downed aircraft; a pilot and a U.S. Forest Service employee were on board.

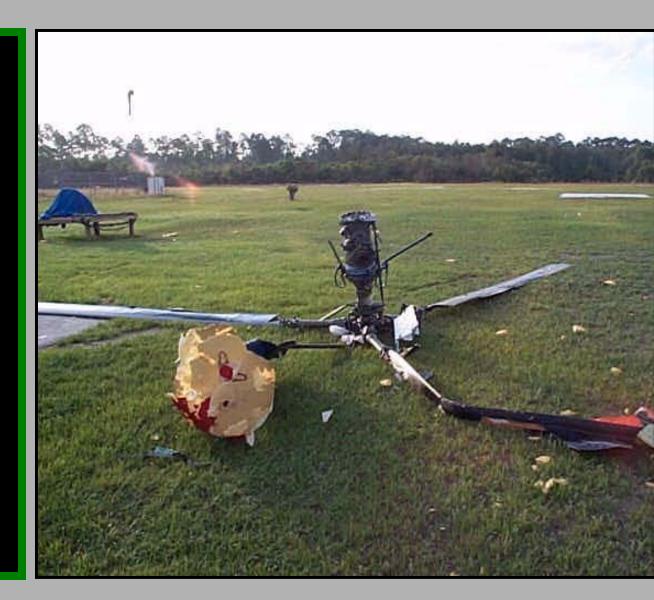
The aircraft landed and shutdown without incident at the search area to confer with a law enforcement officer. The pilot was assured that the chief pilot would be standing by with chocks upon returning to the Helibase.

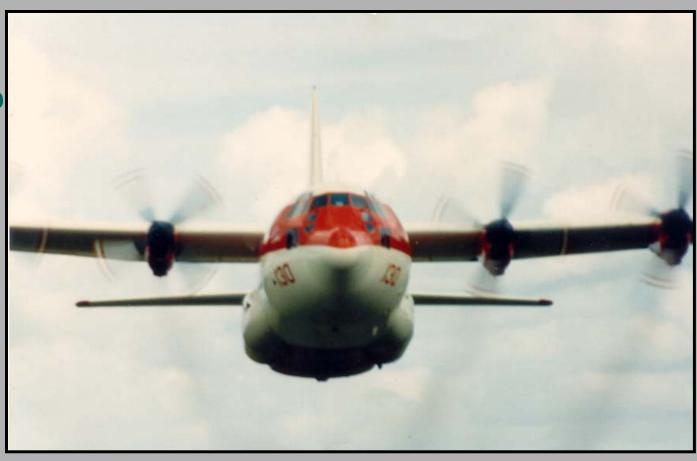
N130HP, broke apart in flight while executing a fire retardant delivery. Videotapes of the accident sequence indicated that the airplane had initiated its retardant delivery run.

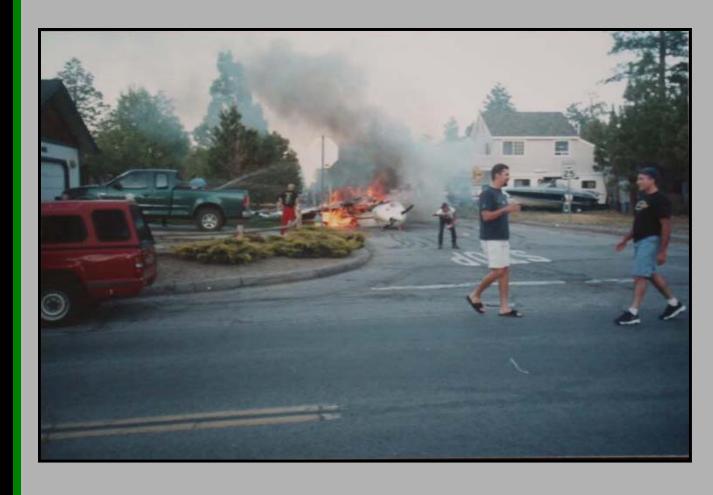
The pilot reported that while on approach, both engines lost total power. Unable to reach the runway, the pilot elected to execute a forced landing to a residential road. After landing hard on the road, the airplane impacted a tree and a fence.

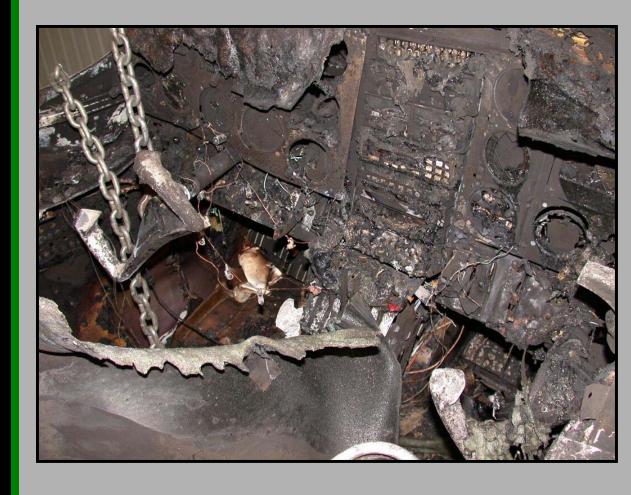
Due to a compromise of the evidence, the cause of the loss of power is of an undetermined nature at this time.

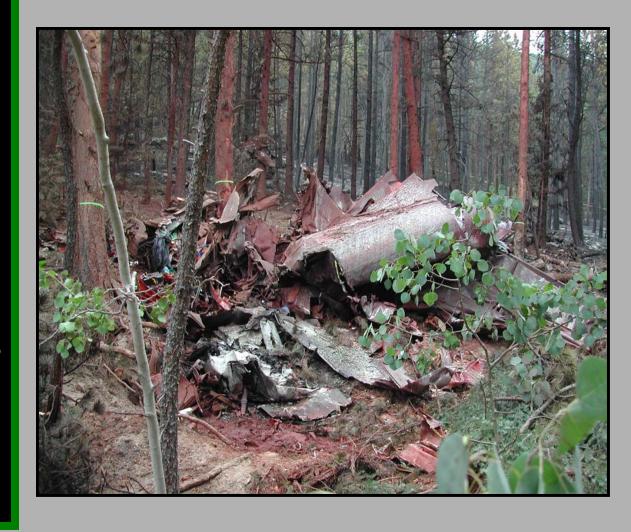
The copilot of T-161 said Tanker 123 was in his base turn for the drop and in a "smooth 15 to 20 degree bank turn," when the left wing separated from the airplane. "The aircraft then went into a rotation and impacted the ground."

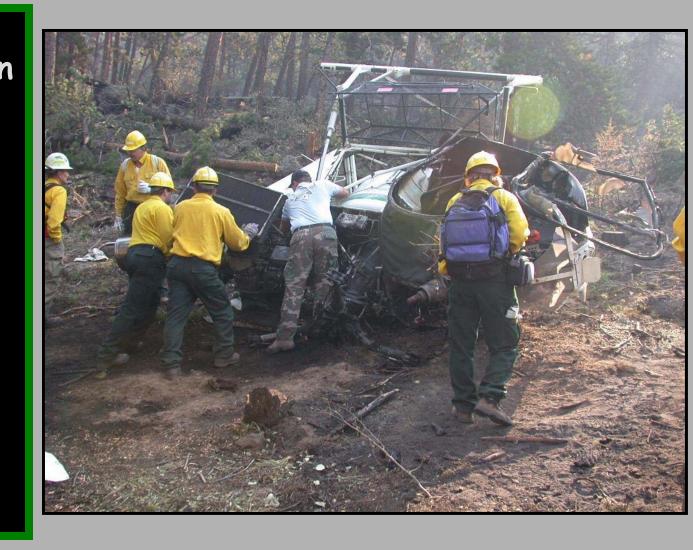
Witnesses heard the pilot give a warning over the radio: "Helicopter going down." They heard a high pitched whine and saw the main rotor blades turning slowly as the helicopter descended. There was a post impact ground fire that was quickly extinguished.

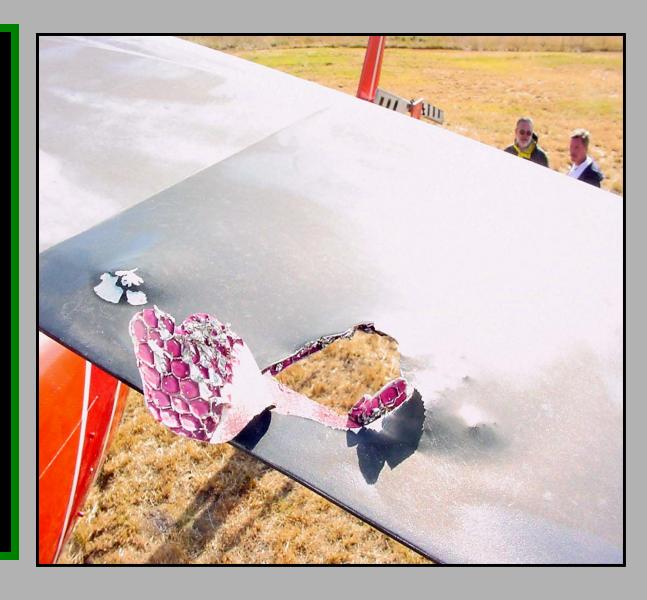
Beaverhead-Deerlodge NF August 24, 2002

Several missions had been flown the day of the accident and the pilot was unsure as to when the damage occurred.

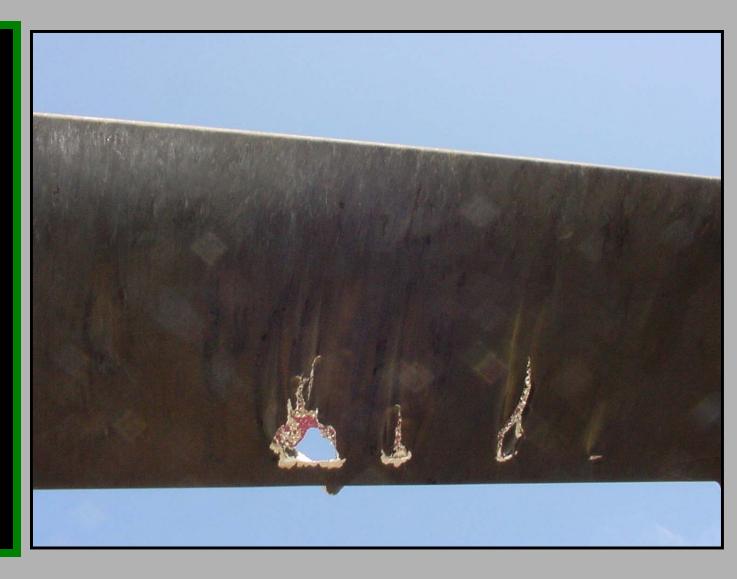
Beaverhead-Deerlodge NF August 24, 2002

The pilot later said he was "heli-mopping" when he descended into the trees with the 50 foot long line. During this maneuver, the main rotor blades came in contact with trees.

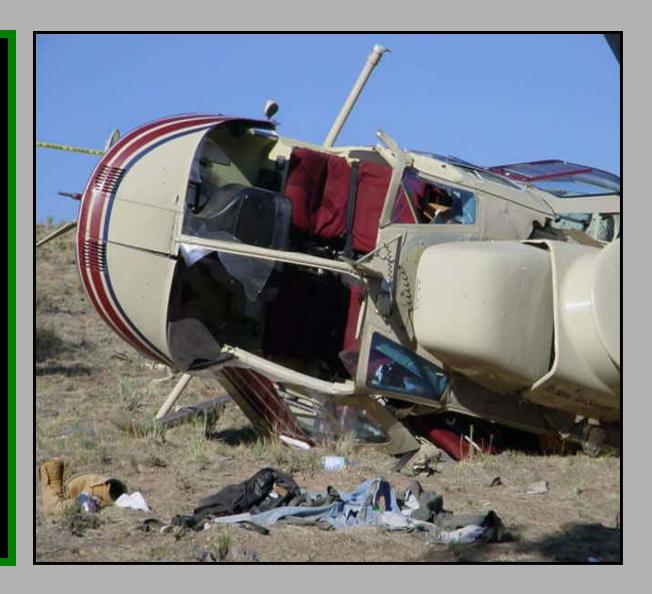
Rio Grande NF August 26, 2002

Witnesses reported the helicopter was approaching to land in gusty wind conditions when it started spinning to the right. It collided with trees, struck the ground, and rolled over.

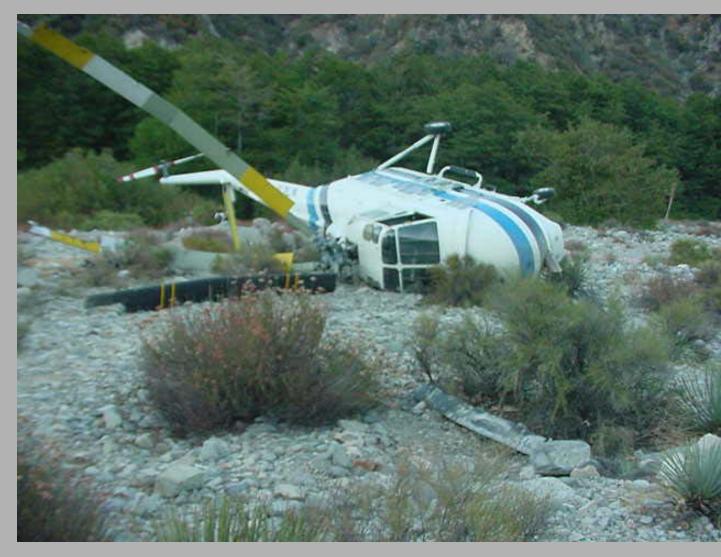
N747A, collided with terrain while attempting a precautionary landing in a dry creek bed. The helicopter sustained substantial damage and the pilot, the sole occupant, was not injured.

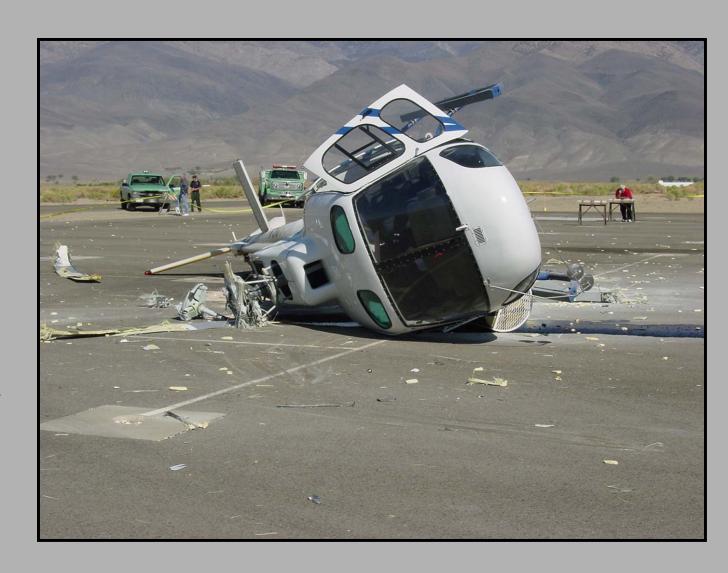
AS350-B3, N352SA, collided with terrain during a premature liftoff while engaged in a predeparture hydraulic flight control check.

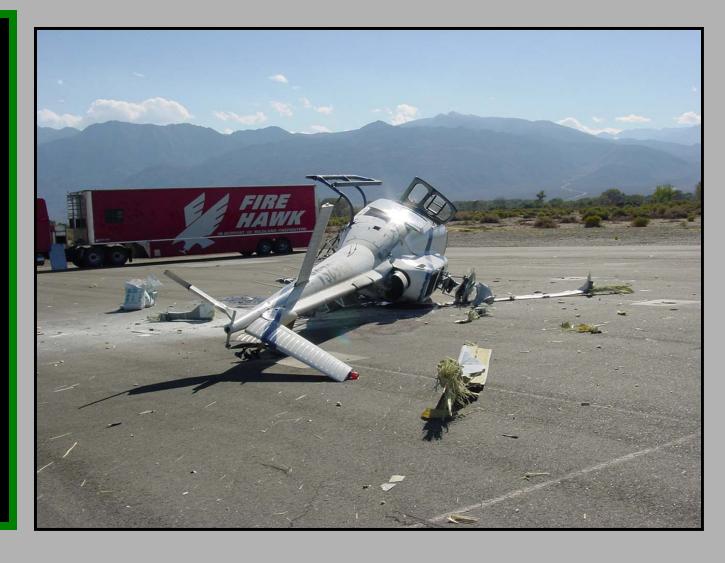
The collective had been placed in the down and locked position. After depressing the hydraulic test switch, the pilot moved the cyclic fore and aft to confirm there was remaining pressure.

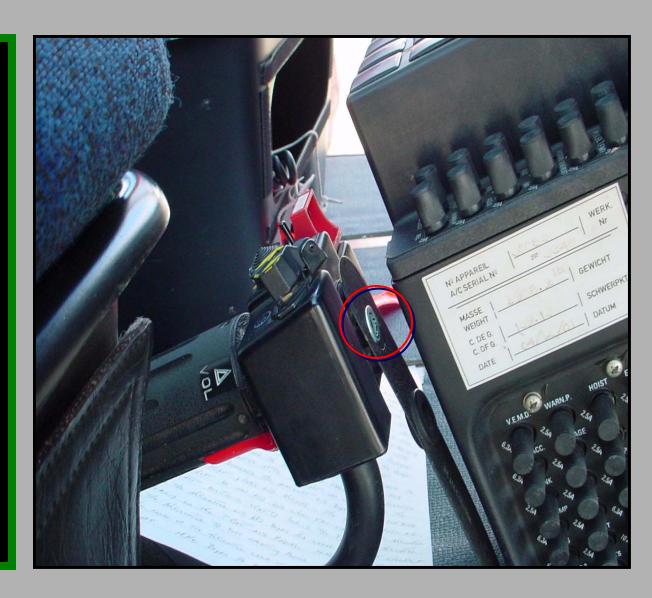
The collective rose uncommanded and the helicopter moved forward in a nose down attitude. The main rotor struck the ground and the helicopter made two revolutions before rolling over onto its side.

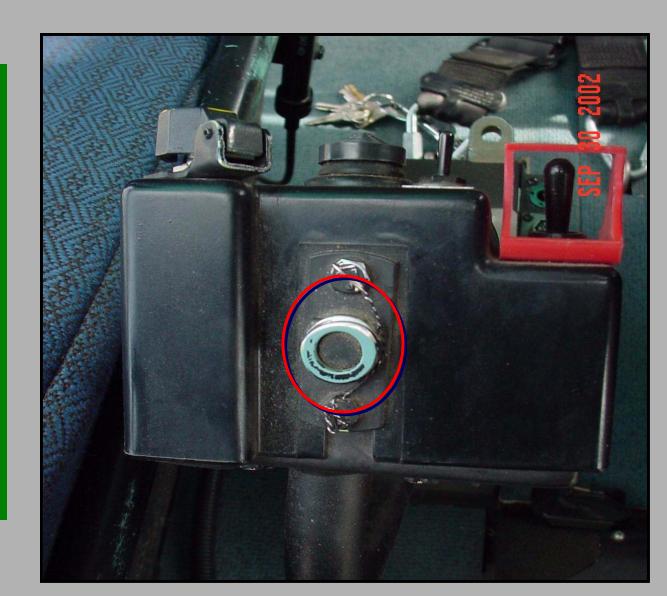
The collective's locking mechanism stud was worn and the collective came loose during movement of the cyclic.
