# *Aviation Accident Review*

**FY03**

## **USDA Forest Service Aviation Accident Review**

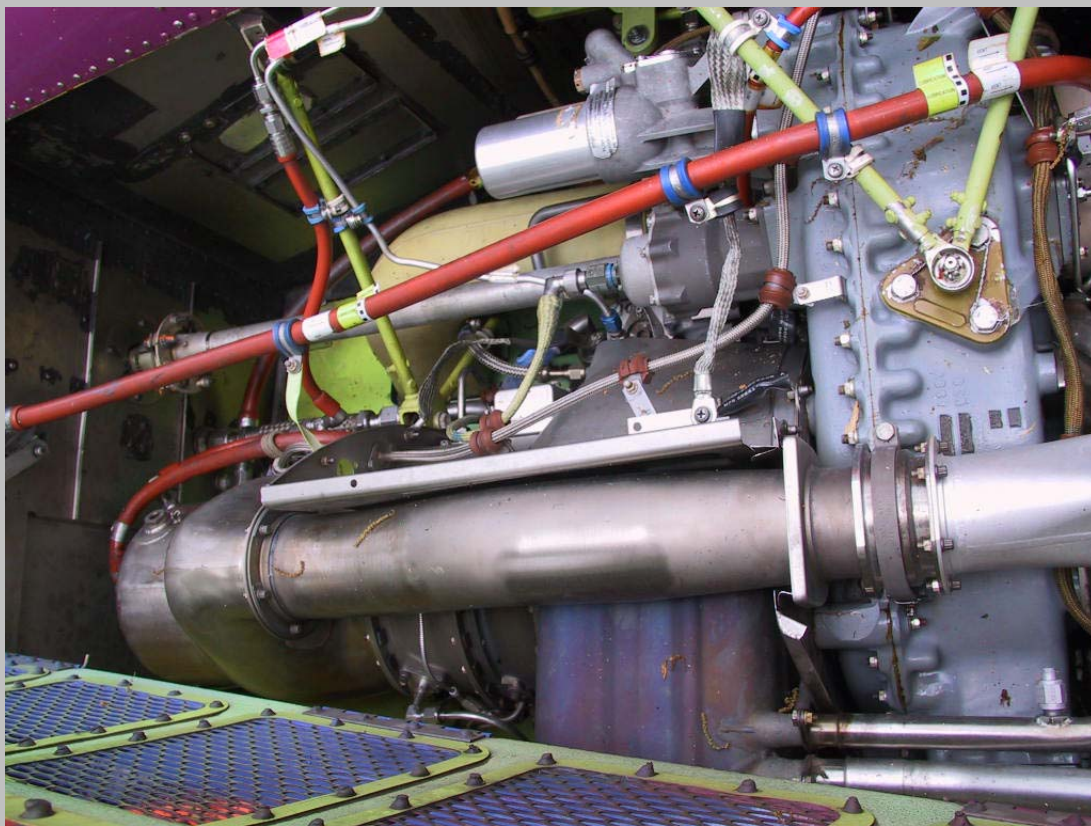
After the wreckage was recovered, the engine was removed and set up in a test cell. The engine operated normally in the manual mode.

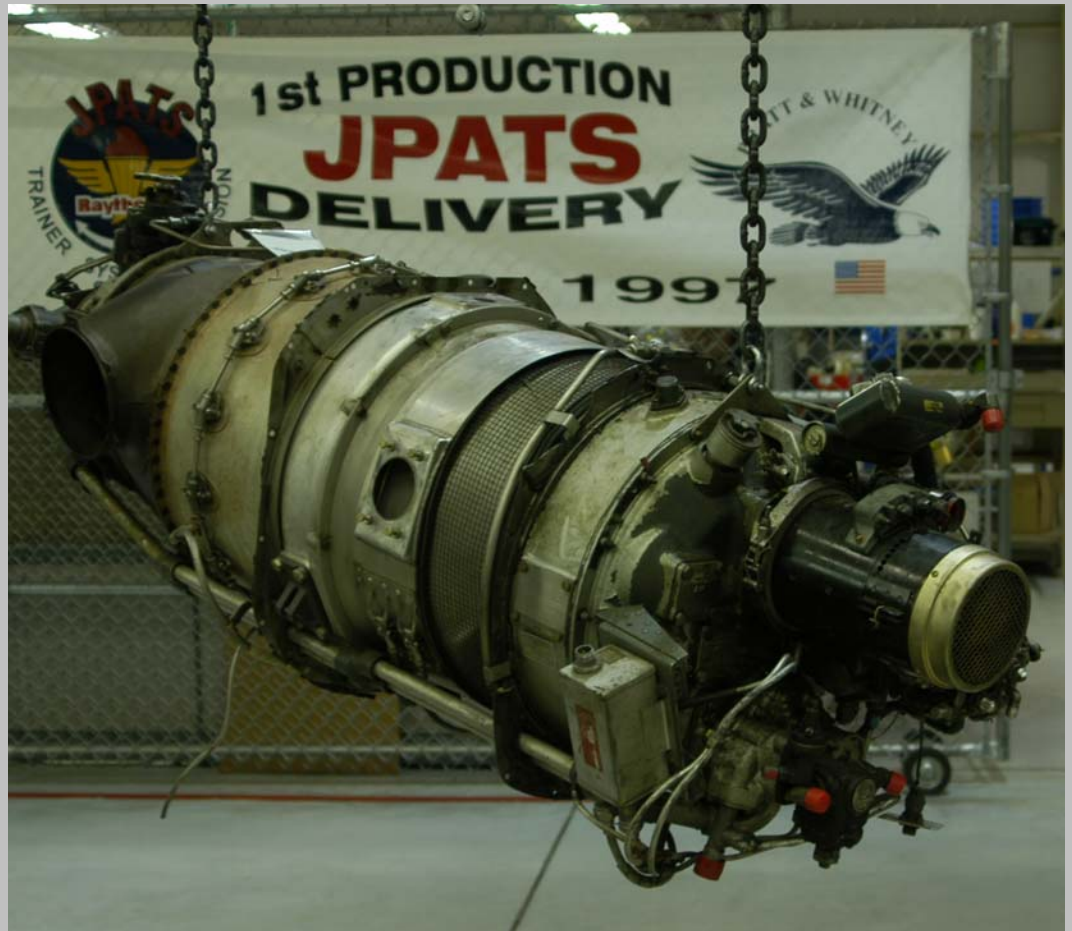
The engine was reported to have a total time of 26,775 hours, including 10,708.9 hours since last overhaul and was retained for further examination.

The tear down analysis revealed excessive damage to the compressor blades and other turbine components

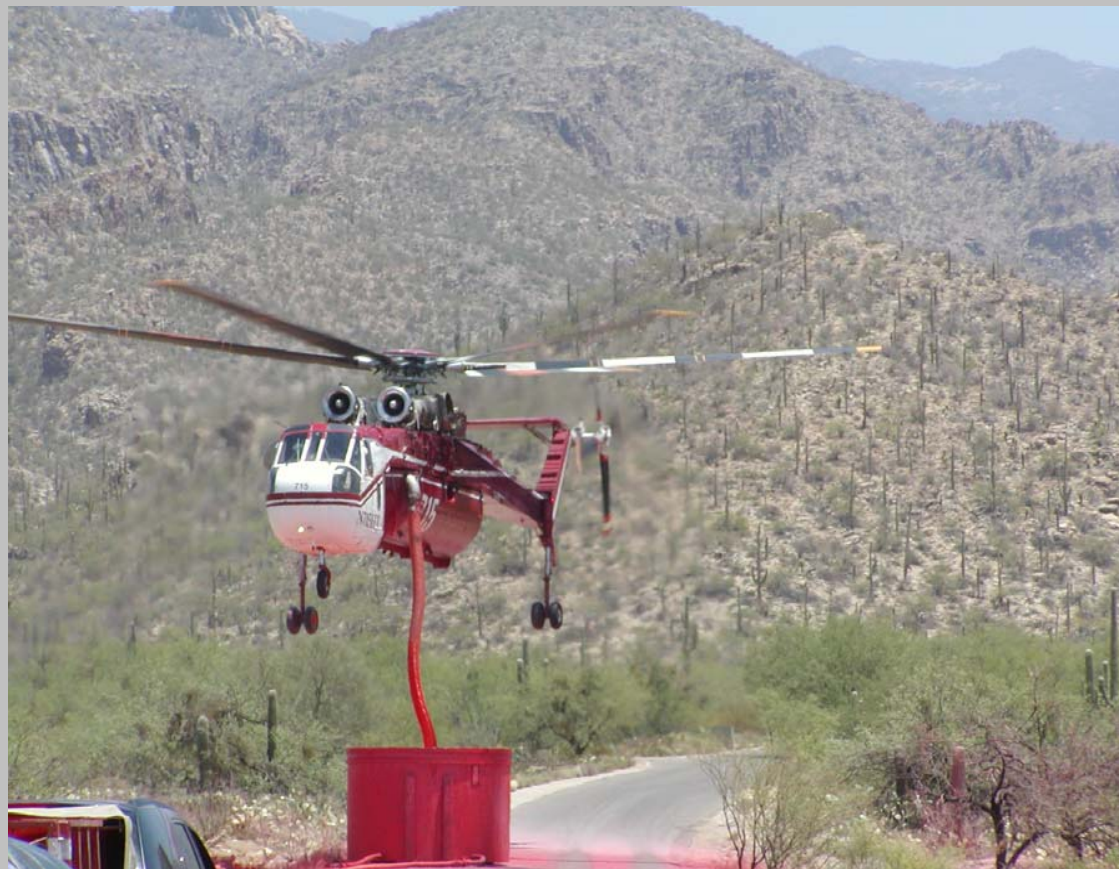
Maintenance personnel discovered the exhaust tube on the left engine was damaged. The helicopter was shutdown and examined

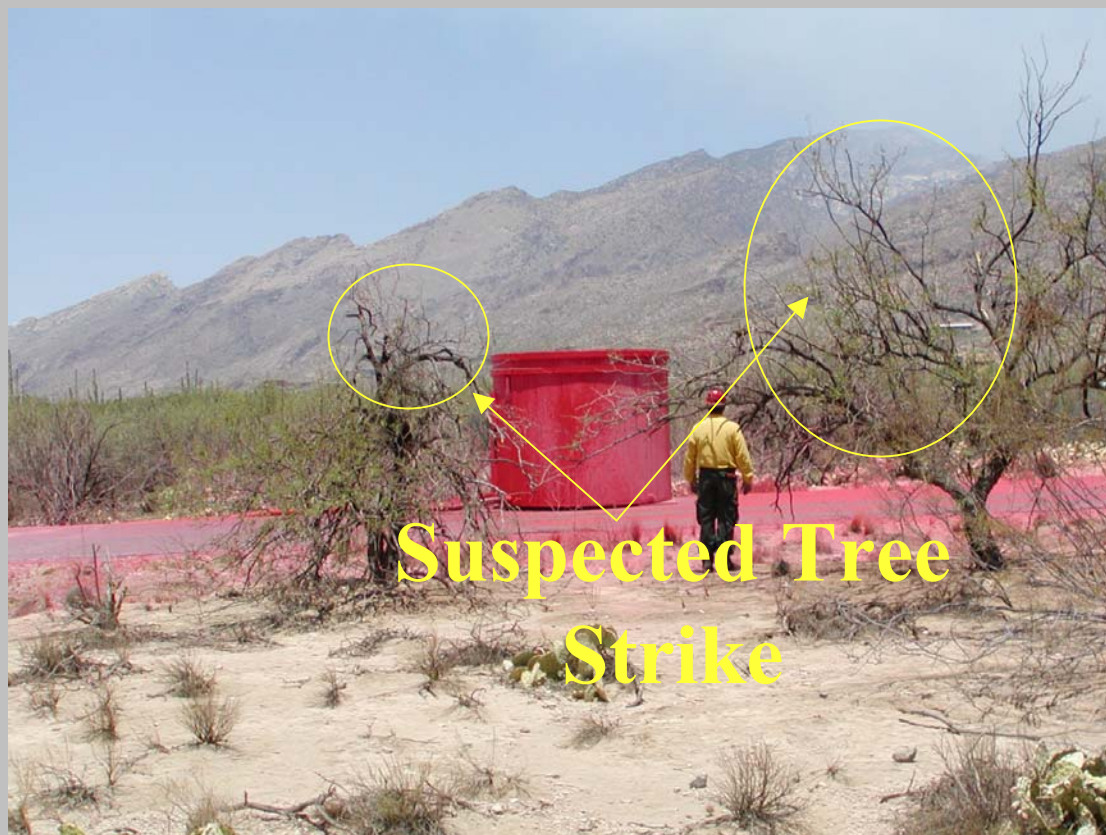
Misjudgment of aircraft clearance to trees, and loss of pilot situational awareness. The failure by both dip site personnel and pilots to assess unseen hazard of trees at dip site.

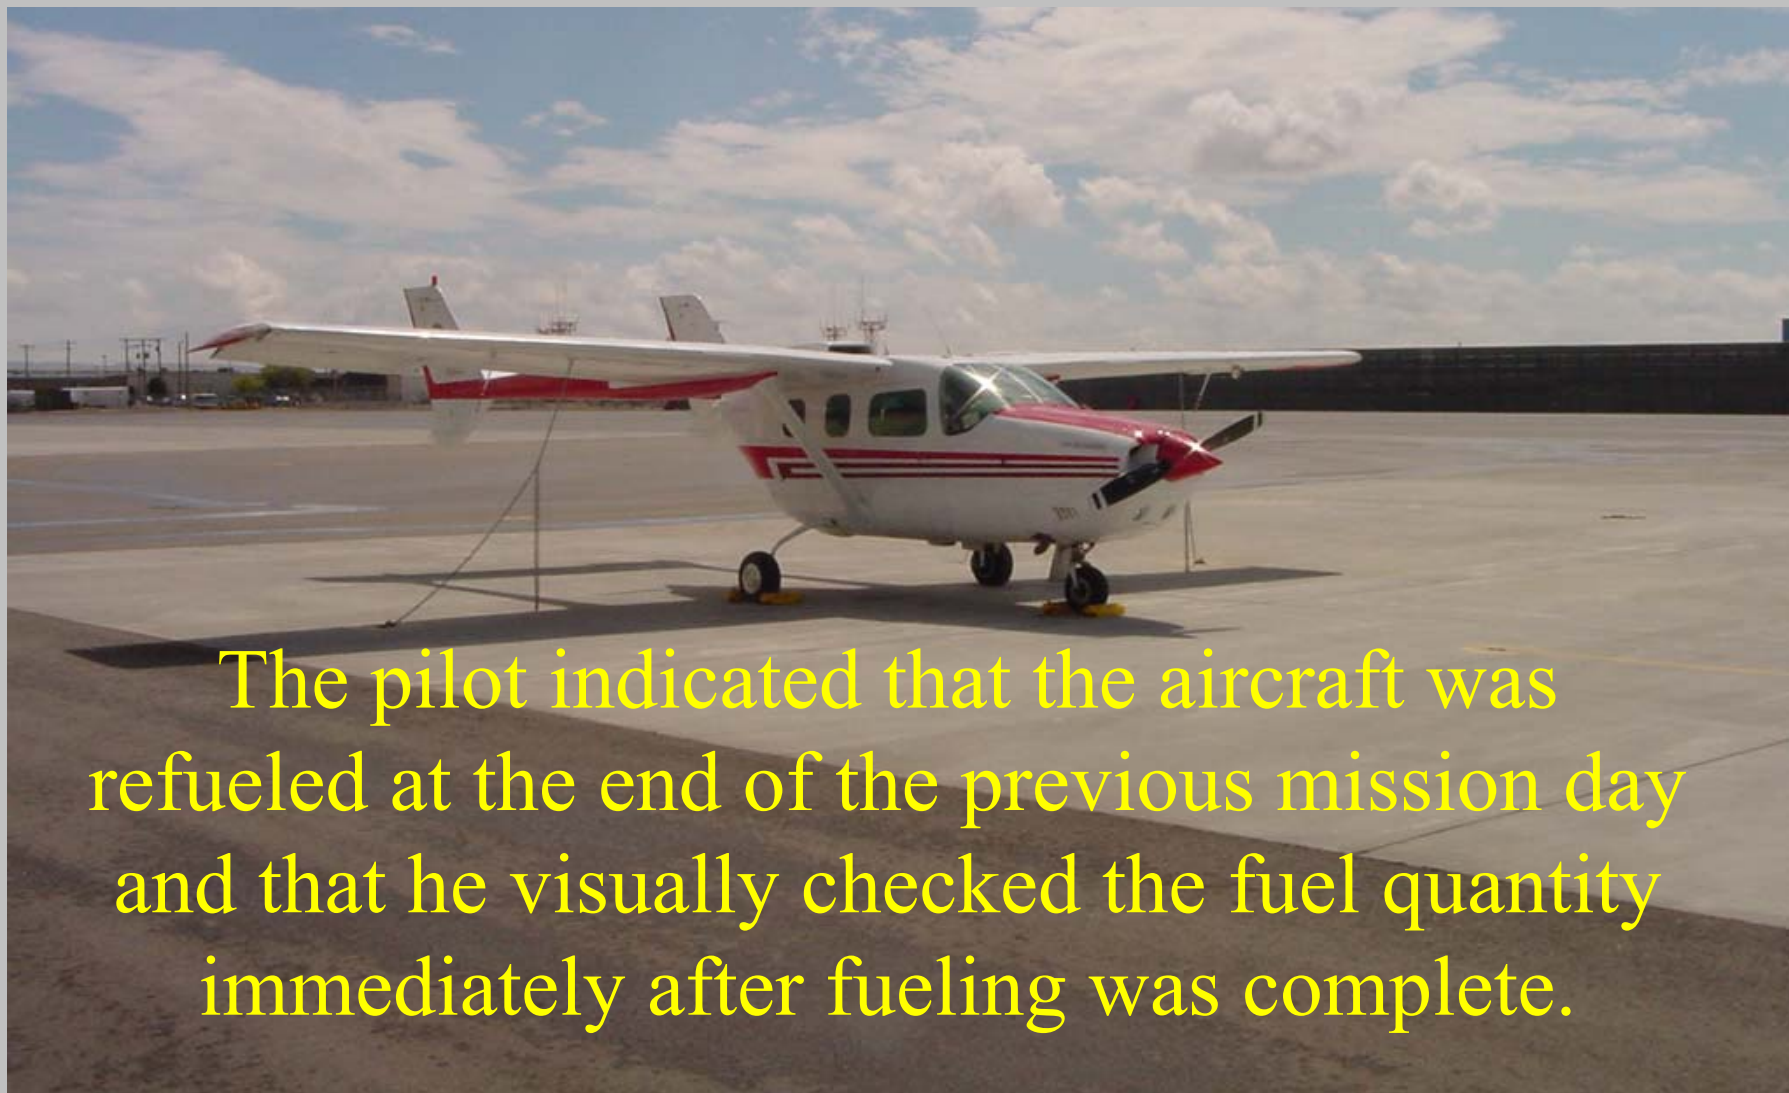
The pilot indicated that the aircraft was refueled at the end of the previous mission day and that he visually checked the fuel quantity immediately after fueling was complete.

The pilot said he checked the fuel gauges before the flight and they were accurate, but upon inspection after the incident, the following condition was observed with full tanks. (74 Gallons)

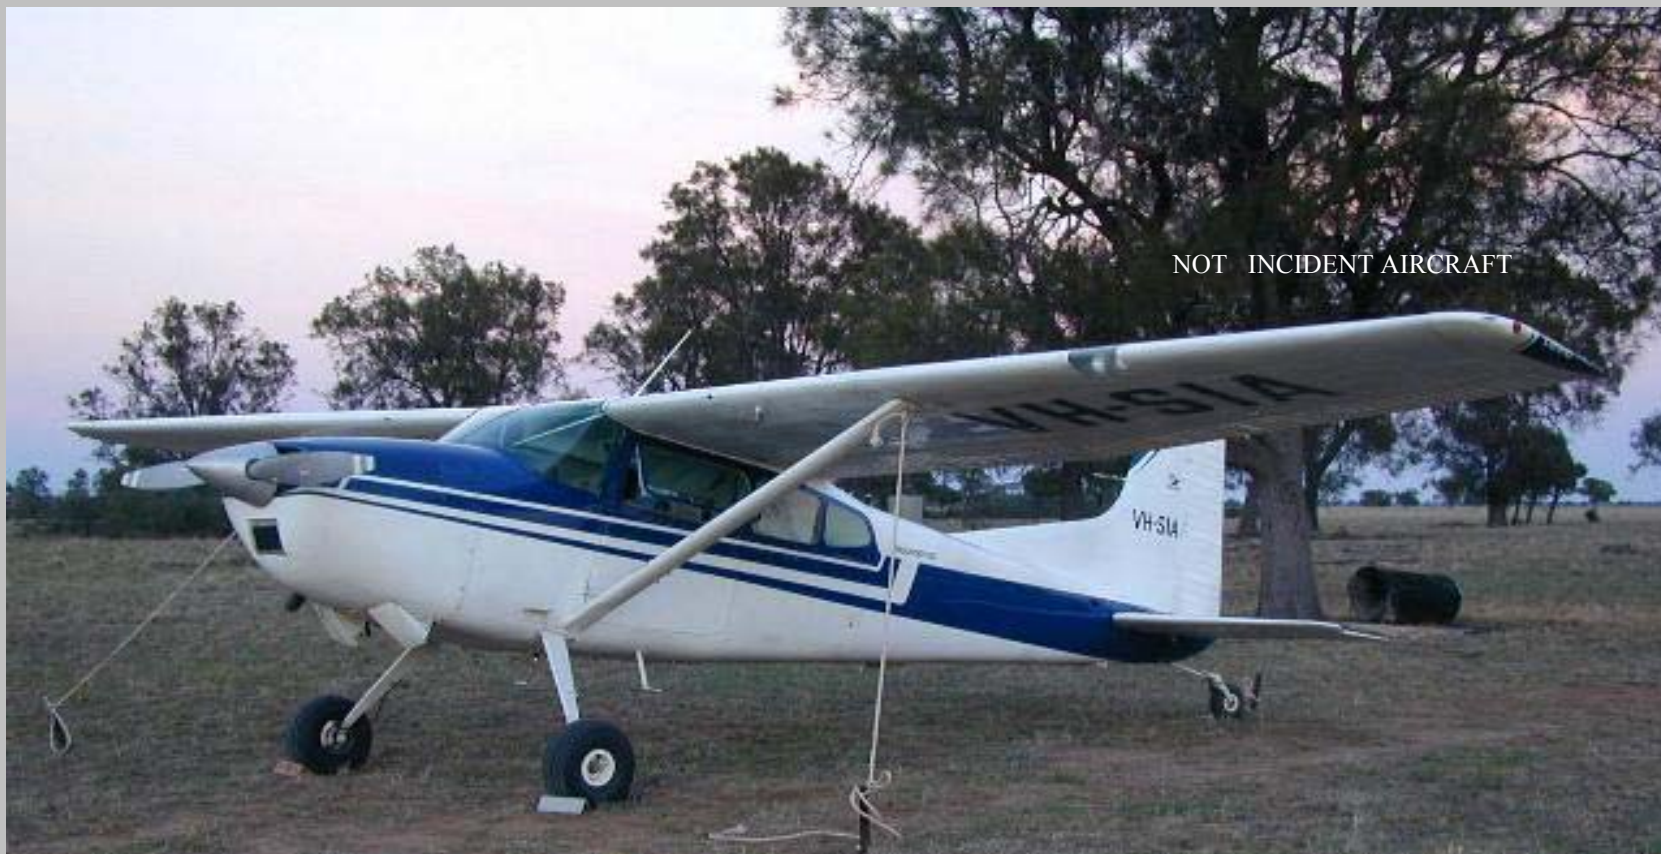
NOT INCIDENT AIRCRAFT

The pilot serviced the aircraft with fuel that was needed for the mission himself. He put all the additional required fuel in the left wing tank.
