# FY06 Forest Service Aviation Accident Review

NTSB Identification: **SEA06TA152**

NTSB Identification: **LAX06GA254**

NTSB Identification: **SEA06GA158**

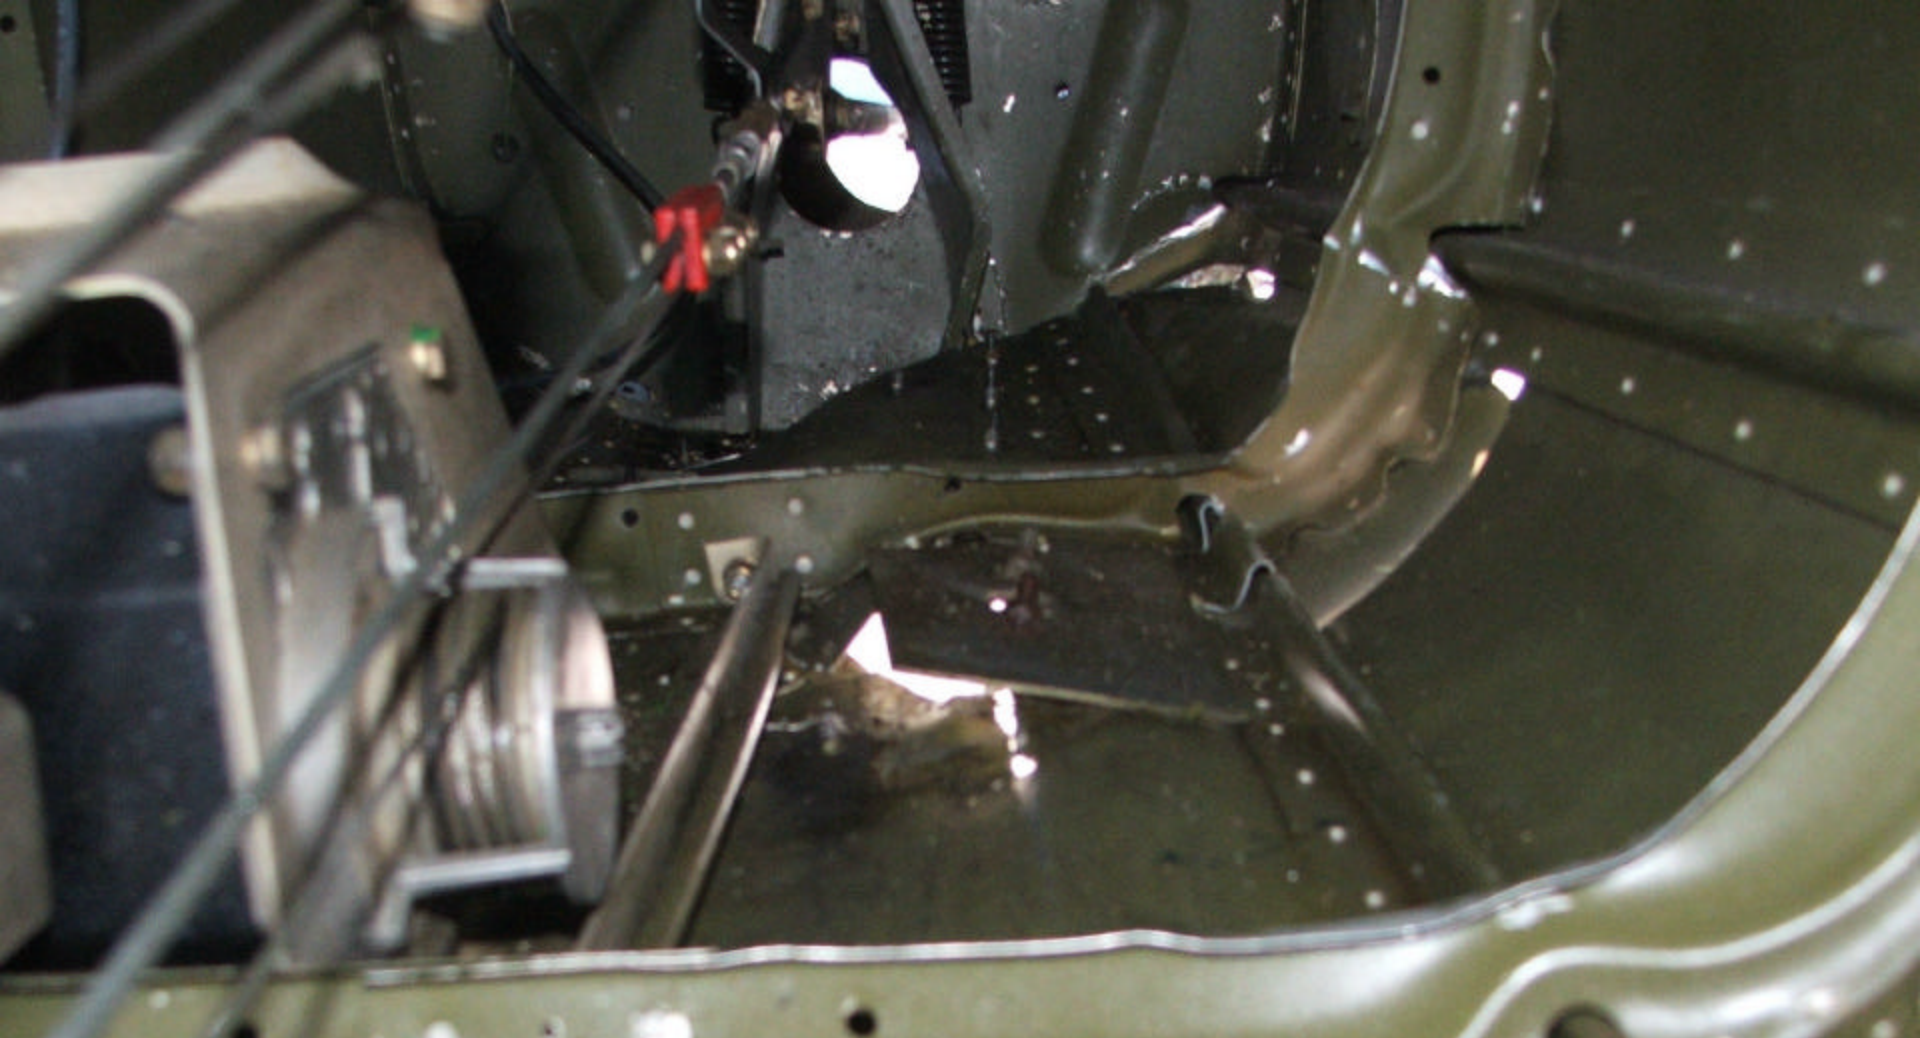
After the aircraft came to rest the pilot shut down the aircraft and inspected the aircraft for damage. The pilot is a FAA licensed Airframe and Powerplant mechanic. The pilot discussed the extent of damage to the FS employee and convinced the FS employee that they had no significant damage that would hinder flight capabilities.

Damage was limited to the left side tail section below the level of the horizontal stab. Bulkhead frames and a few stringers were damaged and bent. The exterior skin in this area was also damaged as well as the skin on the underside of the tail cone.

There was no damage to any flight controls, cables, or wing surfaces. A bracket that holds a pulley for one of the elevator cables was deformed but did not displace the alignment of the cable travel.

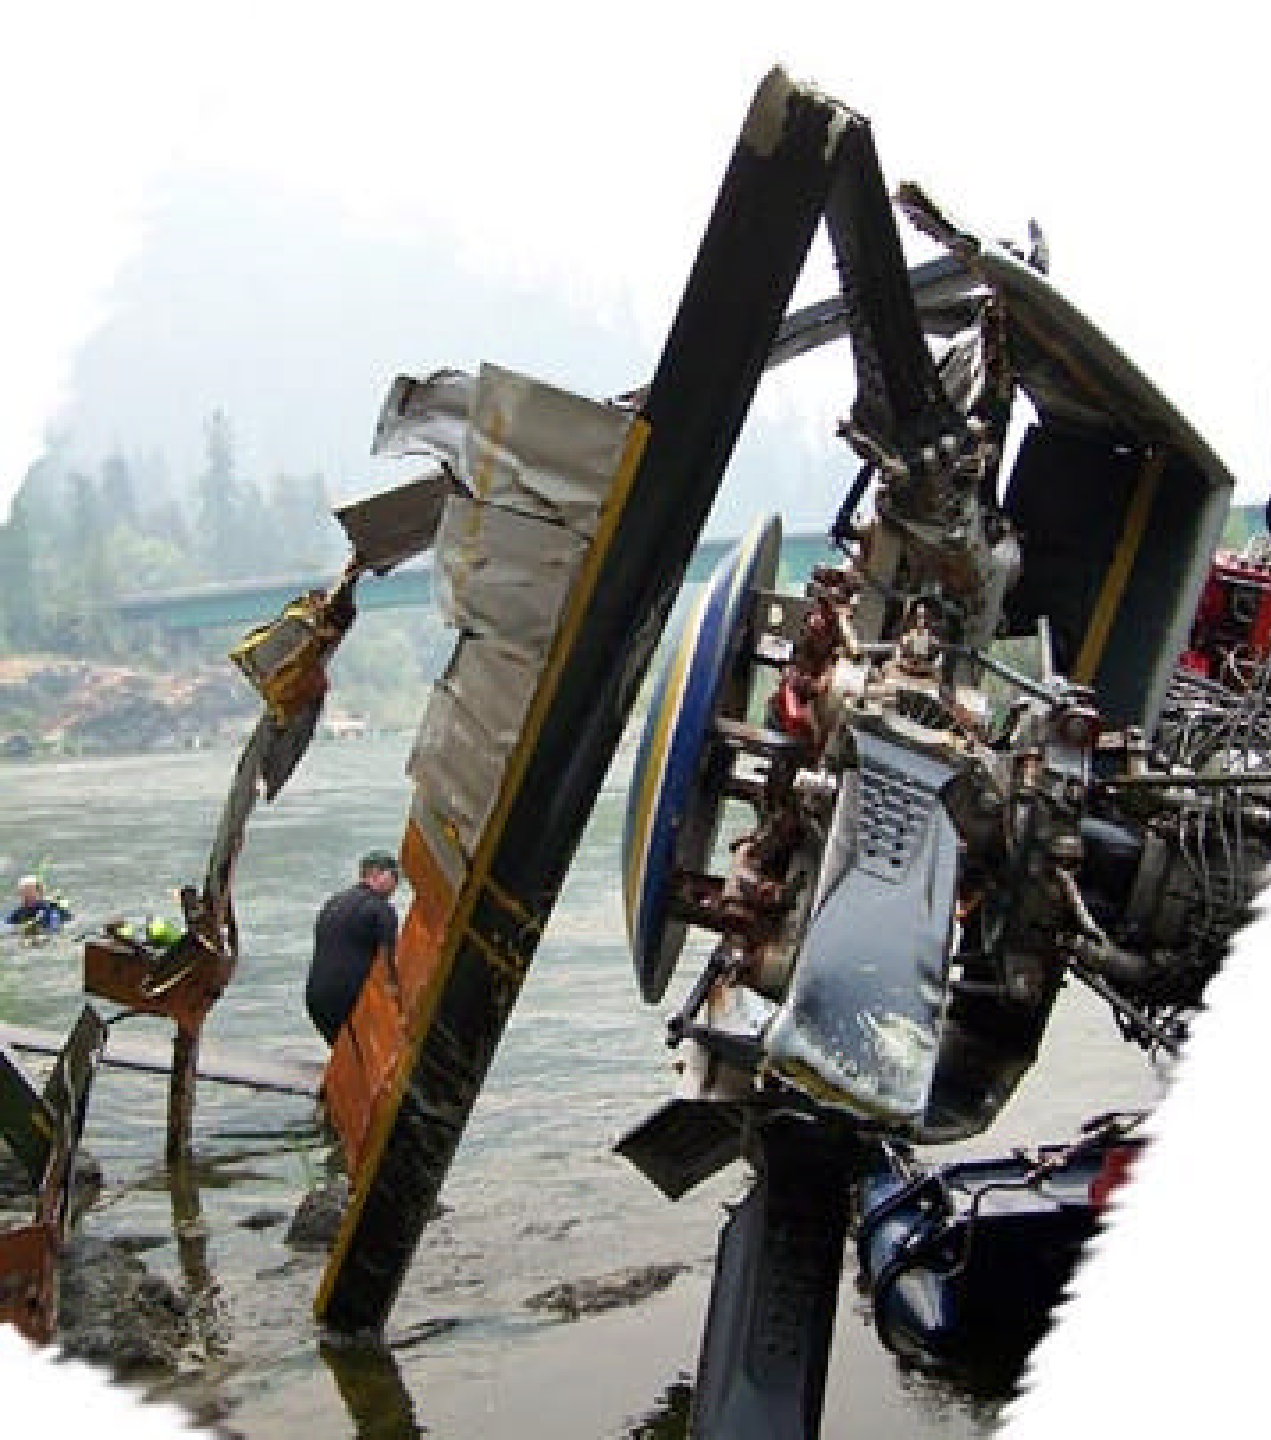
The witness observed the helicopter flying over a stone riverbed toward the Independence Bridge. He then noticed a large piece fall off the helicopter, which was later identified as the tail rotor gearbox with three of the four tail rotor blades attached to the hub.

The helicopter pitched nose low at an approximate 45-degree nose down attitude while rotating around its vertical axis. The helicopter impacted the opposite side of the river/shoreline. The witness immediately called the USFS to report the accident.

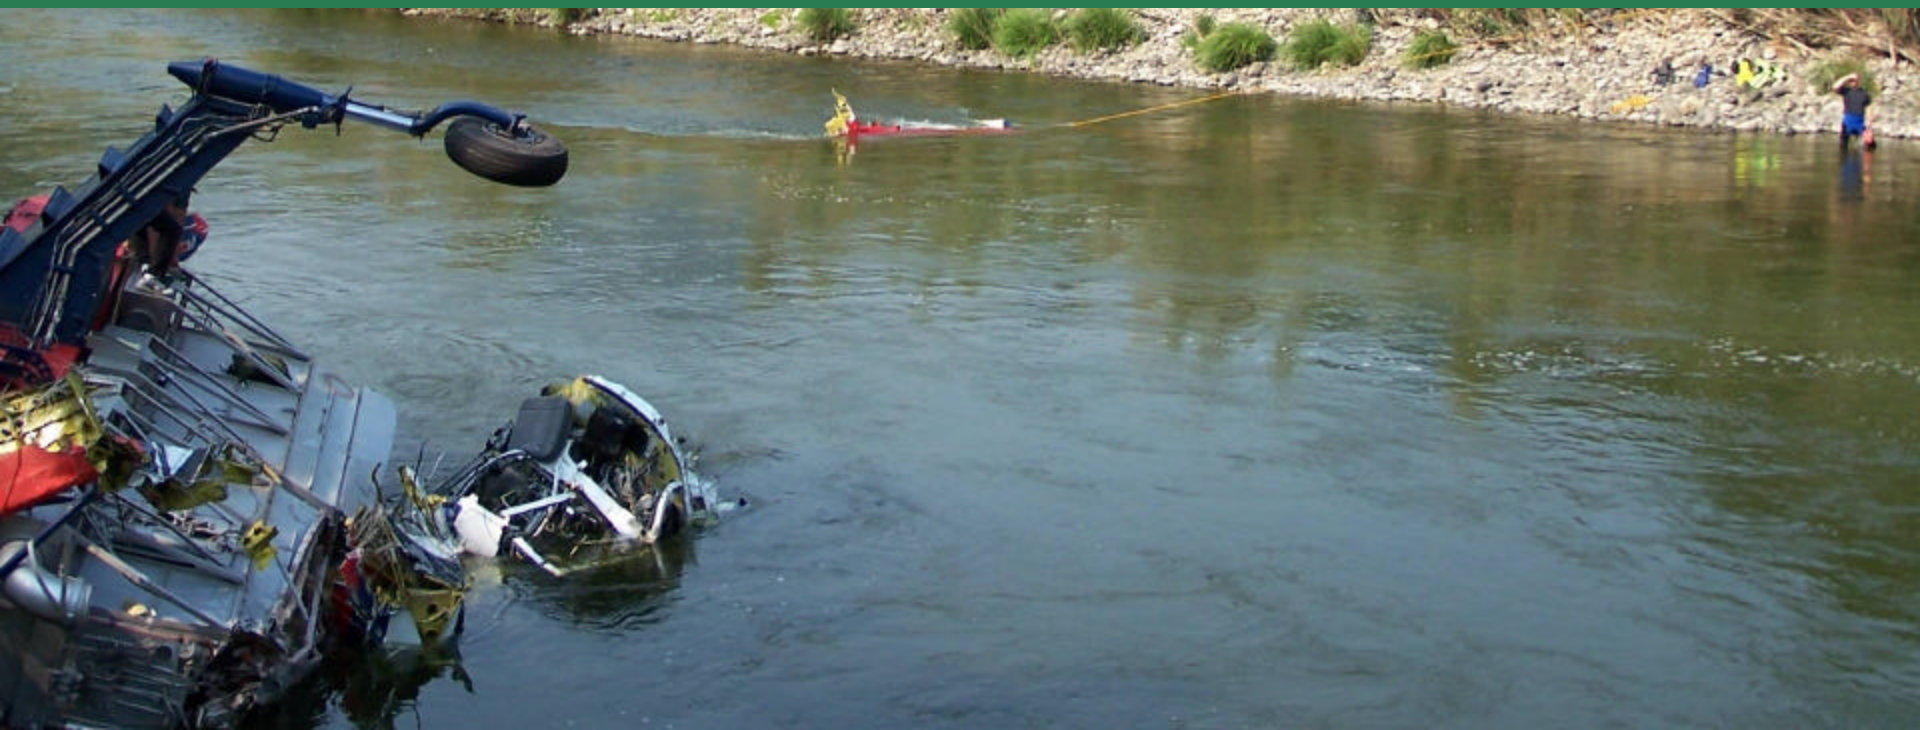
Examination of the tail rotor system revealed that the blade associated with the red collar/spindle was missing and has not been located. The spindle was fractured inboard of where the sleeve assembly would attach to the spindle. It was noted that the location of the fracture would not normally be visible in an assembled component.

The fractured spindle was removed from the tail rotor hub and shipped to the National Transportation Safety Board Materials Laboratory in Washington, D.C., for further examination.

On December 22, 2005, the tail rotor hub assembly underwent a overhaul, which included the fluorescent penetrate inspection of the spindle.

The tail rotor hub assembly accumulated about 323.6 hours following its last overhaul. The spindle was not a life limited component.

- Review the maintenance performance of this contractor.
- Review our Forest Service procedures and our ability to follow through when concerns are identified.
- Assure the Region has action plans to implement findings of systems reviews and appropriate oversight to assure compliance with action items.

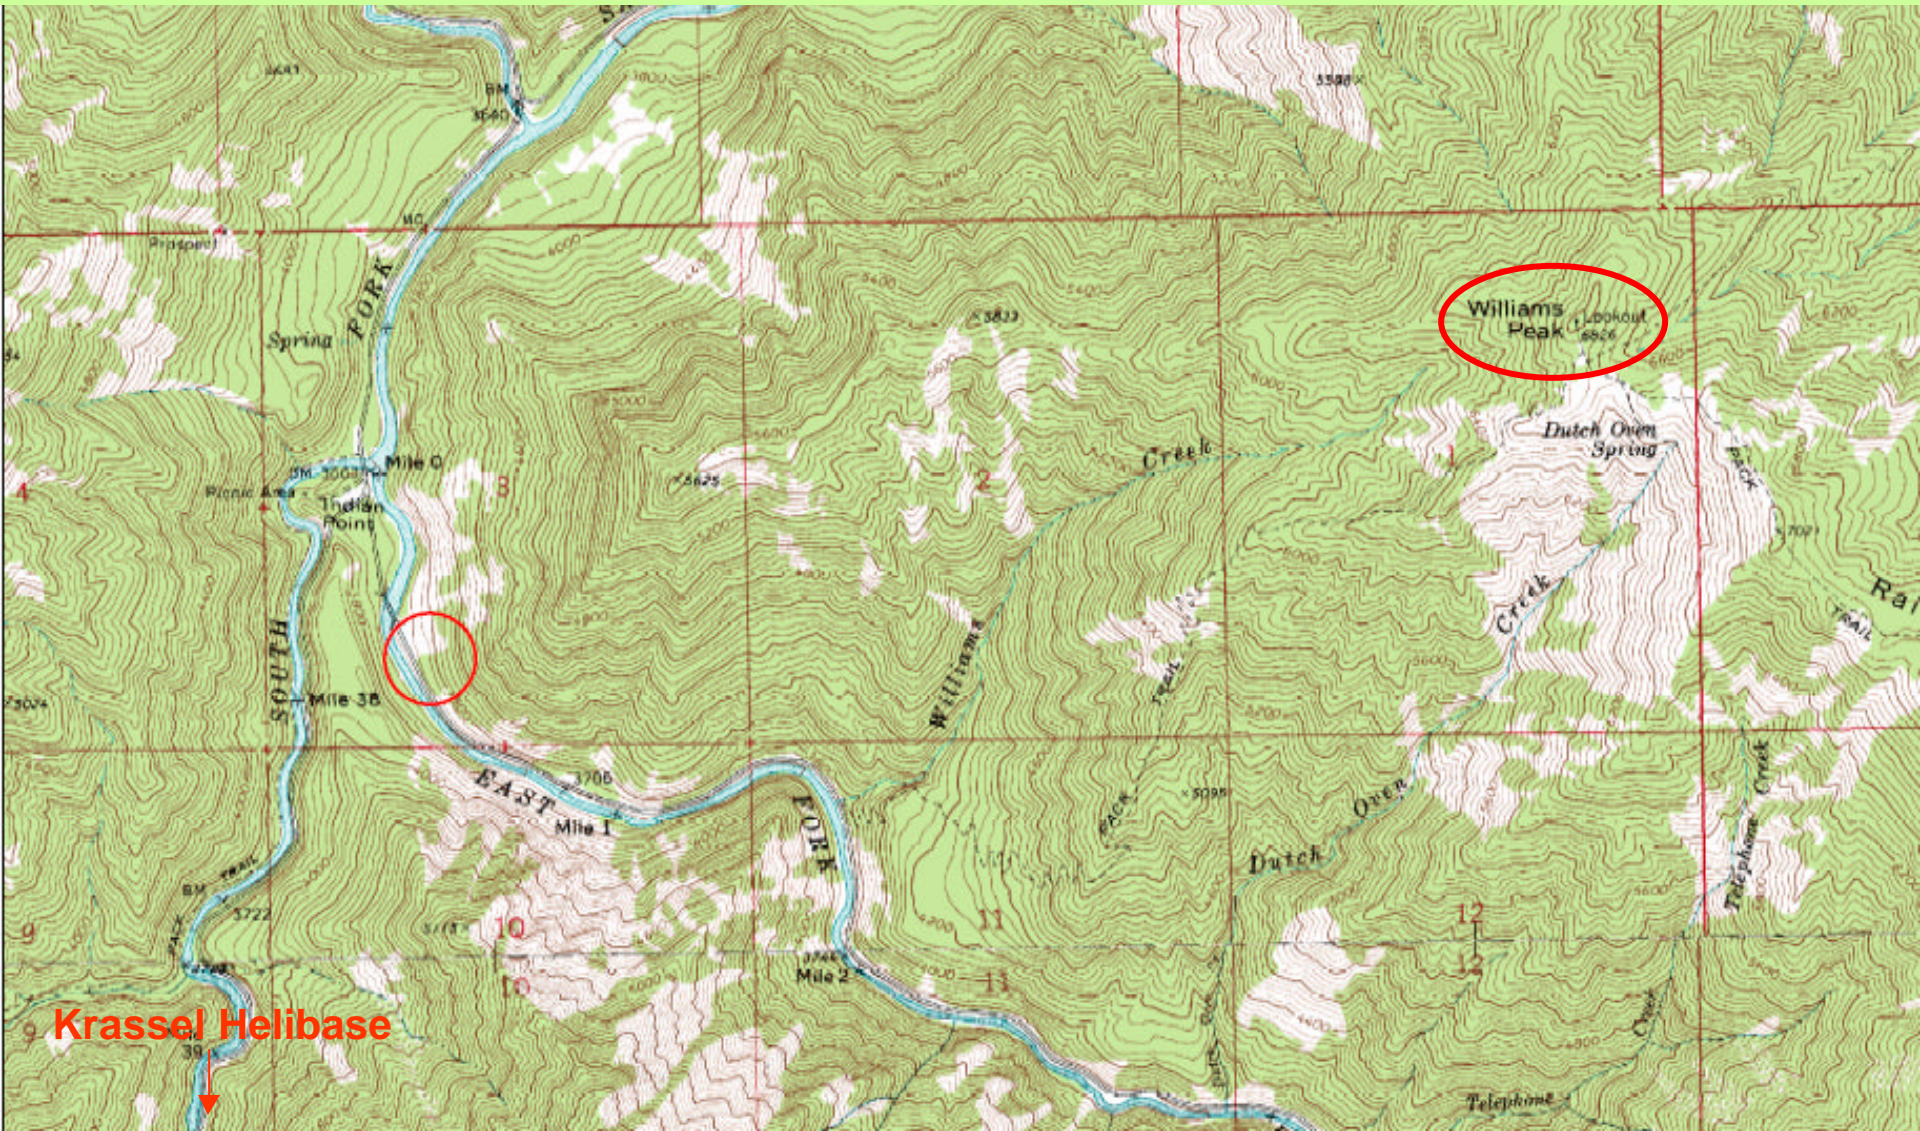
# AREA MAP

The debris included the tail-cone with its vertical and dorsal fins, the tail rotor gear box cover, one tail rotor blade, the top half of the upper wire cutter, and several five gallon potable water containers (cubies), and other miscellaneous refuse.

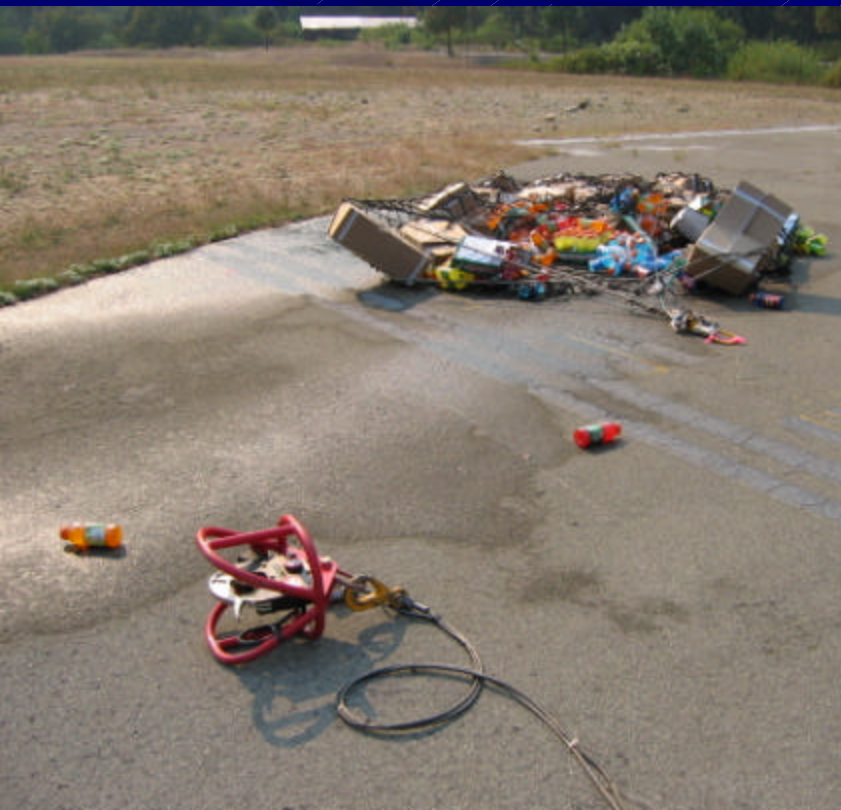
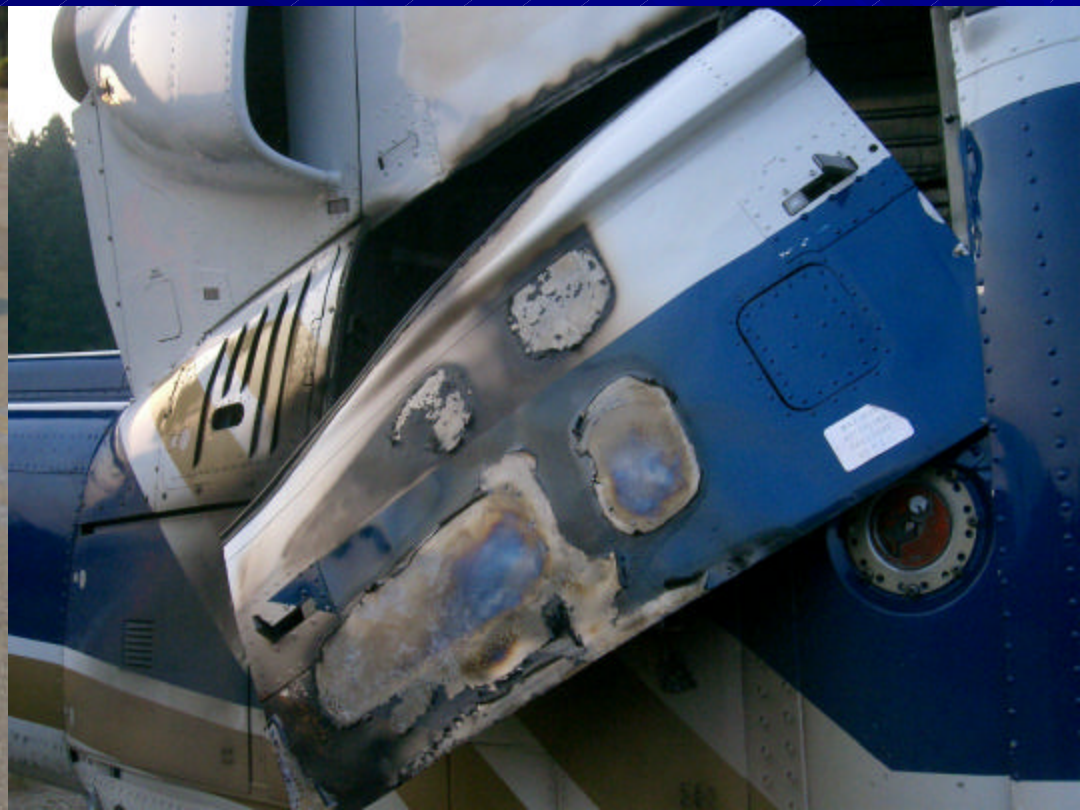
The interior of engine compartment suffered major heat damage affecting the firewall and engine compartment deck due to escaping turbine gases.

A post-landing examination of the helicopter revealed that a puncture from the inside out existed in the hot section of the right engine. The engine compartment, engine deck, firewall, cowling attachment point, and other accessories on the right side of the helicopter sustained damage.

Initial engine teardown analysis determined an internal engine component failure. The engine manufacturer, FAA and NTSB are doing further analysis and metallurgy tests.
