UNITED STATES
DEPARTMENT OF AGRICULTURE
FOREST SERVICE

FATAL AVIATION
ACCIDENT HISTORY

Compiled By: Candy S. Rock FitzPatrick

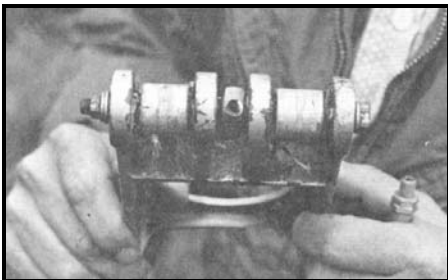
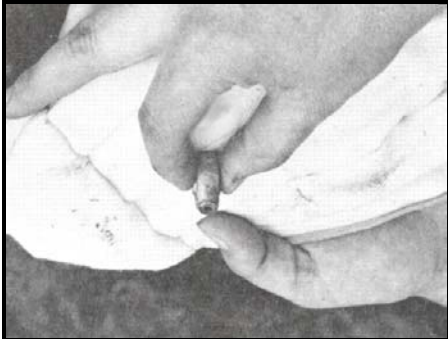
The engine, fuel control, and governor were disassembled for further investigation. There were no unusual results discovered. All systems were inspected at the mishap scene. The only apparent failure of a component, not thought to be impact related, was of the cyclic control isolation link. The rod end of this isolation link that attached to the cyclic control bell cranks, which are mounted to the transmission, appeared to have fatigue failure. This was later confirmed by microscopic examination at the NTSB laboratory. A failure of this type would have most probably resulted in loss of cyclic control.

Hiller Model 12J3 wreckage.
