Wind Turbine Lightning Protection Project

1999—2001

Brian McNiff
McNiff Light Industry
Harborside, Maine

NREL Technical Monitor: Eduard Muljadi

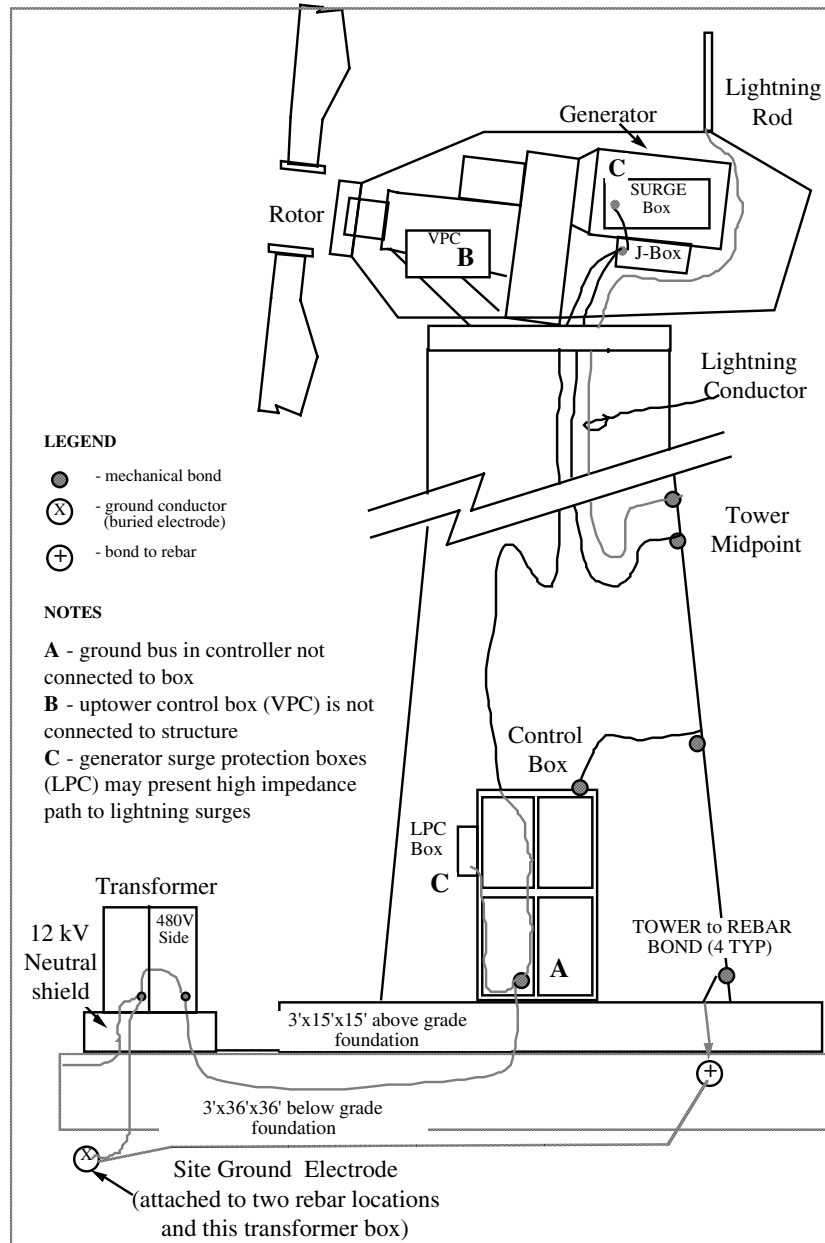
Figure 11. GMP/Zond Z-40FS grounding and bonding

6. A ground strap (2Ø bare braid) is connected between the transformer secondary case and the controller ground bus (see item 2).

7. Each turbine has a separate transformer (wye-wye, 12 kV to 480 V), and its primary is conducted with concentric neutral braids on all three conductors. These braids are terminated on a ground bus on the primary side of each transformer case. A bare conductor (2Ø bare braid) is buried in the feeder trench (direct burial in crushed granite and gravel) throughout the whole site to augment the ground. This is probably 1.2 km (4,000 ft) of buried conductor. All transformer ground buses are connected to this counterpoise by 2Ø bare braid.

4. The VPC box is not bonded to turbine frame or anywhere else. It is mounted on rubber vibration mounts that stand the box off from the gearbox by about 19 mm (0.75 in.) (see Figure 11). The ground path is assumed to be in sensor or control wires and shields to sensor housings or base controller. It is recommended that the VPC be bonded to the local frame in at least two places.

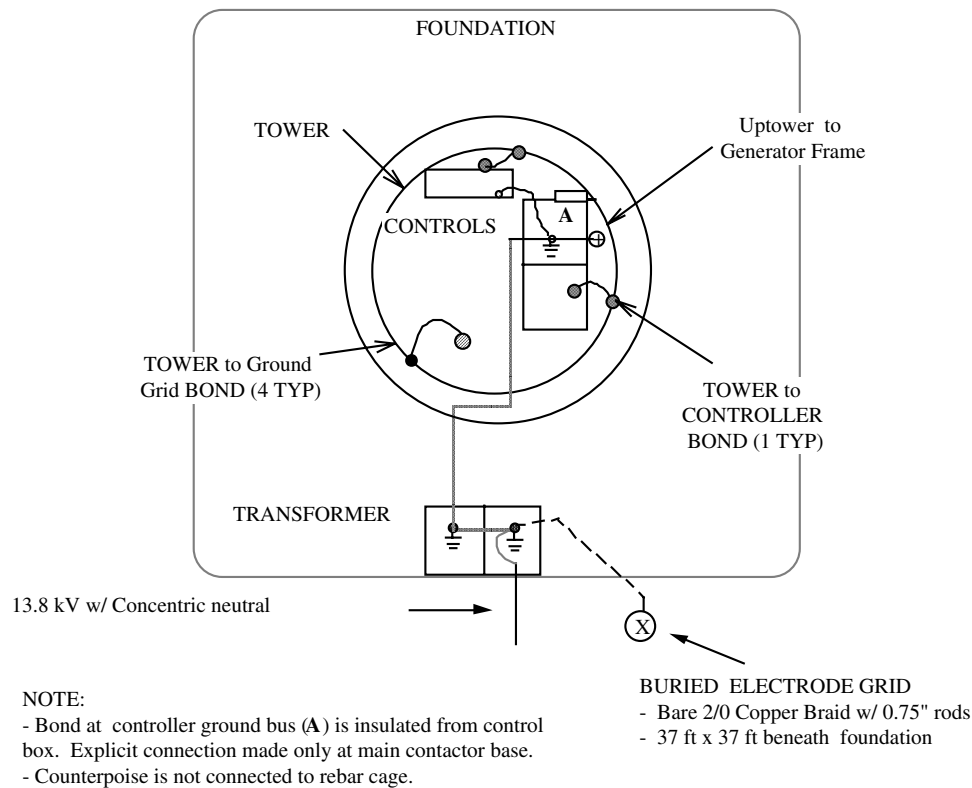
Figure 17. Algona Z-50 grounding details

The grounding system is good, but the in-turbine bonding practices were observed to be poor. Figure 18 and Figure 17 show the grounding schema. Following are observations regarding the grounding system:

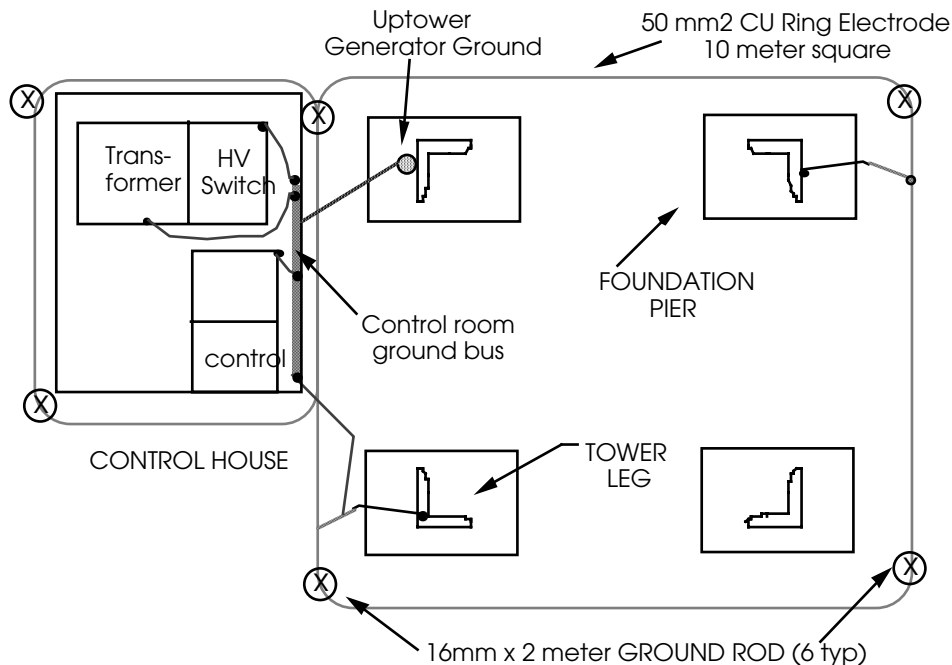
Figure 23. IVPC Vestas V44 grounding

These installations were equipped with a rather significant earth electrode (see Figure 23) to terminate and dissipate lightning strokes to the wind turbine structure. The electrode in the ground is 50 mm² (No. 1 AWG) copper installed in a pair of loops about the tower foundation and the control house buried at about 1 m (3.3 ft). It amounts to over 50 m (164 ft) of electrode with 6 ground rods (vertical electrodes) of 16 mm by 2 m (0.6 in. by 6.5 ft). The primary high-voltage conductors are buried in a trench with a bare conductor that connects the adjacent grounding electrodes.
