GAO

OVERSEAS PRESENCE

Conditions of Overseas
Diplomatic Facilities

Statement of Jess T. Ford
Director, International Affairs and Trade

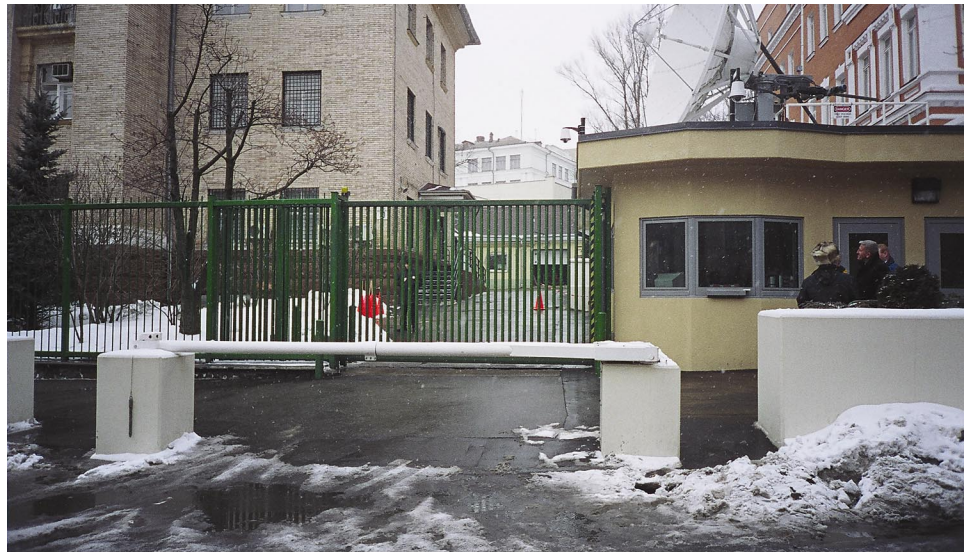
Figure 10: Newly Upgraded Compound Access Control Booth

We also found that 108 posts either lack or have inadequate compound access control, a system of gates, barriers, and guard booths that is used to pre-screen personnel and vehicles before entering the embassy grounds. At one embassy we visited, visa applicants could gain access to the embassy building prior to undergoing proper screening, which would be a serious concern in the case of a terrorist action. Figure 9 depicts an inadequate compound access control booth, which is located within the embassy compound. The Security Officer acknowledged that this was a serious weakness and that visitors were not screened adequately before entering the embassy building. Construction of a new compound access control system is scheduled to begin in May 2003. Figure 10 depicts a
