Research
Paper
FPL-RP-560

Field Performance of Timber Bridges

12. Christian Hollow Stress-Laminated Box-Beam Bridge

January 1998

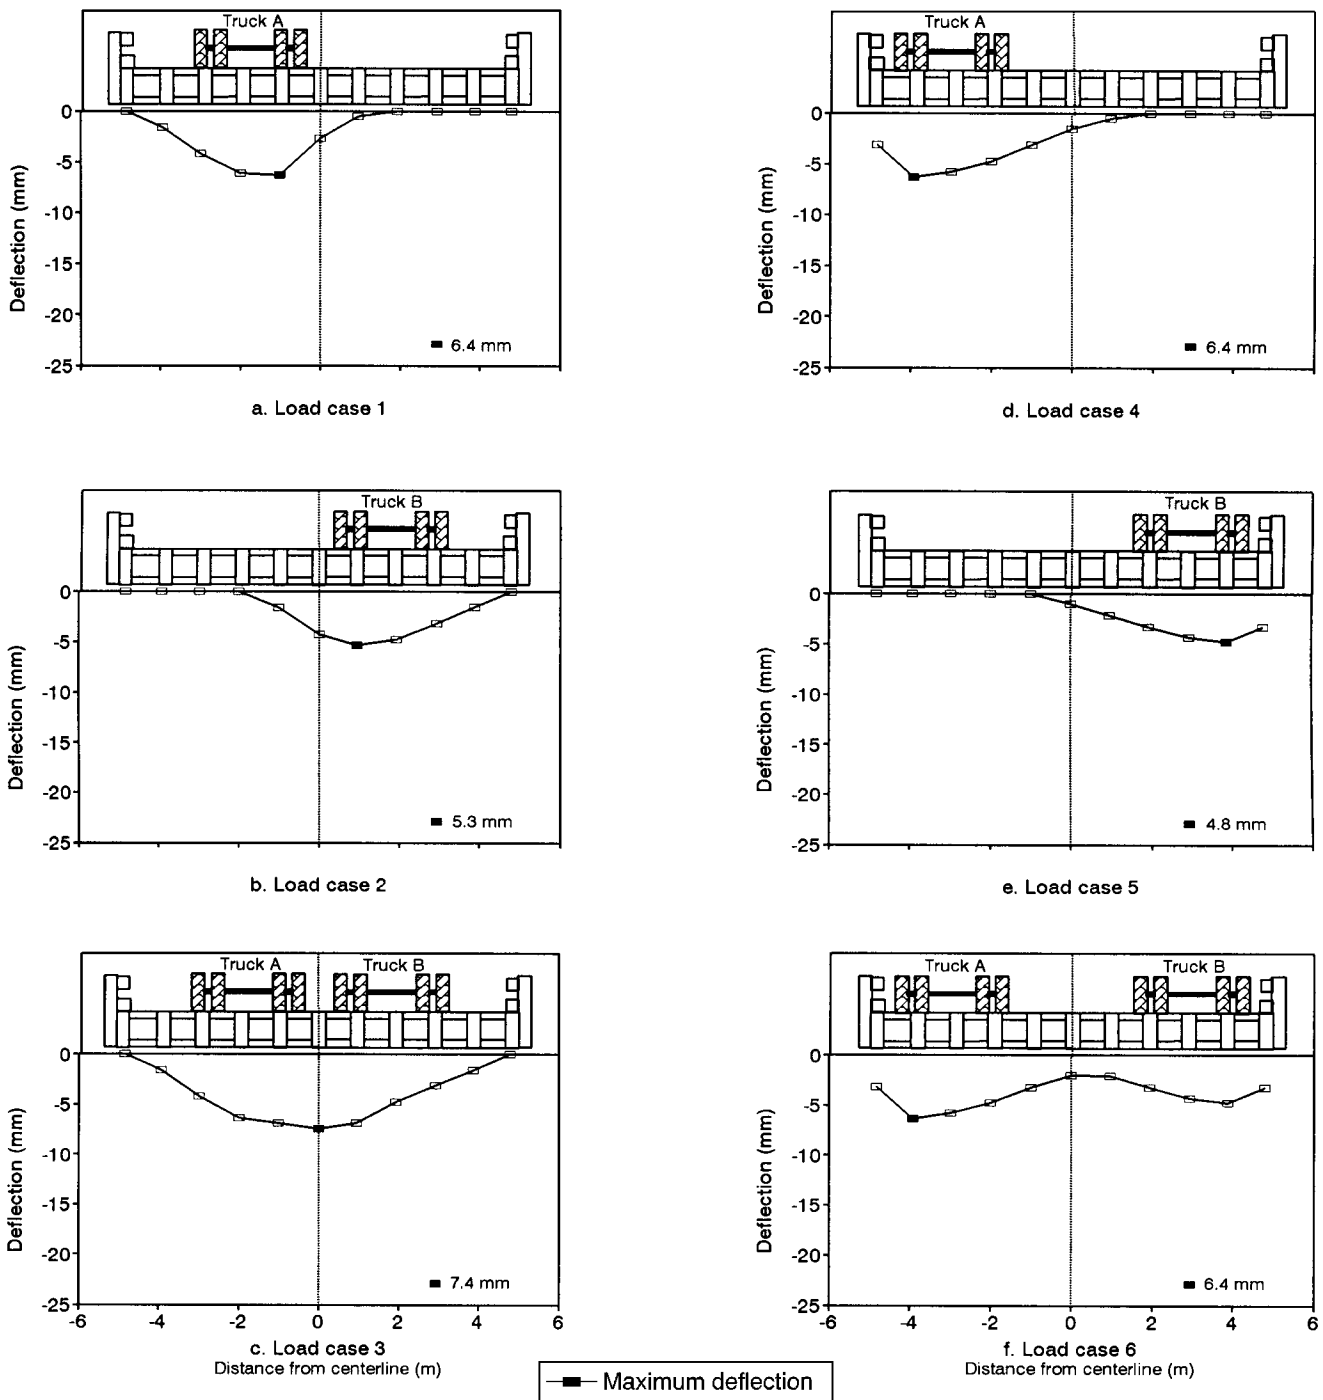
Figure 15—Load test 1 transverse deflection measured at the centerspan of the bridge (looking east). Cross sections of the bridge and vehicle positions are shown to aid interpretation and are not to scale.

Transverse deflection for load test 1 is presented in Figure 15. The maximum deflections for load cases 1 and 2

occurred under the inside truck wheel line and measured 6.4 and 5.3 mm (0.25 and 0.21 in.), respectively (Fig. 15a,b). For load case 3, the maximum measured deflection of 7.4 mm (0.29 in.) was at the roadway centerline and was the largest measured deflection of all load cases (Fig. 15c). Maximum deflections for load cases 4 and 5 measured 6.4 and 4.8 mm (0.25 and 0.19 in.), respectively, and occurred near the outside truck wheel line (Fig. 15d,e). The maximum deflection for load case 6 measured 6.4 mm (0.25 in.) and was under the outside wheel line of truck A (Fig. 15f). For both the centered and eccentric load cases, the deflected shape of the cross section of the centerspan follows the symmetrical truck positions, with maximum measured deflections for the single truck load cases occurring at the same relative positions for the two truck locations.

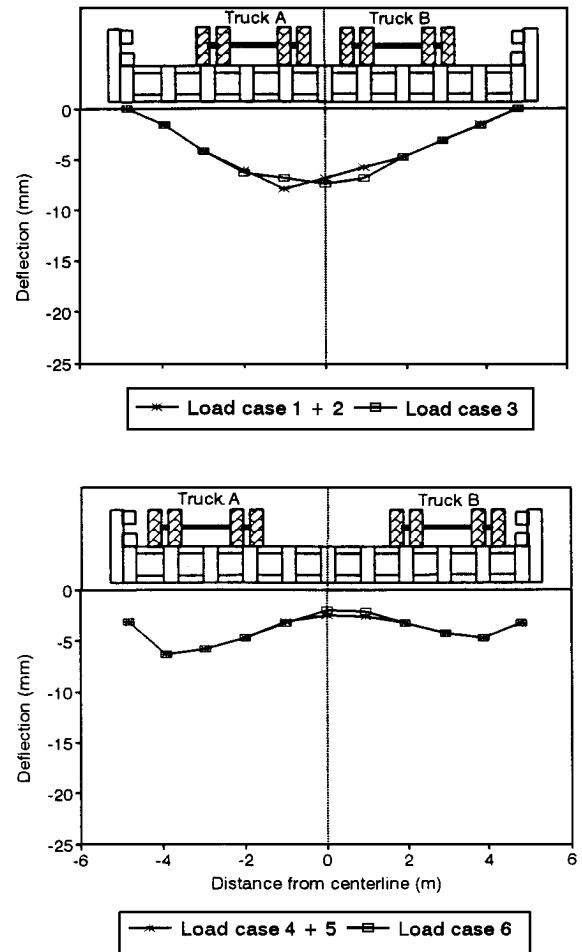
Assuming accurate load test results and linear-elastic behavior, the sum of the deflection resulting from individual truck loads should equal the deflection from both trucks applied simultaneously. Figure 16 shows the load test 1 comparison between individual and simultaneous truck loading. As shown in Figure 16, the two plots are nearly identical with only minor variations, which are within the accuracy of the measurements. From this information, it can be concluded that bridge behavior was within the linear-elastic range.

Figure 16—Load test 1 comparisons (looking east): (top) the sum of the measured deflections from load cases 1 and 2 to the measured deflections for load case 3; (bottom) the sum of the measured deflections from load cases 4 and 5 to the measured deflections for load case 6.

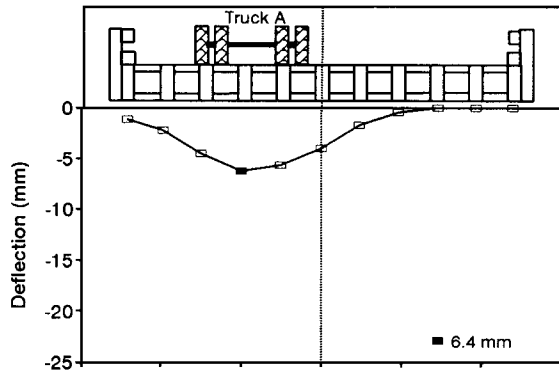
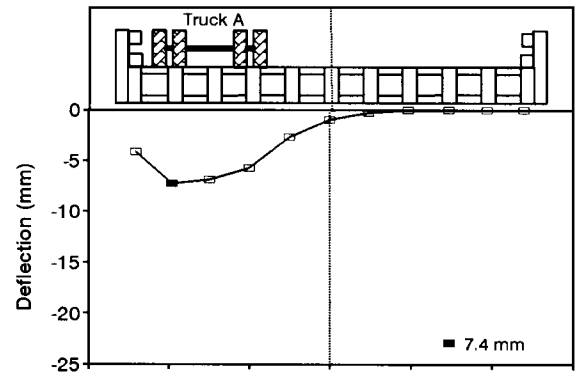
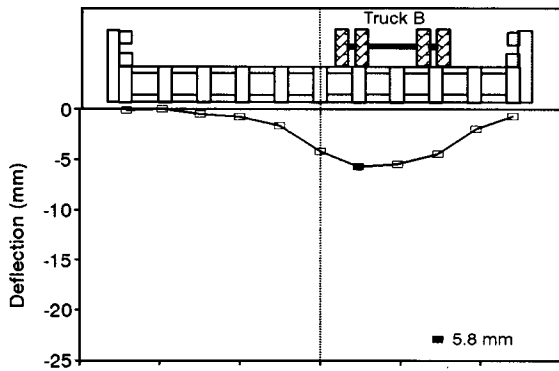
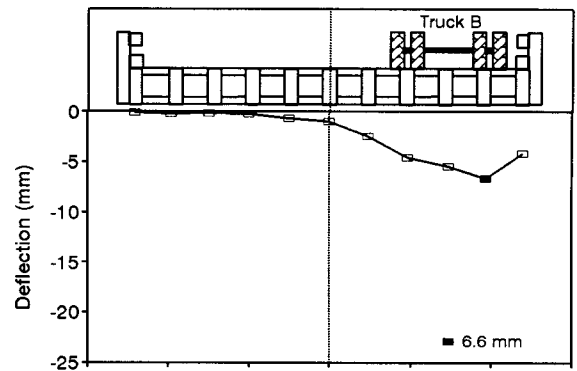
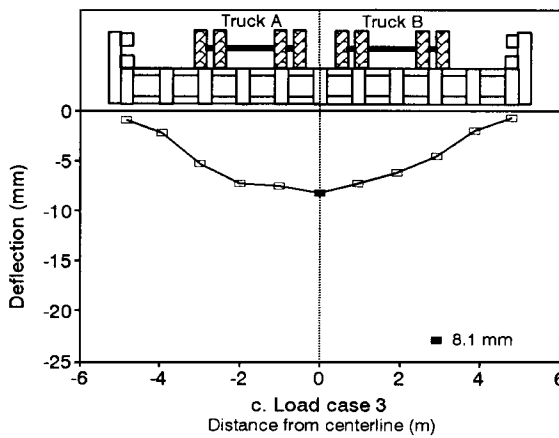
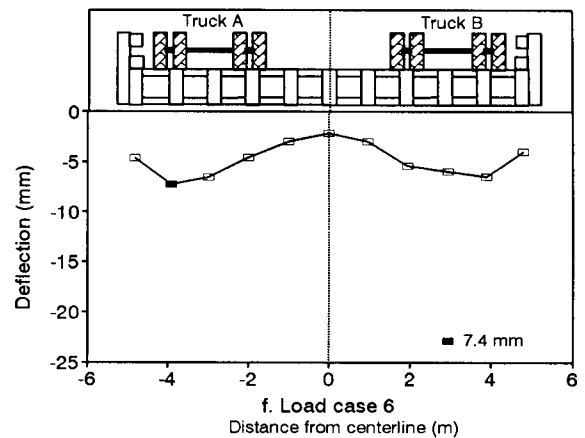
Transverse deflection for load test 2 is presented in Figure 17. The maximum deflection of 6.4 mm (0.25 in.) for load case 1 occurred near the outside wheel line (Fig. 17a), and the maximum deflection of 5.8 mm (0.23 in.) for load case 2 occurred near the inside truck wheel line (Fig. 17b). For load case 3, the maximum deflection of 8.1 mm (0.32 in.) was measured at the roadway centerline and was again the largest deflection for all load cases (Fig. 17c). Maximum deflections for load cases 4 and 5 occurred near the outside truck wheel line and measured 7.4 and 6.6 mm (0.29 and 0.26 in.), respectively (Fig. 17d,e). The maximum deflection for load case 6 measured 7.4 mm (0.29 in.) and was near the outside wheel line of truck A (Fig. 17f).

Figure 17—Load test 2 transverse deflection measured at the bridge centerspan (looking east). Cross sections of the bridge and vehicle positions are shown to aid interpretation and are not to scale.

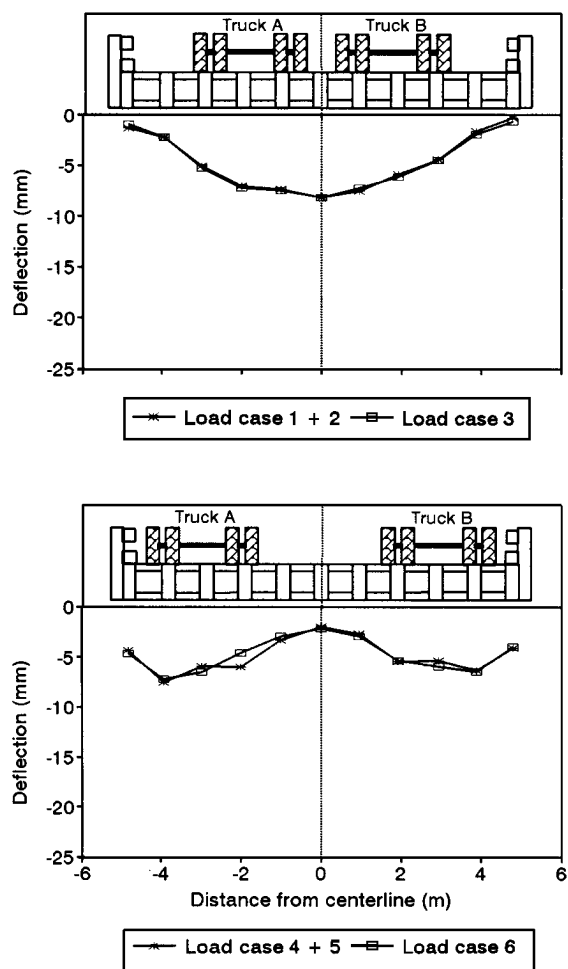
Figure 18 shows the load test 2 comparison between individual and simultaneous truck loading. As with load test 1, the two plots are nearly identical, indicating that bridge behavior was within the linear-elastic range.

Figure 18—Load test 2 comparisons (looking east): (top) the sum of the measured deflections from load cases 1 and 2 to the measured deflections for load case 3; (bottom); the sum of the measured deflections from load cases 4 and 5 to the measured deflections for load case 6.

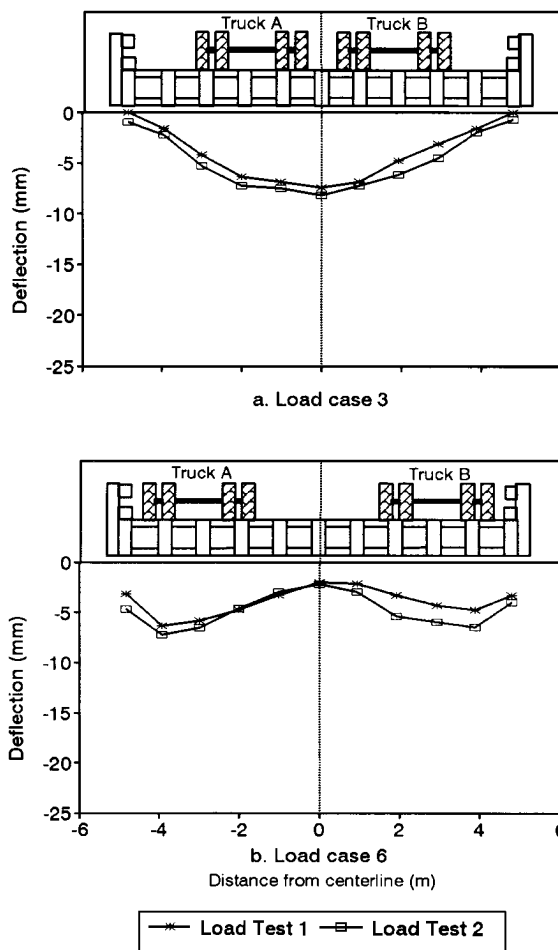
A comparison of measured deflections for both load tests is presented in Figure 19 for load cases 3 and 6. The plots are similar in shape, but load test 2 deflections are greater at numerous data point locations. Different load testing conditions may have caused greater deflections for load test 2, especially the differences in truck loads and interlaminar compression. Load test 2 trucks were approximately 5 percent heavier than those for load test 1, which would tend to cause slightly greater deflections for load test 2. In addition, interlaminar compression was 207 kPa (30 lb/in²) less at load test 2 than at load test 1. A lower interlaminar compression of this magnitude has been shown to result in greater relative deflections. The combined effect of these different

load test conditions resulted in the greater deflections observed in load test 2.

Figure 19—Comparison of measured deflections for load tests 1 and 2 (looking east).
