Frank Preusser & Associates, Inc.

Deterioration and Preservation of Porous Stone Royal Presidio Chapel, Monterey, California

Final Report to NPS/NCPTT

February 1996

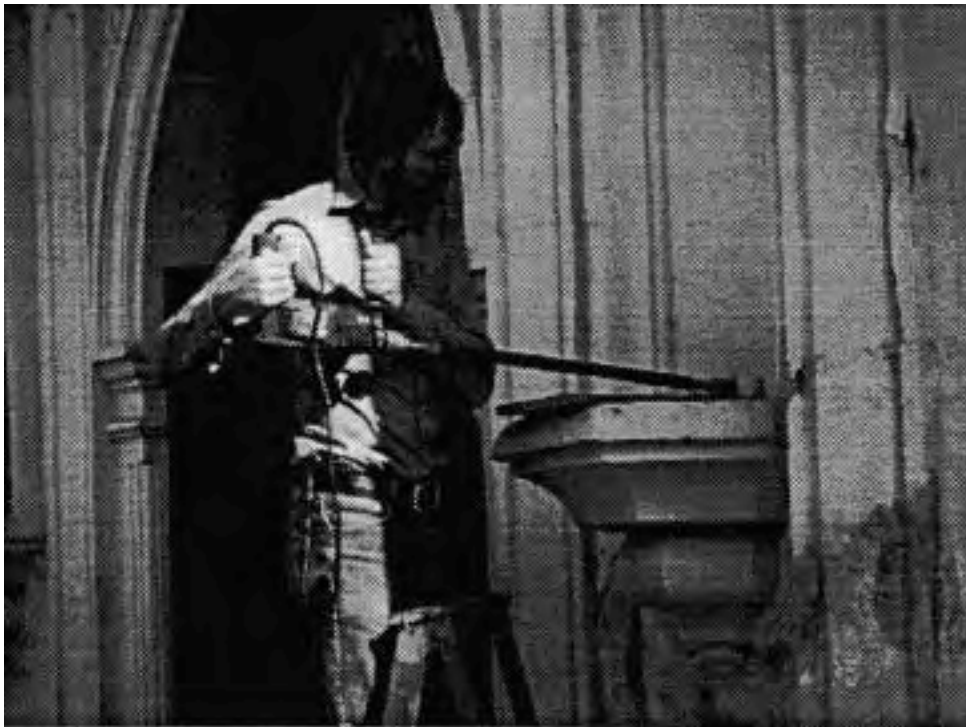
Figure 7: Drill Coring

On May 18, 1995, a 1¹/₄" drill core was taken for additional analyses.

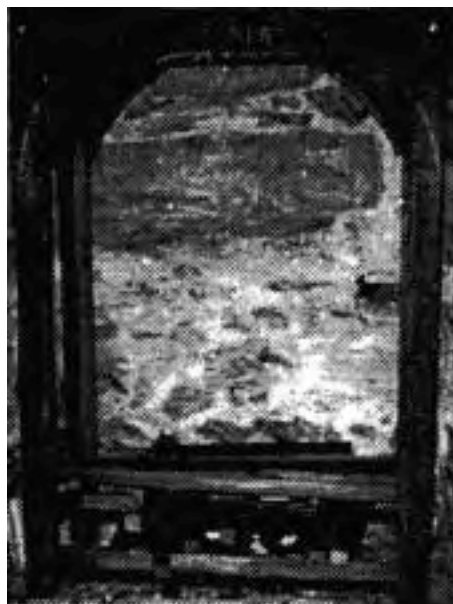
Figure 8: View of the Wall Construction behind The Facade From the Interior
Stone Rubble and Lime Mortar

The facade pointing mortar and the mortar removed from deep within the wall by core drilling are similar in grainsize distribution to each other and different from two other samples, including a sample removed from the attic (see below). They possess weight fractions of sand which increase linearly up to and beyond the coarsest screen mesh used (0.85 mm). They possess a high lime content which is slightly overestimated due to the inclusion of coarse beach sand which includes detrital shell fragments. A few grains of material which are thought to be bone fragments were also noted.

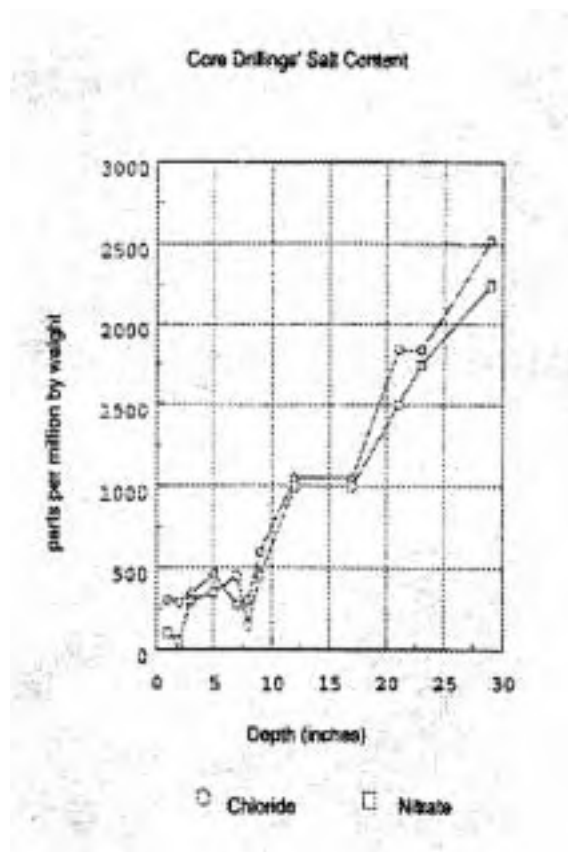
Chloride and nitrate concentrations increased inside the stone in a linear relationship with the depth of the sample (see figure 9).

Figure 9: Chloride and Nitrate Concentrations vs. Depth, from Twilley (1996)

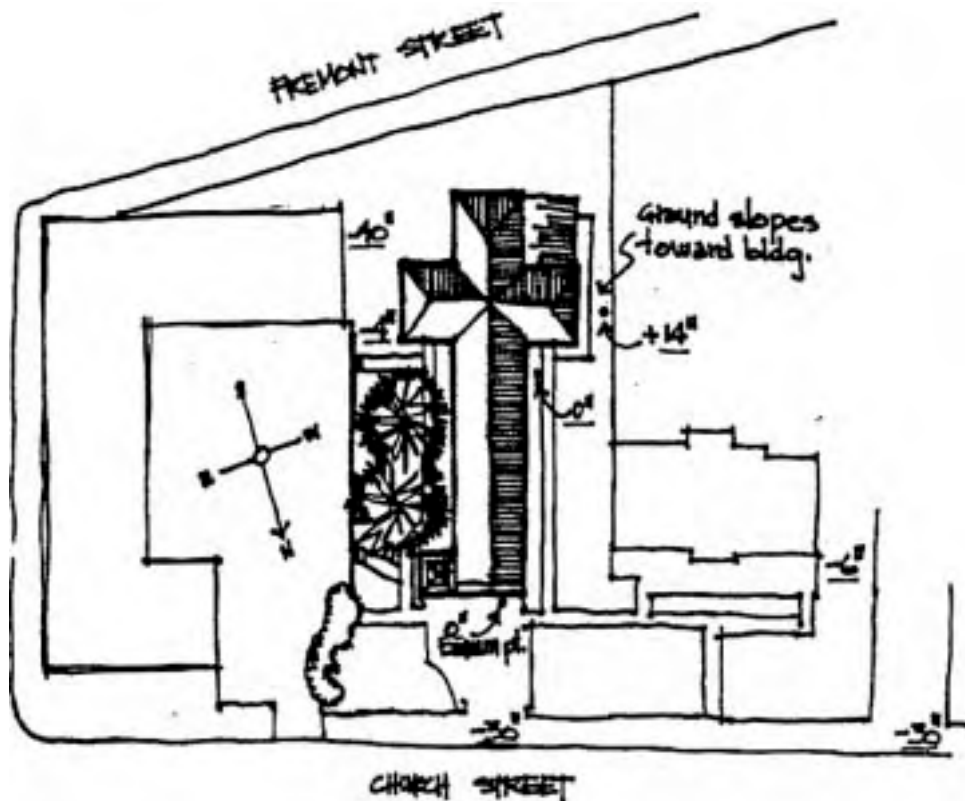
The ground falls away rather dramatically to the south and southeast, and more gradually to the north, the east and the northwest. The only exception is west of the west transept where there is a negative slope toward the building from the school (see figure 10)

Figure 10: Sketch site plan. The numbers are the distances in inches above or below the data point at the front door sill. From Crosby (1995)

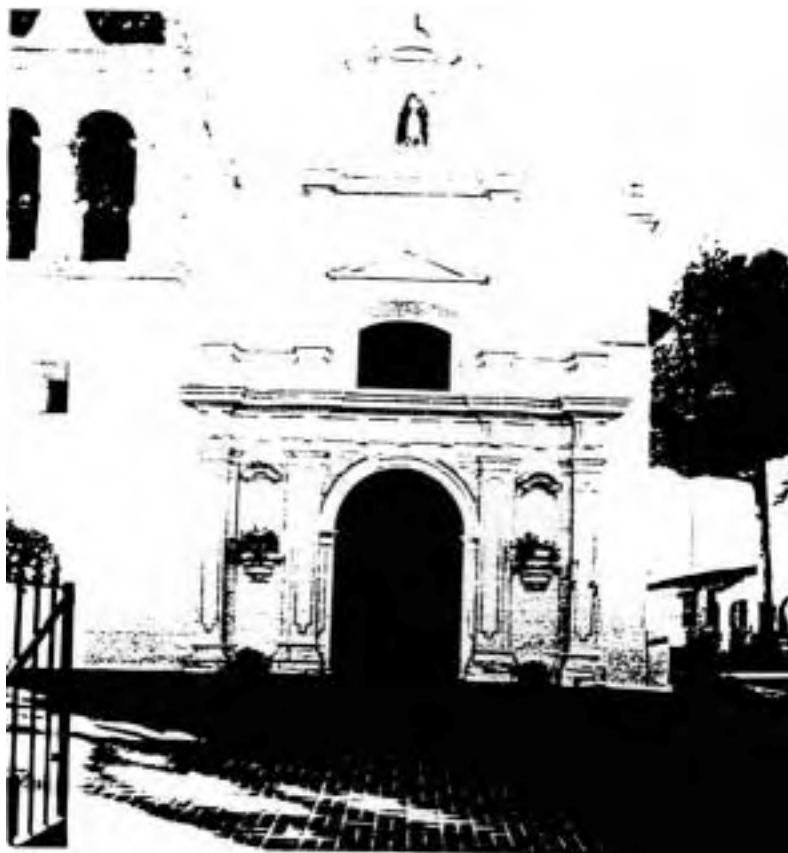
Figure 2: View of the front facade of the Chapel. The well executed architectural sculpture is one of the most outstanding features of the structure.

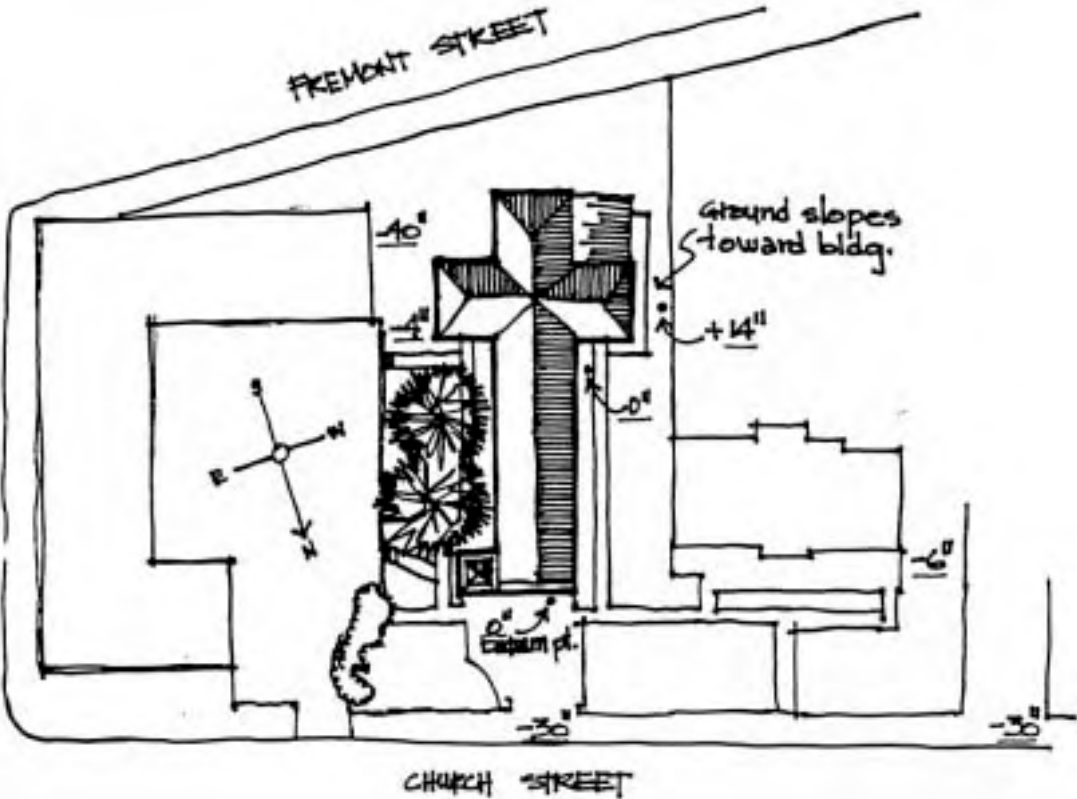
Figure 3 is a reproduction of the site plan developed in 1934 by the Historic American Building Survey. The immediate site is bounded on the north by Church Street, on the south by Fremont street, on the east by Cortez Street and on the west by a drive from Church Street on the west side of the Parish House. The ground falls away rather dramatically to the south and southeast, and more gradually to the north, the east and the northwest. The only exception is west of the west transept where there is a negative slope toward the building from the school. The chapel is surrounded

Figure 3: Sketch site plan based on the 1943 HABS drawings. The red numbers are the distances in inches above or below a data point at the front door sill.

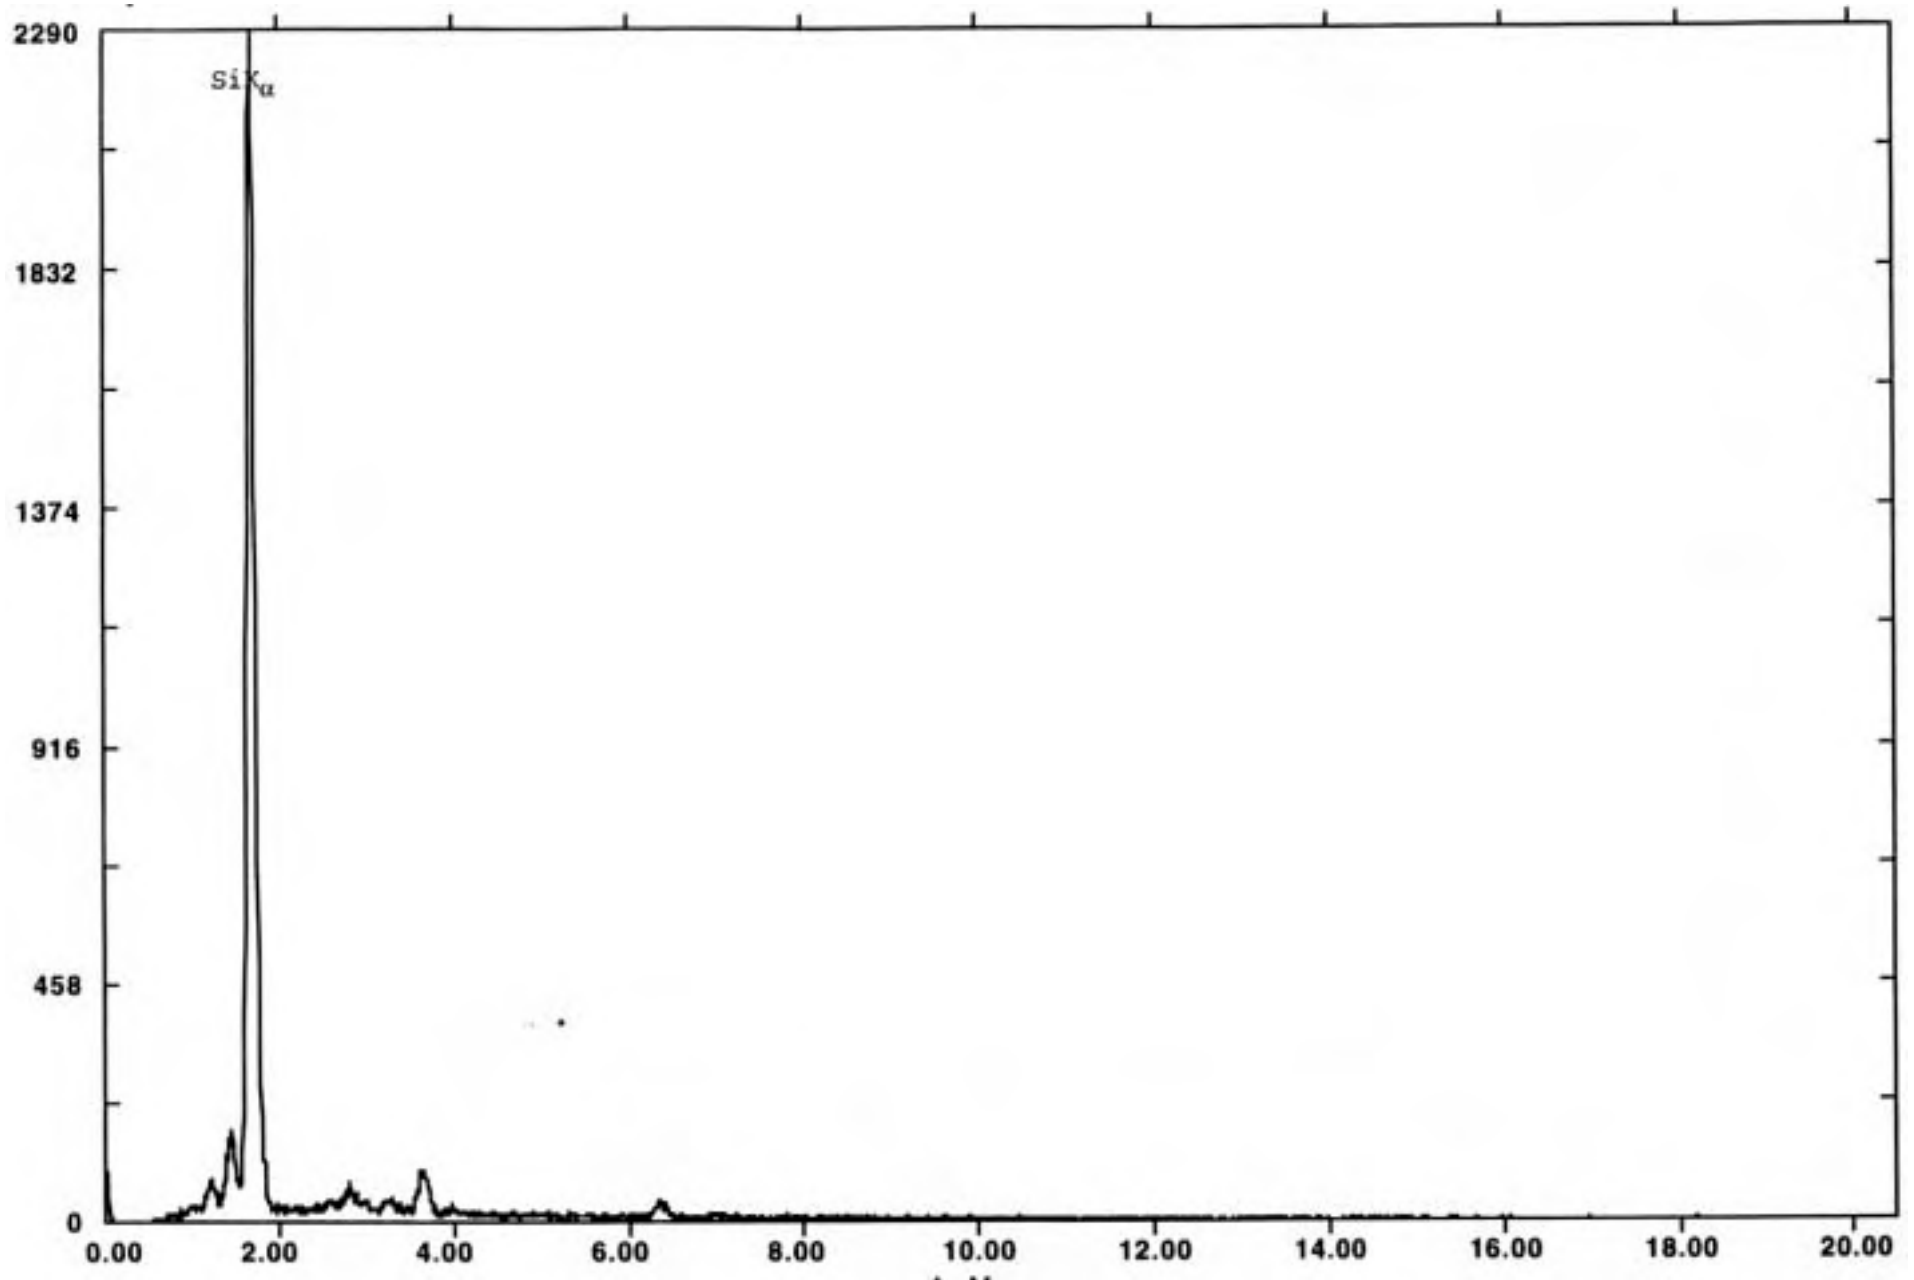
Clast cavity wall, #17
